**Fall 2001 Trip Reports Summary:**

**Archaeological Site Monitoring and Management, and Colorado River Fund  
Activities Along the Colorado River in Grand Canyon National Park.**

Jennifer L. Kunde

RCMP Report No. 69  
Flagstaff, Arizona

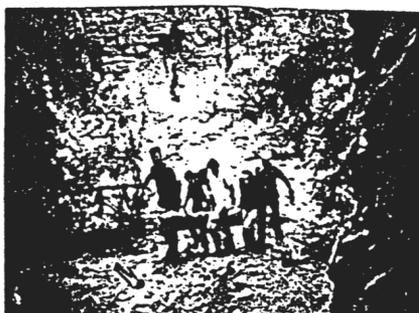
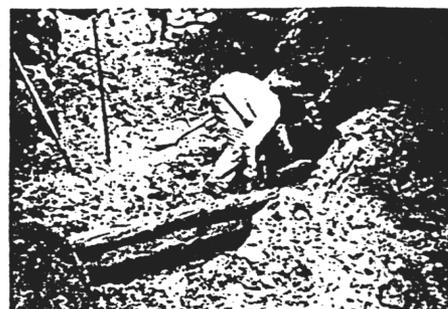
These images show the repair that was done to the trail that ascends to the shelf where the archaeology sites are located. Several large logs were transported from the river and placed as checks to hinder erosion that may occur from rainwater runoff.

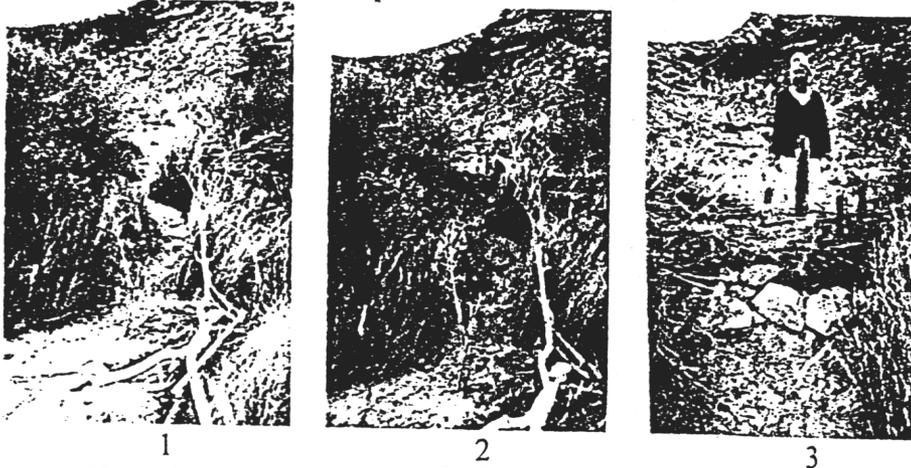
These images show the construction of the Zuni dam check.

Lisa Leap led a group of three that monitored the multiple trailing that has funneled visitors through the arch. sites on the alluvial shelf. After discussion it was agreed that previous attempts to direct hikers through the wash had been unsuccessful and that a new trail, well defined and circumnavigating the most sensitive sites may be more effective. This was done. In the afternoon, this same contingent built a Zuni dam check to stop traffic at one trail in the center of camp.

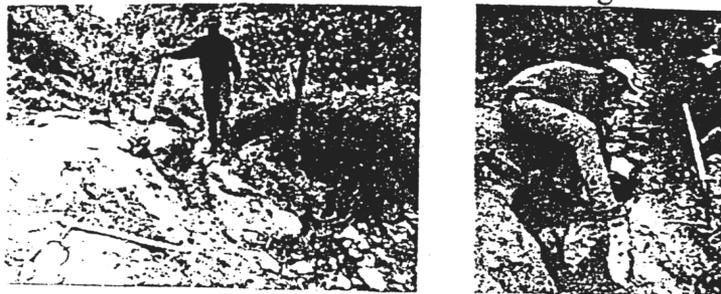
The trip broke into three groups, two being trails projects and one being revegetation. Five people led by Bryan Edwards hiked up Saddle Canyon to reestablish the parts of the trail that had been destroyed by last summers flood. All together they built 16 rock checks at 8 different creek crossings, 6 eight-step stairways and numerous single rock checks. These two images show the repair at one of the crossings.

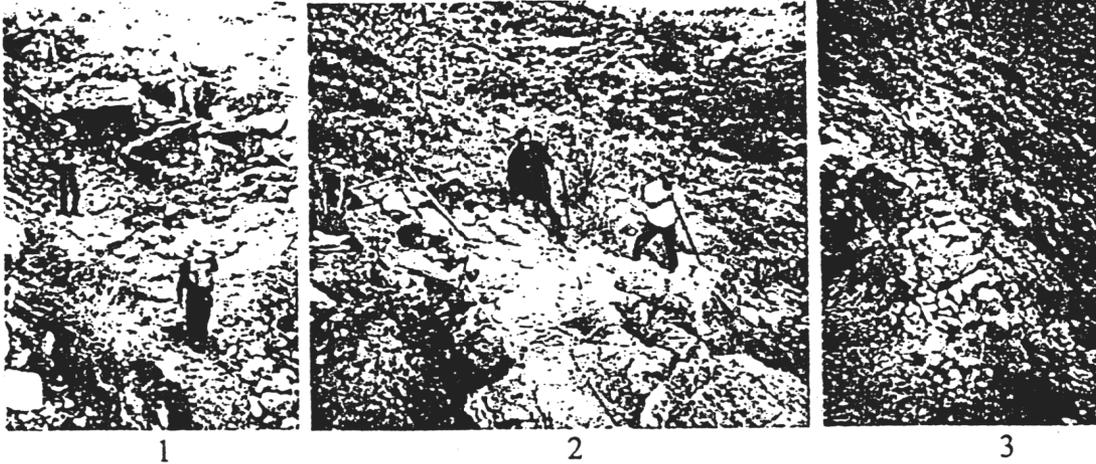
These images show the area to be repaired, the pulley system in use, and the final product.

Bill Allen led a group of six on a large project that was located at the first steep slope that begins the trail to the inner canyon. A pulley was anchored to a large boulder which held the safety line that was used to control the path of several 600 lb boulders dragged up the side of the hill. This was the first time that such a device was used on a resource trip, so extreme caution was used. It turned out to be an excellent safety item.

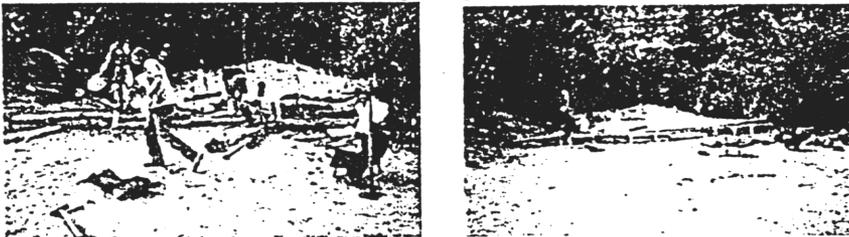
These two images show the retaining wall during and after construction.

After camp was set up, Lisa went to monitor the granaries, the two Rachels went to monitor any multiple trailing to do the next day, and the remainder of the group built a 1 1/2' high retaining wall from logs brought to camp. Recent floods have been washing sand into the river that was deposited higher than the level of the controlled river flood of 45,000 cfs. This means that it is doubtful that any sand will be deposited at this level any time soon, and an effort to keep it up high is worthwhile.
