**1993 Summary Report:
Monitoring of Archaeological
Sites Along the Colorado River
Corridor in Grand Canyon National Park
(Cooperative Work Order 8005-8-002)**

NPS Project Archaeologists
Christopher Coder
Lisa Leap

July 1994

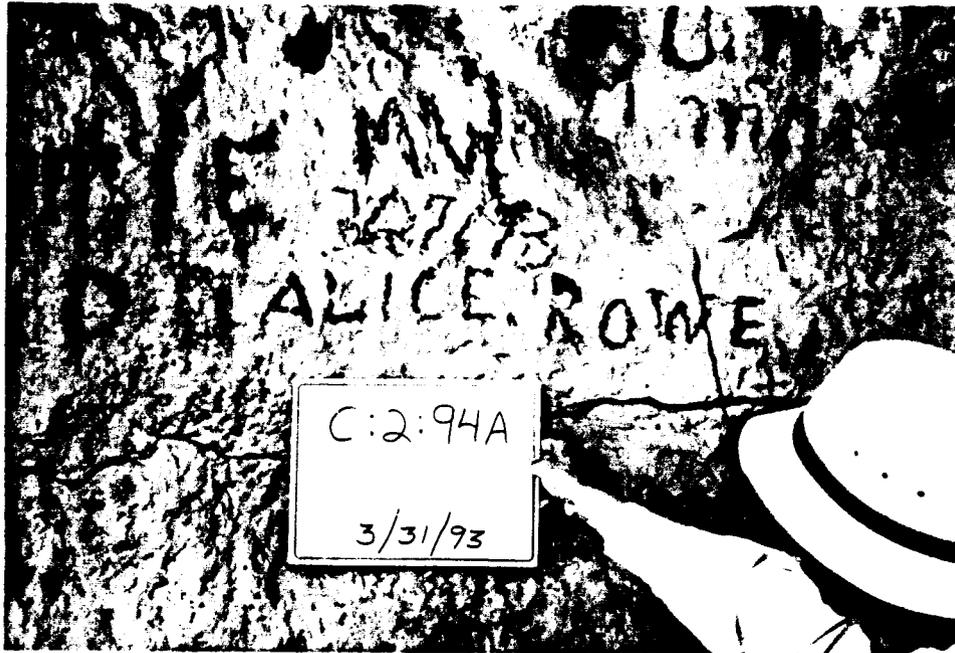
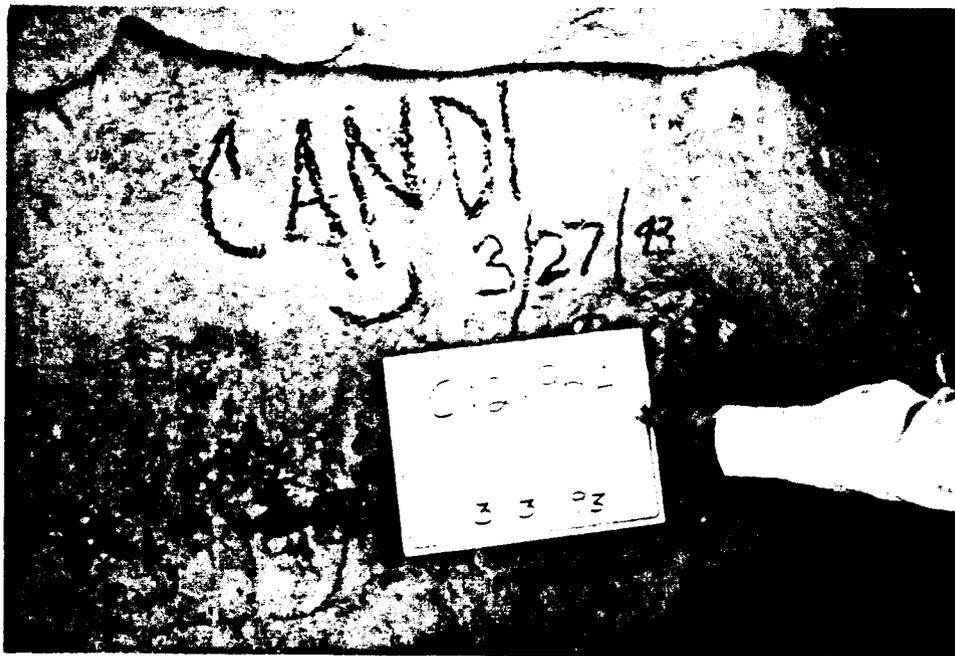
Figure 3

Figures 3 and 4 illustrate examples of vandalism occurring within the past year. The culprits have conveniently dated their work which took place four days prior to the photographs. The vandalism compromises a historical ferry crossing dating to the late 19th century. Alice Rowe (upper photograph) was at the location (C:02:094) with her husband Jack on November 13, 1896 as they waited to cross the river on their way to have their marriage sealed at the Temple in St. George, Utah.

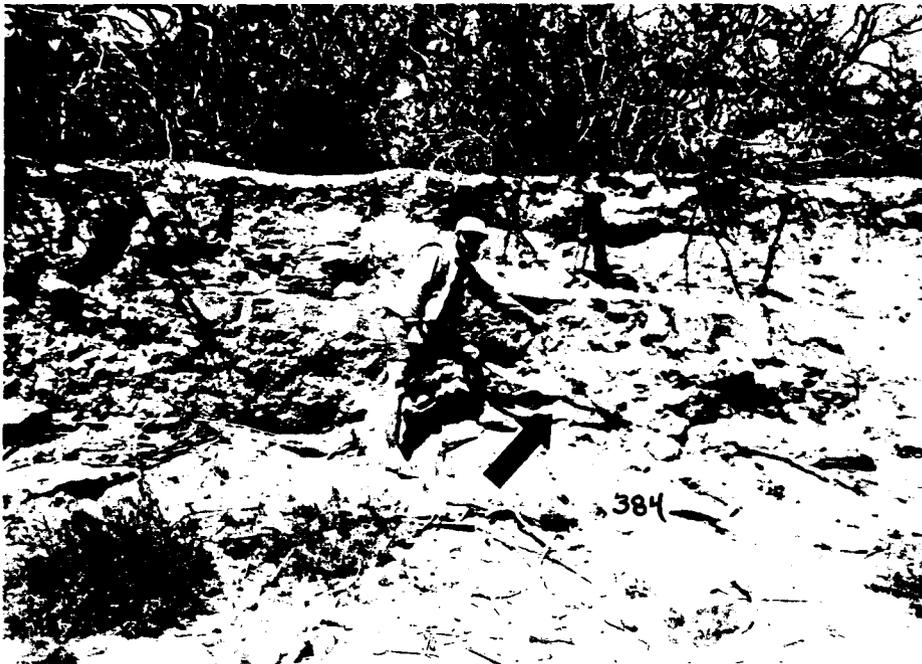
Figure 6. Cutbank erosion at C:13:384. Much of the debris placed here by the USGS in November 1991 has been removed by annual flooding. Note slumped sediment in lower photograph (black arrow). Archaeologist is pointing to location of buried hearth under fill.

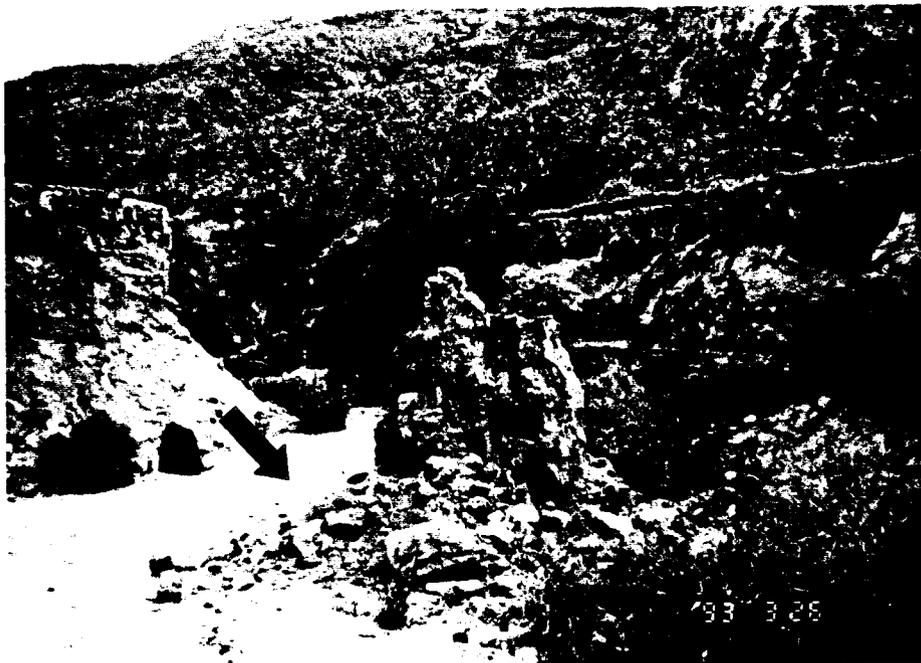
Figure 11. Comparison illustrating the pervasive nature of erosion at G:03:064. Arrow in upper photo indicates slump that has since been removed by runoff. The arrow in the lower photo indicates new slump. Note vertical cracks developing on the right side of the isolated column.

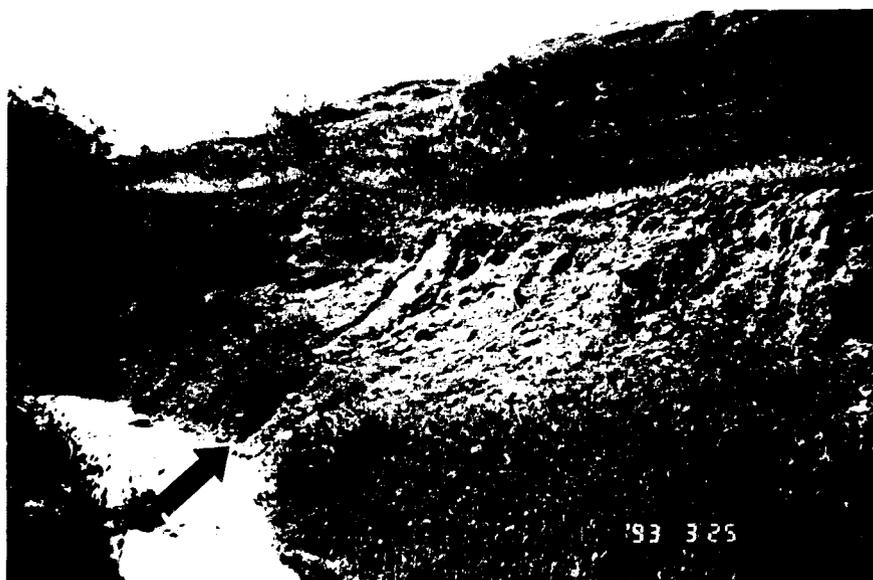
Figure 12. Ongoing erosion of truncated roaster at G:03:064. Arrows indicate degree of entrenchment in seasonal channels on surface of slumped sediment below the feature. This particular comparison documents almost two meters of linear growth in less than a single year. The growth of the arroyo complex at this location may be attributable to base level lowering in the main channel of the Colorado.
