**SUMMARY REPORT FOR 1992 GCES MONITORING
OF ARCHAEOLOGICAL SITES FROM LEES
FERRY TO SEPARATION CANYON,
GRAND CANYON NATIONAL PARK**

February 1994

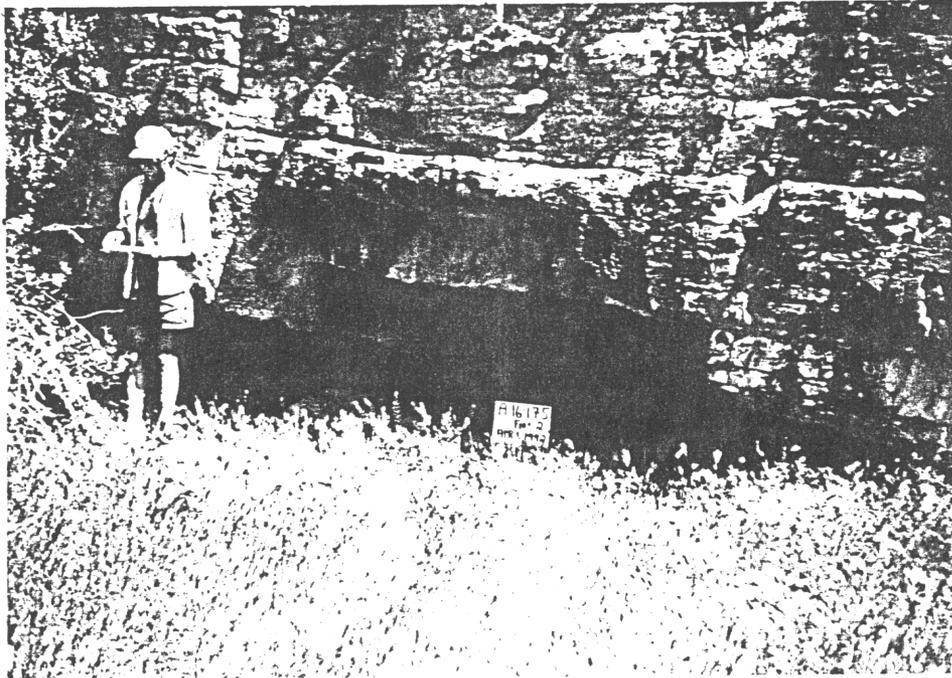
Figure 3. Photo comparison of ground cover at different times of the year at A:16:175A. These photographs are taken at the same locality, but from a different angle, and they illustrate the differences that occur in ground cover during late winter.

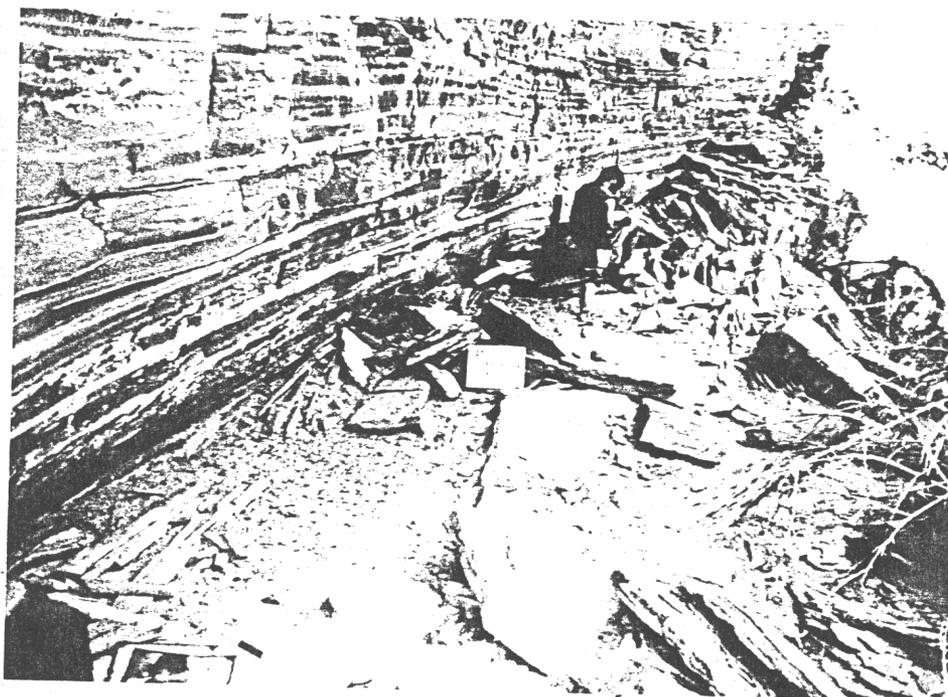
Figure 4. Photographs of the types of erosion at A:16:162A, which are common to bench and rockshelter sites. Virtually no change took place on the surface through time.

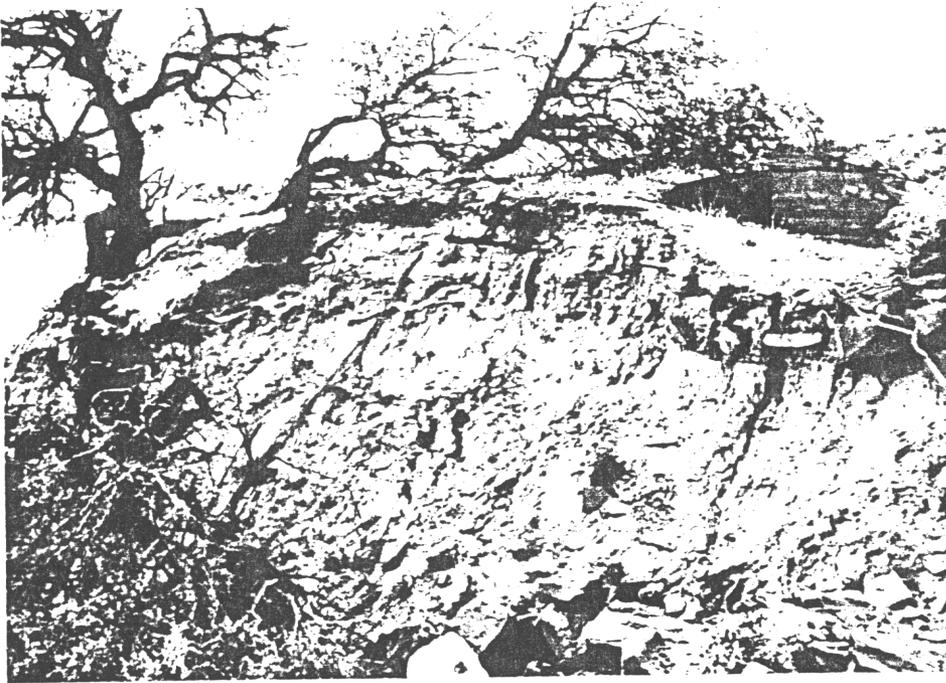
Figure 5. Photo comparison of surface vegetation and side canyon flooding at C:13:291. The cutbank in these photographs was caused by a side canyon flood in 1989. The slope has adjusted and come to an angle of repose in the later photograph. Feature 2 on this particular site is a charcoal lens exposed in the face of a cutbank. Note the difference in surface vegetation between April and October.

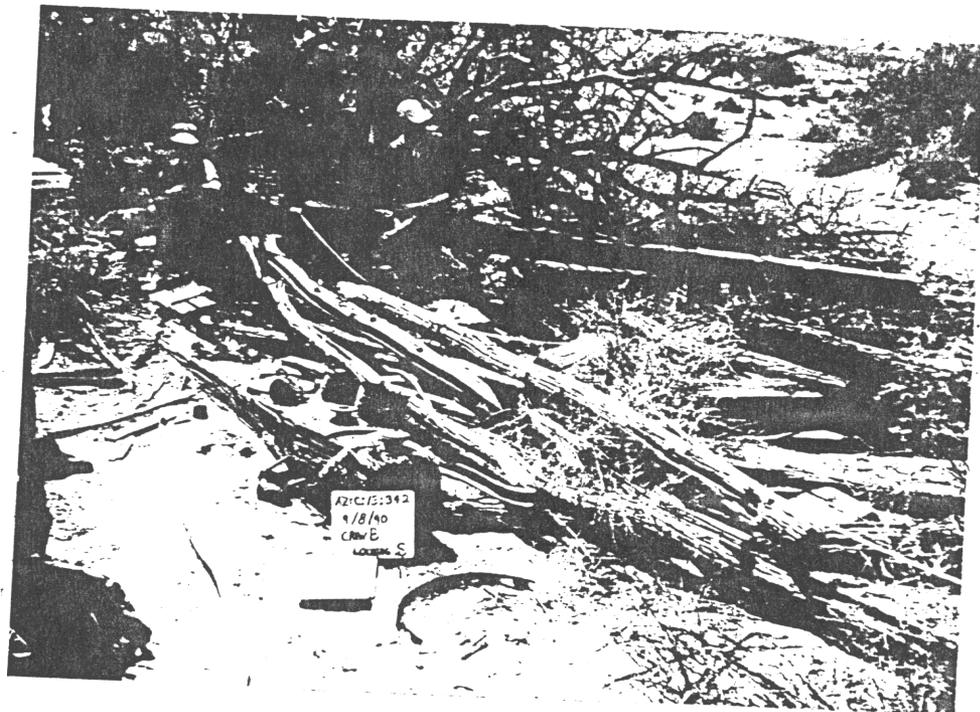
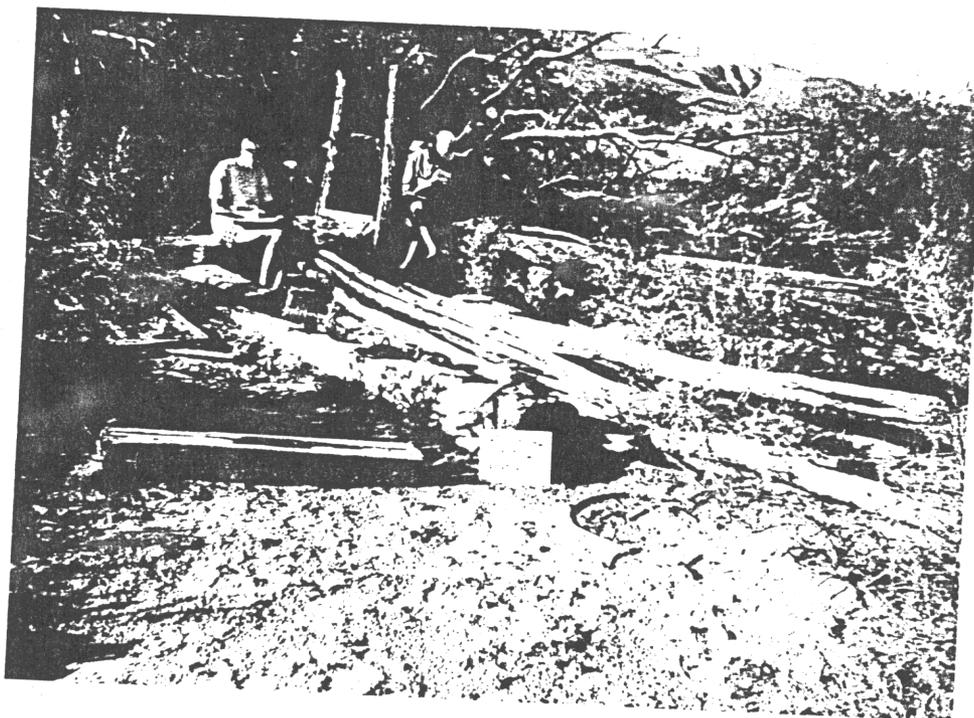
Figure 6. Photo comparison showing minor changes at historic site C:13:342. The site dates to turn-of-the-century prospecting along the river corridor. These photographs were taken approximately 2 years apart and show no significant changes. Minor rearrangement of artifacts on the wood beam indicates that some visitation is taking place.

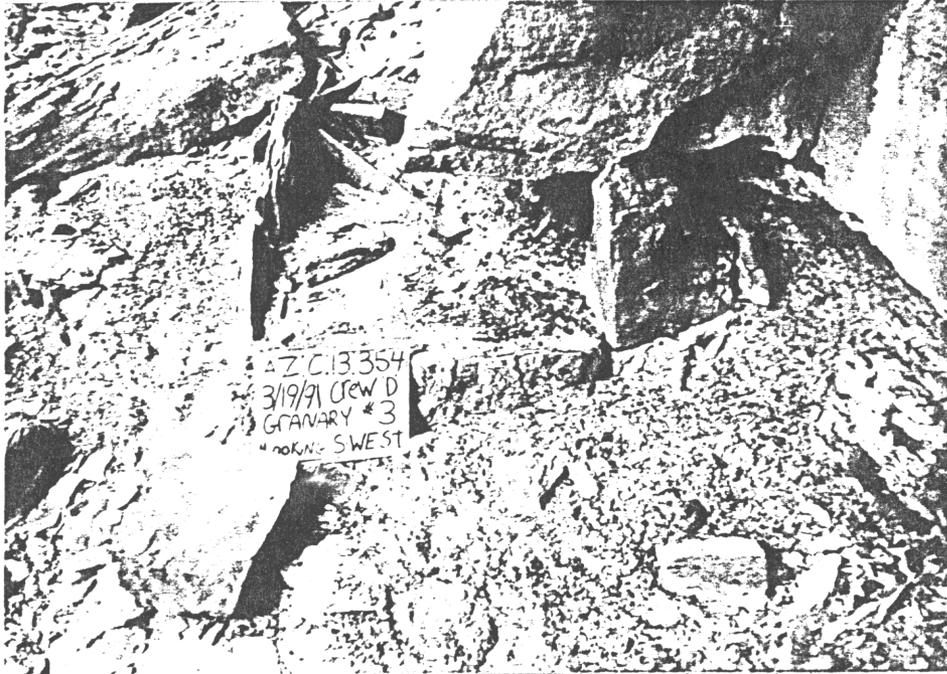
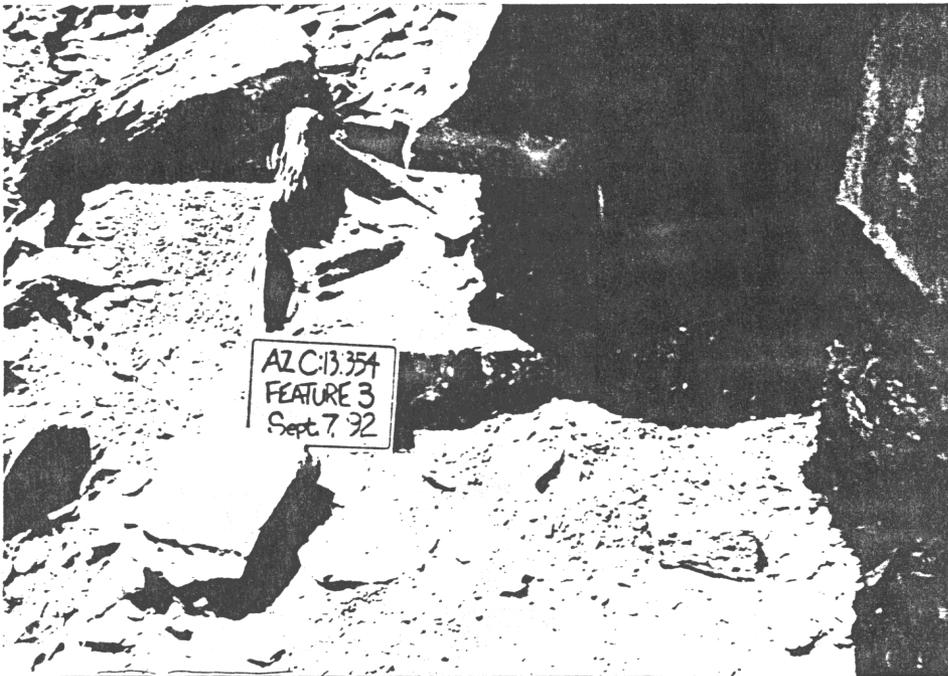
Figure 7. Photo comparison of several deteriorating granaries at C:13:354. Feature 3 makes use of a partial overhang and retains most of its original base outline. No changes took place between March 1991 and September 1992. The top photo was taken in late winter at about 9:00 a.m. and the bottom photo was taken at noon in late summer.

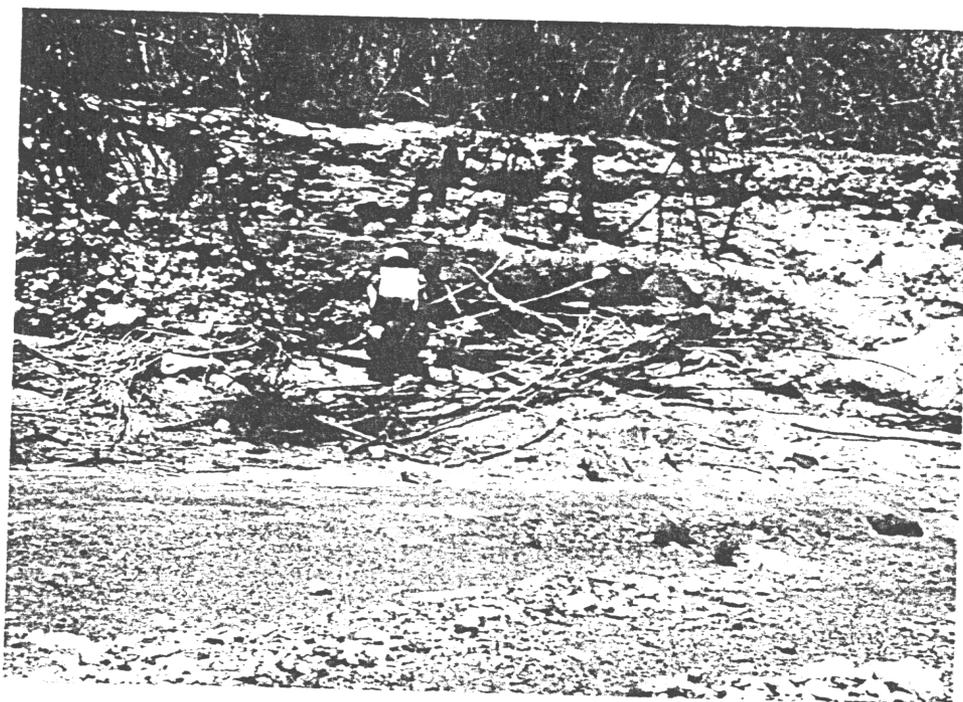
Figure 8. Photo comparison of side canyon flooding at C:13:384. This cutbank, which contains cultural materials, is subject to annual and sporadic side canyon flooding. Eventually the cultural materials will be undercut by these floods. The sticks and brush seen in the bottom photograph were placed by the USGS research trip in the late winter of 1991-1992.
