Erosion Control Project at Palisades
Delta along the Colorado River Corridor
Grand Canyon National Park

Prepared by
GCES Project Archaeologists
Lisa M. Leap
Christopher M. Coder
Cultural Resource Management
Grand Canyon National Park

December, 1995

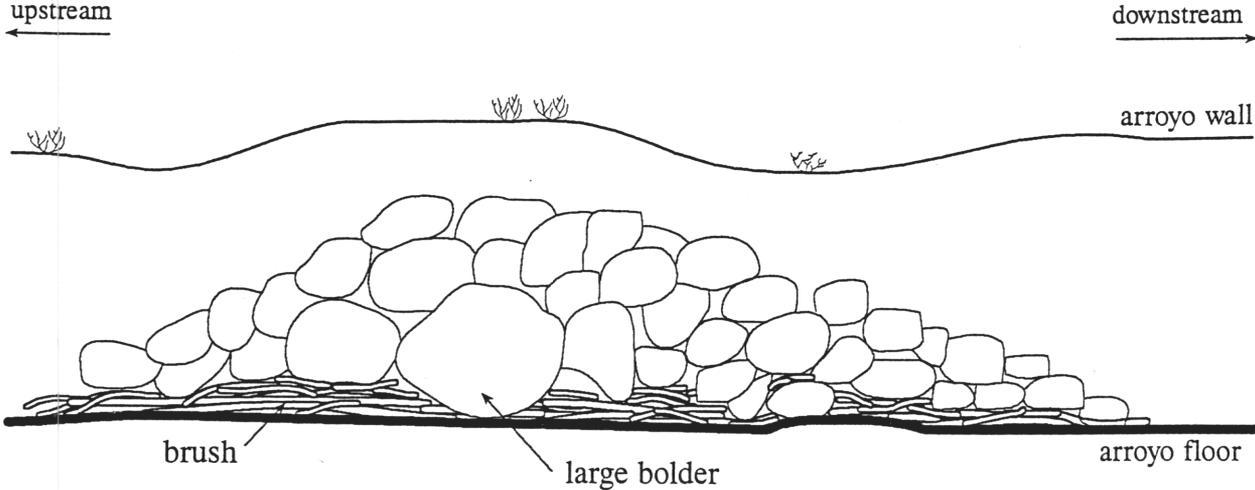
Rock Check Cross-section

Figure 2. Cross-section and photograph of a rock check.

The procedures to build a log or rock check begins with laying an initial thick bed of brush on the arroyo floor followed by placing two rows of large boulders (or a log) in the center of the brush, perpendicular to the walls. Thirdly, medium to small cobbles were placed on either side of the center of the check, inserting each rock to fit like a puzzle. This is called "rock rubbing". Finally, a steep grade of ramped rock is built on the upstream side and a gradual grade is built on the downstream side. As a standard procedure, larger rocks are placed on the bottom and smaller rocks on top. (When checks were constructed off the sites and logs were used, a shovel full of the arroyo's side wall was taken out to place the ends of the log in the walls for more support.) See Figures 2 and 3 for a photograph and cross-section of a rock and log check.

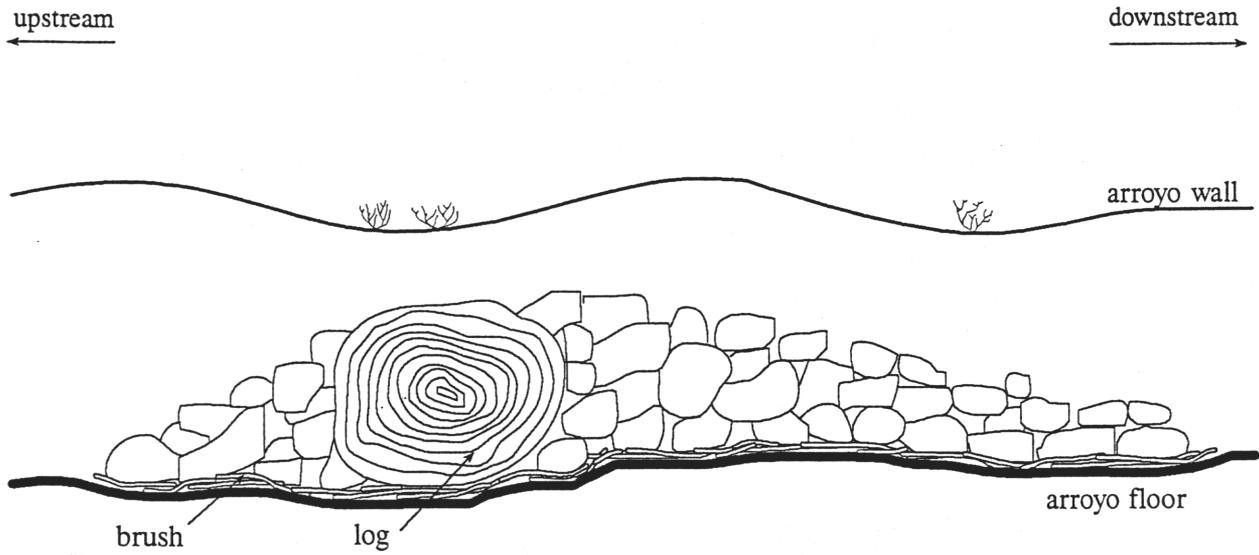
Log Check Cross-section

Figure 3. Cross-section and photograph of a log check.

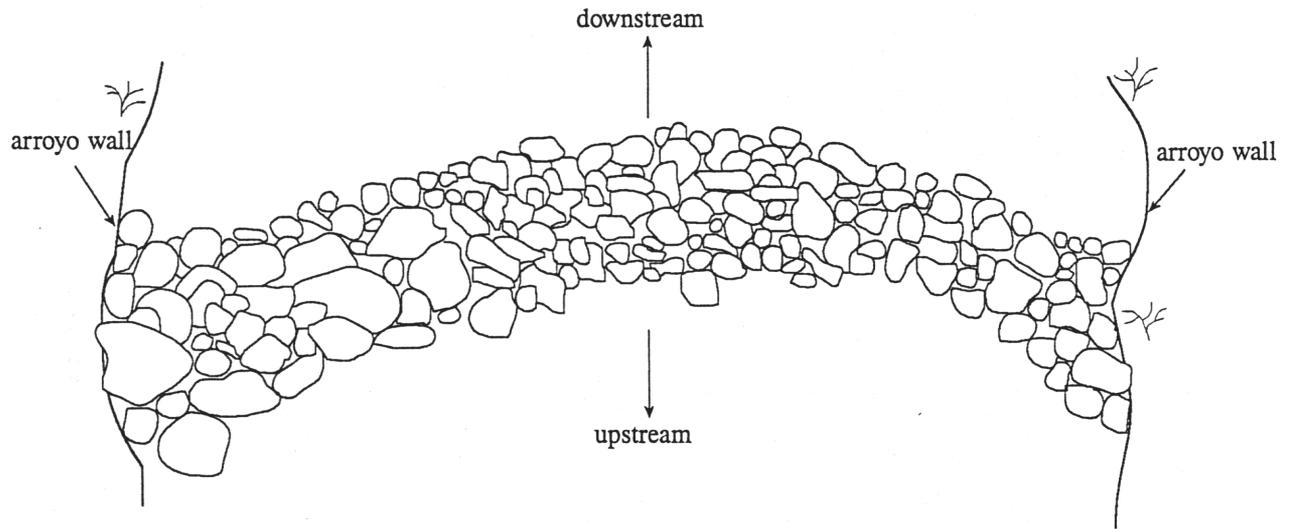
"Horseshoe" Check Plan View

The cross-section is the same as a rock check.
Brush was always placed on the arroyo floor.

Figure 5. Planview and photograph of a "horseshoe" check.

A fourth style of dam was constructed similar to a log or rock check, yet, the only difference was that the planview is in the shape of a horseshoe. This "horseshoe" check was fabricated in sections where the arroyos were wide and shallow. See Figure 5 for the planview and photograph of a "horseshoe" check.

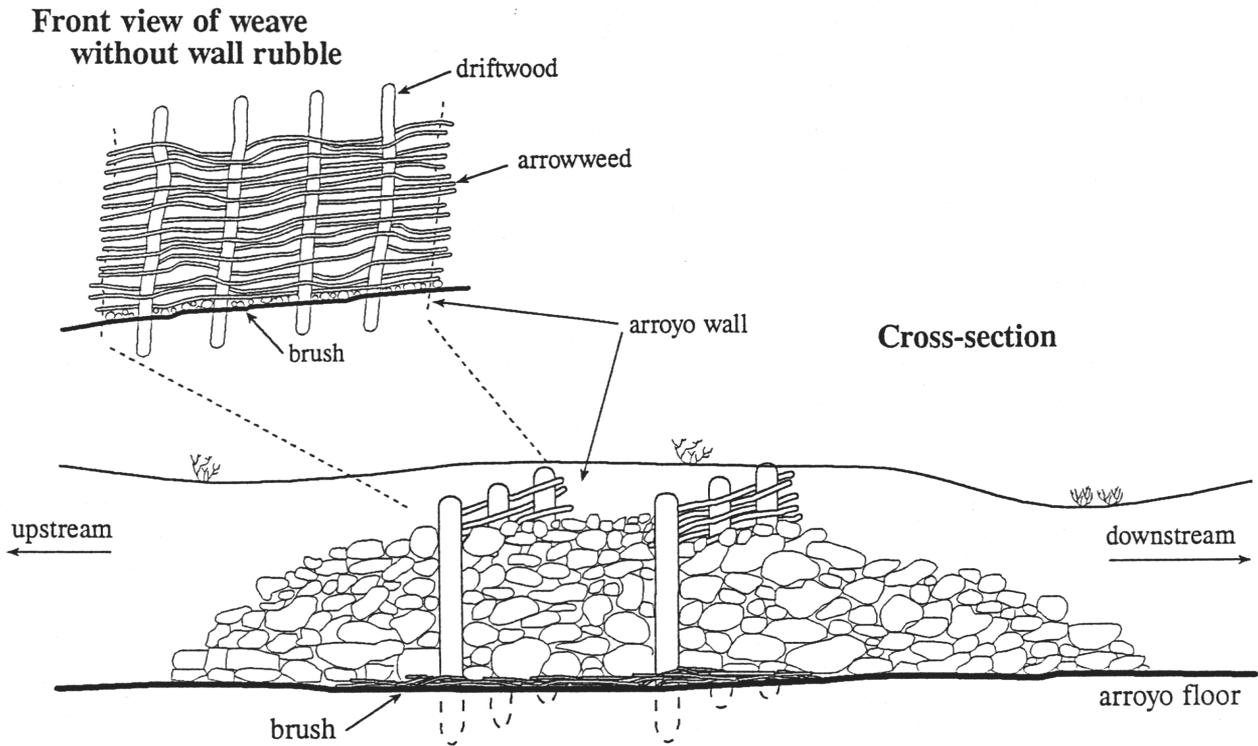
"Basket Weave" Check

Figure 6. Front view sketch of "basket weave" and photograph of a "basket weave" check.

The fifth checkdam style is called a "basket weave" check. This is a very different structure, and was built in deep, narrow sections of the arroyo. The "basket" check was constructed of driftwood branches, brush, arrowweed and rock. The driftwood branches were cut and shaped to about 1 m in height and were placed upright in the arroyo, approximately .30 m apart, to form the outline of a rectangle. An abundance of brush was placed on the arroyo's floor between the posts. Arrowweed was then forced into the arroyo side wall and woven in basket like fashion through the driftwood posts. This process was repeated until a rectangular-shaped box of driftwood posts and arrowweed was created. Small to large rocks were selectively placed inside the "basket" for additional support. A steep grade of large to small cobbles were placed on the outside and upstream side of the dam, and a more gradual rock grade was built on the outside and downstream side of the dam. See Figure 6. for a front view of the weave, and a sketch and photograph of the final product.
