MEMORANDUM

COLETON CANYON ENVIRONMENTAL
STUDIES OFFICE

Subject: Fiscal Year 96-1 Resource Monitoring Trip Report

The annual resource river monitoring trip (FY 96-1) was conducted October 11-26, 1995, from Lee's Ferry to Diamond Creek. Although we had several agendas, i.e., recreation work, water quality, 34 sites were monitored for the GCES archaeological river corridor program. Several sites visited on this trip include annual and semi-annual sites and 13 "no impact" control sites. These "no impact" sites represent a 10% sample of the sites that were categorized as having no impact prior to the interim flow regime. Several of these "no impact" sites will change in FY97 because it was determined on this trip that they are located above 300,000 cfs.

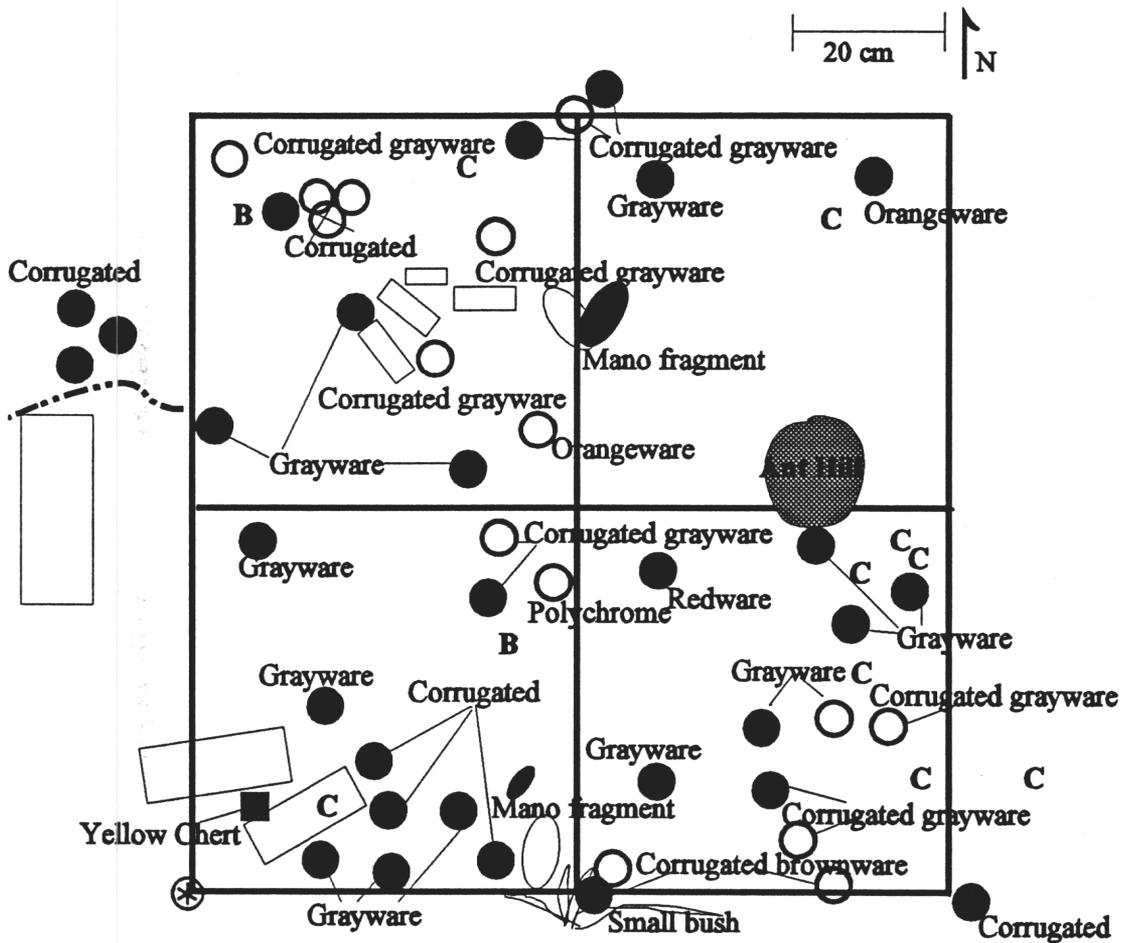
An ant hill exists in the unit but there does not appear to be artifacts coming out of the hill. There is a small gully adjacent and to the west of the unit. Hundreds of artifacts are washing downslope in this gully.

Initially, 18 ceramic artifacts plus one bone were identified. During the second observation, lithics and charcoal were first identified. There was also a large increase in the number of identifiable ceramic artifacts. The total artifact count increased by 33 artifacts. This increase could be due to the surface erosion that is occurring on the terrace edge, running off into the adjacent gully. Only one of the previously identified artifacts was not relocated. Artifacts previously identified are not moving out of the surface analysis unit, but new artifacts are being identified.

C:13:385	Time 1 Artifacts Observed	Time 2 Artifacts Observed	Percent Change in Artifact Density
	18	51	183% increase

C:13:385 Surface Analysis Unit near Feature 2. Initiated 94-3 (MJ 3-1-94), analyzed 96-1 (JLK 10-16-95). B = bone C = charcoal
 Small pieces of sandstone are covering the surface area.
 There is a gully forming directly west of the unit. A substantially sized ant hill is located within the unit. As of 96-1, no artifacts appeared to have been brought up from the ant hill.

It is recommended that the monitoring schedule be adjusted so that the disappearance of this artifact concentration and possible cist can be monitored more closely. The bone in the NW corner of the unit may be a human metatarsal.
