**Archaeological Site Monitoring and Management
Activities along the Colorado River in Grand
Canyon National Park**

LISA M. LEAP AND JENNIFER L. DIERKER
Grand Canyon National Park

RCMP Report No. 89
Flagstaff, Arizona

December 2003

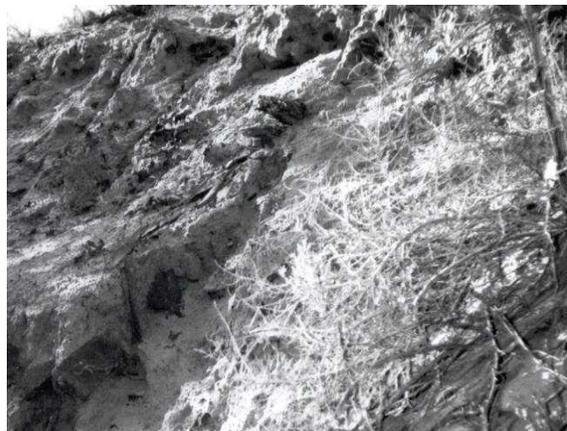
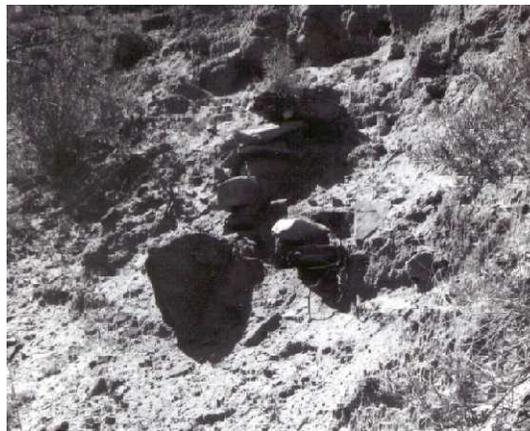
FY03 monitoring staff observed that more sections of the wall are being exposed. In addition to the east-west wall originally recorded, now a wall running north south has been exposed. Approximately two to three courses are exposed on the new portion of the wall as shown in Figure 5. The erosion is caused by slump from the downstream slope of the drainage and undercutting from below in the absence of flood deposits in the mouth of this drainage. The drainage is widening. Excavation continues to be recommended. Annual monitoring will continue.

Figure 5. Site C:13:347, partial wall exposure in 12/1990, (b) the same wall in 3/2003.

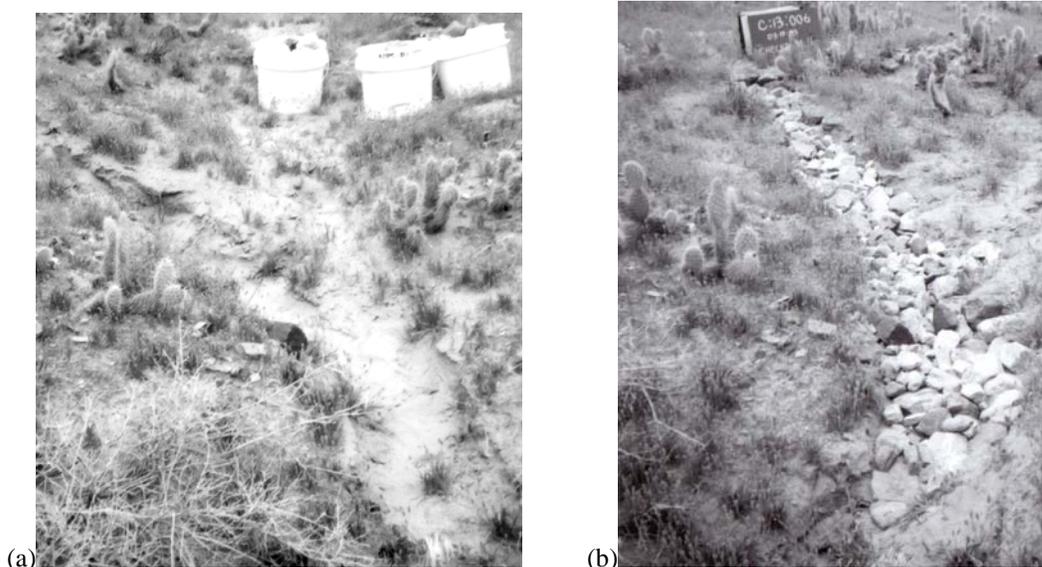
GCMRC sponsored a checkdam research project supervised by Joel Pederson (University of Utah). This site was selected and research began in FY00 and the results were drafted in FY03 (Pederson 2001). Nickpoints and plunge pools at Checkdams 3, 4, 7, 8 and 11 required maintenance. Four new checkdams were also constructed. A new drainage has developed this year that merges with the main drainage creating a third arm of this drainage. Figure 6 shows before and after photographs of how this drainage was treated with a rock lining.

Figure 6. Site C:13:006, Checkdam 15: newly developed drainage prior to rock lining (Photo a). Photo b illustrates the drainage after treatment.

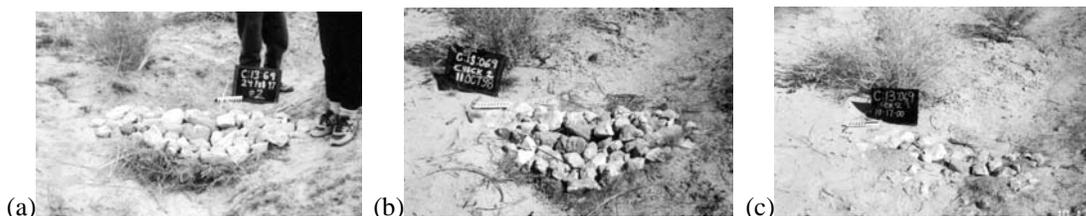
Figure 7. Site C:13:006, Checkdam 2: observed during three separate monitoring and maintenance episodes (Photo a 1997, Photo b 1998, and Photo c 2000). Note extensive sediment accumulation along both the upstream and downstream sides of the checkdam (Photo c).

The checkdams, originally constructed in FY97 by Zuni/RCMP crewmembers required no maintenance until FY02. Checkdam 4 was breached in FY02 and again in FY03. Checkdam 1 has been buried by eolian processes of the dune moving across the upper portion of the drainage. In FY03 the drainage was very active below the features, exposing new cultural material. Maintenance was conducted at Checkdams 2 and 4.

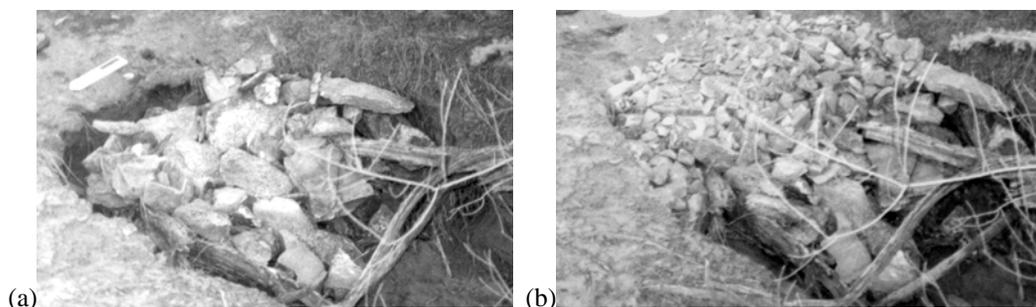
Five checkdams were initially constructed in FY97. In FY00 September rains breached three checkdams. Maintenance work conducted the following February resulted in merging two checkdams into one and constructing two new checkdams. Minor maintenance occurred in FY00 and FY01. Checkdam 2 was blown out in FY02 but not repaired. In FY03, maintenance was required due to the presence of a plunge pool below Checkdam 1. The headcut was filled in with granite rock and brush. The drainage below Checkdam 1 is too deep to fill in. The upper drainage appears to be inactive. Figure 8 shows before and after photographs of treatment to Checkdam 1. Small gravels and brush were used to fill in the spaces between the drainage wall and the checkdam and the spaces between large rocks in the checkdam itself.

Figure 8. Site G:03:002, Checkdam 1: an example of treating headcut advancement (Photo a) with small gravels and brush (Photo b).

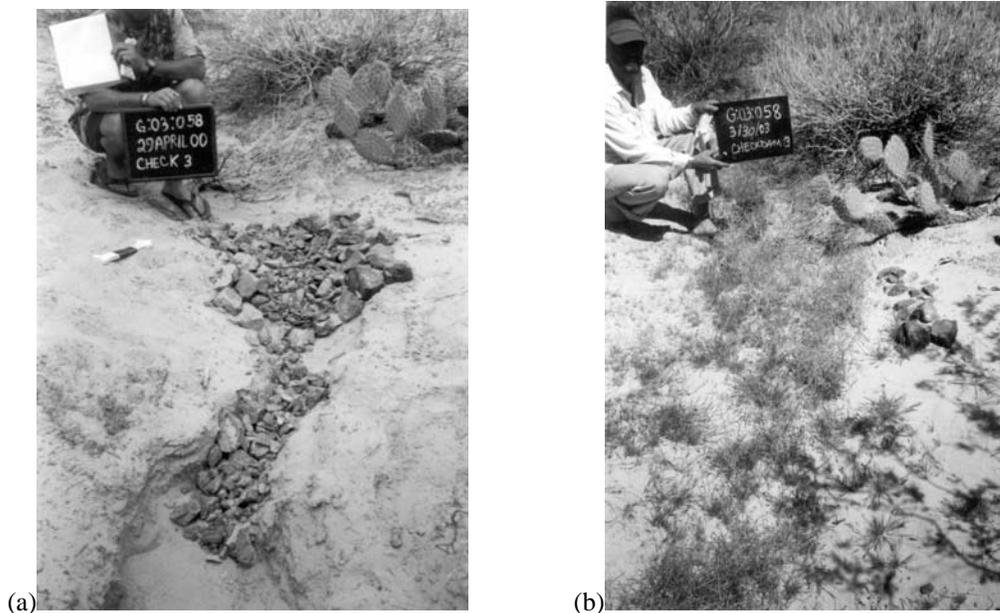
Initial checkdam construction consisted of two rock and brush checkdams in one drainage in FY97. In FY99, several new nickpoints appeared in the drainage resulting in the construction of four new checkdams. The drainage continued to be extremely active with all checkdams obliterated and reconstructed and two new checkdams constructed. The drainages were inactive for the next two years. In FY03 the checkdams were covered in sediments and vegetation as shown in Figure 9. The drainages have completely filled in with sediment and vegetation is growing throughout the drainage. The checkdams have been successful and are barely visible on the surface. No work was necessary.

Figure 9. Site G:03:058, Checkdams 8 and 9 in 2000 (Photo a) and again in 2003 (Photo b).

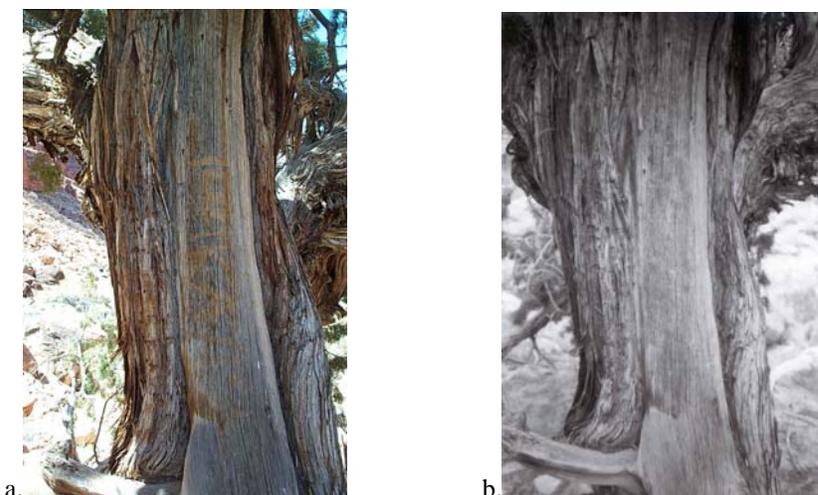
In May 9, 2002 a commercial river guide reported the following at Phantom Ranch: "Harry McDonald inscription on a juniper tree, circa Stanton expedition, has new damage/graffiti above it. Dead bark of tree defaced above the inscription". This information was sent to the river patrol rangers.

On May 10 this information was given to NPS archaeologists. Fortunately there was an NPS river patrol trip leaving a few days after receipt of this information. An NPS archaeologist went on the river trip to complete a more detailed assessment. The archaeologists noted that the incised, scratched graffiti was not as deep or clean as a knife cut, but it looked like the vandal used a rock or stick. It extended above the H. McD inscription and was not decipherable (see Figure 12a). There was also incised graffiti noted on a nearby boulder ["TLS 2000" AND "RYAN SWEENEY"].

Figure 12. Graffiti recorded by NPS archaeologists at site C:05:007 in May 2002 (Photo a). On 3-18-03 base Park archaeologists (Jan Balsom and Grace Ellis) removed the graffiti with sandpaper (Photo b).

On the FY03 BOR sponsored trip base funded Park archaeologists used sandpaper to remove the vandalism on the tree (see Figure 12b) and the rock. Additional work on the boulder with graffiti included mixing clay and water and covering the rock to mask the incised lettering. Because this is only a mask, it is imperative to revisit the site to determine if additional removal is necessary. The San Juan BLM was contacted regarding the removal of graffiti on desert varnish. We anticipate applying their methods to this site if necessary. The NPS ARPA officer, Joe Sumner is investigating the case.
