Bridge Canyon Project, Arizona

Geology of the

UPPER GNEISS DAM SITE

March 1943

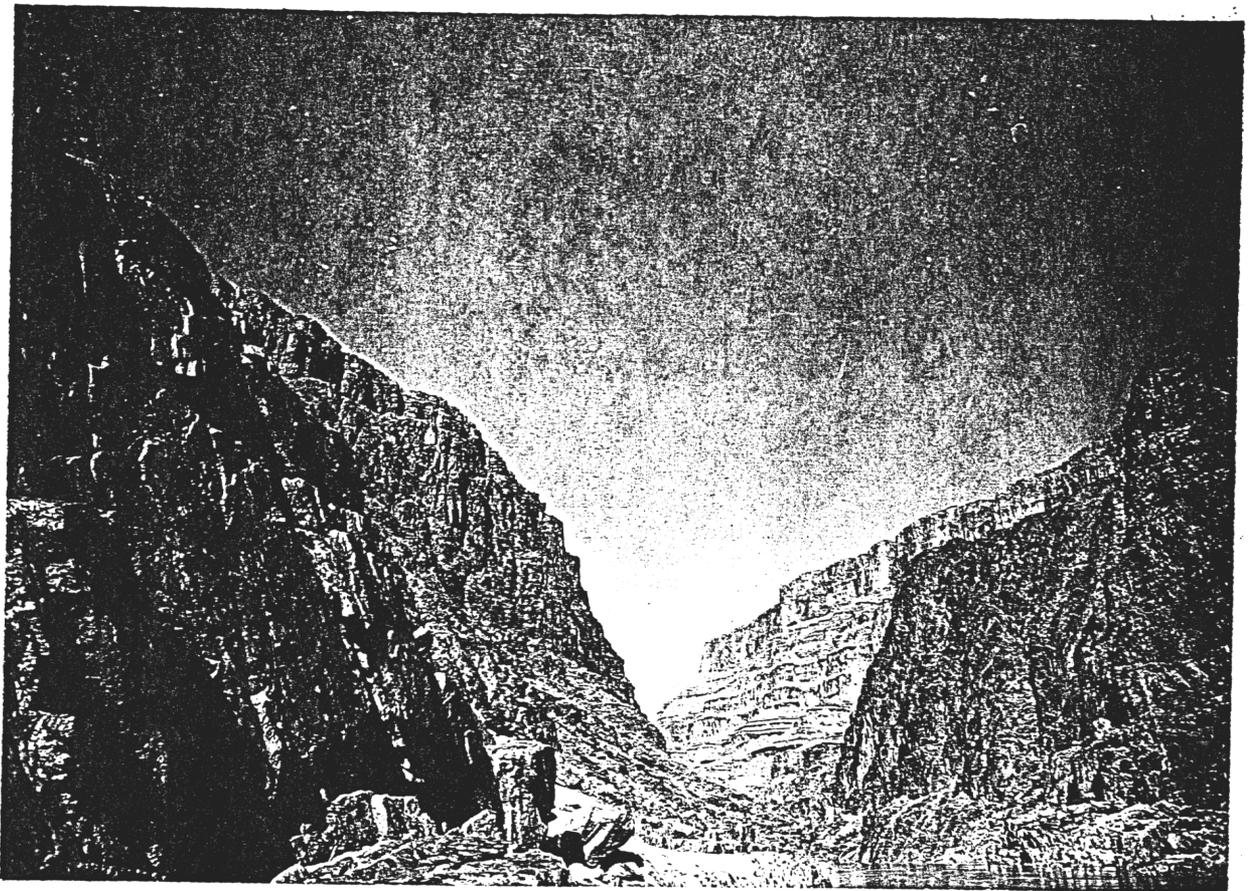
Profile of Upper Gneiss site from 2000 feet upstream. Fault or open fissure is seen on the right abutment.

Panoramic view of right abutment, Upper Gneiss site.

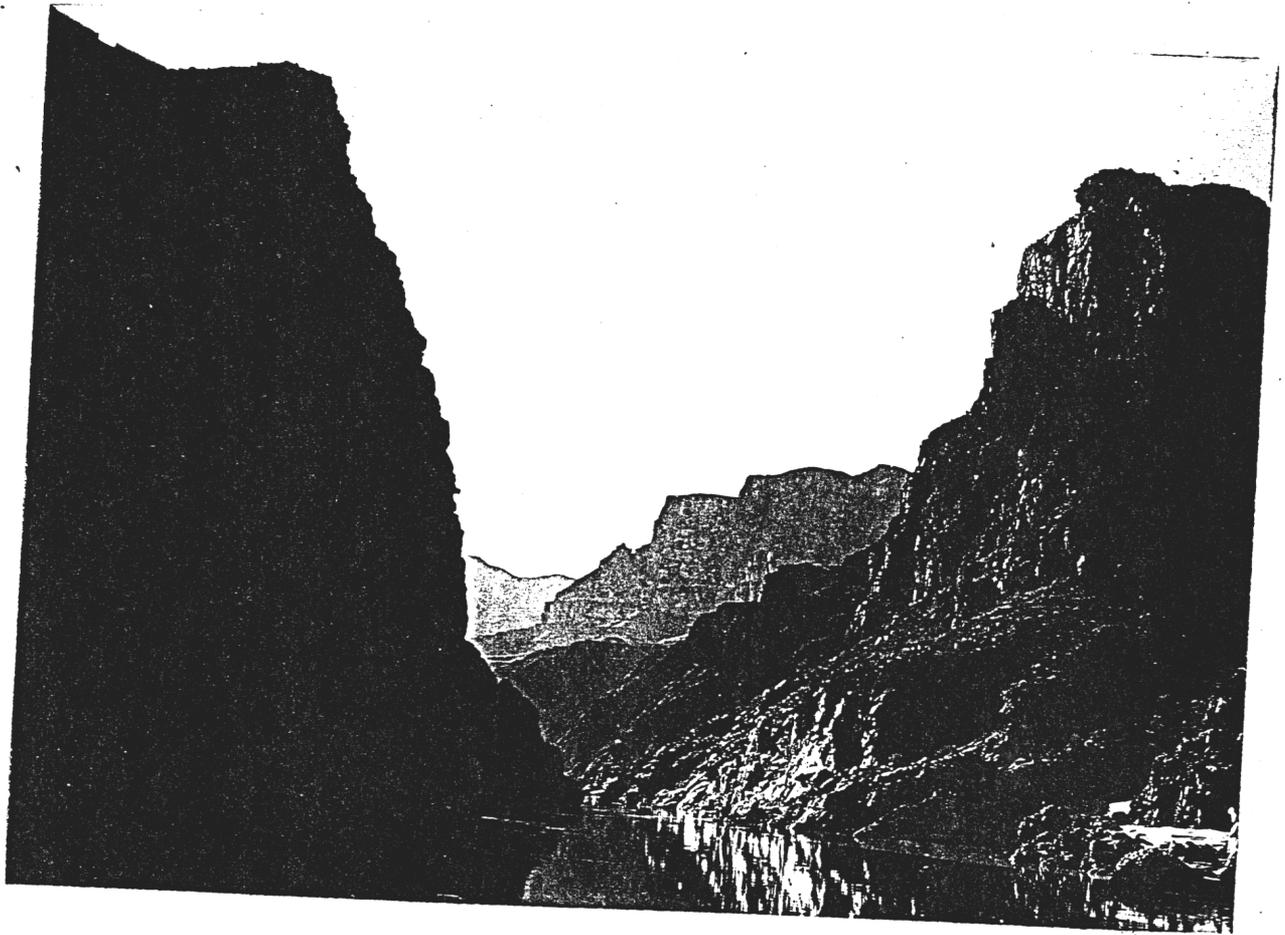
Profile of Upper Gneiss dam site from 2000 feet downstream

Panoramic view of left abutment, Upper Gneiss site.

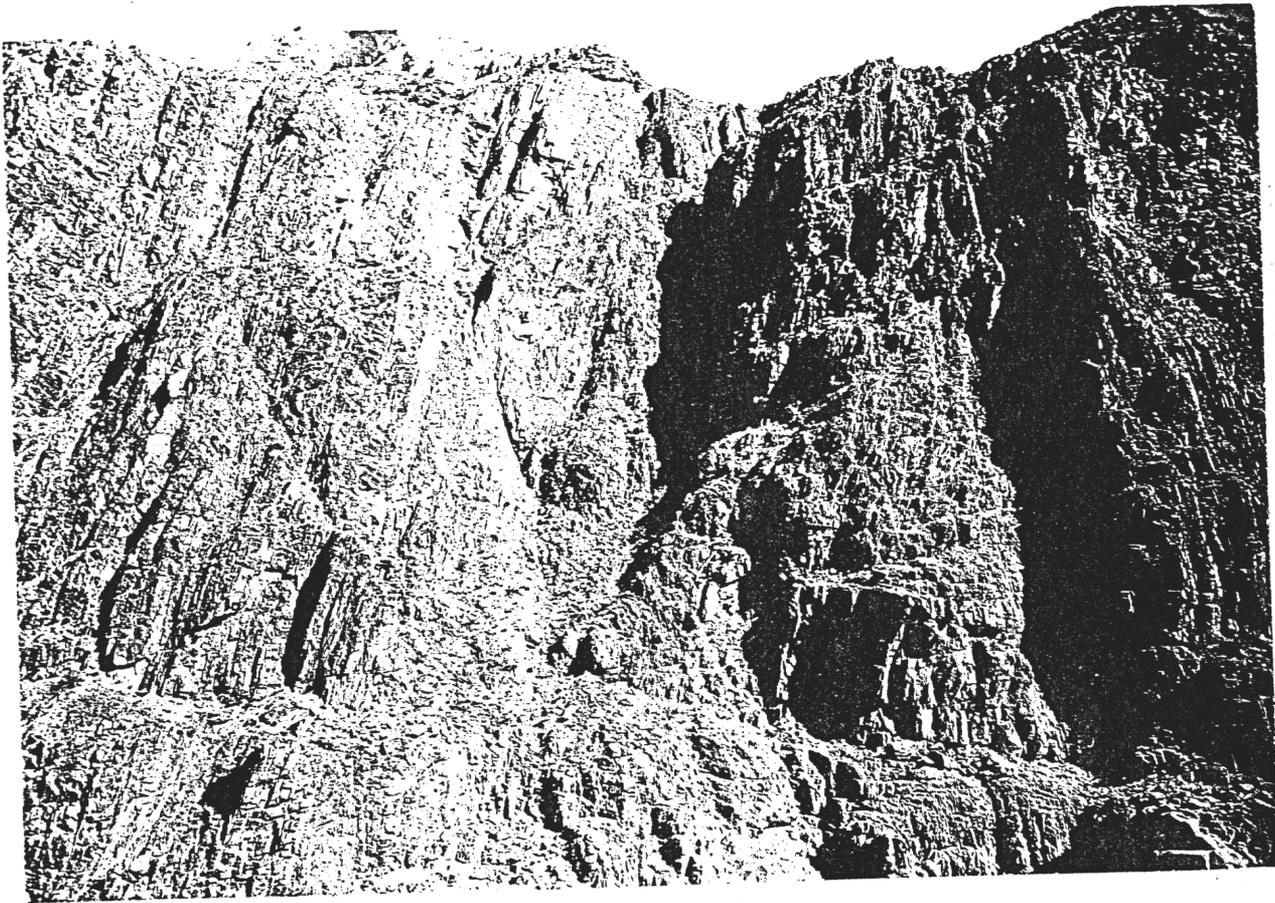
Right abutment Upper Gneiss site showing schistosity planes and two prominent joints.

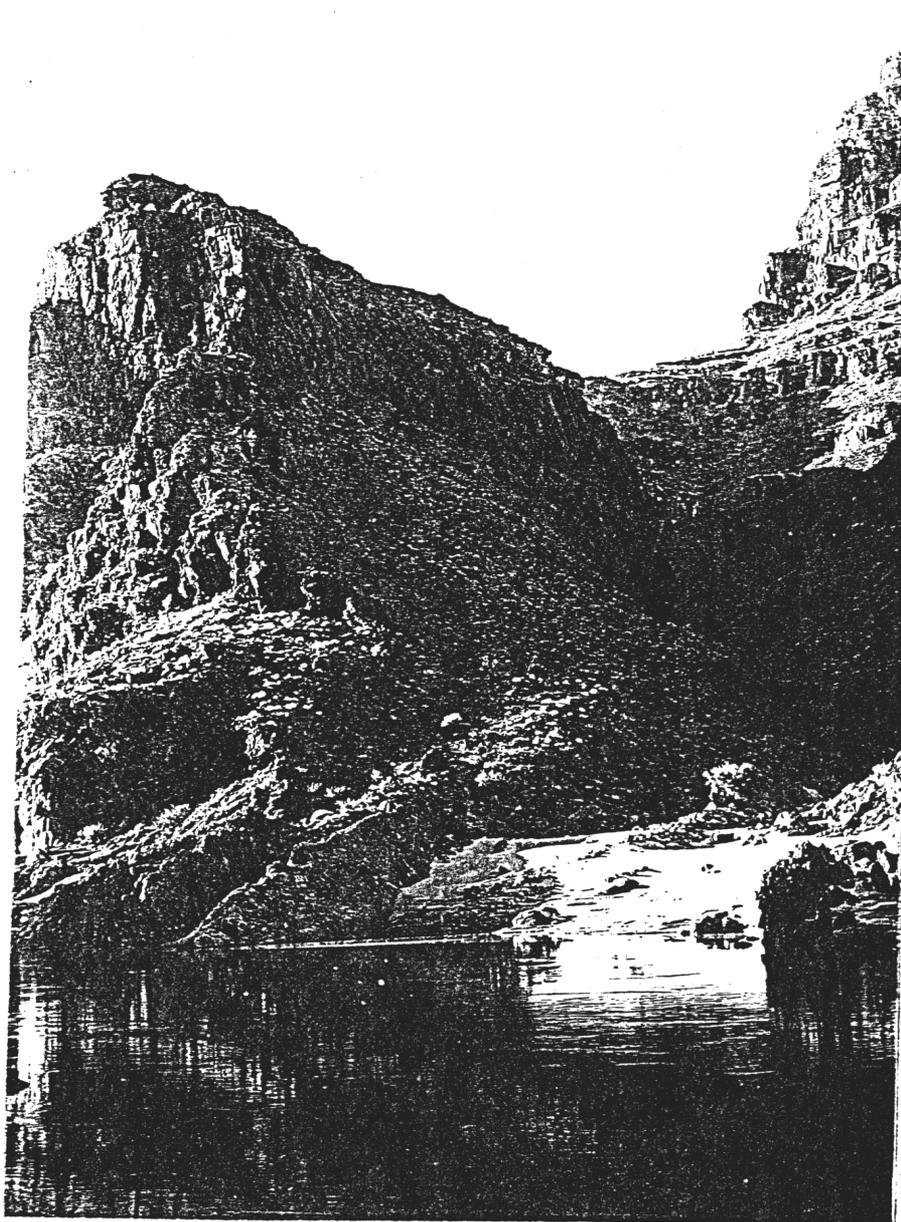
Detail of tunnel outlet portal and view of Spillway draw, Upper Gneiss site. Strata marked B. W. in foreground is a metamorphosed limestone in the mica schists showing sedimentary origin of the schists.

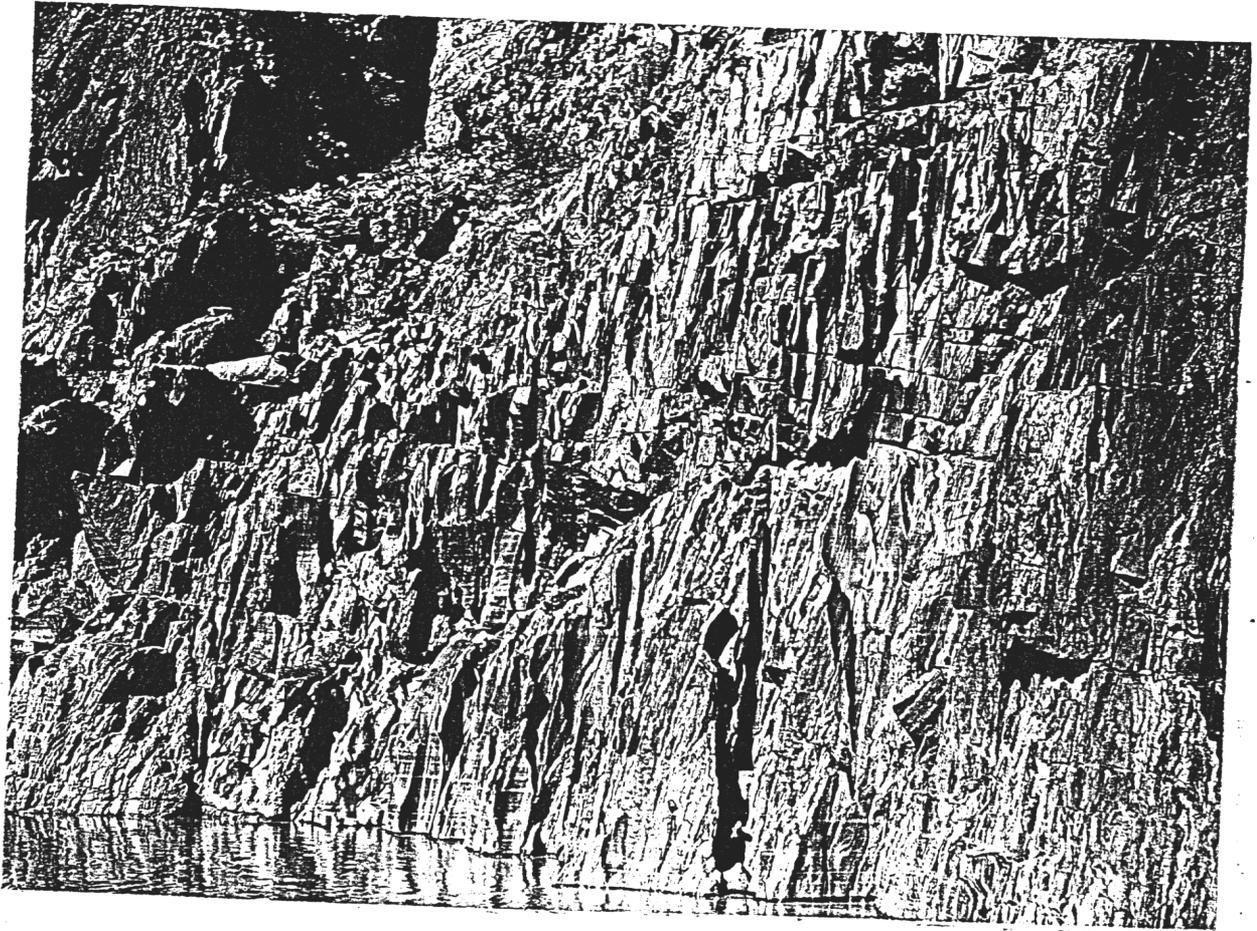
Upper Gneiss dam site on right side near axis. Shows fluting and polishing in the hard granite gneiss. This is a result of river action during flood season.

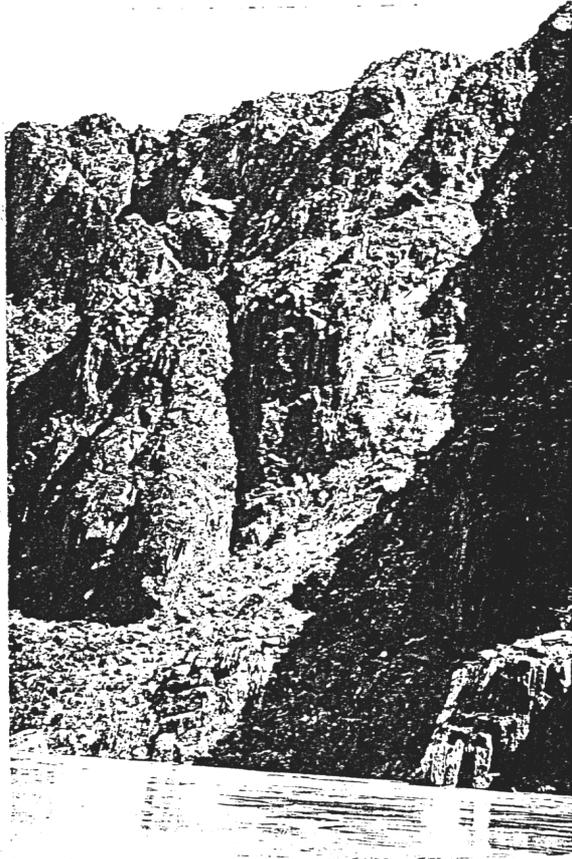
Fault or open fissure on right abutment of Upper Gneiss site.
