SPILLWAY TESTS AT GLEN CANYON DAM

July 1985

Engineering and Research Center

U. S. Department of the Interior
Bureau of Reclamation

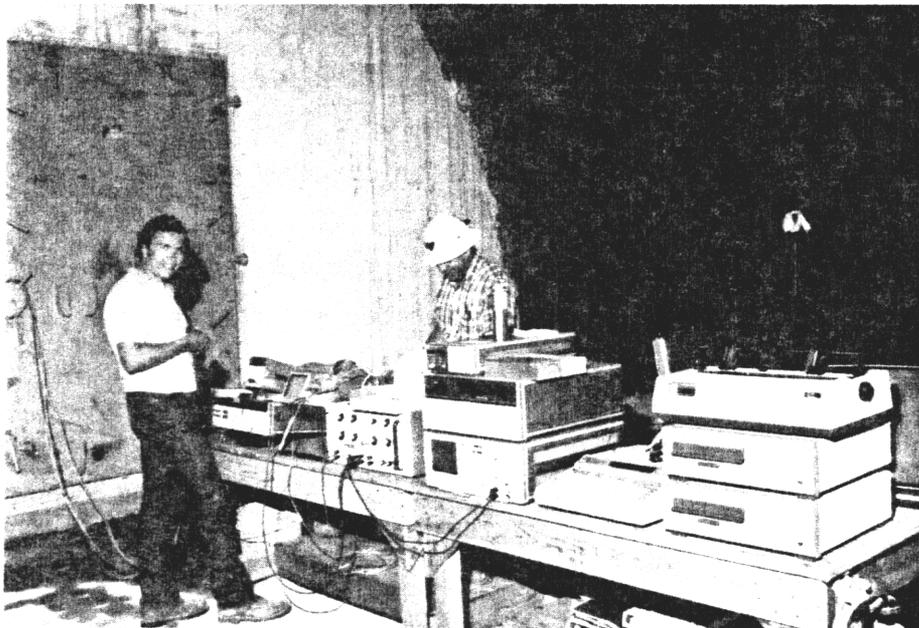
Figure 2. - Data acquisition equipment in the access tunnel. (Note watertight door leading into spillway tunnel.)

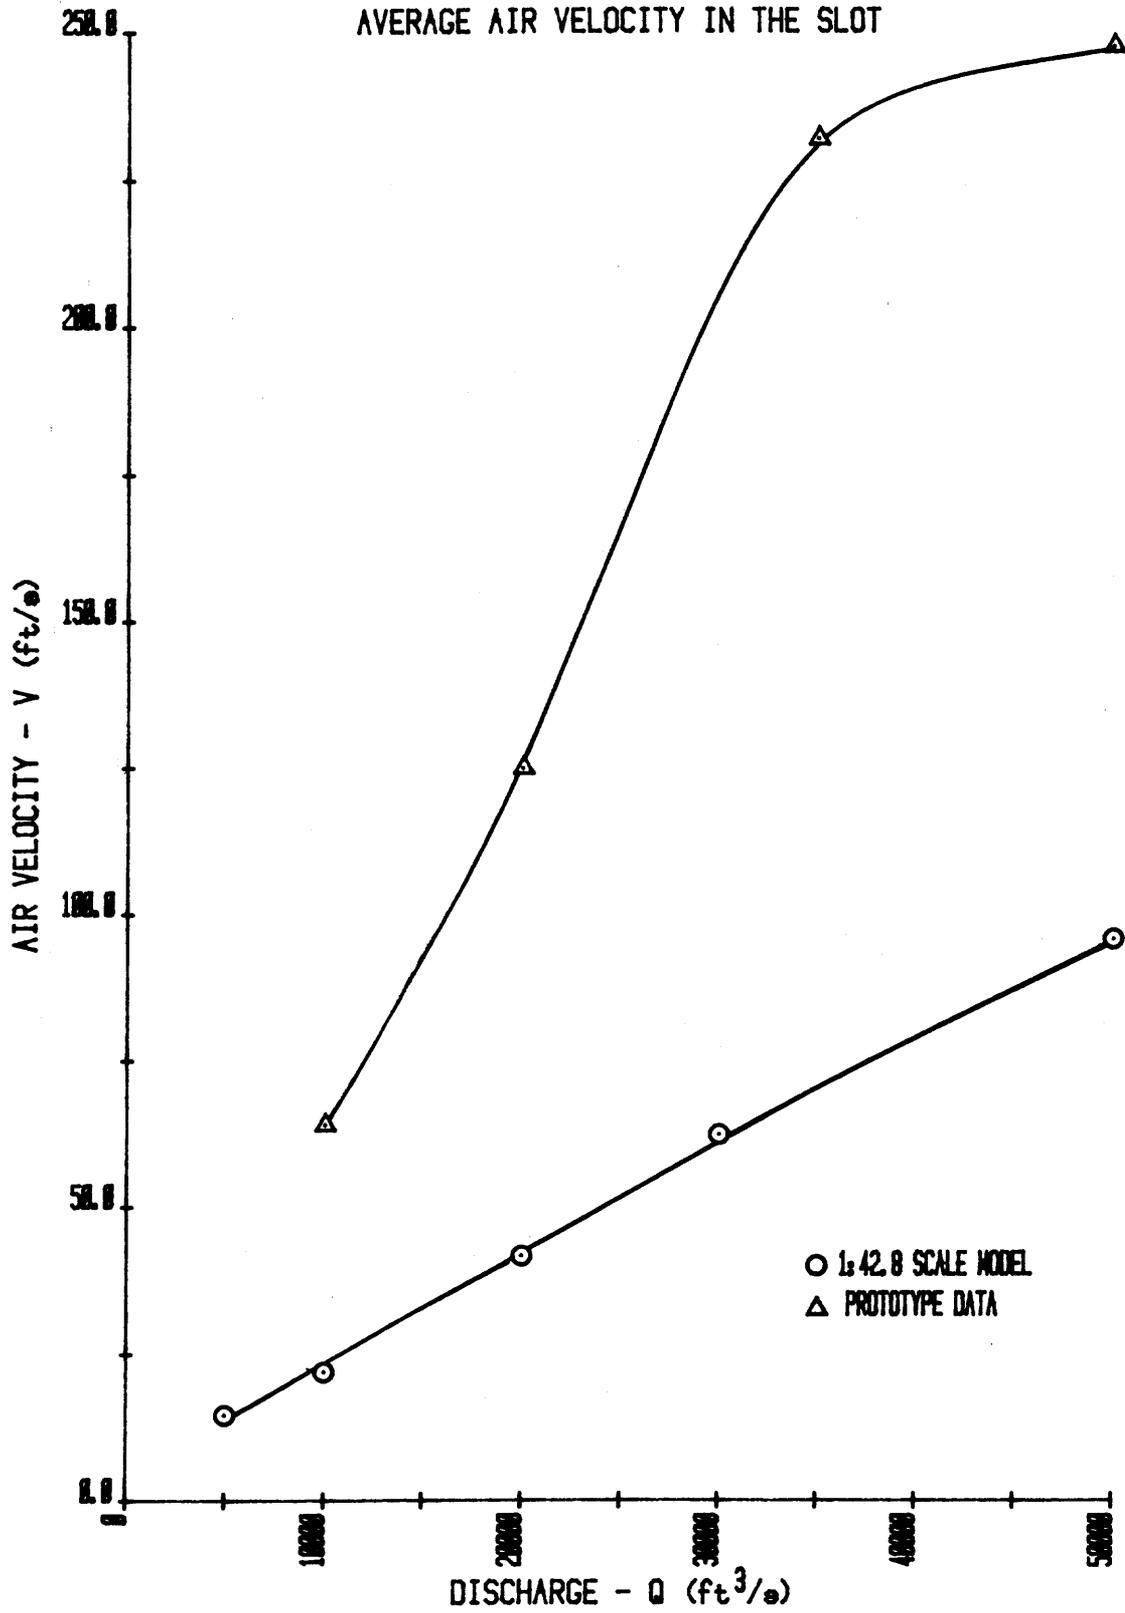
Figure 3. - Air velocity measurements in the air slot.

A comparison of these velocities with scaled model values is shown on figure 3. The single point velocity data can be integrated into a volumetric flowrate by assuming a velocity distribution in the slot. A standard logarithmic distribution was assumed along with symmetric performance of the slot. A comparison of air demand, for model, prototype, and computed data is shown on figure 4. It should be noted that measurements in the model and prototype only reflect air demand passing through the slot. Additional air is entrained through shear drag on the free surfaces of the jet and at flows below 30,000 ft³/s air may enter beneath the jet downstream from the slot because the sides of the jet are not sealed against the tunnel walls.

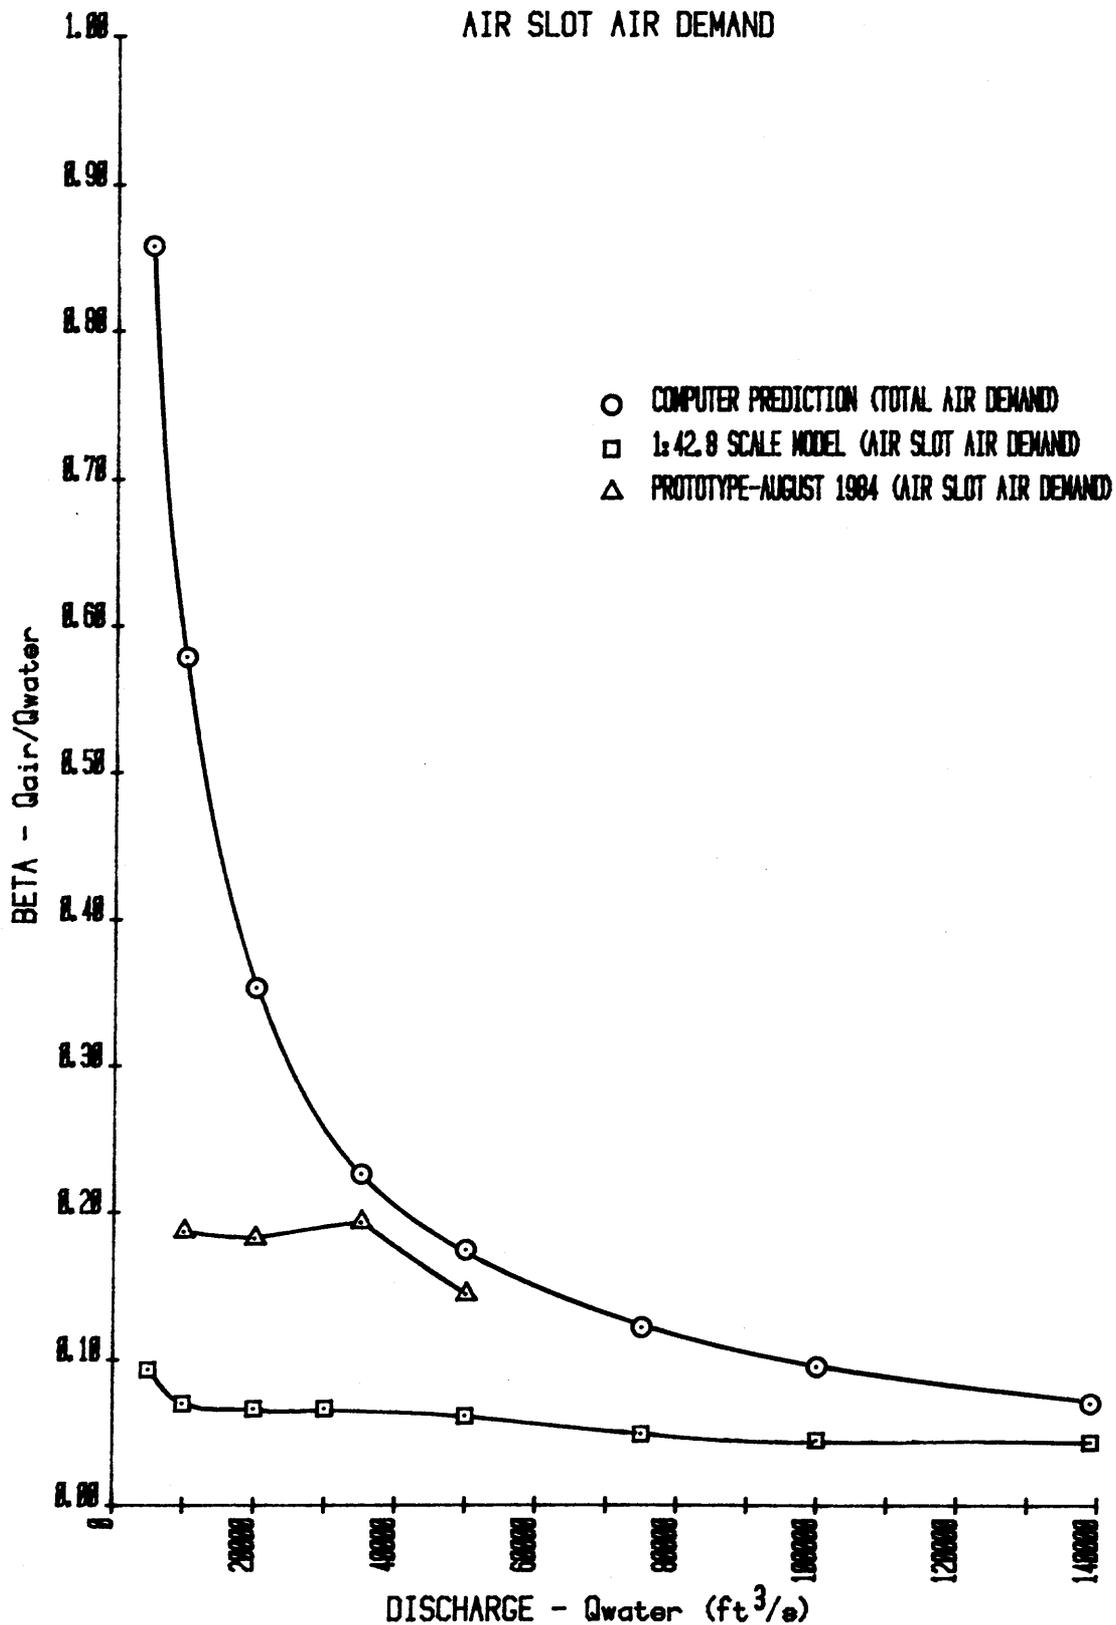
Figure 4. - Air demand comparison - computed-model-prototype.

In the case of the Glen Canyon spillway air slot, small discharges send flow over the ramp in a long free fall. At these flows, air flow is not forced to pass through the slot in order to aerate the jet. However, as the flow increases, the sides of the jet are sealed off by the tunnel walls. This forces most of the air to flow through the slot in order to supply the cavity beneath the jet. This phenomenon can be seen on figure 4 by observing the unusual bump in the prototype air demand curve. Between the 20,000- and 40,000-ft³/s flows, the sides of the jet begin to seal off, forcing the majority of air to pass through the air slot. The error in scaling the prototype air demand is due largely to similitude errors in modeling the turbulence.

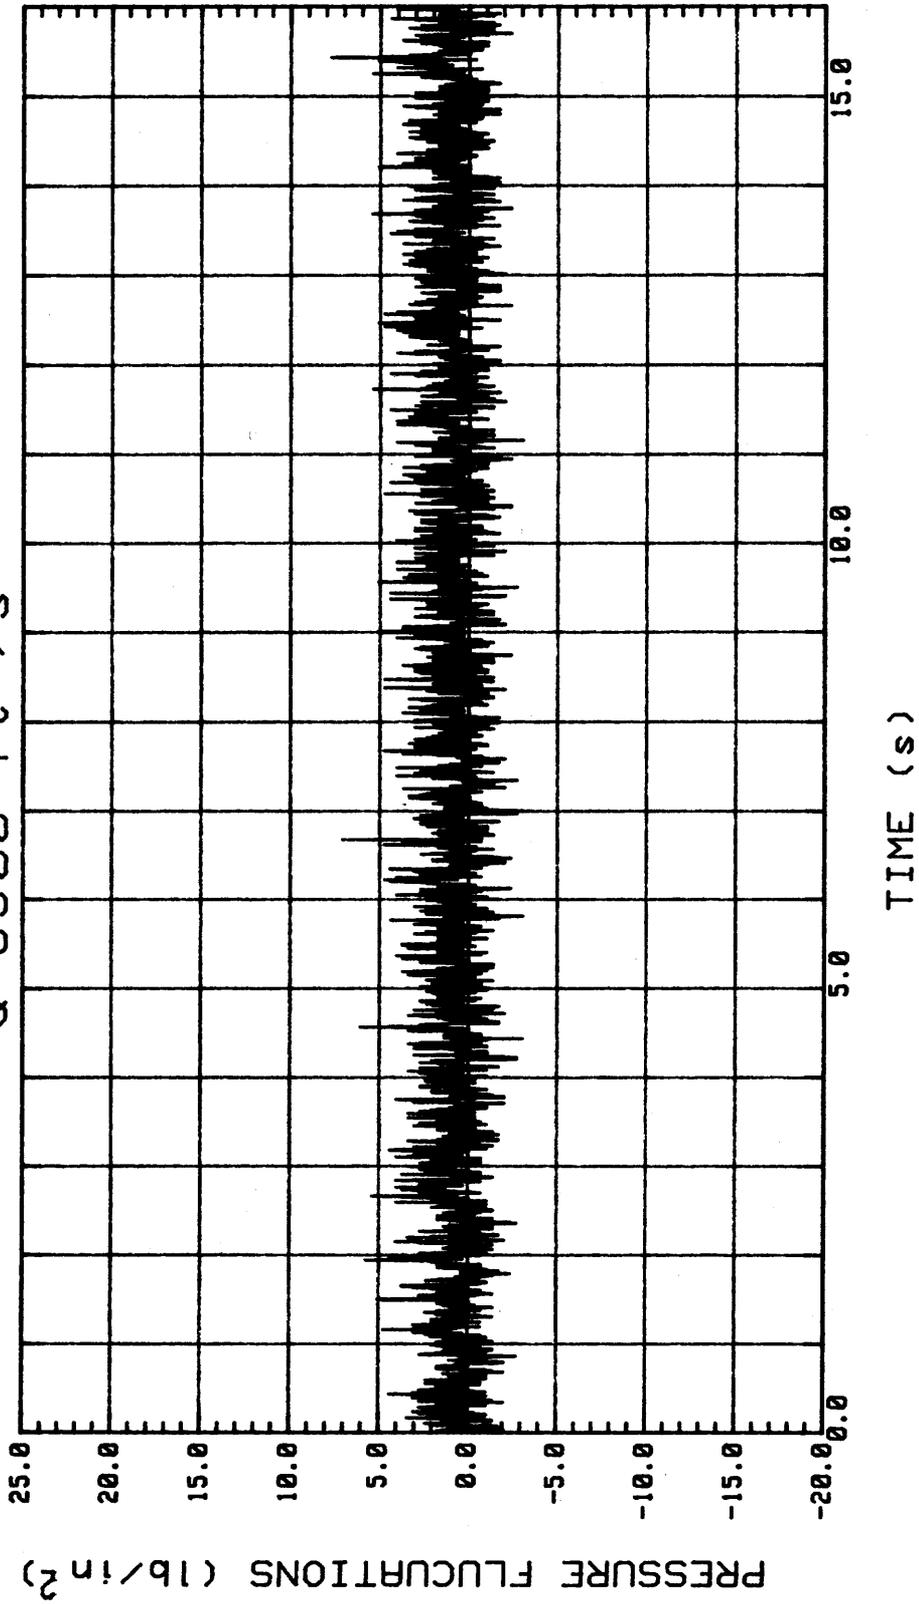
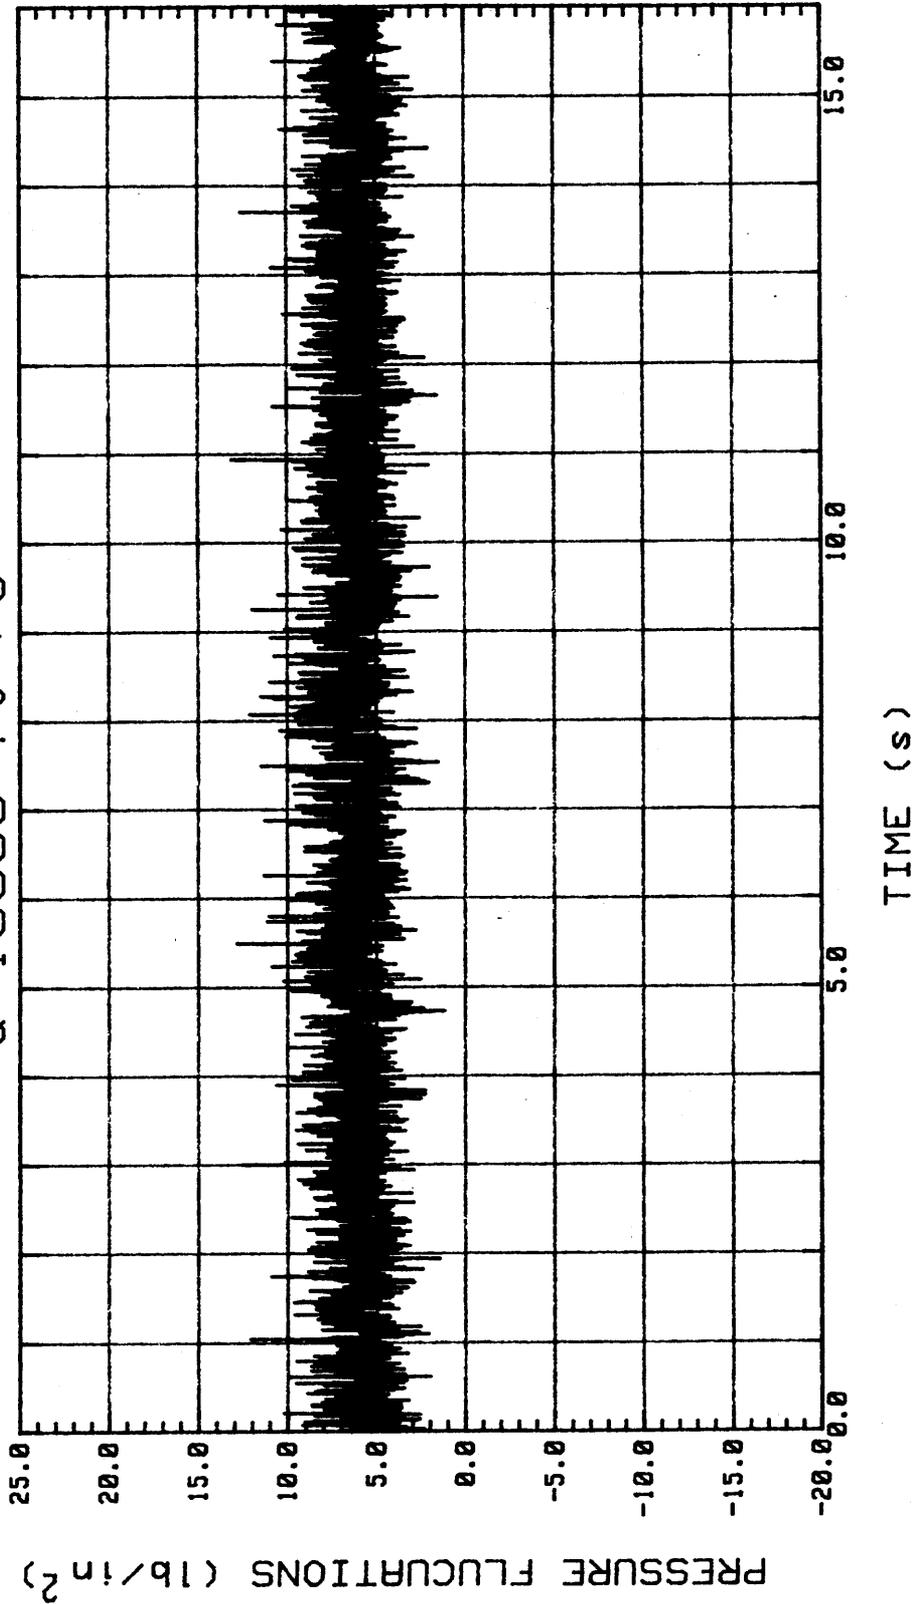
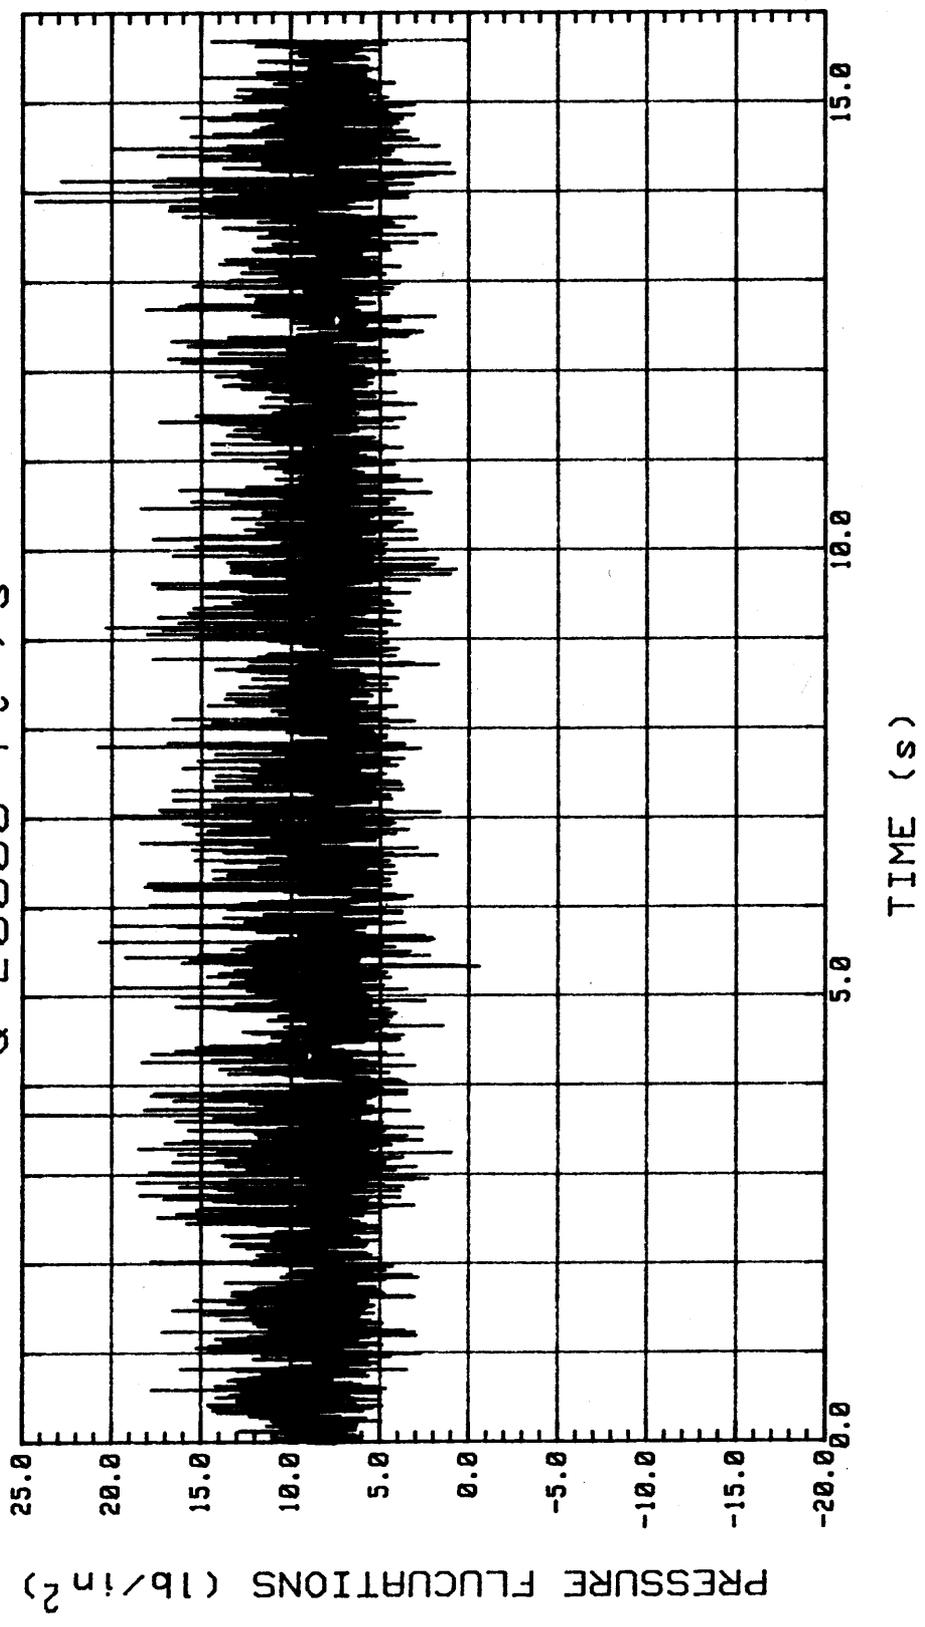
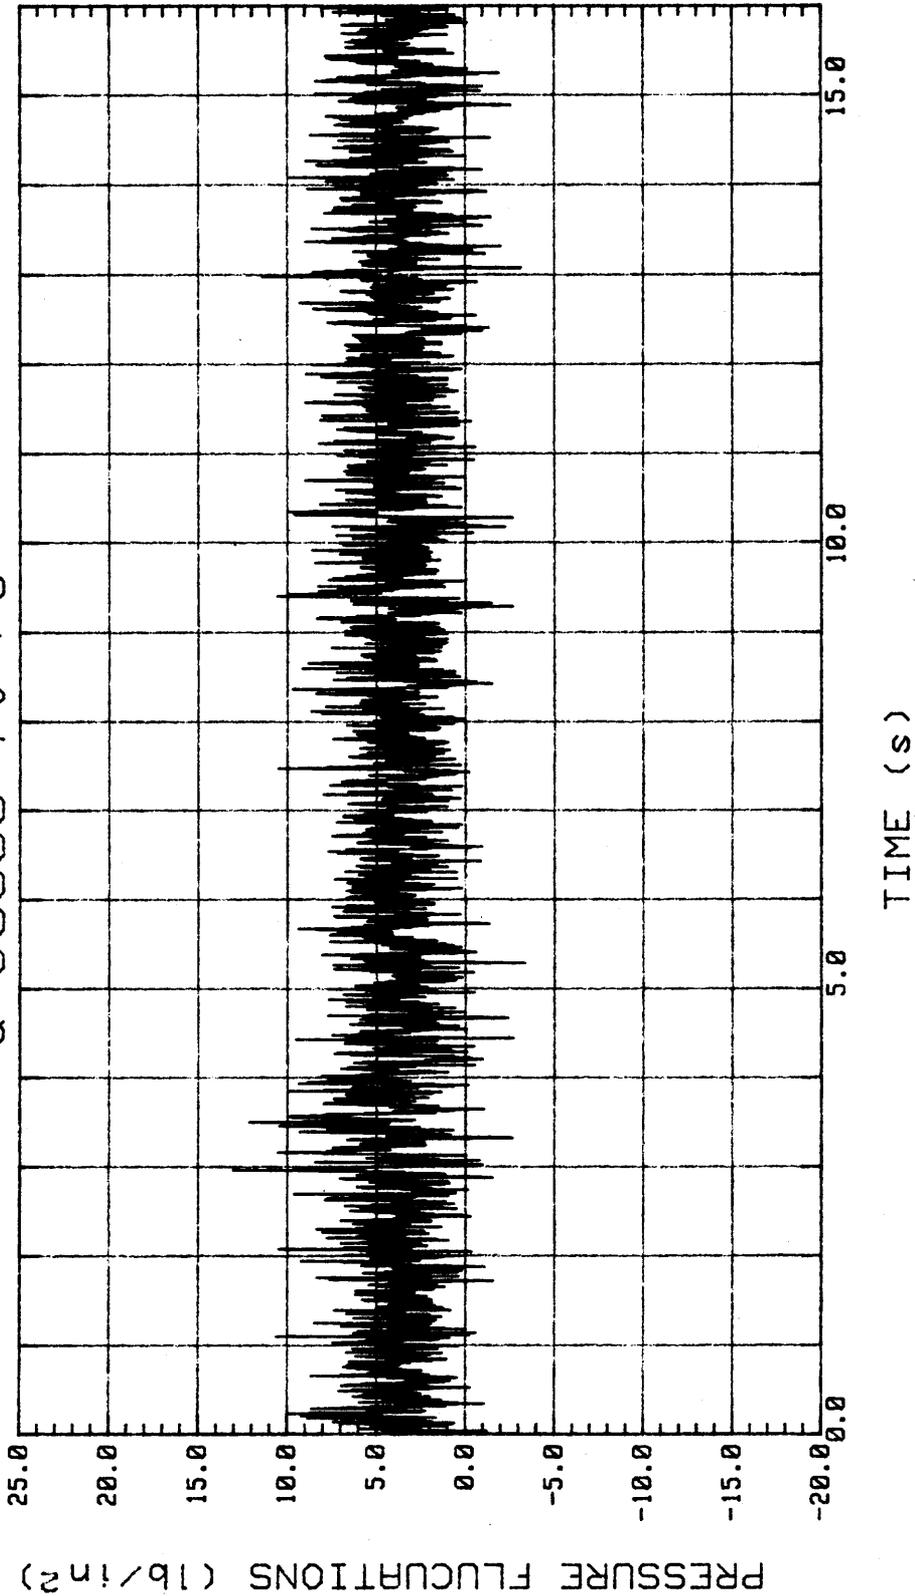
The dynamic pressure fluctuations measured at Boxes 2, 3, and 7 were digitally recorded for five different flowrates. Time records of the fluctuations are shown on figures 5 through 18. The analog pressure fluctuation signals also were fed into a spectrum analyzer. Figure 19 shows a typical spectrum plot from the transducer in Box 7 for flowrates of 10,000, 20,000, and 35,000 ft³/s.

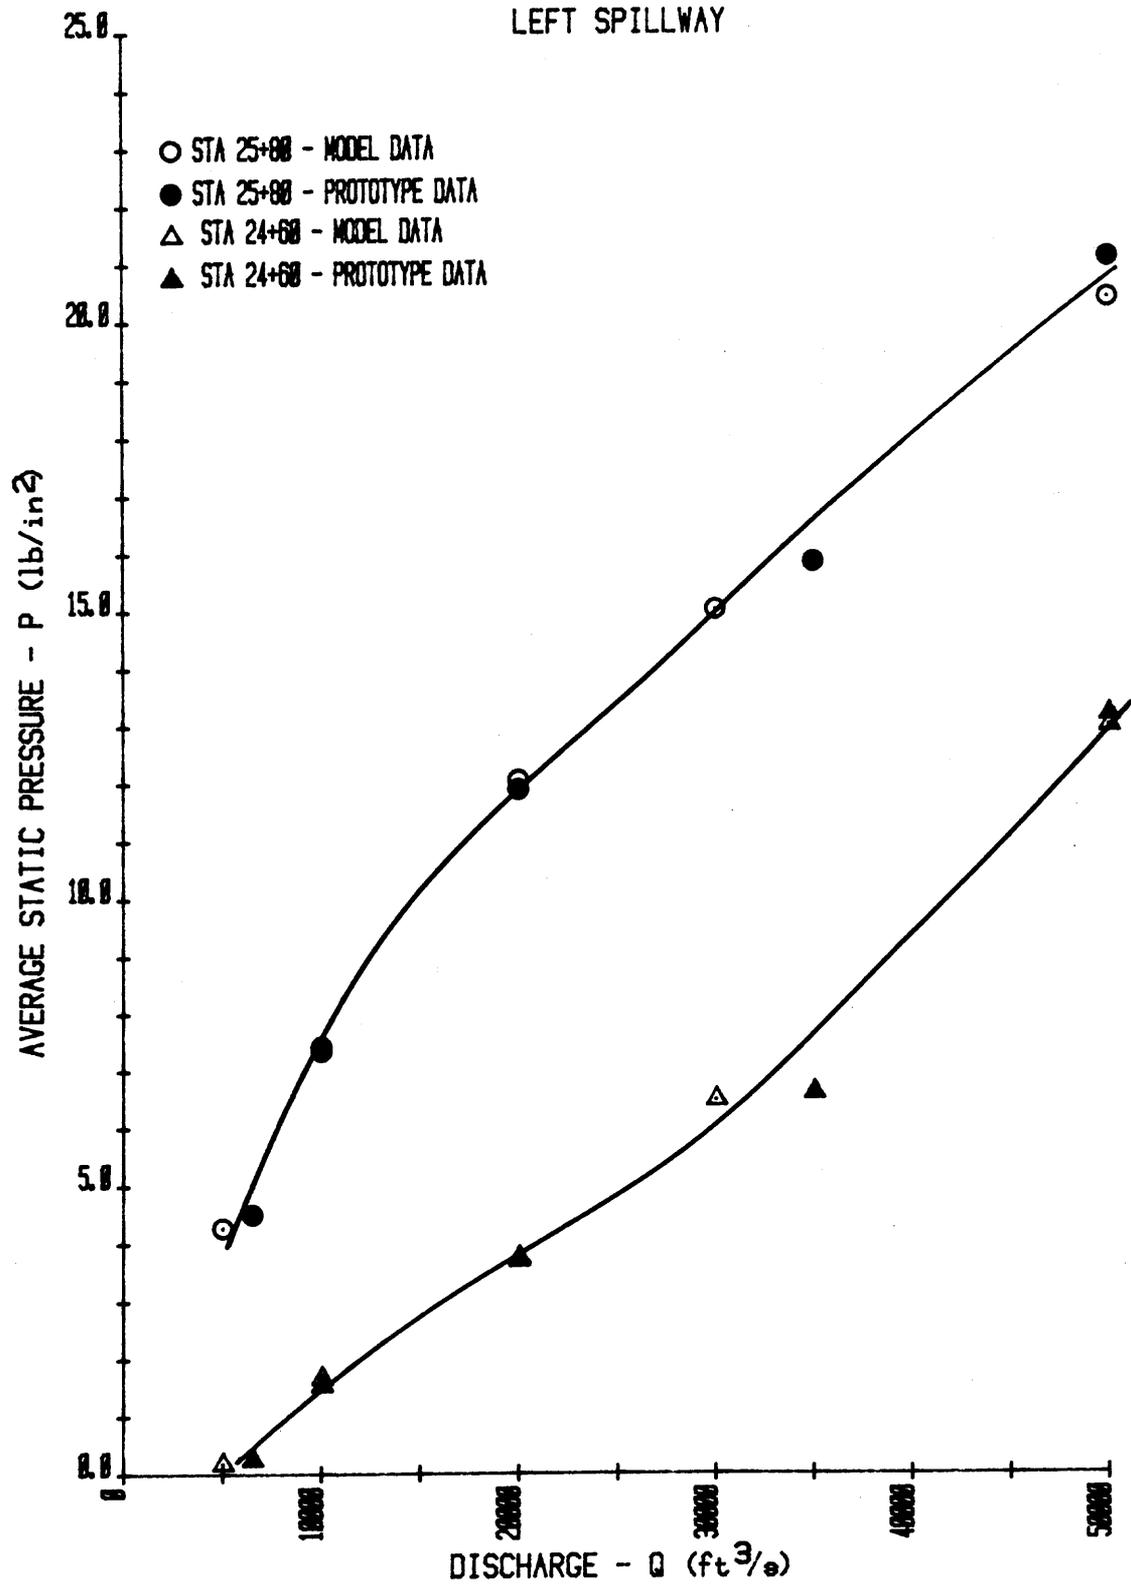
Figure 20. - Model-prototype comparison of static pressures at sta. 24+60 (Box 6), and Sta. 25+80 (Box 3).

A comparison of model and prototype static pressures from the available data is shown on figure 20. These compare well; however, dynamic pressure fluctuations present problems with scaling since, not only amplitudes, but frequencies are important. The mean pressure fluctuations for all flowrates were positive. This indicates that there are more positive pulses than negative, or that the amplitude of the positive spikes was much greater.

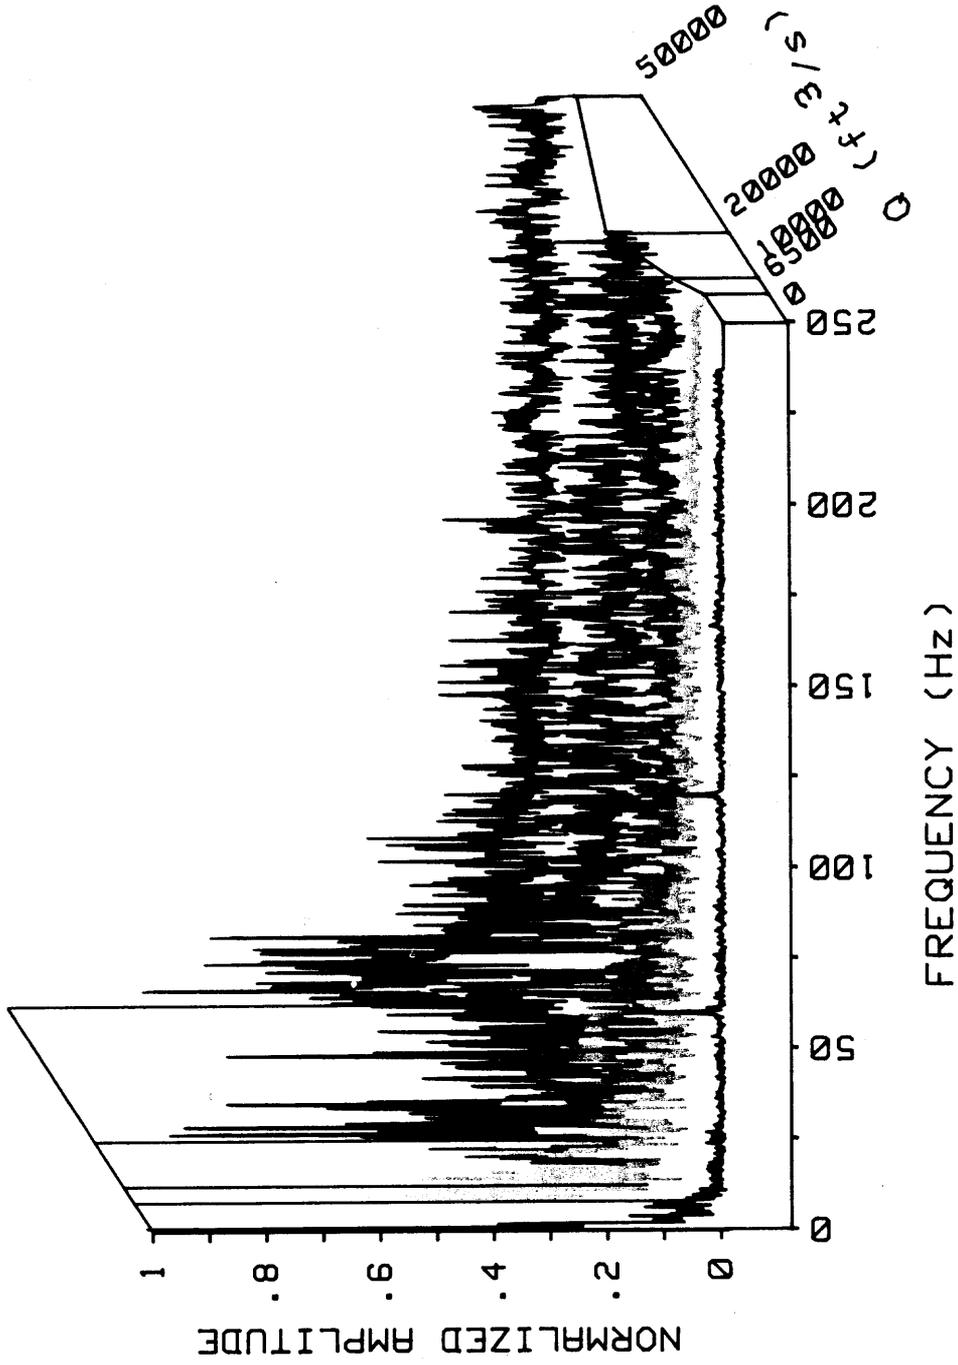
Figure 21. - Prototype frequency spectrums (by FFT) of dynamic pressure fluctuations at Sta. 24+20 (Box 7).

Both methods yielded similar results. The spectrum analyzer was capable of covering a frequency range up to 25 kHz, while the digital data allowed frequency analysis only up to 250 Hz. The major energy in the frequency spectrum occurred below 100 Hz as shown on figure 21; this is FFT data from digital recordings (Refer to figure 19 for a similar plot of spectrum analyzer data.). Correlation between model and prototype dynamic pressure fluctuations was not found. Frequency appears to function as a dependant variable; therefore, it does not allow separate scaling of the fluctuation amplitudes. The model spectrums show major spectral power caused by bubble noise which does not show up in the prototype.
