# Hydrogeology and Deformation of Sandbars in Response to Fluctuations in Flow of the Colorado River in the Grand Canyon, Arizona

U.S. GEOLOGICAL SURVEY  
Water-Resources Investigations Report 95—4010

By MICHAEL C. CARPENTER, ROBERT L. CARRUTH,  
JAMES B. FINK, JAMES K. BOLING, and  
BRIAN L. CLUER

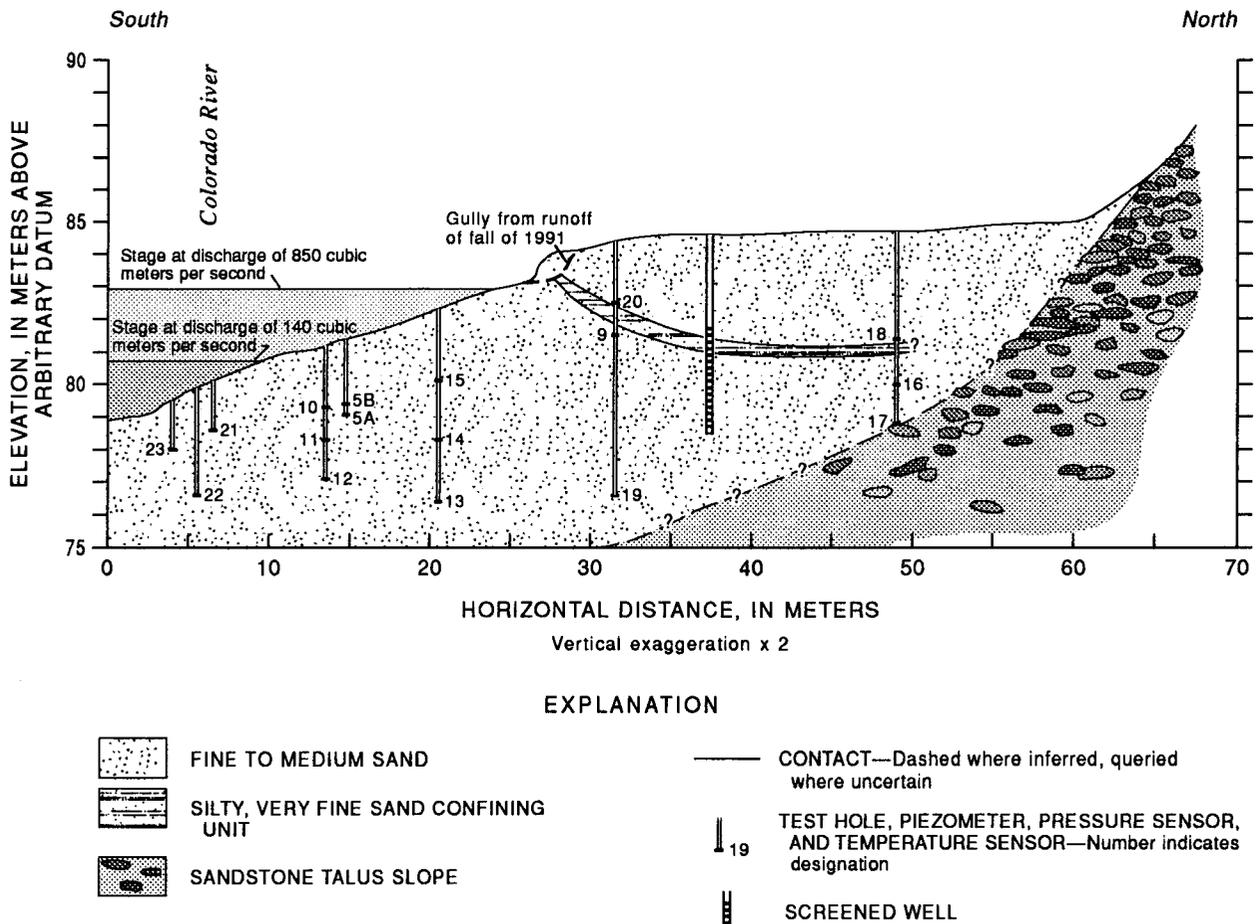
Figure 2. Geologic section and location of sensors at sandbar -6.5R, upstream from Lees Ferry.

Sandbar -6.5R<sup>1</sup> (fig. 2), upstream from Lees Ferry, consisted of a unit of homogeneous fine to medium sand underlain by a confining unit of silty, very fine sand. The confining unit was 0.14 m thick where it cropped out in a gully that was eroded into the sandbar in the fall of 1991. The unit dipped toward the back of the sandbar where it flattened and attained a depth of about 3.5 m. The confining unit was underlain by another unit of fine to medium sand. The back boundary of the sandbar was sloping talus and there was no return channel.

This sandbar had a gentle slope in the zone of fluctuating river stage and exhibited a seepage face with rill erosion but did not exhibit slumping and fissuring. This sandbar was considered to be a control for comparison with the two deforming sandbars. Tilt sensors were not installed in sandbar -6.5R; therefore, this sandbar is not discussed further in this report.

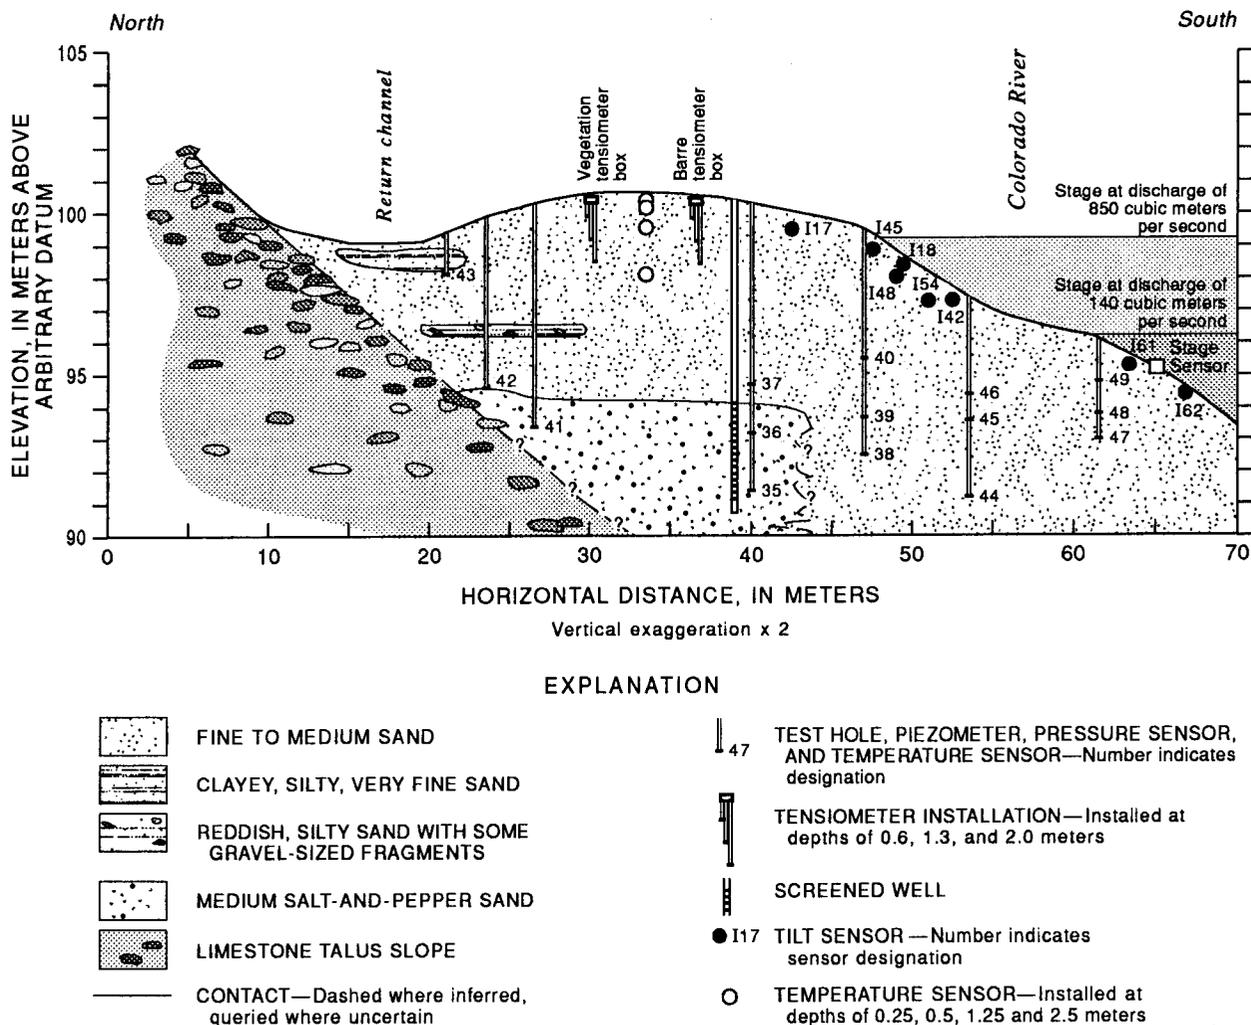
**Figure 3.** Geologic section and location of sensors at sandbar 43.1L, opposite Anasazi Bridge.

Sandbar 43.1L (fig. 3) consisted of homogeneous fine to medium sand overlying medium salt-and-pepper sand at a depth of 6 m. The back boundary was talus with a narrow, deep return channel underlain by a thin, clayey silty sand. A

second reddish, silty sand with some gravel occurred at a depth of about 4 m in the back of the sandbar. The zone of fluctuating river stage was a steeply sloping face that exhibited rill erosion, slumping, and fissuring.

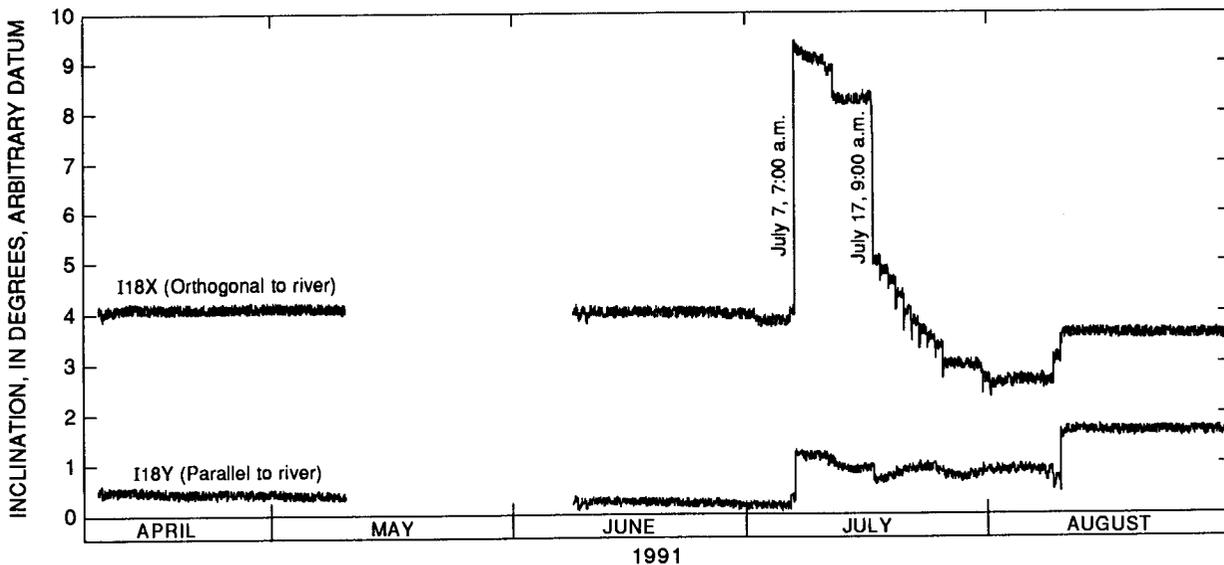
Figure 6. Tilt for sensor I18 at sandbar 43.1L, opposite Anasazi Bridge, April 8 through August 31, 1991.

At sandbar 43.1L, a sequence of tilts occurred from July 7, 1991, through July 17, 1991 (fig. 6). The tilts were at least five times greater in the  $x$  tilt sensor, which is oriented orthogonal to the river, than in the  $y$  tilt sensor, which is oriented parallel to the river. The major tilts were preceded by tilt of  $-0.1^\circ$  toward the river (along the  $x$  axis) on the morning of July 2, and tilt of  $0.1^\circ$  toward the river

on the evening of July 6. At 8:00 a.m. on July 7, tilt of  $5.5^\circ$  occurred toward the river. At 9:00 a.m. on July 12, tilt of  $-0.5^\circ$  occurred; and at 9:00 a.m. on July 17, an additional tilt of  $-3.3^\circ$  occurred. These major tilts were followed by continued negative tilt in the  $x$  sensor from July 18 to July 26, punctuated with daily spikes of about  $-0.4^\circ$  that occurred in the morning. With the single exception of the precursor positive tilt on July 6, all of the sudden tilts occurred on downward limbs of the hydrographs (figs. 7-11)

when the effective stress (intergranular stress) in the sandbar face was increasing. The hypothesis suggested by this sequence of tilts is slumping or rotational failure, in which tilt sensor I18 was within a slump block during the major upward tilt on July 7, followed by several occurrences of creep. An alternative hypothesis is slumping with tilt sensor I18 within the slump block on July 7 followed by slumping with tilt sensor I18 outside

the slump block on subsequent tilts. The sensor may have had a tendency to realign itself in a preferred orientation or may have been affected by the cable connecting the sensor to the datalogger, in spite of efforts to prevent such problems. The slope failure was shallow because none of the nearby tilt sensors—I17, I45, I48, or I54—(fig. 3) exhibited any tilt during April to July 1991. Tilt sensor I42 failed in April 1991. The probable cause of slope

failure on this sandbar was oversteepening of the lower part of the slope in the zone of fluctuating river stage. This conclusion was supported by evidence of rill erosion in daily photographs taken automatically from the opposite bank (Cluer, 1991). Rilling was enhanced during fluctuating weekend low flows (fig. 7). Rilling was intense after about 1.5 days during research steady low flows.

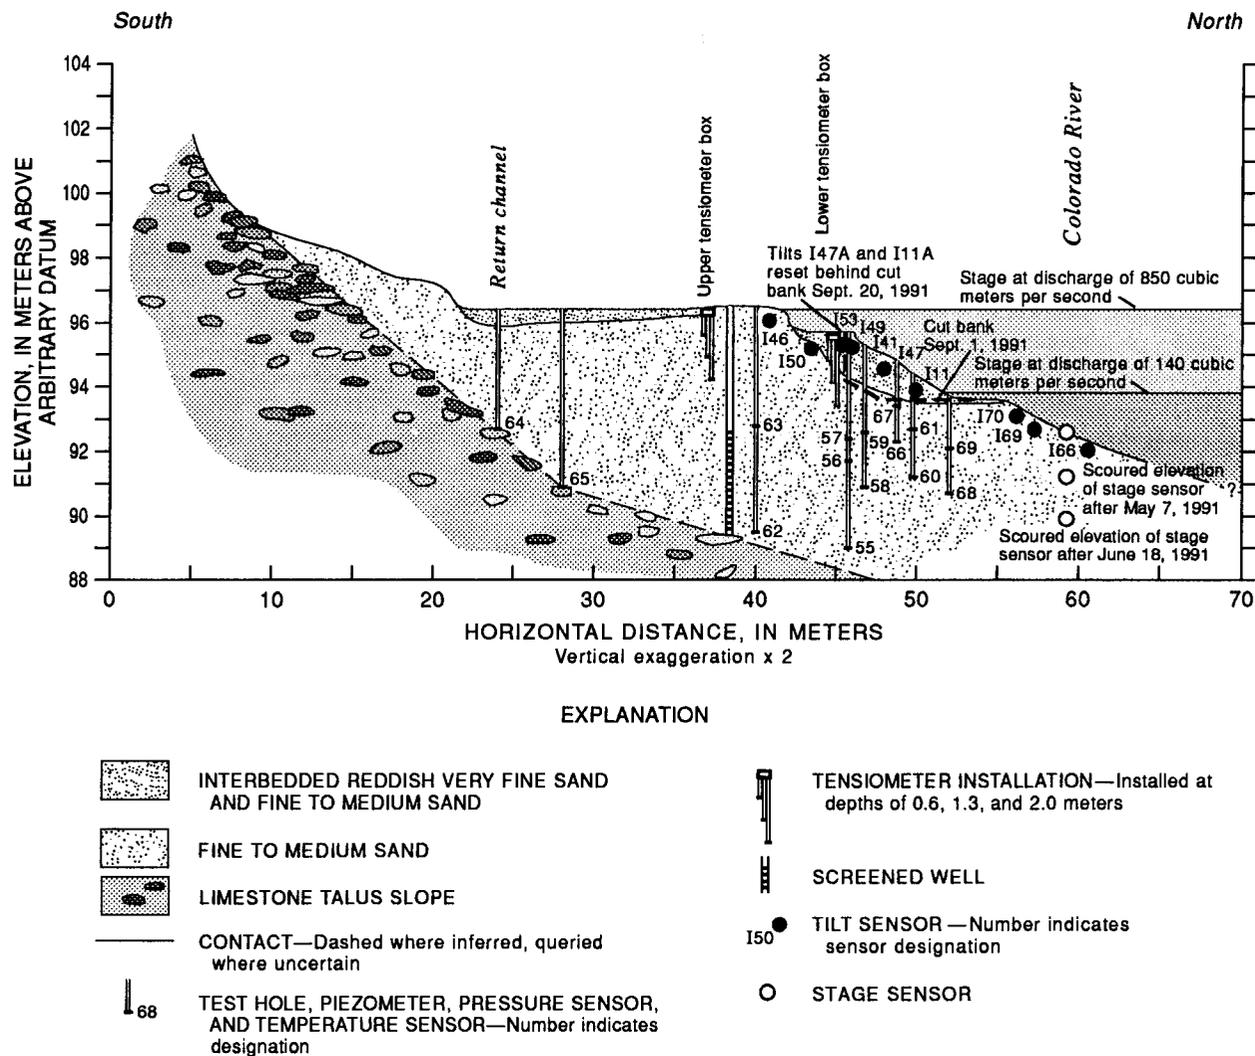
**Figure 12.** Geologic section and location of sensors at sandbar 172.3L, downstream from the mouth of National Canyon.

Sandbar 172.3L (fig. 12) consisted of inter-layered fine to medium sand and silty, very fine sand. The back boundary was talus abutted by a broad shallow return channel underlain by silty fine sand. The zone of fluctuating river stage was a steeply sloping face with a bench that was underlain by reddish, silty, very fine sand interlayered with fine to medium sand. This sandbar exhibited rill erosion, slumping, and fissuring.

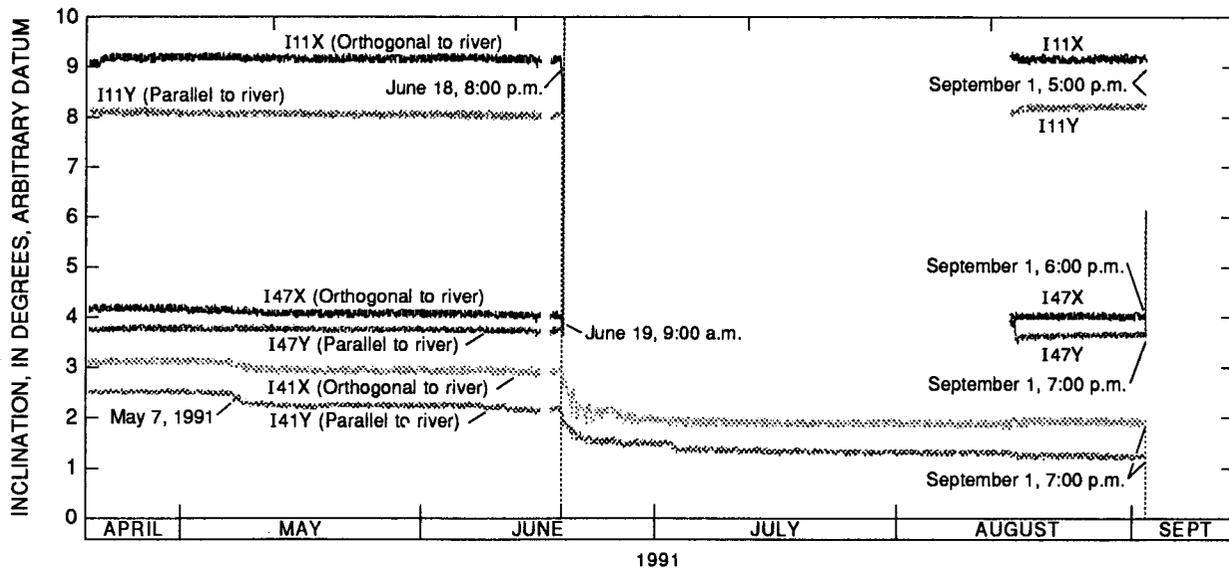
**Figure 14.** Tilt for sensor I18, I41, and I47 at sandbar 172.3L, downstream from the mouth of National Canyon, April 19 through September 12, 1991.

Several tilts occurred at sandbar 172.3L. At this sandbar, the tilts documented by tilt sensors occurred on the rising limb of a hydrograph and probably were all related to scour. Major scour accompanied by tilt began about 11:00 p.m. April 17 and lasted until about 1:30 a.m. April 18, 1991. This scour was observed by the crew installing the sensors before sensors were operational in the sandbar. In this scour event, which also occurred on the rising limb of the hydrograph, a large sand peninsula in the upstream end of the eddy was completely eroded. Scour events documented by tilt sensors and daily photographs taken automatically by a camera on the opposite bank include May 7, 1991, at about 7:30 p.m.; May 13, 1991; June 18, 1991, about 7:30 p.m.; and September 1, 1991. Minor tilting of  $-0.3^\circ$  in both axes of tilt sensor I41 occurred in the 2 days following the May 7 tilt (fig. 14). No other tilt sensors exhibited any tilt during this period.

On June 18, tilt sensor I11 went off scale at  $\pm 12^\circ$  about 8:00 p.m. Sensors I41 and I47 tilted about 9:00 a.m. on June 19. Sensor I41 tilted  $-1.1^\circ$  in the  $x$ -axis and  $-0.7^\circ$  in the  $y$ -axis in the 5 days following June 18. The succession of tilts from sensors in the river to sensors farther into the sandbar indicated failure by scour. On September 1, 1991, the entire face of sandbar 172.3L was scoured. Tilt sensor I11 went off scale
