U.S. Geological Survey
Geologic Investigations Series I-2663
Online version 1.0

Map Showing Quaternary Geology and Geomorphology of the Lees Ferry Area, Glen Canyon, Arizona

Present (1996) and Past (1921) Views of the Lees Ferry Area

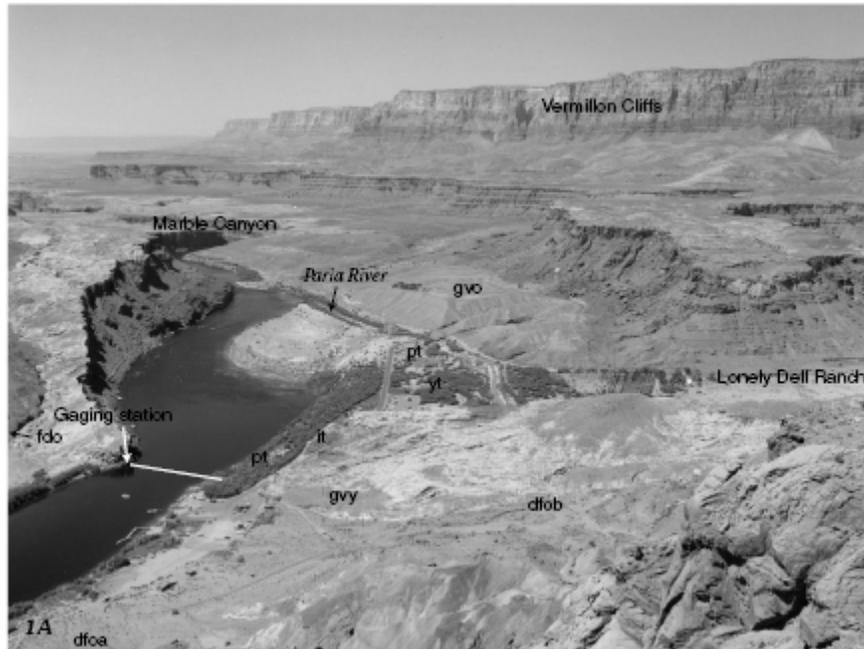
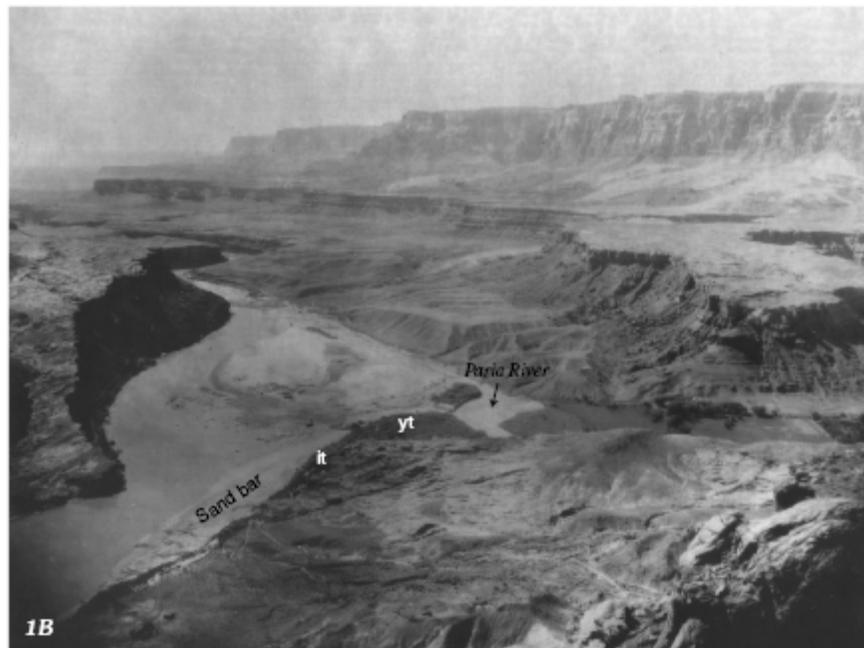
Figure 1. (A) Colorado River and Lees Ferry area from Spencer Trail; view to the southwest, photograph taken May 8, 1996 by Richard Hereford. (B) Approximately same scene as 1A, photograph taken 1921. Several of the mapped units are shown with labels; line across river is cableway. From Emery Kolb Collection (accession no. 568-4600), Special Collections Library, Northern Arizona University, Flagstaff.

The landscape of the Lees Ferry and Lonely Dell Ranch area has changed noticeably in the past 75 years (figs. 1 and 2). These rematched photos capture two unrelated types of change. The landscape reflects changes in local land use along the Colorado River and a decrease in the width of the channels of the Colorado and Paria Rivers.

Present land use is now almost entirely recreational, involving fishing, launching point for whitewater rafting in the Grand Canyon, and hiking. The area was developed for recreation beginning in 1963. This development resulted in the disturbed areas, roads, parking areas, boat launching ramps, and National Park Service (NPS) facilities shown on the geologic map and figure 1A. Traditional uses were agriculture, livestock raising, hydraulic mining, and transportation. Interestingly, this early activity was less visible in the landscape than development for recreation, as shown by figure 1 (A and B).

The channel of the Colorado River is substantially narrower than in 1921 (fig. 1). The width of the channel immediately downstream of the right-bank cableway is about 50 m less than in 1921. Most of this decrease is from aggradation of the pre-dam terrace (pt) on a sand bar visible in the 1921 photograph (fig. 1B). Aerial photographs show that the former sandbar had become vegetated by at least 1937. The relatively low flows after the 1921 flood of 6,250 m³/s (220,000 ft³/s) resulted in deposition of sand on a floodplain in the former channel adjacent to the terrace rise of the intermediate terrace (it). The pre-dam terrace (pt) has evidently been little affected by regulated

streamflow since closure of Glen Canyon Dam in 1963. Steep banks have been cut into the terrace; otherwise it has not been eroded any more than the width of the post-dam zone (pdz), which varies from 0–20 m at this locality. Vegetation on all the terraces has also changed substantially. In 1923, sandbar willow was the dominant shrub and saltcedar was probably absent (Turner and Karpiscak, 1980), whereas today saltcedar is the dominant shrub and less than two dozen willow remain only as stumps in the mapped area.

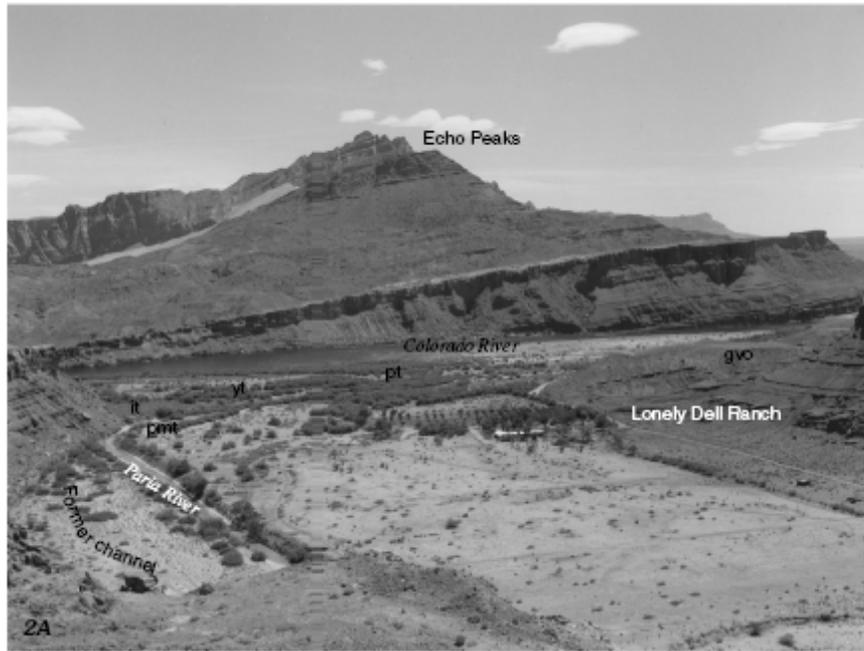
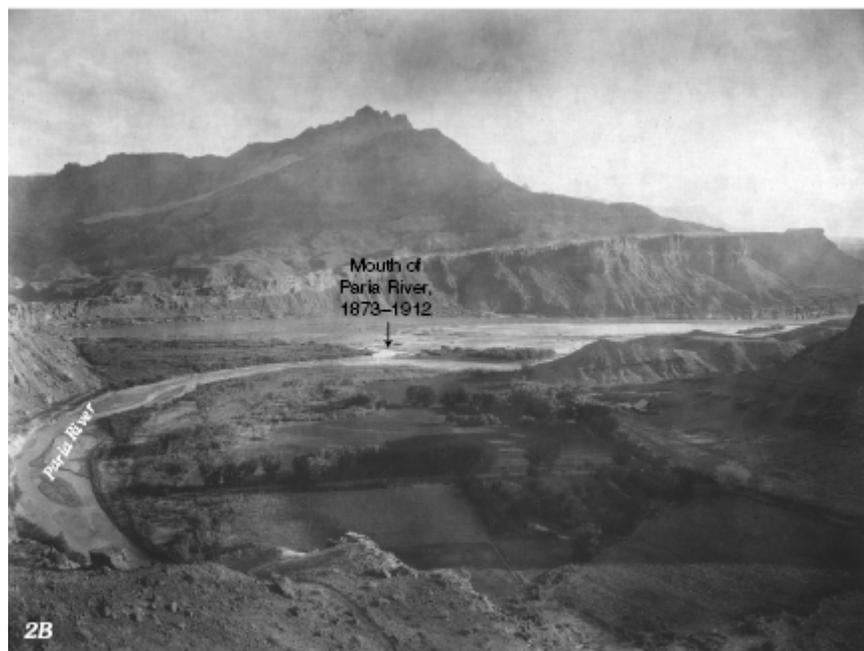
Figure 2. (A) Lonely Dell Ranch and Lees Ferry area; view to southeast, photograph taken May 7, 1996 by Richard Hereford. (B) Approximately same scene as 2A, photograph taken 1921. Several of the mapped units are shown where they occur at the north boundary of map area. From Emery Kolb Collection (accession no. 568-1383), Special Collections Library, Northern Arizona University, Flagstaff.

The landscape of the Lonely Dell Ranch area has changed the least from human activity (fig. 2). Hiking is the principal recreational use of this area, leaving little mark on the landscape, as suggested by figure 2A. The once productive agricultural fields near the ranch are now abandoned (fig. 2B). The orchards are maintained by the NPS, but the surrounding fields are not irrigated or planted. Future NPS plans include small native grass plots for restoration projects (K. Crumbo, oral commun.).

The channel of the Paria River is also substantially narrower than in 1921 (fig. 2). This decrease in channel width began during the early 1940s (Hereford, 1986). Aggradation along with narrowing of the former channel (fig. 2A) built up the modern terrace of the Paria River (pmt). In addition, the junction of the Paria with the Colorado River shifted southwest 1.5 km (0.9 mi) in 1912 according to Reilly (1999). A photograph taken in 1873 (Turner and Karpiscak, 1980, fig. 32A) shows the mouth of the river southwest of the long-term parking lot, on what is now the pre-dam terrace. This junction was abandoned after 1912 and before 1917 and was subsequently covered by deposition of the pre-dam terrace (pt) and modern terrace of the Paria River.
