**MONITORING THE EFFECTS OF INTERIM FLOWS FROM GLEN CANYON DAM ON
SAND BAR DYNAMICS AND CAMPSITE SIZE IN THE COLORADO RIVER
CORRIDOR, GRAND CANYON NATIONAL PARK, ARIZONA**

DRAFT FINAL REPORT: 1 October, 1994

**Stanley S. Beus, Matthew A. Kaplinski, Joseph E. Hazel Jr.
Geology Department
Northern Arizona University, Campus Box 4099
Flagstaff, AZ 86011**

Short Title of Work: INTERIM FLOW SAND BAR SURVEY: Annual Report

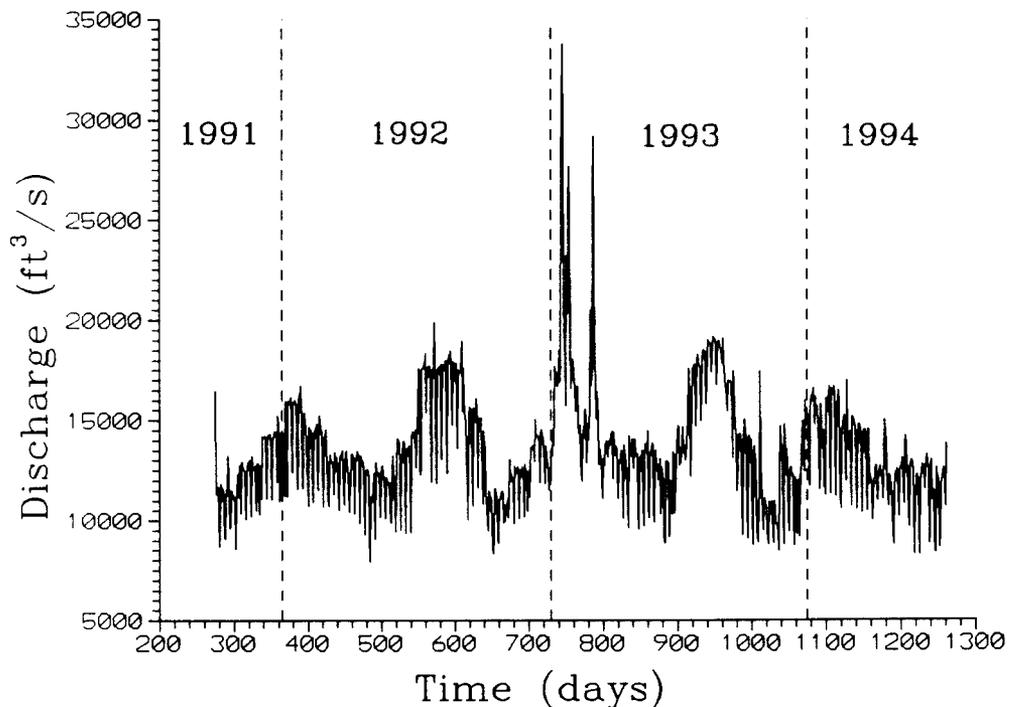
Figure 2. Daily maximum discharge hydrograph from Colorado River gauge near Grand Canyon (RM 88) for the interval between October 1991 and June 1994.

The IF have been in effect since August, 1991 (Figure 2) and will continue until a ROD is reached for the GCD-EIS. The IF limit the maximum discharge to 566 m³/s (20,000 ft³/s), the minimum to 142 m³/s (5,000 ft³/s), with rates of up- and downramp to 57 m³/s/hr (2,000 ft³/s/hr) and 42.5 m³/s/hr (1,500 ft³/s/hr), respectively. Daily change cannot exceed 142 m³/s (5,000 ft³/s). These IF consist of low-, medium-, and high-volume months, with low flows during the late Spring and late Fall, moderate flows in May and September, and high flows during mid-Summer and mid-Winter.

Natural flood events along the Little Colorado River during January and February, 1993, caused a significant deviation from the lower-volume interim flow regimes along the mainstem Colorado River (Figure 2). Three flood events occurred on the LCR on January 12-16, January 19-23, and February, 23-26, 1993, that raised flows in the mainstem Colorado to 960 m³/s (34,000 ft³/s), 764 m³/s (27,000 ft³/s), and 849 m³/s (30,000 ft³/s) respectively. Sand was deposited in nearly every eddy downstream of the LCR-Colorado confluence for at least 30 miles, either adding to existing deposits or filling empty eddies. (Hazel et al., 1993).

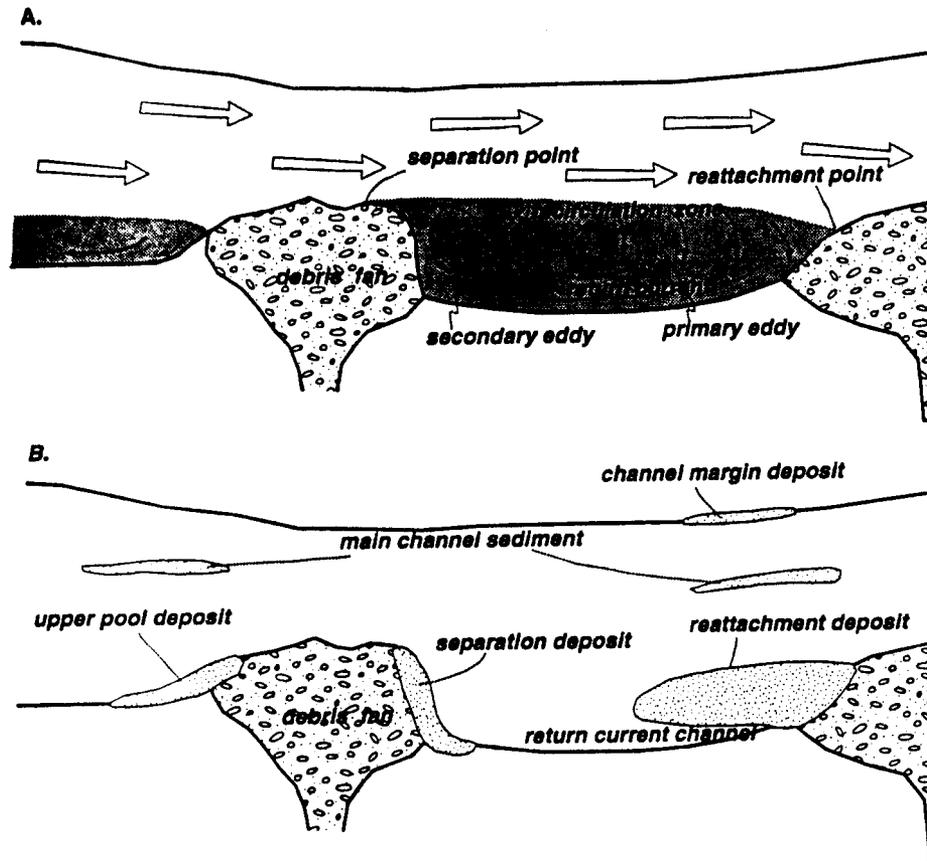
Figure 3. Schematic diagram showing flow patterns and configuration of bed deposits in a typical recirculation zone. A) flow patterns. B) Configuration of bed deposits. Modified from Schmidt and Graf (1990).

Sand storage in recirculation zones varies with changes in discharge, size and dimensions of debris fans, and tributary sand input. Sand is therefore a sensitive indicator of dam operations and consequent cause and effect relationships. Depending on the operating regime for GCD the balance between sand supply and main channel transport can be positive or negative (Smillie, et al., 1992). Since much of the remaining sediment in the Colorado River below GCD is stored in recirculation zones, the effects of IF operations on the stability and morphology of sand bar deposits is closely linked to how recirculation zones respond to alternative water release patterns.

During lower discharge flow regimes such as IF, recirculation zones generally consist of a primary eddy and large areas of both the reattachment and separation bars are exposed. The reattachment deposit may fill much of the recirculation zone beneath the primary eddy. As discharge increases and recirculation zones expand, more area is inundated, and secondary eddies or low velocity zones develop upstream of the return current channel. Return-current channels are excavated by the increase in current velocity as flow across the

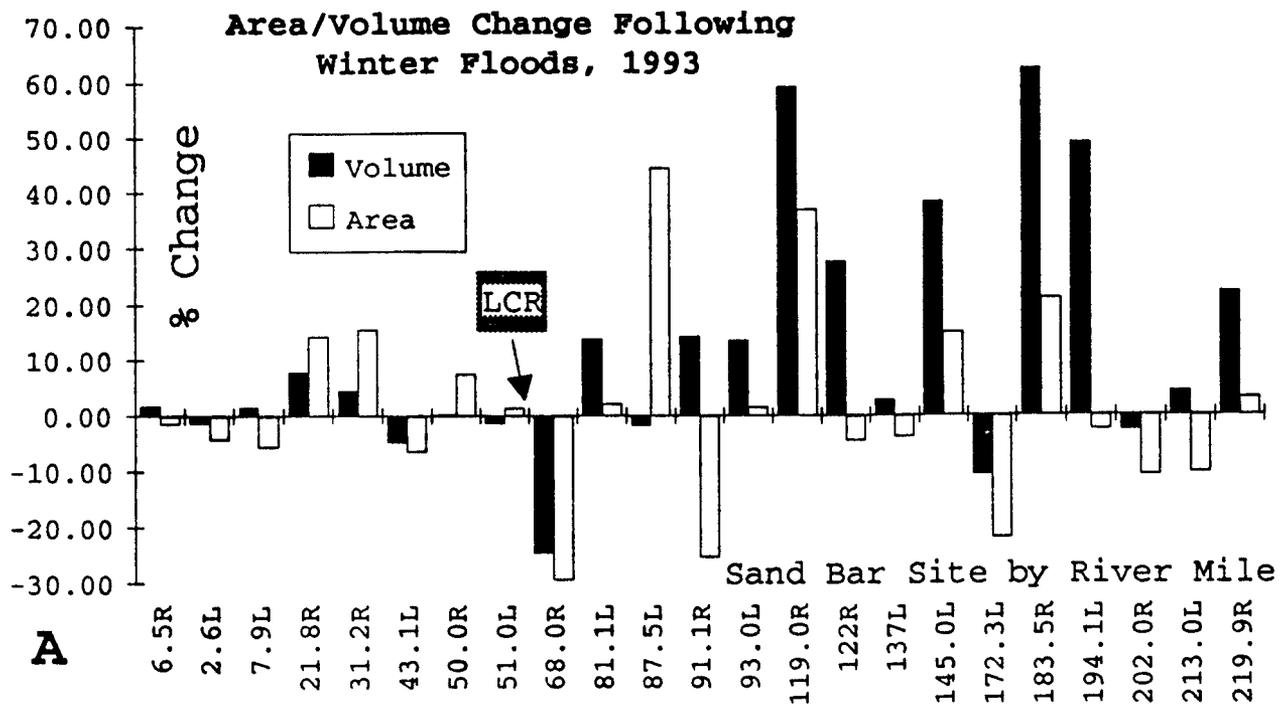
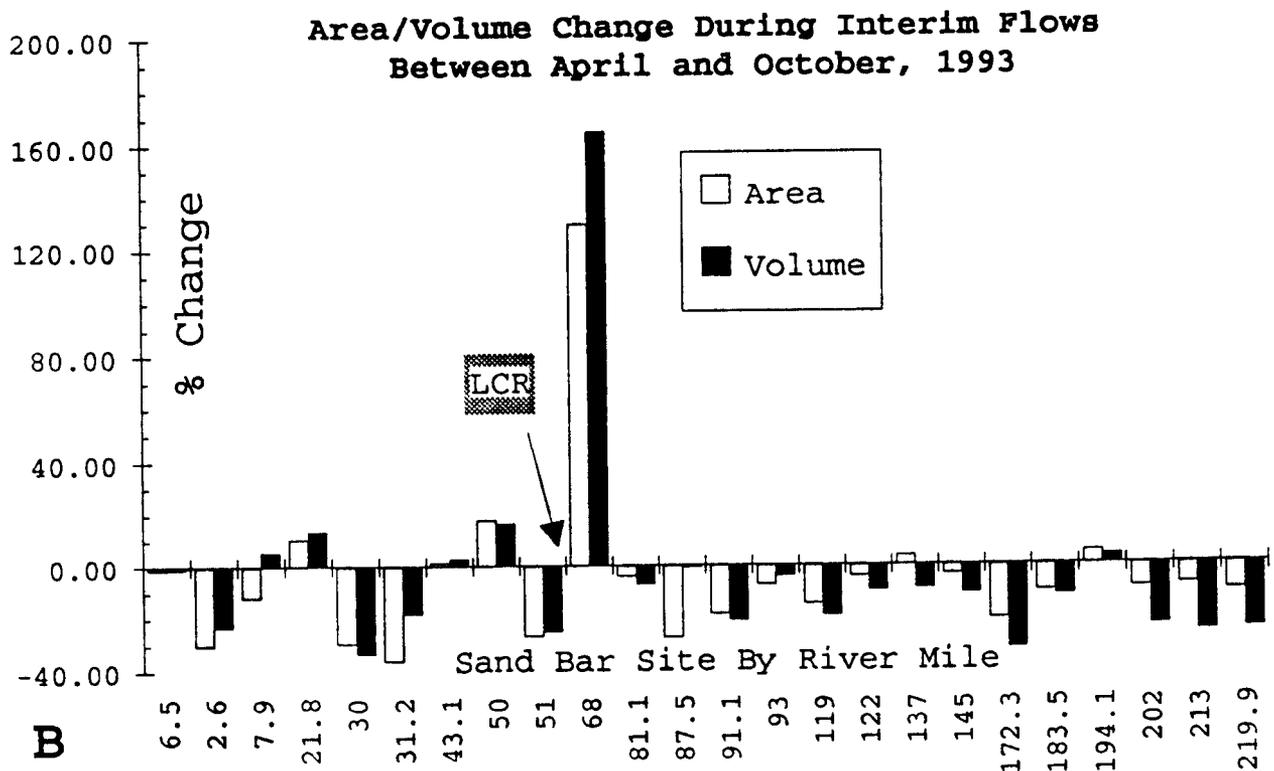
Figure 4. Net HAZ volume and area change for A) 23 sand bars between the October 1992 and April 1993 surveys; and B) sand bar volume and area change between April and October 1993. Note the dynamic sand bar response to the floods downstream from the LCR in A and loss of HAZ volume in these same bars in B.

with HAZ depletion in recirculation zones (Figure 4b). In addition, two large HAZ volume losses (see volume plots in Appendix A: RM 2.6; RM51) are probably the result of bar failure (Appendix A: RM2.6, profile 6).

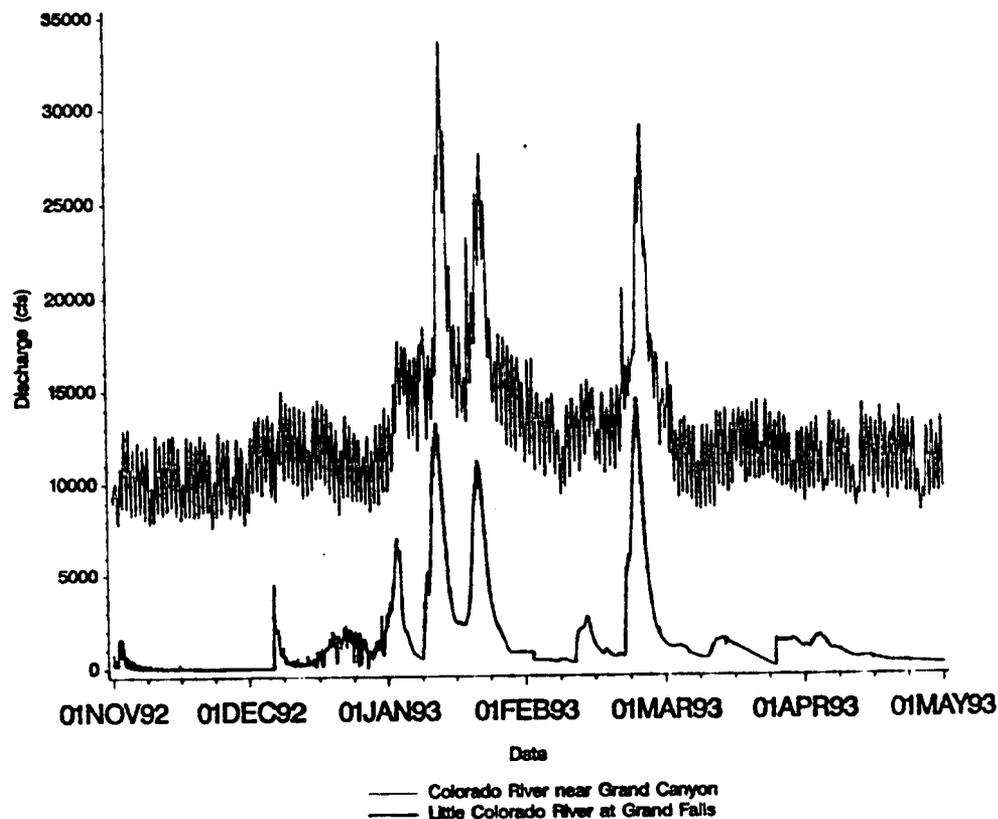
Figure 5. Hydrograph from the Colorado River (RM 88) and the Little Colorado River at Grand Falls for the interval between the October, 1992 and April, 1993.

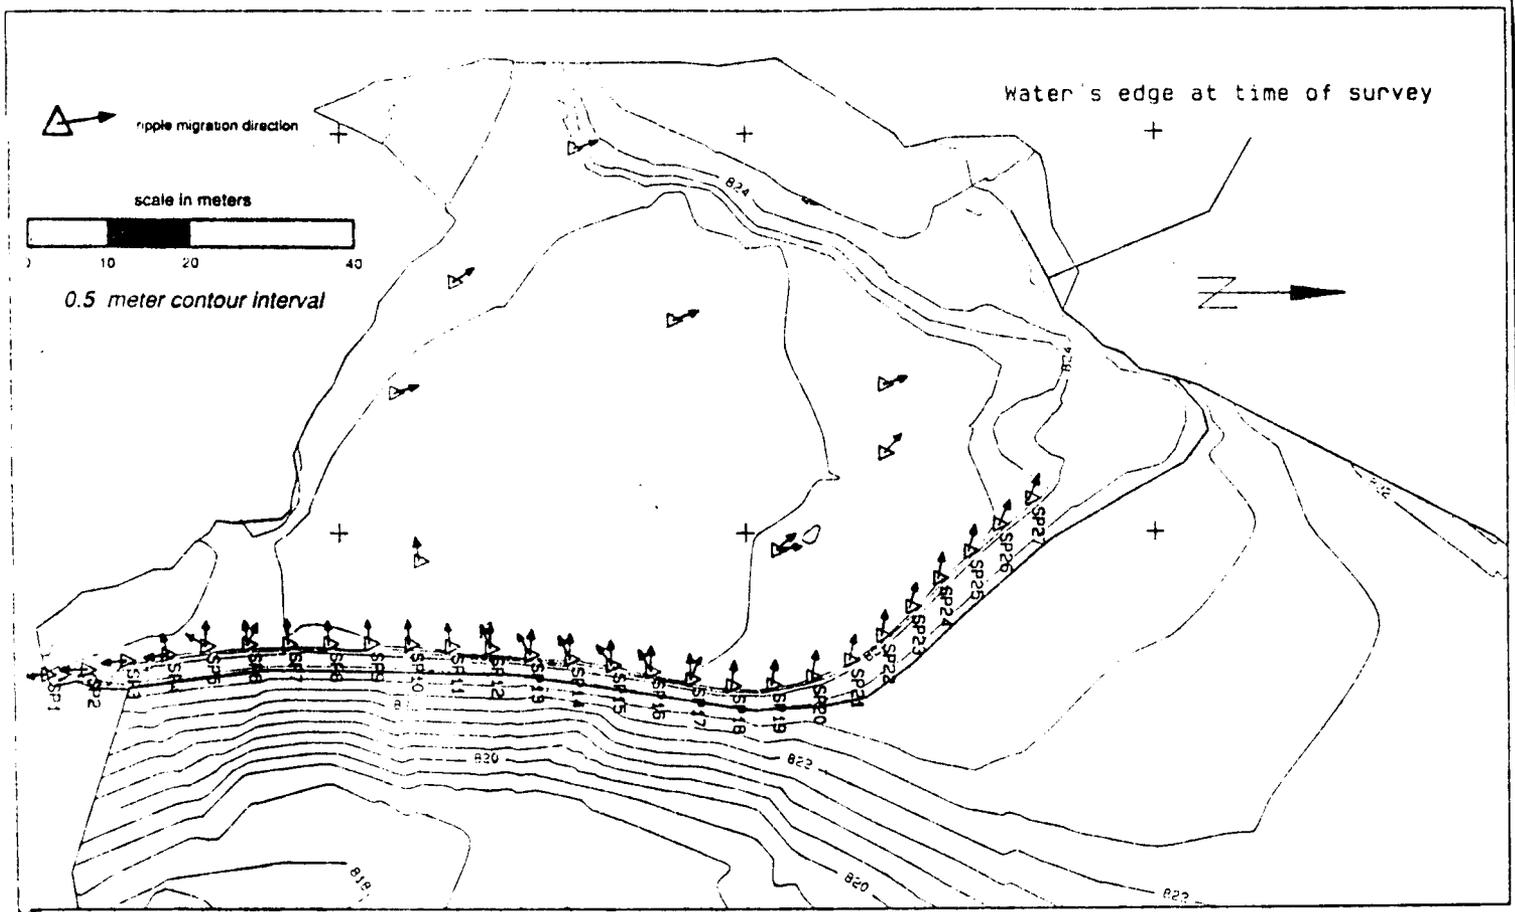
Figure 6. a) Topographic map of study site showing sedimentologic sampling locations. b) Schematic cross section (SP1 to SP27) of the reattachment bar.

sand bar evolution. Sedimentary structures exposed along this cutbank suggest that deposition began near the center of the eddy. The structures during this first stage are mainly overlapping scour pits filled with trough-shaped sets of cross-beds caused by subaqueous dunes migrating onshore. Continued deposition, accompanied by migration of ripples, caused the bar to expand until it approached the water surface throughout most of the eddy.

The sand bar was deposited entirely during the three flood events. The majority of the bar was deposited during the first, and largest of the three floods. The bar is comprised of three main stratigraphic units (Figure 6). Initial deposition (Unit 1) began during the first tributary flood event on January 12, 1993. As the flood elevated river stage and delivered large amounts of sediment, large-scale bedforms migrated into and across the empty eddy system accompanied by climbing ripple structures adjacent to the debris fan. The migration of the large-scale bedforms deposited an overlapping sequence of scour pits filled with trough-shaped sets of cross-beds (Rubin, 1987). This style of deposition continued until dune height approached the water surface. The majority of these bedforms were located near the center of the eddy and underly the topographically highest portion of the bar. The second unit was comprised mainly of climbing ripple structures that migrated onshore and onlap the upstream portion of the central core (unit 1) of the bar. Unit 3 overlies both units 1 & 2 and is characterized by horizontal plane beds at the downstream end of the bar that changed laterally into small-scale trough cross beds at the upstream portion of the bar platform. Unit 3 represented the final phase of deposition within the eddy and was the result of bedforms migrating bankward into the the eddy return current channel (Rubin et al., 1990). Units 2 and 3 could either be the product of the second or third flood events or the result of changes in flow regime due to daily dam fluctuations. Although inconclusive, we prefer the latter explanation, especially in reference to unit 2, because of the lack of clearly defined erosional scour surfaces. In addition, stage elevations during the second and third flood events were not as high and may have only slightly overtopped the first flood bar platform. The two later floods do appear to have aggraded the lower-elevation, upstream portion of the bar platform.

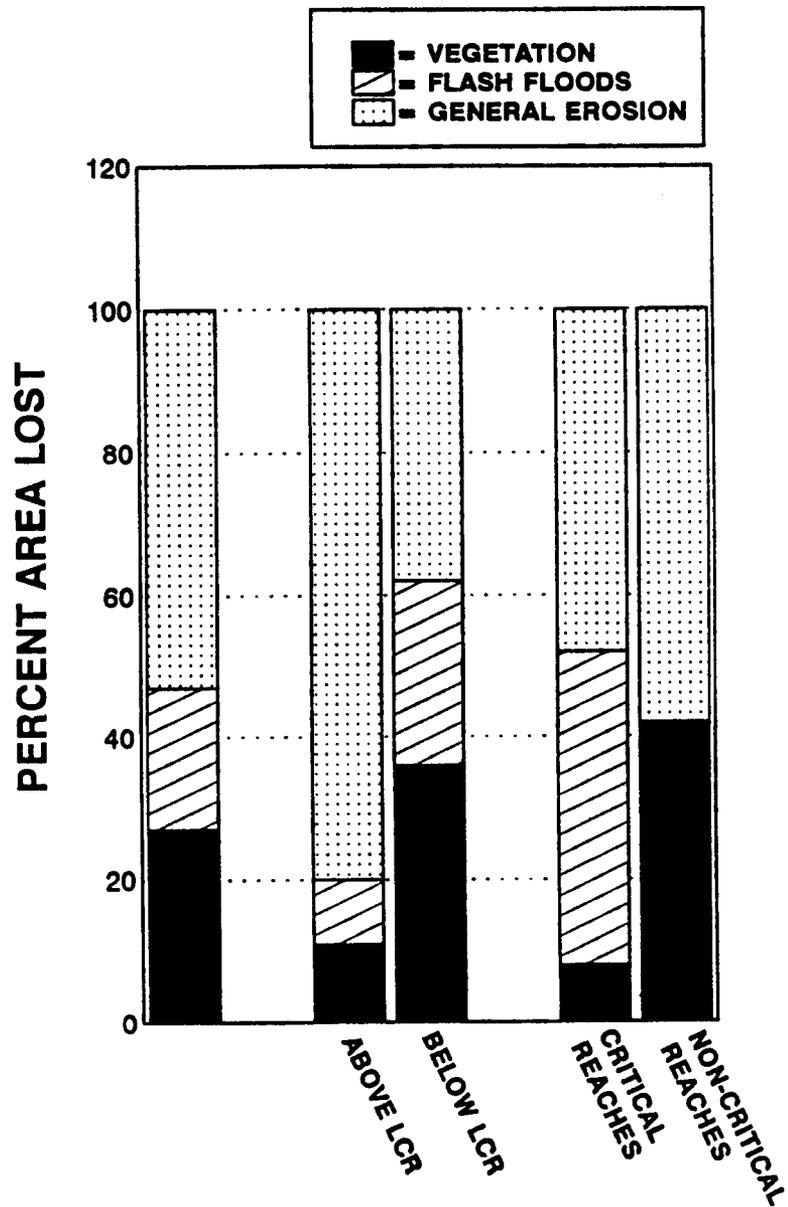
Figure 9. Percent camping area lost by vegetation growth, flash flooding, and general erosion causing sand loss above 226 m³/s or slope steepening. Percent campsite area lost above versus below the LCR caused by these factors. Percent area in critical versus non-critical reaches caused by these factors.

Twenty-seven percent of the lost campsite area between 1991 and 1994 was caused by vegetation growth (Figure 9). Most (61%) of this vegetation growth occurred below 708 m³/s. A much higher percentage of the area lost below the LCR was due to vegetation growth (36%) than above the LCR (11%). The differences in vegetation growth between critical and non-critical reaches are even more pronounced. Nearly half (44%) of the loss in campsite area in non-critical reaches between 1991 and 1994 was caused by vegetation growth, compared with only 8% in critical reaches.

Flash flooding was responsible for 20% of the lost campsite area between 1991 and 1994 (Figure 9). This high percentage results from severe flash flooding that drastically affected campsites between RM 155 and 161. Heavy rains on August 20, 1993 caused debris flows which according to historical photographs had not occurred in that area for over 100 years. These debris flows destroyed two campsites, RM 157.7R and 160.9R, and flooding from this event severely limited the size of two campsites, RM 155.7R, and 158.5R. Unfortunately, these campsites are in close proximity to Havasu canyon, an area that has the largest discrepancy between campsite supply versus demand in the Grand Canyon. If this flooding event had not occurred, flash flooding would have been responsible for 6% rather than 20% of lost campsite area between 1991 and 1994. The percentage of lost area below the LCR due to flash flooding (26%) was three times higher than that above the LCR (9%, Figure 9). Flash flood damage occurred almost exclusively in critical reaches, causing 0% of the lost campsite area in non-critical reaches between 1991 and 1994 and 44% of that in critical reaches. These percentages, however, are also affected by the 1993 flooding event. If it had not occurred, 4% rather than 26% of lost area below the LCR would have been lost due to flash flooding, and 35% rather than 44% of the lost area in critical reaches would have been lost due to flash flooding between 1991 and 1994. Flash flooding caused the loss of an additional 936 m² in campsite area between 1991 and 1994, but both aggradation during the 1993 flooding events and flattening out of flash flood gullies enabled this additional area to be useable for camping by 1994.

Approximately half (53%) of campsite area lost between 1991 and 1994 was due to erosion of sand above 226 m³/s or to increased slope so that the sand could not be used for camping (Figure 9). The percentage of area lost due to these factors above the LCR (80%) was twice that as below the LCR (38%). Percentages in critical versus non-critical reaches were similar.

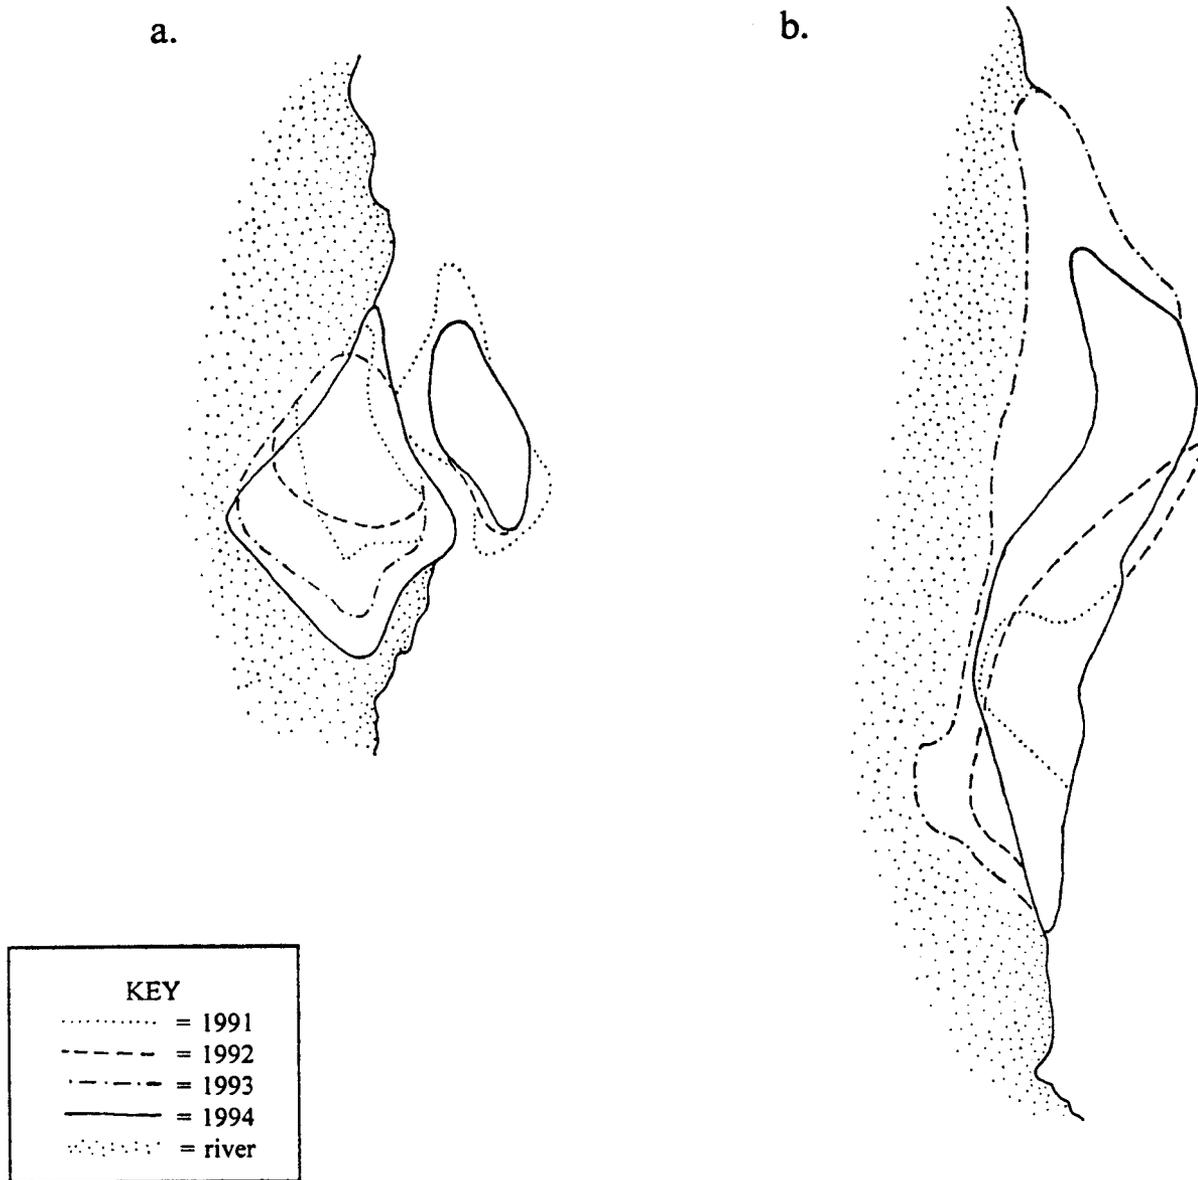
Figure 10. a) Campsite at RM 21.9R showing changes in campsite area below 708 m³/s between years. Low water area increased with each year, and higher terraced area decreased as river's edge of terrace migrated shoreward. b) Campsite at RM 61.7R, just downstream from the LCR, showing effects of 1993 flooding events on campsite area below 708 m³/s, with a large increase in 1993 and a substantial decrease in 1994.
