**EFFECTS OF A
BEACH/HABITAT-BUILDING FLOW ON
CAMPSITES IN THE GRAND CANYON**

FINAL REPORT

January 6, 1997

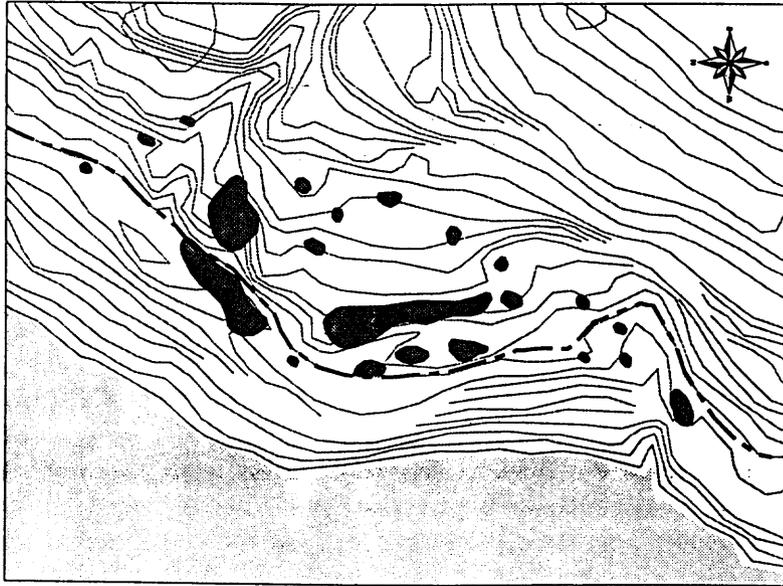
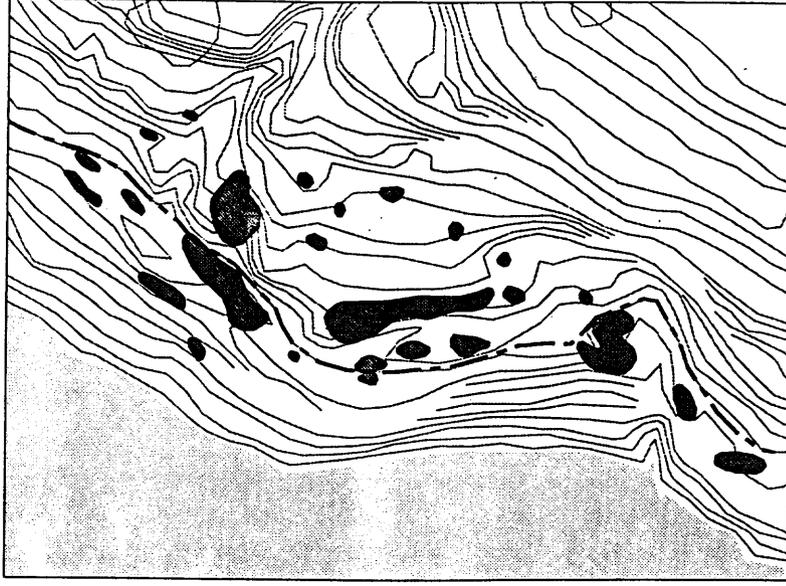
Campable Area: 44.2L, Eminence

Campable Area = 870 m²

Campable Area = 1230 m²

Campable Area = 1080 m²

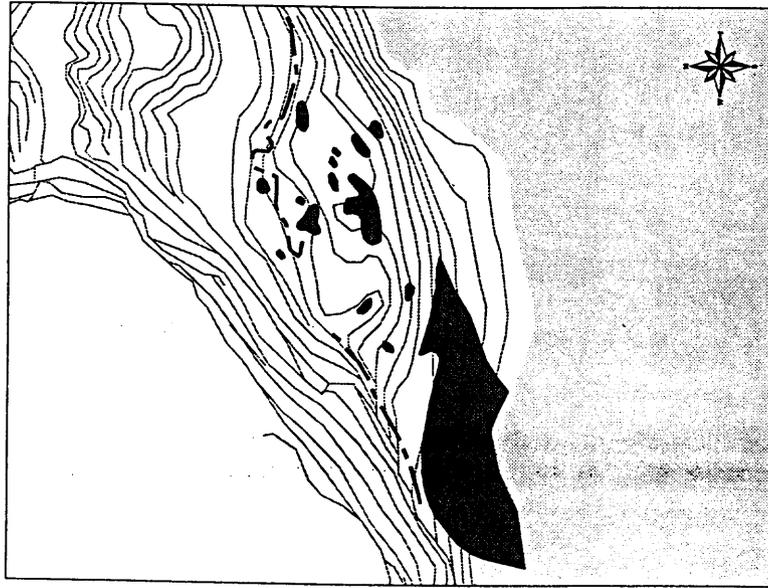
Campable Area: 61.7R, below LCR island

Campable Area = 990 m²

Campable Area = 200 m²

Campable Area = 170 m²

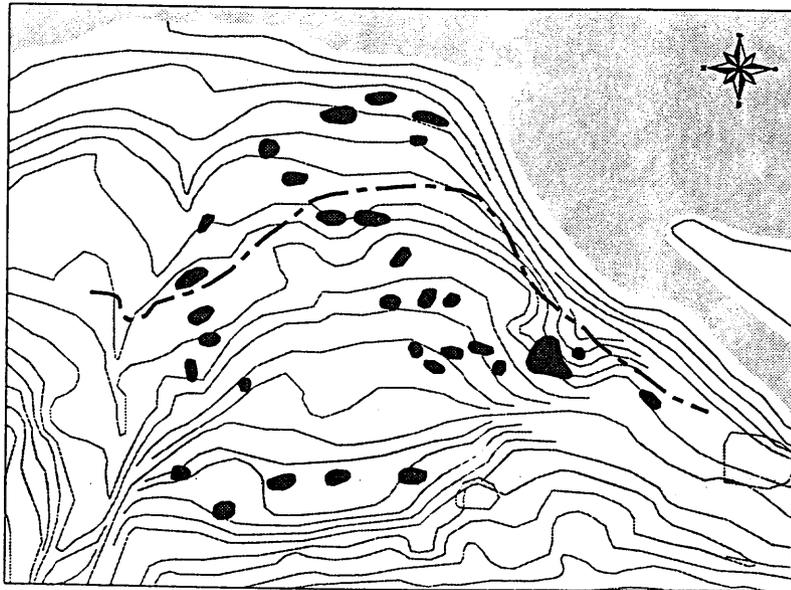
Campable Area: 64.7R, Carbon

Campable Area = 300 m²

Campable Area = 880 m²

Campable Area = 500 m²
