FINAL REPORT:

Aerial Photography of the GCES-II
Test Flows and Interim Flows.

Part One:
Analysis of Test Flows

Brian L. Cluer

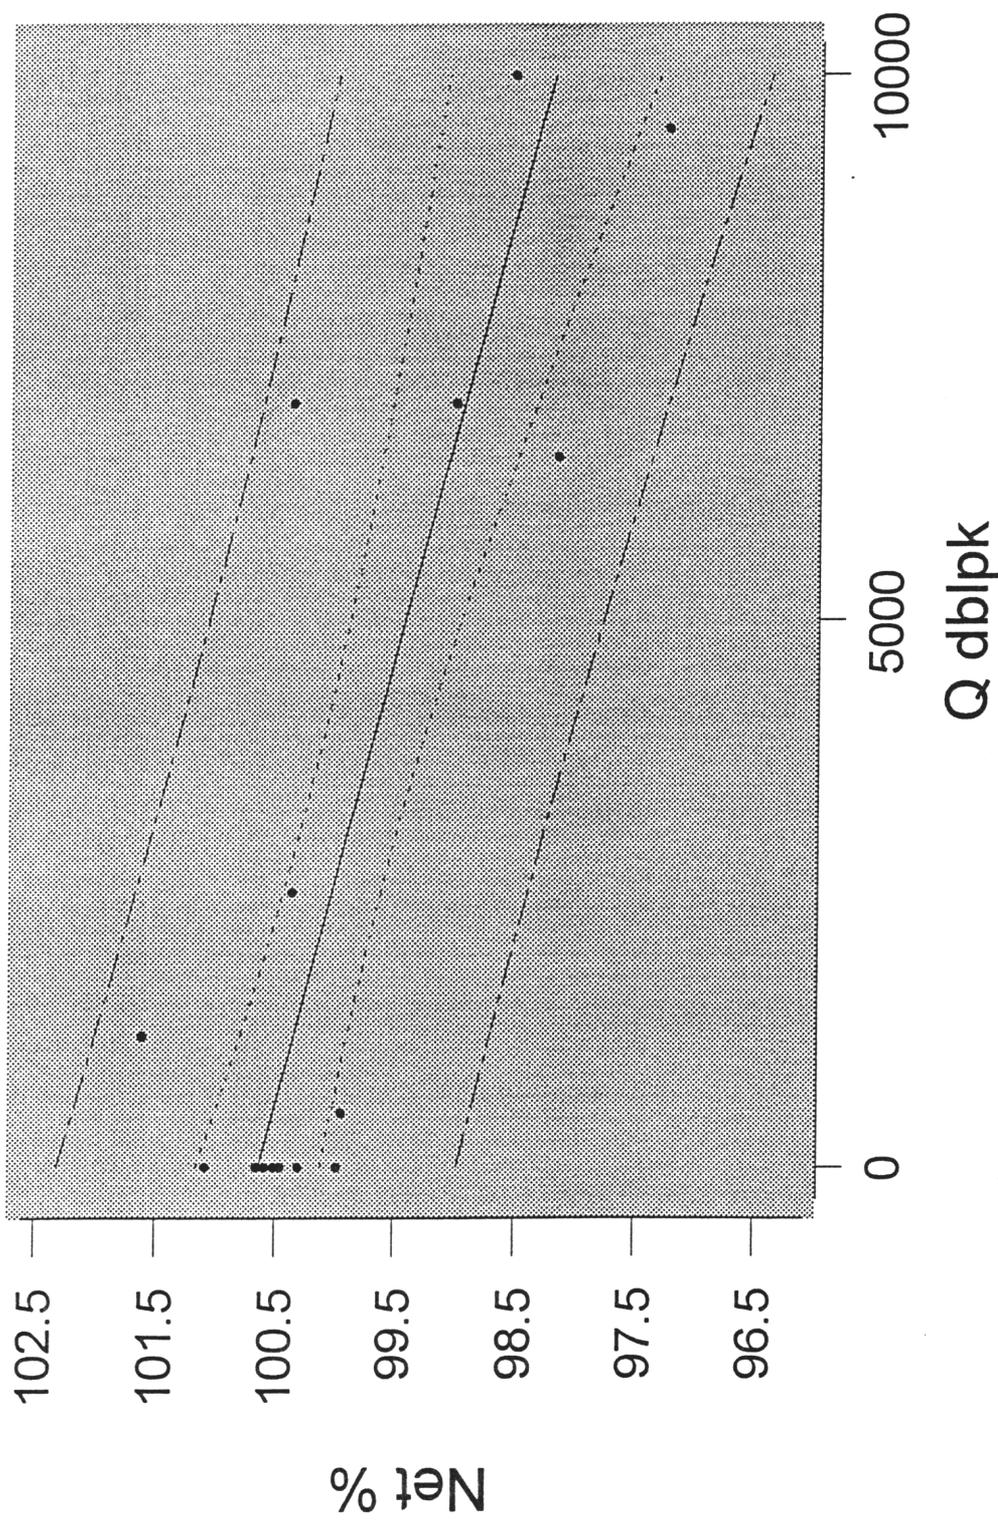
$Y = 100.64 - 2.45E-04X$
 R-Squared = 0.641
 --- 95.0% Confidence Bands --- 95.0% Prediction Bands

Figure 2. Fit of regression model for net area as a percentage of original area versus the discharge for double peaked flows.

The net area and reworked area models have R^2 values of 0.64 and 0.63, respectively (figures 2 and 3), and the parameters are significantly correlated at $\alpha = 0.05$ (p-values $\ll 0.001$). Standard diagnostic procedures (residual plots, normal probability plots, variance inflation factor, and Cook's Distance test) revealed no gross violations of the assumptions of linear regression (figures 4 and 5). The parameter TONS was transformed using the square root function following inspection of a scatter plot. The transformation resulted in slight improvement in R^2 values from 0.62 to 0.63.

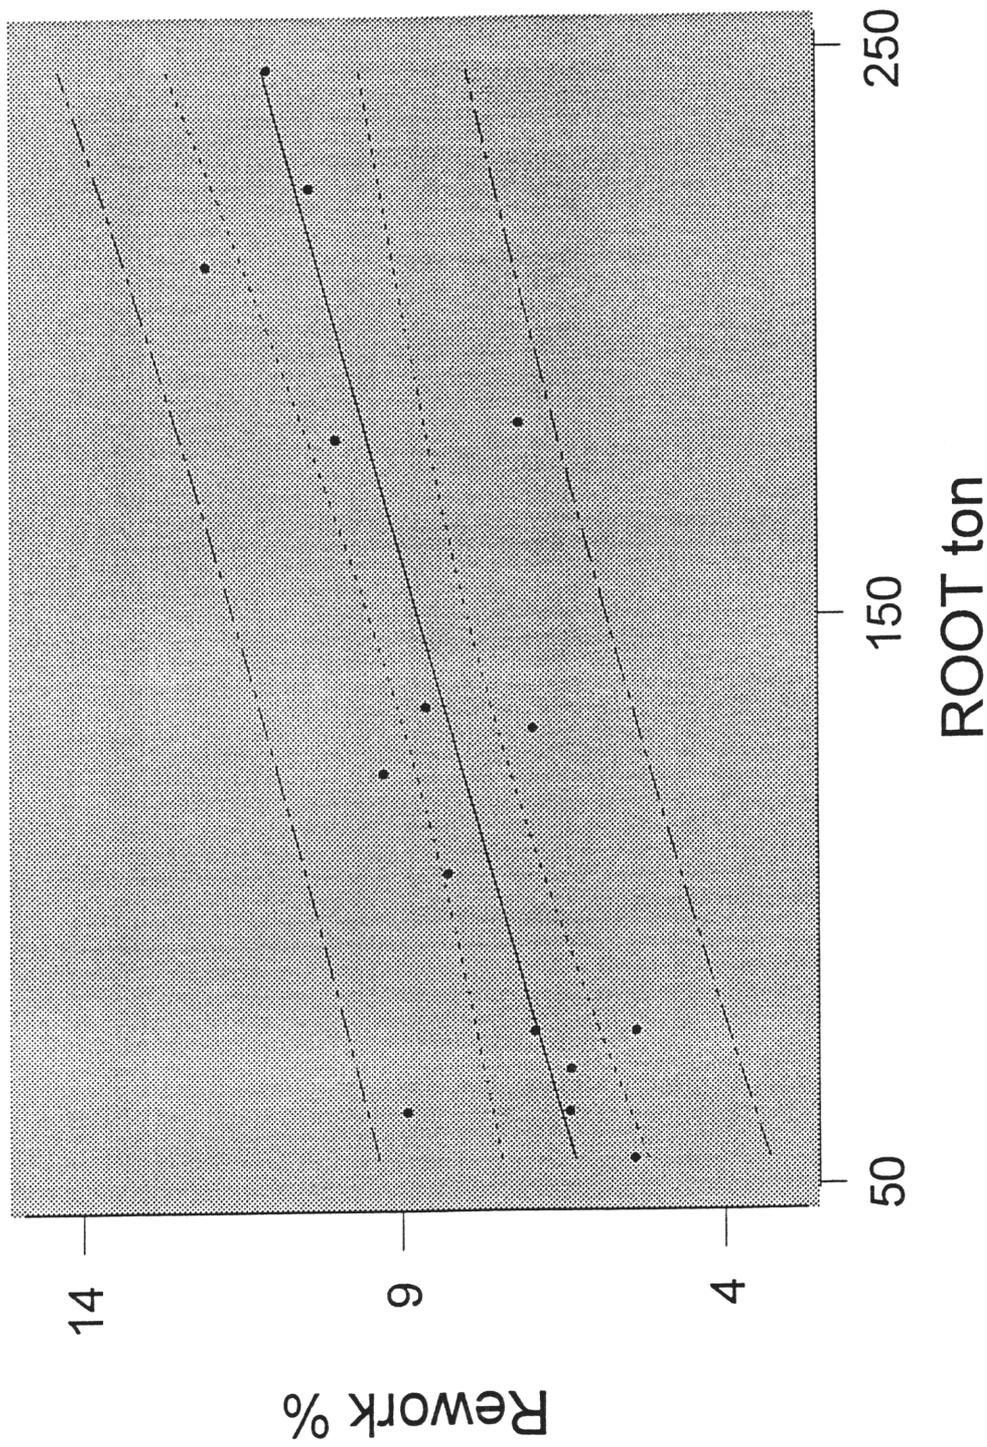
$$Y = 4.94343 + 2.52E-02X$$

R-Squared = 0.632

Figure 3. Fit of regression model for reworked area as a percentage of the original area versus transport capacity.

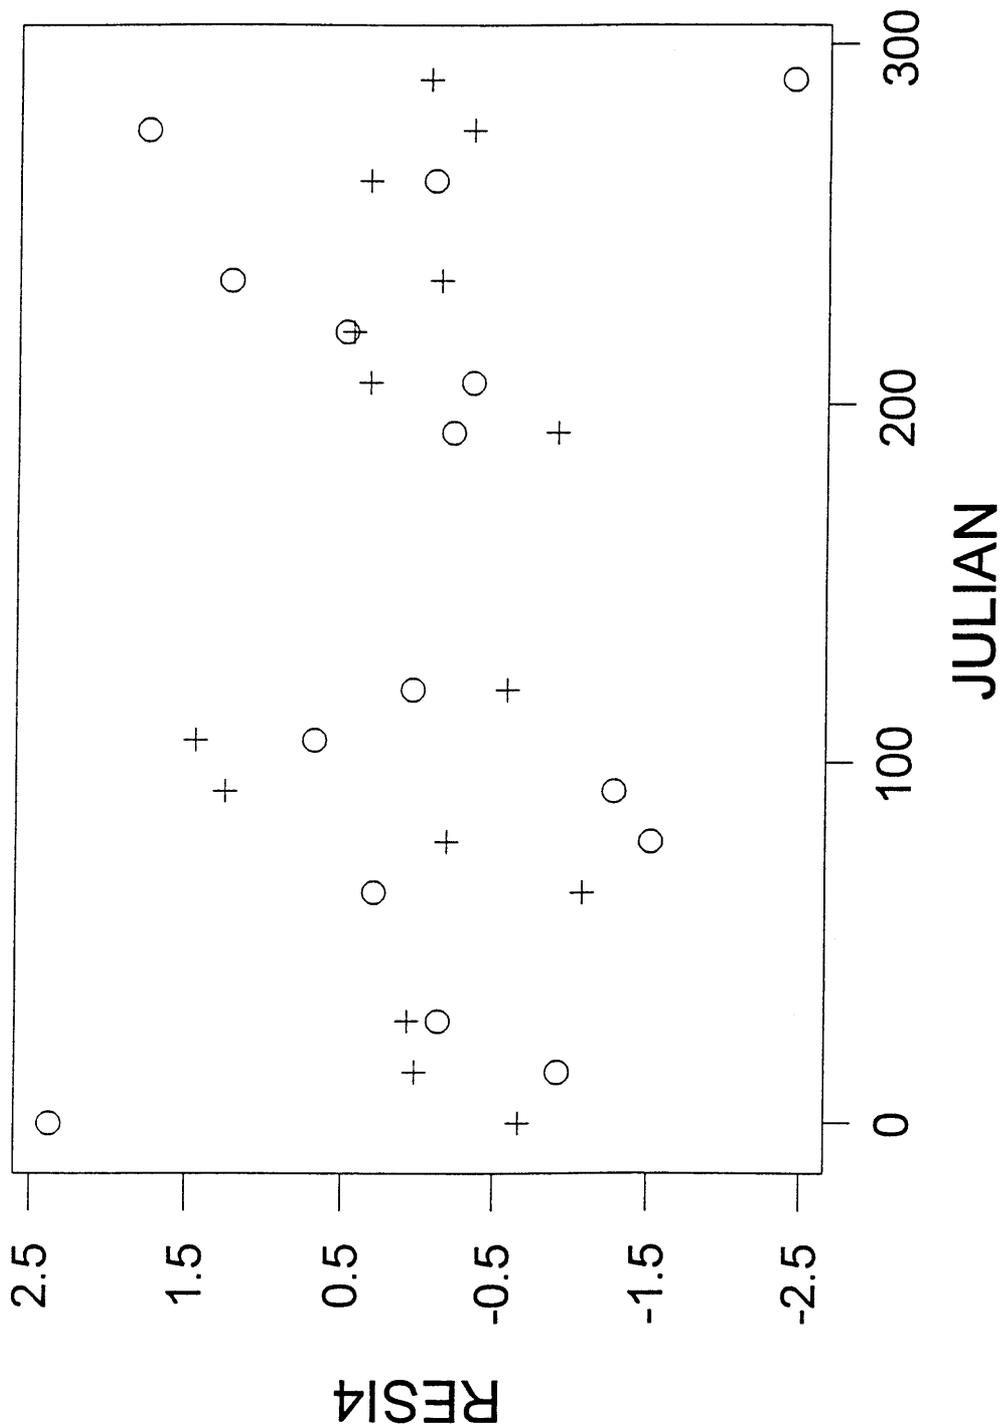
Figure 6. Time series plot of the model residuals indicating irregular cyclic pattern. Circles are for the reworked area residuals and the pluses are for the net area residuals.

Iterative autocorrelation of percent net area was performed at time shifts (14-days) of 2-7 until the best fits were found at time shifts of 5 or 6. Classical decomposition was also performed on percent net area, giving similar results. Although the cyclic models were somewhat successful in predicting temporal oscillations, there was a tendency for the models to under predict the cyclic peak magnitude in sand bar area as well as a temporal lag problem that developed beyond one cycle. The temporal lag problem resulted in prediction series out of phase with the response series. Lag in this data set is due to the temporal irregularity of the time series -- the cycles have different wavelengths. Therefore it was concluded that the selected parameters may be serially correlated with a relationship more complex than autocorrelation can describe. More complex time series analysis is possible but would require breaking the series into individual cycles or synthetically deriving a new sample from the time series which is characterized by only 15 time-steps. This analysis is recommended for future investigation because it offers the possibility of predicting the response of sandbars to dam operations that were not tested directly.
