ANALYSIS  
of  
EROSION TRENDS

Of the Sedimentary Deposits  
In the Grand Canyon

Dr. Robert Dolan  
Coastal Research Associates

January 16, 1981

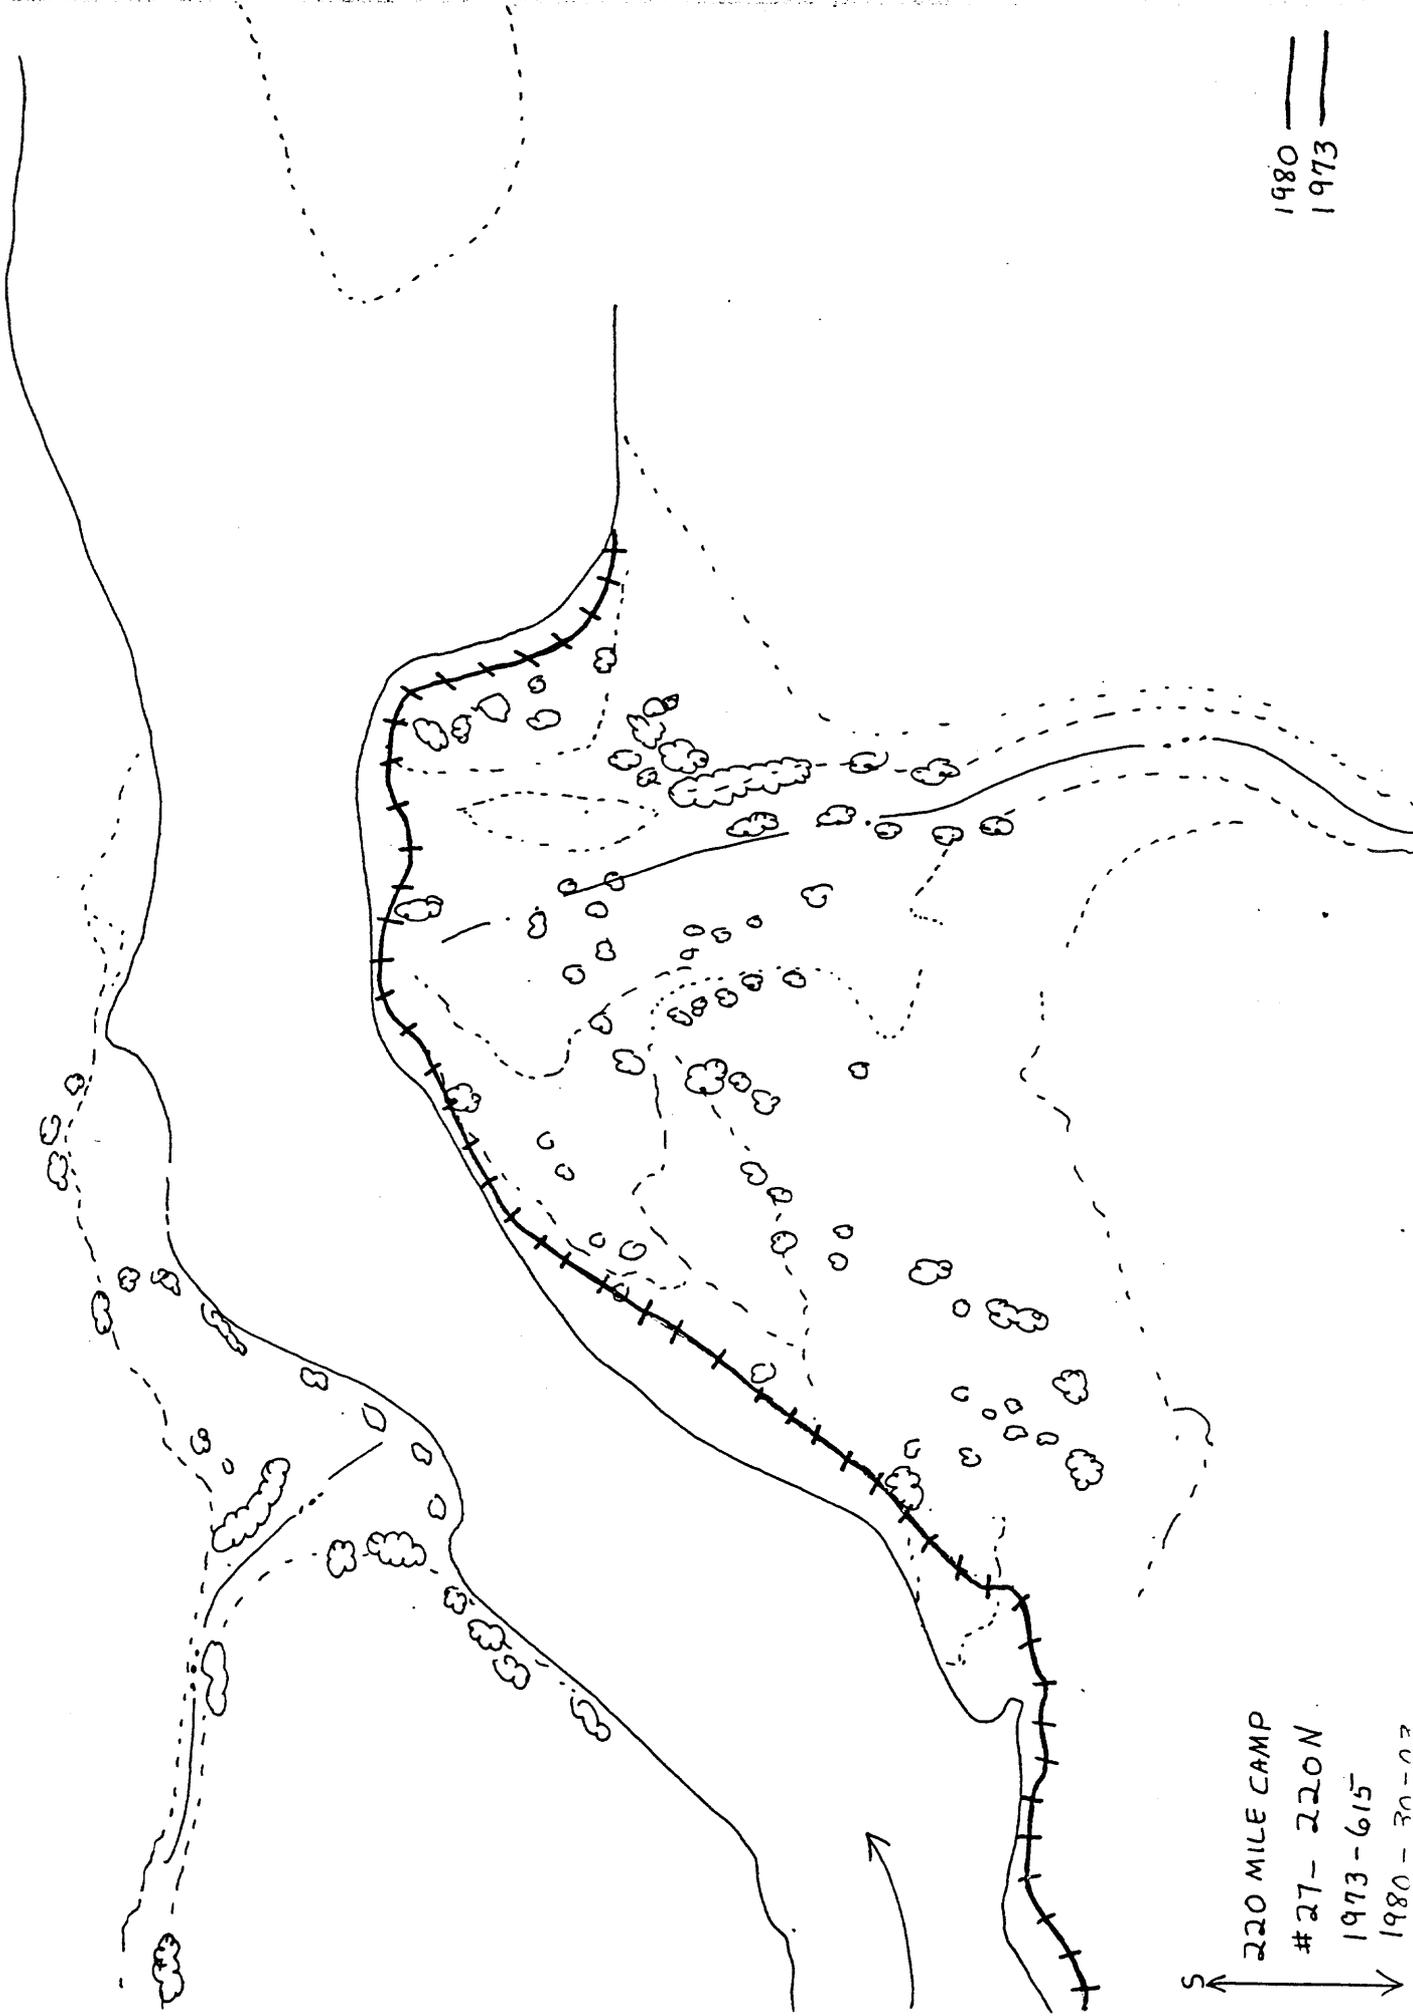
S ↓  
220 MILE CAMP  
#27-220N  
1973-615  
1980-30-03

1980 ———  
1973 - - - -
