GEOMORPHOLOGY AND VEGETATION CHANGE AT COLORADO RIVER  
CAMPSITES, MARBLE AND GRAND CANYONS, AZ

Submitted in Partial Fulfillment  
of the Requirements for the degree of  
Master of Science  
in Geology

Northern Arizona University

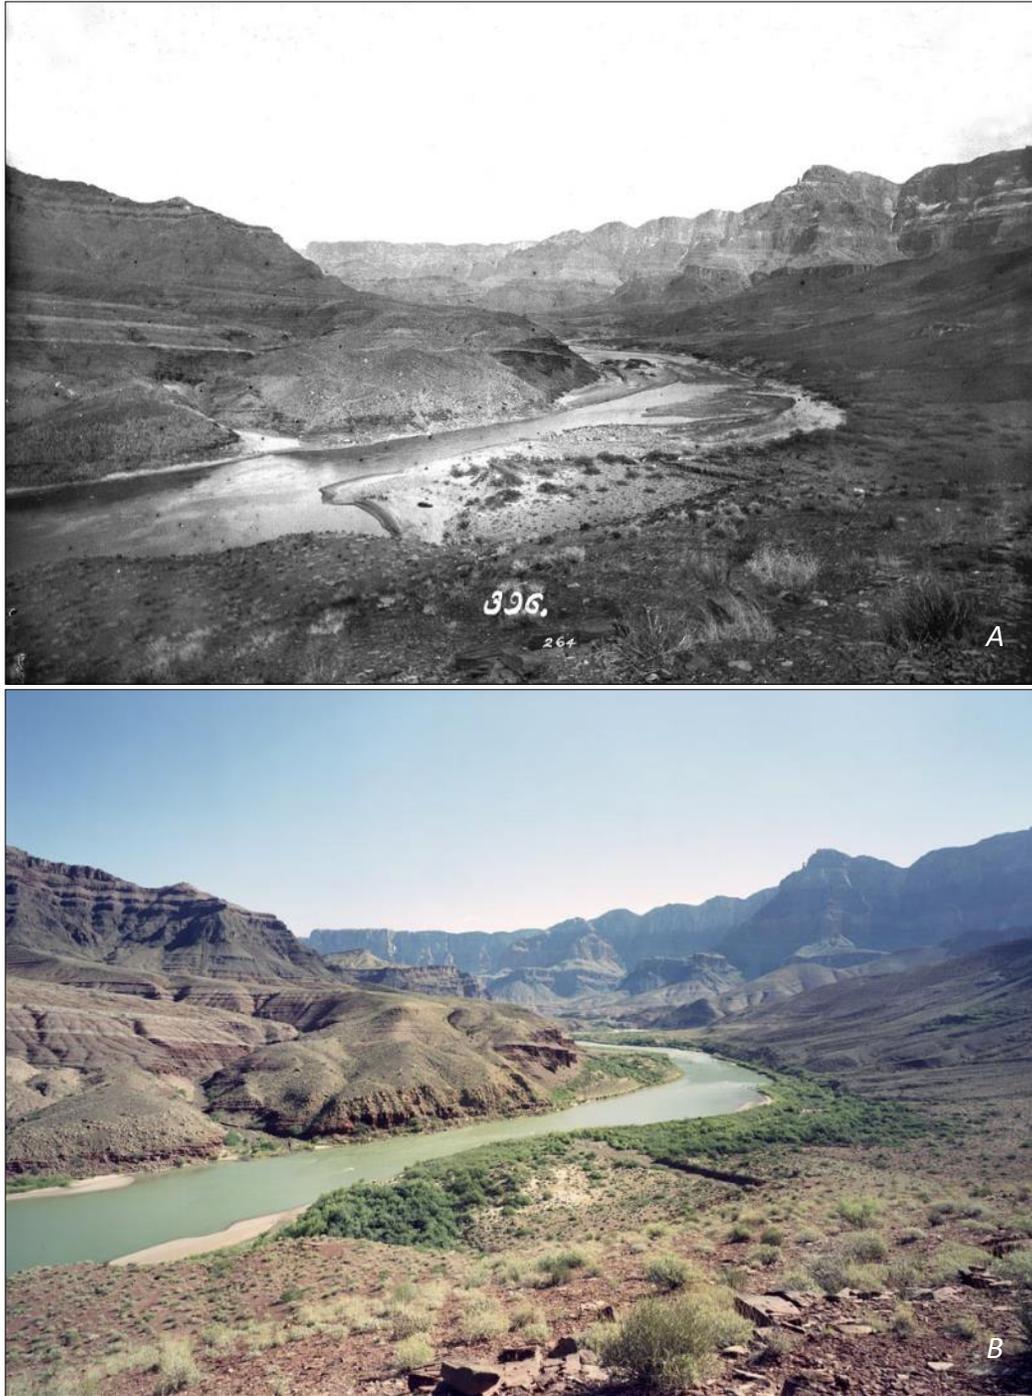
**Figure 7.** Upstream view from Cardenas Hilltop near river mile 71.3 showing the dramatic increase in vegetation and decrease in sandbar area. (A) Photograph taken by Robert B. Stanton on January 23<sup>rd</sup>, 1890. (B) Matched photograph taken on September 20<sup>th</sup>, 2010 by Bill Lemke. Photographs courtesy of the U.S. Geological Survey, Desert Laboratory Repeat Photography Collection.

(Fig. 7). Prior to the construction of Glen Canyon Dam, riparian vegetation was sparse along the river corridor due to frequent flooding events. Following the closure of the dam, vegetation expanded along the river corridor until the occurrence of large flooding events from 1983-1986. The 1983-1986 floods were caused by unusually large excess runoff which could not be stored in the Lake Powell reservoir, resulting in large flood releases from the dam. The largest release occurred in June 1983 at a peak discharge of 97,300 ft<sup>3</sup>/s (Schmidt and Grams, 2011a). These large floods scoured out most of the vegetation that had colonized sandbars in the preceding decades (Stevens and Waring, 1986; Stevens and others, 1995). Vegetation recolonized sandbars along the corridor following the 1983-1986 floods and during the period of interim flow in the early 1990's (Stevens and Ayers, 1995). This led to a reduction in the number of campsites from the mid-1980's to the mid-1990's due to expansion of riparian vegetation, particularly in critical reaches (Kearsley and Warren, 1993; Kearsley and others, 1994). Vegetation continues to expand along the river corridor due to flow regulation (Sankey and others, *in review*).

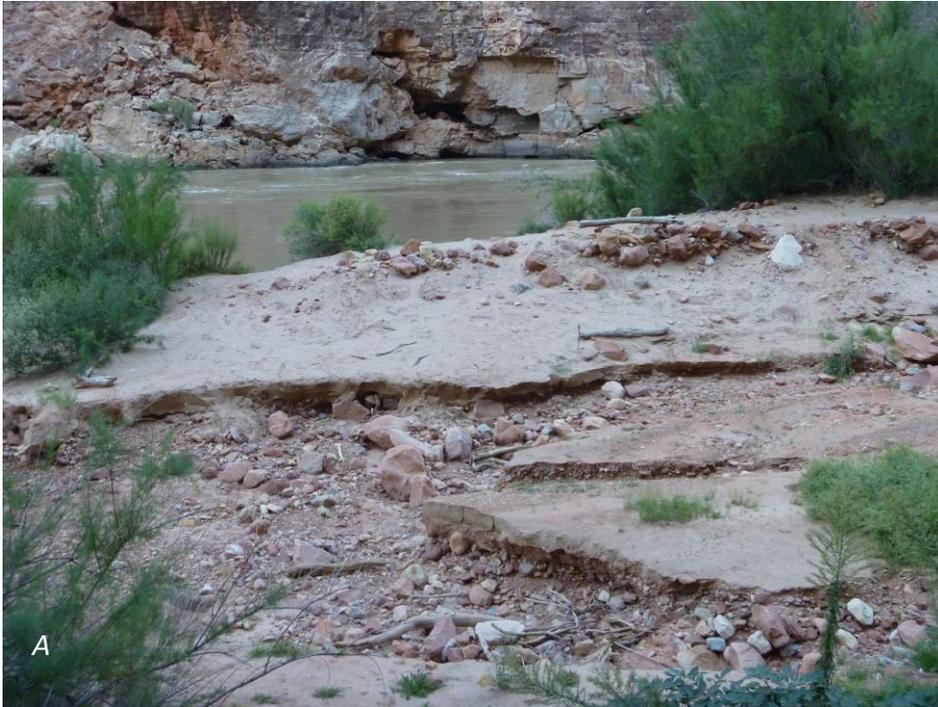
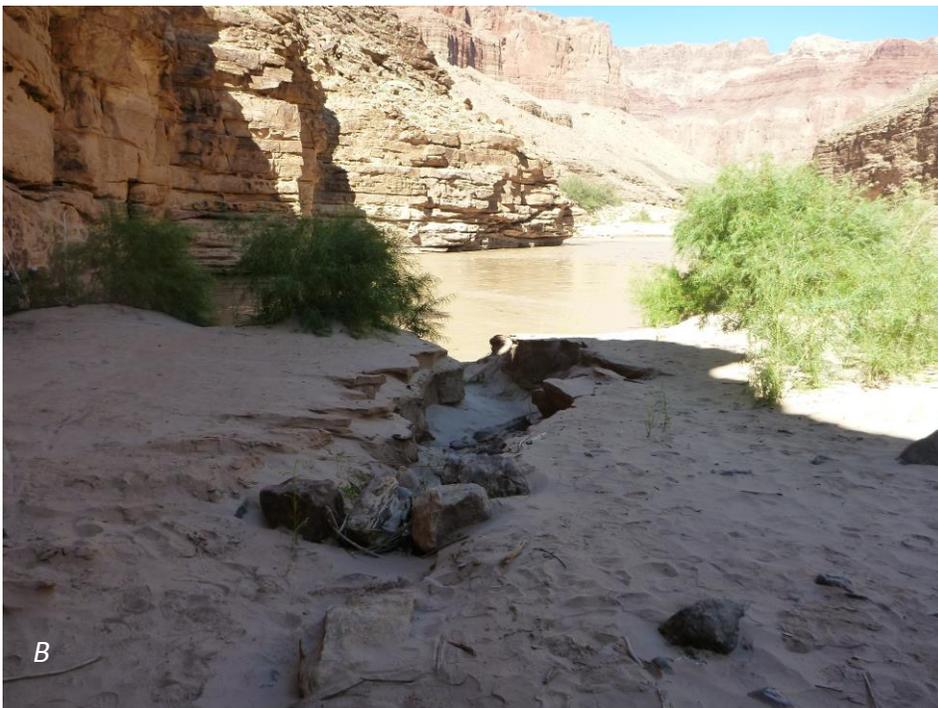
**Figure 13.** Examples of gulying caused by hillslope runoff at (A) Nautiloid (RM 35.0L) and (B) Crash Canyon (RM 62.9R) leading to recent losses in campsite area. Top photograph at Nautiloid was taken on 9/24/2013 and is looking down on the tributary channel that cuts through the site. Bottom photograph at Crash Canyon was taken on 9/27/2013 by Paul Grams looking upstream.

In an effort to distinguish erosion caused by hillslope runoff from erosion caused by fluvial process, gullies were identified from the 2002 and 2009 sandbar surfaces using a combination of elevation and slope data. Gullies are drainage features that incise into the sandbar surface and are caused by hillslope runoff generated from storm events. Gullies can be small surface features (less than 0.5 m in width or depth) or can be large features that are several meters in width or depth (Fig. 13). Flow direction and flow

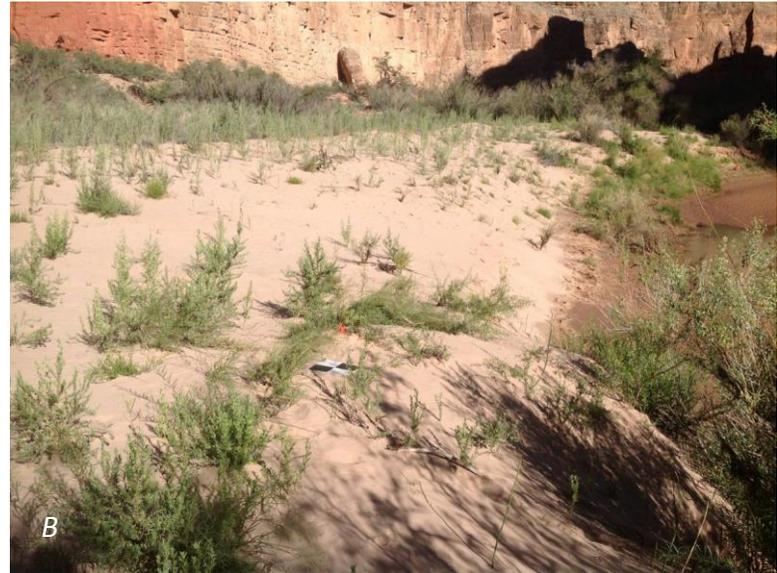
**Figure 33.** Vegetation cover map (A) and photograph (B) at Anasazi Bridge (RM 43. 5L) showing the under representation of vegetation cover detected by the NDVI classification. Note the many small patches of vegetation (shown in the NIR band) that have not been detected within the extent of mapped campsite area. Much of the vegetation present is individual arrowweed plants as seen in the photograph taken on 9/24/2013. Location and direction of photograph indicated with arrow.

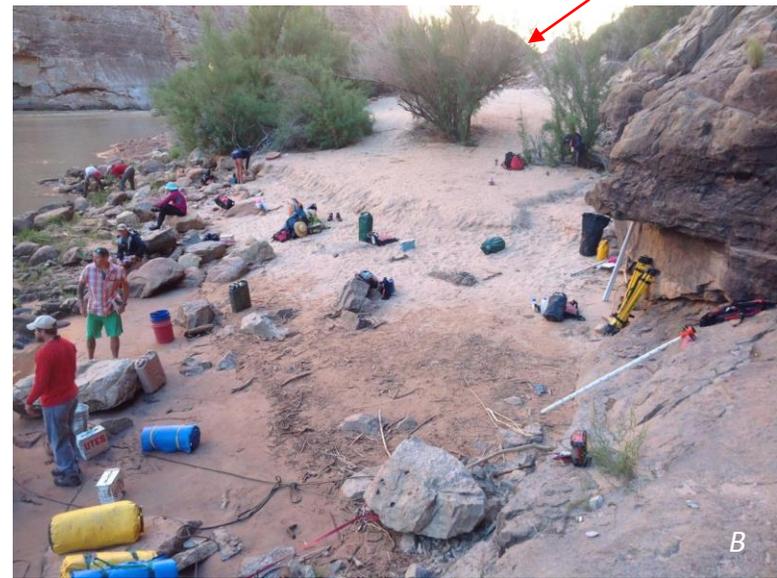
**Figure 34.** Vegetation cover map (A) and photograph (B) at Nautiloid Camp (RM 35.1L) illustrating how the amount of campsite loss due to vegetation expansion can be overestimated. Tamarisk canopies can overhang campsite areas. From an aerial perspective these campsite areas might look entirely vegetated, but areas underneath the canopies might still be used (red arrow). Photograph taken on 9/24/2013. Location and direction of photograph indicated with white arrow.

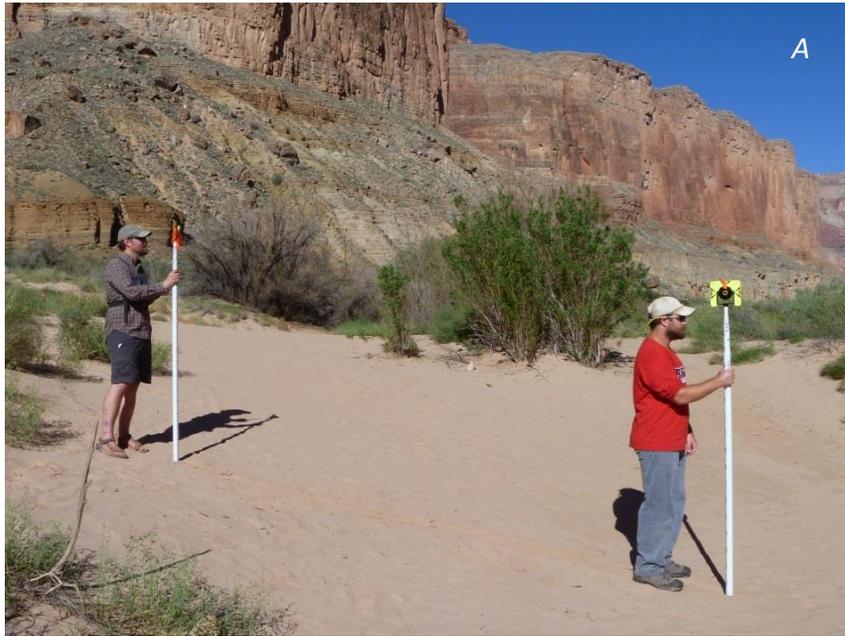
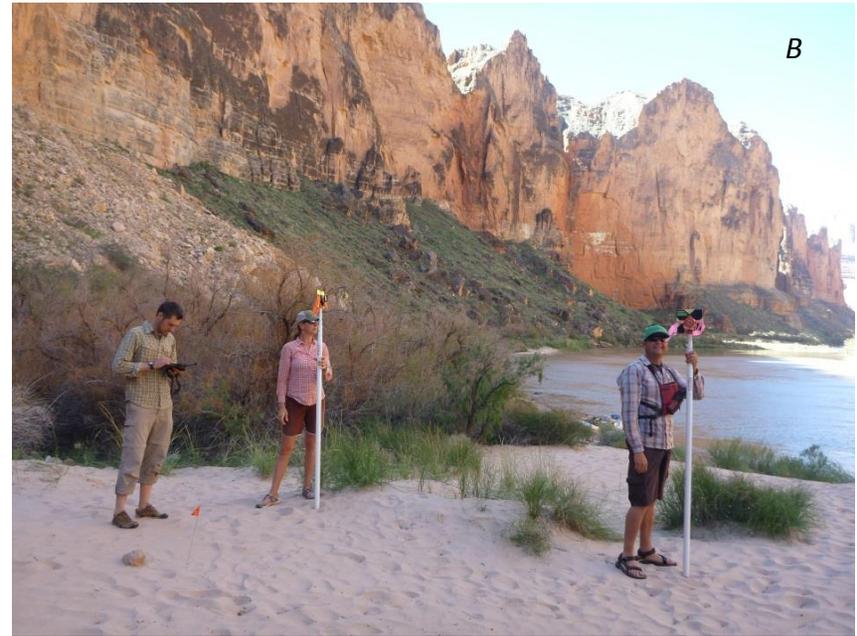
**Figure 37.** Photographs of repeat campsite surveys. *A*, Repeat total station survey at Dinosaur Camp (RM 50. 1R). *B*, tablet and total station surveys being conducted concurrently at Eminence Camp (RM 44. 4L).

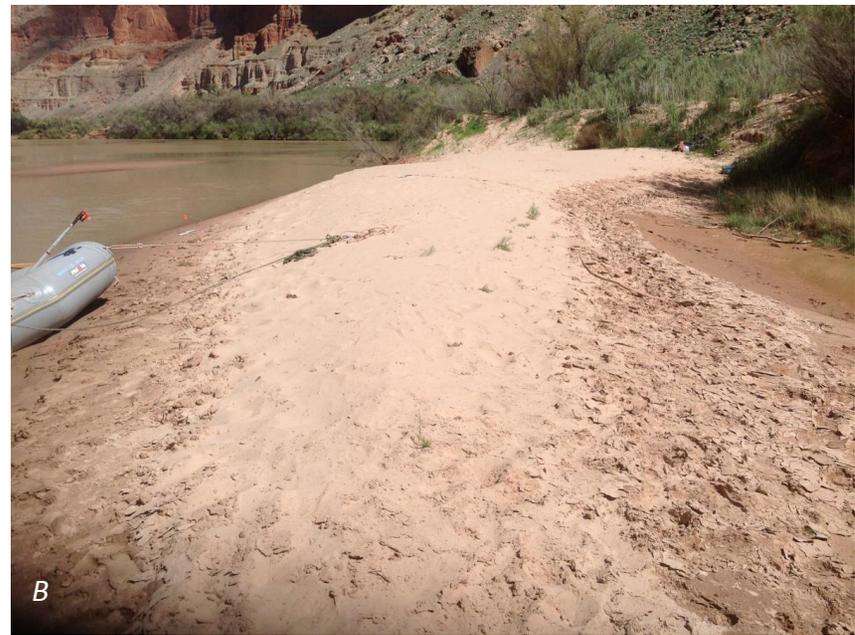
**Figure 46.** Example of the limitations of using imagery (A) that predates the field survey by 4 years. Low elevations bars can be drastically different in appearance from the 2009 imagery, as shown at 51 Mile camp (RM 51.5L). Total station and tablet surveys were conducted independently on 9/26/2014 and show the error of the tablet survey at the low elevation portion of the sandbar. Location and direction of the photograph (B), taken on the same day as the survey, indicated with arrow.
