Stranding of Rainbow Trout during Experimental Fluctuating Releases from Glen Canyon Dam on the Colorado River

Submitted to:
**U.S. Geological Survey
Grand Canyon Monitoring and Research Center
2255 N. Gemini Drive, Room 340
Flagstaff, Arizona 86001**

July 9, 2003

EcoPlan Biological Resources Report 02-606

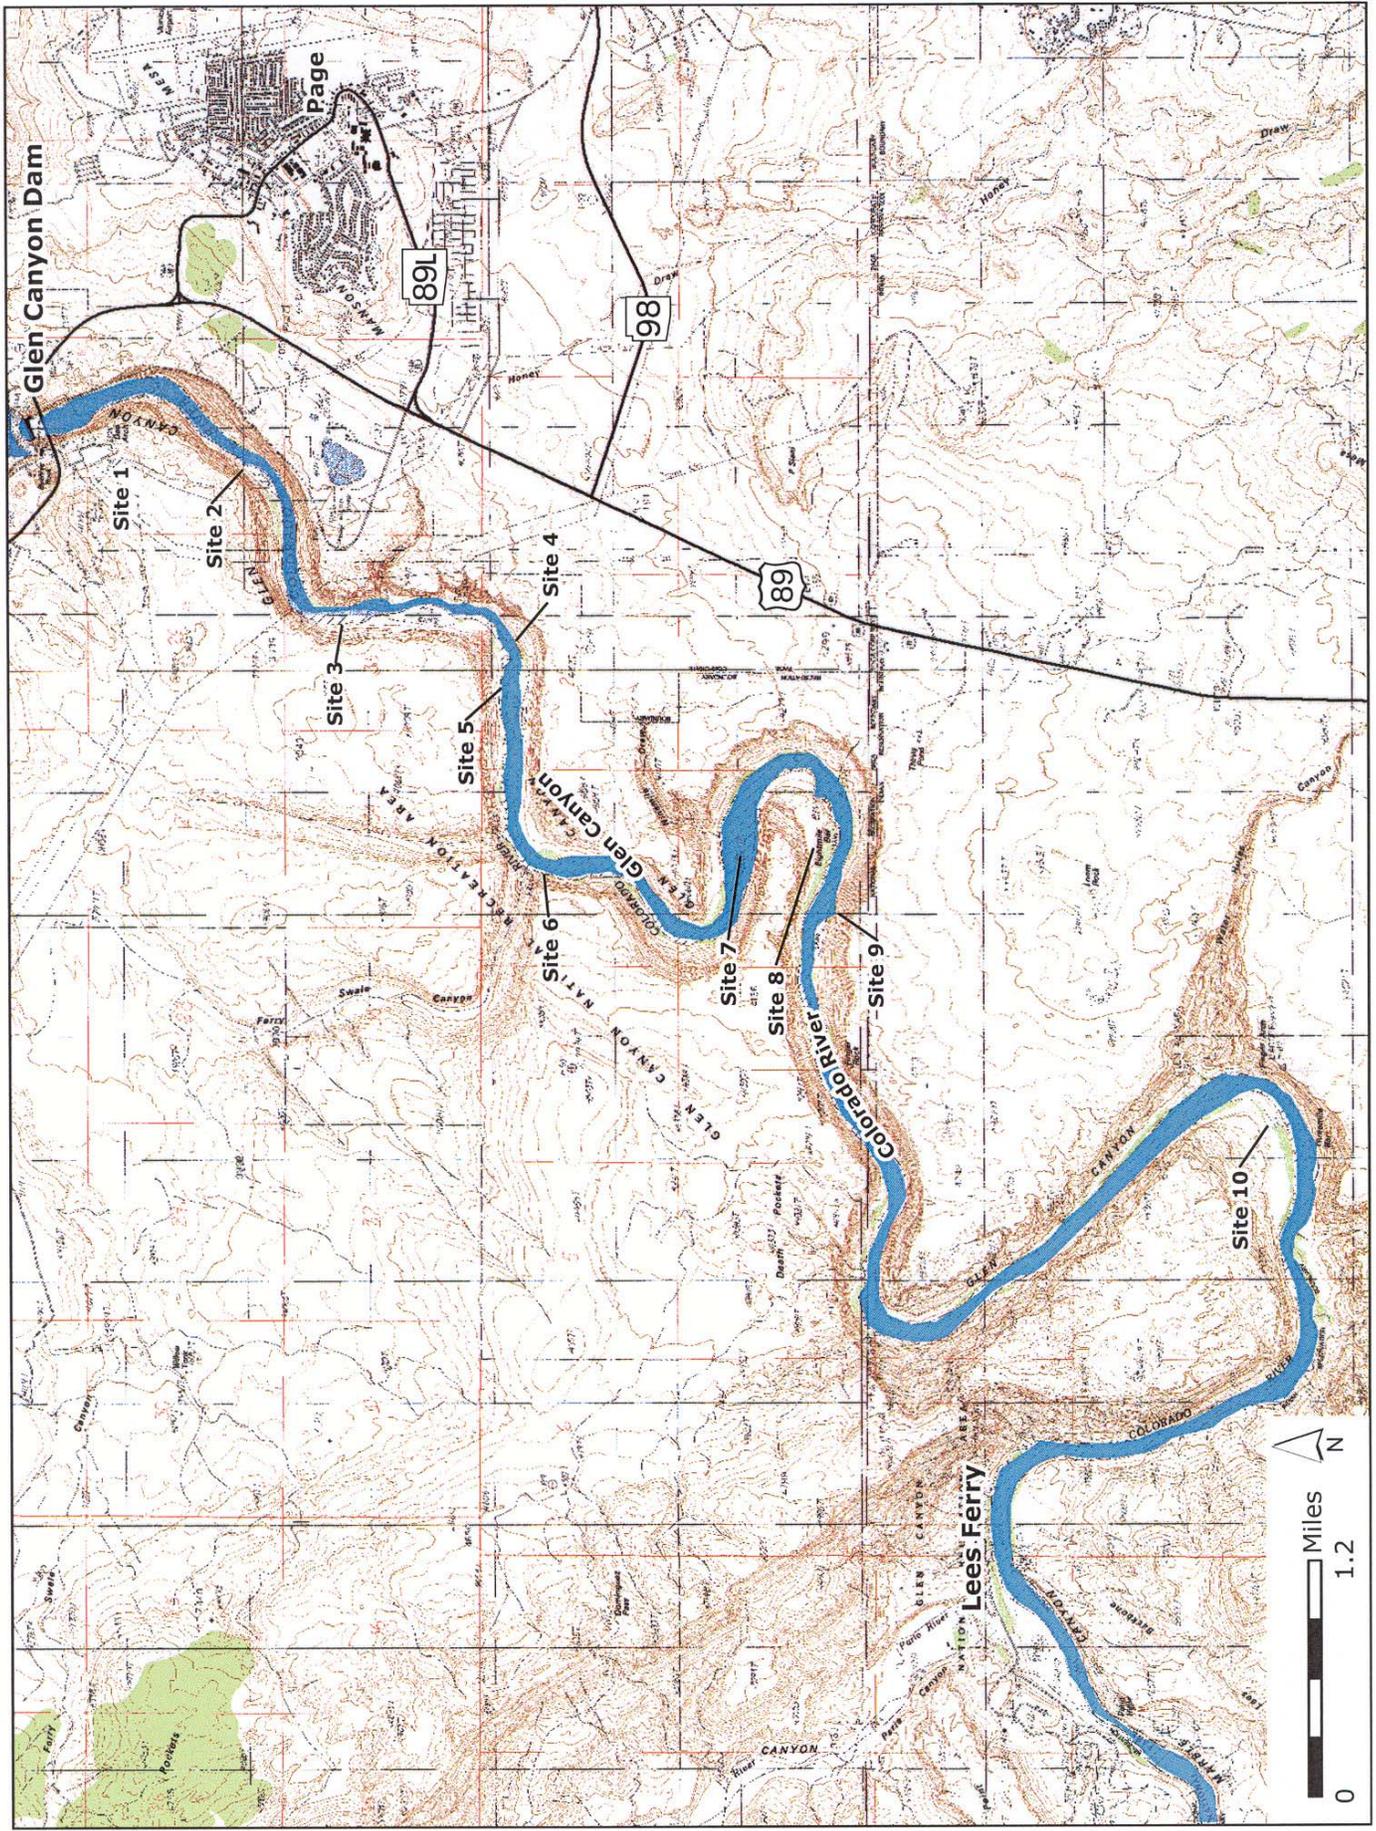
Figure 2. Project Vicinity Showing Sites Monitored for Stranded Trout.

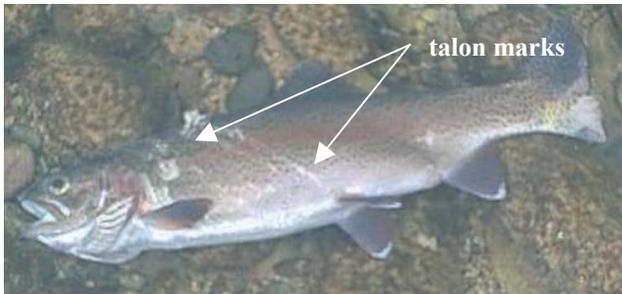
Photograph 1. Stranded fish with talon marks present.

A total of 503 adult fish were found stranded during this three-month study. Seven percent (36 fish) of stranded fish were dead or dying (Figure 5). Stranded fish (dead) ranged from 200 mm to 455 mm TL (Figure 6) and from 85 g to 1,200 g in weight (Figure 7). Some (10 fish, 28 percent) of the stranded fish, both alive and dead, showed indications of predation, i.e. fish that were still alive had talon marks along their flanks, while dead fish had wounds that varied from talon marks (Photograph 1) along the flanks to missing portions of their anatomy (i.e. eyes, gills, and internal organs [Photograph 2]). It is unclear whether fish (dead) with talon marks or any other wounds, received these prior to or after their death. Bald Eagles and Osprey are present within the project area and could be responsible for the talon marks either before or after the fish had died.

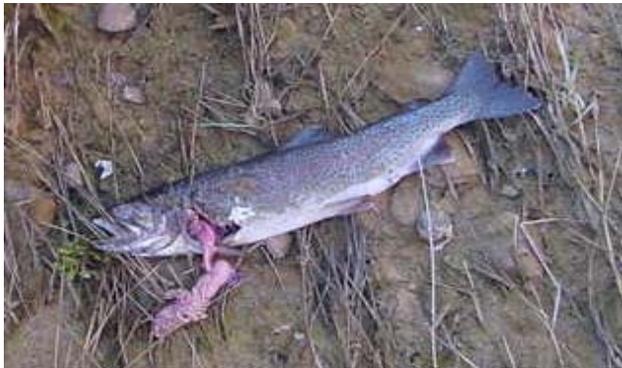
Photograph 2. Stranded fish that exhibits signs of predation.

There was no significant trend between the size of stranded fish and time in which they were stranded ($r^2 = 0.0004$ [Figure 9]). Some of the stranded fish, both alive and dead, showed indications of predation; fish that were still alive had talon marks along their flanks, while in addition to talon marks, the dead fish had more lethal wounds (i.e. missing eyes, gills, and internal organs). It is difficult to discern if these wounds were a result of stranding or resulted in the fish being stranded. The fluctuating river level may have helped to increase predation pressure on the rainbow trout by reducing the amount of deep water that could be utilized by the fish as refuge from predators.

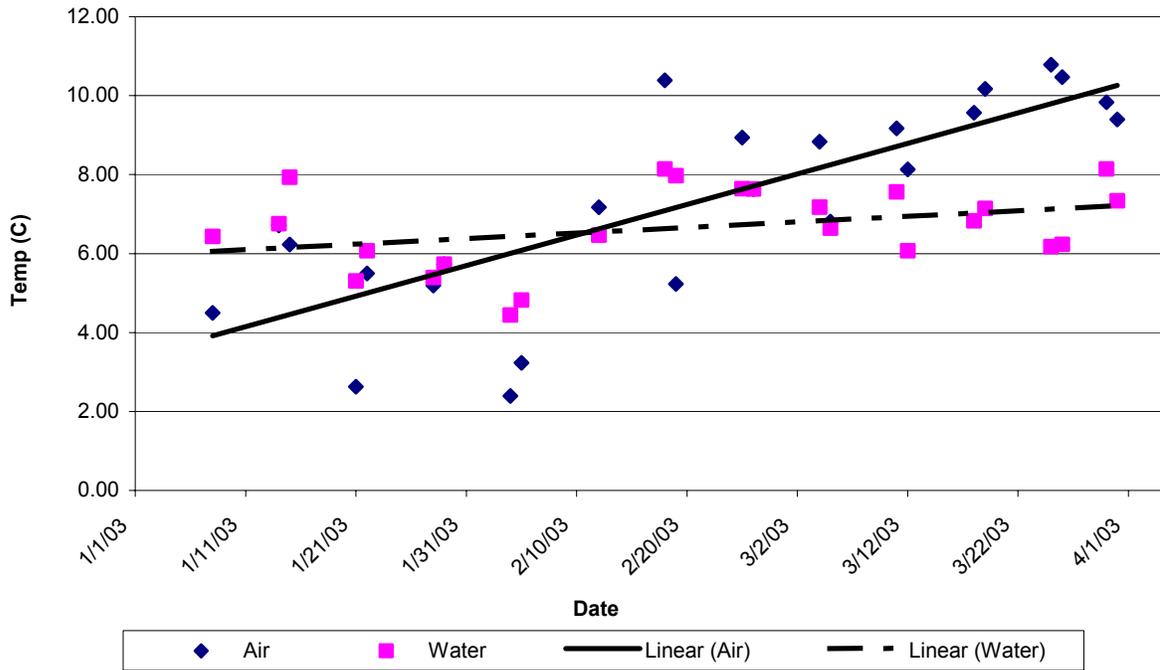
Figure 3: Mean Daily Air and Water Temperatures Over the 2003 Experiment

Throughout the experiment, air and water temperatures were collected at each site during each sampling day. The average water temperature was 6.68 degrees Celsius (VAR = 1) with the average air temperature being 7.28 degrees Celsius (VAR = 6.6) (Figure 3). Water temperatures remained nearly constant due to the deep hypolimnial release of water from Lake Powell through Glen Canyon Dam and the winter cooling of the epilimnion bringing the temperatures of the upper and lower water depths closer.

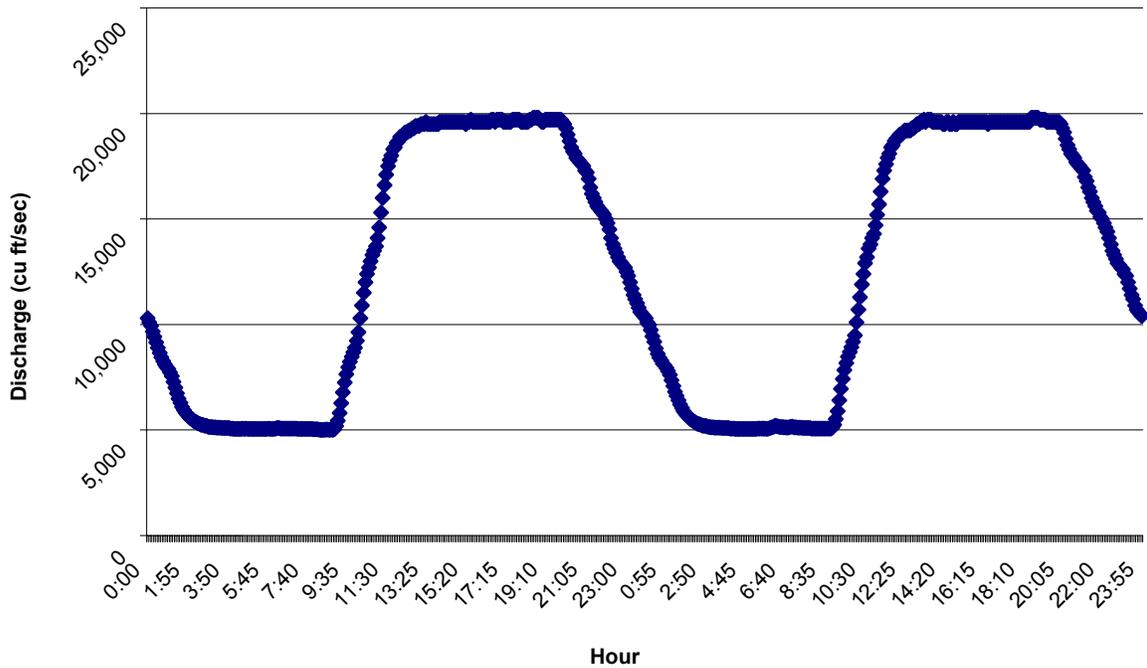
Figure 4: Typical Glen Canyon Dam Experimental Releases for the 2003 Experiment

of the experiment reached a daily maximum of 20,000 cfs and a minimum of 5,000 cfs with a maximum 5,000 cfs/hour upramp and 2,500 cfs/hour downramp (Figure 4).

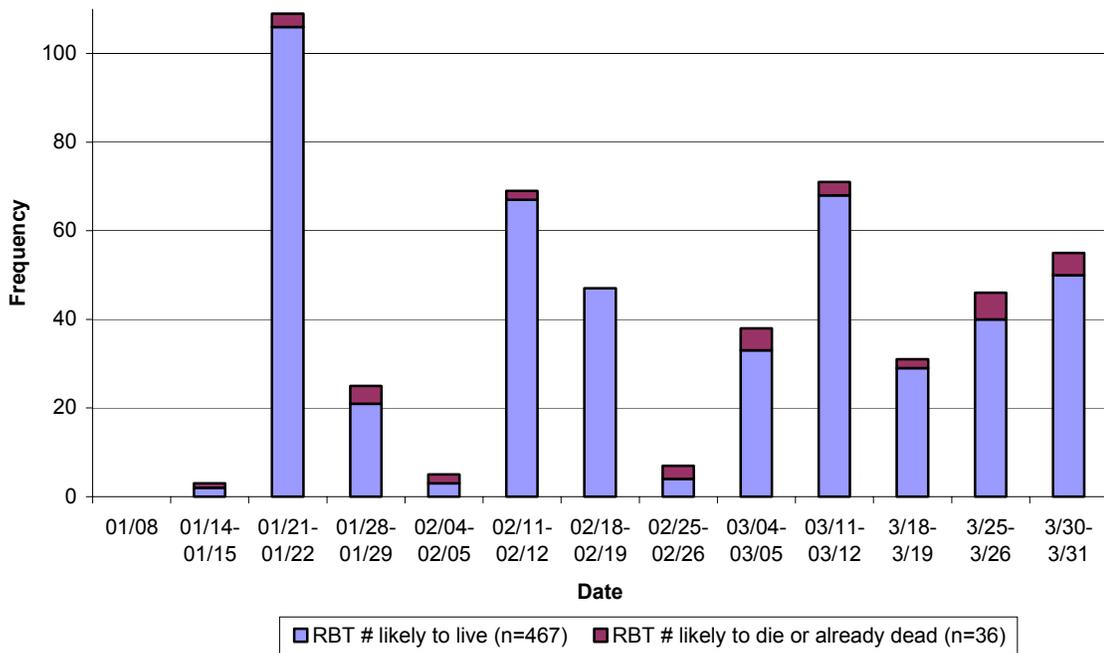
Figure 5: Numbers of Rainbow Trout Encountered During the Stranding Survey

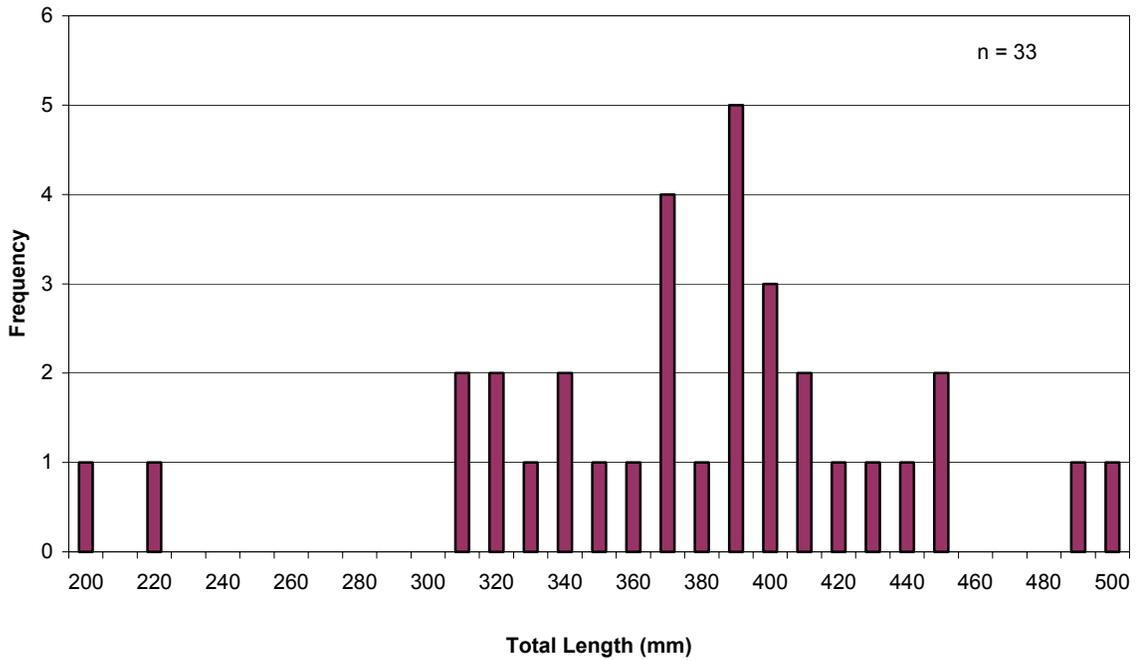
Figure 6: Length Frequency Distribution of Dead RBT

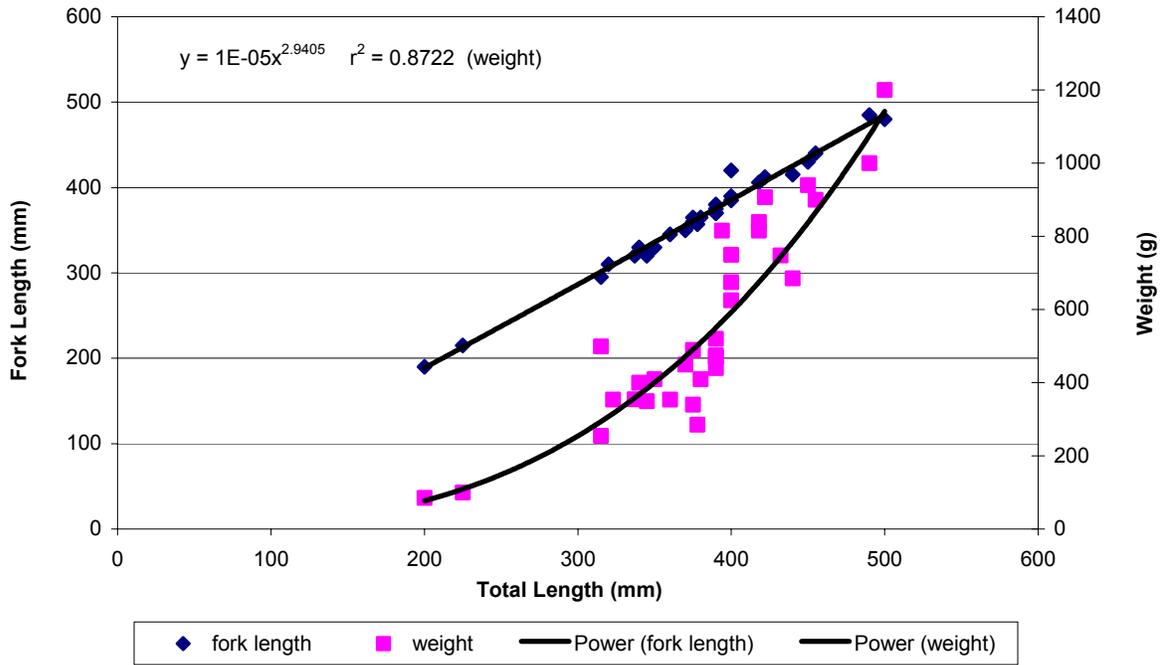
Figure 7: Length-weight Ratio for Stranded (dead) Fish

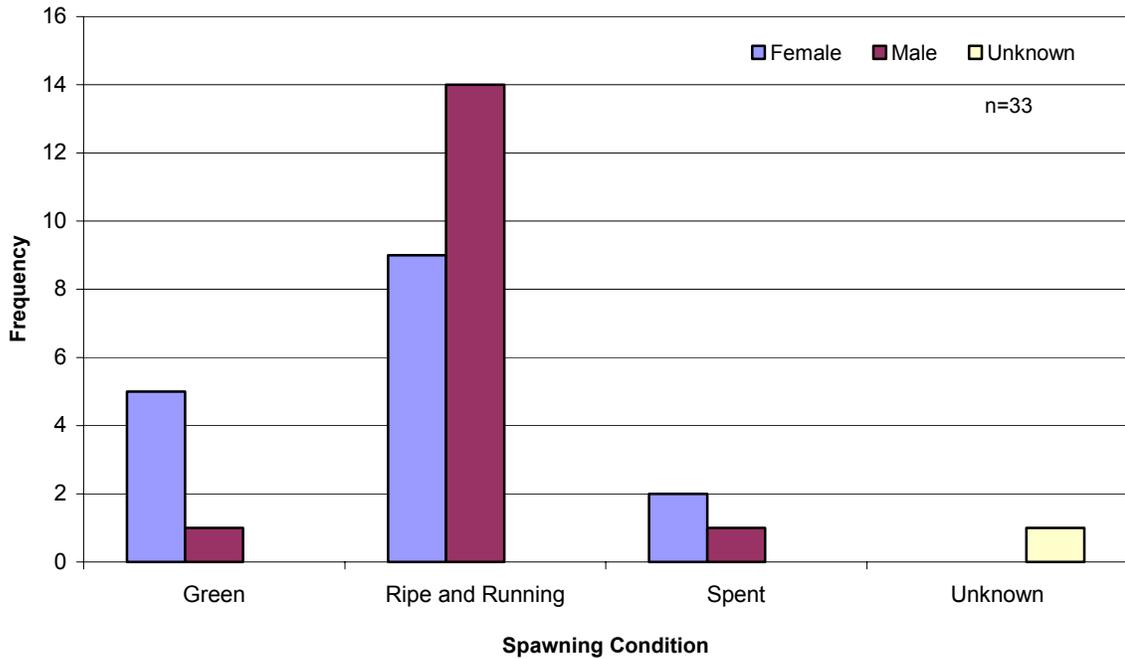
Figure 8: Spawning Condition and Sex of Stranded Rainbow Trout

Even numbers of male and female fish died after becoming stranded over the 3-month period (16 male, 16 female, and one unknown fish [due to small size and age]). Seventy percent of the dead stranded fish were ripe and running (Figure 8).

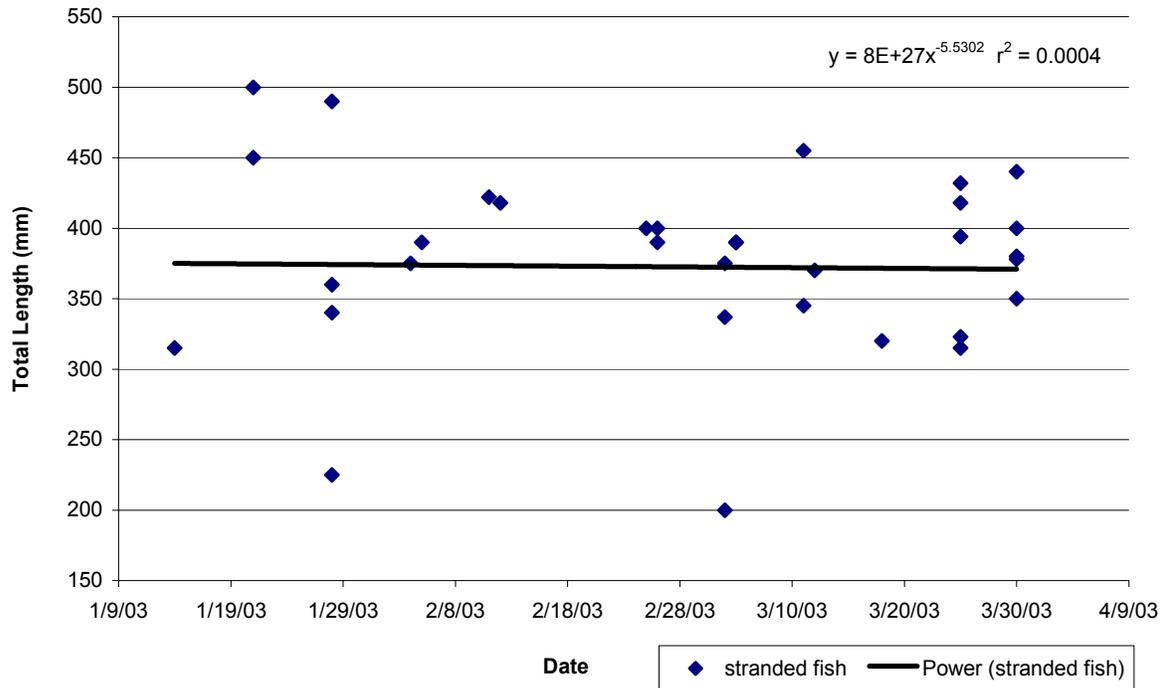
Figure 9: Size of Dead Stranded Rainbow Trout Over Time

The mean total length (TL) of RBT found within the Lees Ferry reach in 2002 was 234 mm (SD = 88, n = 3409)(Joe Slaughter 2003), whereas the mean TL of stranded RBT was larger at 378 mm (SD = 63, n = 36). RBT lengths in 1991 were 352 mm (SD = 117, n = 228), but, like 2003, stranded fish also were larger at 437 mm (SD = 53, n = 496). Size of fish stranded in 2003 remained constant throughout the study (Figure 9).

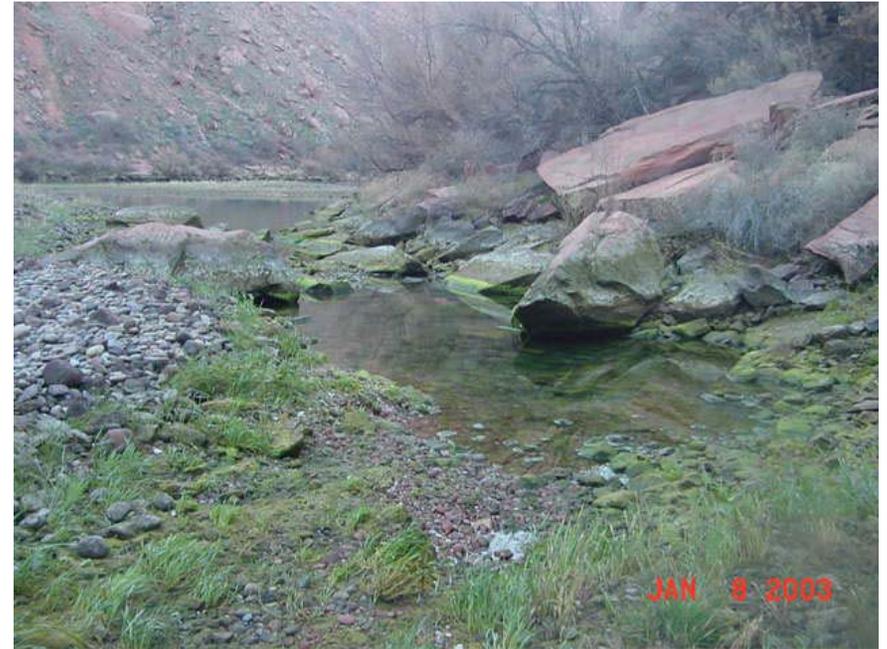
Photo 6. View looking at a pool immediately south of Location C of Site 1. The pool has a river connection.

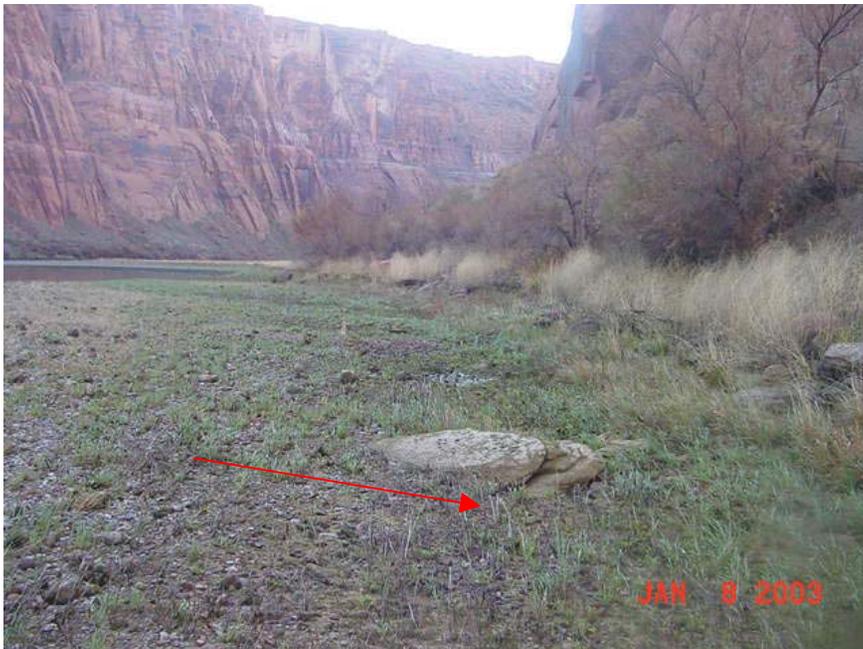
Photo 11. View looking at the middle of Site 3. The rock has been an area of stranding (red arrow).

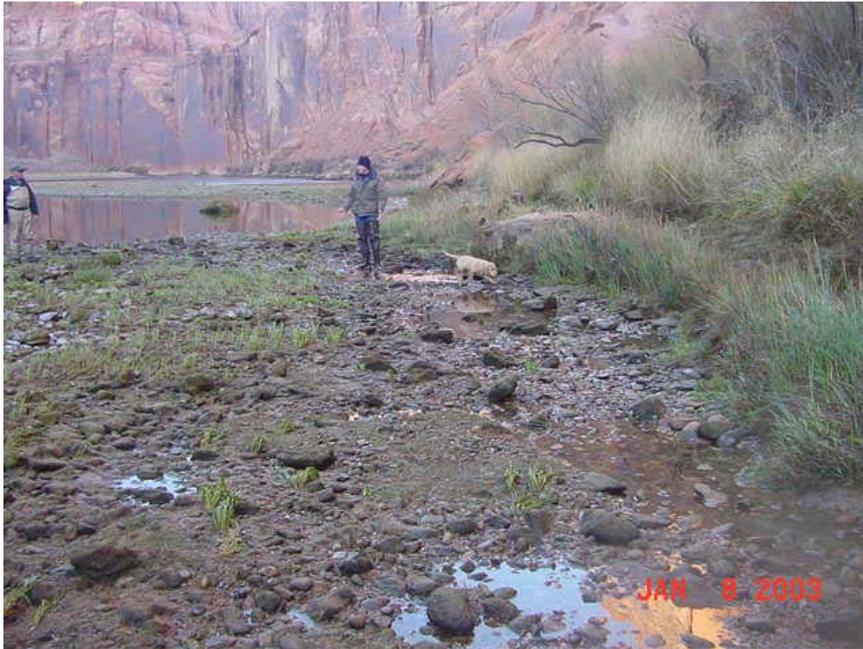
Photo 17. View looking south at the large pool just south of Location C in Site 5. The pool traps fish, but is deep enough for them to survive.
