GRAND CANYON MONITORING PROJECT 1992-1999:
SYNTHESIS AND ANNUAL REPORT FY99

Grand Canyon National Park and
Northern Arizona University
Cooperative Agreement CA 8210-97-002

RCMP Report No. 66
Flagstaff, Arizona

January, 2000

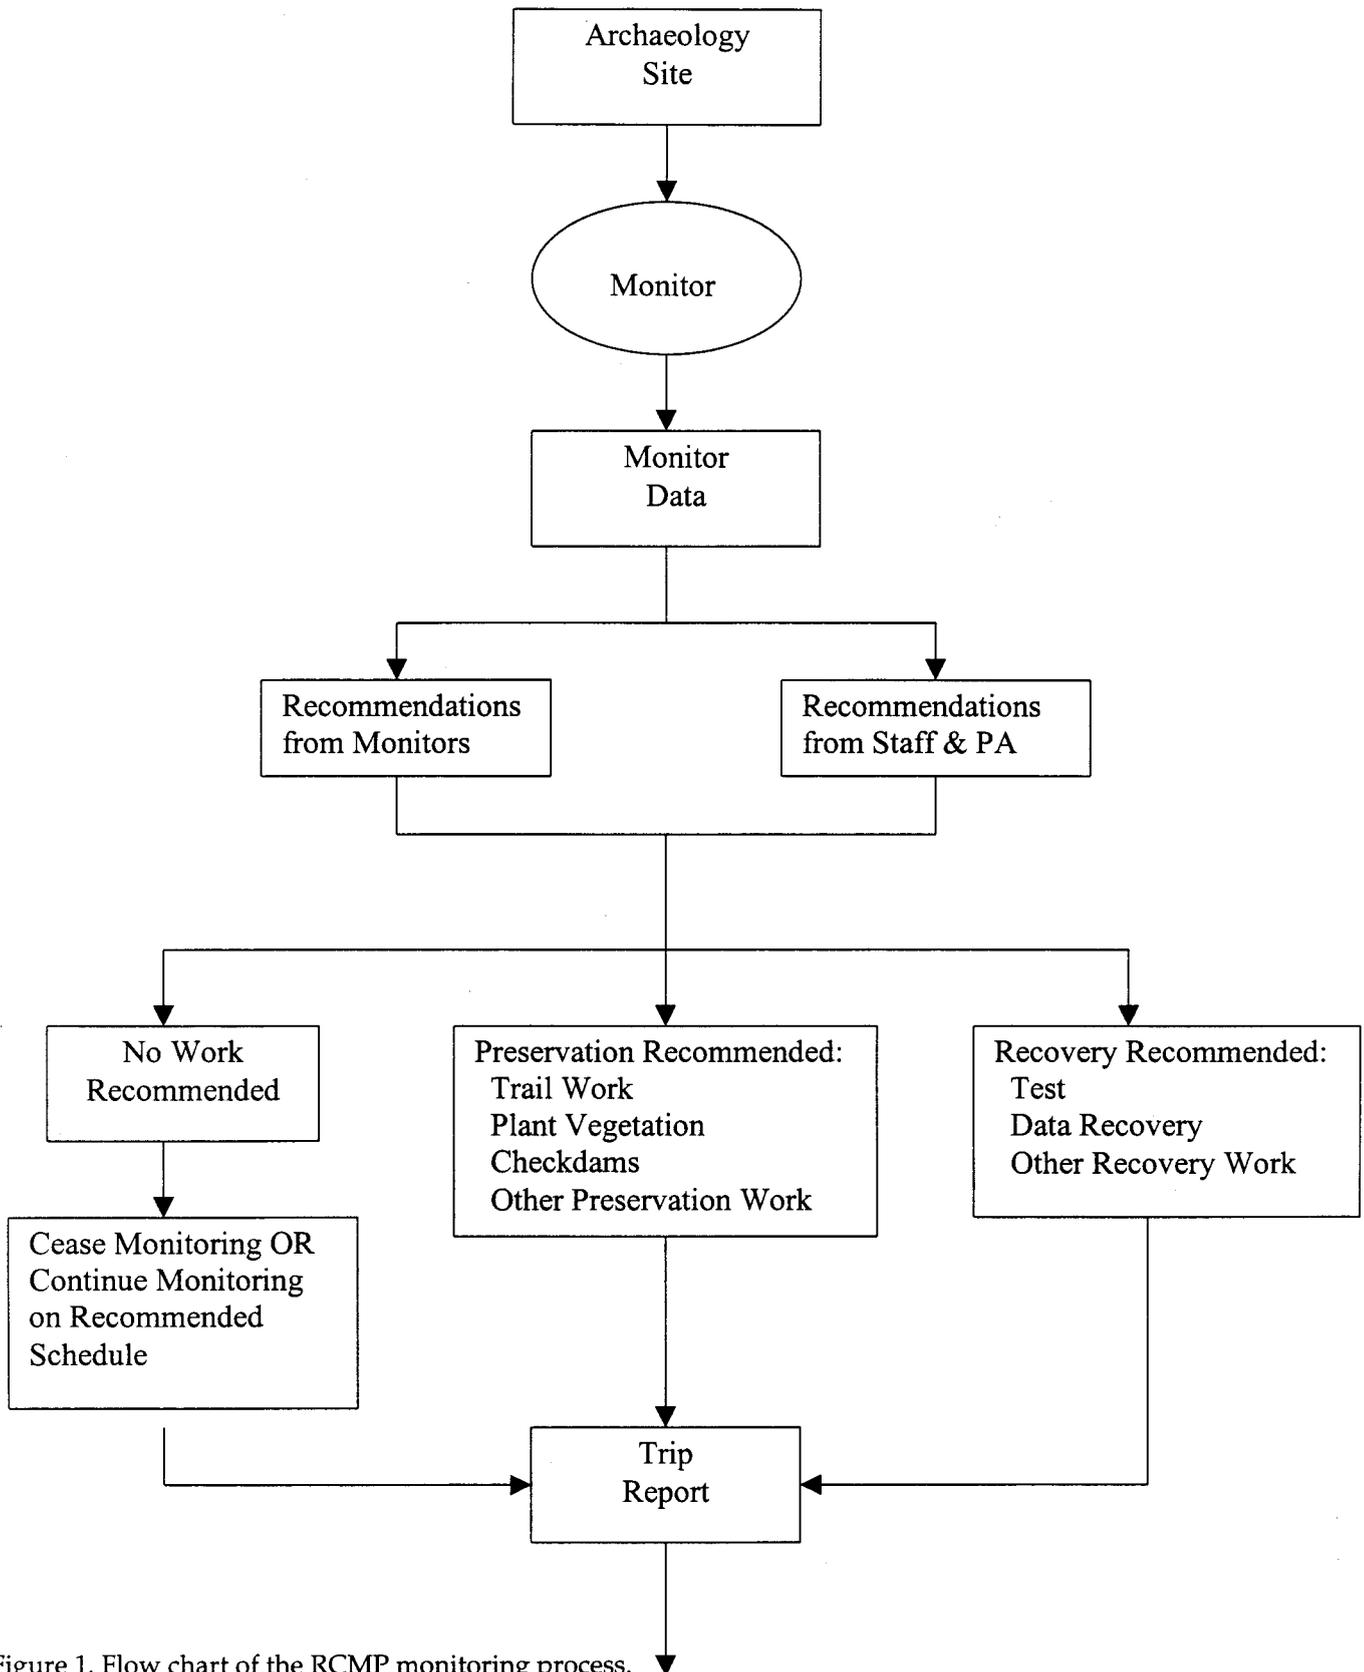
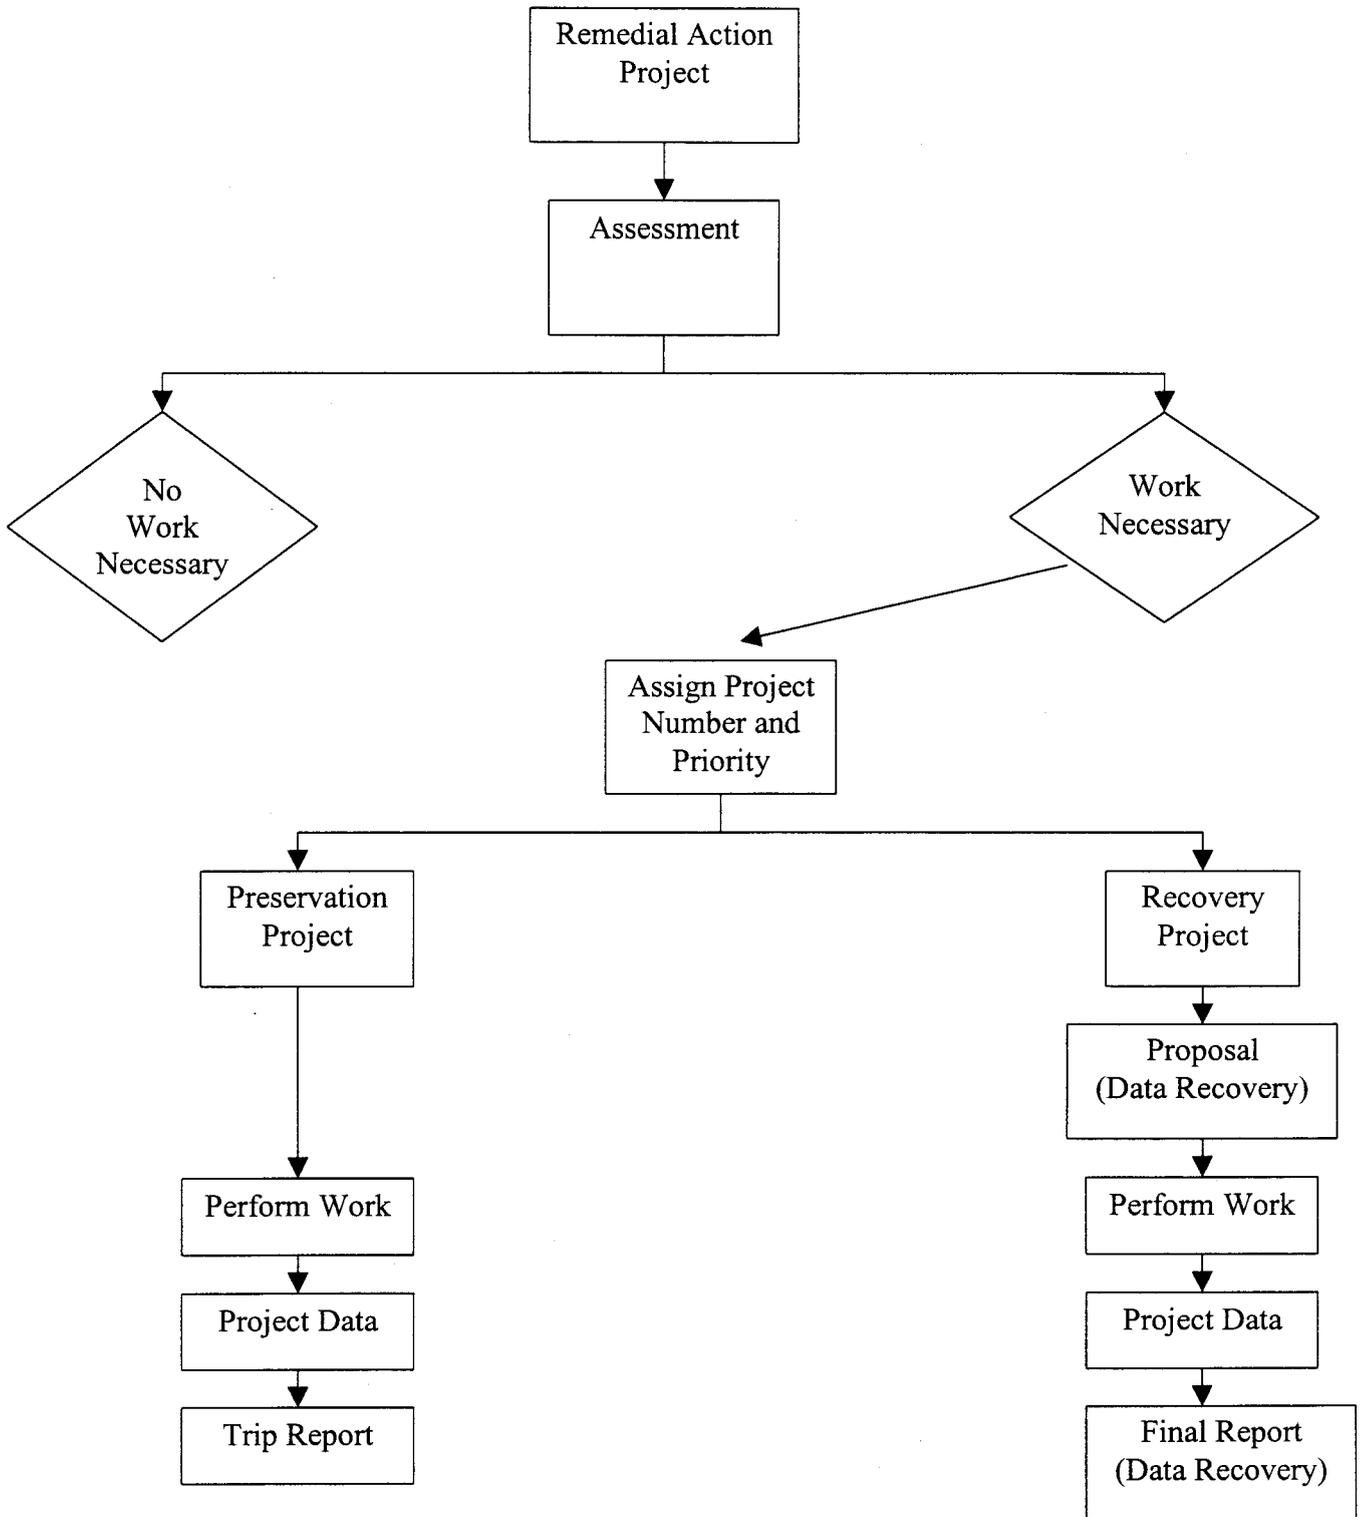
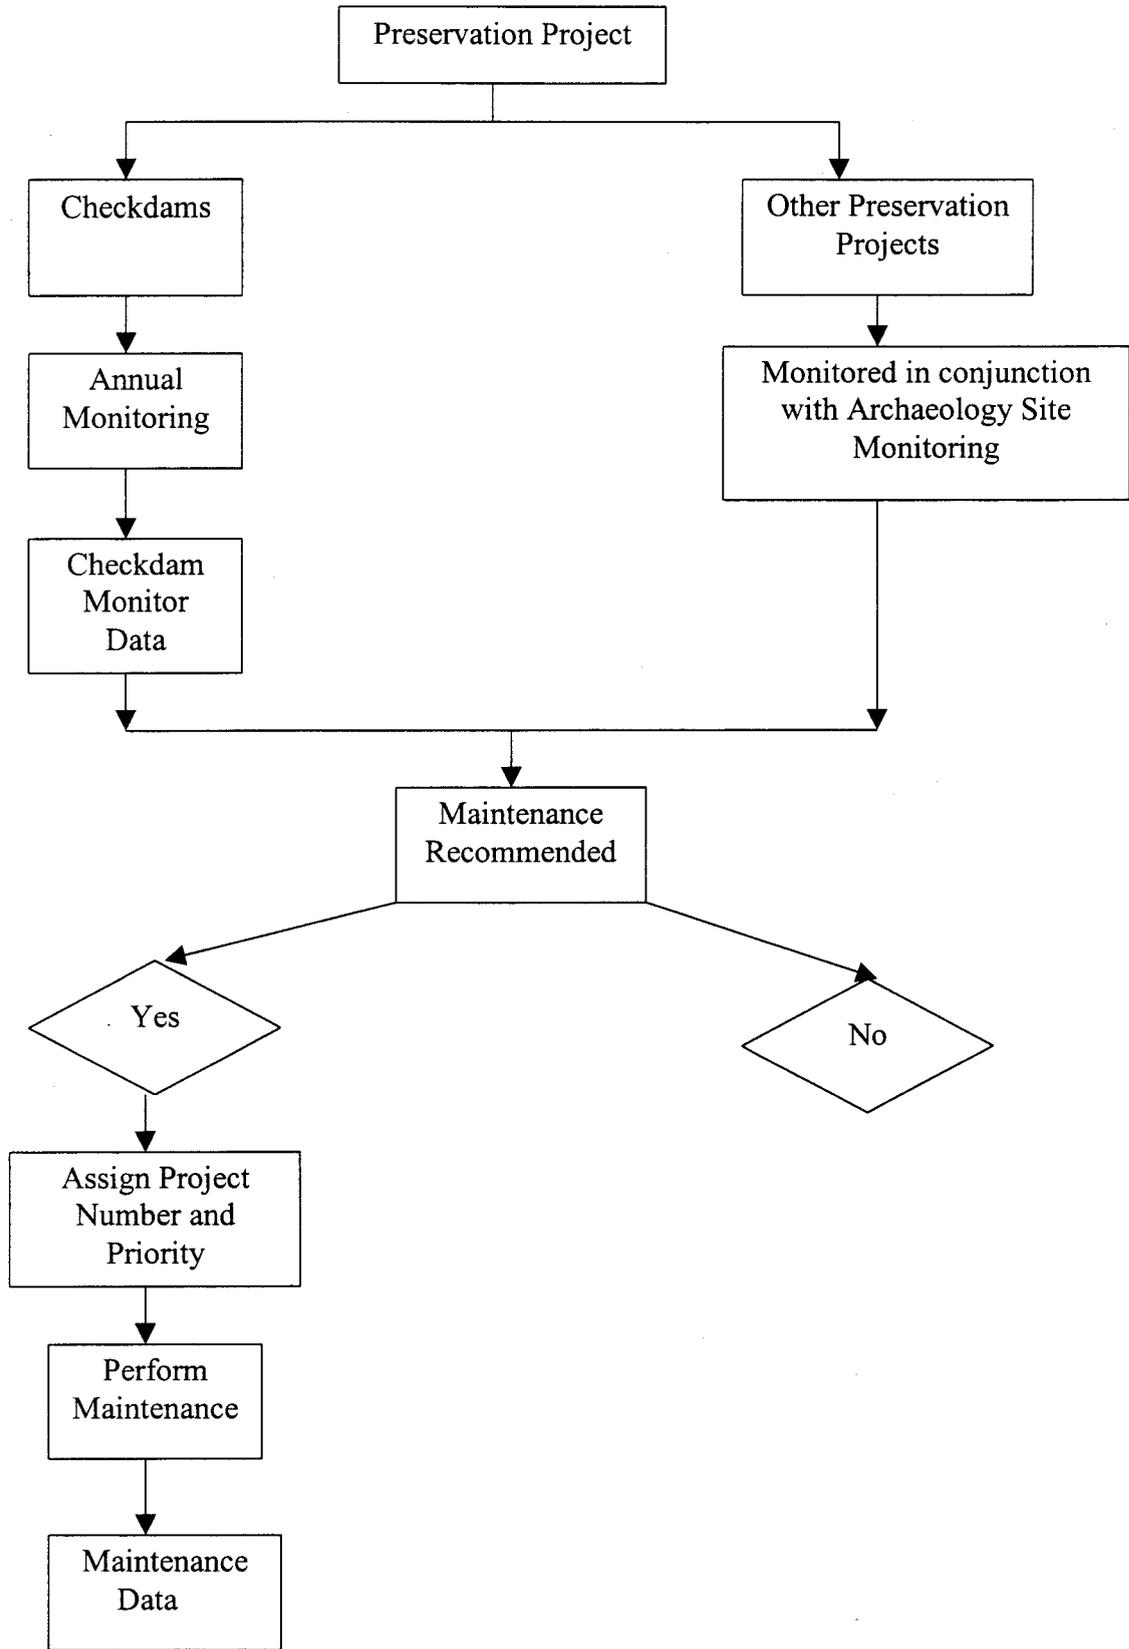
Figure 1. Flow chart of the RCMP monitoring process.

To *monitor* site condition is to determine the extent of any deviation from the recorded baseline. Field notes and photographs aid in observing and comparing change. Staff members review previous monitoring forms, IMACs site description forms, photographs, and baseline information, and then observe current conditions to determine the degree of change, thus generating new site condition data.

Generation of *monitoring data* occurs when staff members fill out a River Corridor Archaeological Site Monitoring Form (see Appendix A), and take additional or repeat photographs of a site, feature, or overview. The current monitoring form consists of 30 questions that record who is monitoring, what impacts are being observed, whether drainages at the site flow directly to the Colorado River, side canyons, or percolate into alluvial terraces, whether visitor-related impacts are present, and site management recommendations. Three comment fields are also provided for narrative descriptions of impacts observed and management issues. This information is recorded in the field and then entered into a relational database in the laboratory for data management. In addition to generating data related to overall site condition based on the presence or absence of certain impacts, recommendations for treatment are also made in both the field and laboratory to curtail further losses of cultural remains at the site.

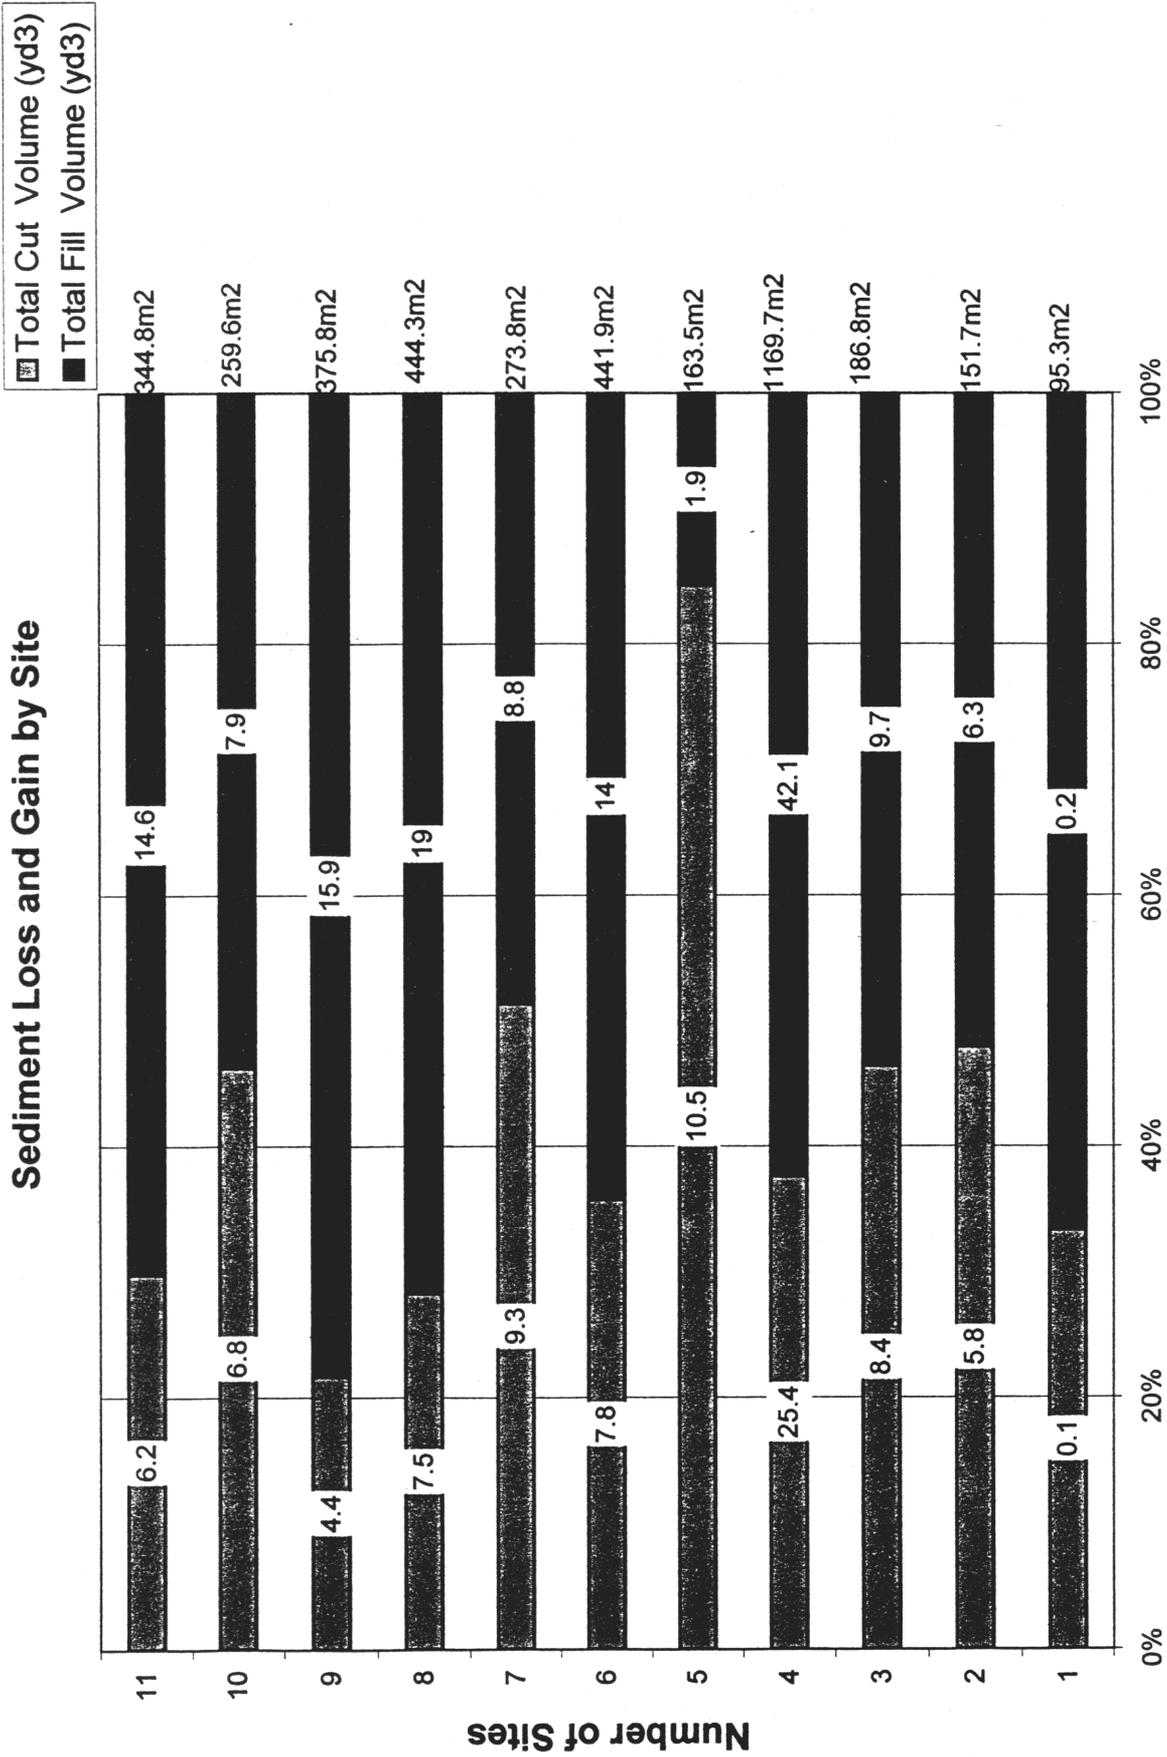
Figure 4. Preliminary results of the repeat-mapping efforts illustrating the amount of sediment either deposited or eroded away since the initial mapping of the site.

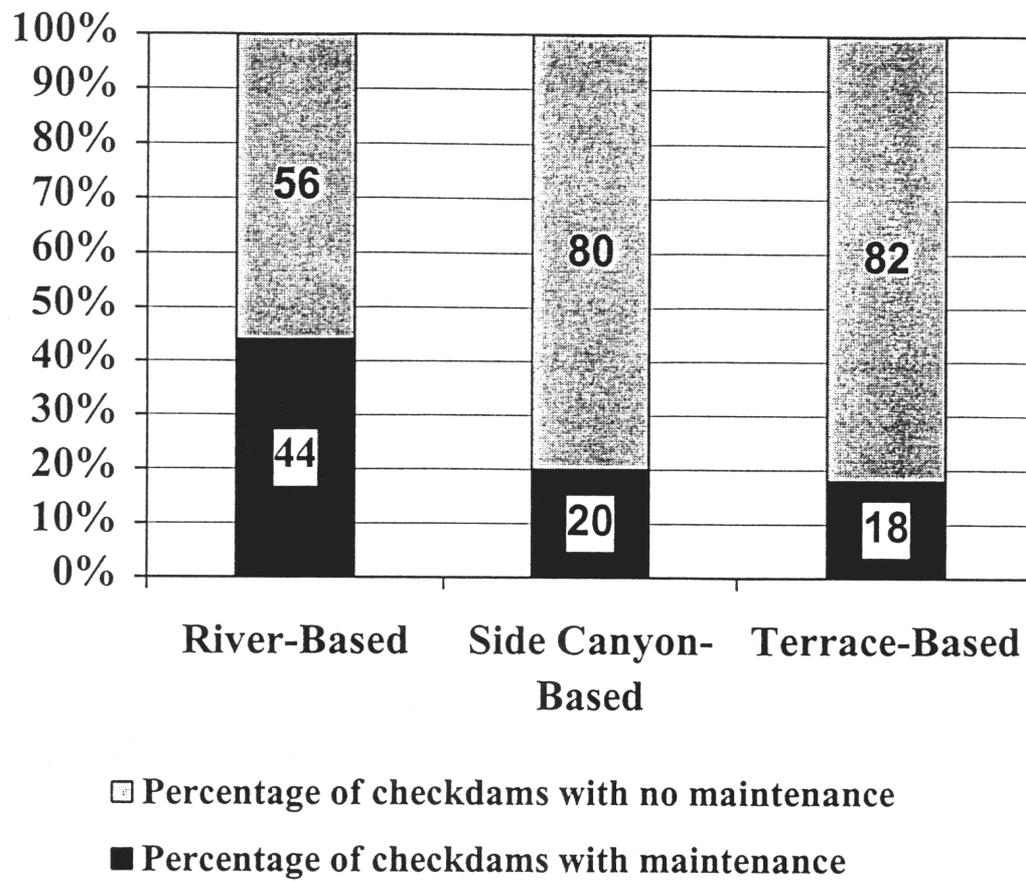
Figure 5. Percentage of checkdam maintenance on sites categorized by drainage type.

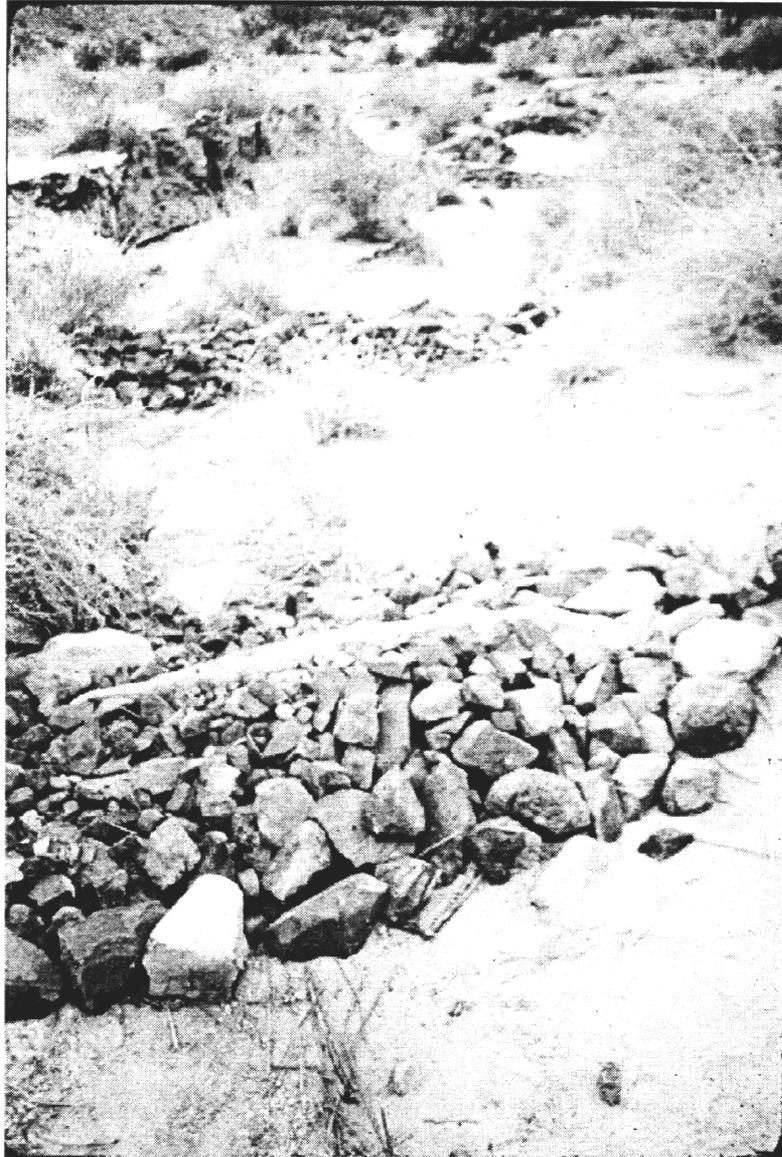
Figure 6. A very common style of checkdam constructed at Palisades Delta in September 1995.

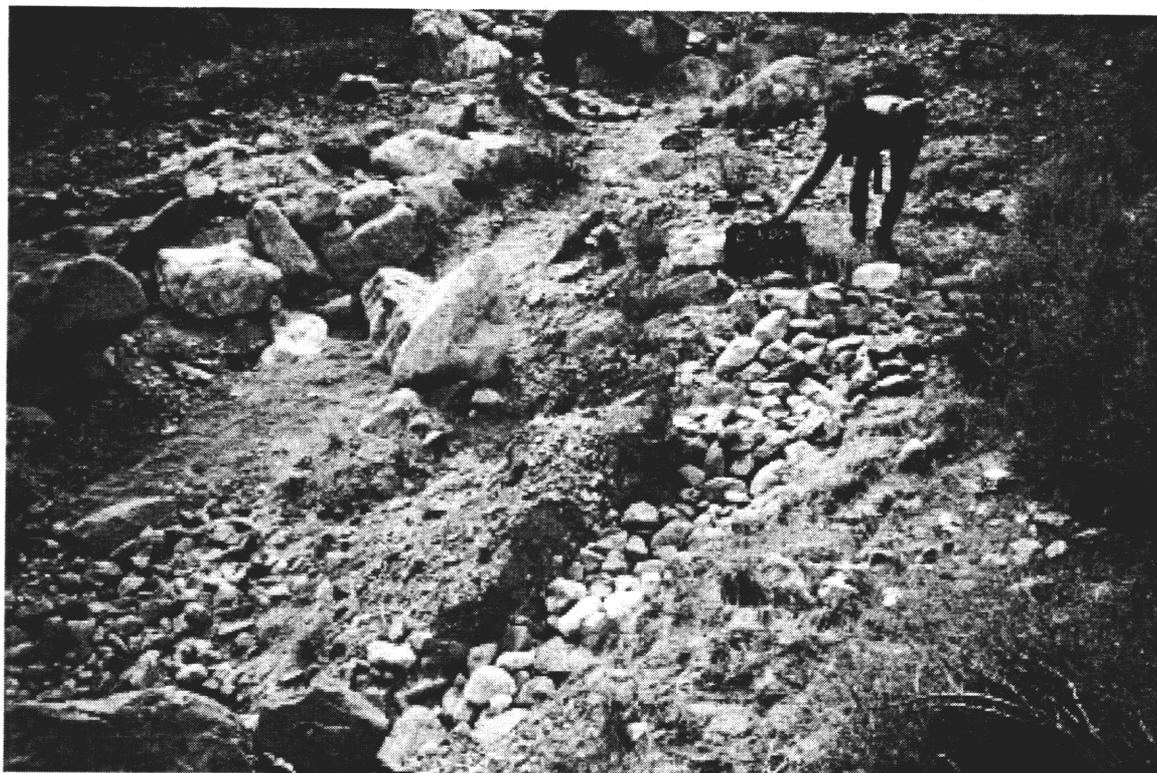
Figure 7. Photograph illustrating the type of checkdam used most commonly since FY96. The Zuni have gone from the traditional "rock check" to rock and gravel linings as seen here at 60 Mile Canyon.

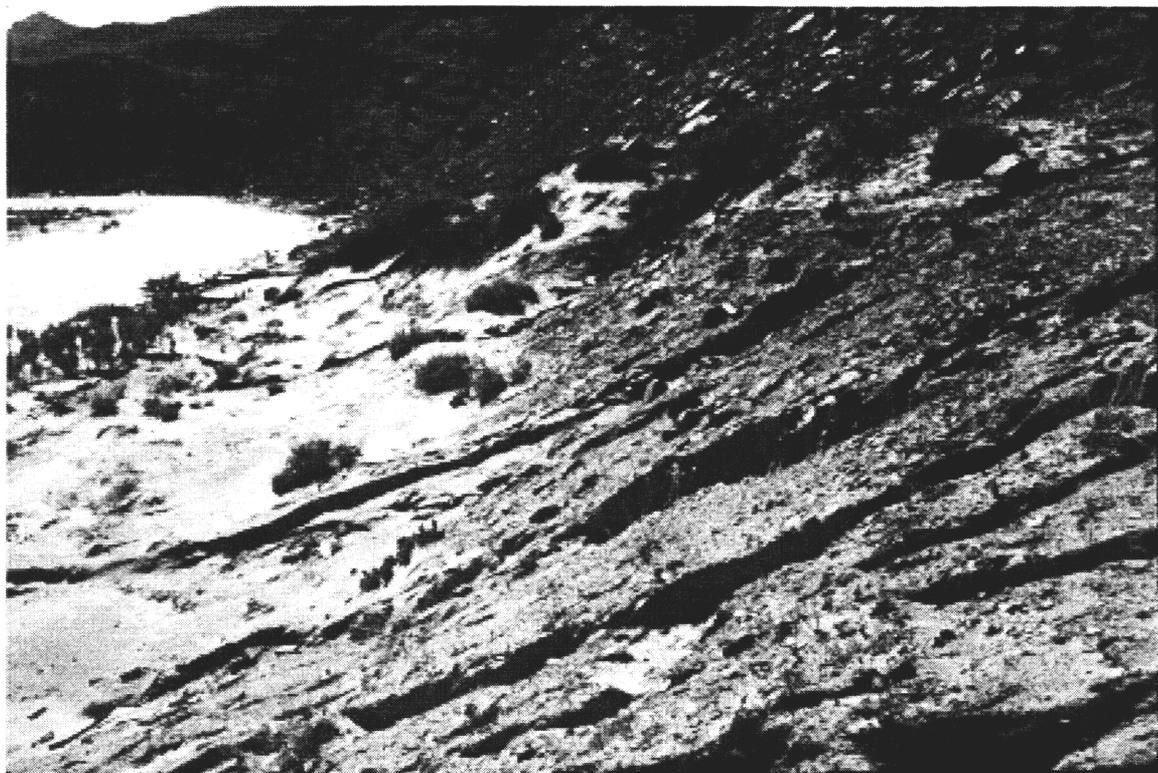
Figure 9. September 1983 photo illustrating the extensive river-based drainages throughout C:13:010; notice that many of the drainages are bisecting the alluvial terraces on their way to the river.

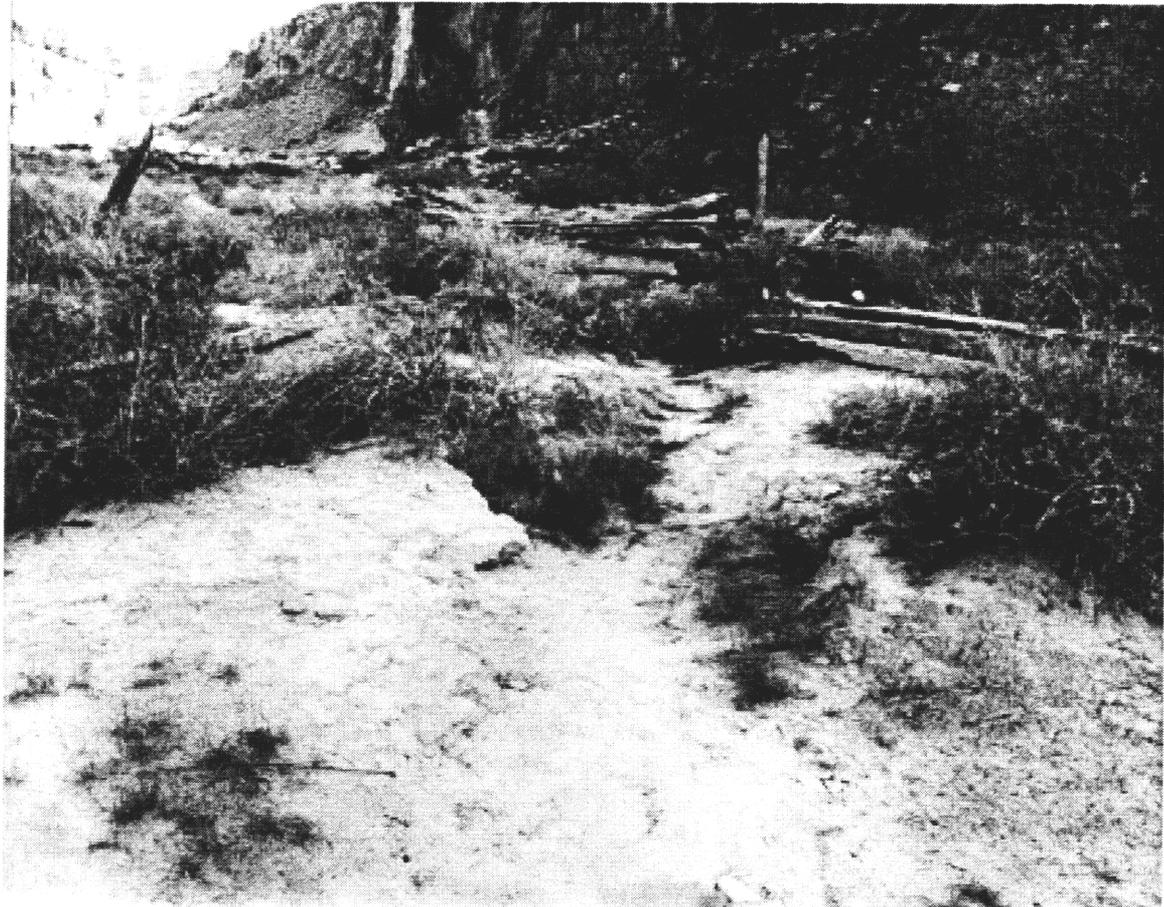
Figure 10. Gullying observed and recorded in FY95 at site C:13:098. The gully extends toward the cabin and travels down to a more extensive drainage system that bisects site C:13:099. Since this photo, checkdams have been placed in the more extensive system and brush has been thrown over the channel area located in the center of the photograph. As a result, monitors have recorded that this gully has not deepened.

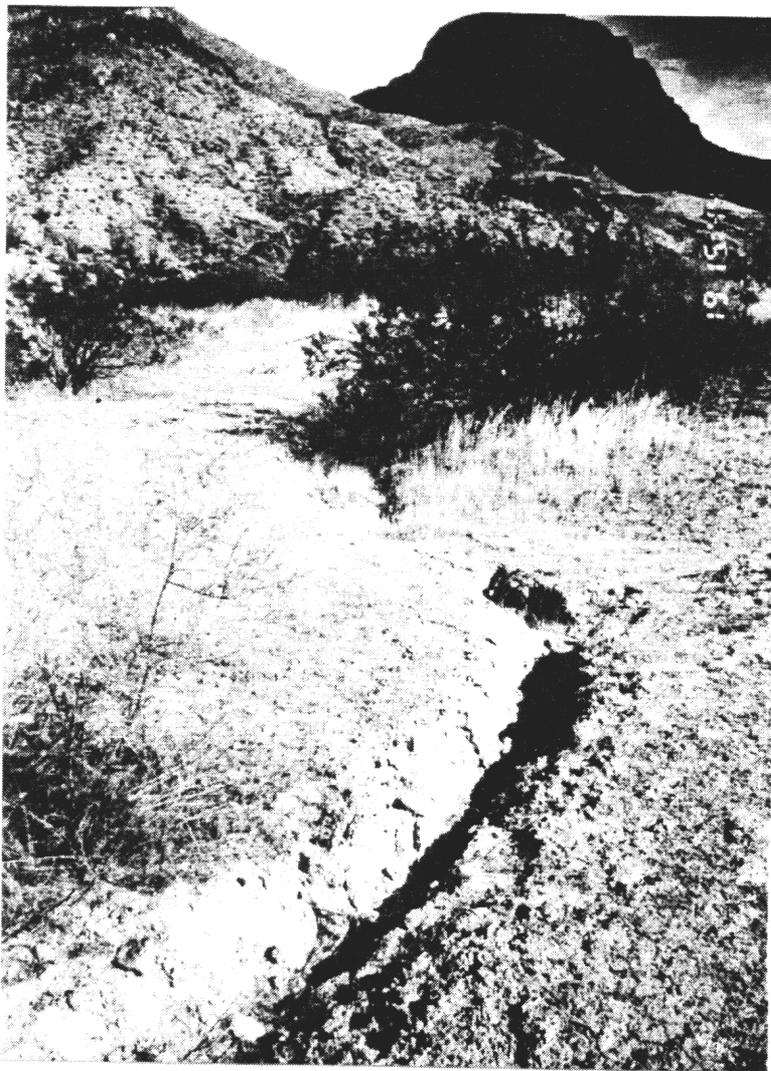
Figure 11. Localized gullying recorded in FY94 at site G:03:024. This gully is directly adjacent to Feature 3, to the left of the photo, and heading directly towards Feature 2, located upslope of Feature 3. Brush checkdams were placed in this gully in FY97. In FY99 heavy rains initiated maintenance of the checkdams, which included adding small gravels to the already existing brush checkdams.

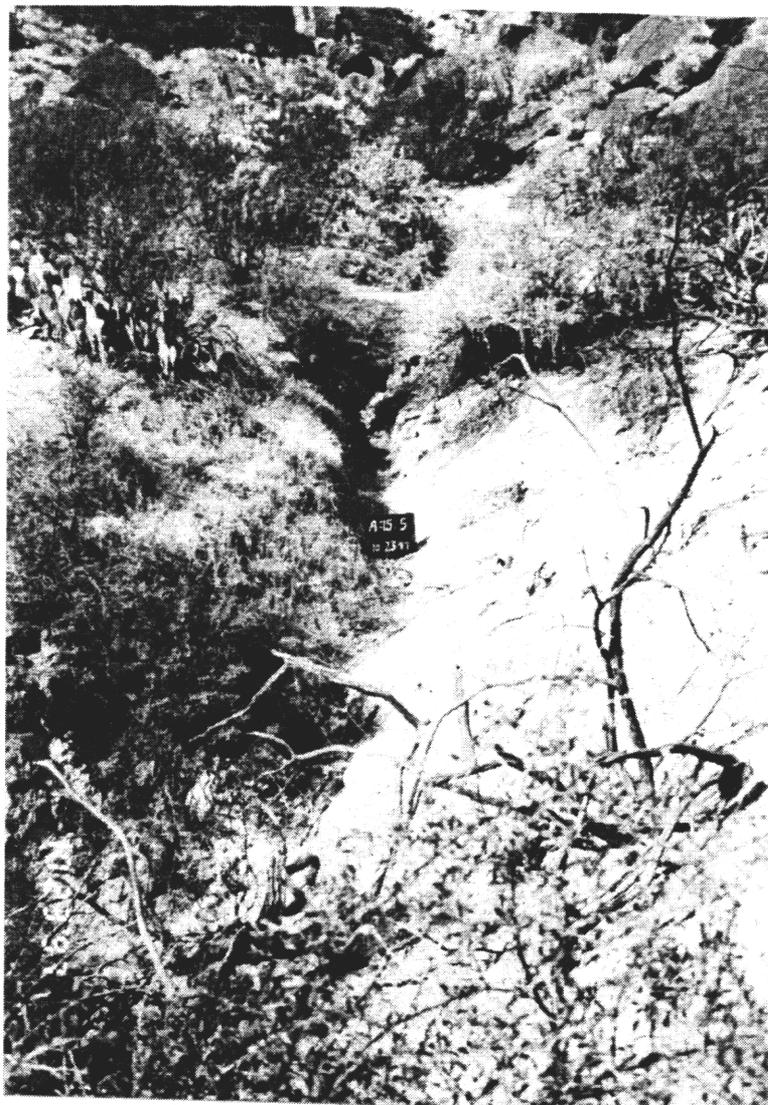
Figure 12. Photograph showing the activity noted at the river-based gully near Feature 2 at A:15:005. In October of 1997 (FY98), the gully demonstrated much activity in the form of several new nickpoints and headward movement of the headcut (toward Feature 2). One major nickpoint is located below the photoboard. Prior to the research flow of 1996, this gully was considered terrace-based.

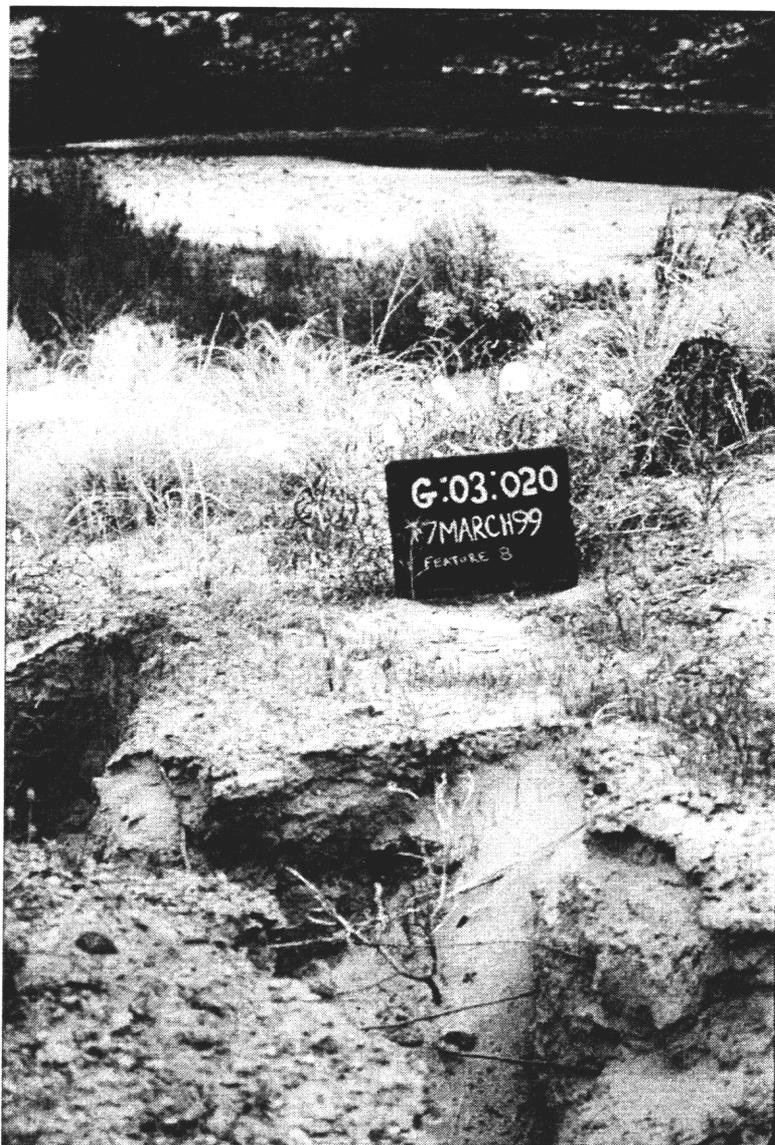
Figure 13. Feature 8 of site G:03:020 was newly exposed in the fall of FY99. This feature and Features 7 and 9 were excavated in the spring of FY99. This former foot path is now a mature river-based gully. No preservation work will be implemented because personnel from the Zuni Conservation Project believe the gully will fill in due to its deep and narrow nature.

In the spring of FY99, Features 7, 8, and 9 were excavated. Results of the excavation will be written and sent to PA members after the collected samples are sent to the appropriate analysts. Currently, the samples are housed at the Flagstaff office until funding is provided. After excavations, trails were obliterated.

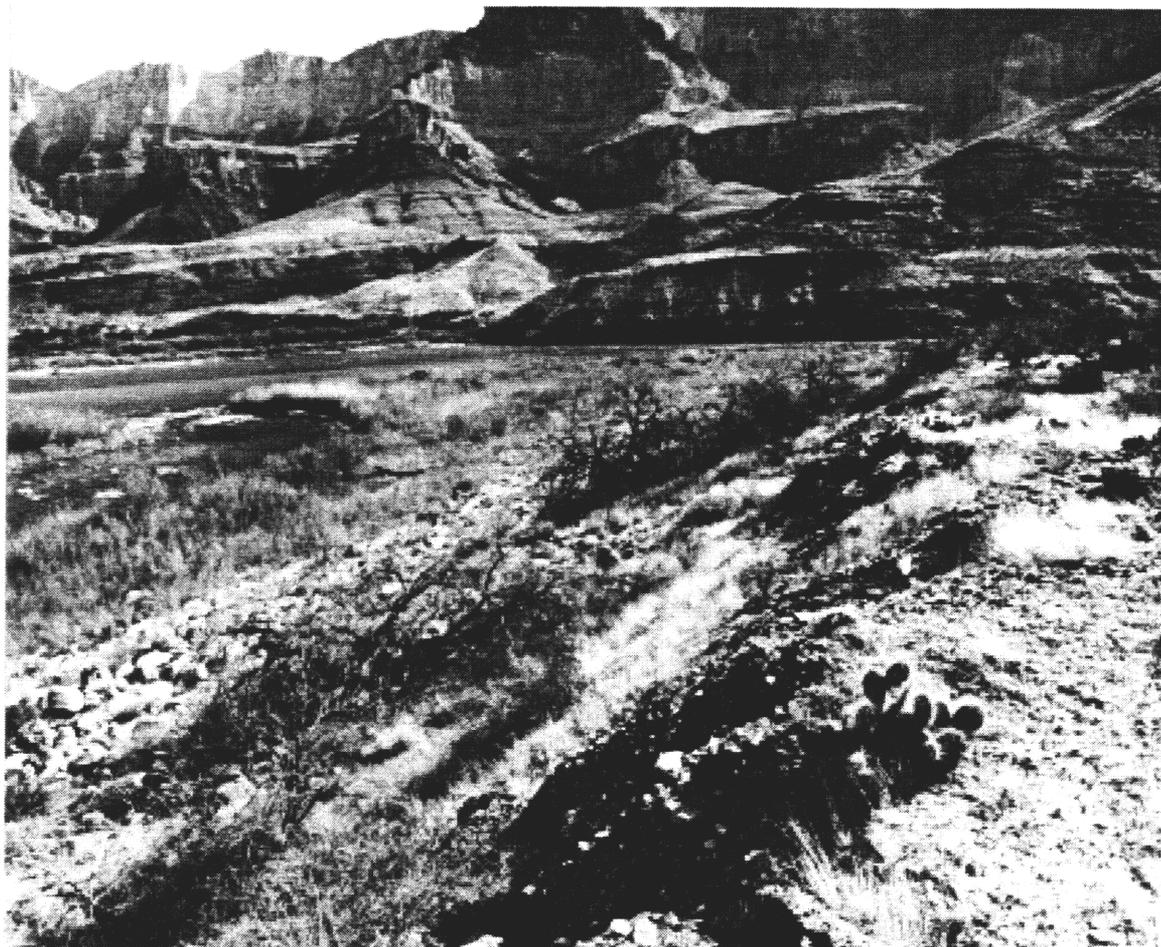
Figure 14. A medium-format photograph of the gullies located near Features 10, 11, and 20 of C:13:009. The features are located on the edge of the bank. This photograph was taken prior to the research flow of 1996. No remedial activities have occurred in this area. In FY99, Features 10 and 20 were recommended for excavation before they are lost to continued gully downcutting.

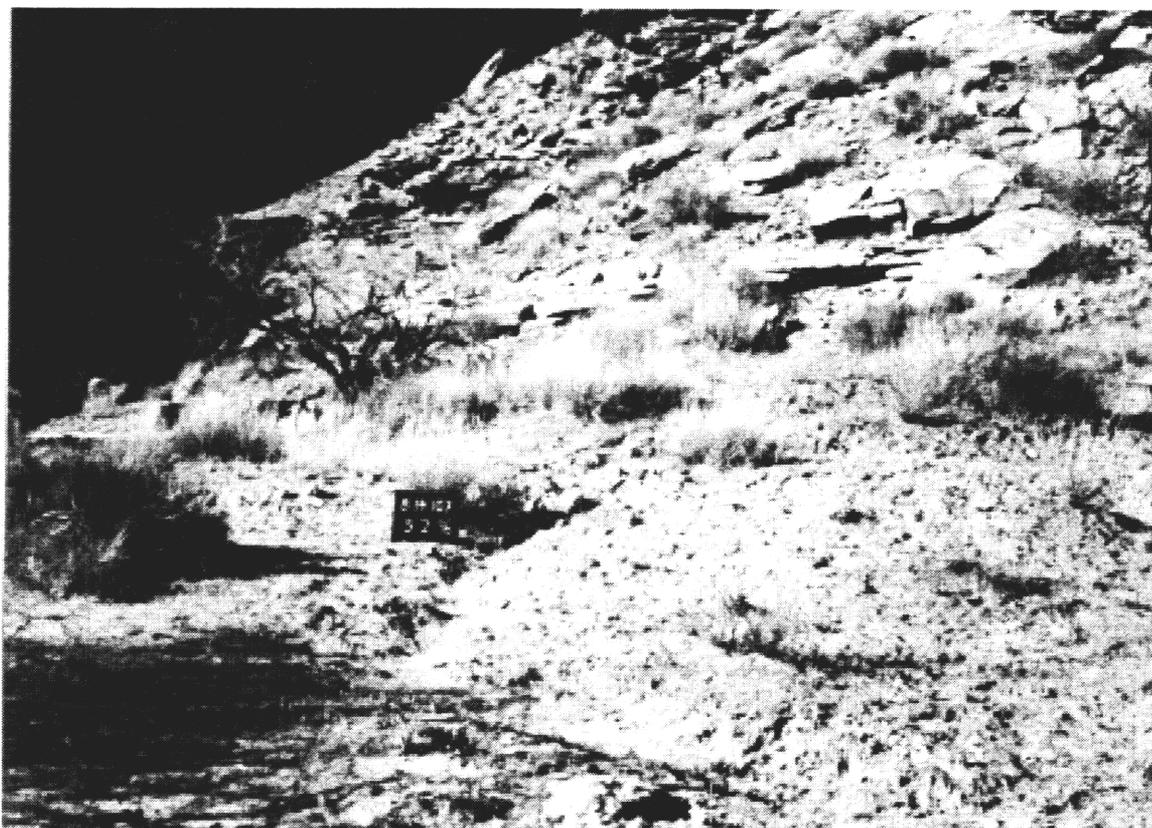
Figure 15. A terrace-based gully bisecting Feature 2 at site B:14:107. Remedial action work completed in FY97 reduced the active gullying at this feature and diverted runoff to a location devoid of cultural materials.

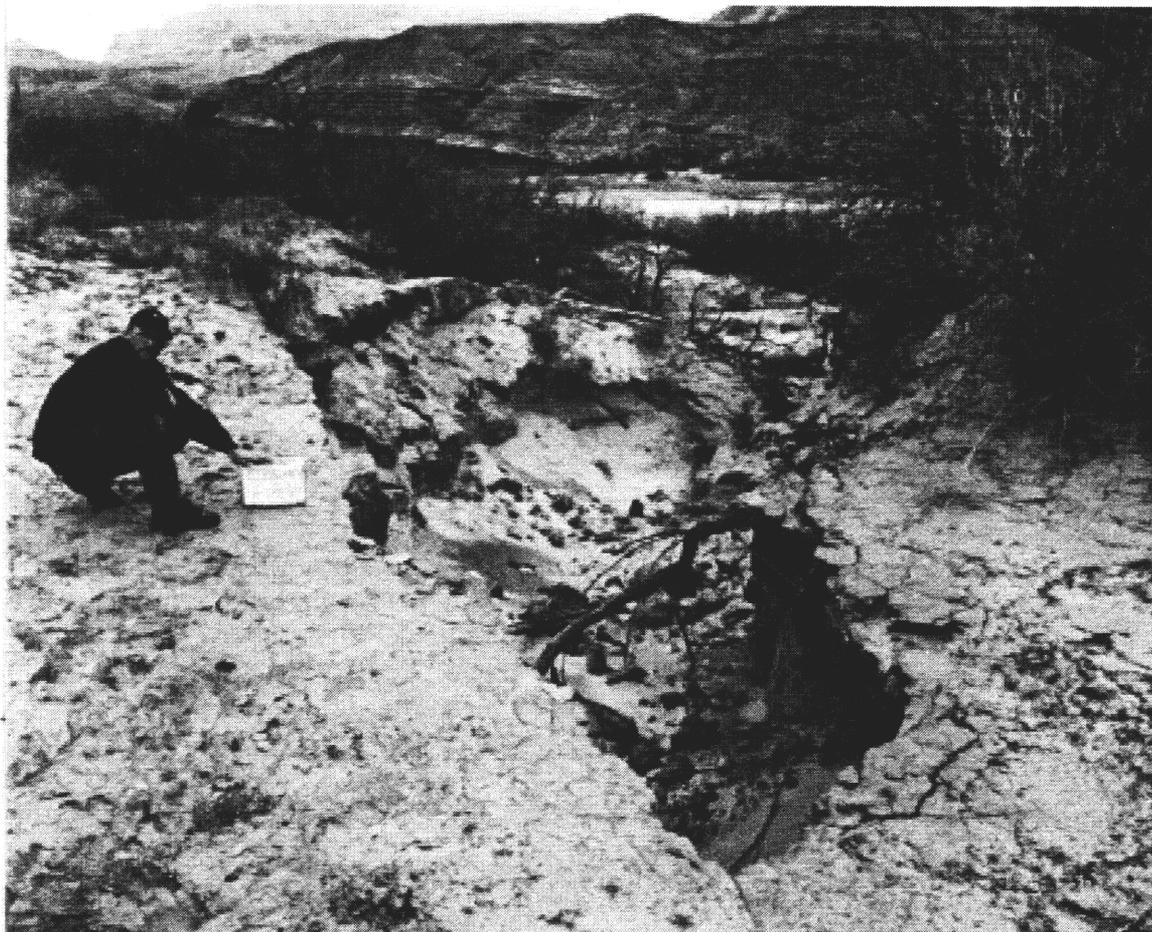
Figure 16. A terrace-based arroyo cutting through C:13:349. The arroyo continues to widen and lengthen, and has been active since it was recorded in 1990. Stabilization by checkdams has been deemed unrealistic given the mature stage of this drainage.

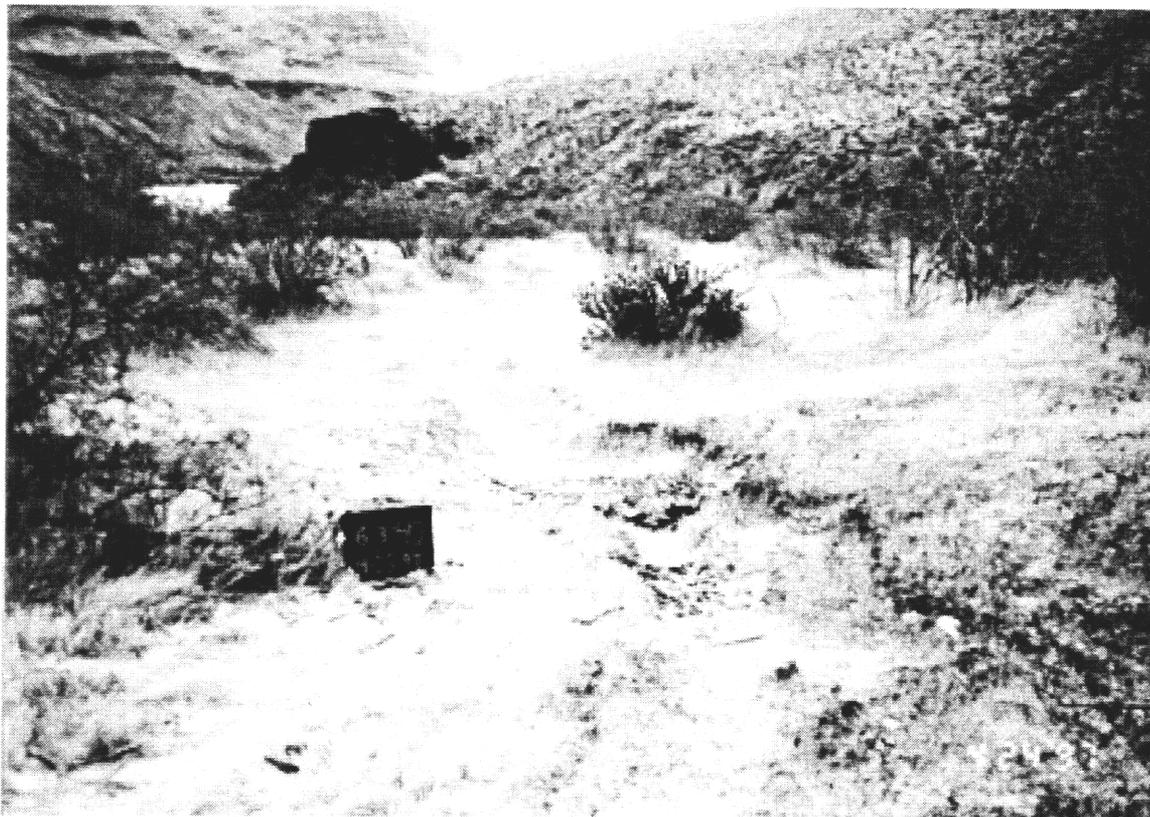
Figure 17. The terrace-based drainage at G:03:040; checkdam construction was completed in FY97. Since then, these brush checkdams have proven to be effective in collecting sediment.

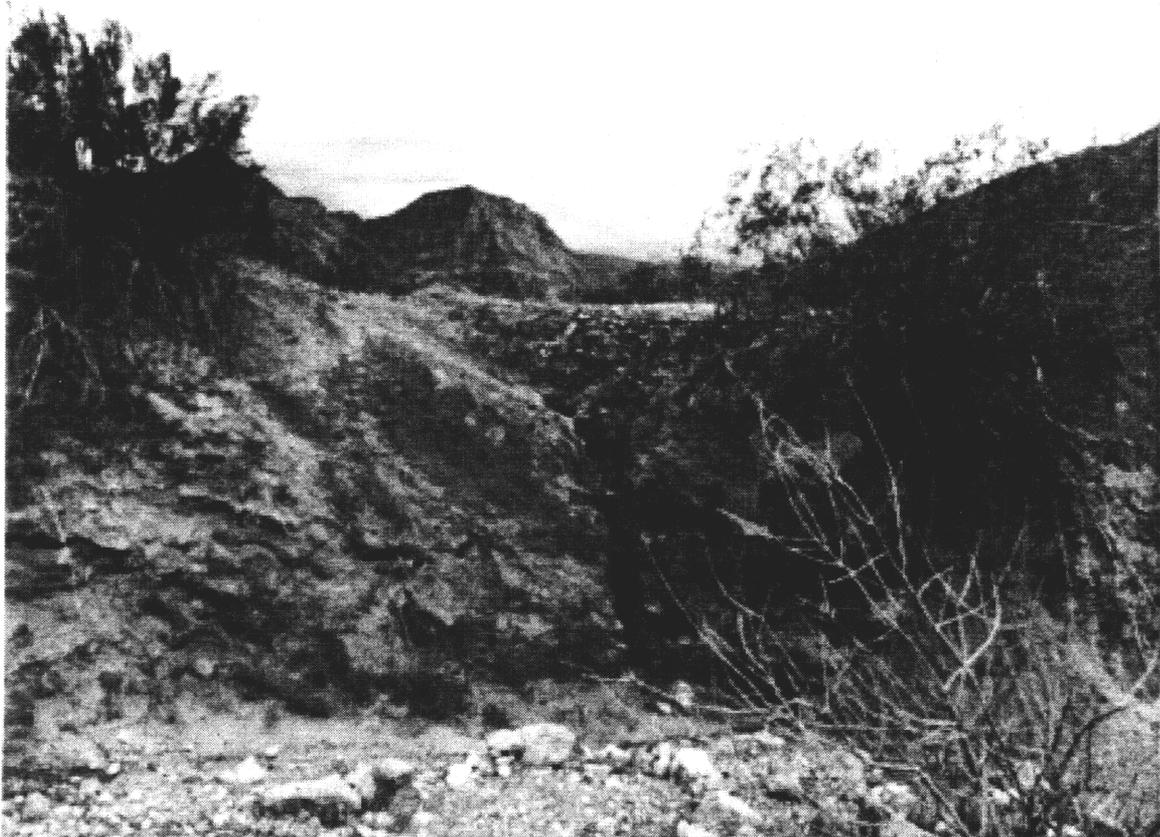
Figure 18. The side canyon-based gully dissecting Locus B, a roasting feature, at G:03:040. In FY97 the Zuni Conservation Project personnel lined the gullies with small cobbles and gravel. After a flash flood in FY99 this entire bank was defaced about a meter back, completely destroying one of the checkdams.

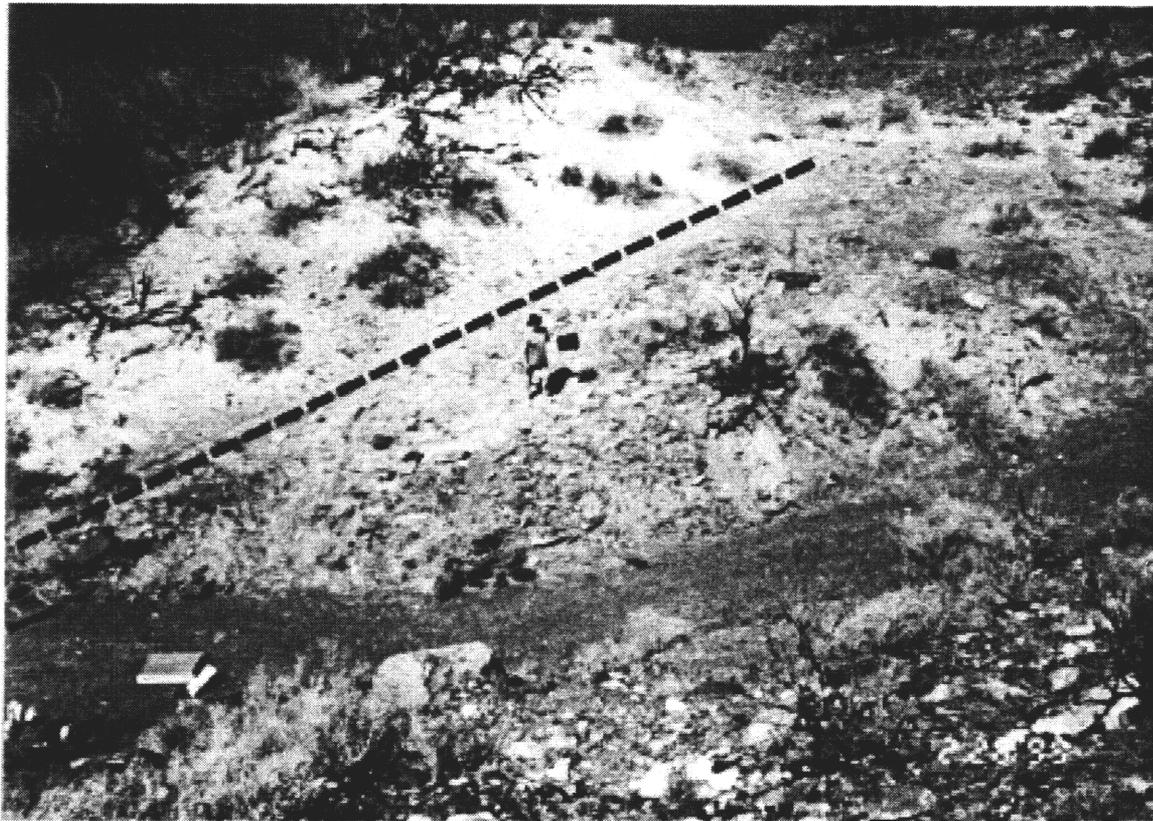
Figure 19. Overview of C:13:343 in relation to an active side canyon (foreground); the side canyon-based drainage is demarcated in photo-center. The drainage bisects the site and feeds directly into the side canyon.
