GRAND CANYON MONITORING PROJECT 1992-1999:
SYNTHESIS AND ANNUAL REPORT FY99

Grand Canyon National Park and
Northern Arizona University
Cooperative Agreement CA 8210-97-002

RCMP Report No. 66
Flagstaff, Arizona

January, 2000

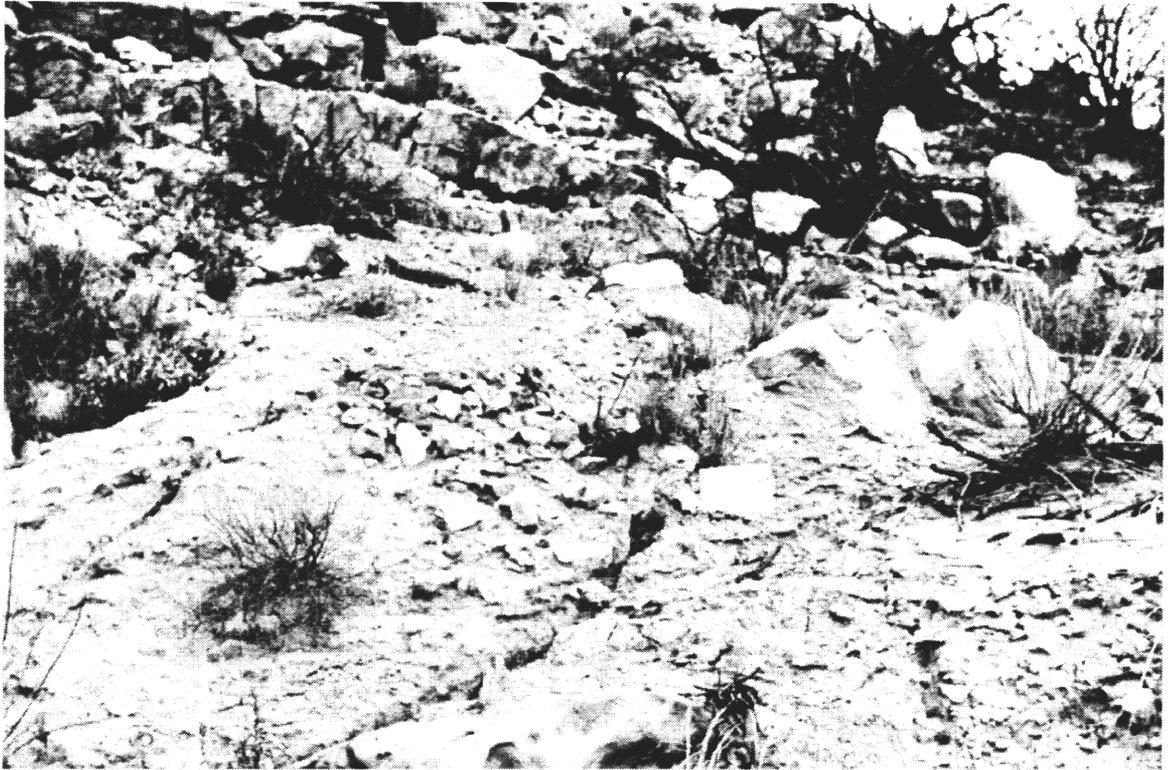
Figure 20. Overview of a side canyon-based drainage impacting Feature 2 at C:13:371.

the river, was plugged by the 1996 research flow (Balsom and Larralde 1996). However, the side canyon has reached the river again and continues to cut through the 45,000 cfs terrace deposited in 1996.

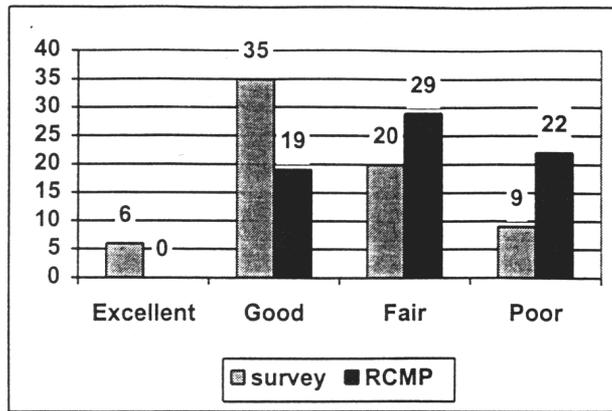
Comparison of survey site condition with RCMP site condition for sites with river-based drainages (sites directly impacted by Dam operations)

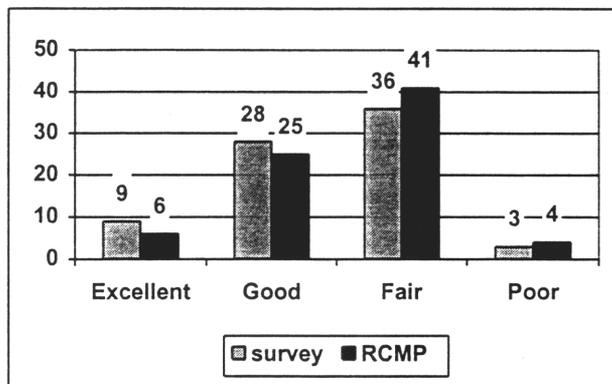
Comparison of survey site condition with RCMP site condition for sites with terrace- and side canyon-based drainages (sites indirectly impacted by Dam operations)

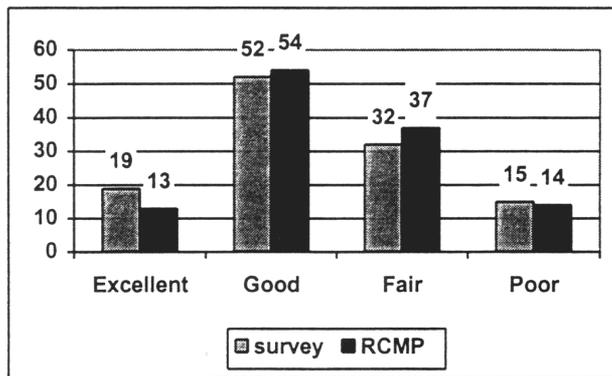
Comparison of survey site condition with RCMP site condition for sites with no drainages (sites potentially impacted by Dam operations)
