Surficial Geology, Geomorphology, and Erosion of
Archeologic Sites along the Colorado River, Eastern
Grand Canyon, Grand Canyon National Park, Arizona

U.S. GEOLOGICAL SURVEY OPEN-FILE REPORT 93-517

Surficial Geology, Geomorphology, and Erosion of Archeologic Sites, along the Colorado River, Eastern Grand Canyon, Grand Canyon National Park, Arizona

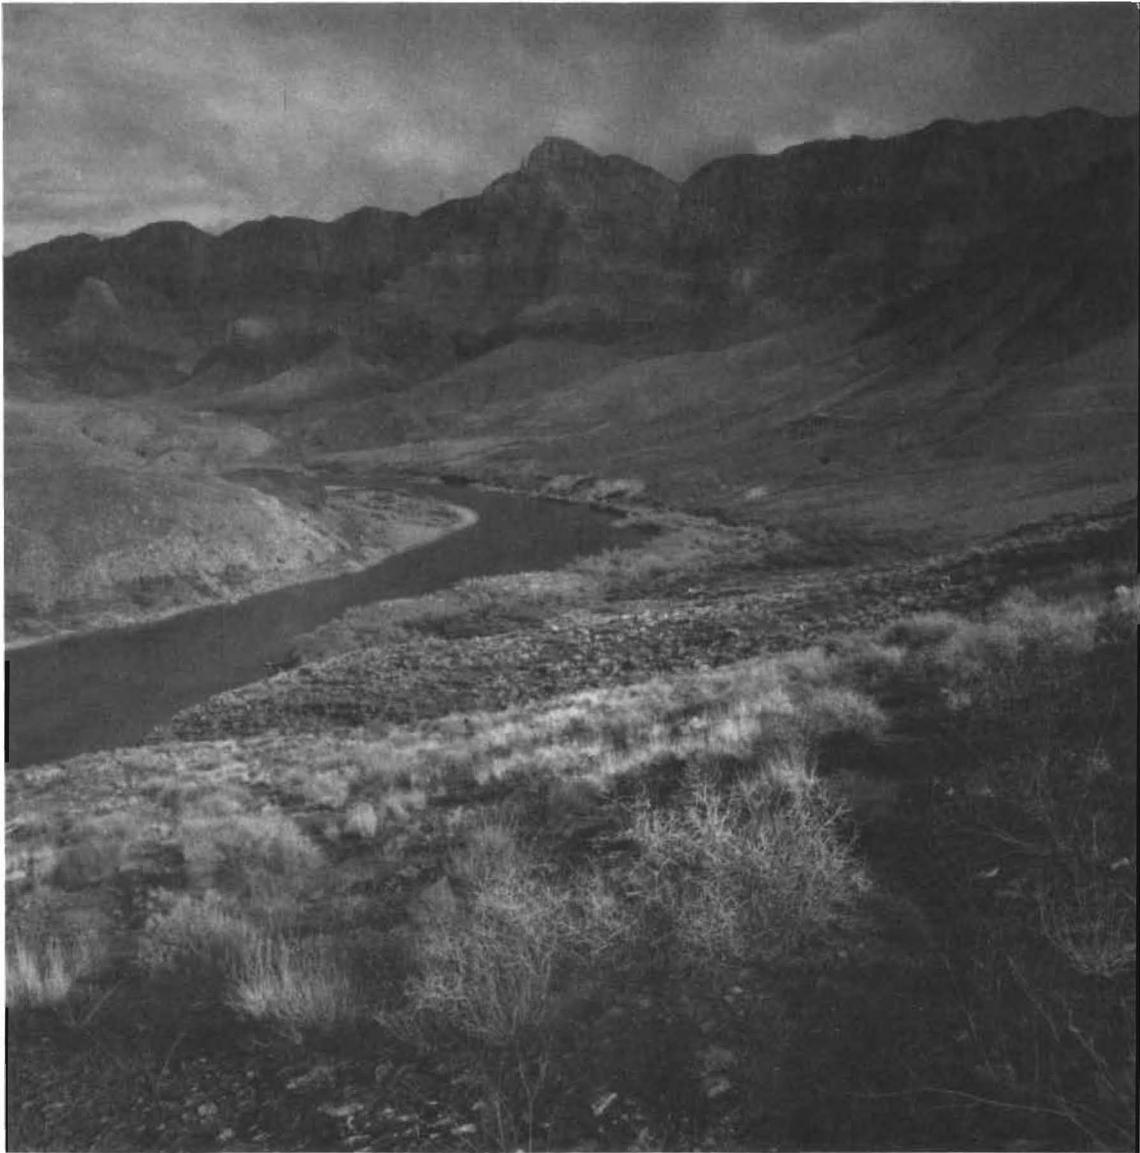
The eastern Grand Canyon in the vicinity of Cardenas Creek, Palisades of the Desert and Commanche Point on the skyline. Deposits of late-Holocene age occur in the vegetated area in the mid-ground on both sides of the river. Pleistocene-age gravel deposits form the steep, elevated banks adjacent to the river. Most of the archeologic remains are near the river and associated with the late-Holocene deposits .

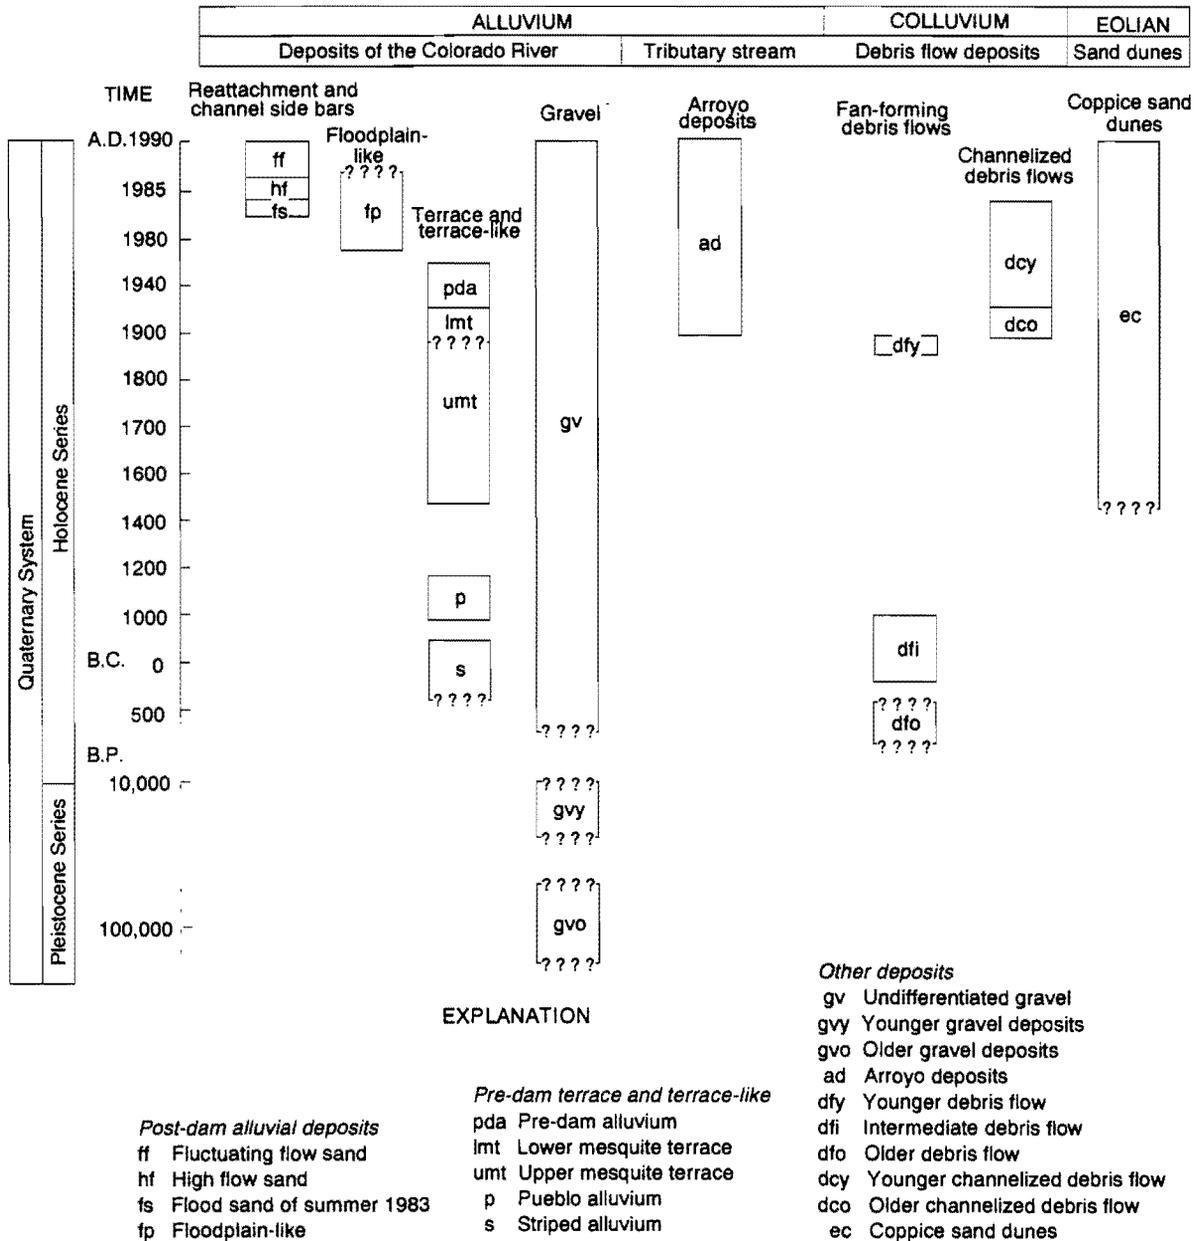
Figure 2. Generalized classification and correlation of late Quaternary deposits. Question marks indicate uncertainty in age of deposits.

Deposits of mostly consolidated gravel (units gvy and gvo of fig. 2) occur just outside of the corridor from near river level to more than 30 m above river level, as measured from the base of the gravel. The gravels are up to

Finally, gravel deposits (unit gv of fig. 2) with exposed thickness of 4-5 m are widespread in the river corridor. The deposits are unconsolidated, have a coarse-sand matrix, and clasts are cobble to boulder size. The clasts are rounded to subrounded and composed of local Paleozoic and Proterozoic formations. The gravel deposits are the substrate for the sand-size Colorado River alluvial deposits (fig. 2). Because of the relatively large size of the gravel clasts, they are immobile under most flow conditions of the Colorado River (except conditions in the rapids) and tributary streams. Thus, the gravel deposits control the position of the river and in places limit downcutting of the tributary streams.

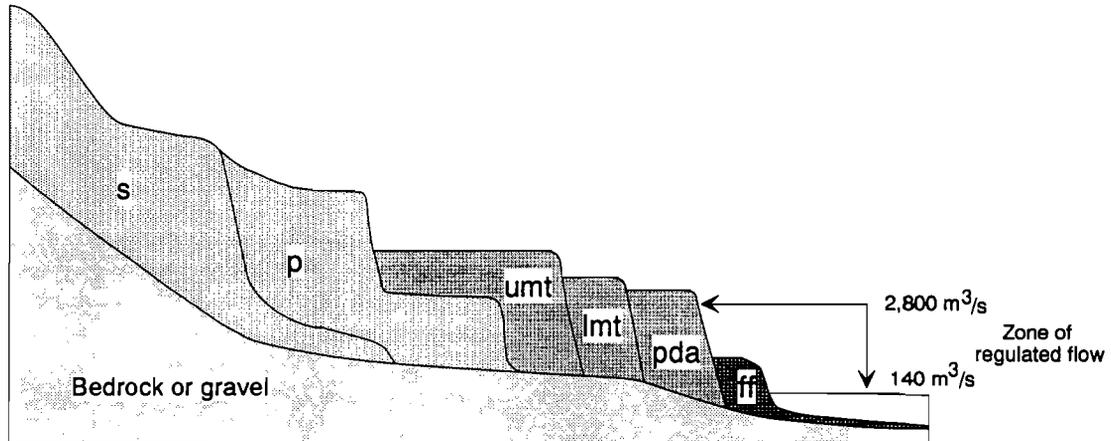
Figure 3. Generalized cross-section showing geomorphic and geologic relations of alluvial deposits. Symbols explained in figure 2.

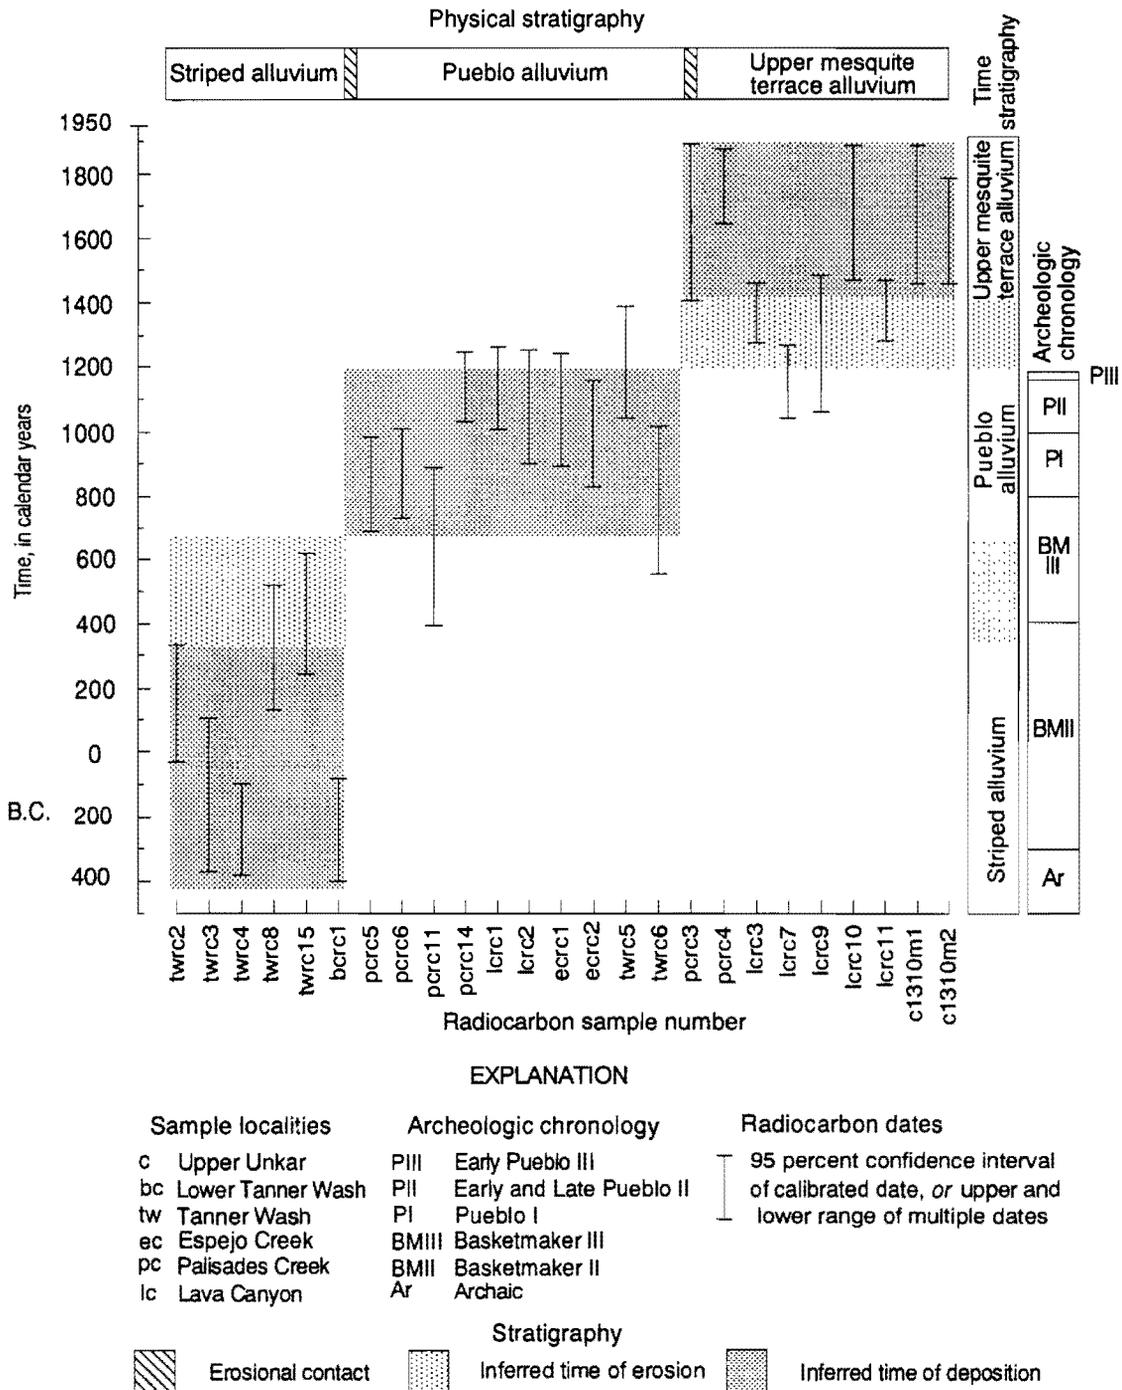
Figure 4. Radiocarbon dates calibrated to calendar years arranged by stratigraphic unit showing relations among physical stratigraphy, time stratigraphy, and archeologic chronology.

figure 4, which shows the age range of 25 radiocarbon dates in calendar years arranged by mapped stratigraphic unit.

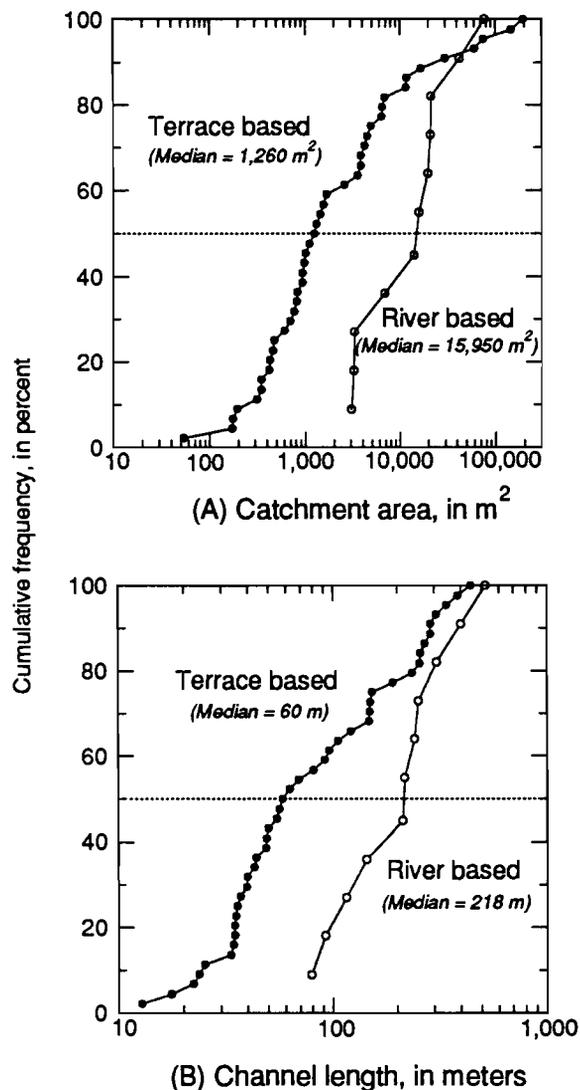
Figure 5. Cumulative frequency distributions of catchment area (A) and channel length (B) of river-based and terrace-based streams.

In addition to effective baselevel, river and terrace-based streams differ in catchment area and channel length. Figure 5 shows the cumulative frequency distributions of catchment area (fig. 5a) and channel length (fig. 5b) of river and terrace-based streams. The median catchment area of river-based streams is about 16,000 m², 12 times larger than the median size of terrace-based streams, which is about 1,300 m² (fig. 5a). Moreover, 63 percent of the terrace-based streams are smaller than the smallest river-based stream, which is about 3,000 m². Variation in the size of river-based catchments is less than one order of magnitude, whereas the size of terrace-based catchments ranges over three orders of magnitude. The difference in channel length (fig. 5b) is similar to the difference in catchment area. River-based streams have longer channels with less variation in length than channels of terrace-based streams. The median channel length of a river-based stream is about 220 m, whereas the median terrace-based channel is only 60 m.

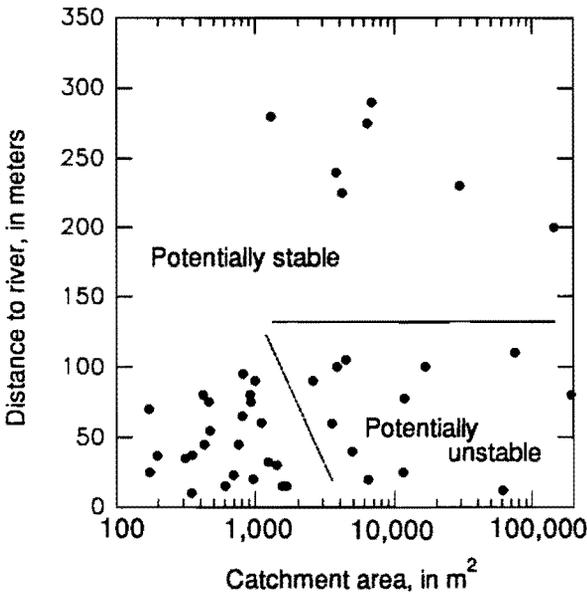
Figure 6. Stability fields of terrace-based streams as a combination of catchment area and distance to the river.

erosional stability of the channel system. Figure 6 shows distance to the river of the terrace-

based channels plotted against basin area. Distance was measured from the end of the stream symbol to the river following the topographic slope along incipient channels and other low-lying areas, which is not necessarily the direct path to the river. Two fields are distinguishable in figure 6 that probably correspond with stable and unstable combinations of catchment area and distance to the river. Potentially unstable channels have relatively large catchment area, and the channels end near the river. The area of these potentially unstable basins is greater than 3,000 m², and the channels end within about 10-100 m of the river.

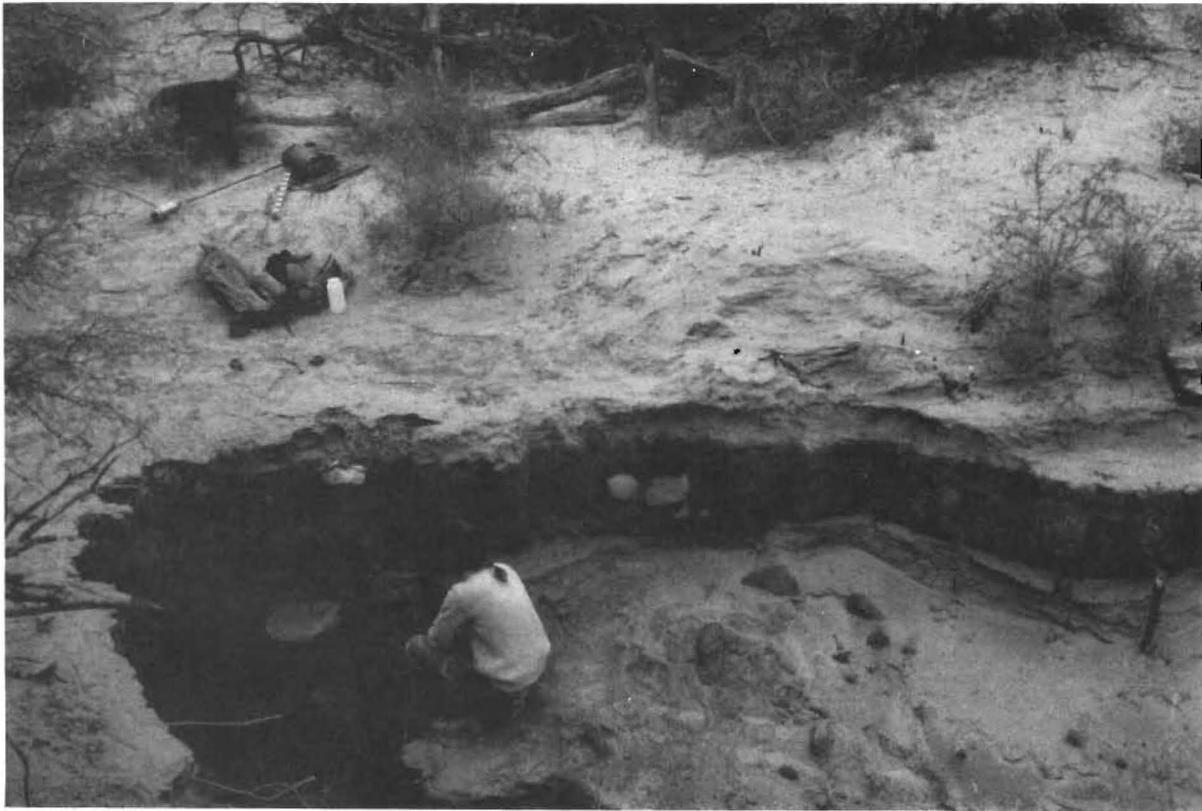
Figure 7. Headcut exposing a metate (grinding stone) in the arroyo of a terrace-based stream in the Lower Tanner Canyon area (fig. 1; Plate 2) in November 1990. The metate was dislodged during runoff and headcut migration in September 1992. The headcut occurs in a low area between two sand mounds of a coppice dune field.

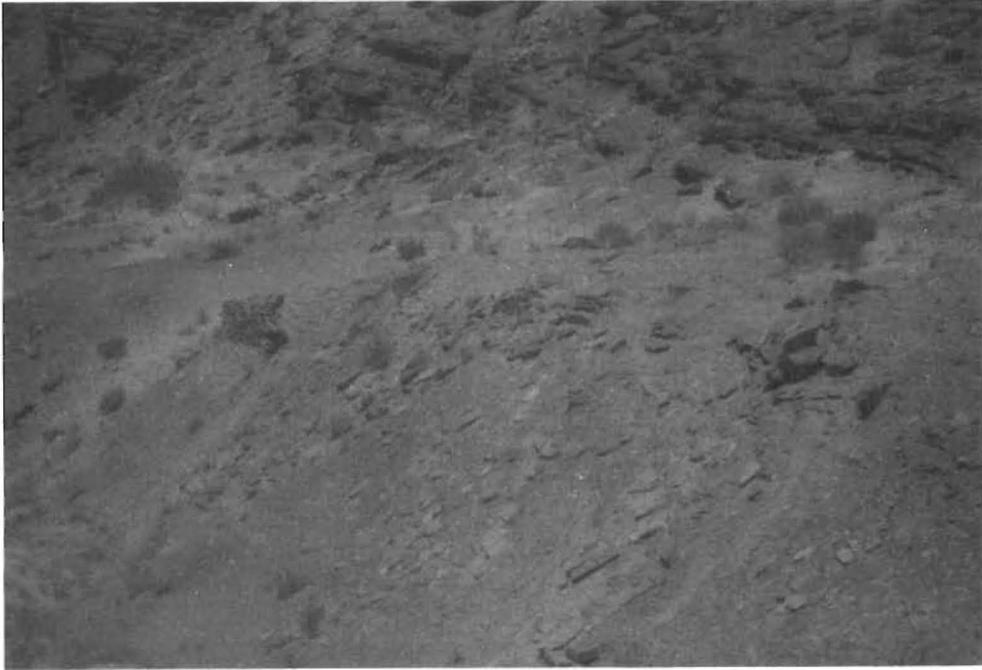
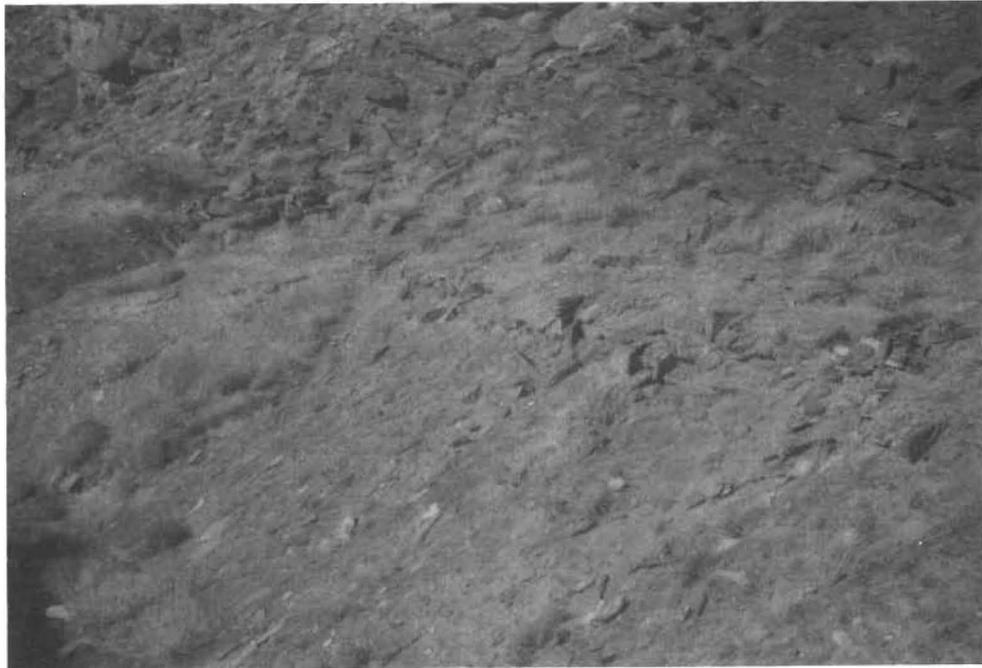
Figure 8. Repeat photographs of locality 1 (Jones, 1986, p. 74) in the Upper Unkar archeologic area showing erosion of archeologic features. (A) Photograph by Robert C. Euler, June 4, 1965, and (B) approximately the same scene, November 16, 1991.

Erosion of the Upper Unkar area is documented by comparison of photographs taken by Robert C. Euler in 1965, 1972, and 1978 with photographs of the same areas taken in 1983 and 1991. These photographs provide evidence of arroyo cutting and erosion of archeologic features by the short tributary streams that drain the river corridor. The photographs are shown in figures 8 and 9. Figure 8a was taken by Euler on June 4, 1965. The approximate location of the photograph station is labelled RCE PS 1 on Plate 1. The view is to the west-northwest across an arroyo that is about 6 m deep. The area lies within locality 1 of Jones (1986, p. 74) and contains 3 structures and 13 features. Another Euler photograph of this area was taken July 11, 1978. The photograph was not relocated, as it was taken from a different perspective and some distance to the left of figure 8a. The 1978 photograph is difficult to compare directly with figure 8a, but the walls of the structure are not present in the photograph.

A photograph taken November 16, 1991 from very close to the Euler photograph site is shown in figure 8b. The arroyo has deepened and widened since 1965, causing extensive damage to the archeologic site. The wall to the left of center in the Euler photograph (fig. 8a) had collapsed (this occurred by July 11, 1978), and the blocks were removed by erosion (fig.

8b). This erosion produced a small, steep arroyo beneath the wall. Other structures present in the central portion of the Euler photograph (fig. 8a) have also collapsed and were removed by erosion. This was evidently caused by widening of the north side of the arroyo. The flat, terrace-like surface between approximately the 811-813 m contours (Plate 1) was wider and extended farther south in 1965 (fig. 8a) than at present (fig. 8b). In addition, the Euler photograph (fig. 8a) shows light-colored eolian sand and alluvium in the channel of the large arroyo. These deposits have been eroded since 1965, and bedrock is now exposed in the channel.

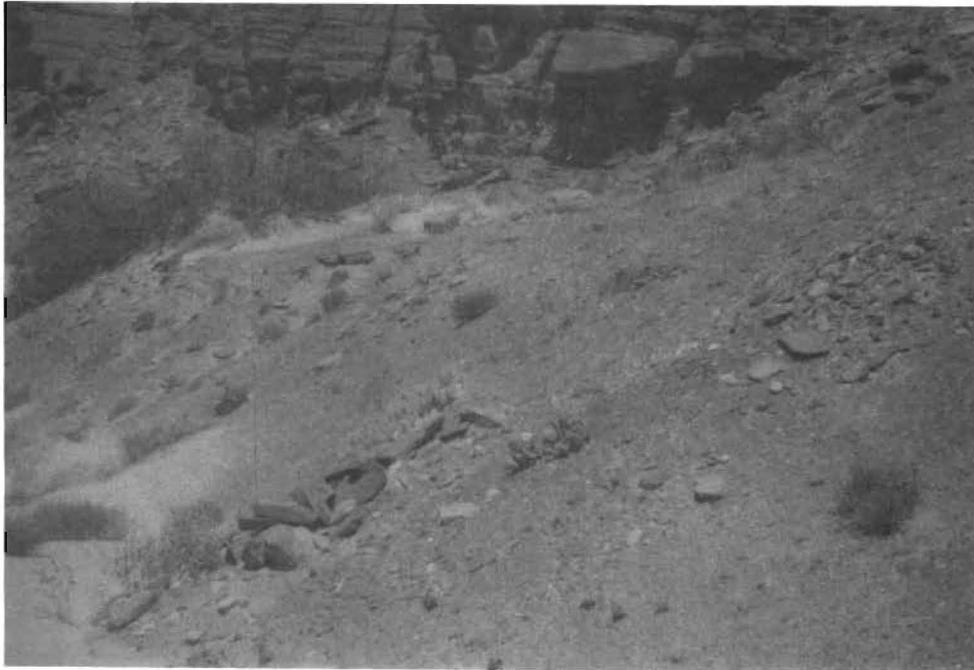
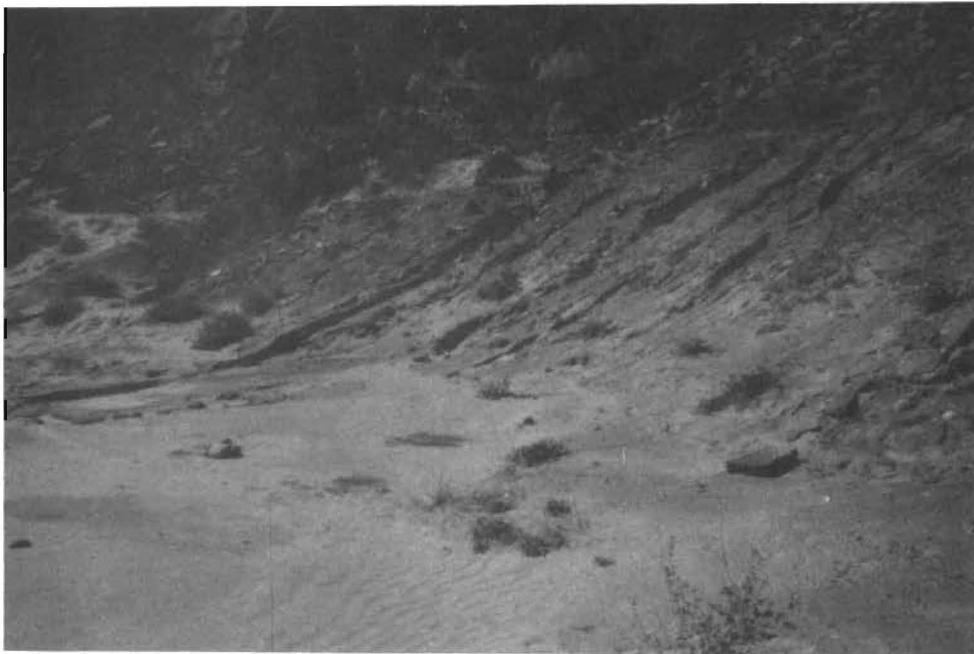
Figure 9. Repeat photographs showing arroyo development and erosion of archeologic features at locality 2 of Jones (1986, p.75). (A) Photograph by Robert C. Euler, June 4, 1965. (B) Photograph of approximately the same area by Janet R. Balsom, September 15, 1983.

In 1965, the terrace rise was relatively undissected (fig. 9a), although a subdued, apparently inactive channel is present in the left center of the photograph. Between 1965 and mid-September 1983, the terrace rise was dissected substantially, as shown by the fresh appearing arroyo in the center of the Balsom photograph (fig. 9b). As previously discussed,

the incipient form of these arroyos is present in the 1980 aerial photographs (table 1). This erosion exposed and damaged several archeologic features that were later excavated by Jones (1986). The terrace in the foreground of figure 9b is the pre-dam alluvium (unit pda of fig. 2) with a thin cover of eolian sand with asymmetric ripple marks.

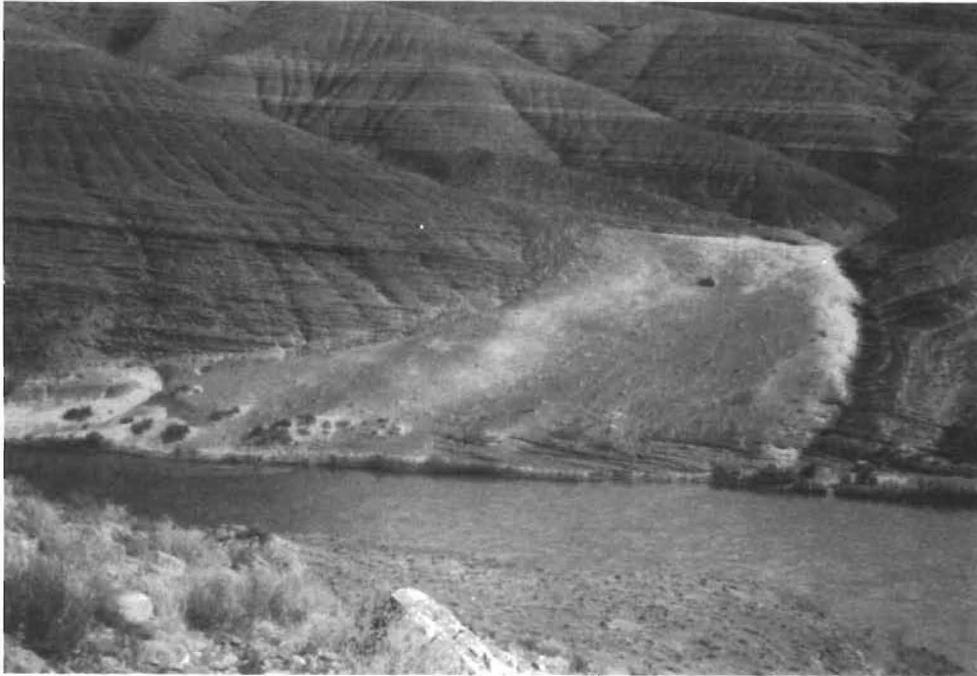
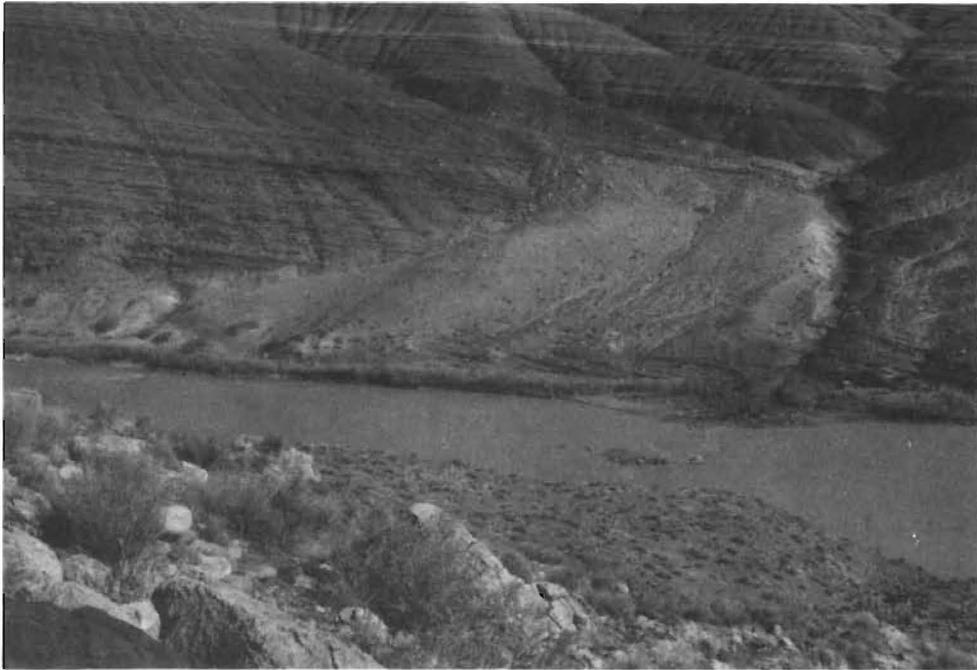
Figure 10. Repeat photographs showing dissection and arroyo development on the north side of the Colorado River in the east portion of the Upper Unkar area (Plate 1). (A) Photograph by Robert C. Euler, May 1972. (B) Approximately the same scene in March 1992.

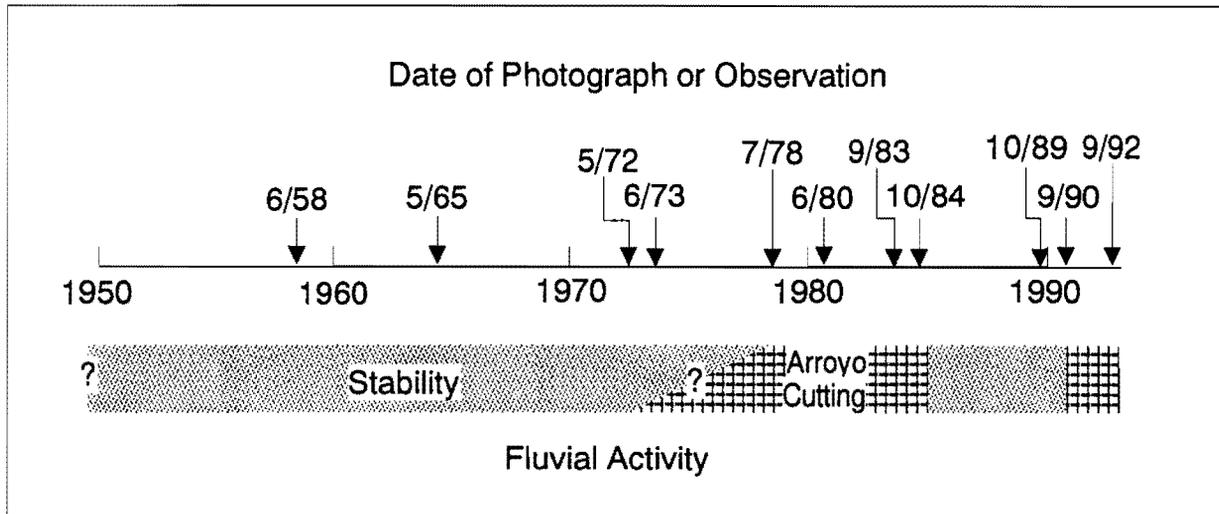
Figure 11. Time line showing fluvial activity in terms of stability (no change) and arroyo cutting based on dates of photographs and field observations.

Figure 11 is a time line showing fluvial activity of eastern Grand Canyon in terms of stability and arroyo cutting as inferred from the aerial photographs, ground-based photographs, and observations discussed previously. This evidence suggests that the tributary streams were stable from June 1958 through June 1973. The arroyo cutting evident in the 1984 aerial photographs was probably underway before June 1980, and possibly underway before July 1978 when a photograph shows erosion of the wall at Upper Unkar. Based on this evidence, arroyo cutting began sometime between June 1973 and July 1978. Climate evidence presented in a following section suggests that arroyo cutting probably began in the fall to winter of 1977-78. The aerial photographs show little change between October 1984 and October 1989; thus, arroyo cutting was largely

The arroyo-cutting episode of the late 1970s to early 1980s indicated by photographic and field evidence (fig. 11) was caused by the unusual rain of fall to winter 1977-78 and 1978-79, warm season 1981, fall to winter 1982-83, warm season 1983 and 1984, and fall to winter 1984-85. In contrast, the apparent stability between 1985 to early 1990 is probably related to the lack of significant precipitation (fig. 23). The early period of stability from at least 1958 until 1973 (fig. 11) is more difficult to interpret. Precipitation was probably adequate in warm season 1963 and 1966, fall to winter 1965-66 and 1966-67, and warm season 1967 and 1972, but the photographic evidence shows no detectable change (fig. 11).

Arroyo cutting increased in the post-dam era, coincident with the erosional damage of archeologic sites (fig. 11). Evidence of arroyo cutting is shown by sequential low-altitude aerial photographs (table 1), ground-based photographs (figs. 8-10), and field observations of ongoing erosion. Arroyos were generally stable from at least 1958 until late 1972-73. Arroyo cutting began in the area sometime between June 1973 and July 1978. This erosional episode lasted until fall to winter of 1984-85. After then until late 1989, aerial photographs show little change in the size and number of arroyos. This period of stability lasted until 1990, when erosion was observed again throughout the area. Erosion during the late 1970s to mid-1980s resulted in widening, deepening, and upstream and downstream extension of existing arroyos, as well as development of new arroyos. The present (1990-92) erosional episode appears to be a continuation of the earlier episode, although the effects are not as severe.

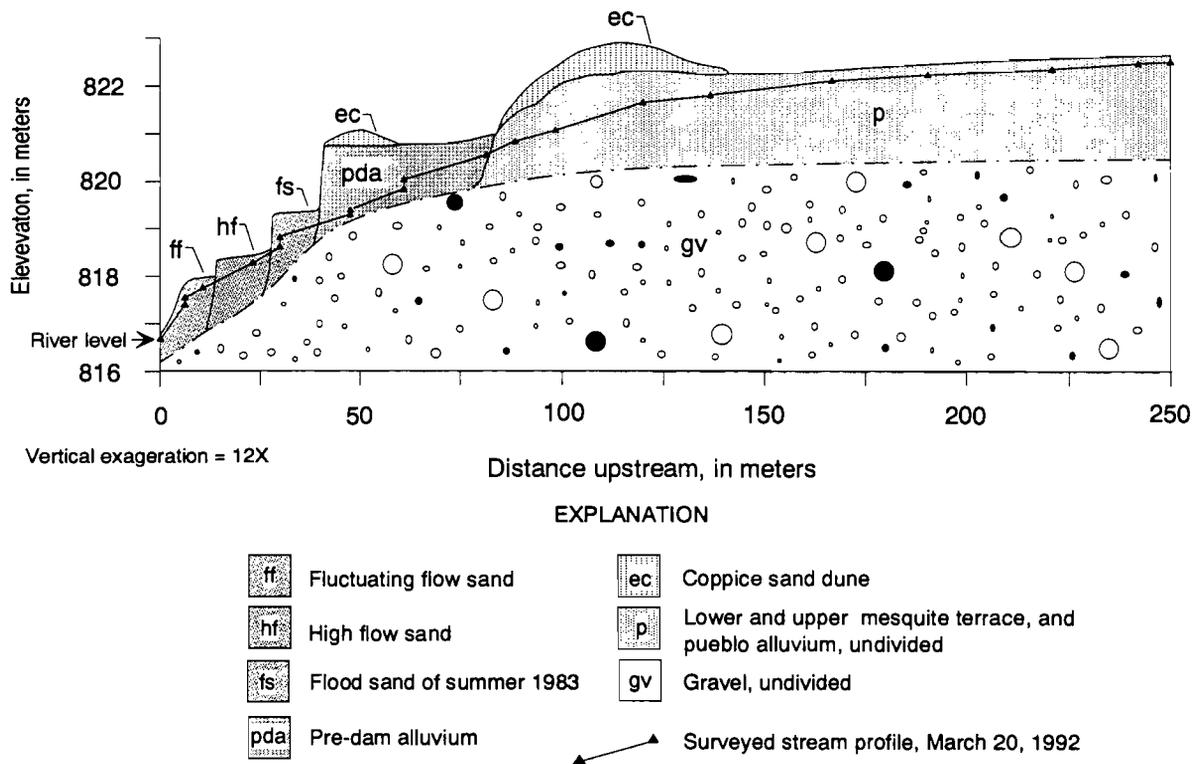
Figure 12. Cross-section showing baselevel control and longitudinal profile of a river-based stream in the Palisades Creek area.

arroyo is the southernmost of the two arroyos south of Palisades Creek (Plate 4) whose transition from terrace based to river based after 1973 was discussed in a preceding section. The present area of the this catchment is 19,600 m².

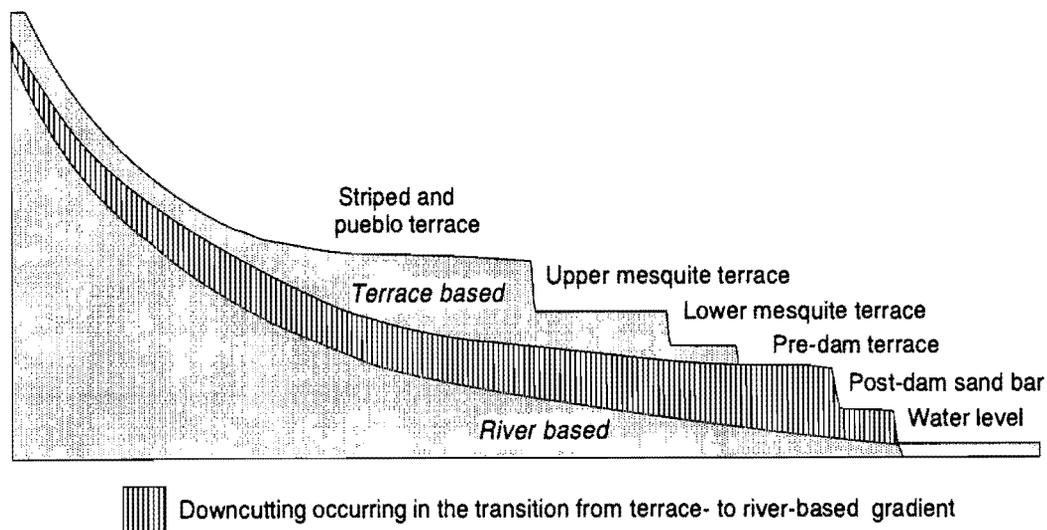
Figure 13. Schematic cross-section showing longitudinal profile and baselevel of river-based and terrace-based channel and downcutting that occurs in the terrace-based to river-based transition.

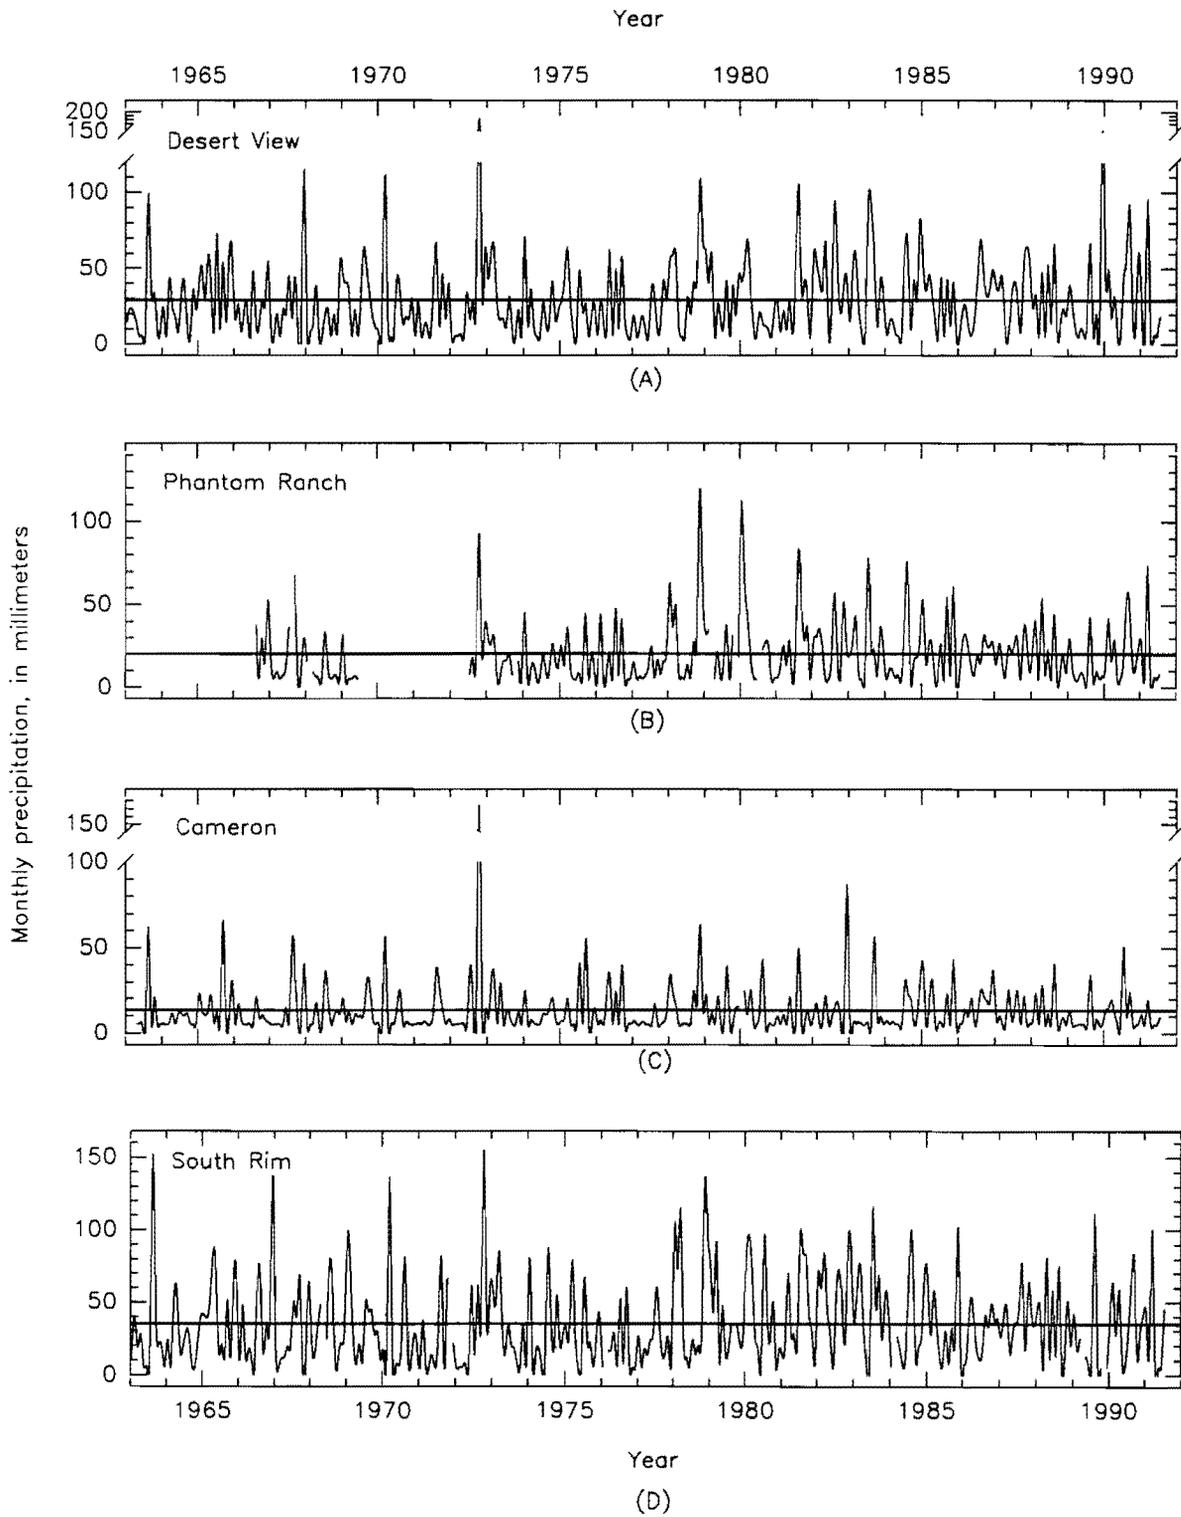
Figure 14. Total monthly precipitation at the four weather stations (table 3) in the Grand Canyon region, breaks show missing data. Horizontal line is the long-term monthly average. (A) Desert View, (B) Phantom Ranch, (C) Cameron, and (D) South Rim.

Although the precipitation of individual storms in arid to semiarid regions varies substantially (Graf, 1988, p. 72-74), the pattern of wet and dry months generally prevails over a large area. Figure 14 is a time series of the total monthly precipitation of the four weather stations. Variation from month-to-month and between stations is substantial. The month-to-month variation results largely from the two wet seasons and from the April-June dry season. Station-to-station variation results from local conditions, primarily elevation. On average, the low-elevation stations (table 3; fig. 14) have the least precipitation.

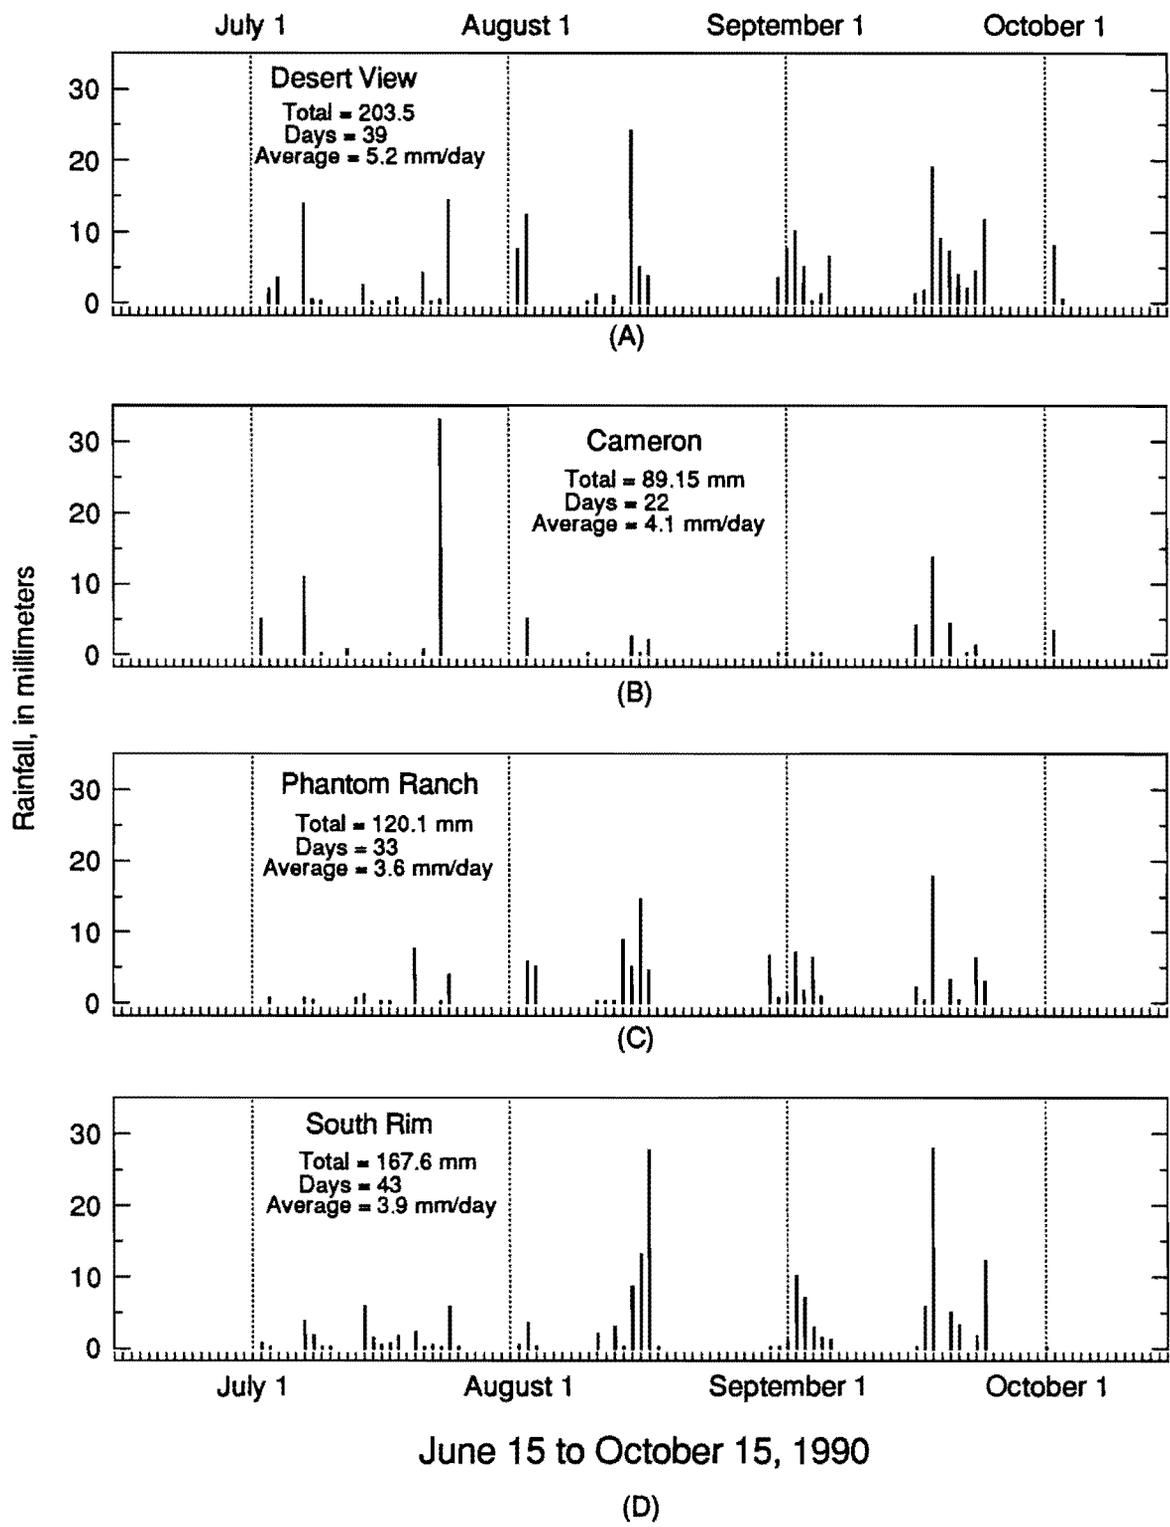
Figure 15. Warm-season rainfall, 1990, a wet season with runoff and debris-flow activity. (A) Desert View, (B) Cameron, (C) Phantom Ranch, and (D) South Rim.

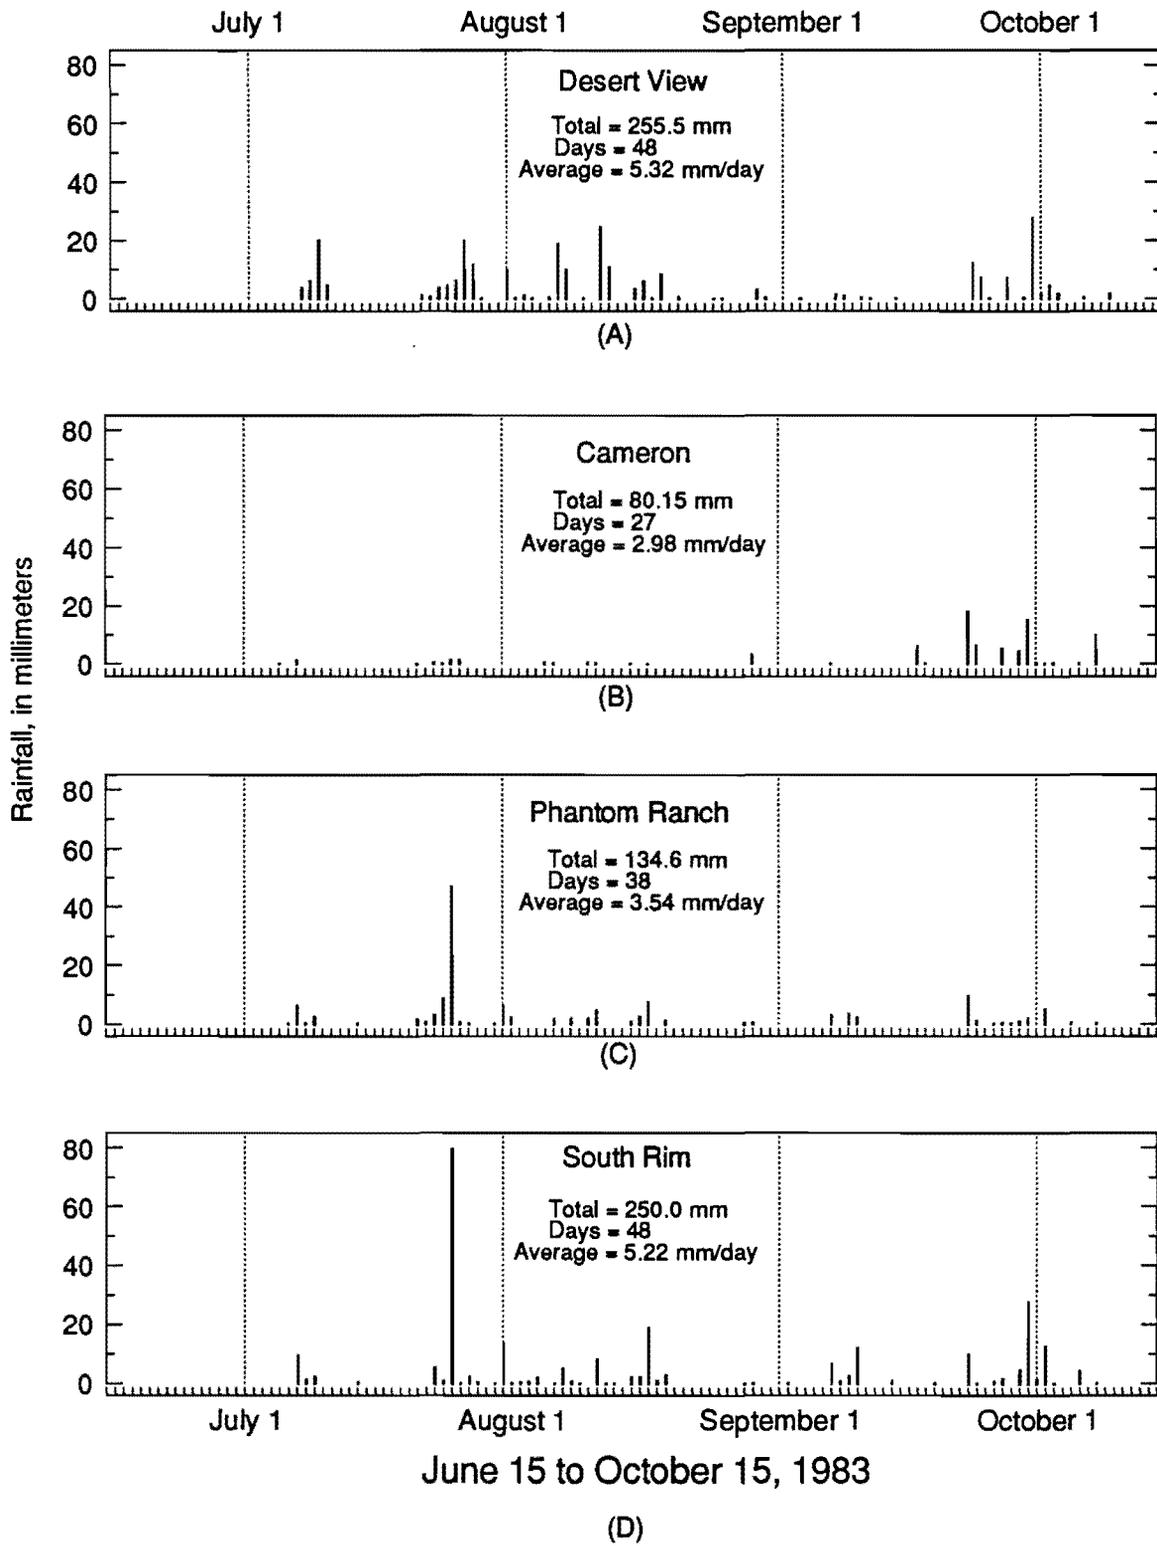
Figure 16. Warm-season rainfall, 1983, a wet season with runoff and debris-flow activity. (A) Desert View, (B) Cameron, (C) Phantom Ranch, and (D) South Rim.
