Surficial Geology, Geomorphology, and Erosion of
Archeologic Sites along the Colorado River, Eastern
Grand Canyon, Grand Canyon National Park, Arizona

U.S. GEOLOGICAL SURVEY OPEN-FILE REPORT 93-517

Surficial Geology, Geomorphology, and Erosion of Archeologic Sites, along the Colorado River, Eastern Grand Canyon, Grand Canyon National Park, Arizona

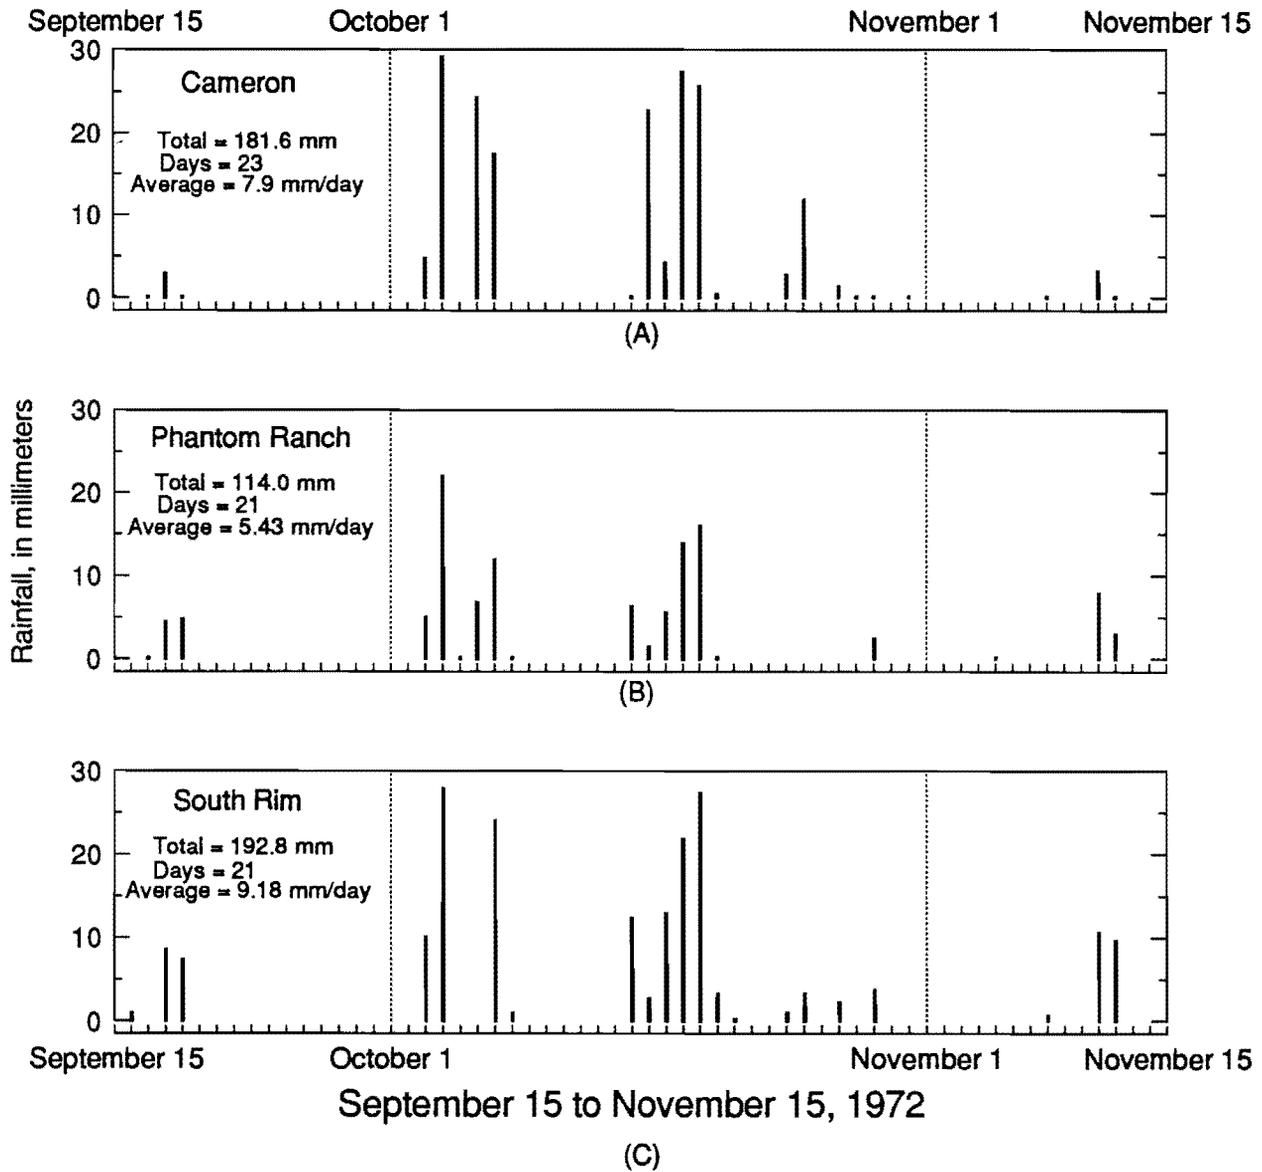
Figure 17. Rainfall from September 15 to November 15, 1972, which includes the wettest October on record. (A) Cameron, (B) Phantom Ranch, and (C) South Rim.

Grand Canyon region occurred during two storms, October 3-8 and October 15-21 (fig. 17). October rainfall at Desert View, Cameron, and South Rim was the largest of any month for the period 1963-1991 (fig. 14). Daily amounts in excess of 20 mm occurred several times at each station. The effects of this unusual rainfall are not well known in Grand Canyon, although destruction of the masonry wall at Upper Unkar (fig. 8) might have occurred during October 1972.

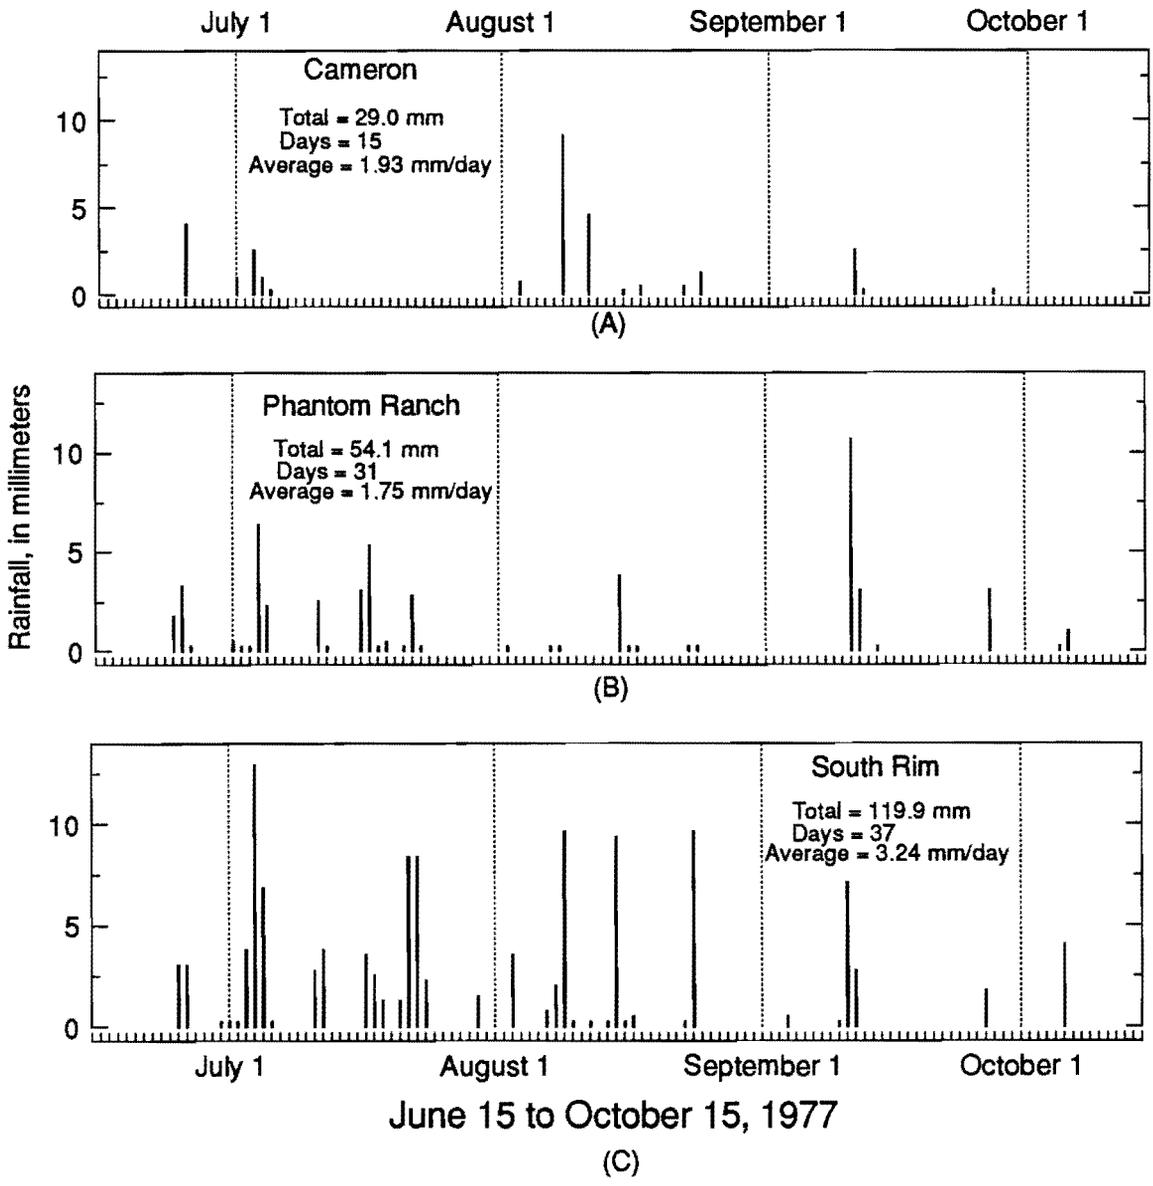
Figure 18. Warm-season rainfall, 1977, a dry season. (A) Cameron, (B) Phantom Ranch, and (C) South Rim.

Figures 18 and 19 show the daily rainfall of two warm seasons, 1973 and 1977, that were unusually dry. In a dry season, daily rainfall is typically much less than in a wet season (figs. 15-17), although the occurrence of rain is about the same in the case of 1977. Total rainfall of a dry season is about 2-3 times less than a wet season, and daily accumulation is also less. Regionally, the mid-1970s were among the driest warm seasons of the century

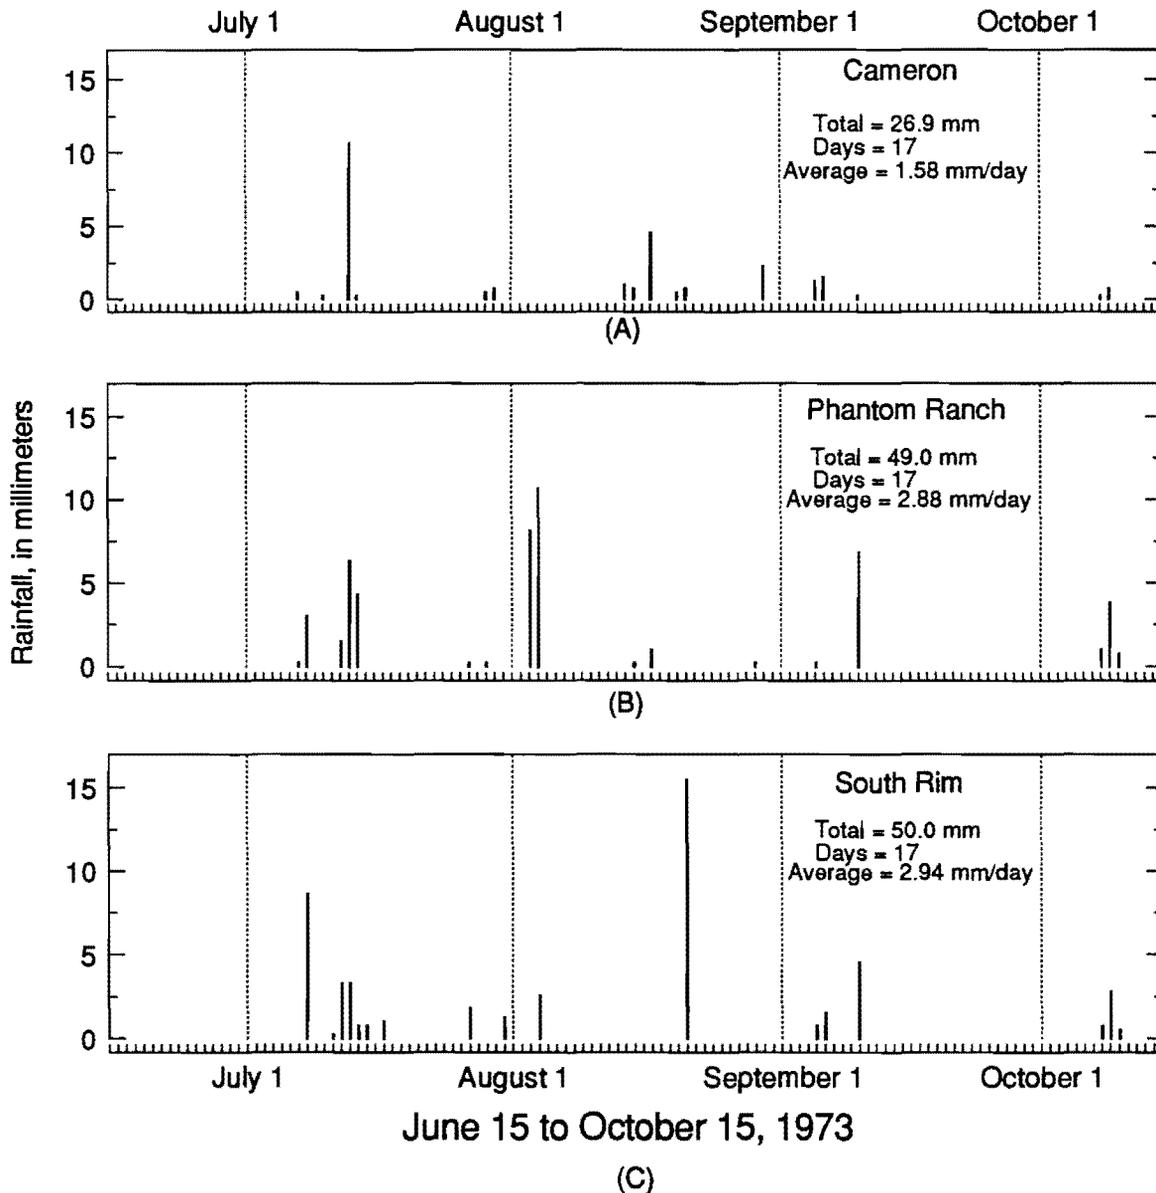
Figure 19. Warm-season rainfall, 1973, a dry season. (A) Cameron, (B) Phantom Ranch, and (C) South Rim.

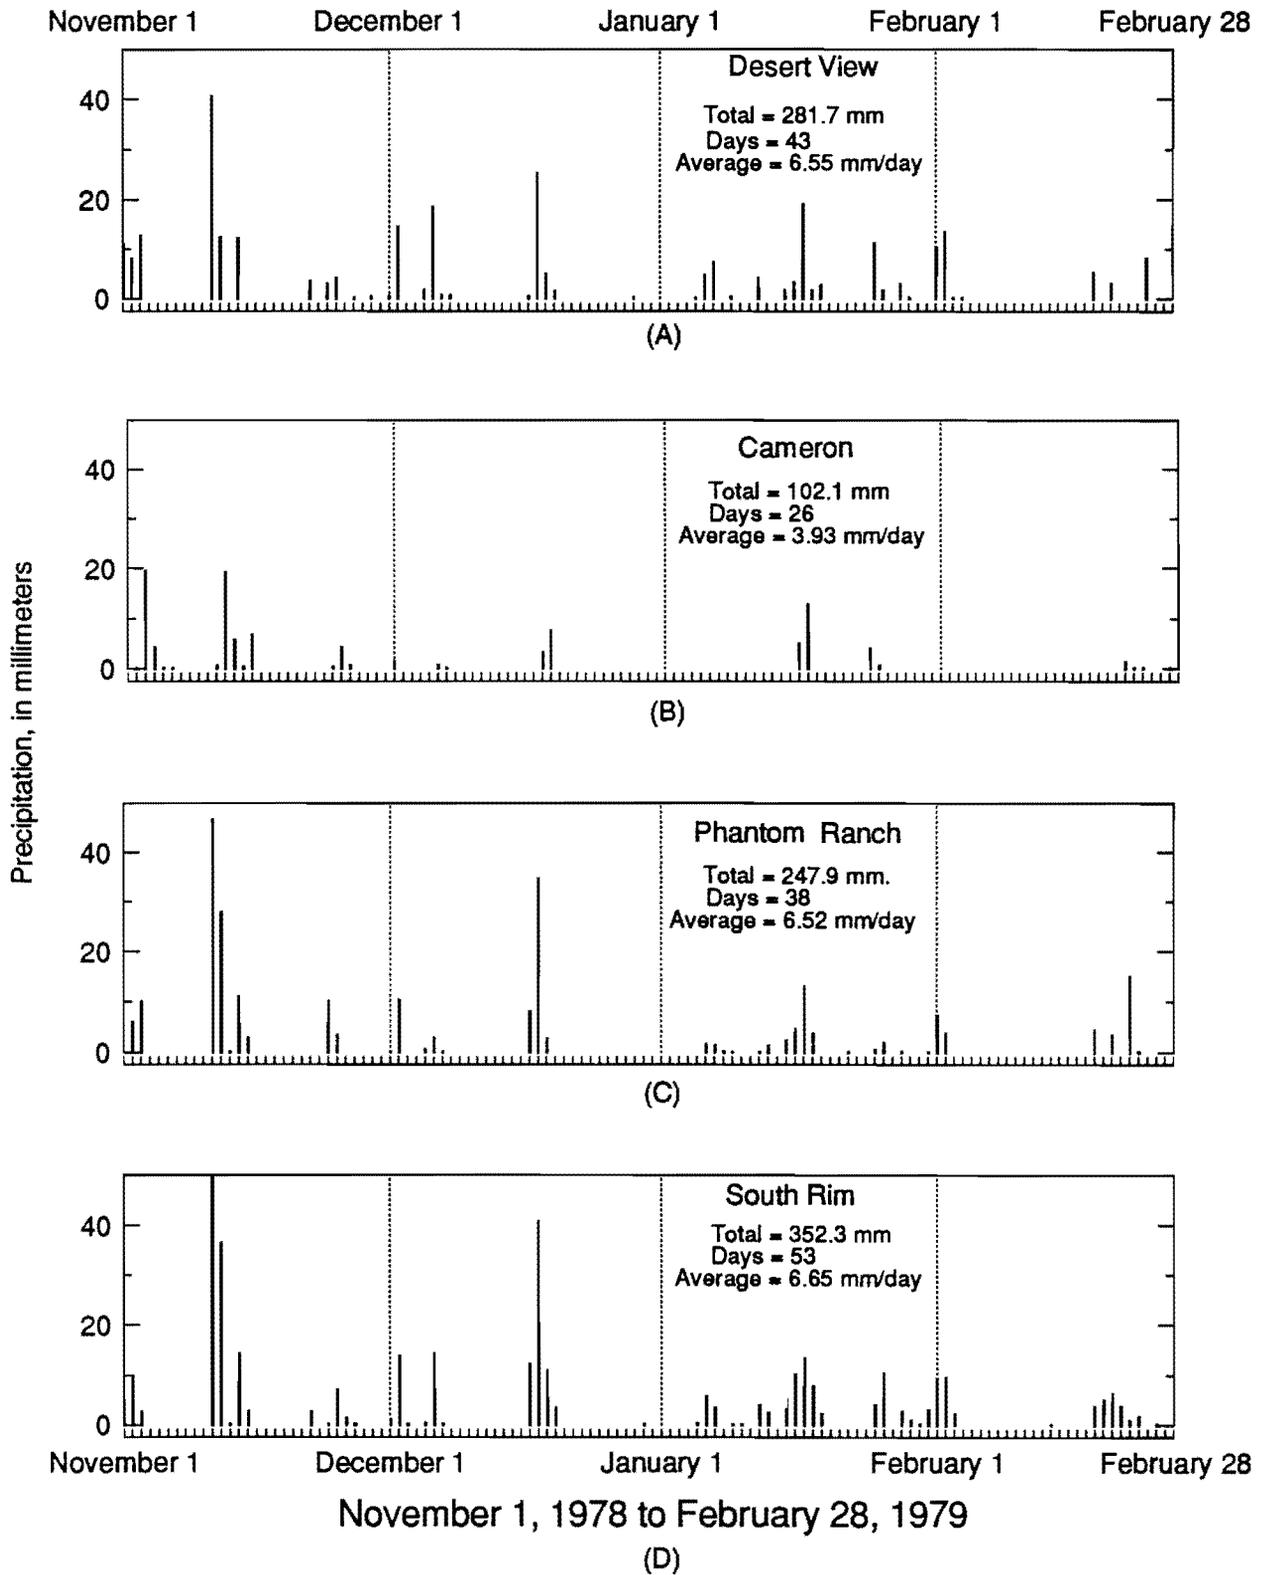
Figure 20. Fall to winter precipitation, 1978-79, a wet season. (A) Desert View, (B) Cameron, (C) Phantom Ranch, and (D) South Rim.

20), but daily accumulation and intensity are substantially less. Rainfall accumulation during a dry winter is about one-third the accumulation of a wet season, and rainfall intensity (mm day⁻¹ or daily total) is about one-half the intensity of a wet season. A rainfall pattern such as this would quite likely not produce significant runoff.

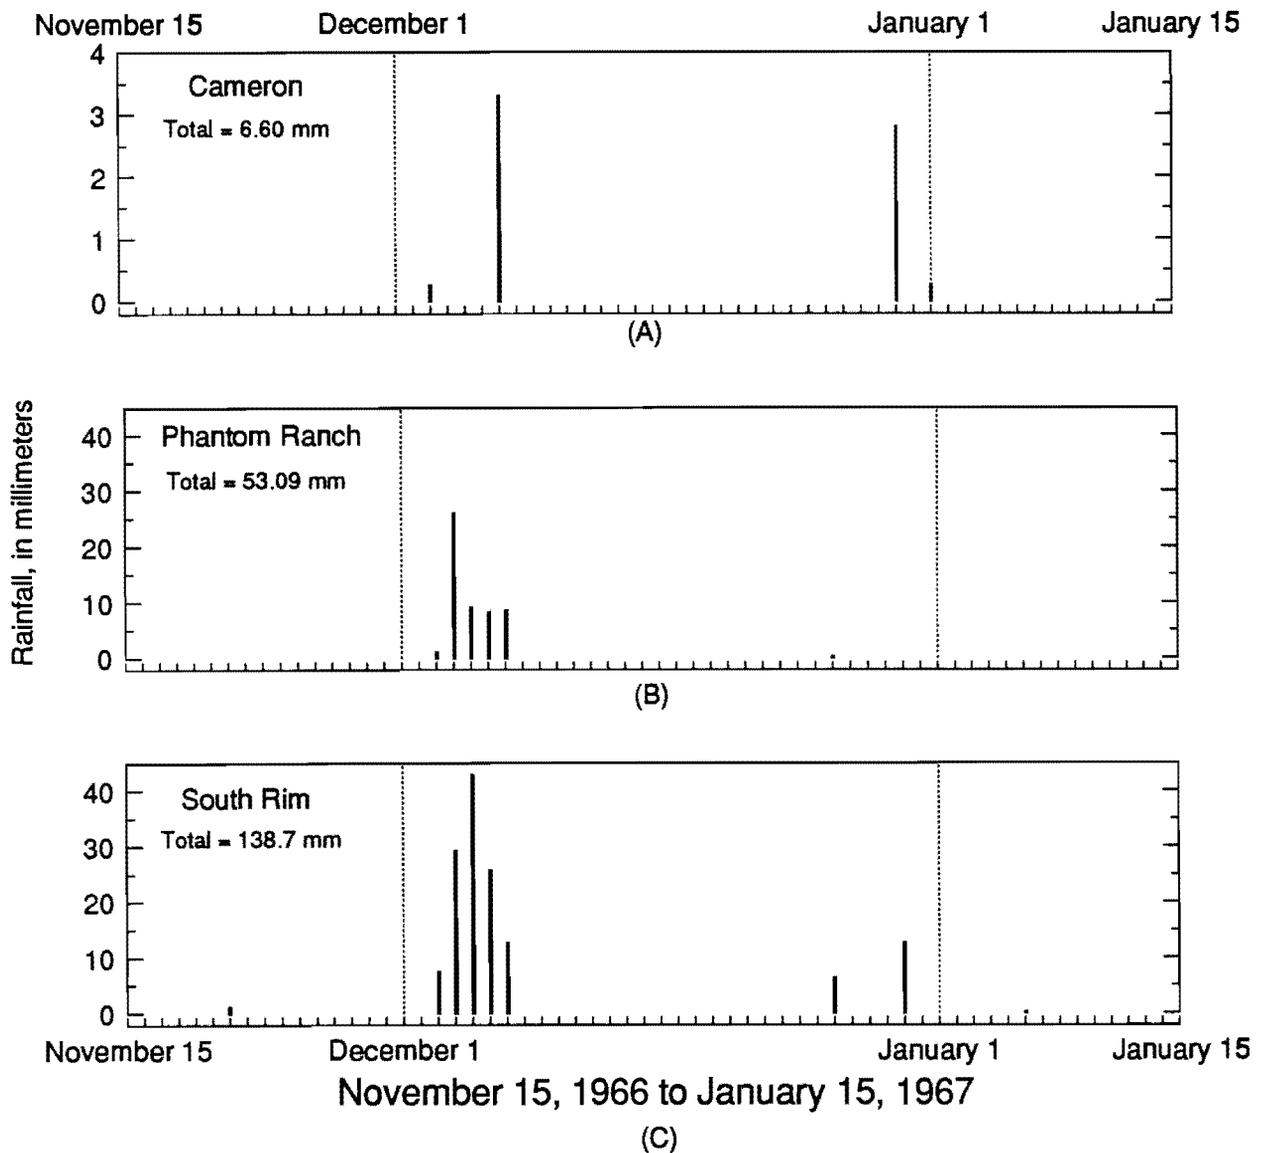
Figure 21. Rainfall from November 15, 1966 to January 15, 1967. Rainfall in December produced widespread runoff and debris-flow activity on the North Rim.

Rainfall during early December 1966 caused floods and debris flows in eastern Grand Canyon, including development of Crystal Creek Rapids (Cooley and others, 1977). The documented effects of this storm include debris flows, extensive arroyo cutting in the

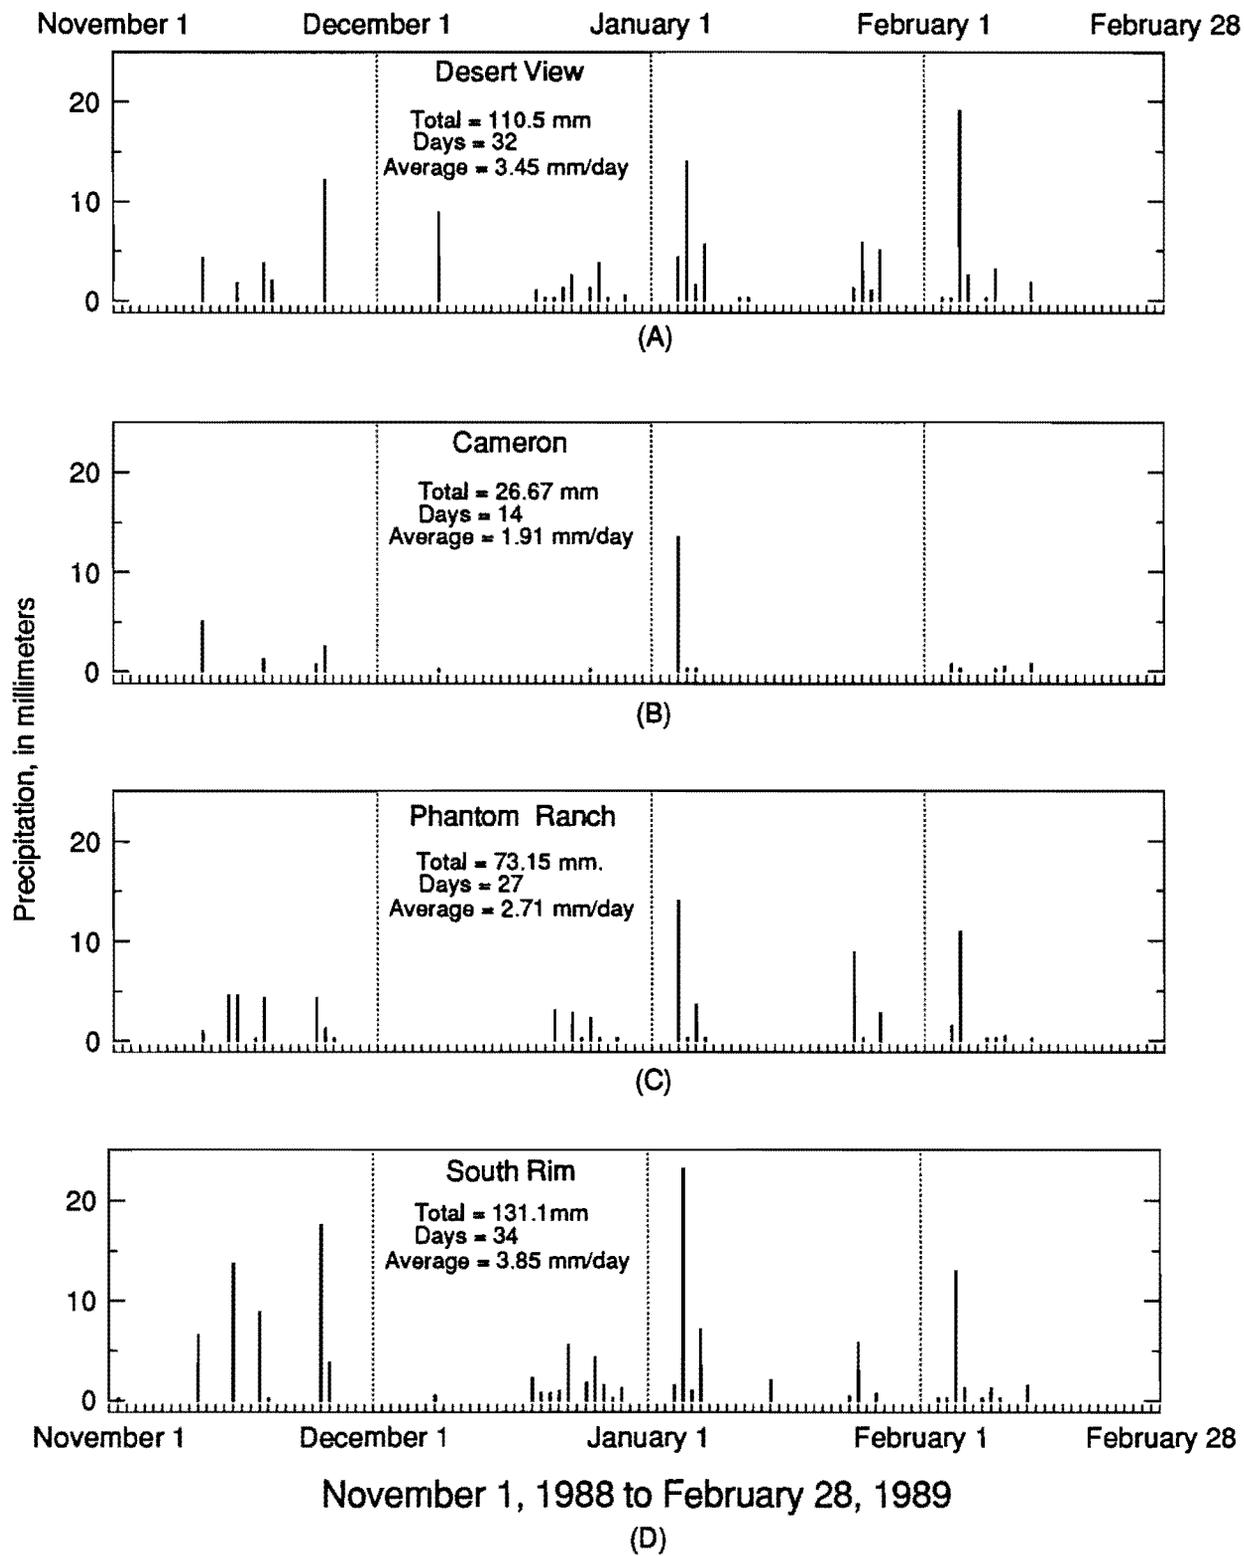
Figure 22. Fall to winter precipitation 1988-89, a dry season. (A) Desert View, (B) Cameron, (C) Phantom Ranch, and (D) South Rim.

An unusually dry season, the fall and winter of 1988-89, is shown in figure 22. The daily rainfall pattern is similar to a wet season (fig.

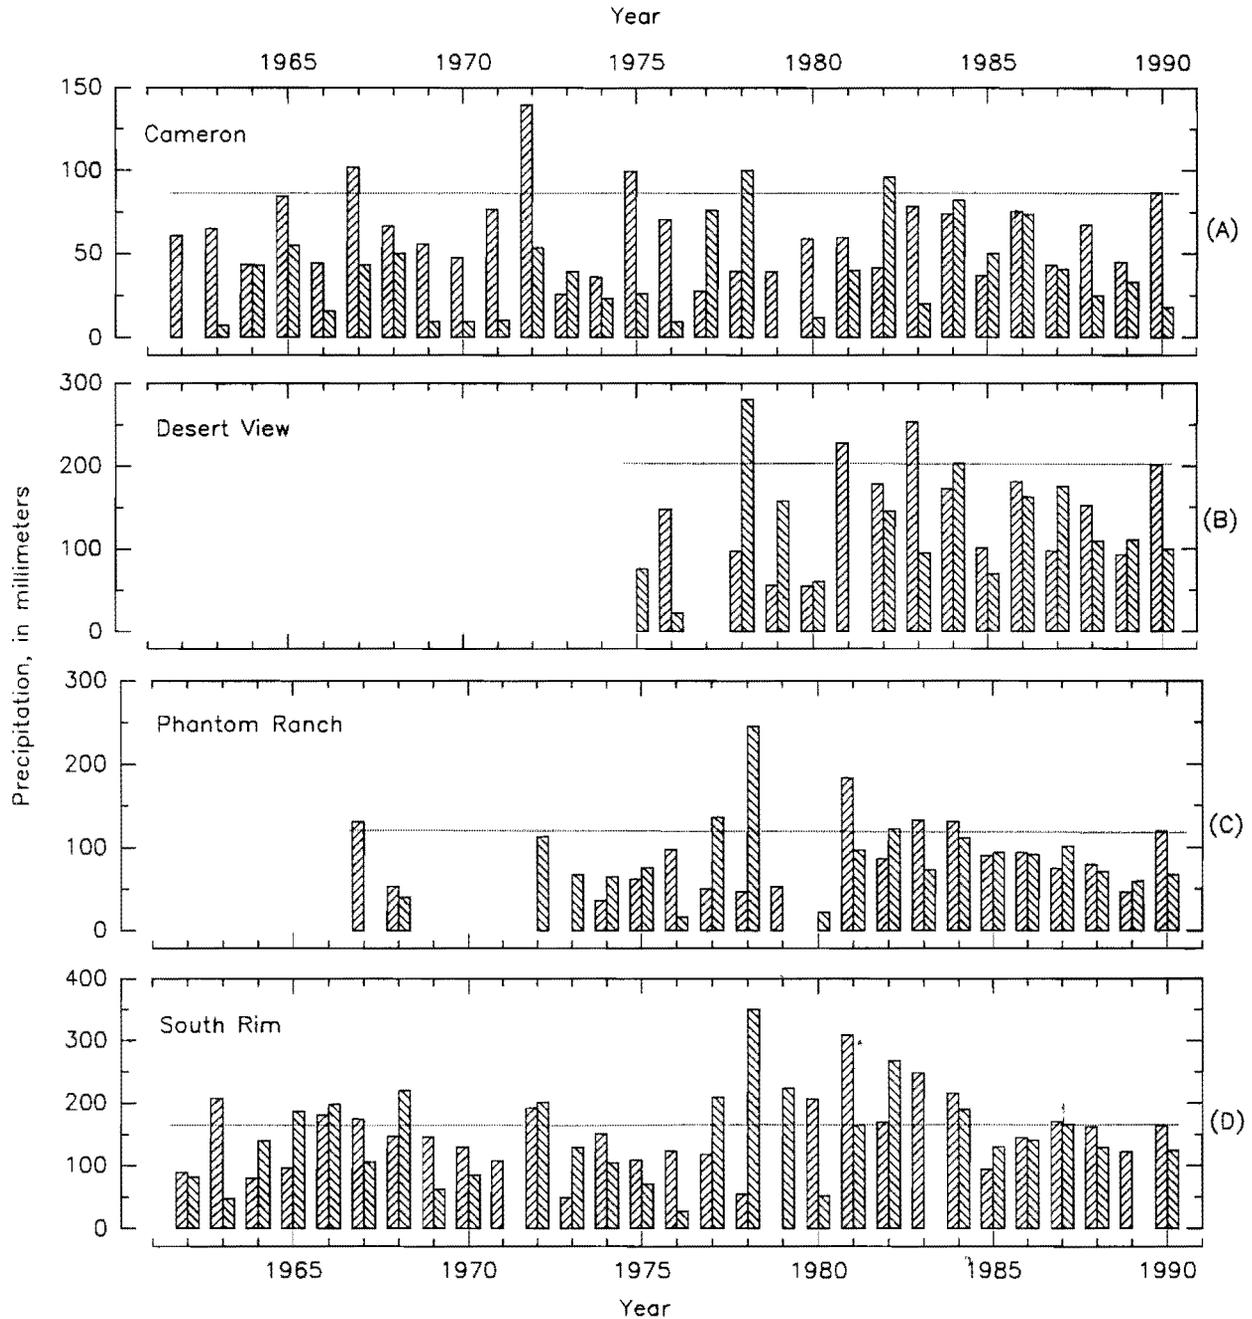
- June 15 to October 15
- November 1 to February 28
- Runoff-producing rainfall of warm season 1990

Figure 23. Total seasonal precipitation at the four weather stations computed from the daily precipitation record. Horizontal line is the rainfall of 1990 warm season, which produced runoff and debris-flow activity in the study area. Missing data shown by a blank space at the year. Fall to winter season is assigned year of the preceding warm season. (A) Cameron, (B) Desert View, (C) Phantom Ranch, and (D) South Rim.

sufficient rainfall to produce runoff. The results are shown in figure 23, which illustrates total rainfall of the warm season and fall to winter season. The latter season is assigned the year of the preceding warm season so that the precipitation is not split between years. The horizontal line is the total rainfall of the 1990 warm season of the particular station. As previously discussed, rainfall of this amount is known to be associated with runoff and debris-flow activity in eastern Grand Canyon. The amount of precipitation necessary to produce significant runoff is assumed to be about the same for each season. Using this assumption, total rainfall of the 1990 warm season was used to censor the data; any season having precipitation below this level probably did not produce enough runoff to cause arroyo cutting.

fall were those of the early 1980s. Fall to winter precipitation was equal to or above the 1990 total at 50 percent or more of the reporting stations in 1965, 1966, 1977, 1978, 1982, and 1984 (fig. 23). Arroyo cutting was probably enhanced during consecutive seasons with unusual precipitation such as 1966 and 1984, as one wet season was followed by another, resulting in favorable antecedent moisture conditions.
