# Recent Vegetation Changes Along the Colorado River Between Glen Canyon Dam and Lake Mead, Arizona

By RAYMOND M. TURNER *and* MARTIN M. KARPISCAK

GEOLOGICAL SURVEY PROFESSIONAL PAPER 1132

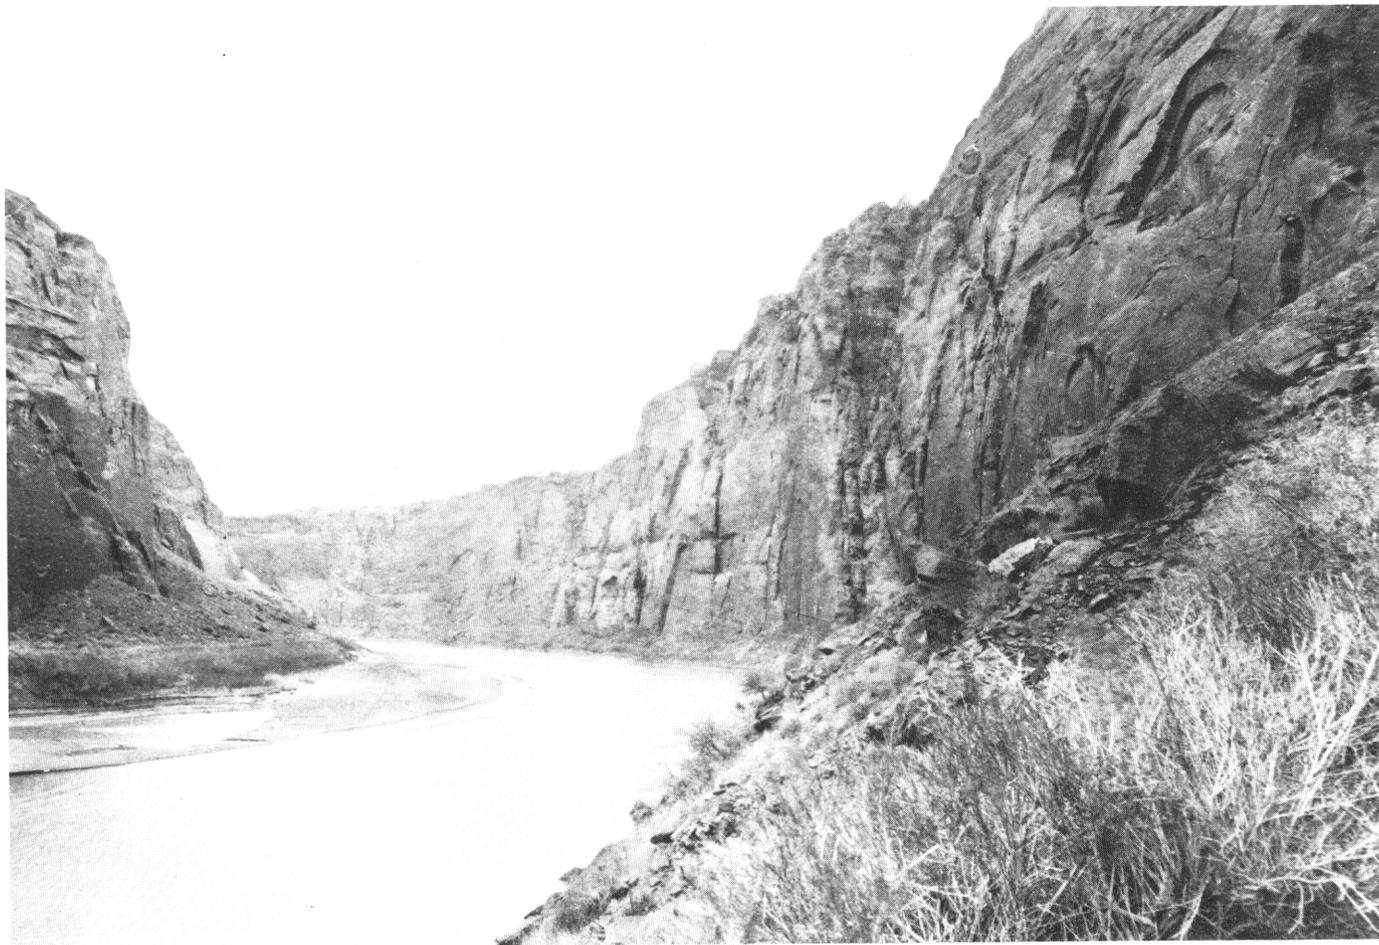
FIGURE 26A.—(1889). F. A. Nims, photographer with the Stanton-Brown railroad survey expeditions, took this photograph looking upstream from a point 1.6 kilometers below the present site of Glen Canyon Dam (24.4 kilometers above Lees Ferry). Woody vegetation on the far bank appears as a dense thicket separated from the water at this river stage by a barren sand bar. The thicket appears to be rabbitbrush. The high sandy terrace supporting the dense growth was a common feature above Lees Ferry but uncommon below. Only in years of extremely high floods would there be overbank flow sufficient to scour out these plants. The sharp lower boundary results from the scouring action of floodwaters. At the base of the distant cliffs above the river in center background are clumps of what appear to be netleaf hackberry. (Altitude 957 meters.)

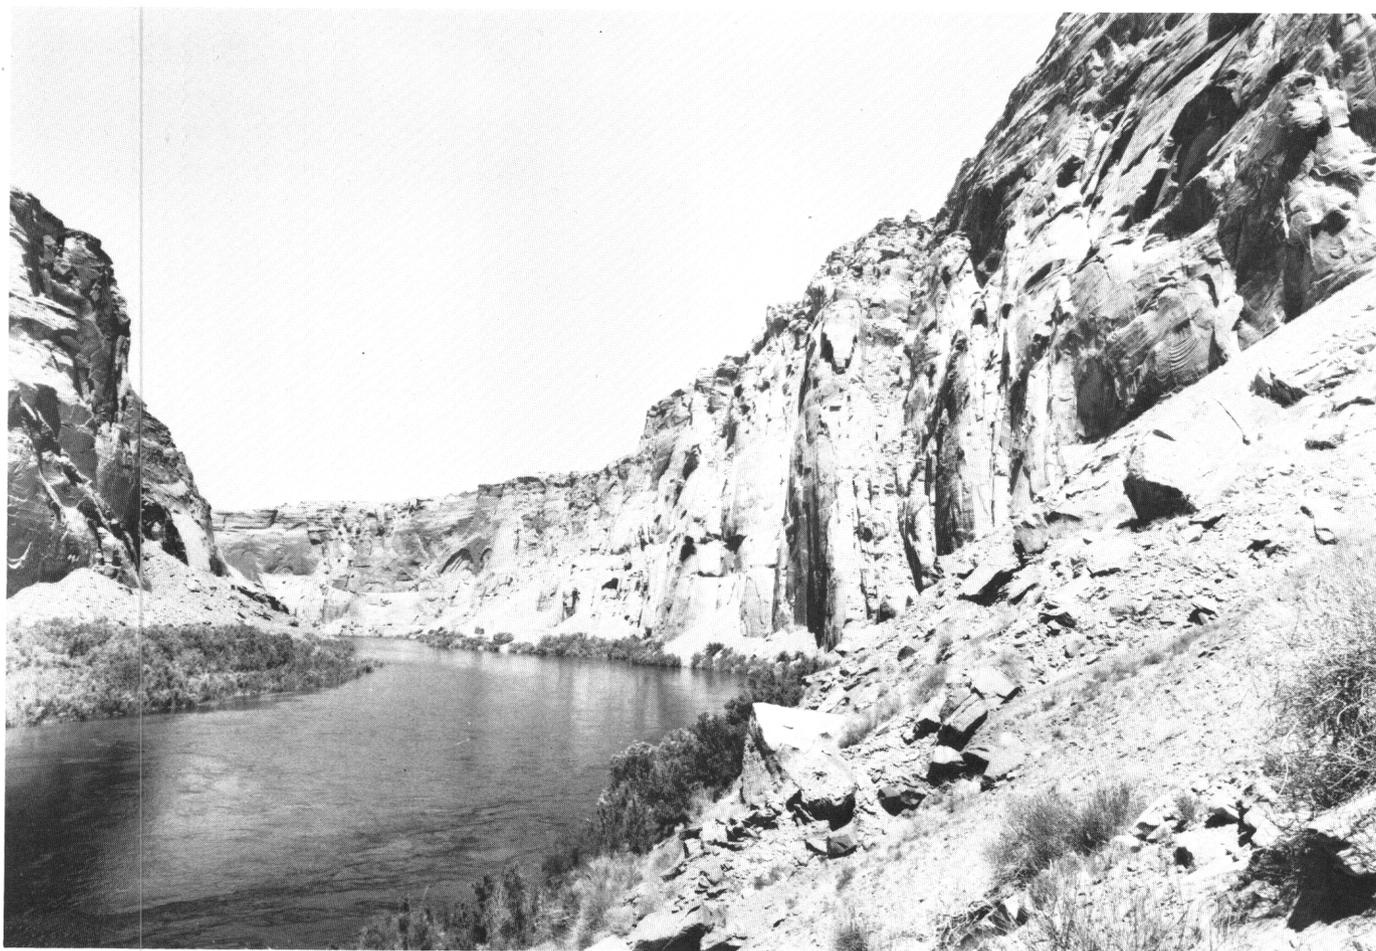
FIGURE 26B.—(1975). Glen Canyon Dam lies just out of view around the bend of the river. Construction activity related to the dam has considerably altered the steep slopes of the left bank. The netleaf hackberry seen in the previous view has been covered by rubble piles below tunnels drilled into the cliffs above. The netleaf hackberry has not reoccupied the niche at the cliff bases, although saltcedar relatively quickly became established along the base of the rubble piles. The foreground has also been altered by rubble from above, although many of the rocks carry over from the older view. The thicket on the opposite bank has enlarged, and its composition has changed—saltcedar dominates today and has spread downward over the barren skirt as far as fluctuations in river level will permit. The photograph was taken at 1330 hours, a time of peak-load demand, and the river is probably at near maximum stage. Large saltcedars dominate on the left bank also, forming a narrow almost continuous streamside band along the base of the steep slopes below the cliffs. Maximum lowering in mean streambed elevation (1.83 meters) occurred during the 1956–59 period at a point near the far bend in the river. Subsequently the channel has been stabilized by gravel and cobble-size armor, eliminating continued degradation (Pemberton, 1976).

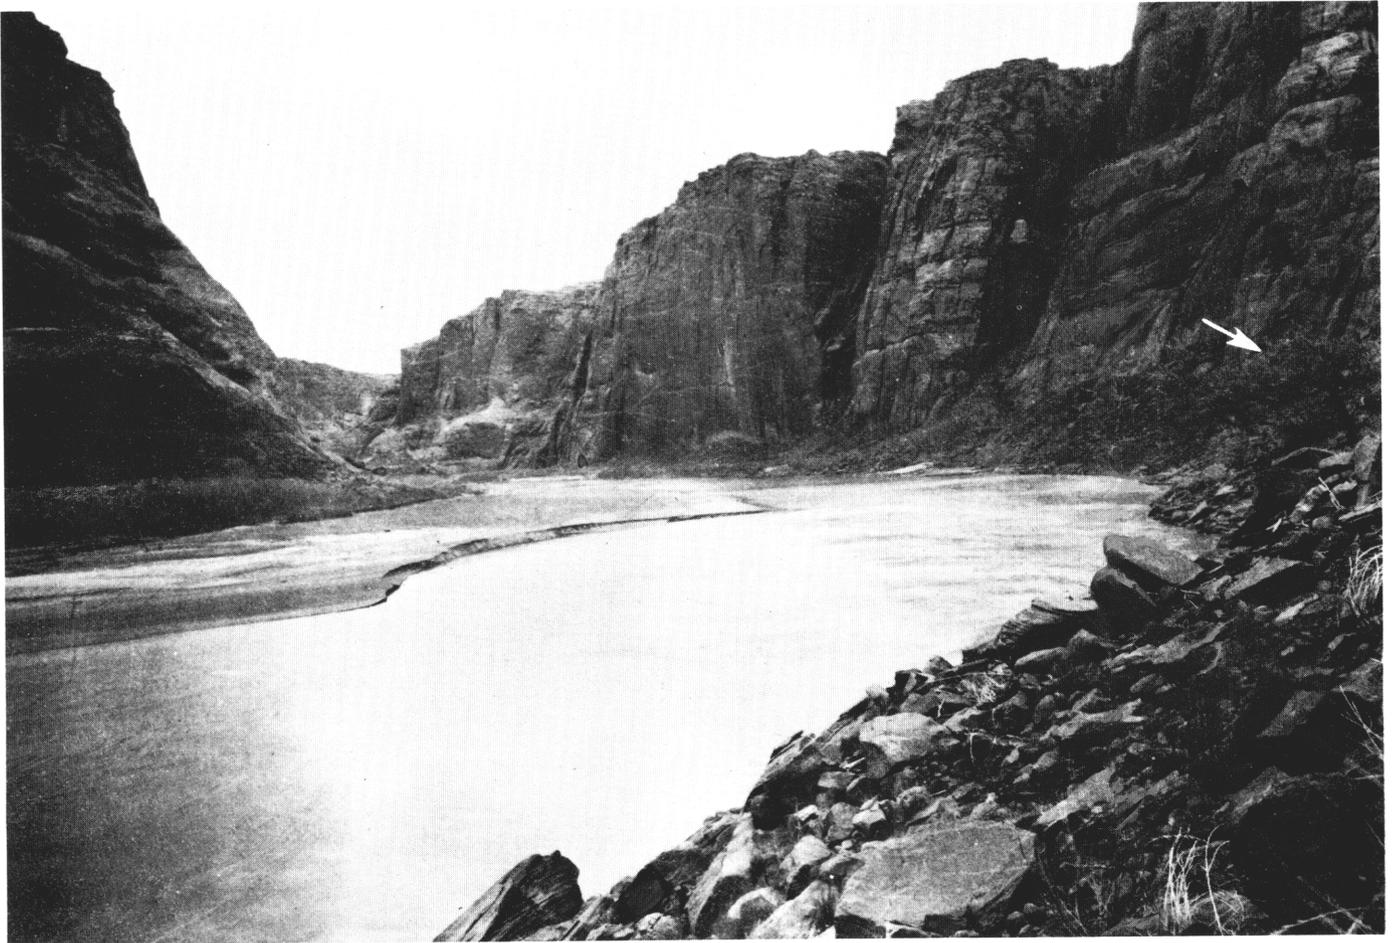
FIGURE 27A.—(1889). The Colorado River is deeply entrenched in the Upper Triassic(?) and Jurassic Navajo Sandstone through the lower section of Glen Canyon between Glen Canyon Dam and Lees Ferry, 20.6 kilometers above Lees Ferry. The view is upstream. The camera station is located near the level of maximum river stage. A single netleaf hackberry (arrow) is at the same level a few hundred feet upstream from the camera. The coarse material of the foreground supports little more than a few grasses and forbs. On the far bank is a thicket of what is probably rabbitbrush. (Altitude 956 meters.)

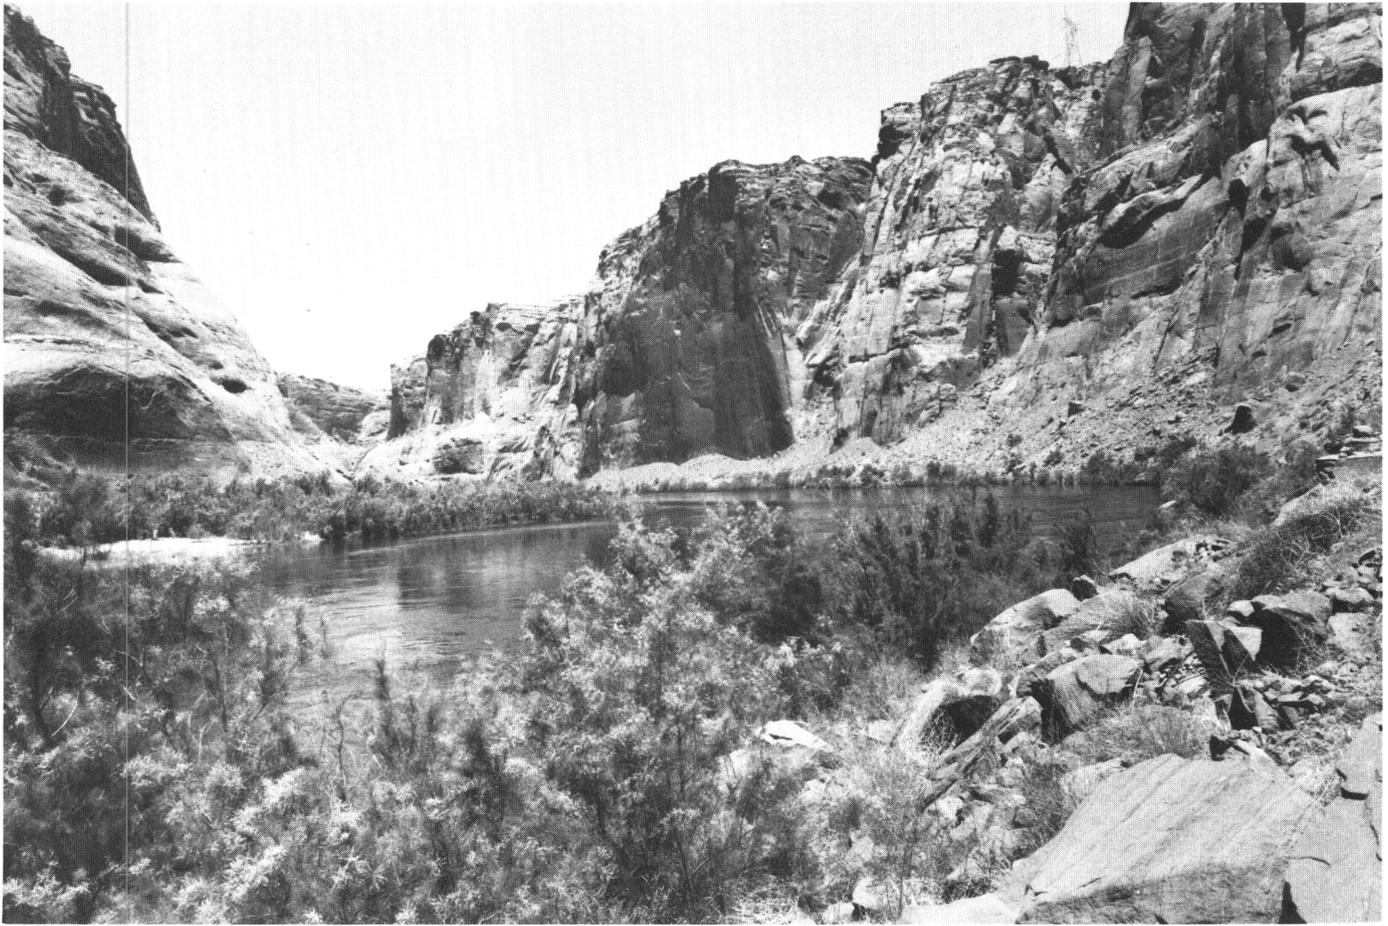
FIGURE 27B.—(1975). Although not an exact match, the new camera position is probably within a few feet of the old. Two towers near the brink of the canyon wall support lines that carry power generated at Glen Canyon Dam. Saltcedar has overgrown both banks and in the vicinity of the camera station occupies what is probably the predam highwater level. Several nearby saltcedars at this level have died. Longleaf brickellia is common on the steep slopes of coarse rubble in the foreground. The sandy bar on the opposite bank is covered by plants to lower levels now than in the earlier view. The deposit is partly submerged by the river, which is at higher stage than before, making difficult any estimate of erosion since the earlier photograph.

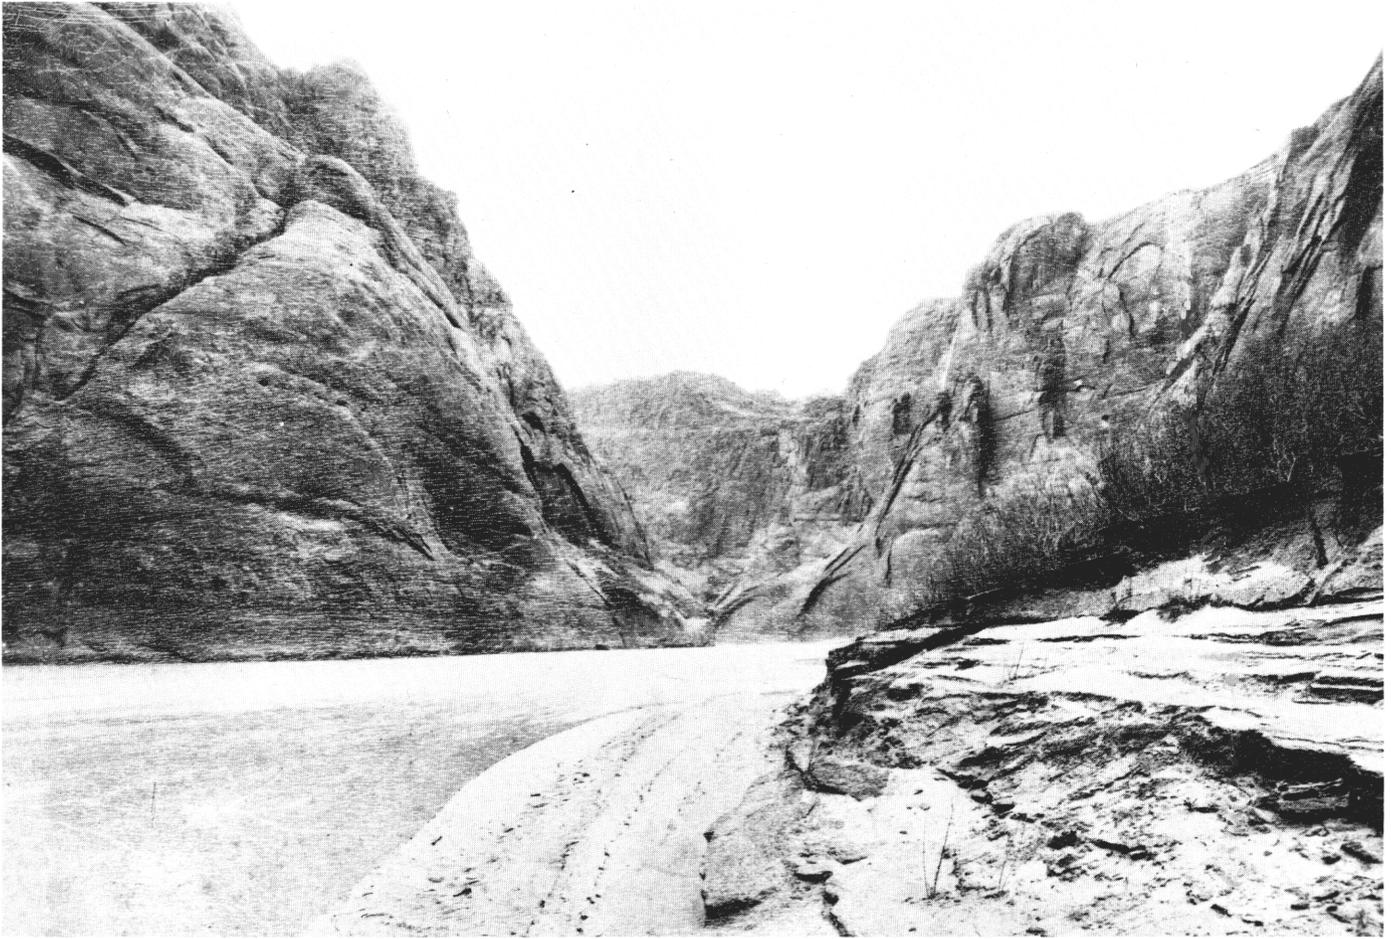
FIGURE 28A.—(1889). This downstream view was taken below the crest of an actively eroding alluvial deposit, 11.3 kilometers above Lees Ferry. Scattered seedlings have become established on the unstable surface marked by horizontal banding. This photograph was taken at a time of low river stage. At the top of the bank can be seen a dense cover of what is probably rabbitbrush. The dense community has been undercut by the river. (Altitude 954 meters.)

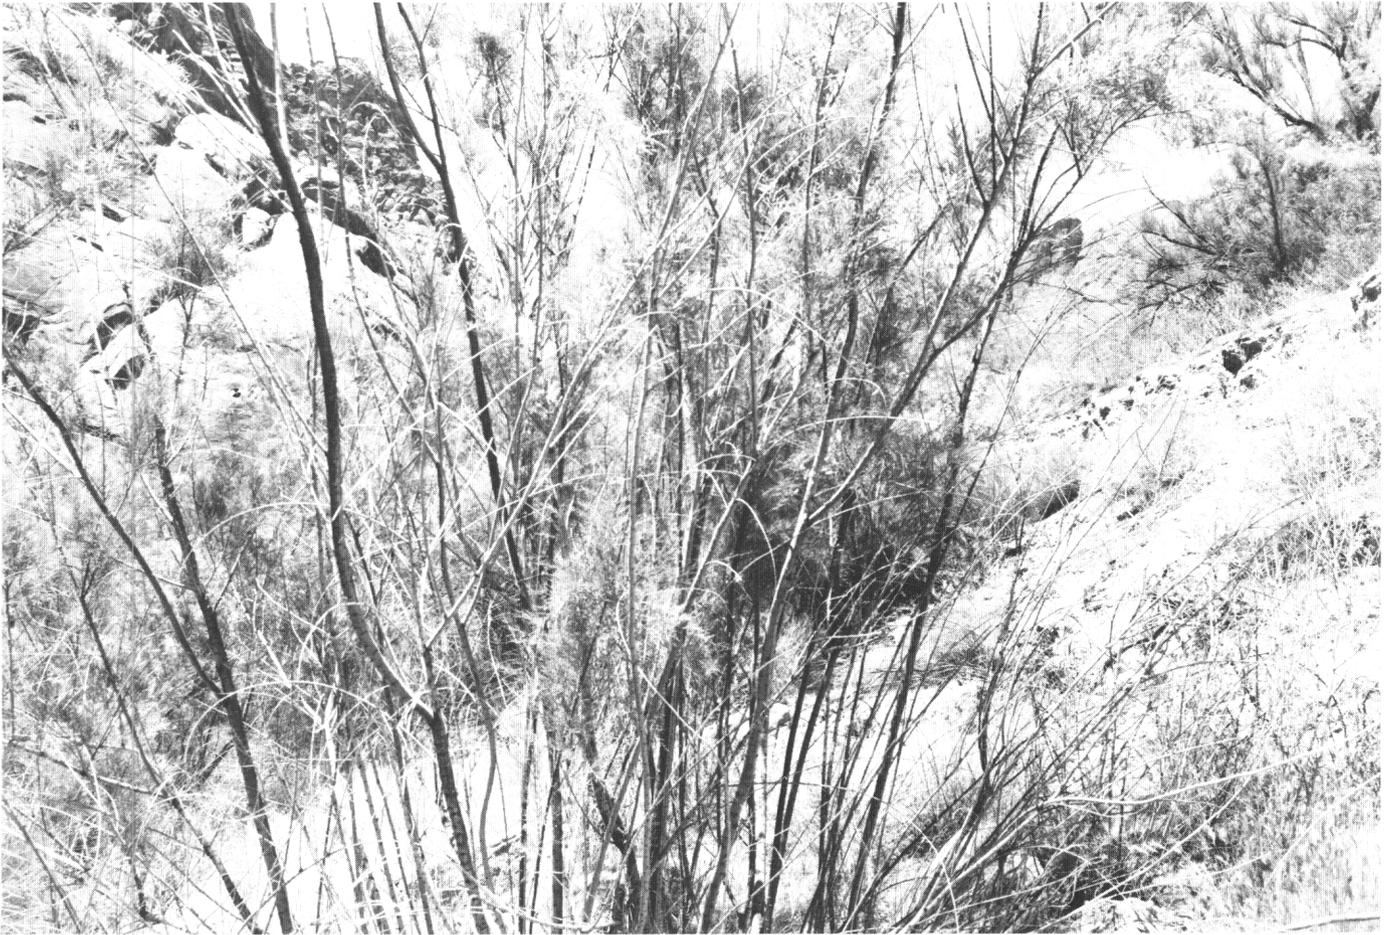
FIGURE 28B.—(1975). The old camera position cannot be exactly located so dense is the vegetation now growing on the alluvial deposit. Saltcedar, arrowweed, and sandbar willow occur from the river's edge up the steep bank, and on to the flat surface above. Rabbitbrush still occurs on top of the terrace where it is mixed with the other riparian species. The dense growth of vegetation providing stability to the steep bank is undoubtedly new since completion of Glen Canyon Dam.

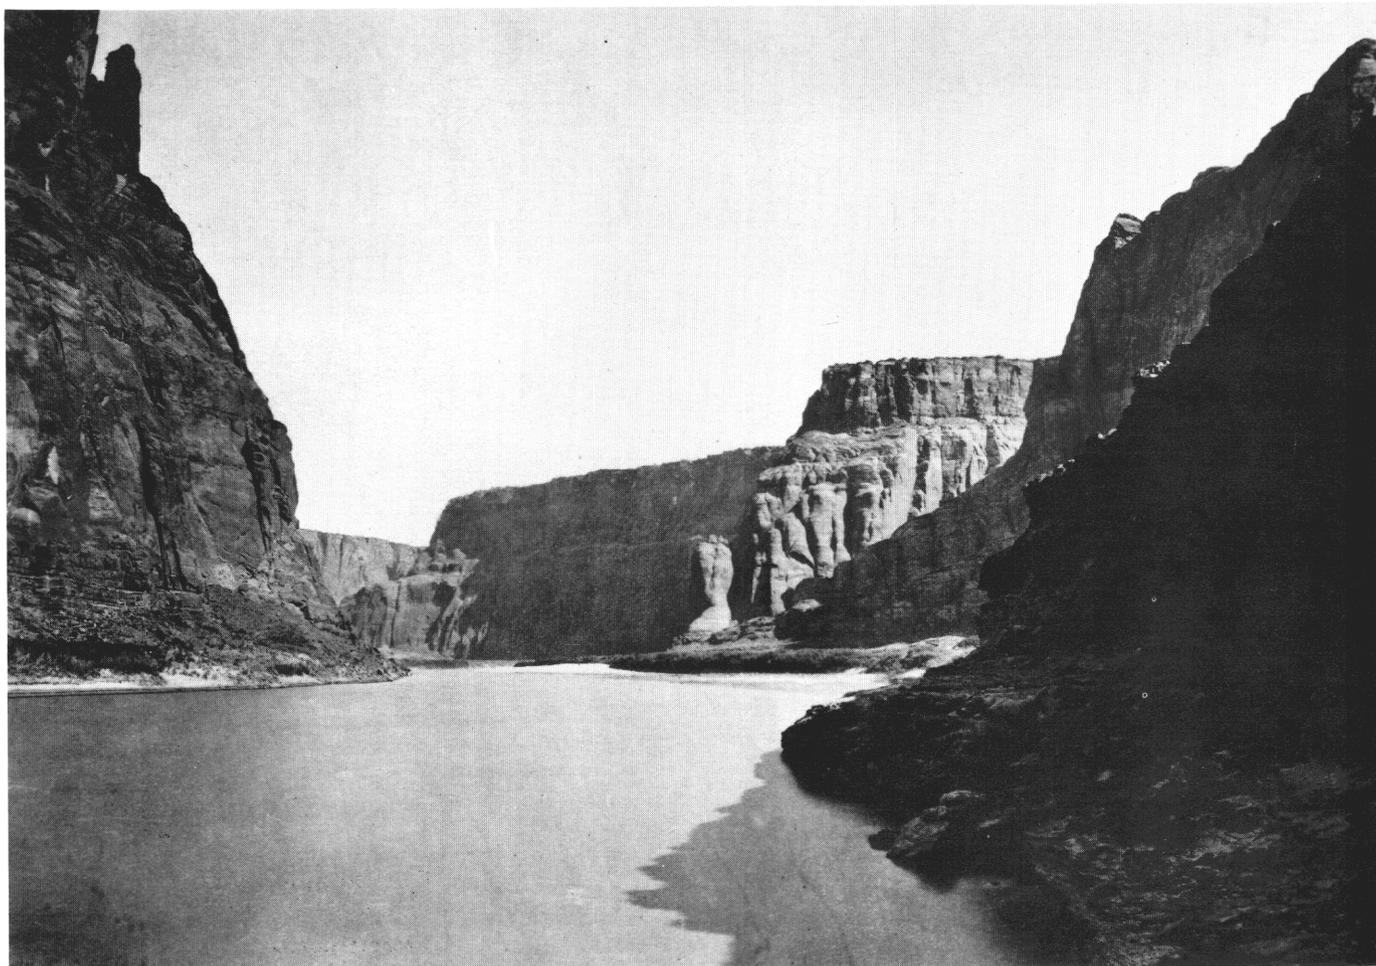
FIGURE 30A.—(1872). This upstream view was taken by William Bell, photographer with the Wheeler Survey. The dense riparian vegetation seen in the background on both banks is typical of beach deposits along this section of the river, 4.8 kilometers above Lees Ferry. At the river stage shown in this picture, the riparian community and the river are separated by bare beach.

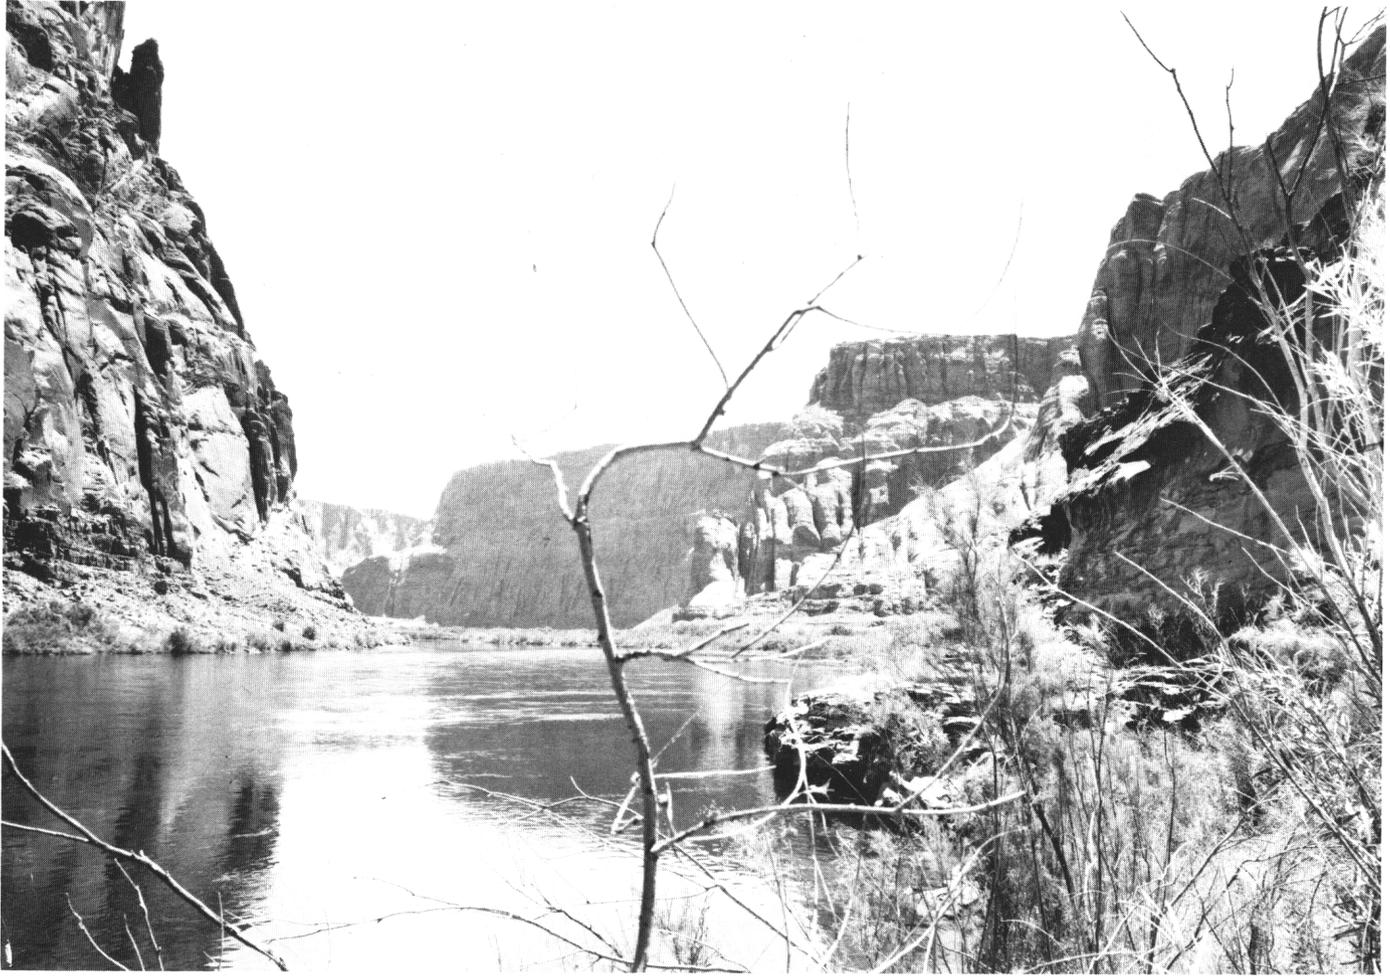
FIGURE 30B.—(1975). The old camera location is overgrown with bushes and lies about 3.0 meters upslope to the right. Judging from the position of the water relative to the rocks at the right, the river stage is roughly the same in the two views, and unlike most of the photograph pairs taken along the river, the river level can therefore be used as a datum for judging changes. Saltcedar and sandbar willow (both visible in the right foreground) grow along the section of the beach that was formerly bare. The large trees at the upper edge of the riparian zone are saltcedars. Cattails grow in a few areas at the river's edge.

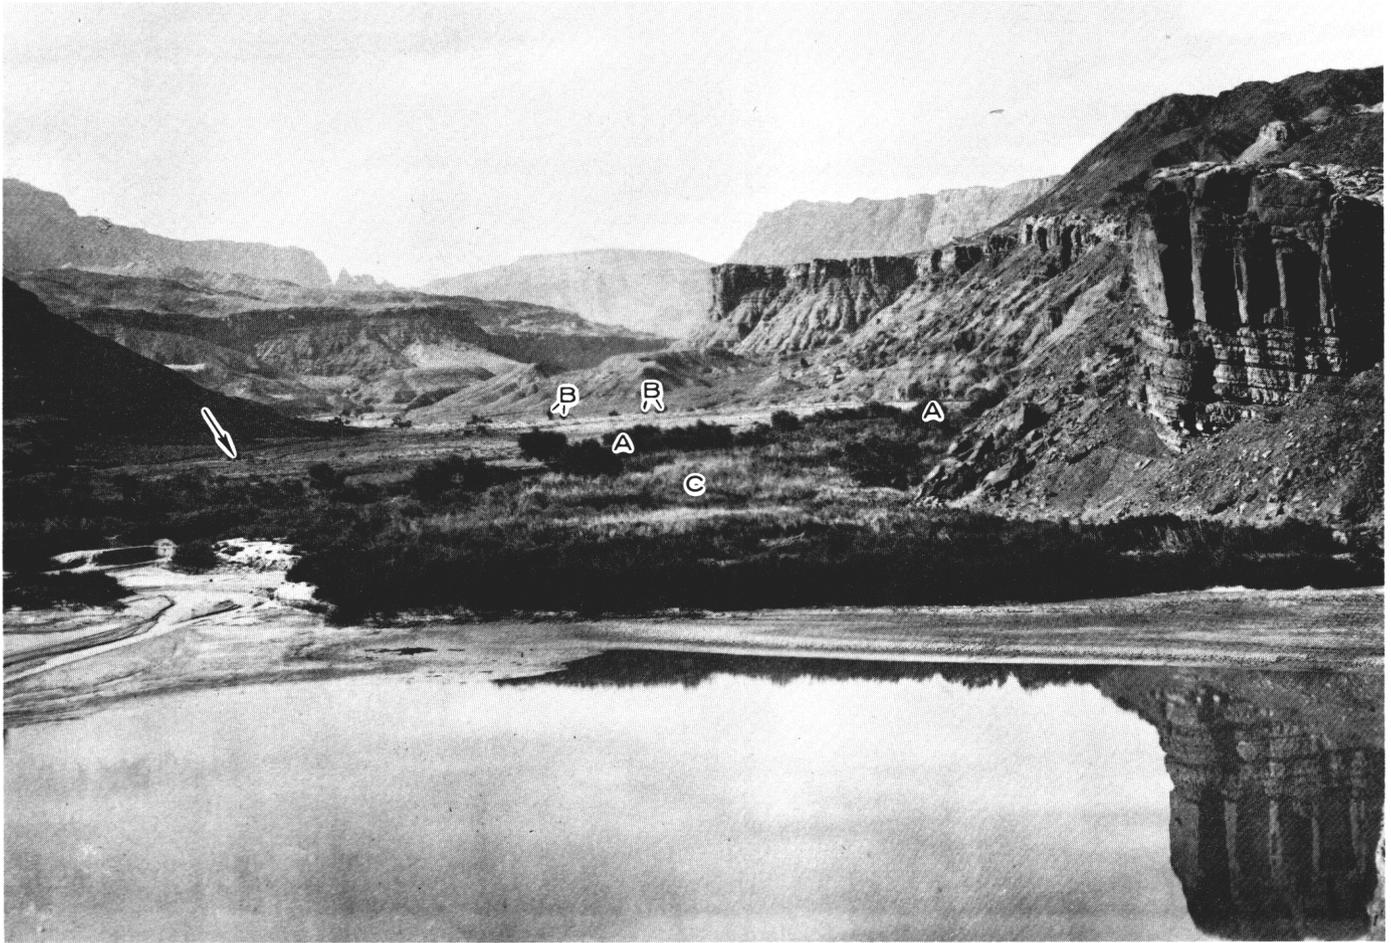
FIGURE 32A.—(1873). The mouth of the Paria River is seen on the left in this northwesterly view looking across the Colorado River and up the valley of the Paria. The main ferry crossing, still little used by the date of this photograph, lies about 2 kilometers upstream from the Paria. This photograph was taken by T. H. O'Sullivan, photographer with the Wheeler Survey (Bartlett, 1962). In 1872, J. D. Lee, his seventeenth wife, Emma, and their children built a house (arrow) and began farming on the broad, flat floor of the Paria River valley, becoming the first permanent residents of the area (Rusho and Crampton, 1975). In 1776 the Spanish padres Dominguez and Escalante camped at the base of the cliff of the Upper Triassic Shinarump Member of the Chinle Formation on the right (Rusho and Crampton, 1975). The large trees lining the Paria are probably willows (A) and Fremont cottonwoods (B). The dense shrub community (C) extending up the Paria on the right is probably mainly rabbitbrush (see fig. 33A). A bare sandy bank slopes from the thicket (of sandbar willow?) to the Colorado River. (Altitude 949 meters.)

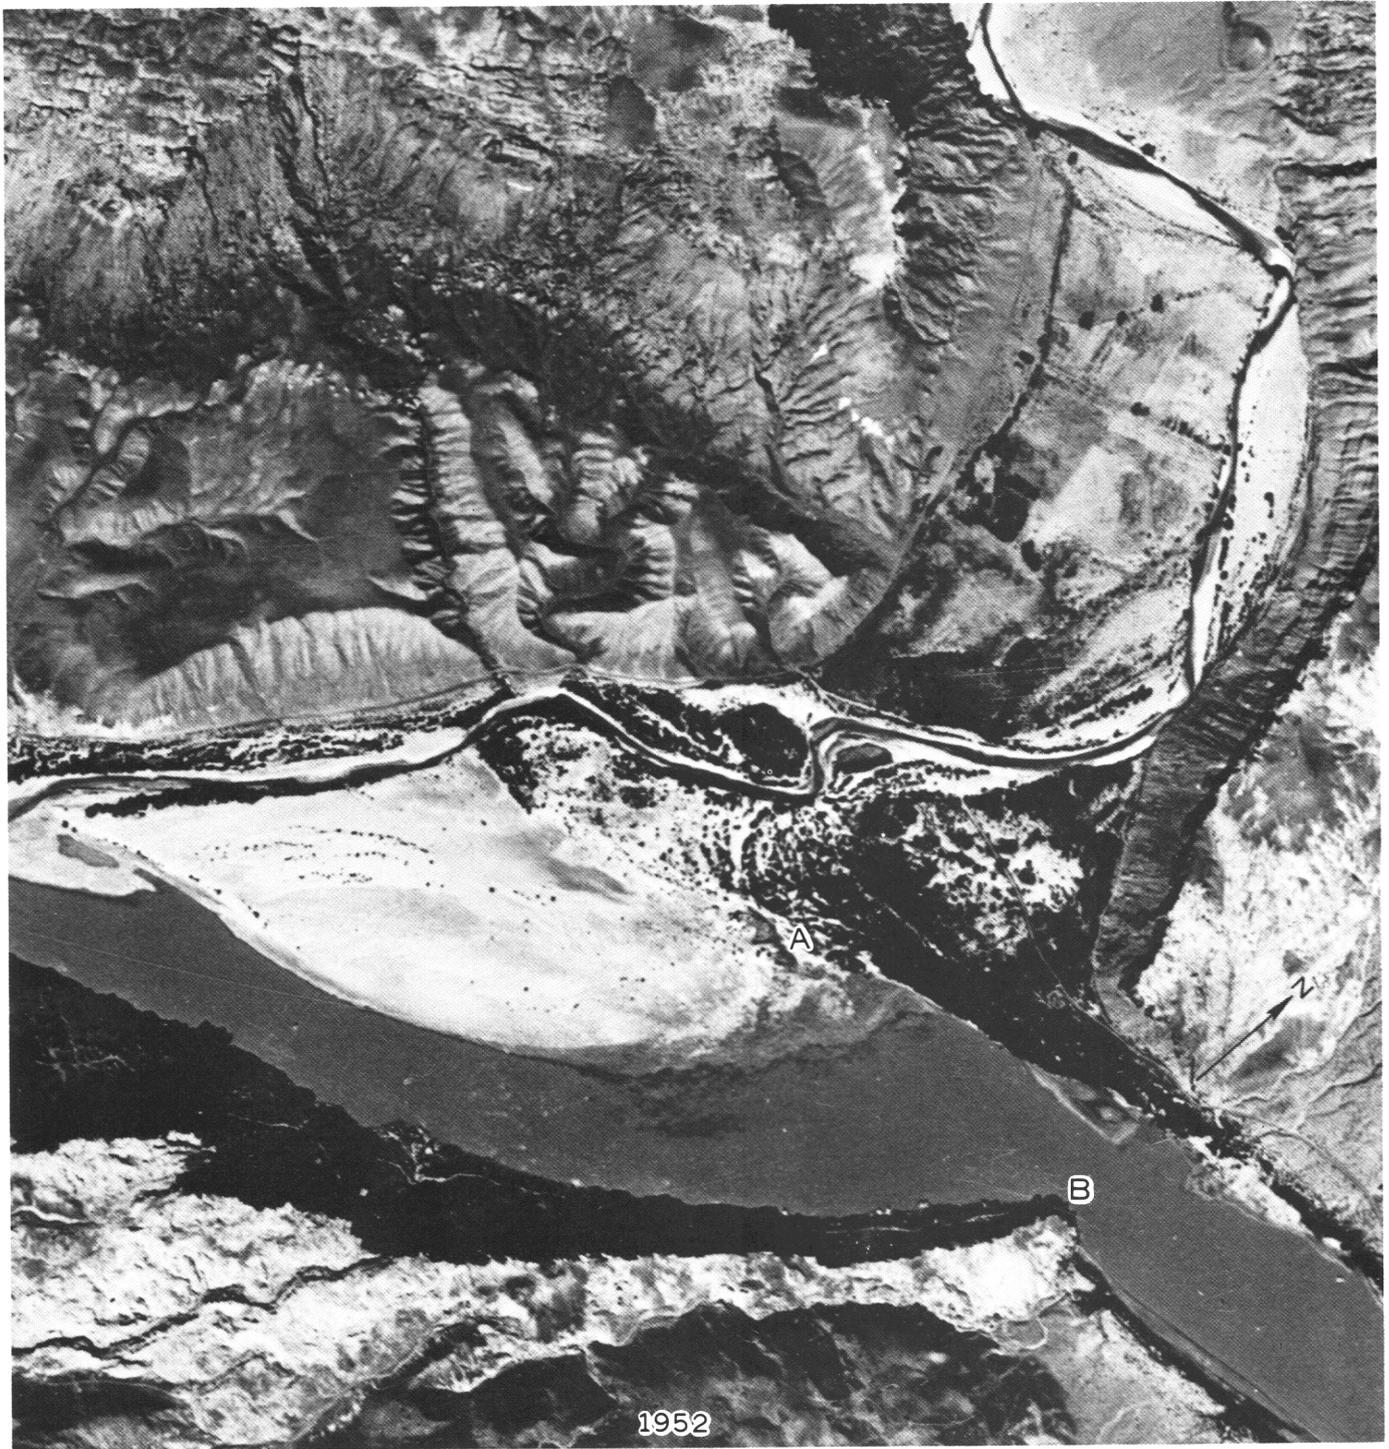
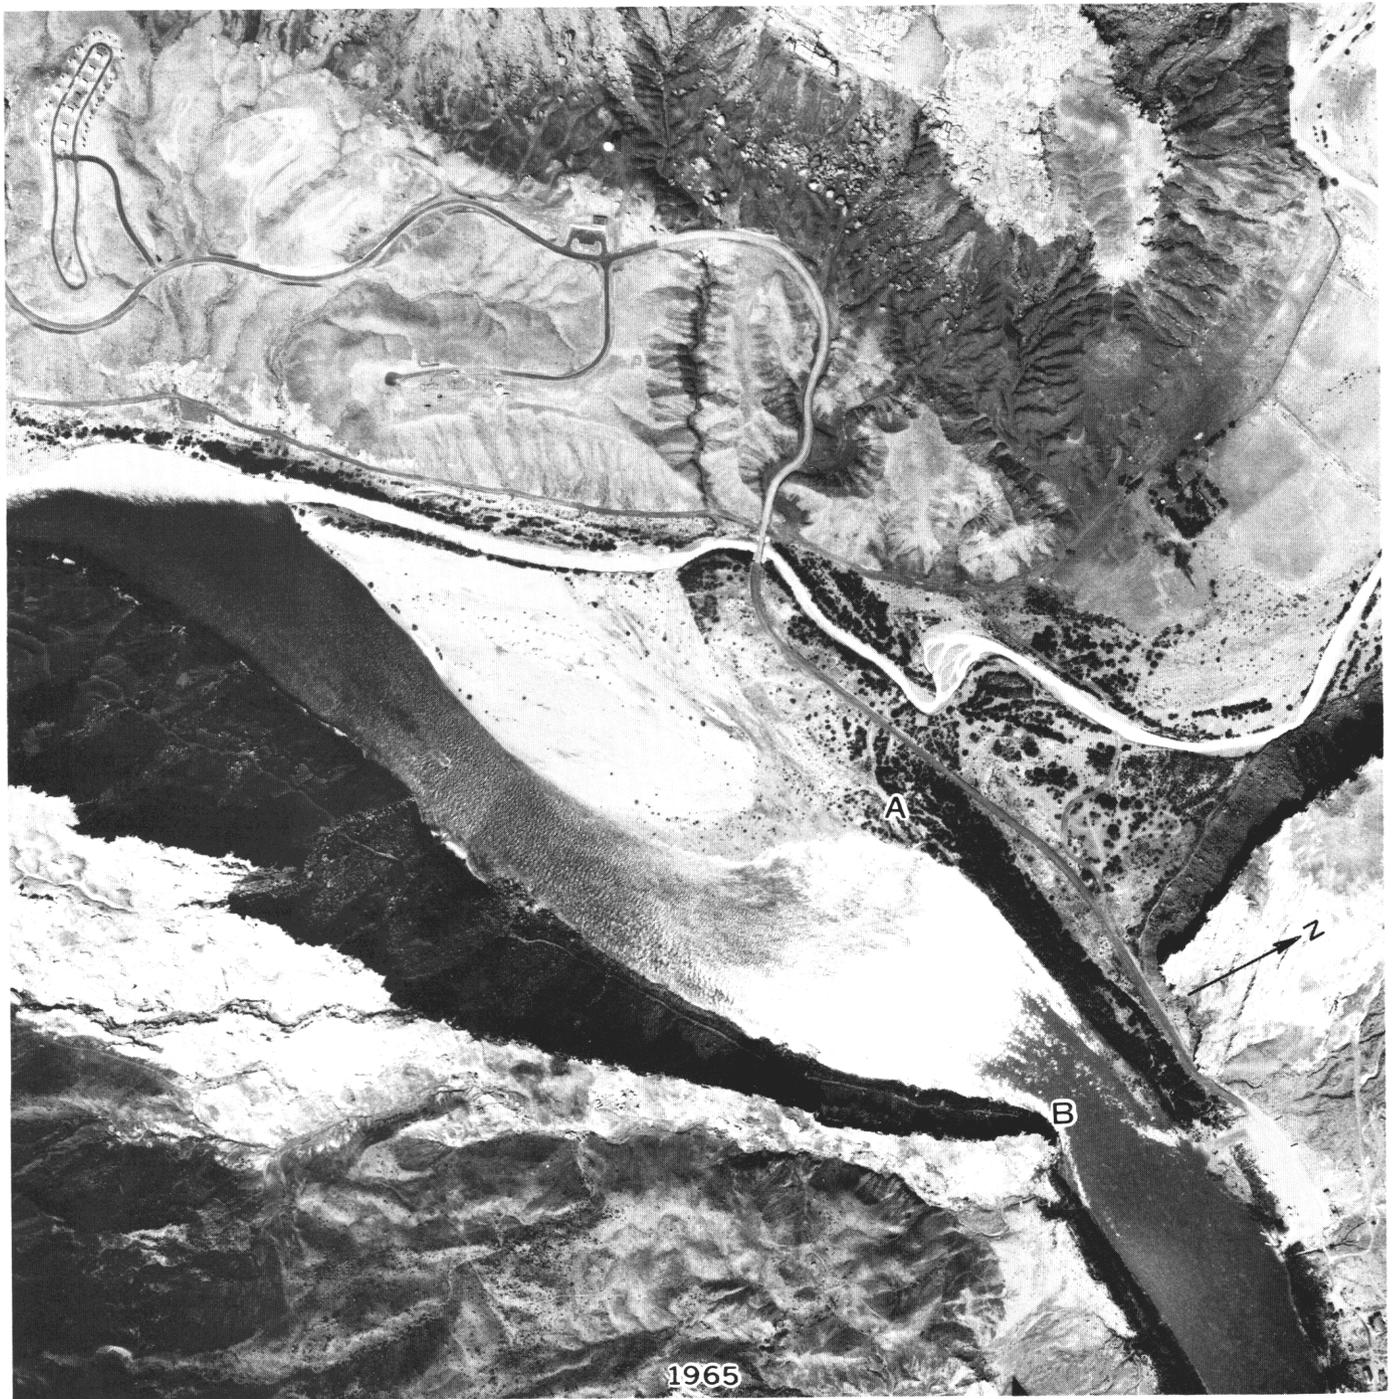
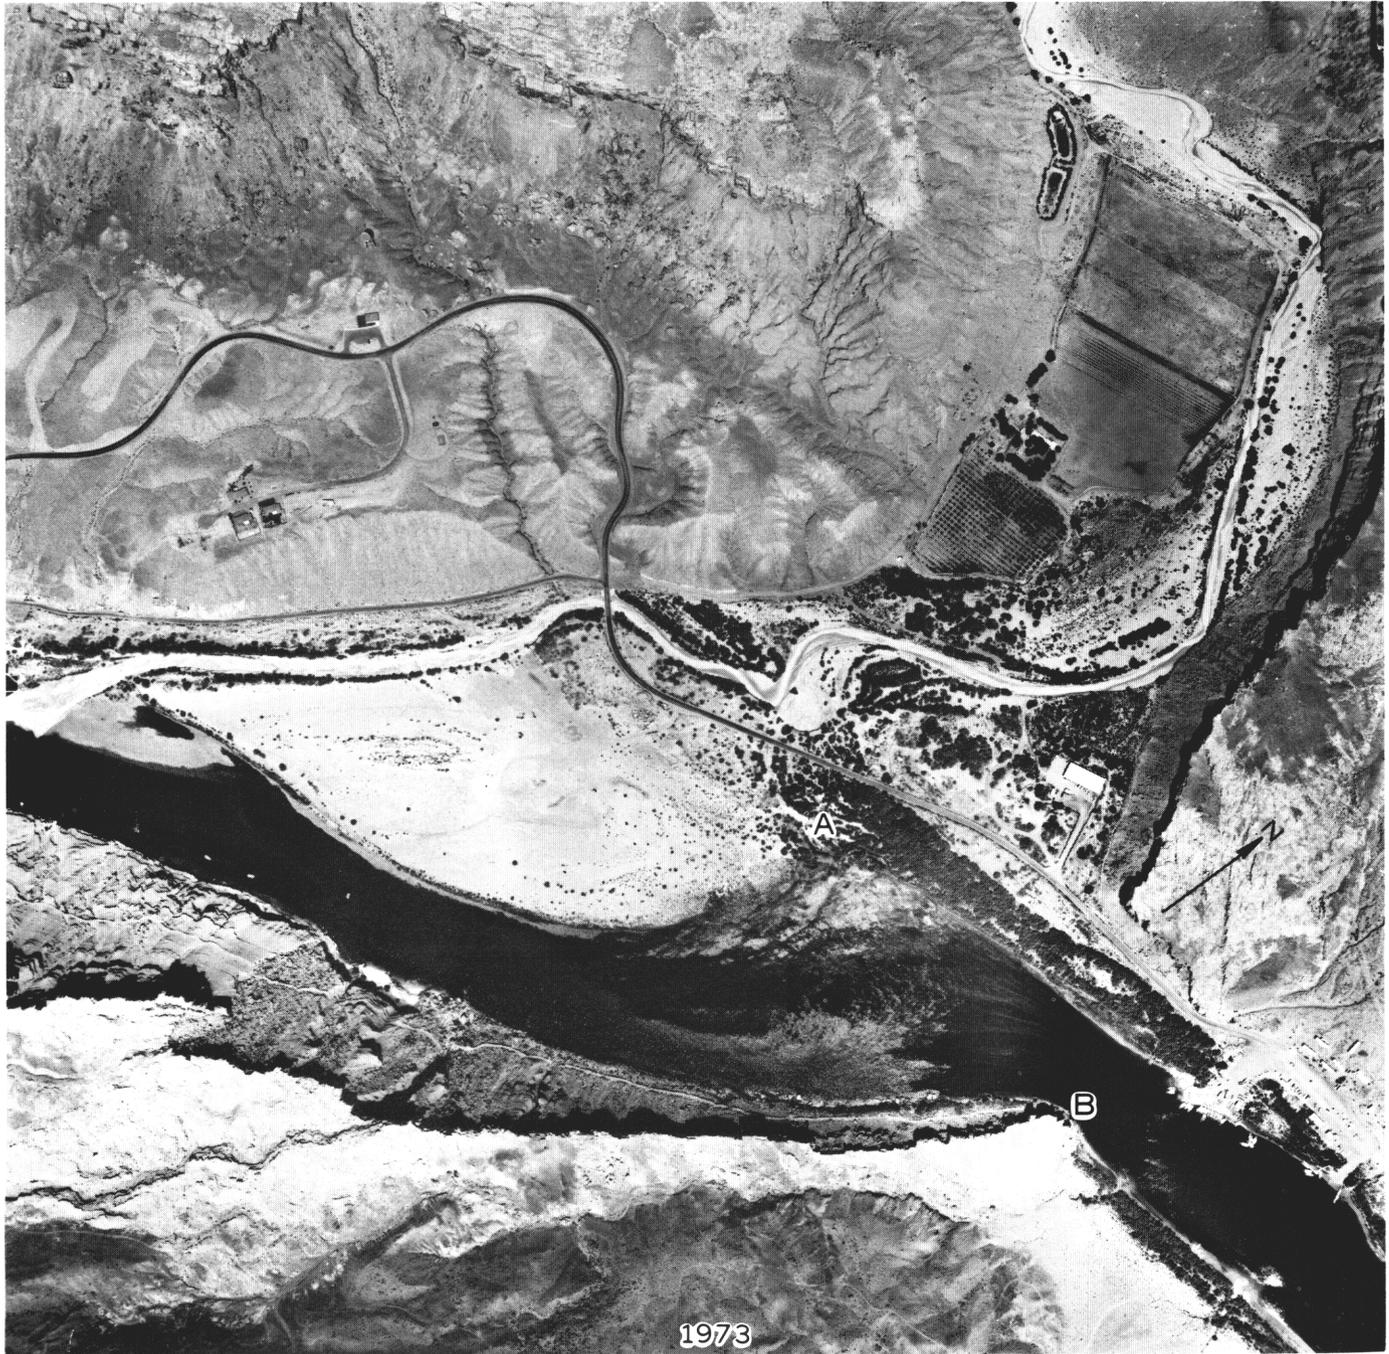
FIGURE 34.—Three aerial photographs, spanning a 21-year period, record conditions at the mouth of the Paria River near Lees Ferry. The photographs were taken on September 24, 1952; May 14, 1965; and June 16, 1973. Many features shown in figures 31 through 33 can be seen in this series of aerial views. The Echo Monocline forms the cliffs to the right of the Paria River which flows toward the Colorado from the upper right of the photographs. The approximate location of the 1873 channel of the Paria (see fig. 33A) is marked with the letter A. The dugway road that was in use until the ferry was abandoned in 1929 can be seen running from point B toward the west above the left bank of the river. The U.S. Geological Survey stream gaging station is located at point B. This is also near the location from which figure 33 was taken.

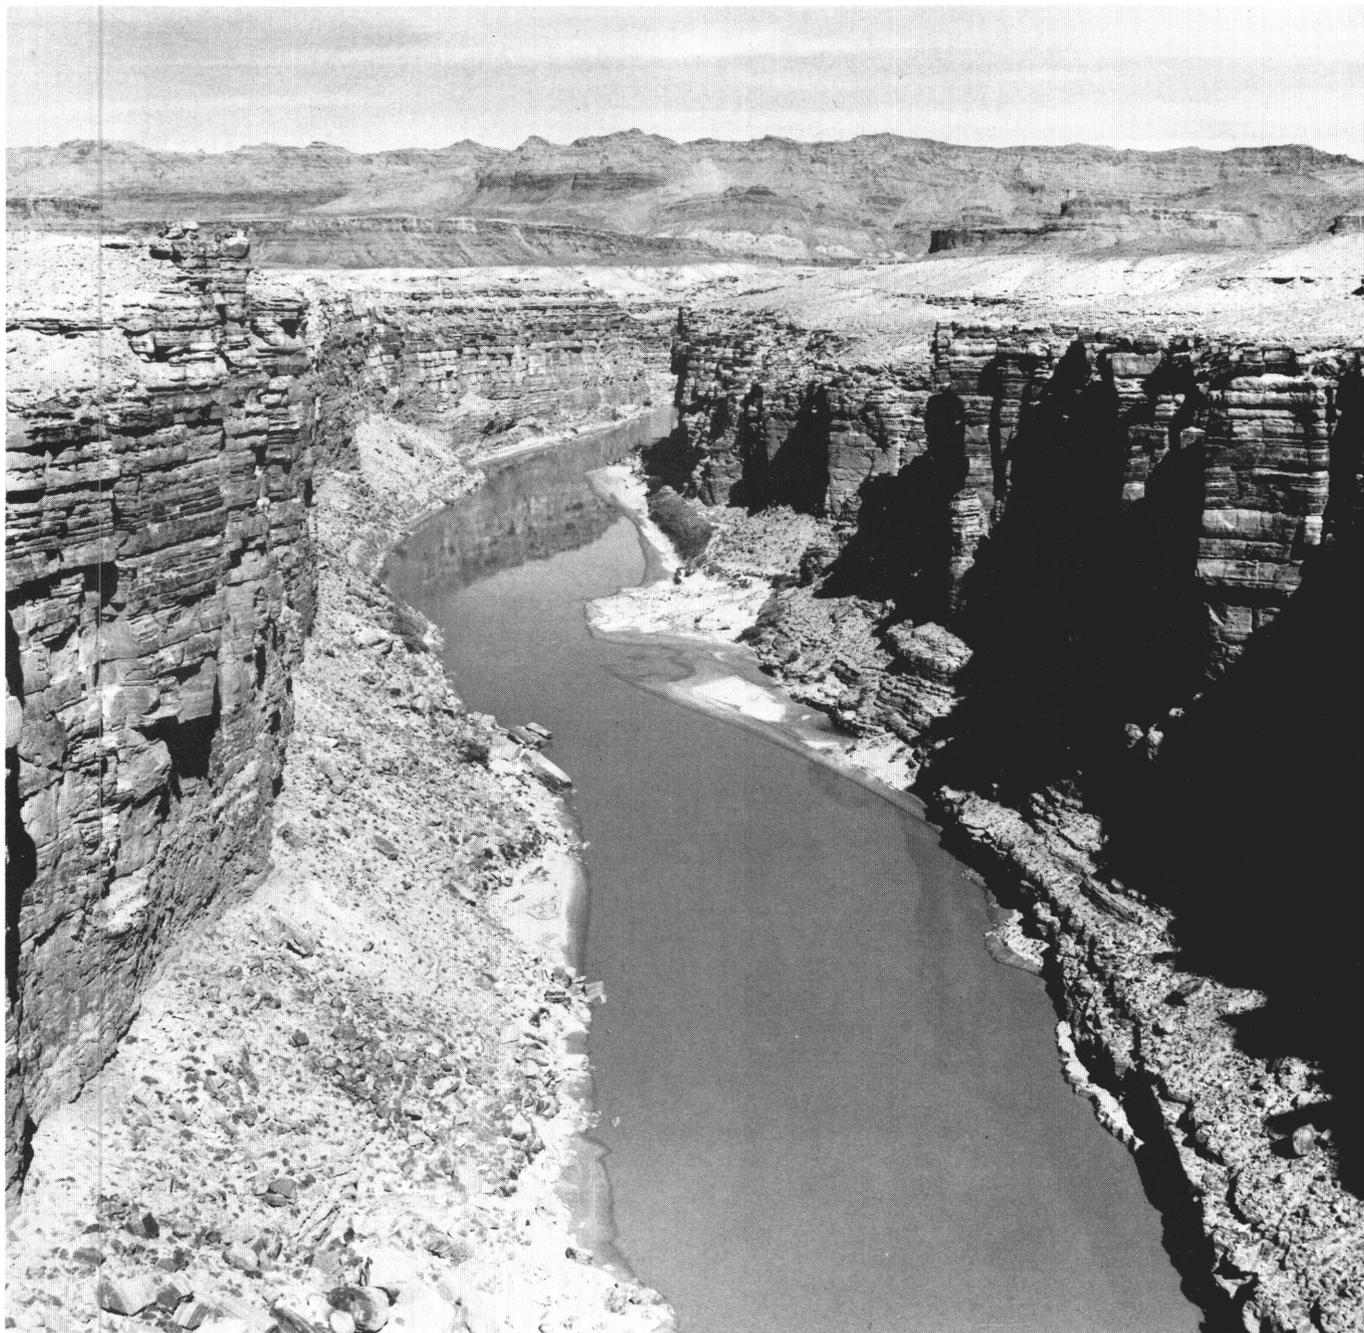
FIGURE 35A.—(1952). This upstream view of the river is from the Navajo Bridge on U.S. Highway 89, 6.9 kilometers below Lees Ferry. The bridge was completed in 1928, after which the ferry at Lees Ferry was abandoned. The vertical cliffs expose rocks of the Lower Permian and Toroweap Formation overlying Kaibab Limestone. The interrupted dense thicket is immediately above the infrequently flooded high water level and is composed of netleaf hackberry and Apache plume. Bare beaches of sand appear at this river stage. (Altitude 942 meters.)
