# Recent Vegetation Changes Along the Colorado River Between Glen Canyon Dam and Lake Mead, Arizona

By RAYMOND M. TURNER *and* MARTIN M. KARPISCAK

GEOLOGICAL SURVEY PROFESSIONAL PAPER 1132

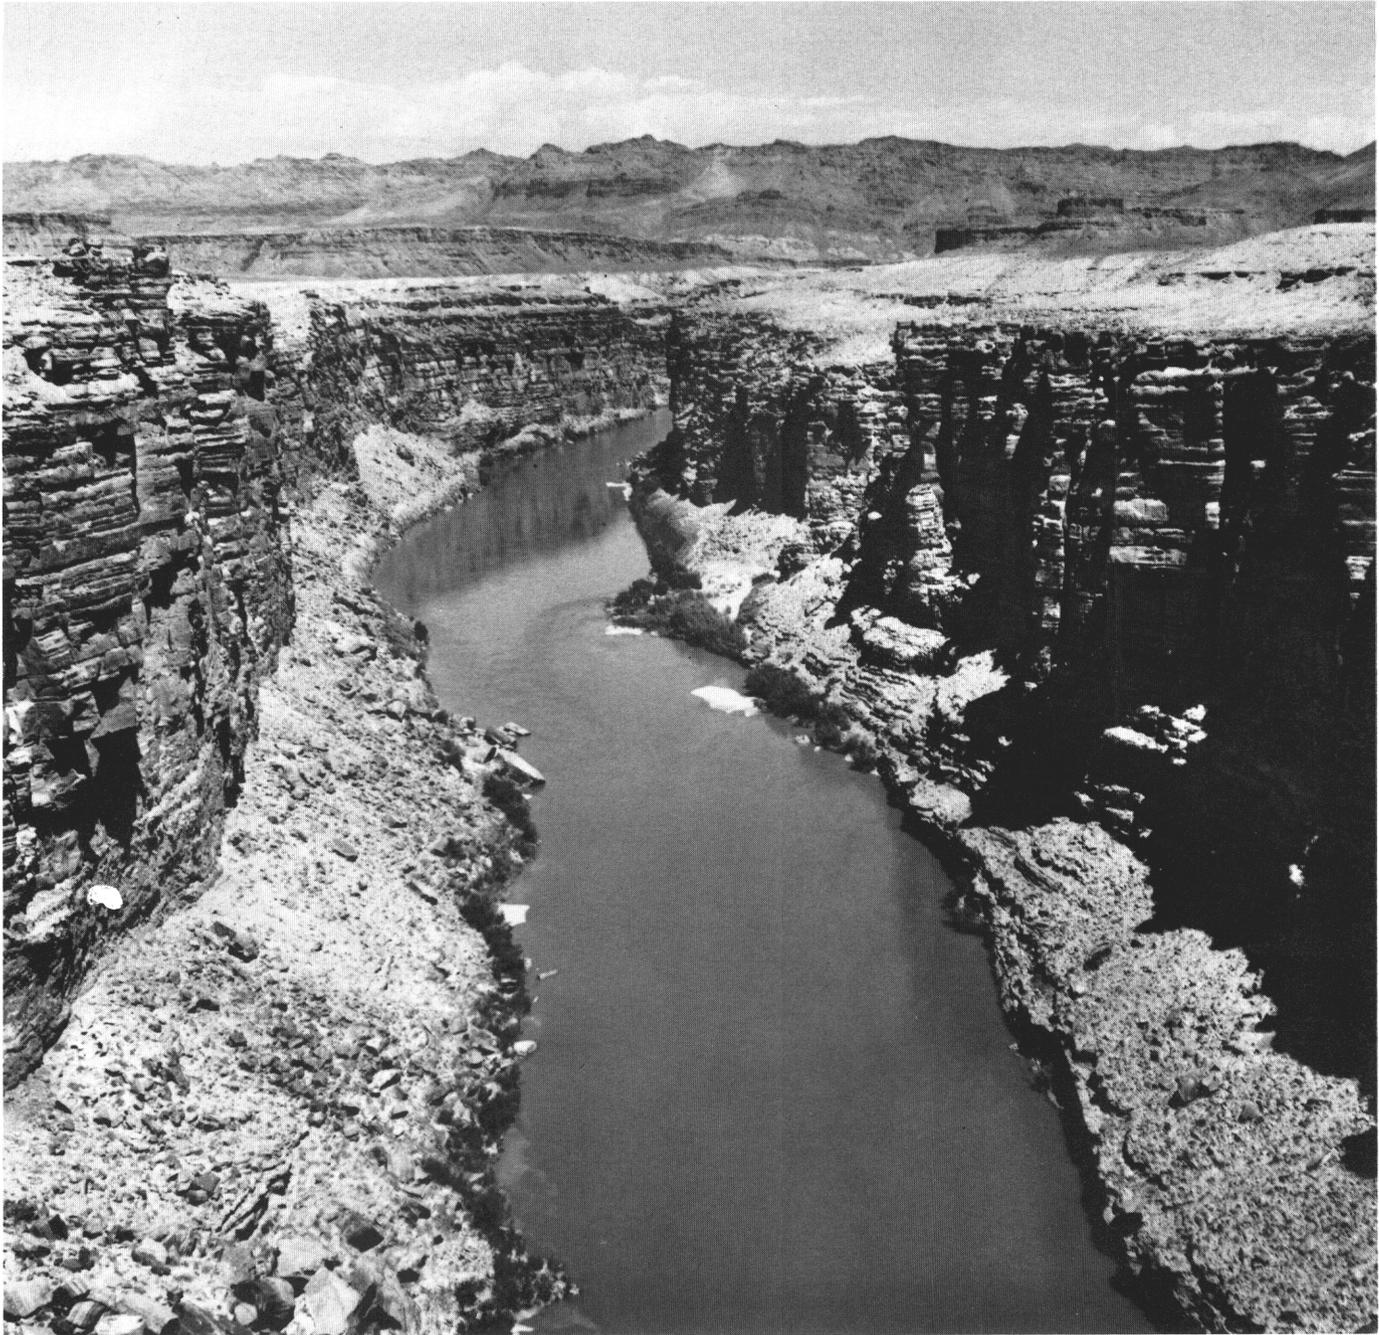
FIGURE 35B.—(1972). The river is at higher stage here than in the 1952 view, and many of the former sandy areas are covered with water. The new dense riparian community is mainly saltcedar, sandbar willow, and Apache plume with infrequent stands of cattails.

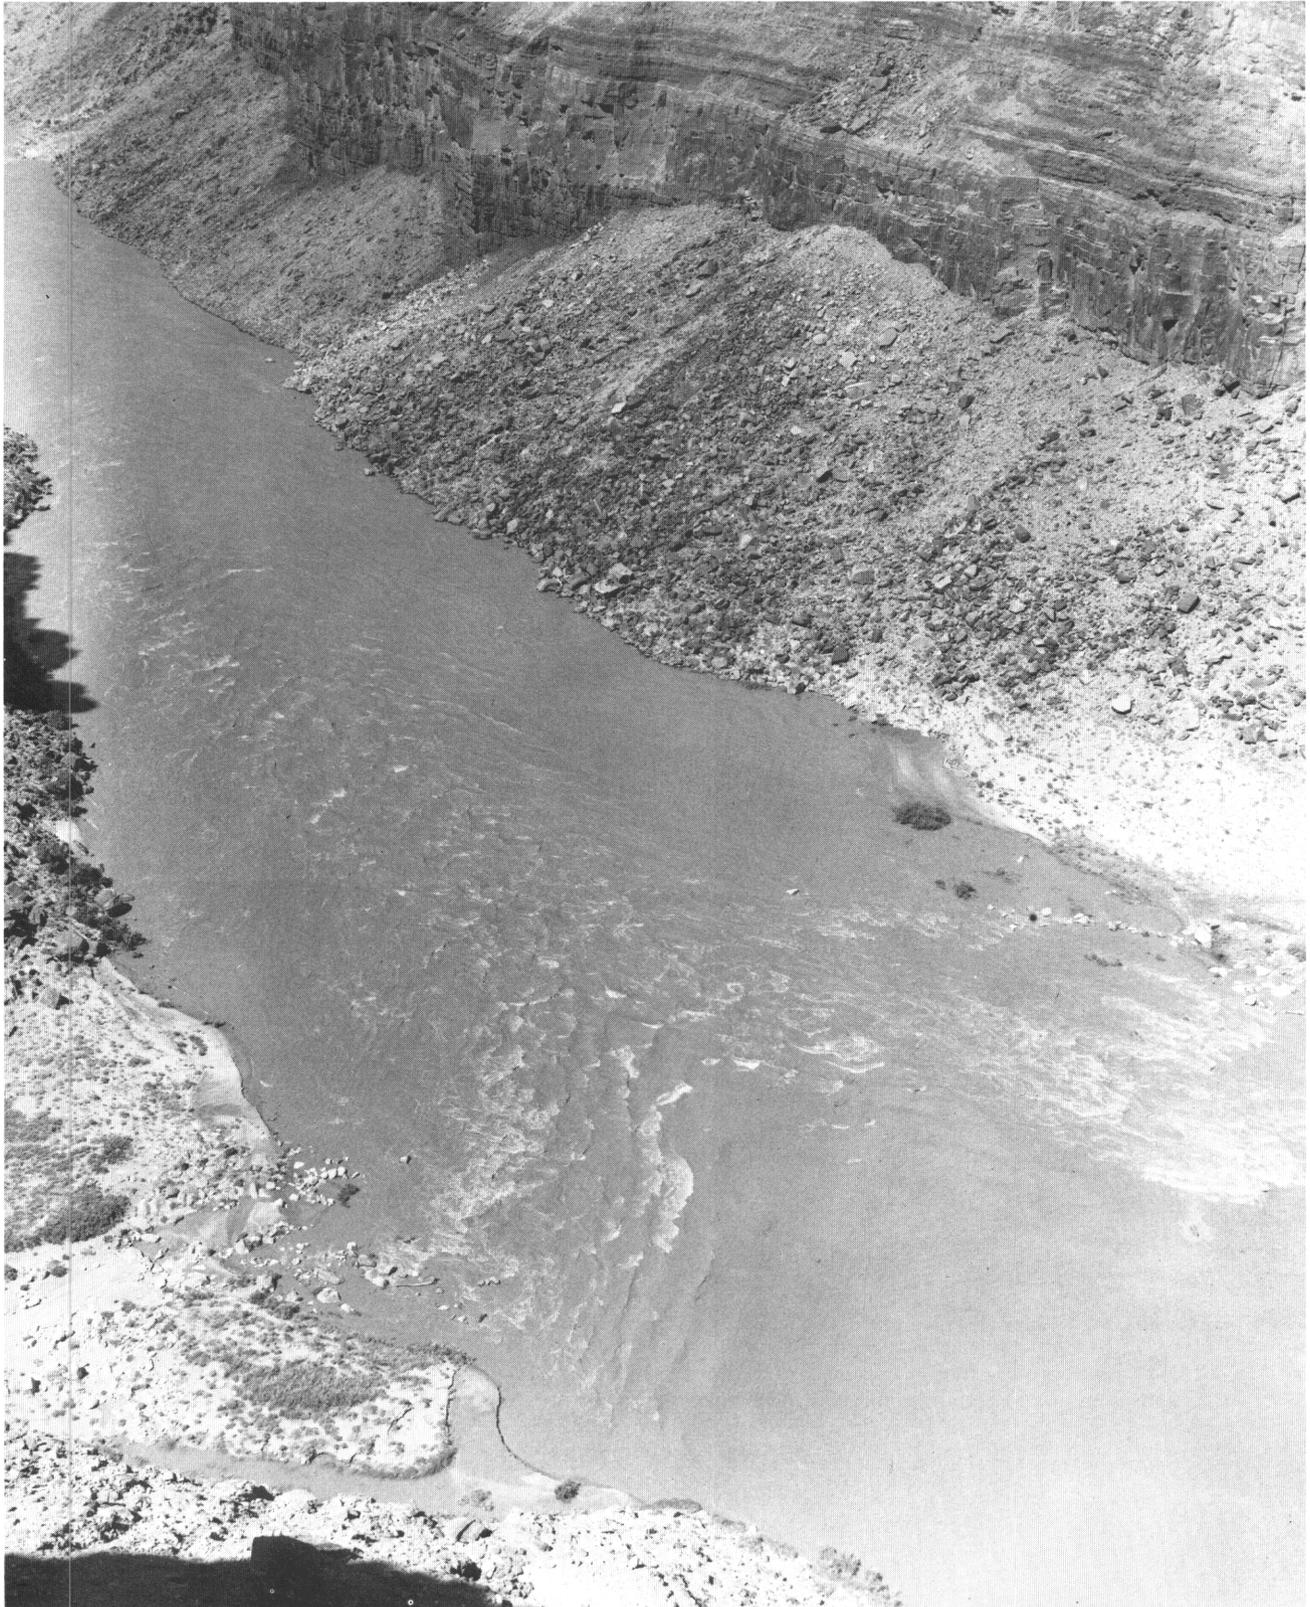
FIGURE 36A. —(1952). Overlooking Badger Creek rapids from a point above the left bank just north of Jackass Creek, 12.6 kilometers below Lees Ferry. Slopewash blankets the Hermit Shale Formation at river level here. The cliffs visible above consist of the Lower Permian Coconino Sandstone and overlying Toroweap Formations. At the time of this photograph (June 19), the discharge for the day at Lees Ferry was 2,799 m<sup>3</sup>/s (U.S. Geol. Survey, issued annually). Note the large shrub surrounded by water just off the right bank. This shrub persists in the 1972 photograph. (Altitude 939 meters.)

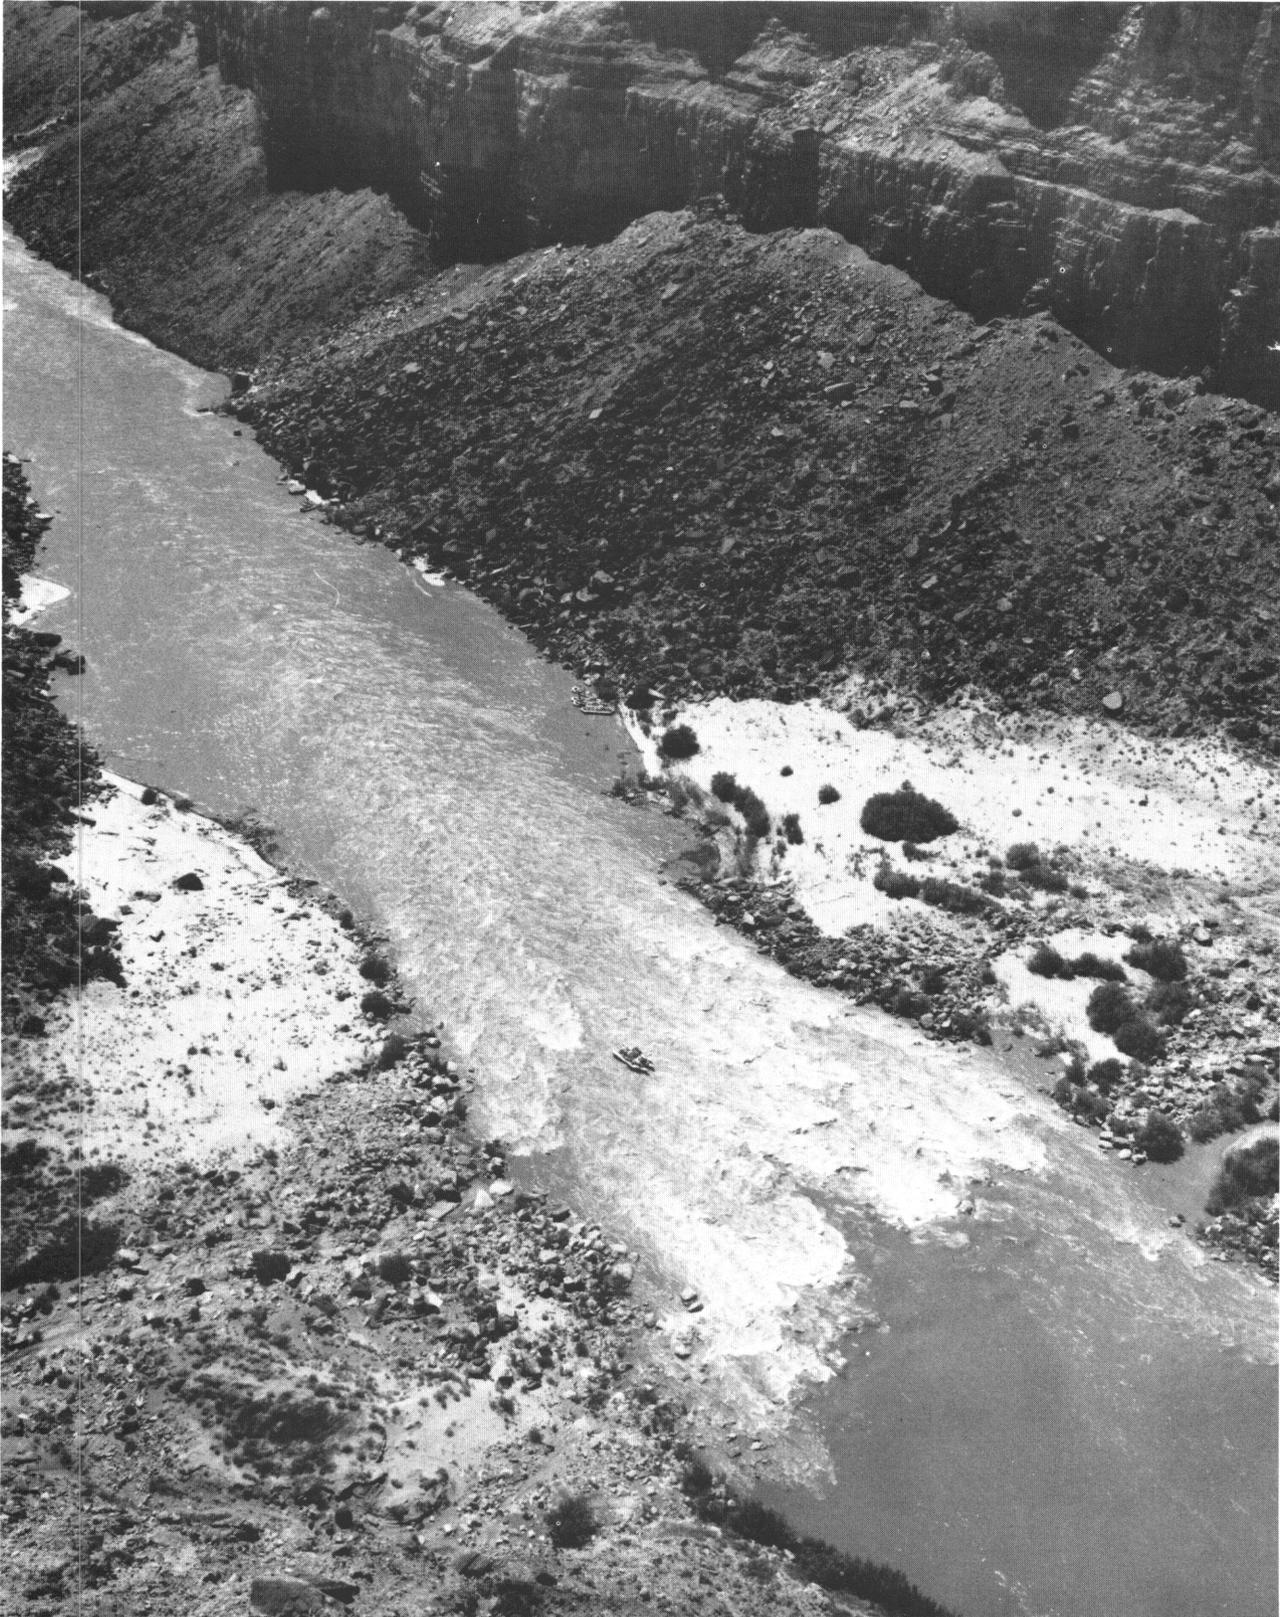
FIGURE 36B.—(1972). The 24-hour discharge at Lees Ferry on the day of this photograph (August 21) was 529.6 m<sup>3</sup>/s, approximately one-fifth the volume for the date of the previous photograph (U.S. Geol. Survey, issued annually). Note the raft passing the Badger Creek rapids and several other rafts near the right bank below the rapids. The water through the rapids is obviously more turbulent at this low stage than at the high stage in the 1952 view. The large shrub of the early view is visible and is saltcedar. This plant was present along the river at many places through the Grand Canyon as early as 1938 (Clover and Jotter, 1944), but it probably grew only at scattered localities at or slightly above the contour of maximum river stage. In this view, saltcedar occurs as an interrupted band along both banks of the river.

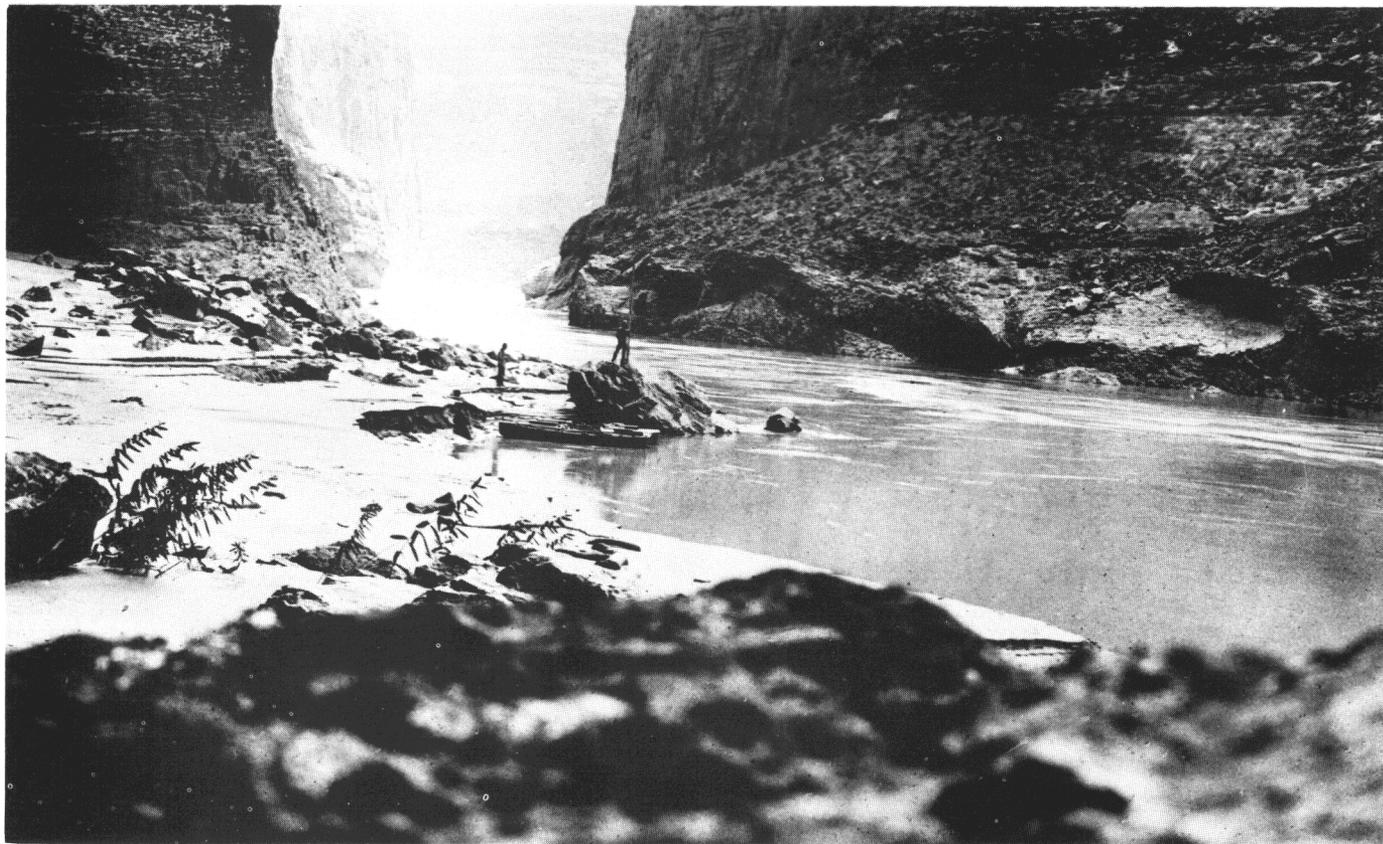
FIGURE 42B.—(1974). Comparison of this photograph with the earlier one reveals several changes. The impact of wave action is no longer apparent away from the river, but wind ripples are evident in the sand of the foreground. Using the collapse blocks as references, it is apparent that aggradation, perhaps from wind, has occurred on the higher parts of the beach and erosion has reduced the sand deposit toward the base of the sloping beach. The sand bar across the river to the right appears new. The only plants visible are scattered saltcedars. The lack of more vegetation probably results from the low light intensity within the cavern and trampling by the thousands of visitors that stop here each year.

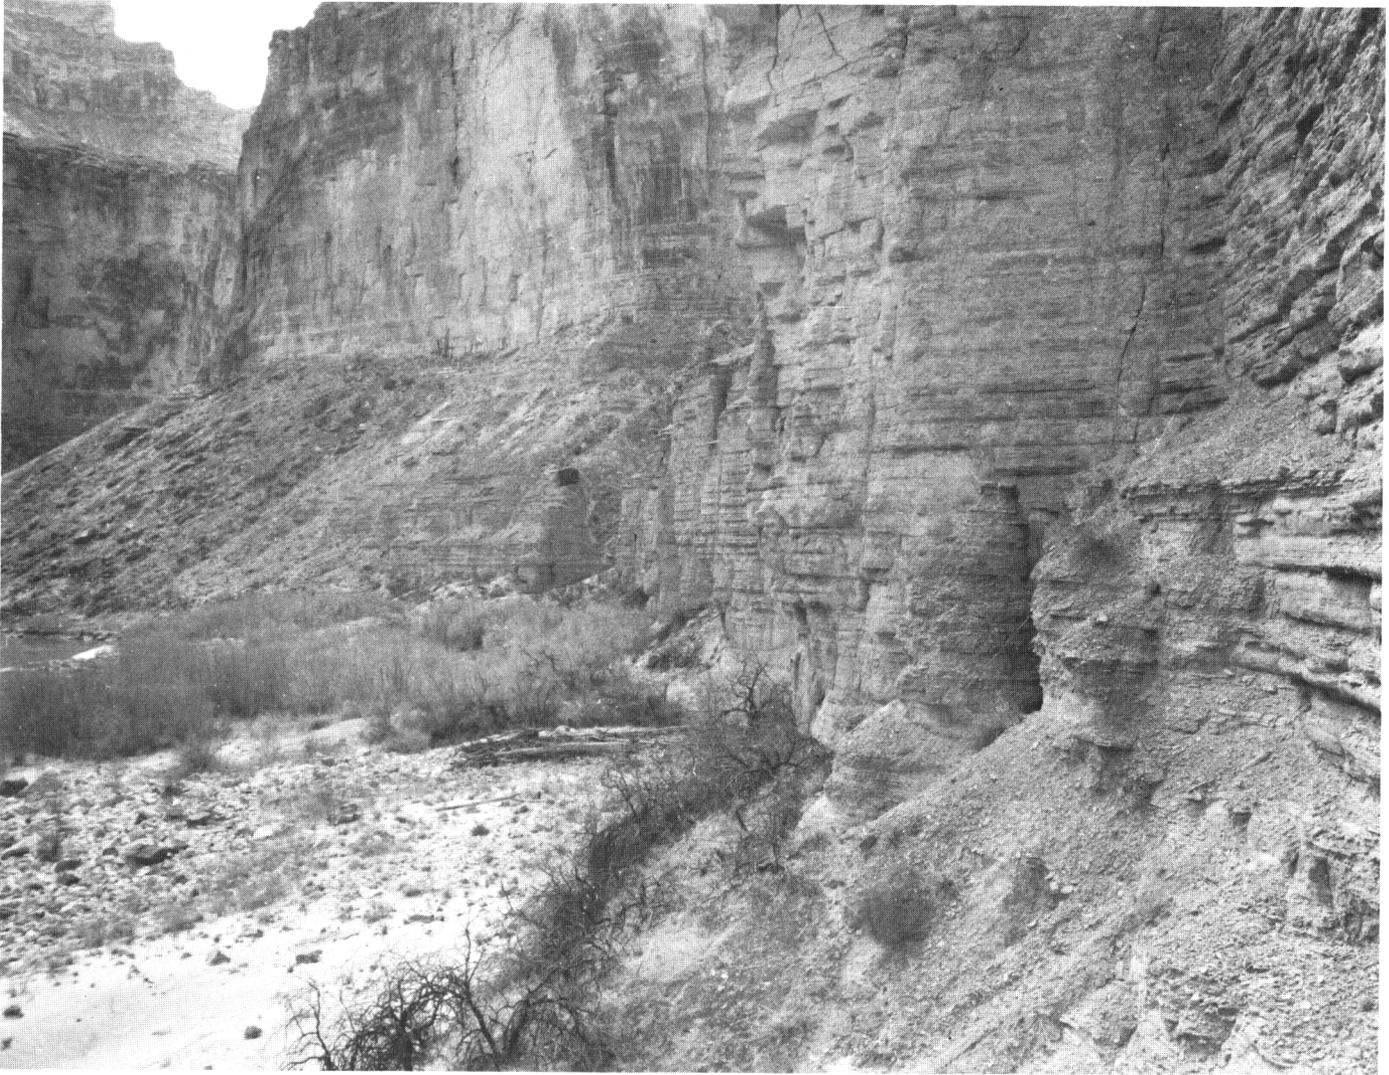
FIGURE 43B.—(1974). Driftwood is still visible in the same location as before, and many boulders are the same in both views. Much of the sand deposit is still relatively unstable and devoid of plants. In this March view the flood-line community, composed mainly of western honey mesquite in this section of Upper Marble Canyon, is leafless and cannot be easily compared with its counterpart in the August 1923 photograph. Western honey mesquite is first seen in the canyon only 11.5 kilometers upriver from here. Some of the plants (jointfir) on the talus slope at the right seem to be the same as those in the earlier view. The vegetation at the river's edge is predominantly saltcedar and willow, with sparse seep willow, arrowweed, and cattail. Other species found on the beach are peppergrass, desert plume, Russian thistle, red brome, globemallow, brittlebush, dyssodia, longleaf brickellia, and desert trumpet.

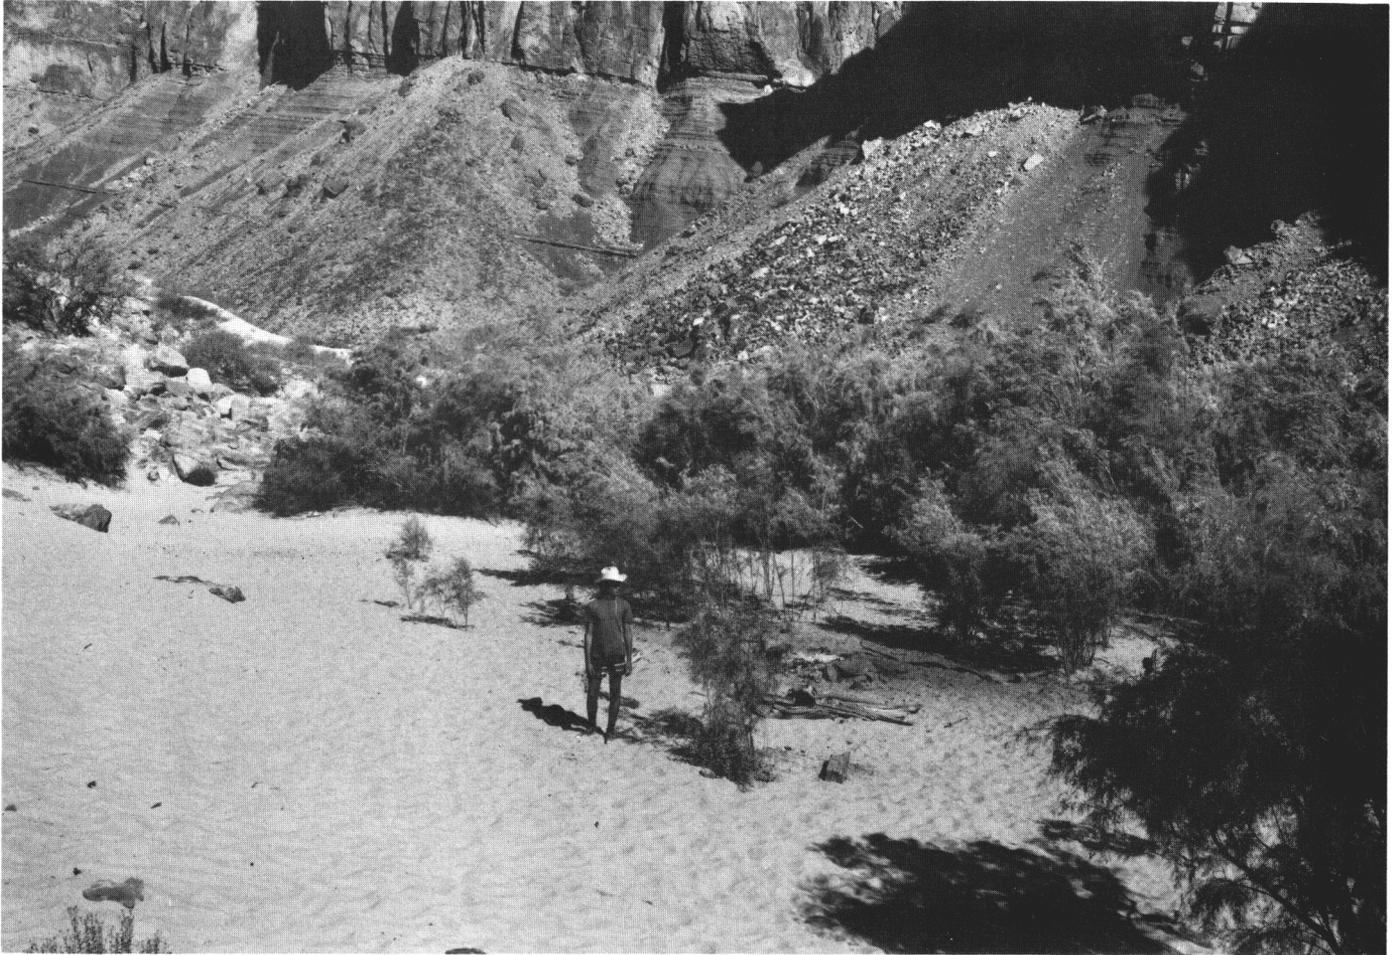
FIGURE 48B.—(1972). The depth of the sand deposit has increased and saltcedar grows densely along the edge of the river. The sand dune is new on the sloping area at left midground. The thicket of desert shrubs at left, comprising western honey mesquite, catclaw, and four-wing saltbush, is rearranged but may have changed little in biomass. The Hance Trail is no longer maintained and is not usable by pack animals. The remains of a campfire and the many human tracks attest to the heavy use the area receives as a campground by parties floating down the river. In 1974 this campsite was given a subjective human impact rating of 20.0 on a scale from 10.0 (no impact) to a maximum impact value of 22.6 (Aitchison, 1976). In spite of the heavy use, saltcedar has become established in abundance.

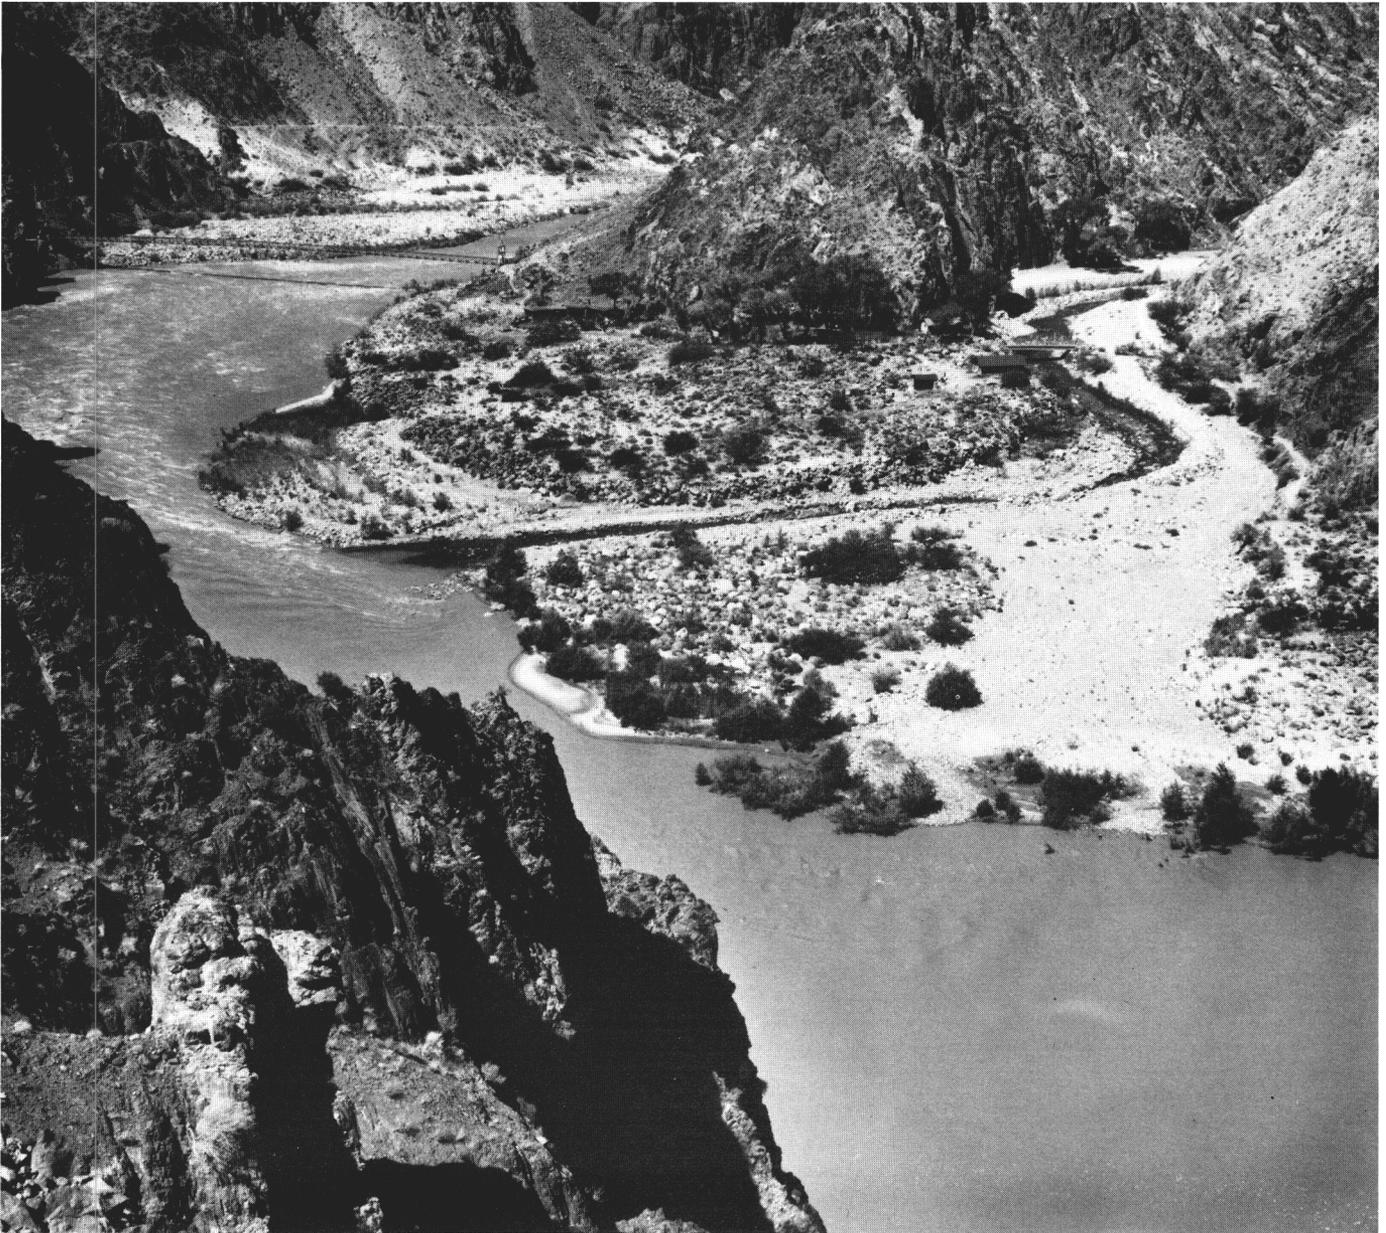
FIGURE 50C.—(1972). In the 9 years since the previous photograph was taken many new features are apparent. In December 1966, record flooding occurred in the Bright Angel watershed and the creek left the old channel, flowing across the debris fan toward the camera point. Boulders in the path of the flood were removed from the fan (or covered?) and finer material was deposited in their place. In the absence of subsequent flooding along the Colorado River, this area has remained free of boulders. The bridge across the Colorado River on the left was built in 1967 and is used as a foot bridge. The bridge also supports a pipeline carrying water from the upper reaches of Bright Angel Creek to the south rim. The cottonwoods at midview have declined as have the mesquites on the right (between the bare fan and the trail above). Plants now occupying the debris fan near the edge of the water include sandbar willow, saltcedar, and several Fremont cottonwood saplings. The fan was visited in May 1978. Beavers had cut the sapling cottonwoods, but the trees had produced multiple basal spouts.

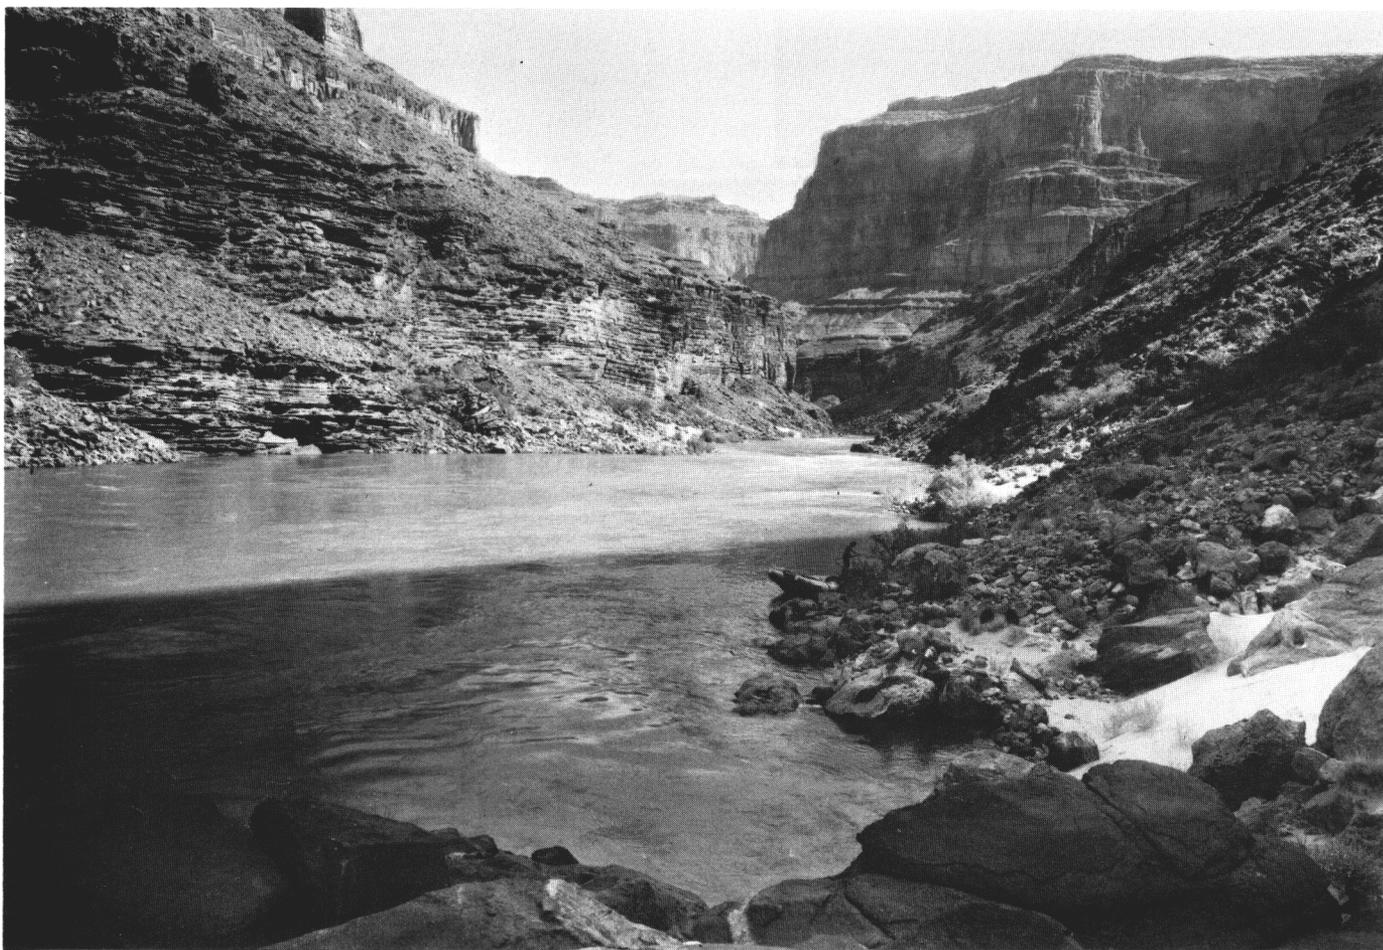
FIGURE 53B. —(1976). The river is at higher stage now than in the earlier view but loss of much of the higher sand deposits is evident. A few plants of *dicoria* occur on the sand. Saltcedar is perhaps 3-4 meters tall where it grows in scattered pockets near the edge of the river.
