DEBRIS FLOW DEPOSITION AND REWORKING BY THE COLORADO RIVER IN  
GRAND CANYON, ARIZONA

Brian John Yanites

In the Graduate College  
THE UNIVERSITY OF ARIZONA  
2005

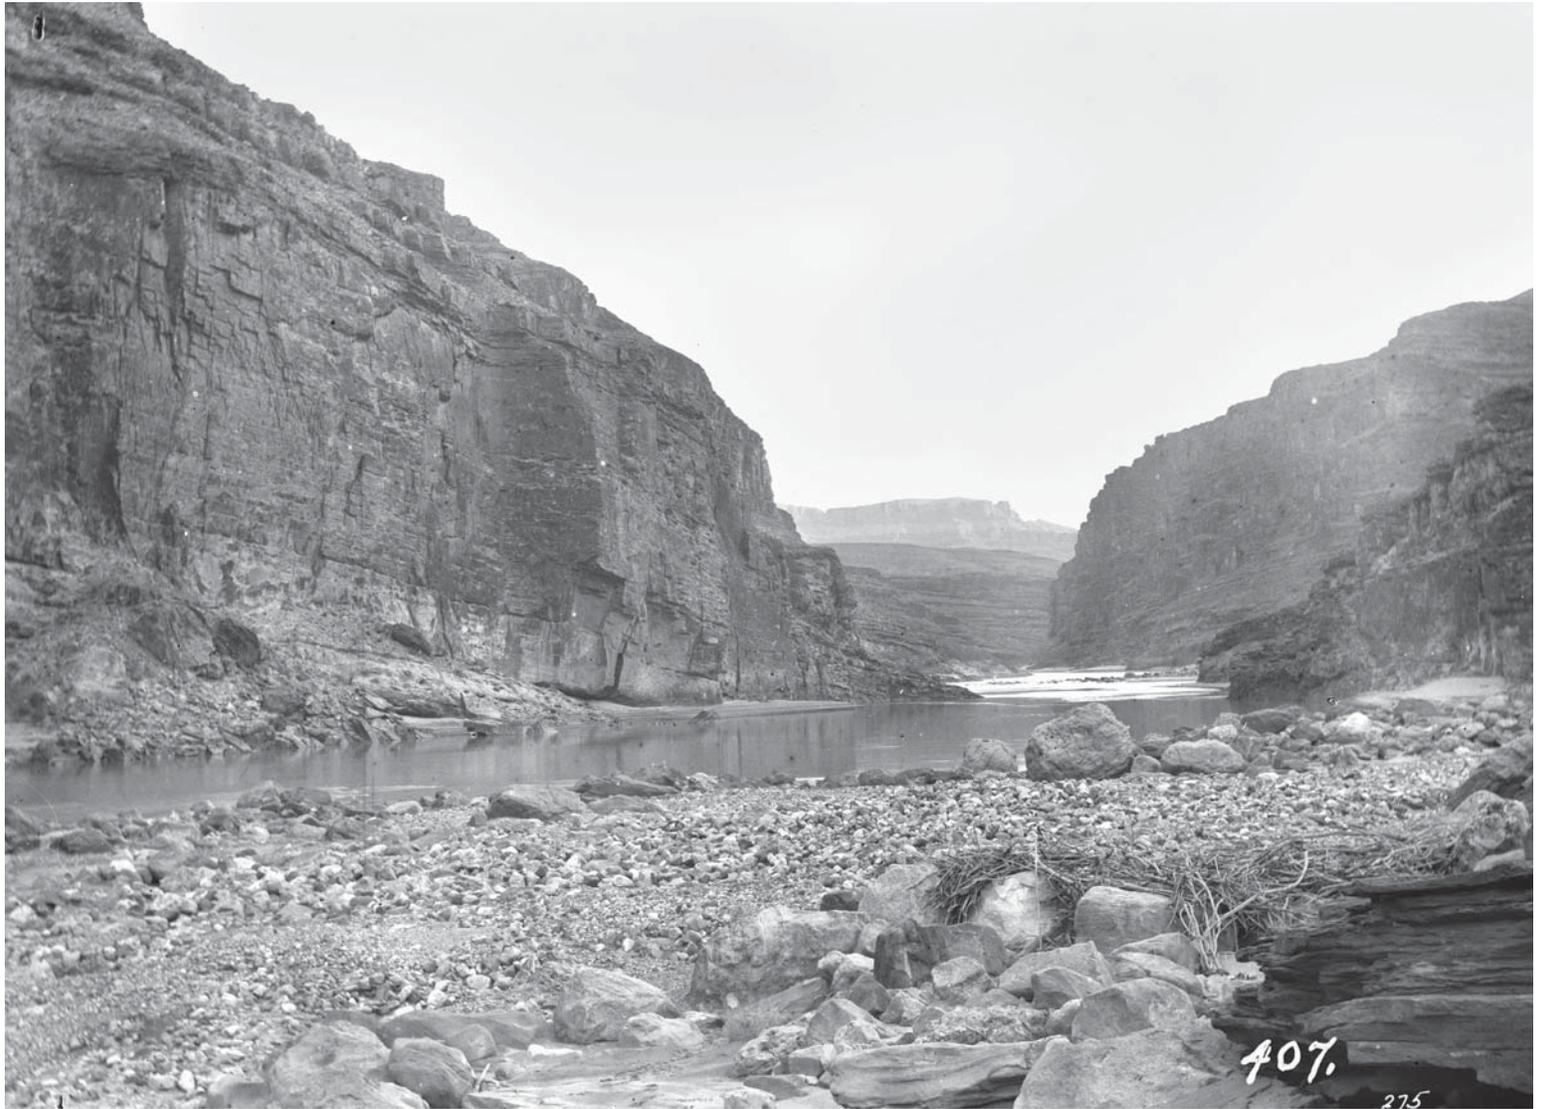
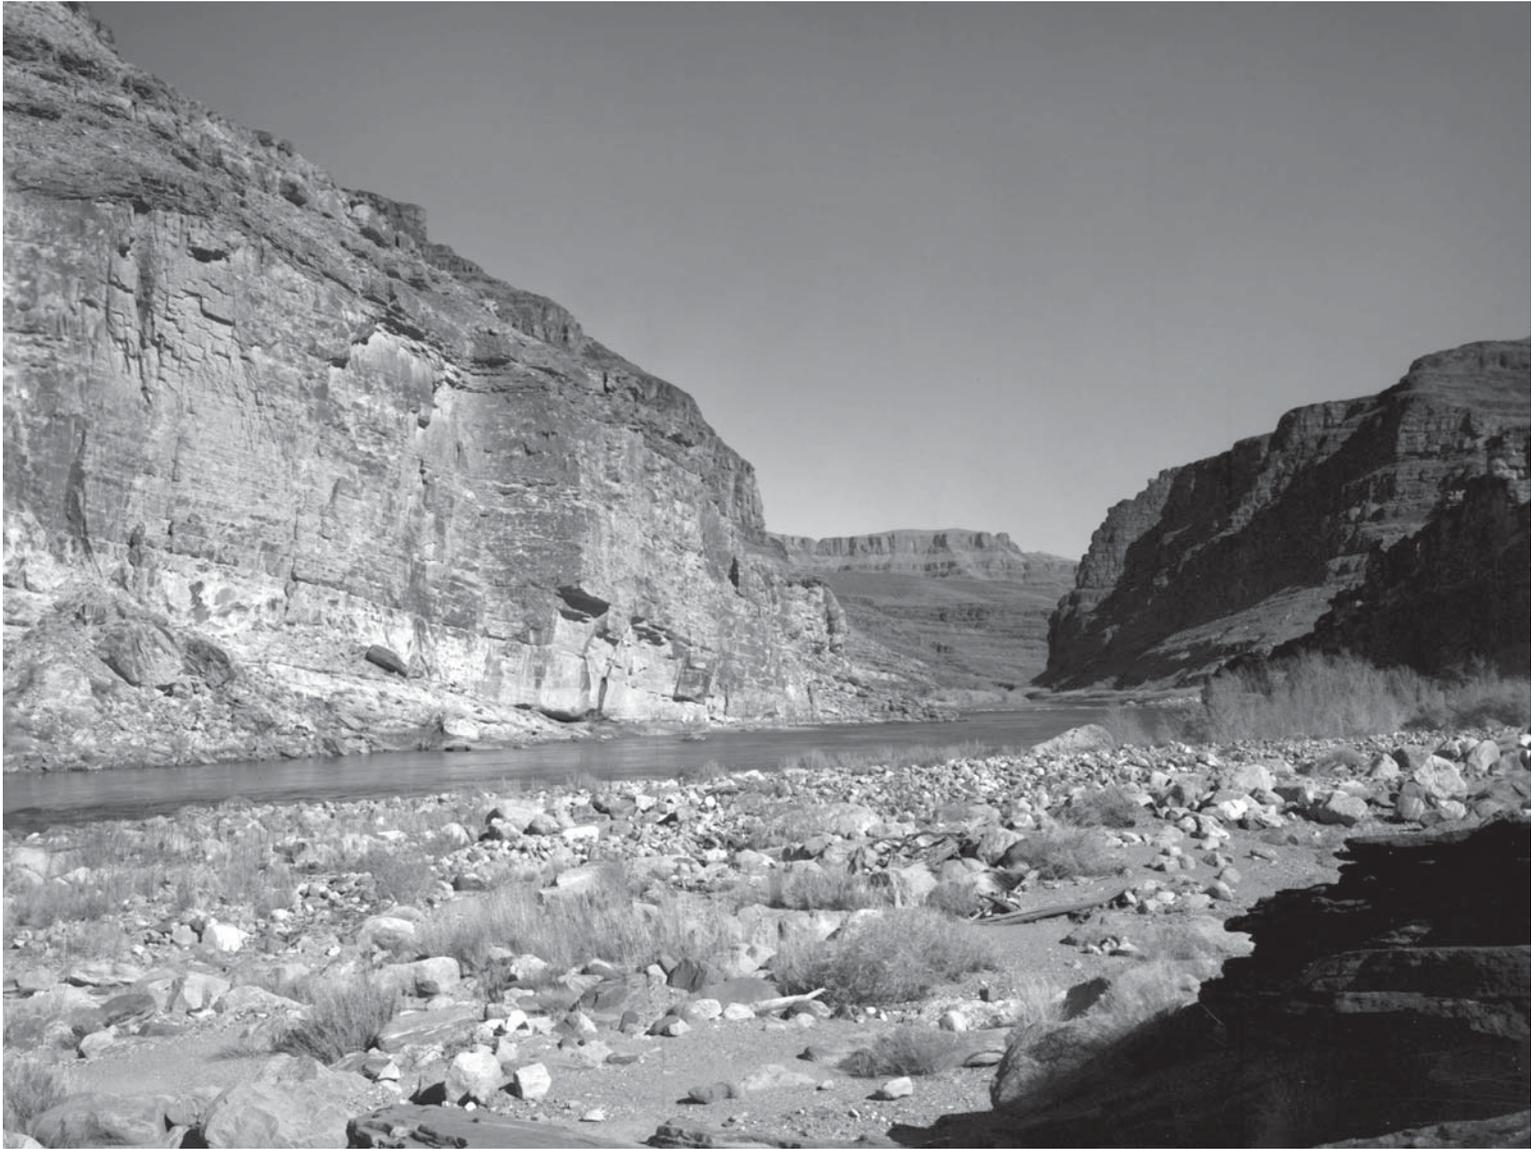
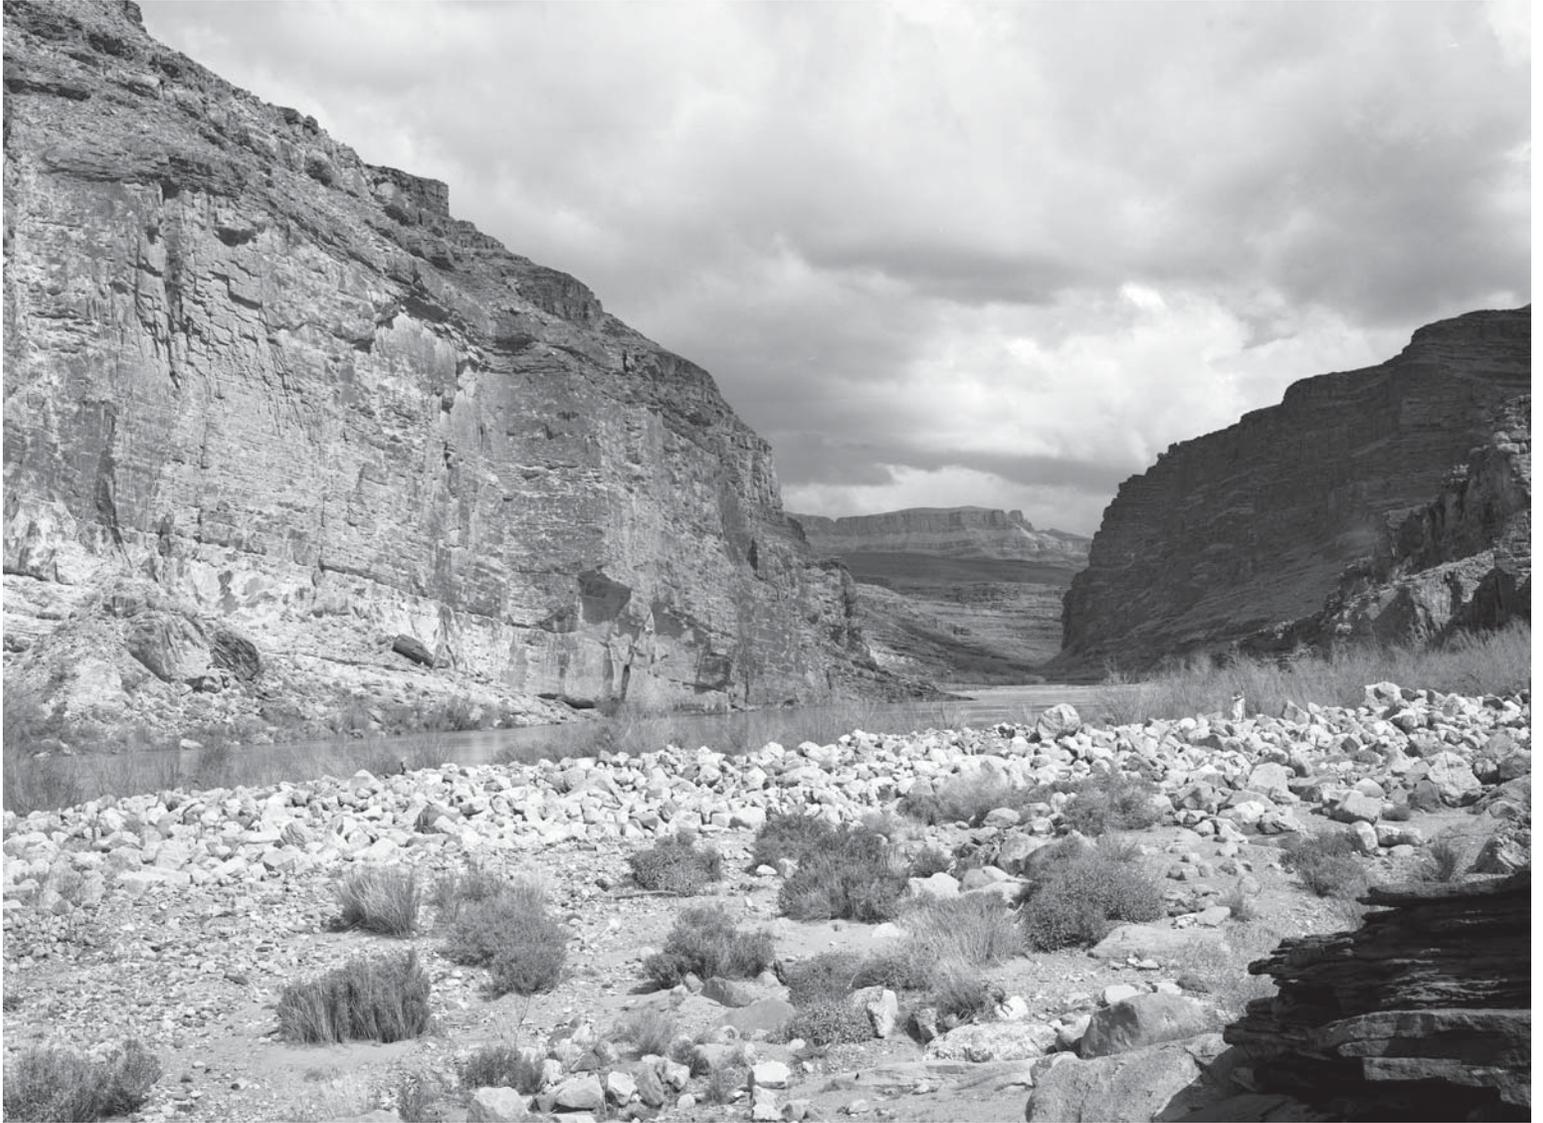
Figure 4A.

An early photograph from the Robert Brewster Stanton expedition of 1890 reveals numerous changes that have taken place over the course of the past century (Figure 4). Increasing vegetation may be the most obvious change, as the encroachment of riparian vegetation has implications for photogrammetry as well as debris-fan stability. Further, and more noteworthy to this study, is the inflation of the debris-fan surface. A large boulder can be seen in the 1890 photograph on the upstream side (river flows from center-right of the photograph to the left) of the fan, just to the right of the middle of the photograph. Part of this same boulder is visible in the 1990 photograph, but a considerable portion of it has been buried. In 2005, the boulder is almost completely buried, found only by field inspection and careful photographic analysis. The photographs also show an expansion of the aerial coverage of the surface by 1990.

It is apparent in repeat photography that the surfaces at these sites have expanded, further constricting the river in addition to inflating the surface since 1890 (Figures 4 and 6). Because the time frame represented by aerial photographs with comparable discharges is limited to the past 21 years, I conclude that the events causing the most significant river constriction happened before the aerial photograph flight of October 22, 1984. *Melis et al.* [1994] report evidence for a debris flow for 75-Mile Wash occurring between 1890-1960, and *Webb et al.* [1988] report debris flows during 1966-1967 and July 1984 at

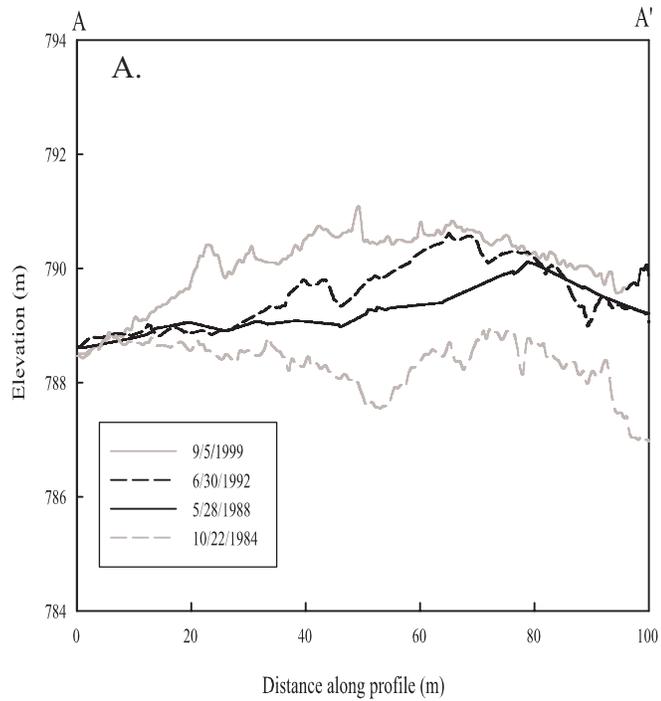
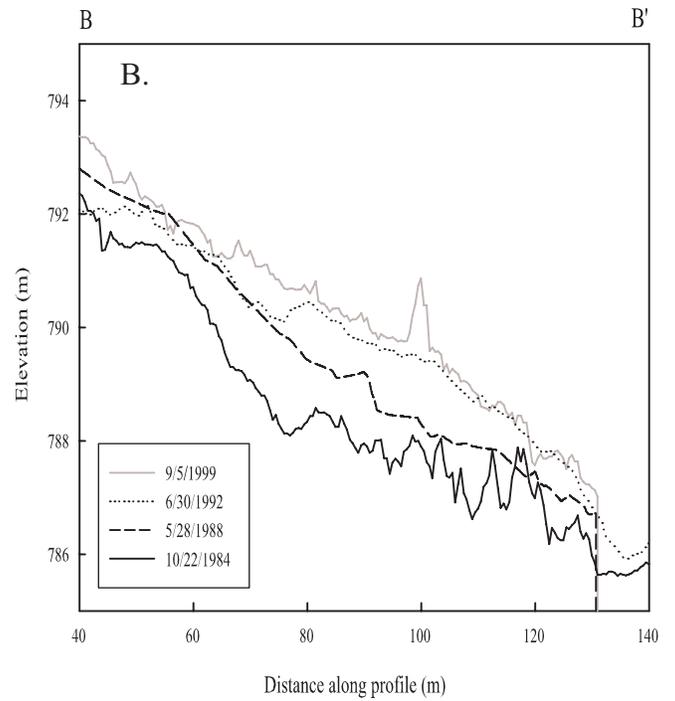
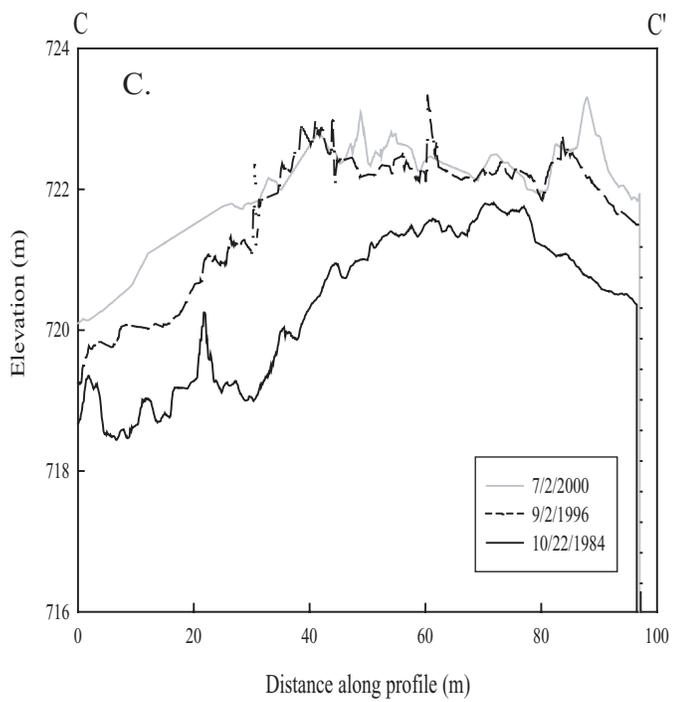
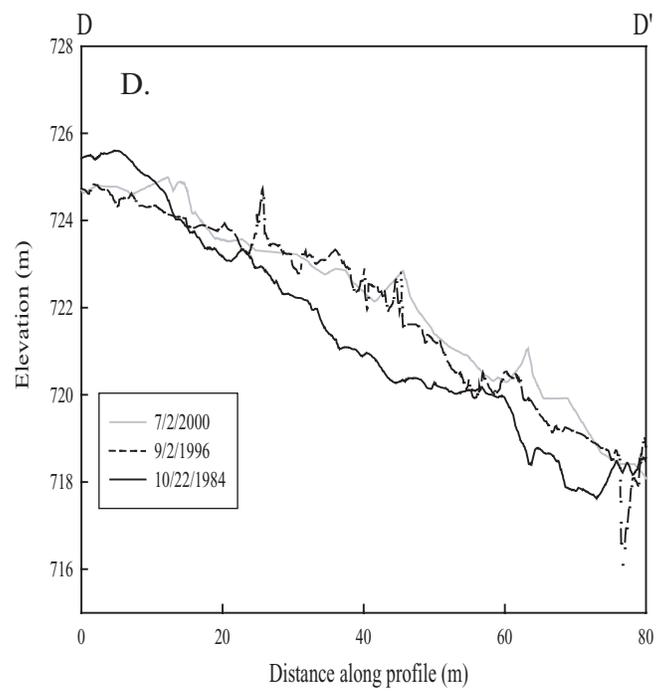
Profiles extracted from the surface models reveal significant increases in surface elevation (Figure 8). For both transects (A-A' and B-B', Figure 8), the 1984 surface is considerably lower than more recent surfaces. The 1988 surface shows the changes brought about by the 1987 debris flow, and the 1992 profiles show the effects of the 1991 event. Not only do these profiles exhibit substantial aggradation (as documented by Webb [1996] using repeat photographs, Figure 4), but they also show a shift in the shape of the profiles. The A-A' comparisons reveal a more negative curvature in the cross-fan profile. The B-B' transect shows that the largest increase in volume is near the geometric center

of the debris-fan, causing a shift from an overall positive curvature of the profile to an overall negative curvature.

Figure 8. Profiles derived from select surface models showing surface inflation and a change in curvature. Locations of transects can be found on Figures 3 and 5. (A) Profiles extracted from 75-Mile Wash surface at transect A-A'. (B) Profiles extracted from 75-Mile Wash surface at B-B'. (C) Profiles from the Monument Creek surface at C-C'. (D) Profiles from the Monument Creek surface at D-D'.

The surface profiles at Monument Creek further illustrate debris-fan aggradation. The 1984 profile reveals a surface that is significantly lower than the more recent surfaces for both transects (Figure 8). Further comparisons reveal a more negative curvature for modern surfaces along the D-D' transect.

The increases in debris-fan elevation are likely to have occurred more recently. Evidence for this lies in the comparison of surface profiles (Figure 8). In every profile, the most recent surface models are the highest overall surface. In addition to the fans increasing in size, they have also changed in form. Early surface models depict a downslope profile have a roughly concave up (positive curvature) shape to it. Most recent profiles show a modification to a concave down (negative curvature) profile. The likely cause of this is a shift of dominant reworking processes. Today, most reworking of fresh debris-flow deposits occurs along the water/debris-fan interface as bank collapse, thus leaving intact the majority of the original deposit. The dominant reworking process before river regulation was natural floods with high stages that would overtop the debris fan, entraining surface particles, in addition to bank reworking. Only the debris fan near the mouth of the tributaries was preserved in form. Not only would this change the concavity but would also lower the surface. Cycles of debris flows and large floods would leave the fan in a relatively stable morphology. Since flow regulation, fans experiencing debris flows have likely not only aggraded as previously suggested [Howard and Dolan, 1981; Webb *et al.*, 1999b] but also changed in form (*i.e.*, more negative concavity).
