## STREAM BANK STABILITY ASSESSMENT IN GRAZED RIPARIAN AREAS

Mark S. Riedel, PhD, Baird & Associates, Madison, WI, [mriedel@baird.com](mailto:mriedel@baird.com); Kenneth N. Brooks, PhD, U. of MN, Forest Resources, St. Paul, MN, [kbrooks@umn.edu](mailto:kbrooks@umn.edu); Elon S. Verry, PhD, Ellen River Partners, Grand Rapids, MN, [sverry@mchsi.com](mailto:sverry@mchsi.com)

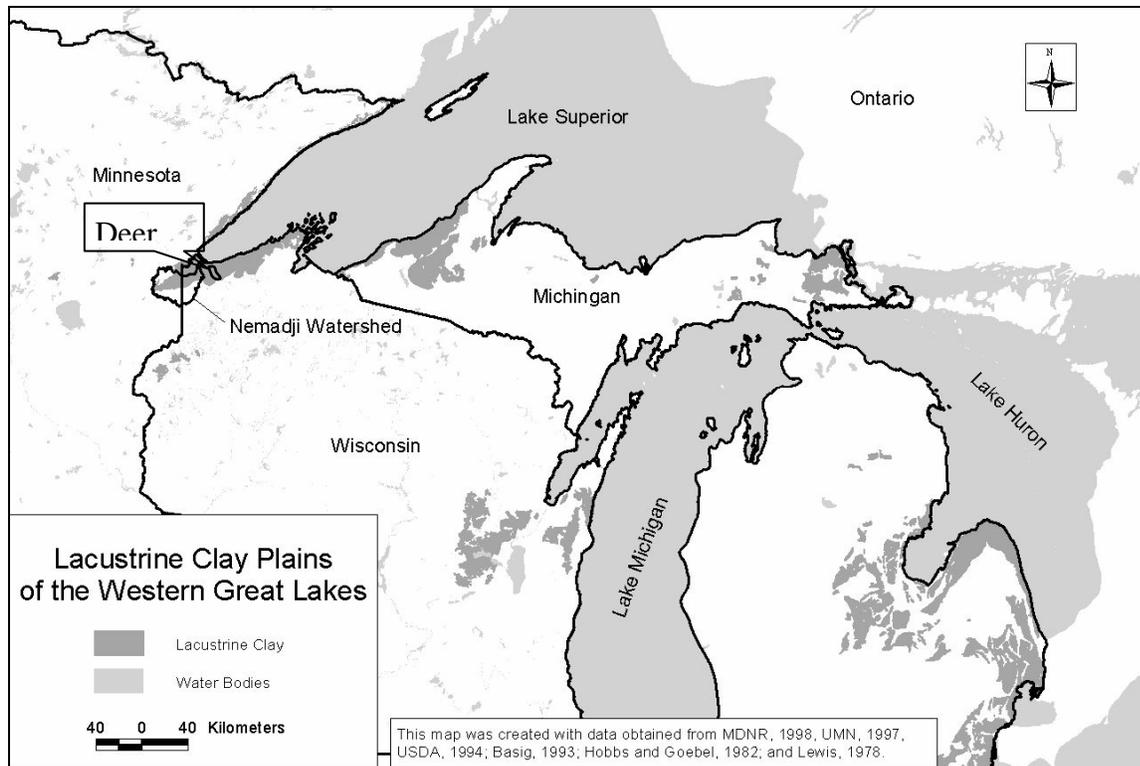
Figure 1 Location of Nemadji Watershed and Lacustrine Clay deposits.

Streams in the Nemadji River Watershed of east central Minnesota and northwestern Wisconsin cut into glacially derived cohesive, lacustrine clay and clay till (Figure 1). This is important

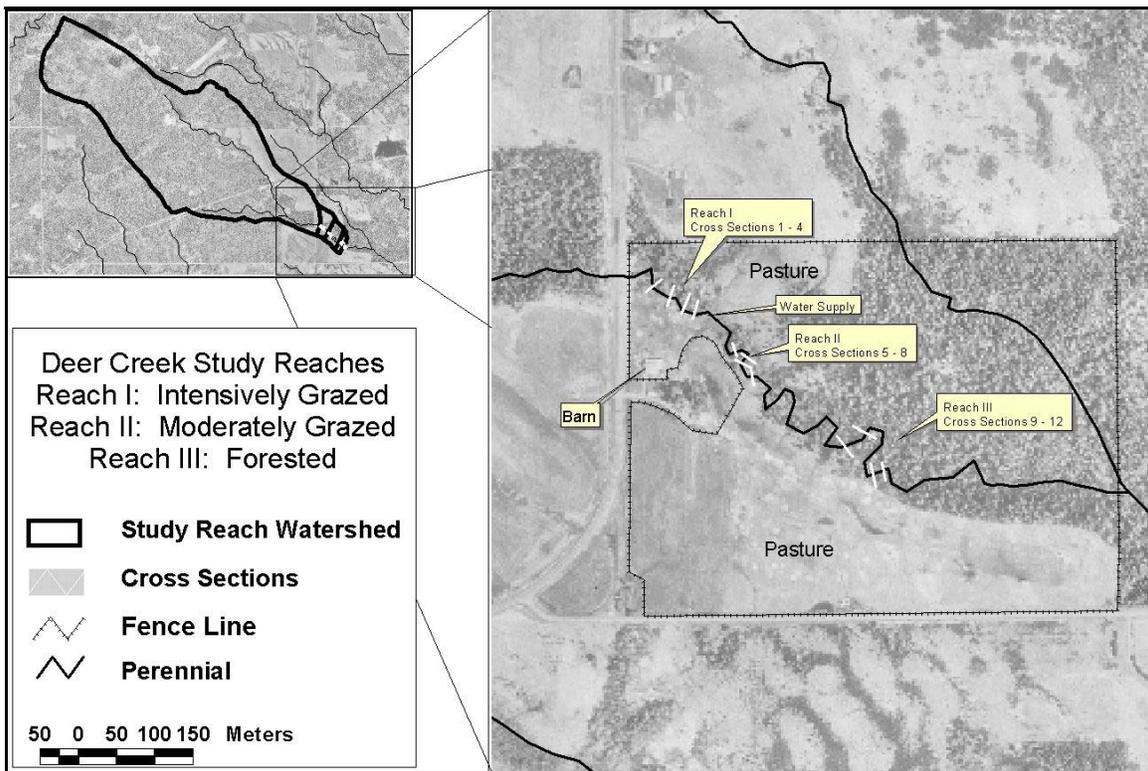
Figure 2 Location of Deer Creek study reaches.

**Site Description:** Three study reaches were installed on Deer Creek (Figure 2). The upstream Reach I (50 m long, 4 cross sections, 3.47 km<sup>2</sup> watershed), separated a barn and adjacent 16 ha pasture. The stream experienced frequent traffic (many times/day) from 40 beef cattle and 25 sheep. Most native cover was gone and streambanks were 20% vegetated with perennial grasses and herbs. Flood plain vegetation consisted of herbaceous plants and perennial grasses, and a 30 % deciduous tree canopy dominated by quaking aspen (*Populus tremuloides*), black ash (*Fraxinus nigra*) and paper birch (*Betula papyrifera*) with diameters ranging from 20 – 50 cm at breast height (dbh).

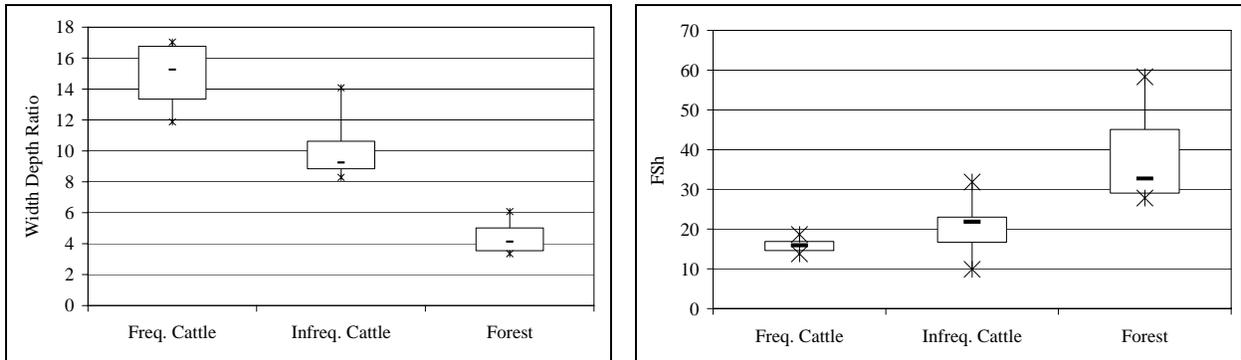
Figure 3 Stem and whisker plots of width depth ratios and mechanistic stream bank stability by reach (n=16/reach) (adapted from Riedel, et al, in review).

Width-depth ratios were largest and stability lowest on grazed reaches (Figure 3).

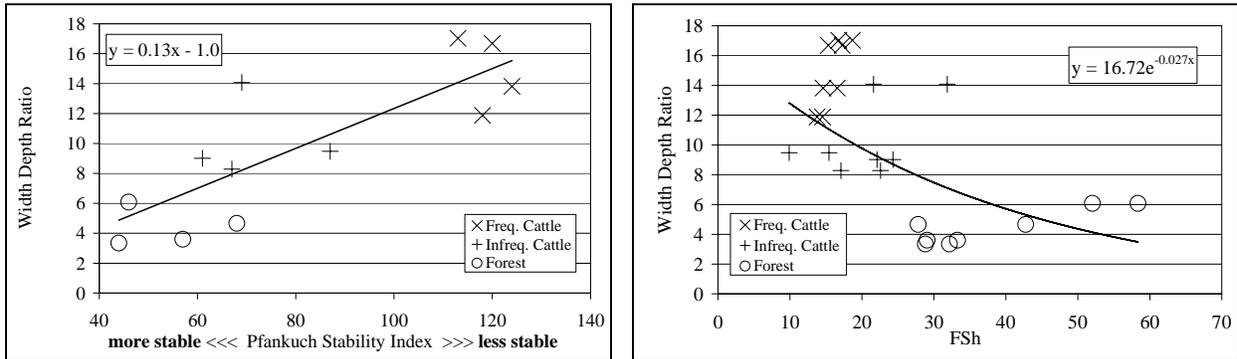
Figure 4 Scatter plots of width depth ratio by PSI and FSh. Note - PSI is inversely related to stability. Upstream / Downstream (dependence) arrangement of sites precludes regression and correlation analyses.

The width-depth ratio of streams increased with PSI (decreasing stability) in the study reaches (Figure 4). Width-depth increased as FSh decreased from forest to cattle sites (Figure 4). While stream banks were fluvially stable, stream beds were generally not stable (Figure 5). Bed stability was near the threshold at the frequent cattle site and declined slightly to the forest site.

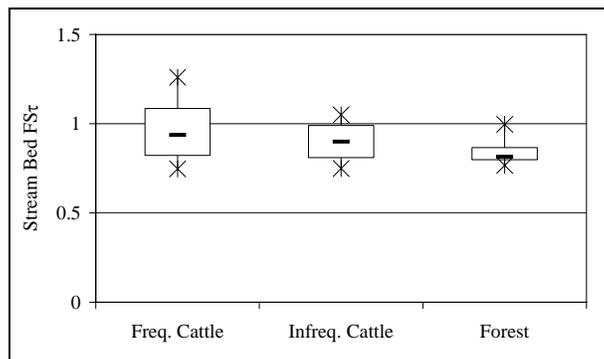
Figure 5 FSt of stream beds for each reach (n=16/reach)

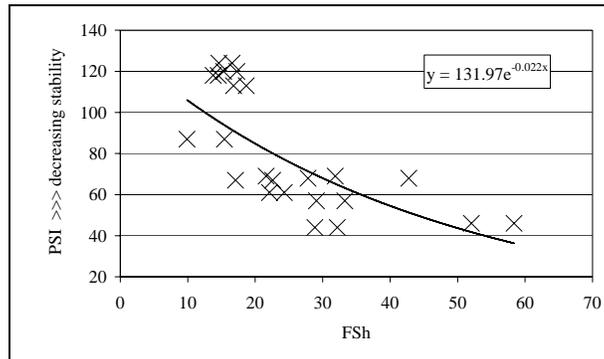
Figure 6 Pfankuch Stability Index (PSI) as related to calculated FSh There are 2 FSh values per reach. Upstream / Downstream (dependence) arrangement of sites precludes regression and correlation analyses.

PSI was inversely correlated to FSh (Figure 6) but independent of stream bed and bank  $FS\tau$ .
