A FARM SEDIMENT TRAP AND POND IN COLUSA COUNTY, CALIFORNIA

**Jack Alderson, Agricultural Engineer, USDA Natural Resources Conservation Service,
Colusa, California, jack.alderson@ca.usda.gov**

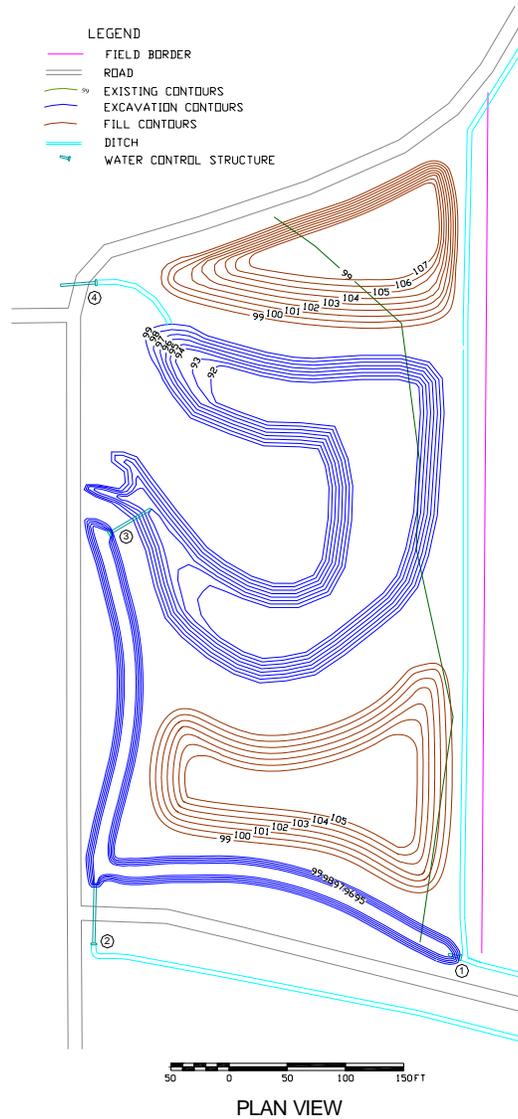
Figure 1 Plan of earthwork.

Within the site, the constructed features are curvilinear. The general nature of the earthwork is shown in Figure 1. We chose these shapes to introduce contrasting elements into the landscape and to suggest natural physiographic forms, but they also have a functional basis. The sediment trap has two long arms that bow out from the road at their centers. Constructing these as relatively narrow, linear channels helps to distribute flow through the full volume of the trap and

allows them to be cleaned from one side by a small excavator. The arc of land between the road and the bowed channel provides space for the sediment to be piled for drying. The two arms of the sediment trap each start at the road where they connect to the existing field ditches. The sediment trap has two curved segments, each 300 feet long with a ten-foot bottom width and four-foot depth. The total excavated volume is 1320 cubic yards and the useable storage volume is 890 cubic yards with a surface area of 9600 square feet.

The primary function of the pond is to provide wildlife habitat, but it also traps sediment, and it too is designed to reduce short-circuit flows between the inlet and outlet without the use of baffles. The shape is from a 1905 topographic map of the area. It is a mirrored and scaled transformation of an oxbow lake along the Sacramento River. The pond was designed with a bottom depth that is seven feet below field level. This depth was chosen to assure a large area of open water. The pond is filled by runoff from winter rains and summer irrigations. Even at low water levels, the depth of water is three to four feet, sufficient to prevent the establishment of emergent vegetation. Emergent vegetation is expected to establish around the perimeter of the pond and especially at the two ends where there are bands with a relatively shallow and fluctuating water depth.

The pond has a flow length of 600 feet. The width varies from less than 30 feet to more than 100 feet. The total excavated volume is 8,700 cubic yards. Filled to a depth one foot below field level, the pond covers one acre and holds 4.8 acre-feet of water.

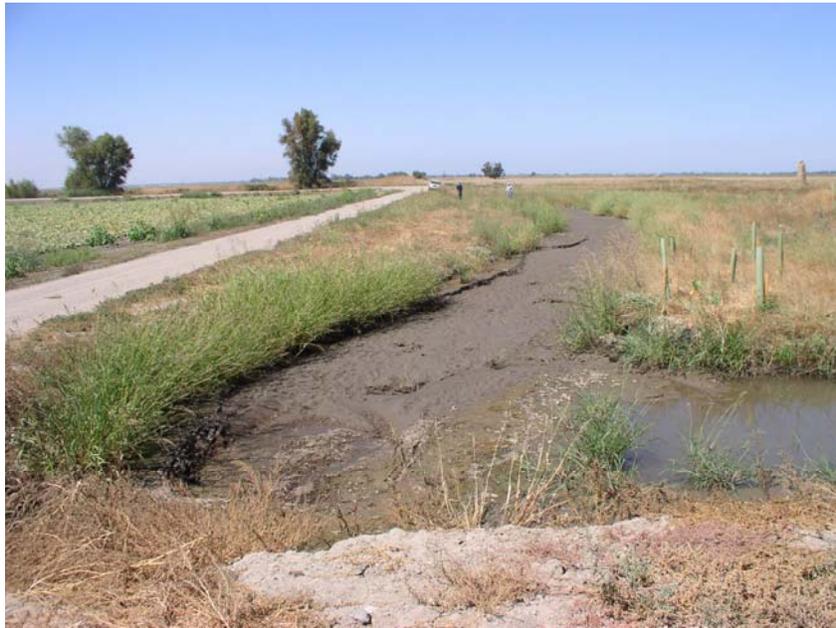
Figure 2 Sediment accumulated in trap.

Near the end of the second growing season after the pond was installed, the landowner reported that there was a danger that the sediment trap would overflow. The trap did not overflow, but by the end of the season the tailwater was running in rivulets over the top of an accumulated mass of sediment. Figure 2 is a photo of the trap at the end of the growing season. The bulk of the sediment came from a tomato field that drained into the downstream arm of the trap. Erosion was evident in the tailwater ditch at the end of this field and in the ends of the furrows where head cutting had occurred. Winter wheat had been grown in this field the previous year, and there had been no evidence of erosion in the field or of sediment accumulation in the trap.

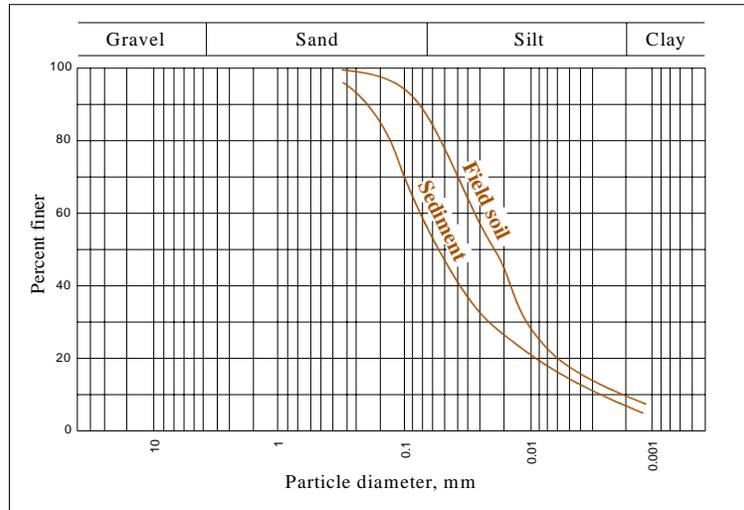
Figure 3 Particle size distributions for field soil and for sediment from the sediment trap.

At the end of the second growing season, we resurveyed the sediment trap to determine how much sediment had accumulated. We also took samples for determining the bulk density and particle size distribution of the sediment and the particle size distribution of the field soil. Four hundred and fifty cubic yards of sediment with an average bulk density of 79 pounds per cubic feet, or 480 tons of sediment, accumulated in the two arms of the sediment trap during the two year period. Figure 3 shows the particle size distributions for the sediment and for the field soil, a silt loam. Based on the difference between the sand fraction of the sediment compared to that of the field soil, the estimated trap efficiency was 23 percent, and the estimated sediment delivery from the fields was 2100 tons. The sediment production is 4.6 tons per acre averaged over the two-year period and the full 230 acres draining into the sediment trap. However, approximately two-thirds of the sediment was delivered from a single 85-acre tomato field during one growing season, a production rate of 16 tons per acre.

One reason for the low trap efficiency is that the arm of the trap that captured the most sediment filled. The Yolo County Resource Conservation District (2002) used inlet and outlet water samples to study sediment trap efficiency. They found that efficiency declined during the season as the trap filled. Mid-season efficiencies varied from 33 to 55 percent in their study. There is relatively little guidance available for sizing sediment traps for agricultural operations where sediment is generated by irrigation water rather than stormwater. The California Regional Water Quality Control Board, San Francisco Bay Region (1999) suggests a general method for sizing silting basins and sediment traps based on flow and the particle size to be trapped. For the Colusa site, the maximum anticipated tailwater flow would be three cubic feet per second, and a sediment trap with 15,000 square feet of area would be required to remove fine silt (0.01 millimeter particle size). This is larger than the useable area of the empty sediment trap, but only about one-third the size of the pond downstream of the sediment trap.
