Clark, Jeffrey J., 1992, Analysis of sediment storage changes of the Colorado River near Nankoweap Rapids in Grand Canyon, Arizona: Unpublished senior thesis, Middlebury College, Middlebury, Vermont, 95 p.

## ABSTRACT

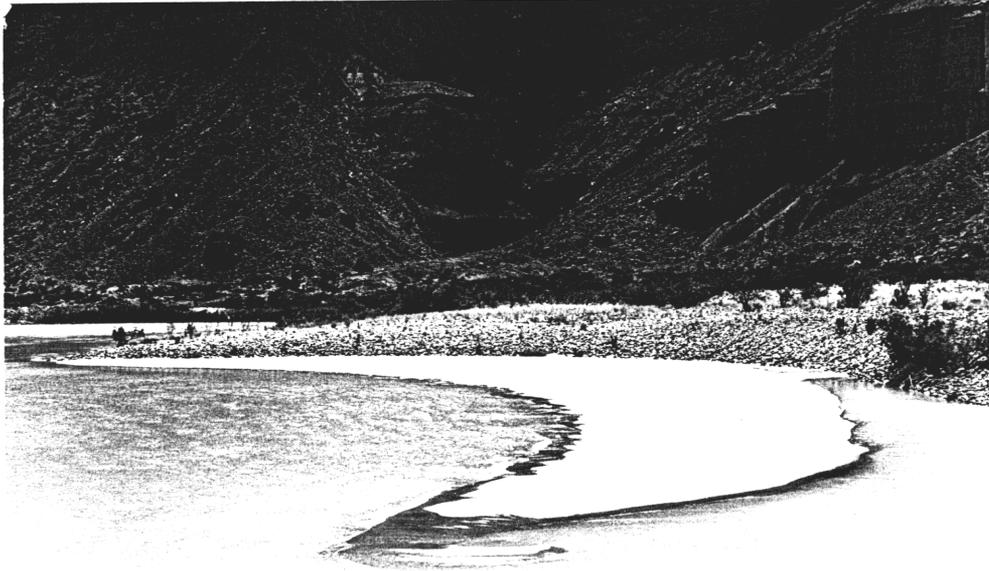
Figure 19a.--Active reattachment bar in a small eddy upstream from Lower Nankoweap beach. Note the eddy return channel and cobble bar.

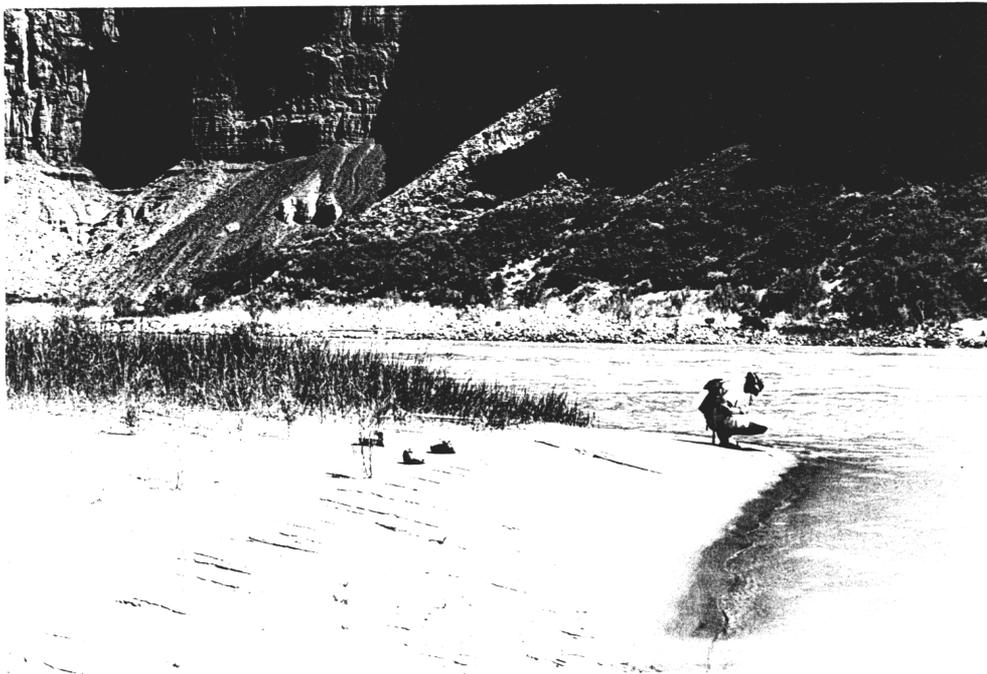
Figure 19b.--Separation bar downstream of Lower Nankoweap beach. The active region has no vegetation.

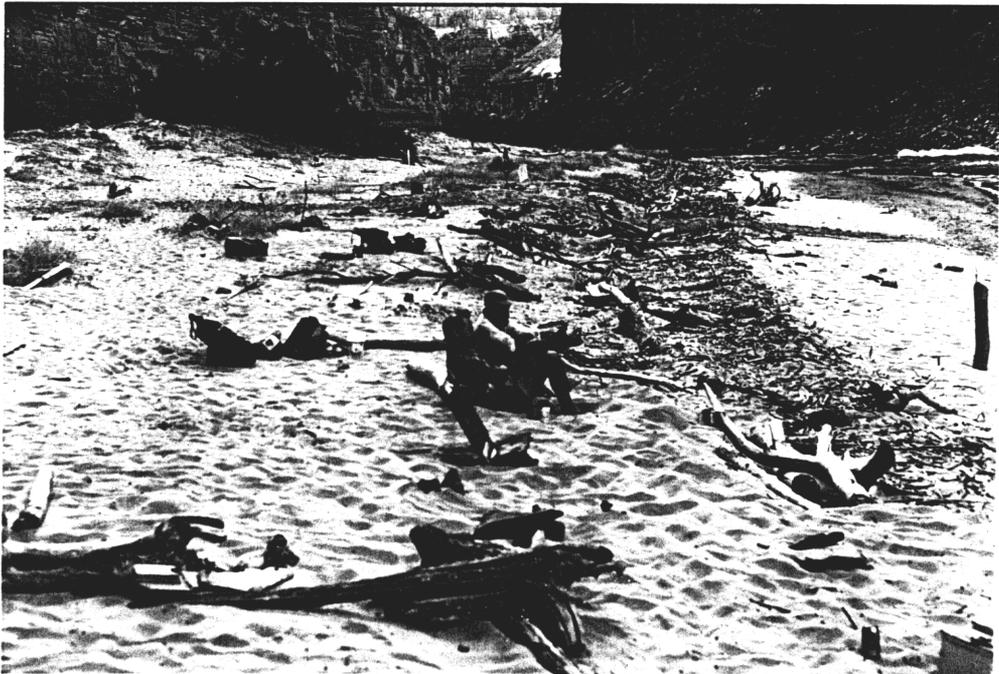
Figure 21b.--View upstream of Fern Glen beach, a large separation bar. The debris line marks the extent of the active unit.
