FINAL REPORT

**Daily Dynamics of Grand Canyon Sandbars;
Monitoring With Terrestrial Photogrammetry**

Department of Geography
Northern Arizona University
Box 15016
Flagstaff, Arizona 86011

Sponsored by the
U. S. Department of the Interior
National Park Service
Cooperative Agreement # CA 8000-8-0002

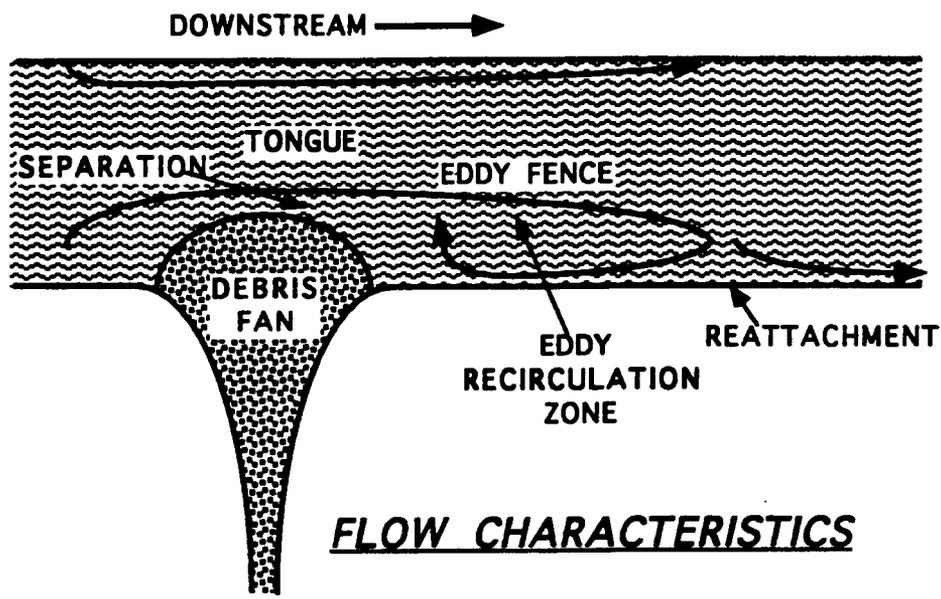
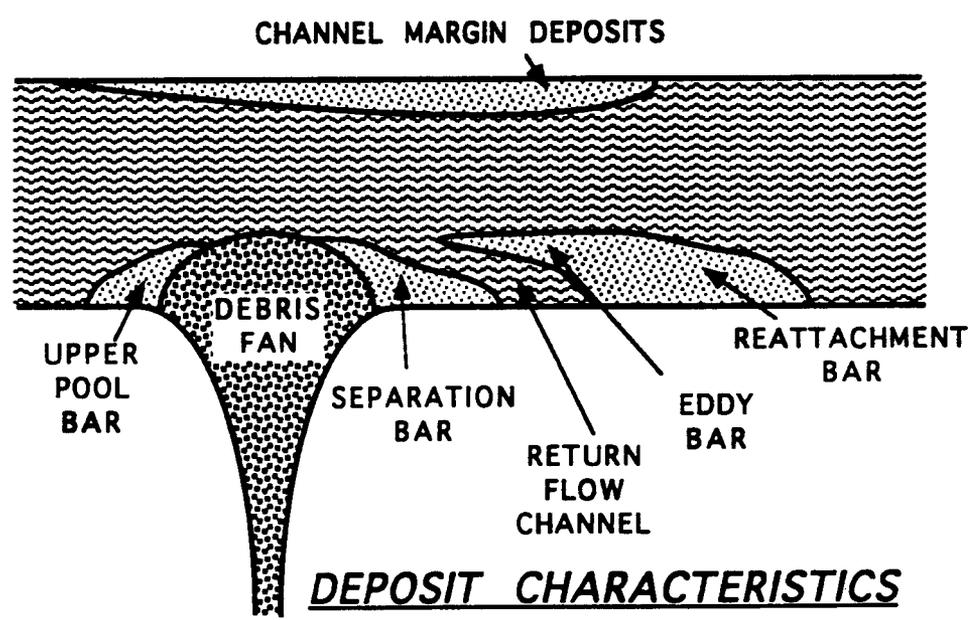
Fig. 1. The top panel illustrates the major hydraulic components of a Grand Canyon rapid and the bottom panel illustrates the resulting alluvial deposits shown at low water.

The usual resulting sandbars are shown under low-stage conditions in Figure 1. Sandbars typically are found along the upstream face of channel constrictions (upper pool bars), along the downstream face of channel constrictions (separation bars), in the quiet water of the eddy center (eddy bars), and at the stagnation zone of the flow attachment (reattachment bars). Zones of low velocity are most commonly associated with debris deposits that form where tributaries and minor side channels introduce large quantities of particles of sizes not readily mobilized by the normal range of discharges. Uncommon depositional environments include point bars on the inside of meanders and thin channel margin sandbars between outcrops of bedrock or large boulders.

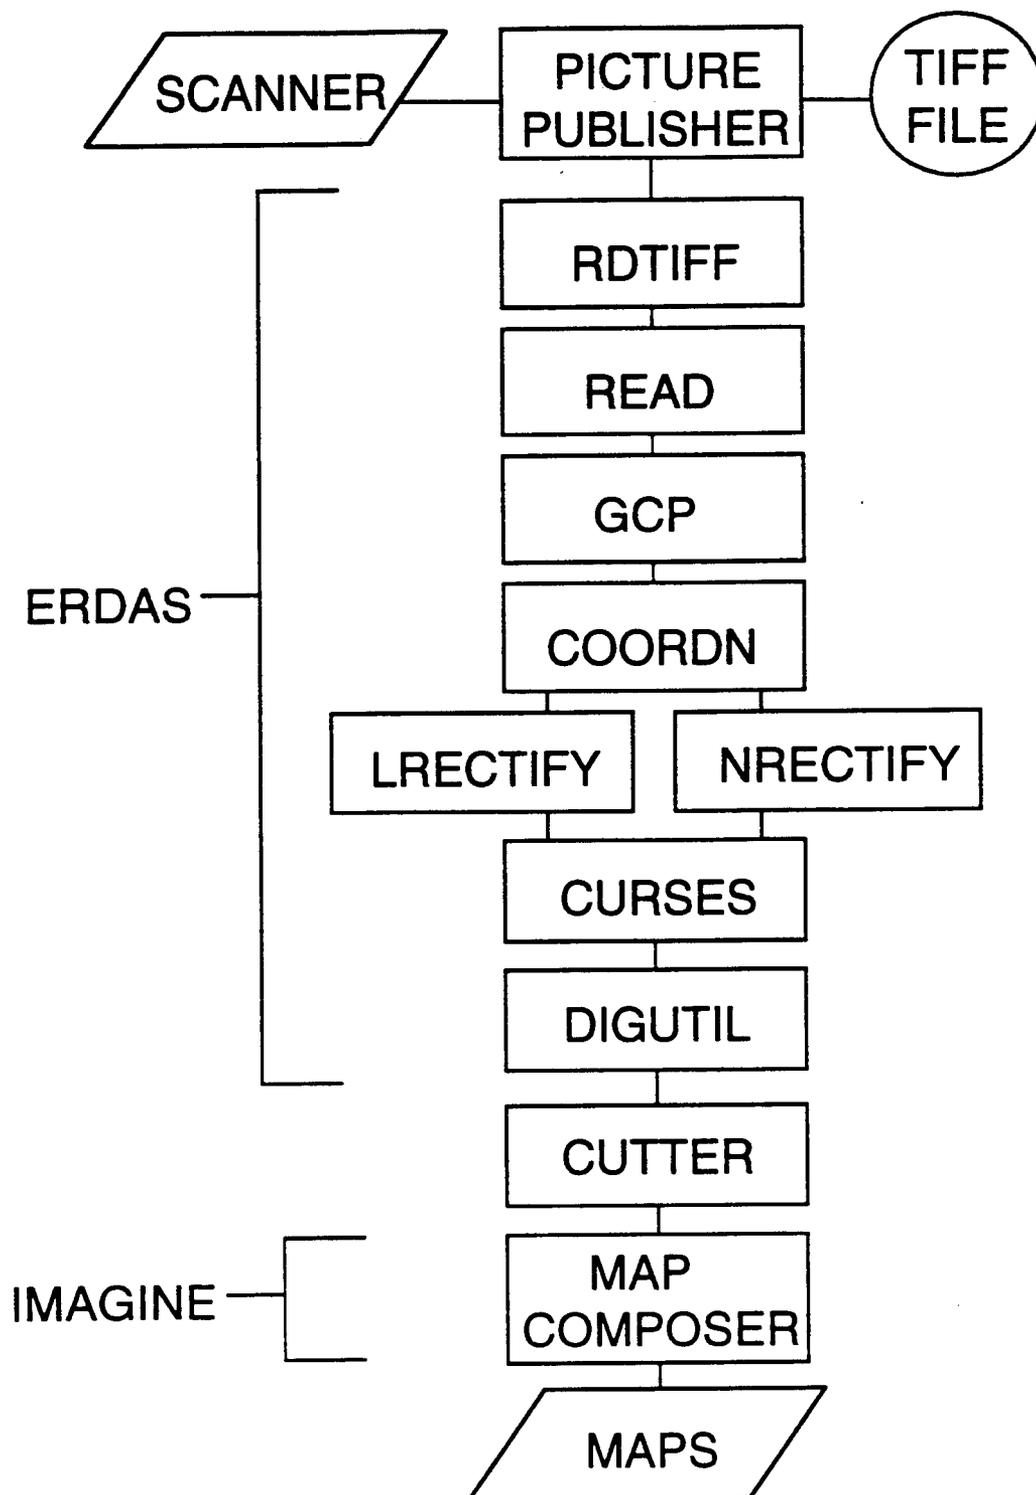
Fig. 4. Major image processing procedures and modules used in this study.

Film was processed conventionally and left in strips to facilitate scanning. A high resolution Nikon LS-3510AF[®] film scanner was used to convert the analog image to digital form. The digital Tagged Image Format File (TIFF) created by the scanner was controlled using Picture Publisher[®] software. The image was imported into ERDAS V.7.5[®] for image rectification and analysis (Figure 4; ERDAS 1992).

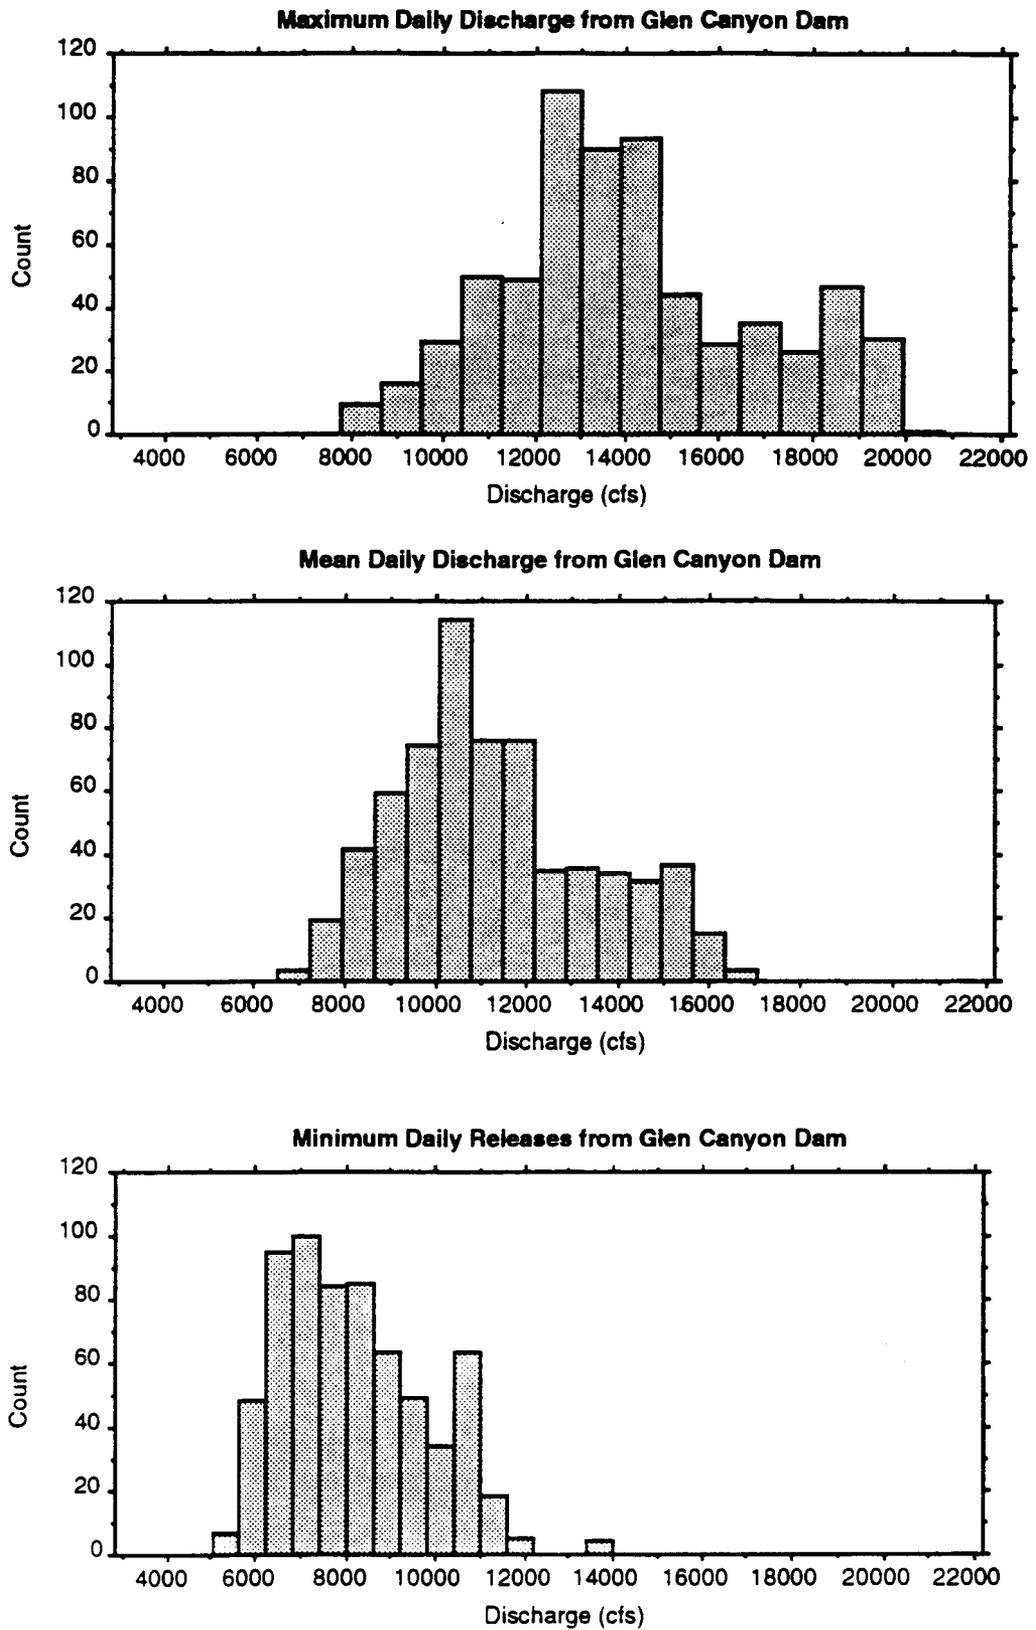
Fig. 8. Frequency distributions of maximum, mean and minimum discharge from Glen Canyon Dam, March 15, 1992 through December 31, 1993.

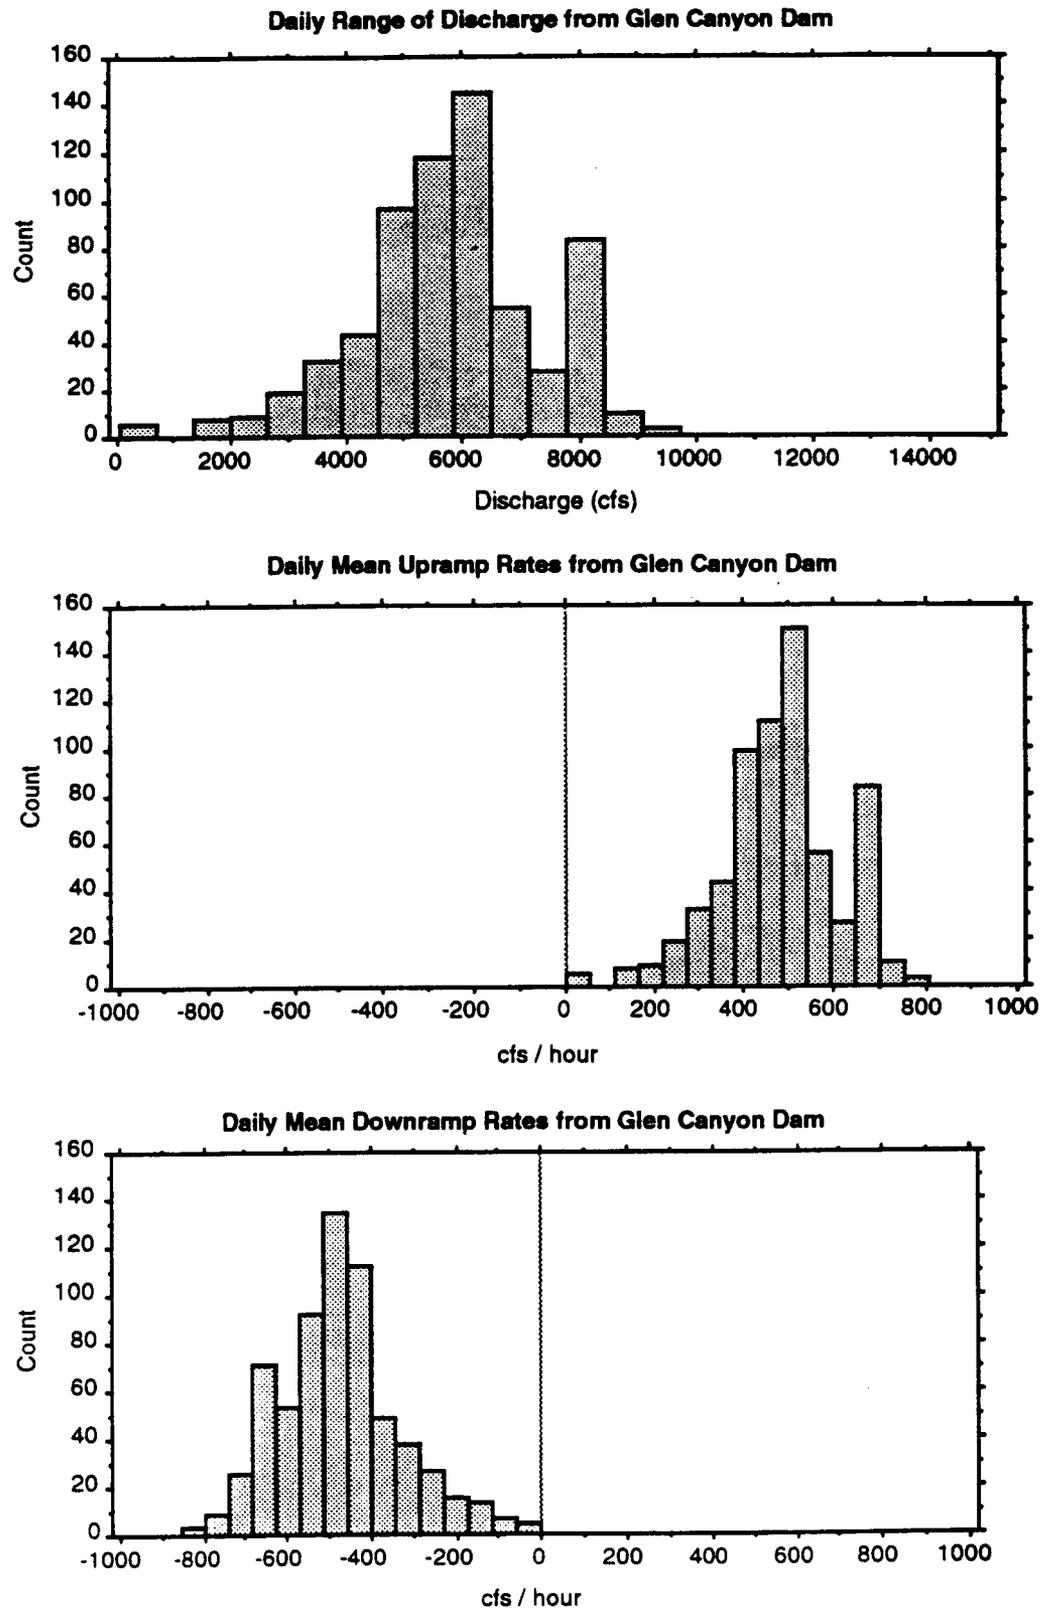
Fig. 9. Frequency distributions of discharge range and mean ramping rates from Glen Canyon Dam, March 15, 1992 through December 31, 1993.

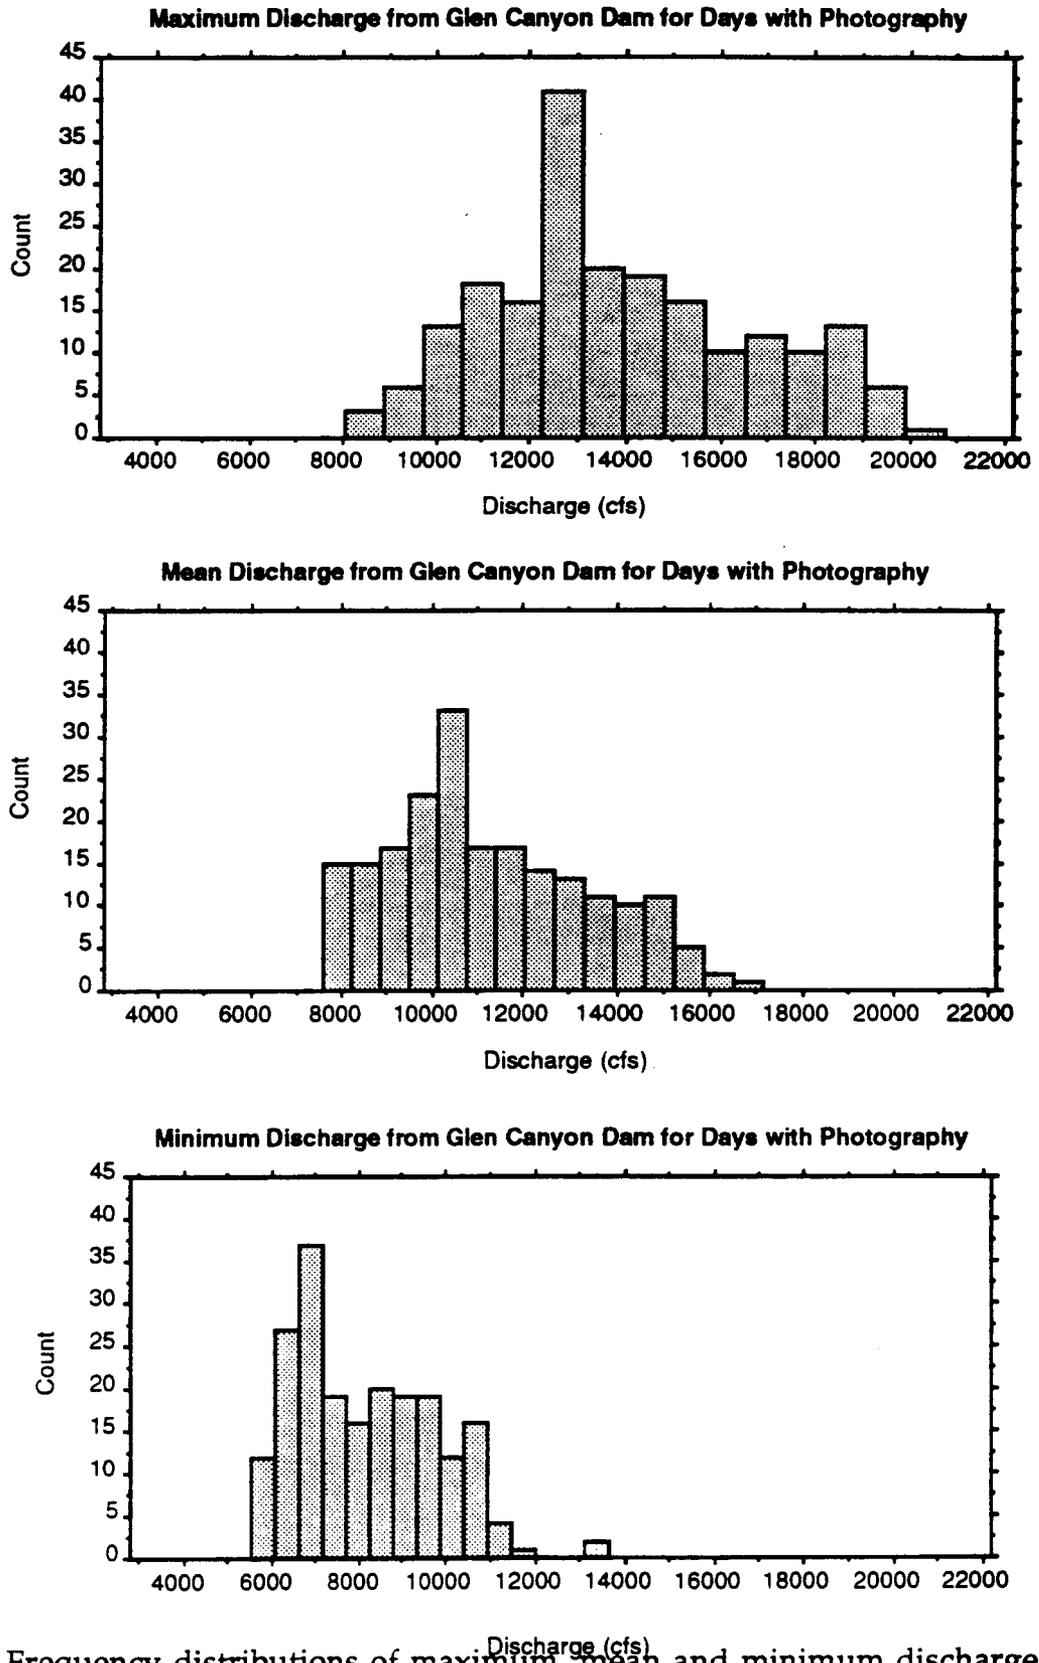
Fig. 10. Frequency distributions of maximum, mean and minimum discharge from Glen Canyon Dam for all days with rectified imagery from March 15, 1992 through December 31, 1993.

Figure 10 indicates maximum, mean and minimum daily discharge frequency for all days where oblique photography was rectified. The similarity in frequency distributions suggests we have area estimates from a representative set of flow conditions.

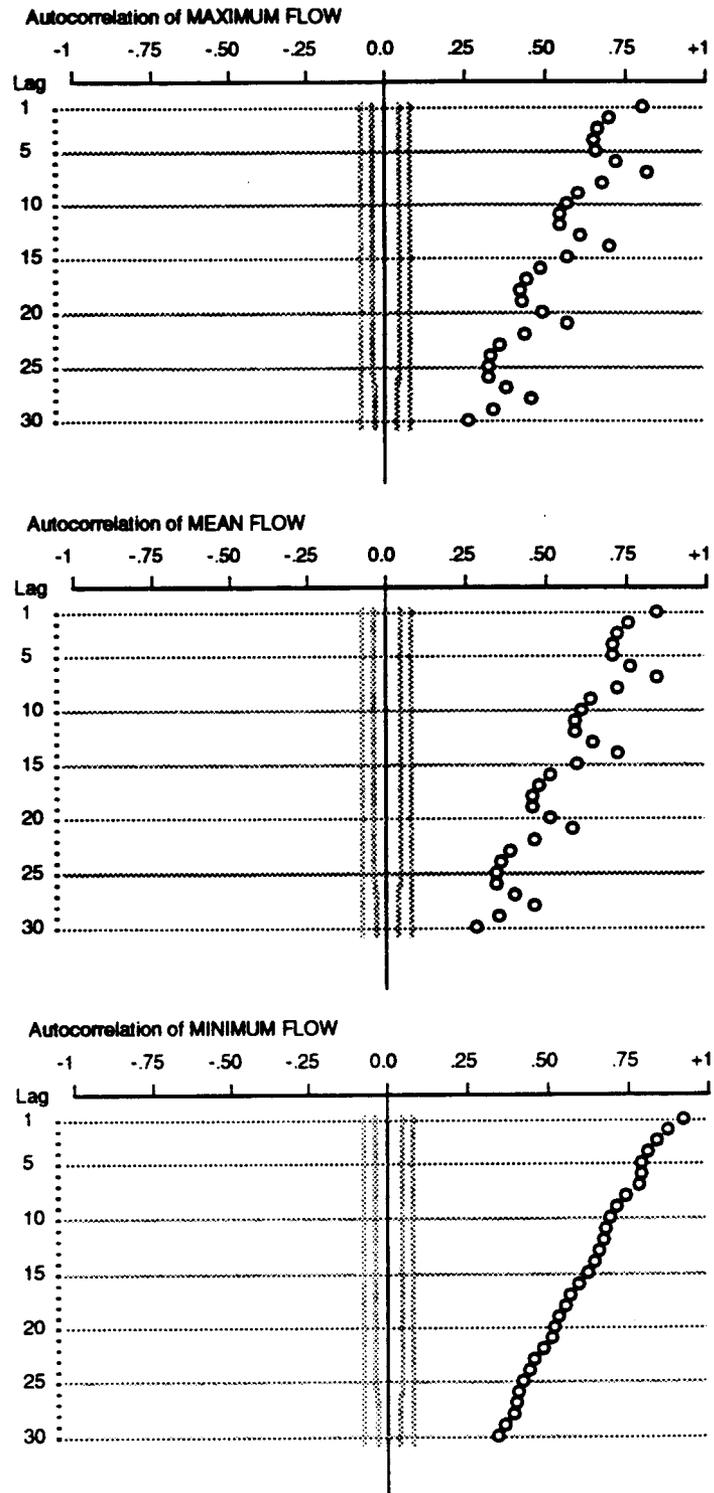
Fig. 11. Correlograms (autocorrelation plots) of maximum, mean and minimum discharge from Glen Canyon Dam, March 15, 1992 through December 31, 1993. The positive peak at the seven day lag (and subsequent seven day harmonics) shows the periodicity introduced by weekend low flows.

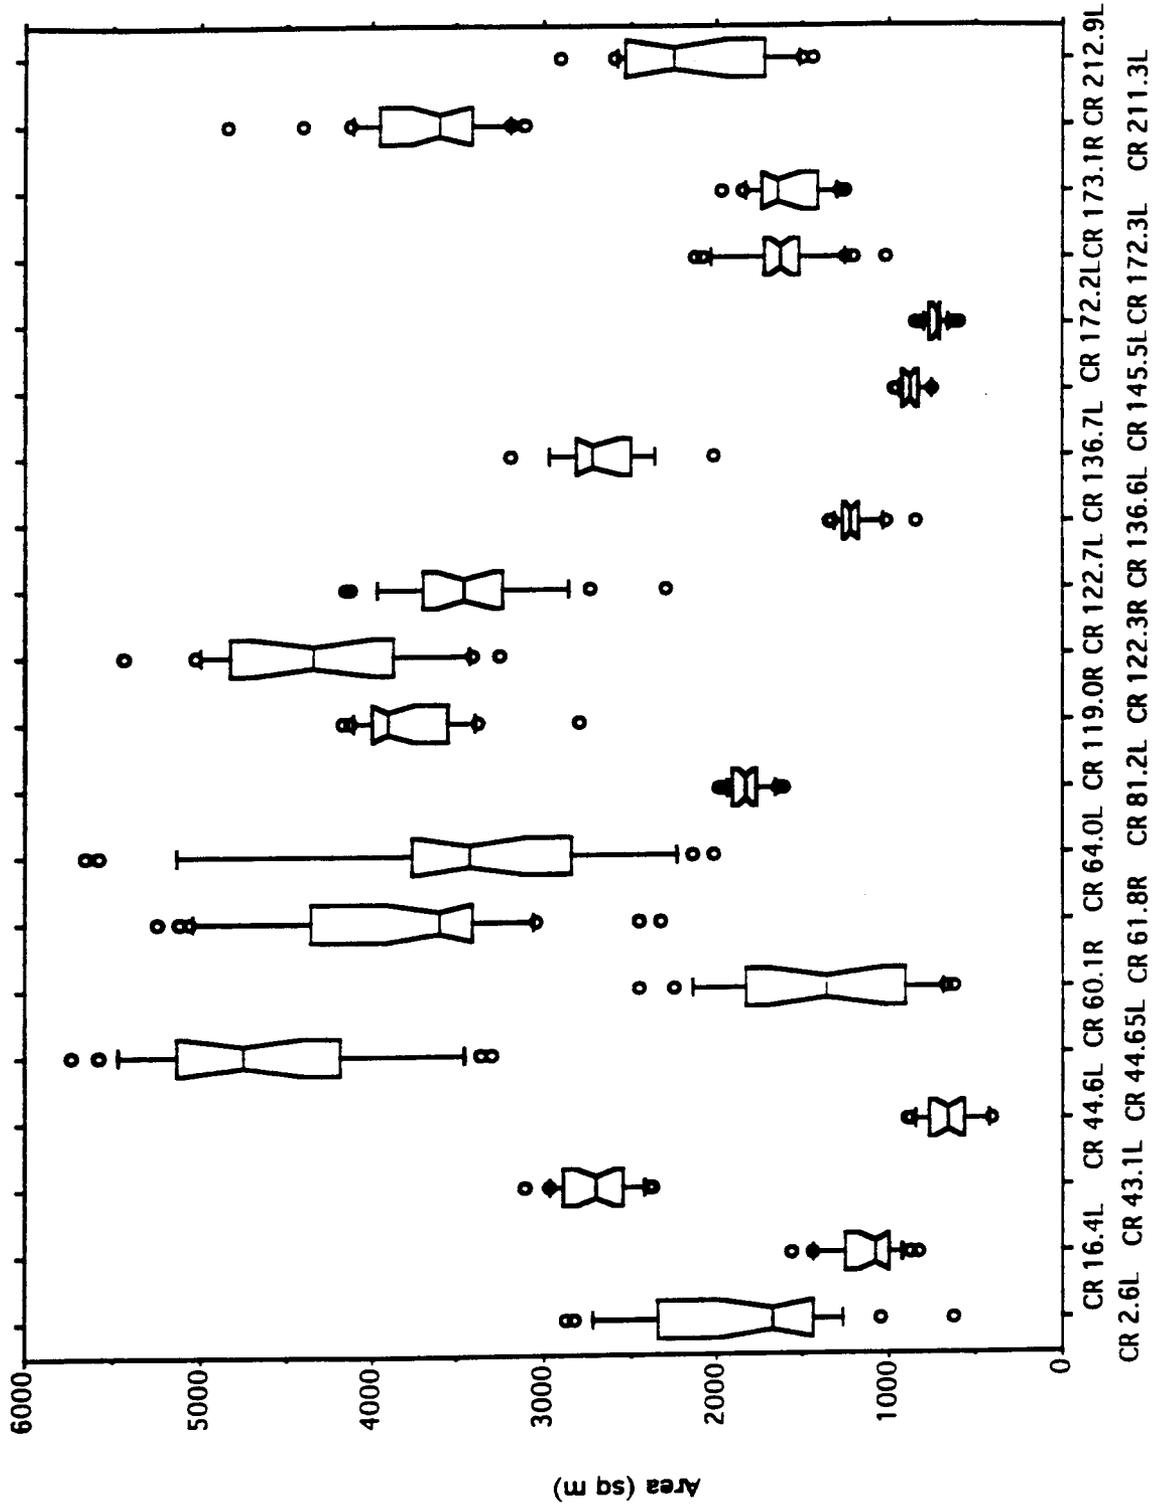
Fig. 55. Box and whisker plots of sandbar area value distribution. The line at the waist of the box is the median, the top of the box is the 75th percentile, the bottom of the box is the 25th percentile, the top whisker is the 90th percentile and the bottom whisker is the 10th percentile. Dots represent individual extreme values. True horizontal axis scale is not implied.

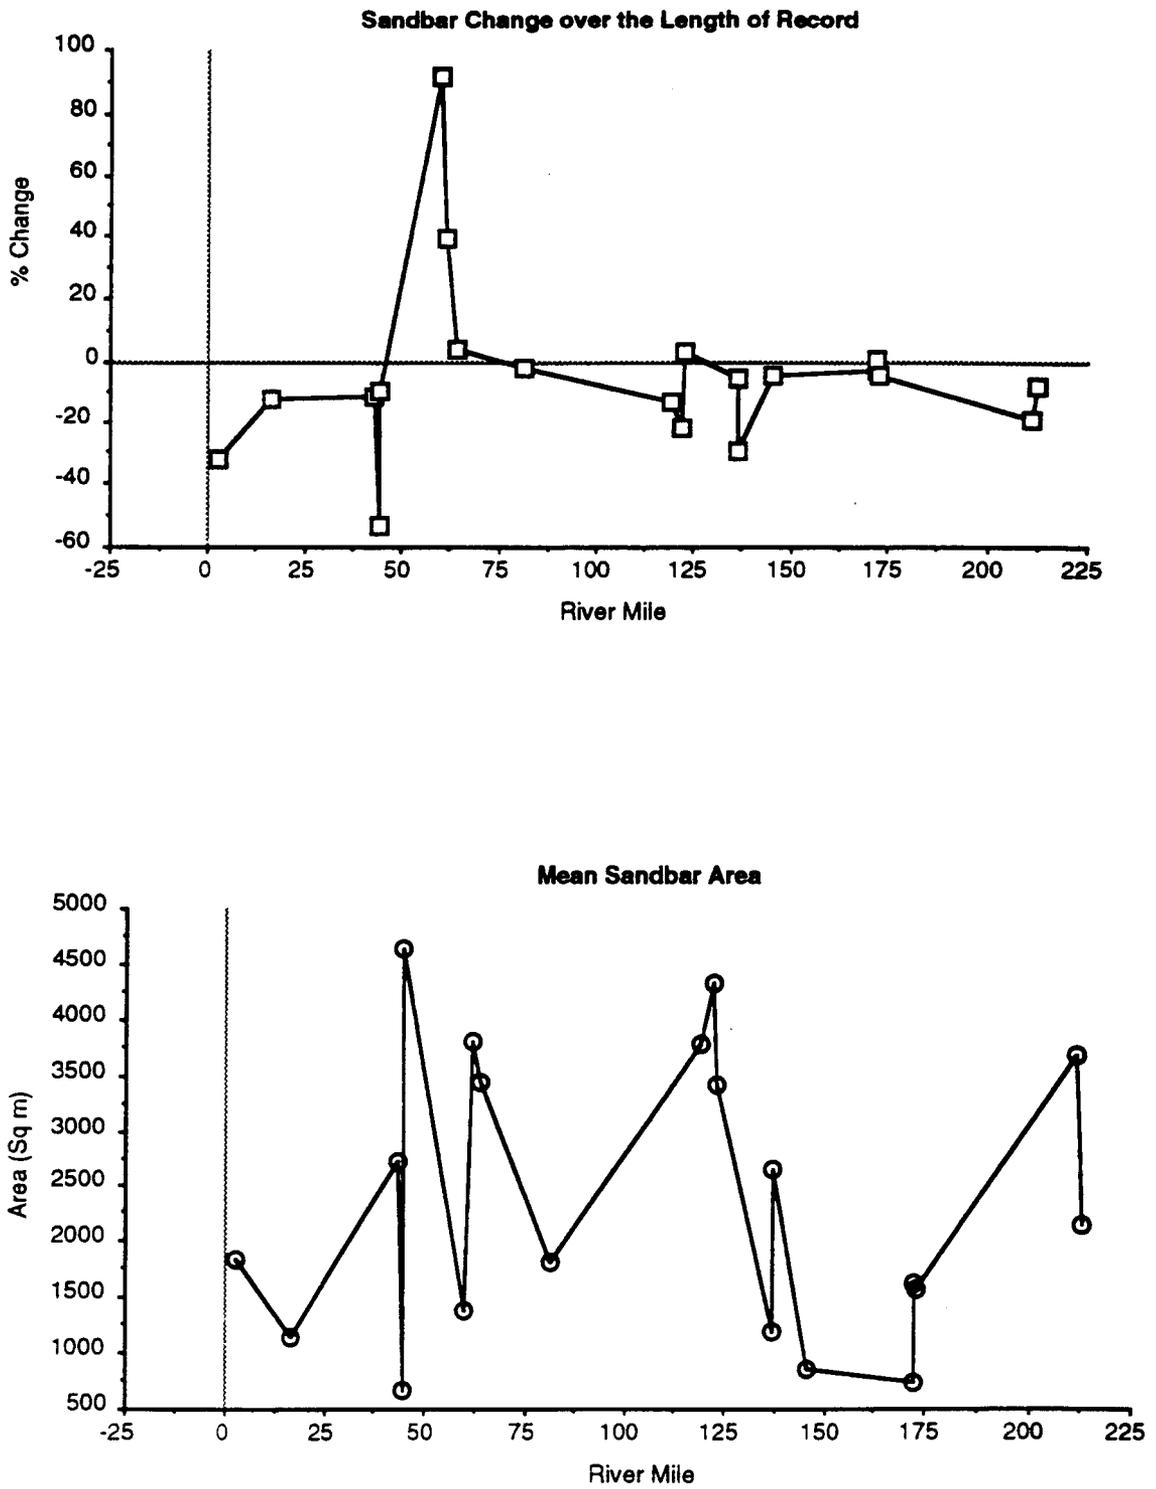
Fig. 56. Relationship between river mile and percent change in area (top) and river mile and mean sandbar area (bottom).

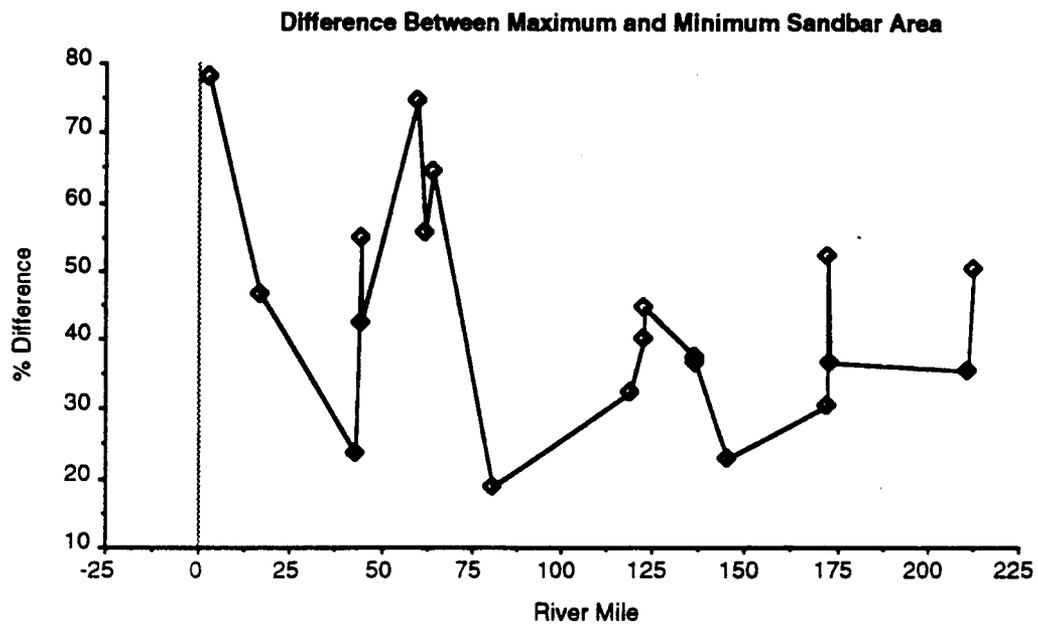
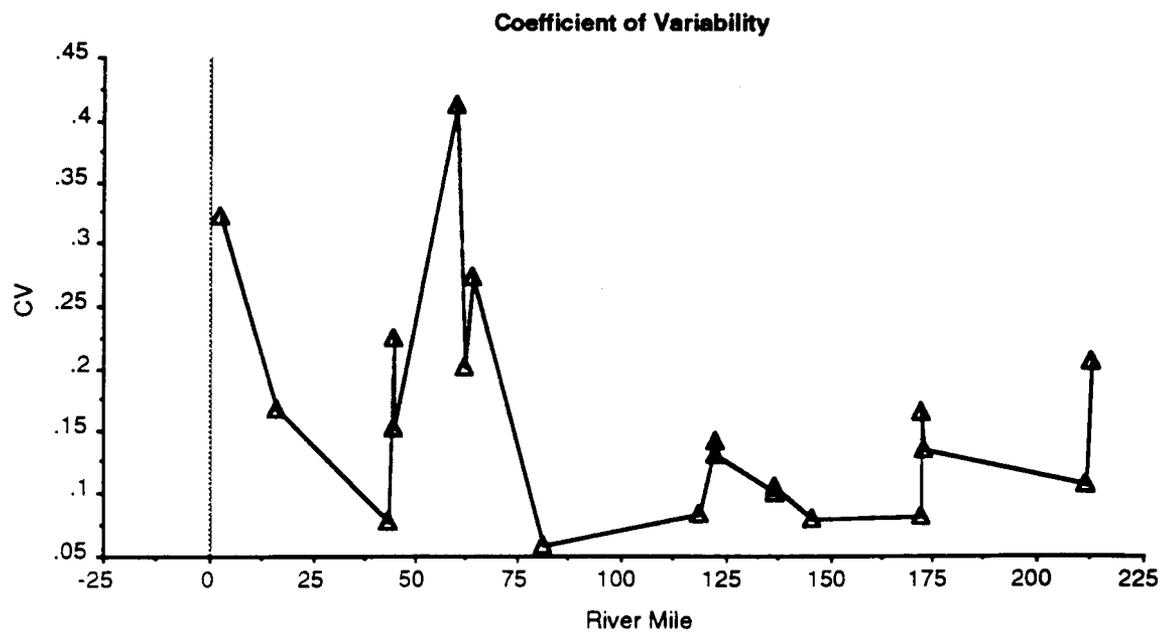
Fig. 57. Relationship between river mile and difference in area (top) and river mile and coefficient of variability (bottom).

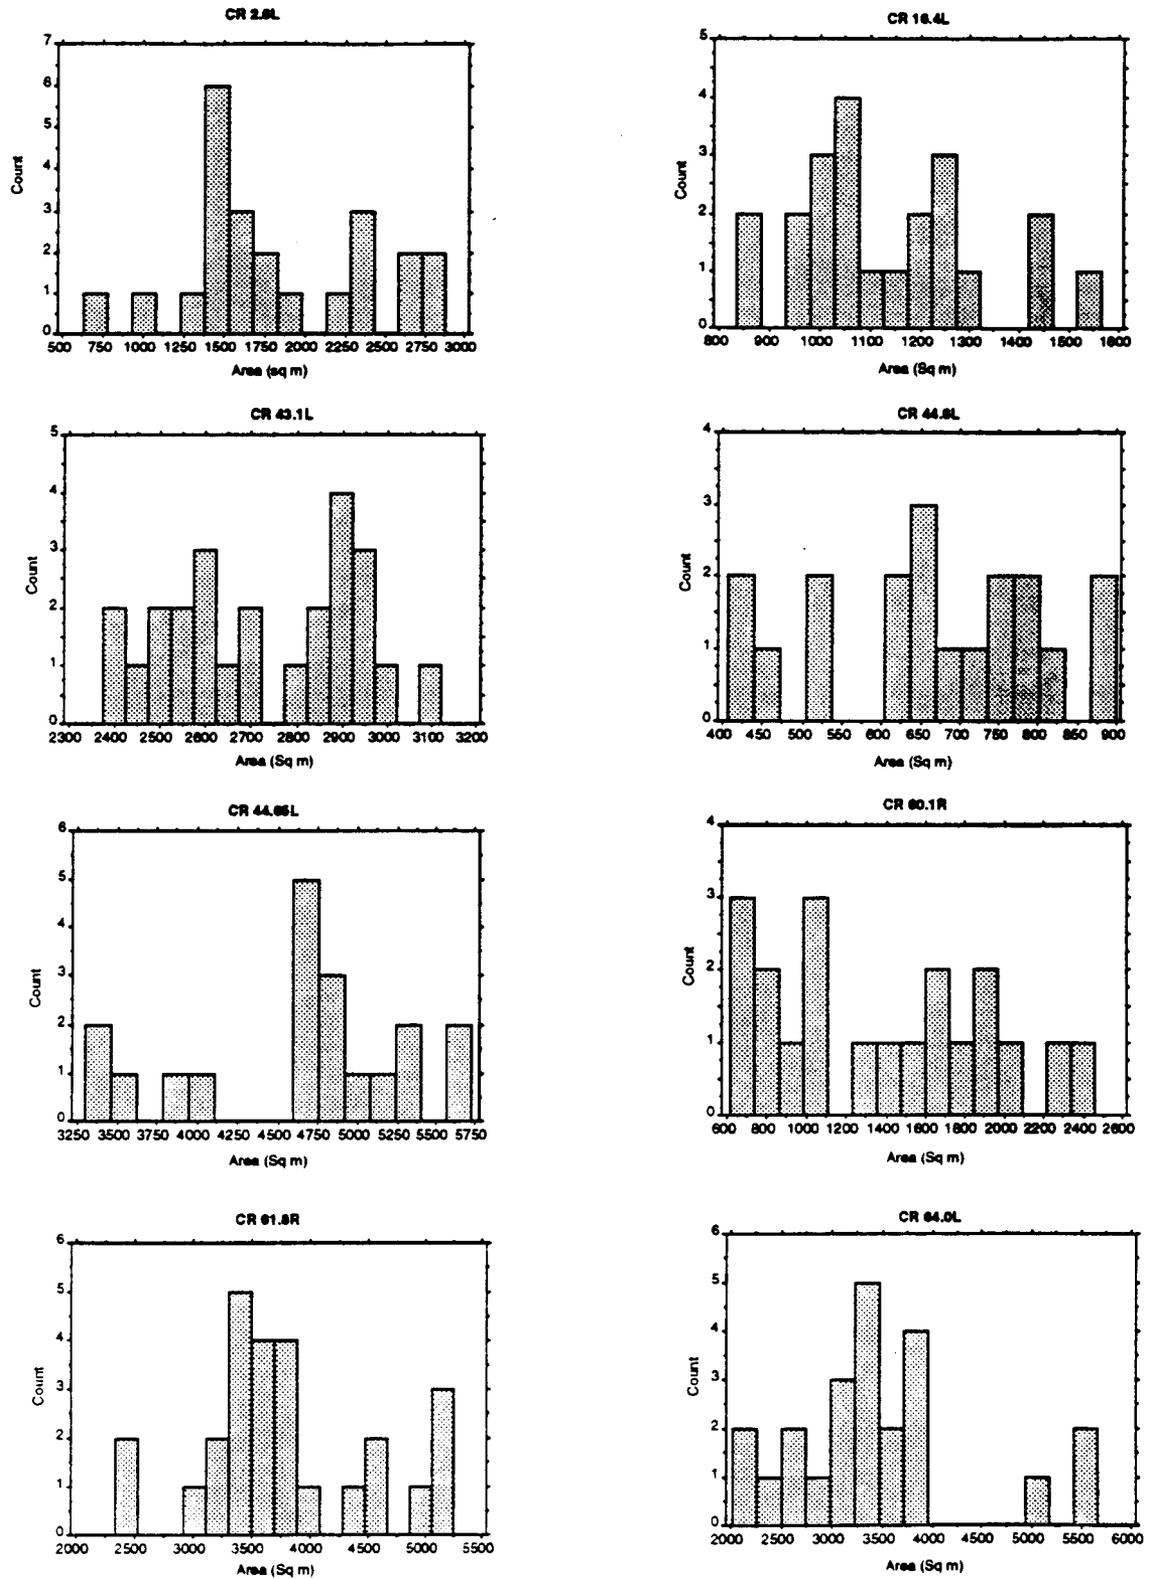
Fig. 58. Composite figure of frequency distributions for the twenty rectified sandbars, March 15, 1992 through December 31, 1993.

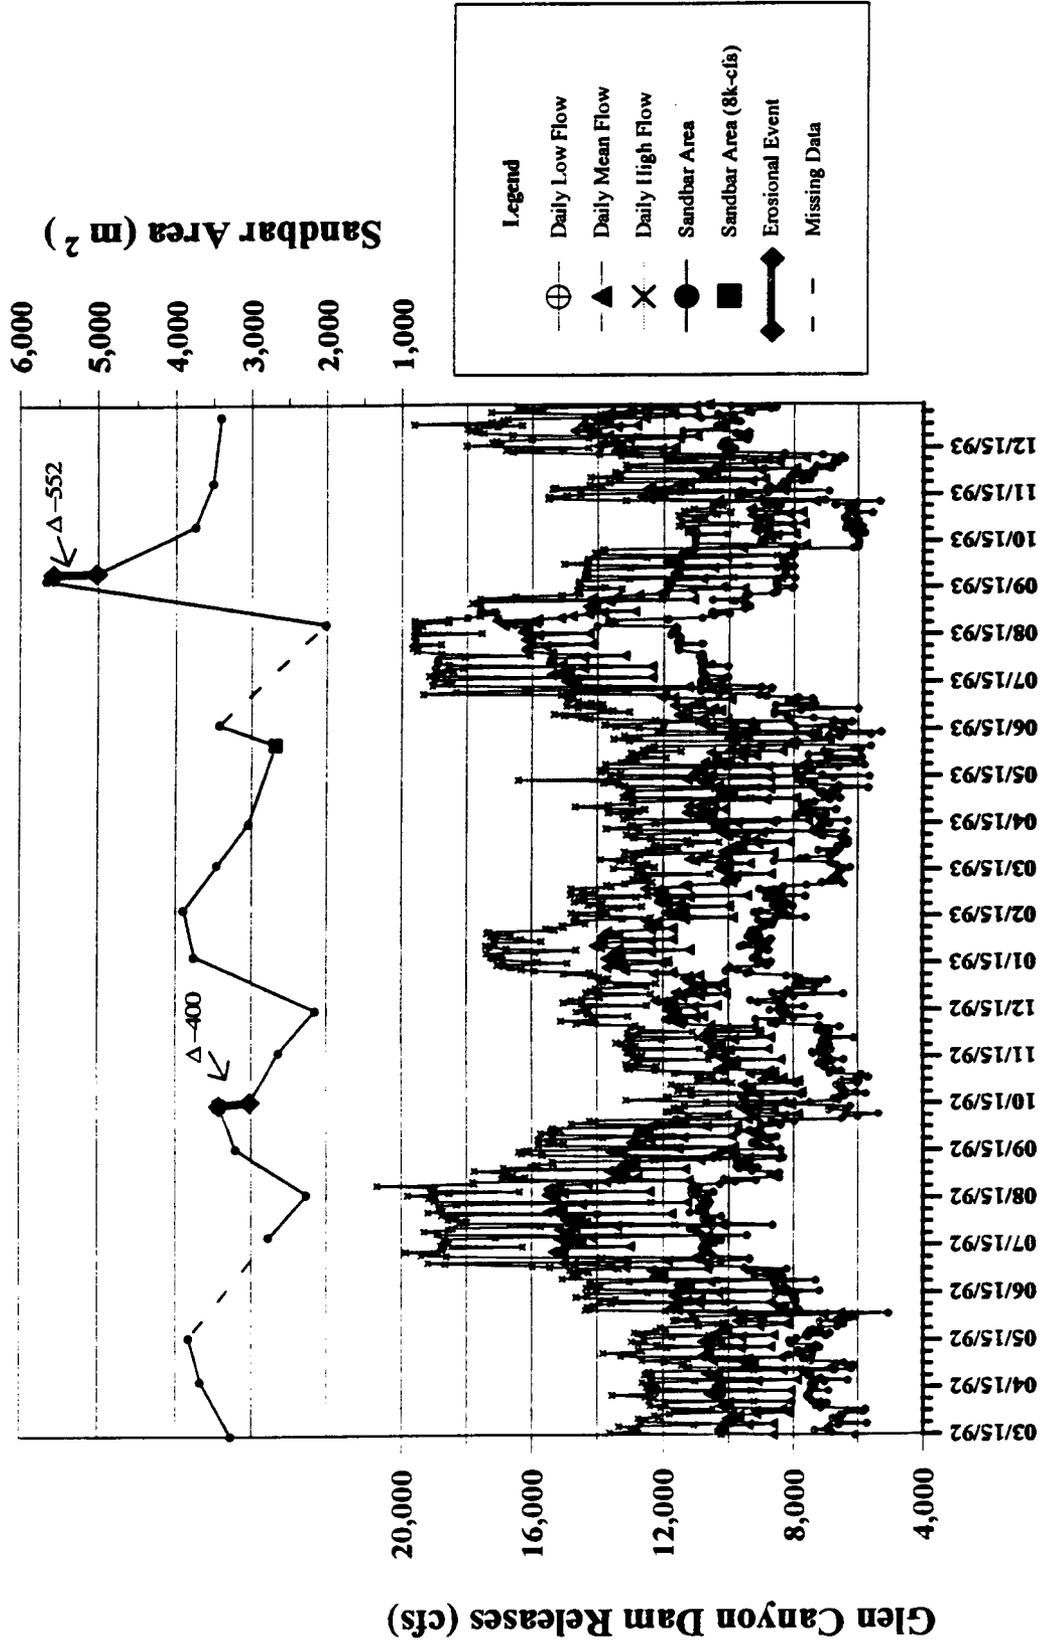
64.0L

Fig. 67. Time-series plot showing area and discharge for sandbar 64.0L.

The next sandbar downstream of the LCR is 64.0L. This site responded similarly to 61.8R in that aggradation was measured coincident with the LCR flood but degradation followed within two months (Figure 67 and 93). Aggradation resumed when mainstem discharges reached summer maximums and the greatest area was measured in September 1993.

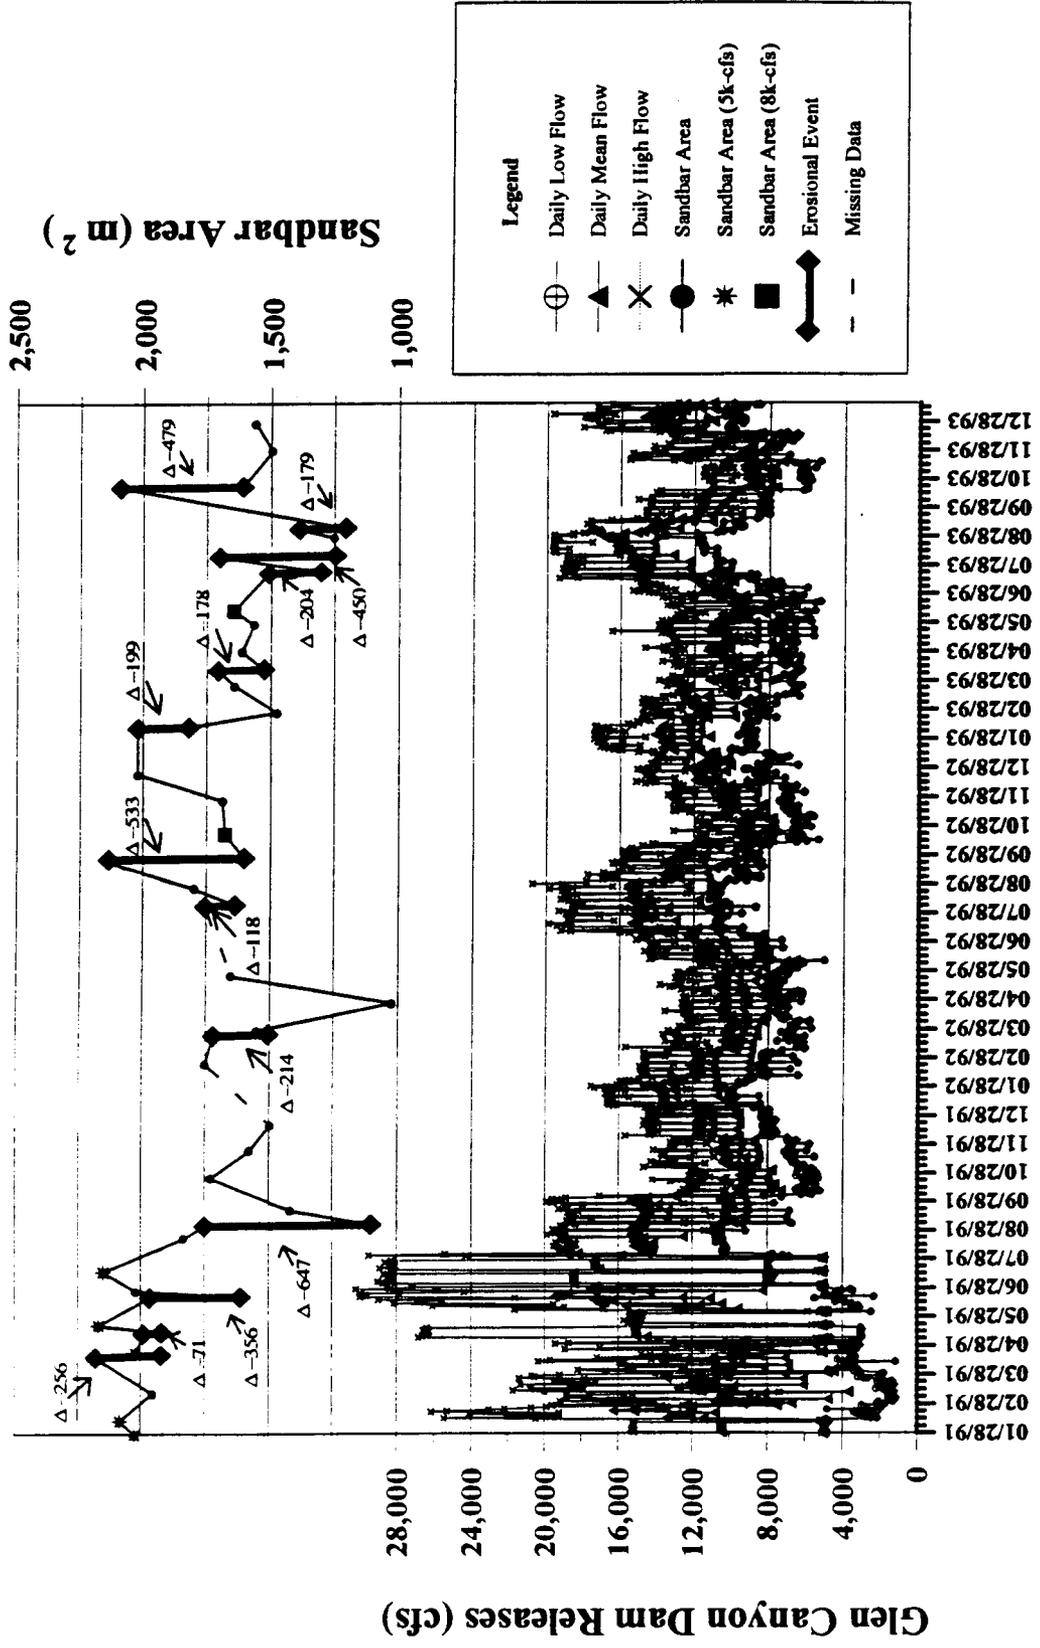
172.3L

Fig. 76. Time-series plot showing area and discharge for sandbar 172.3L. This plot includes a longer record than the other time-series plots. Test flows end and interim flows begin in July 1991.

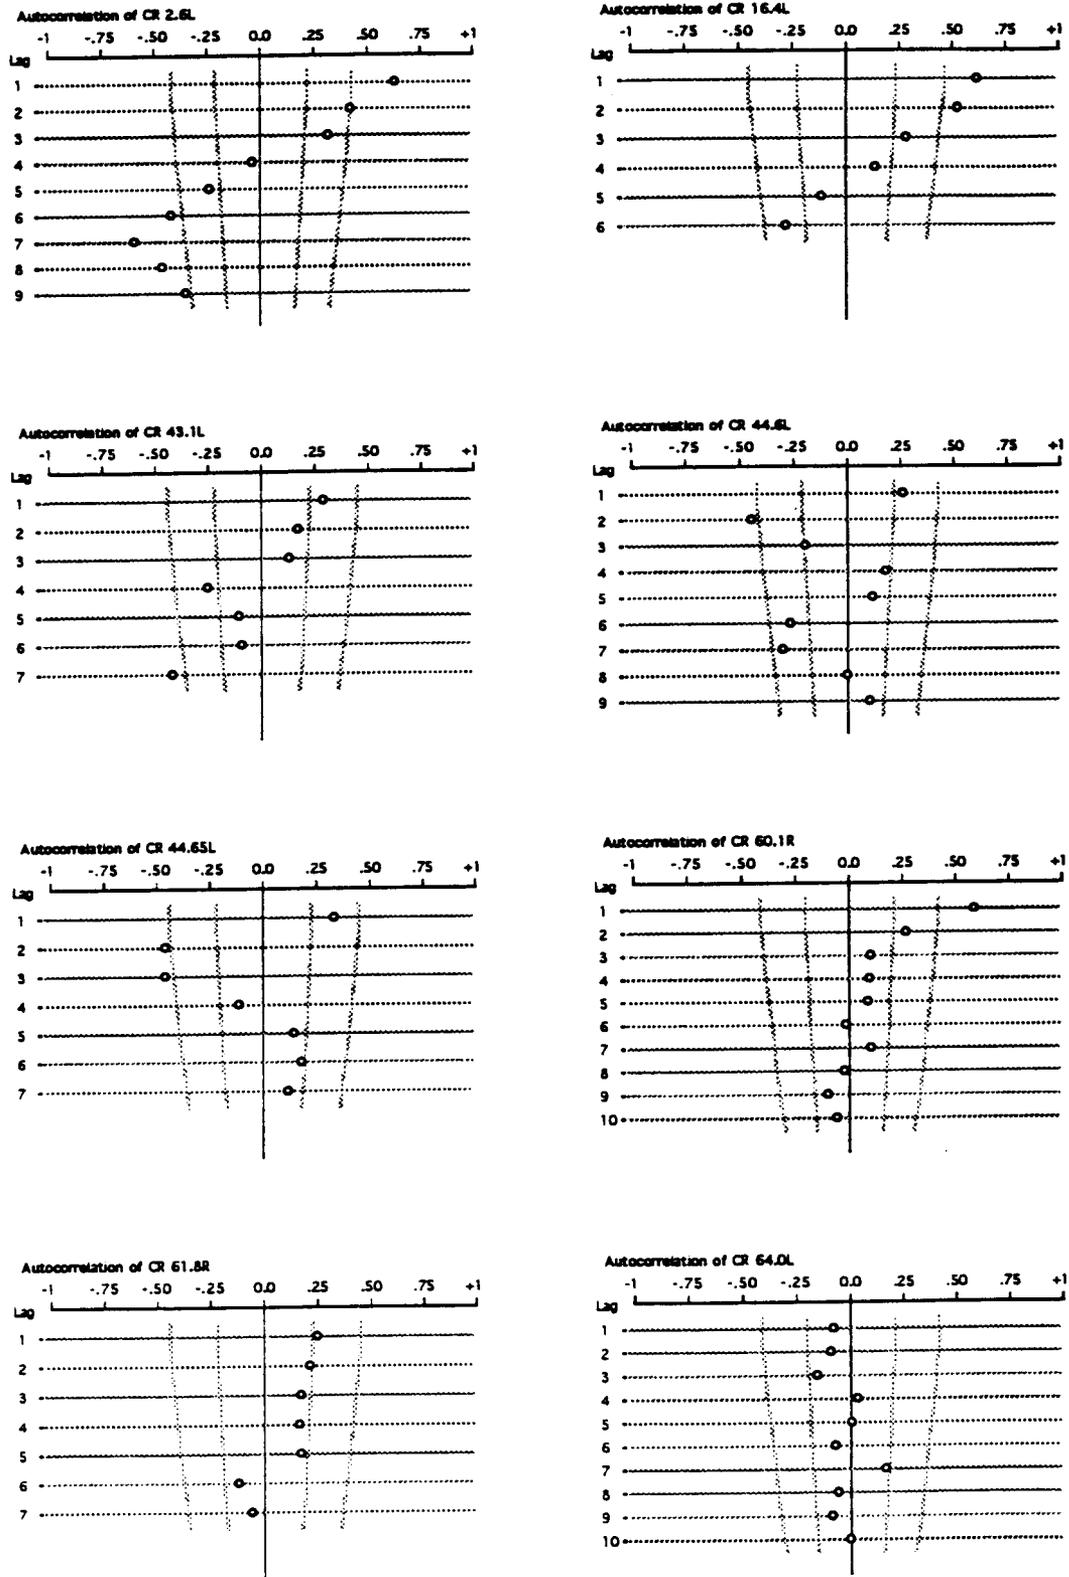
Fig. 80. Composite figure of time-series correlograms for the twenty rectified sandbars, March 15, 1992 through December 31, 1993.

As noted above, a pronounced seasonal variation in sandbar areas is related to discharge and does not necessarily reflect erosional loss or depositional gain in the resulting area. This seasonal cycle is repeated every six months (Table 8) and also shows up as a positive six month lag peak in many of the correlograms in Figure 80 (43.1L, 44.65L, 119.0R, 122.7L, 136.6L, 172.3L and 211.3L).
