FINAL REPORT

**Daily Dynamics of Grand Canyon Sandbars;
Monitoring With Terrestrial Photogrammetry**

Department of Geography
Northern Arizona University
Box 15016
Flagstaff, Arizona 86011

Sponsored by the
U. S. Department of the Interior
National Park Service
Cooperative Agreement # CA 8000-8-0002

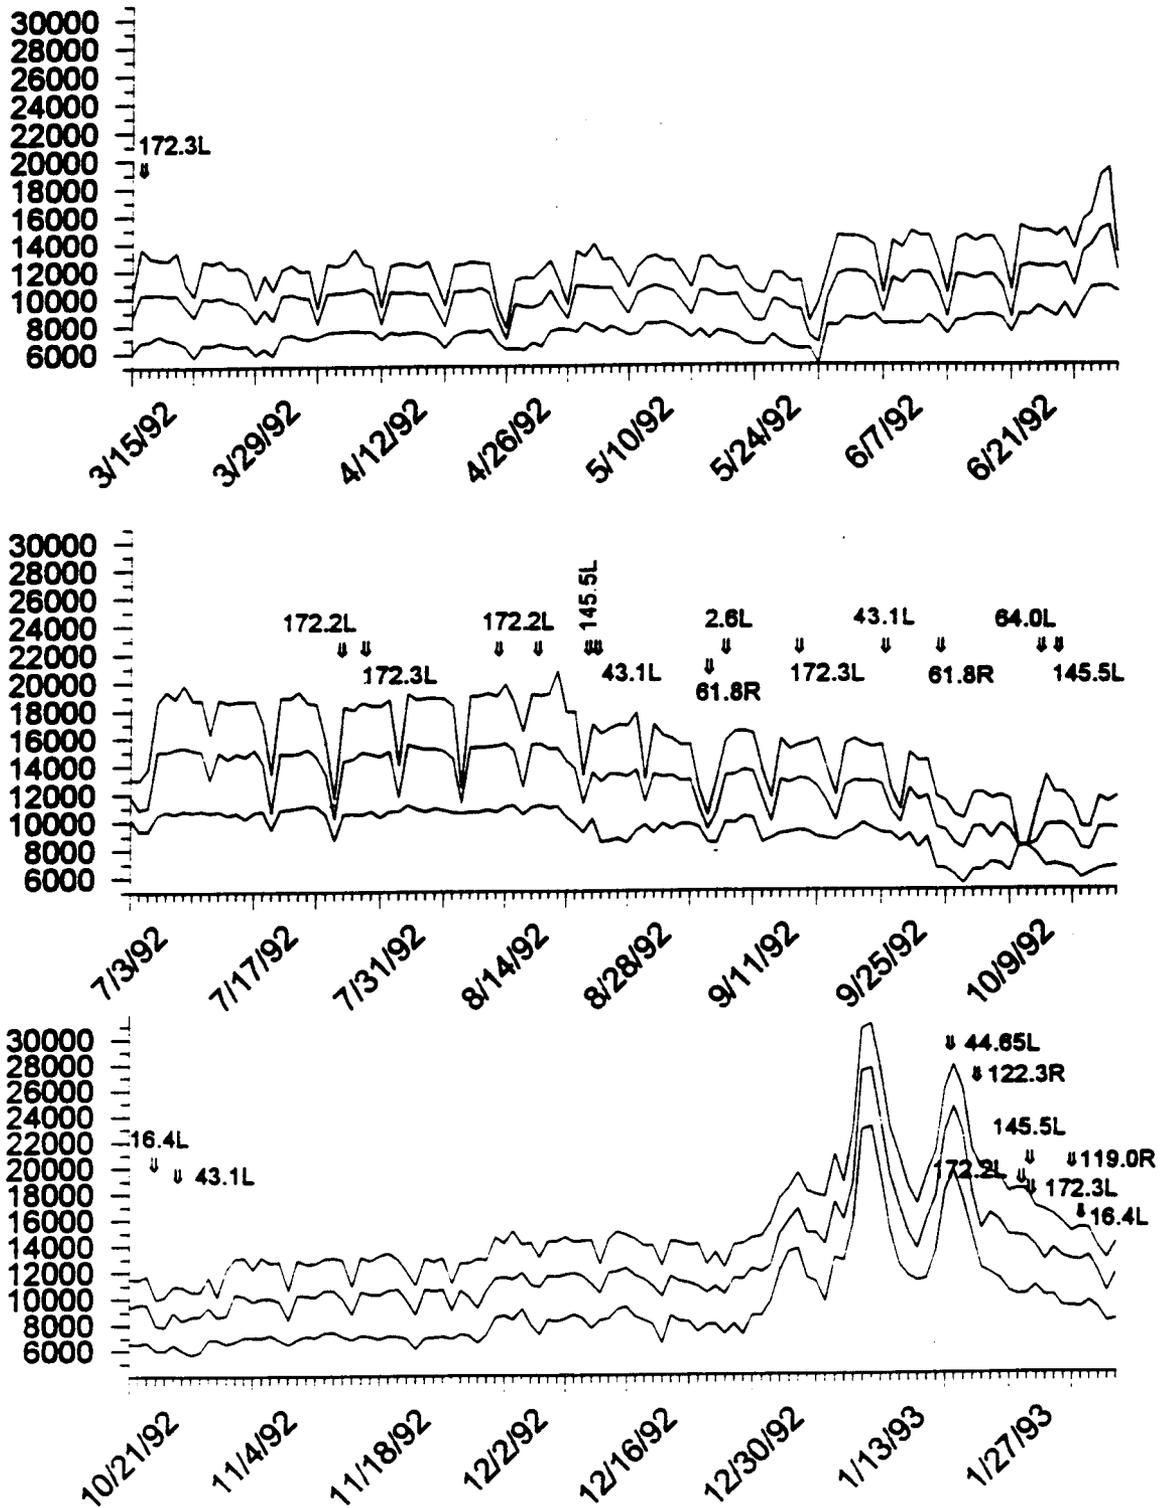
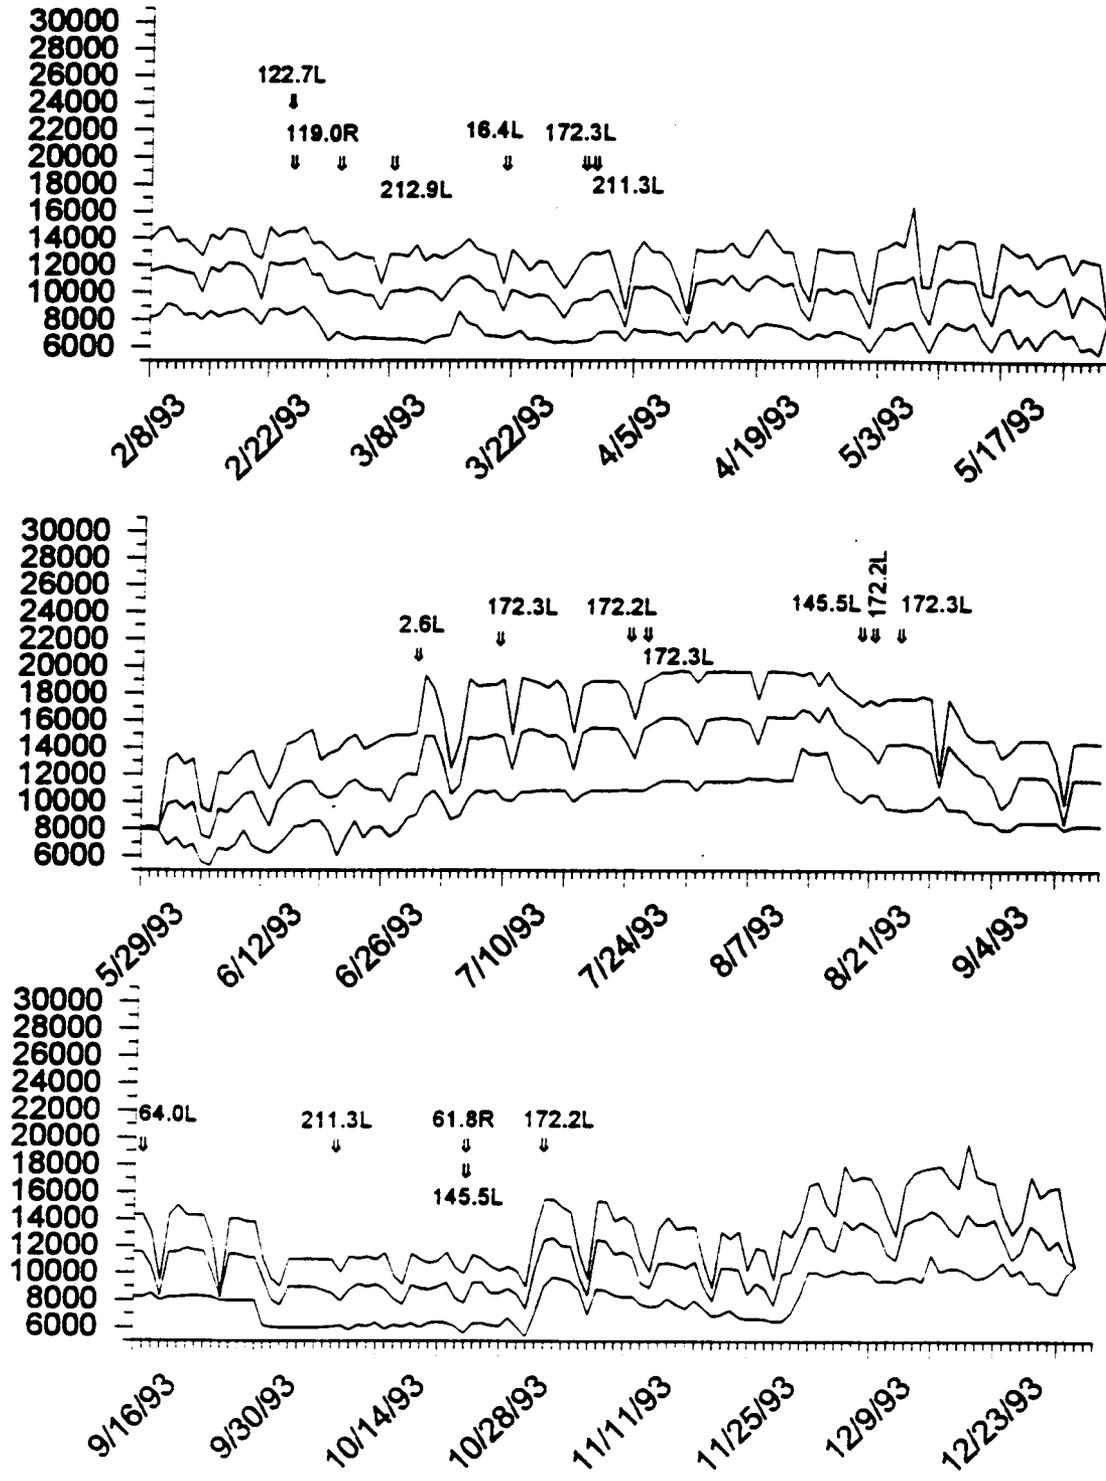
Fig. 90. Erosional event-discharge graphs illustrating the timing and river mile location of erosional events with respect to mainstem discharge (maximum, mean and minimum). Over 70% of the erosional events occurred during or within two days of a weekend low discharge.

Fig. 90 (continued). Erosional event-discharge graphs illustrating the timing and river mile location of erosional events with respect to mainstem discharge (maximum, mean and minimum). Over 70% of the erosional events occurred during or within two days of a weekend low discharge.

A count of erosional events temporally coincident with weekend low flow periods shows that out of 41 events recorded, 17 occurred during a weekend low flow. Ten additional events occurred within one day after a weekend low flow and three events occurred within two days after a low flow. Thus, 73% of the events documented occurred during, or within two days of weekend discharges. Similar results were found during the test flow period when 11 of 23 documented erosional events occurred during, or within two days following a low flow period. This indicates that whatever the processes are that drive erosional events, the processes are triggered by either the low discharge itself or the increased range in discharge resulting from weekend operations.

One hypothesis addressed in the proposal was that daily area records from a large number of sandbars could document spatial and temporal trends. This would improve our understanding of the processes that cause rapid erosional events. This could also provide management alternatives to reduce erosional rates and display potential prolonged benefits of interim flows. Spatial and temporal trends are evident in the 22 month record at 20 sites (Figure 89). Some observations on spatial and temporal trends are described below. During September 1992, eight erosional events occurred at seven sites. The sites were: 2.6L; 43.1L; 136.6L; 172.3L; 211.3L; and 212.9L. Synchronously, three sandbars eroded on January 30, 1993; - 145.5L, 172.2L, and 172.5L. On several occasions two sites eroded on the same day (Figure 90).

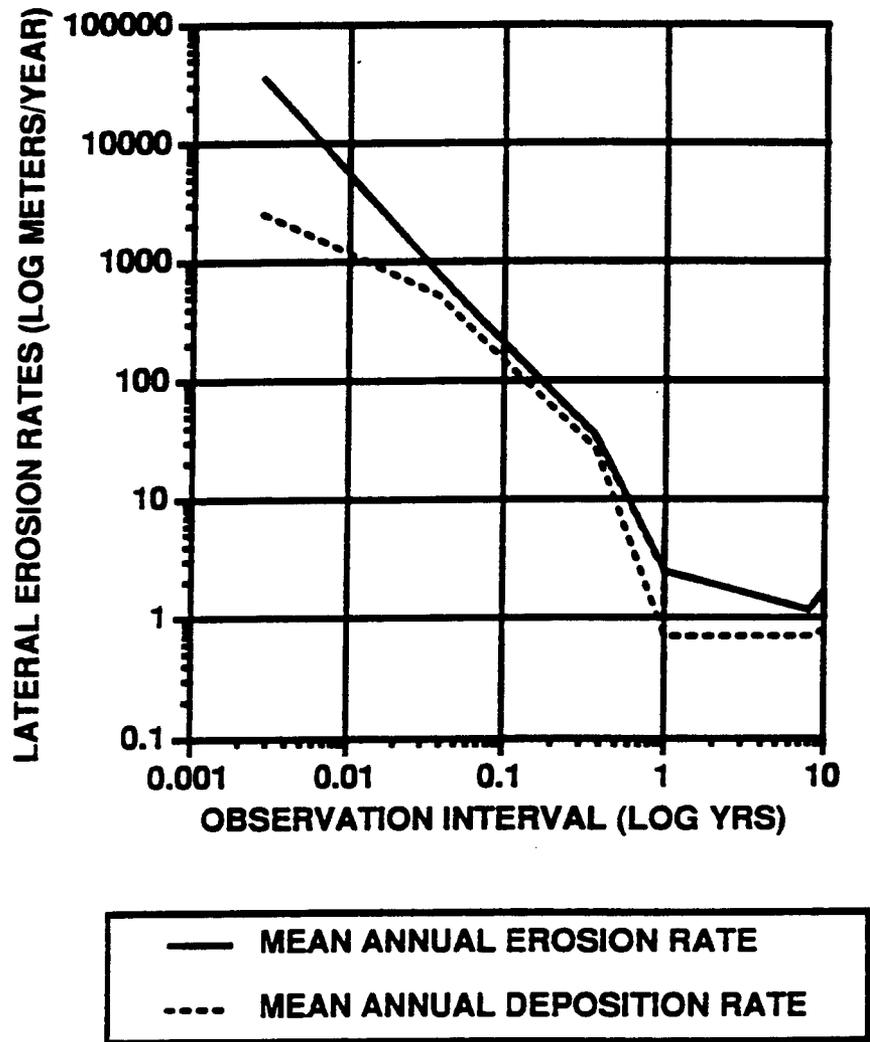
Fig. 91. Log scaled plot of measured lateral erosion rates versus sample frequency.

Reference	Interval	Erosion(m/yr)	Deposition(m/yr)
Beus et. al. 1992	10 Years	0.8	1.7
Howard & Dolan 1979	8 Years	1.15	0.7
Howard & Dolan 1979	1 Year	2.45	0.7
Schmidt & Graf 1990	4.5 Months	34.7	26.7
Beus et. al. 1992	2 Weeks	520	390
Cluer Pres. Comm.	2 Weeks	780	520
This study	Daily	36,500	2,550

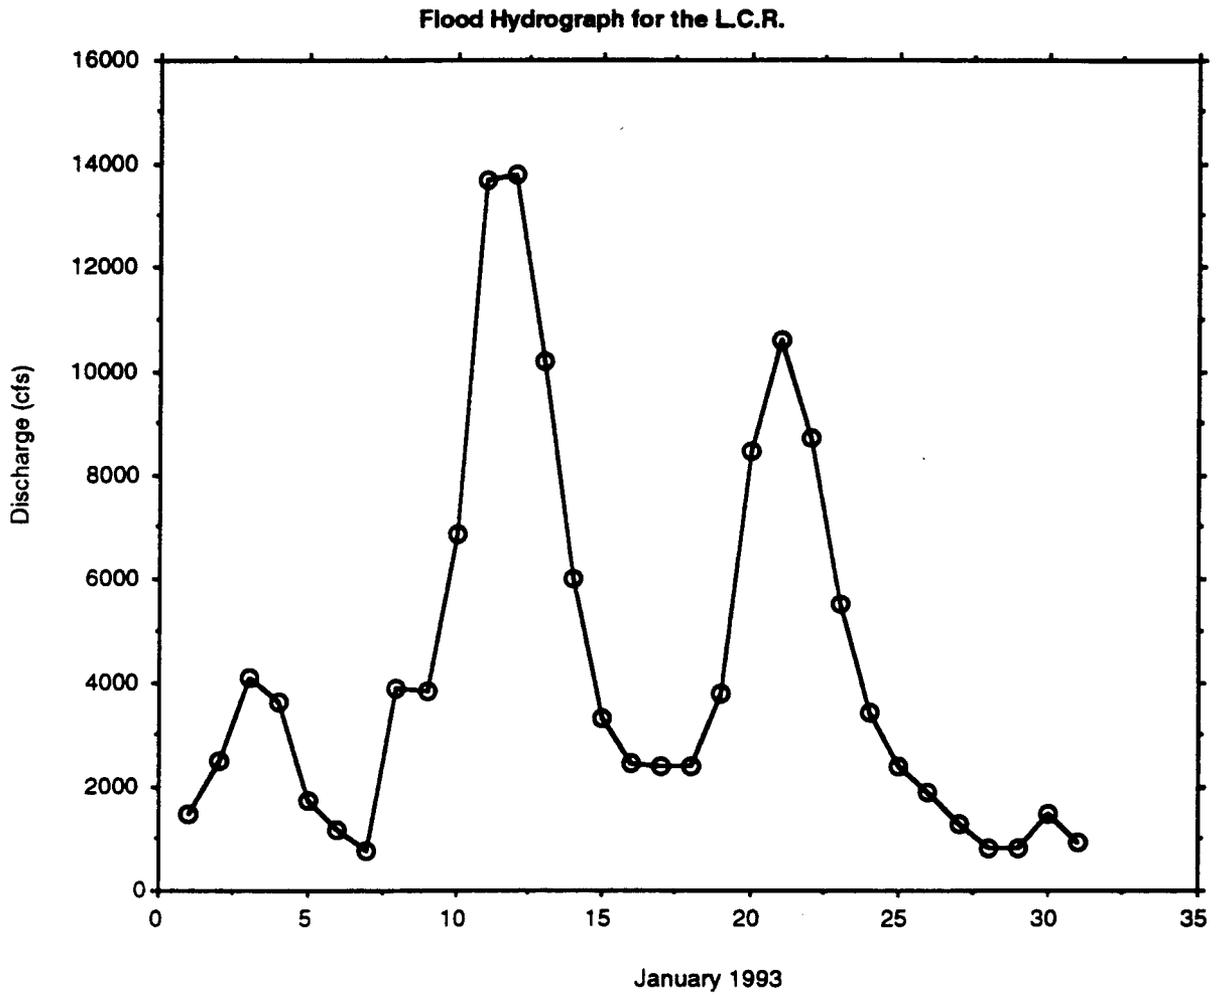
Fig. 92. Flood hydrograph for the Little Colorado River as gauged at Cameron, Arizona, January 1993.

Little Colorado River Peak Flood Discharges. Figure 92 shows the hydrograph for the Little Colorado River as gauged at Cameron, Arizona for the month of January 1993. The hydrograph captures the two main peaks of a snowmelt/rain driven flood. The first peak crests at 13,8000 cfs on January 12 and the second peak crests at 10,600 cfs on January 21. A subsequent flood event also occurred in March 1993. These flood events are significant inputs to mainstem sandbar dynamics as the Little Colorado River is now (post Glen Canyon Dam) the largest single supplier of sediment to the Colorado River in Grand Canyon.

The LCR flooded in January 1993 with discharges exceeding 13,000 cfs for two days (Figure 92). Discharges exceeded 5,000 cfs for five days, January 10-14, and again for four days January 20-23. When combined with dam releases, discharges downstream of the LCR peaked at approximately 31,000 cfs on January 11-12. A second peak of approximately 28,000 cfs occurred on January 21-22, following a five day period of lower discharge after the first peak.

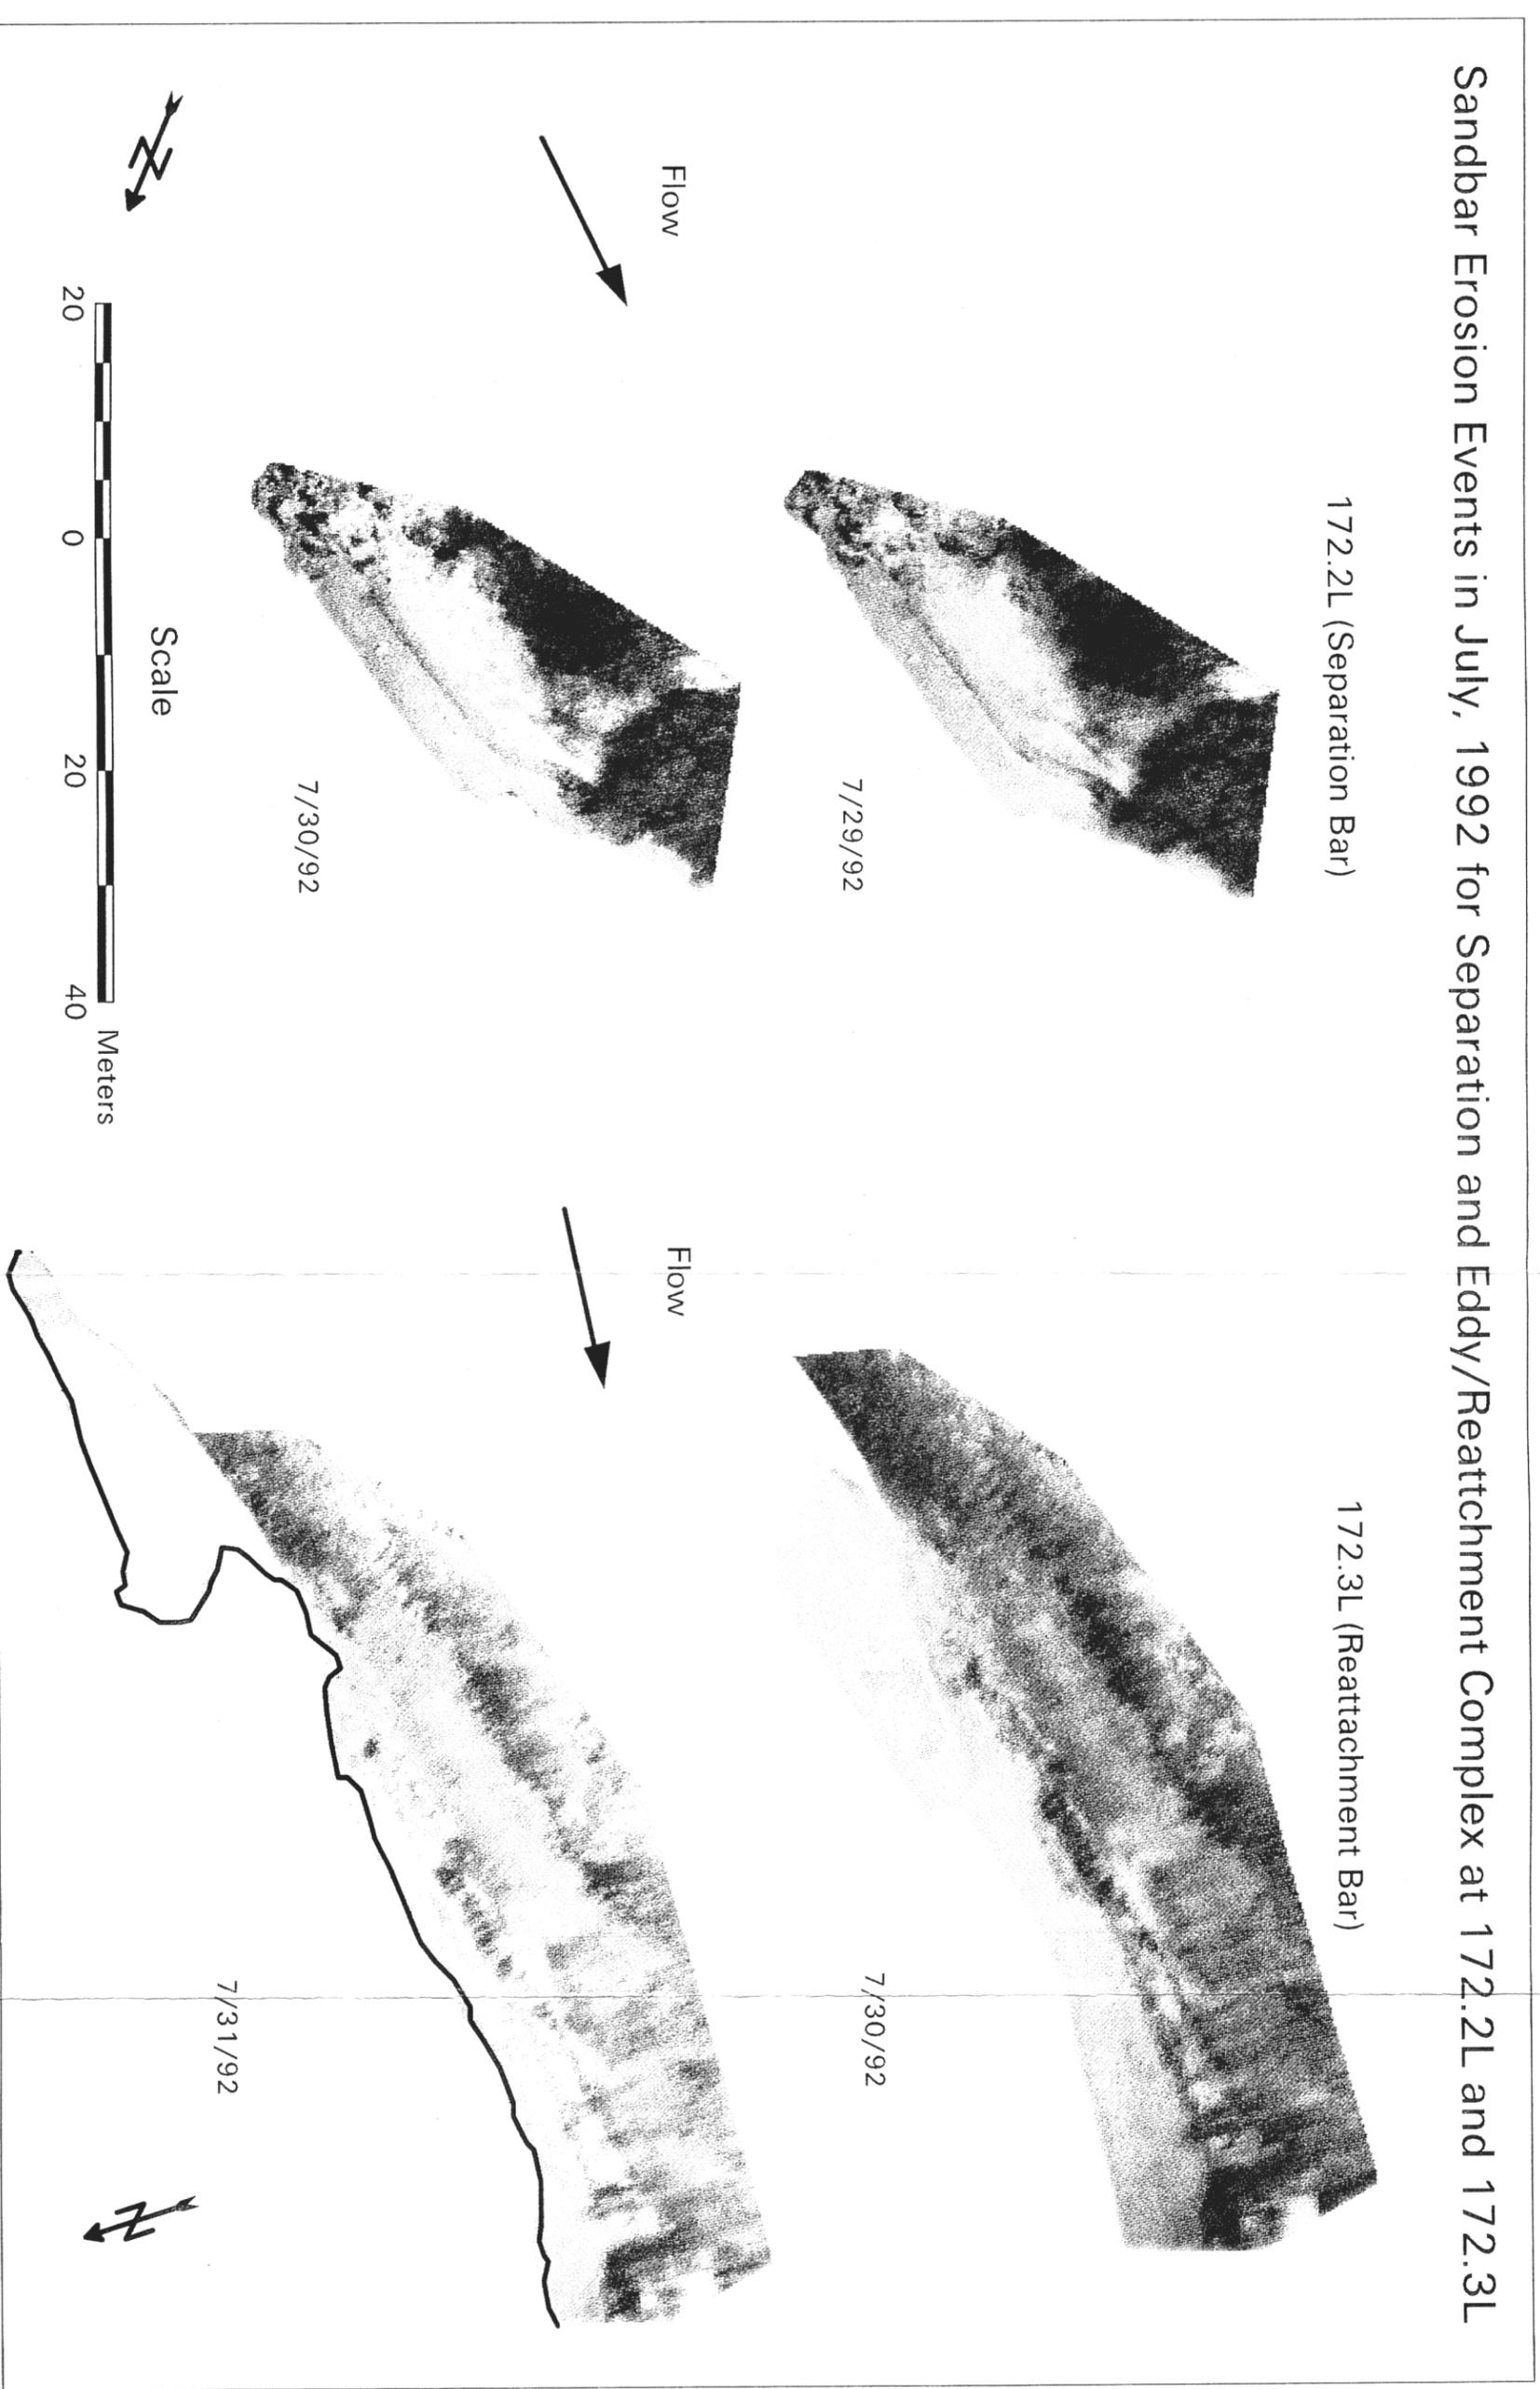
Sandbar Erosion Events in July, 1992 for Separation and Eddy/Reattachment Complex at 172.2L and 172.3L

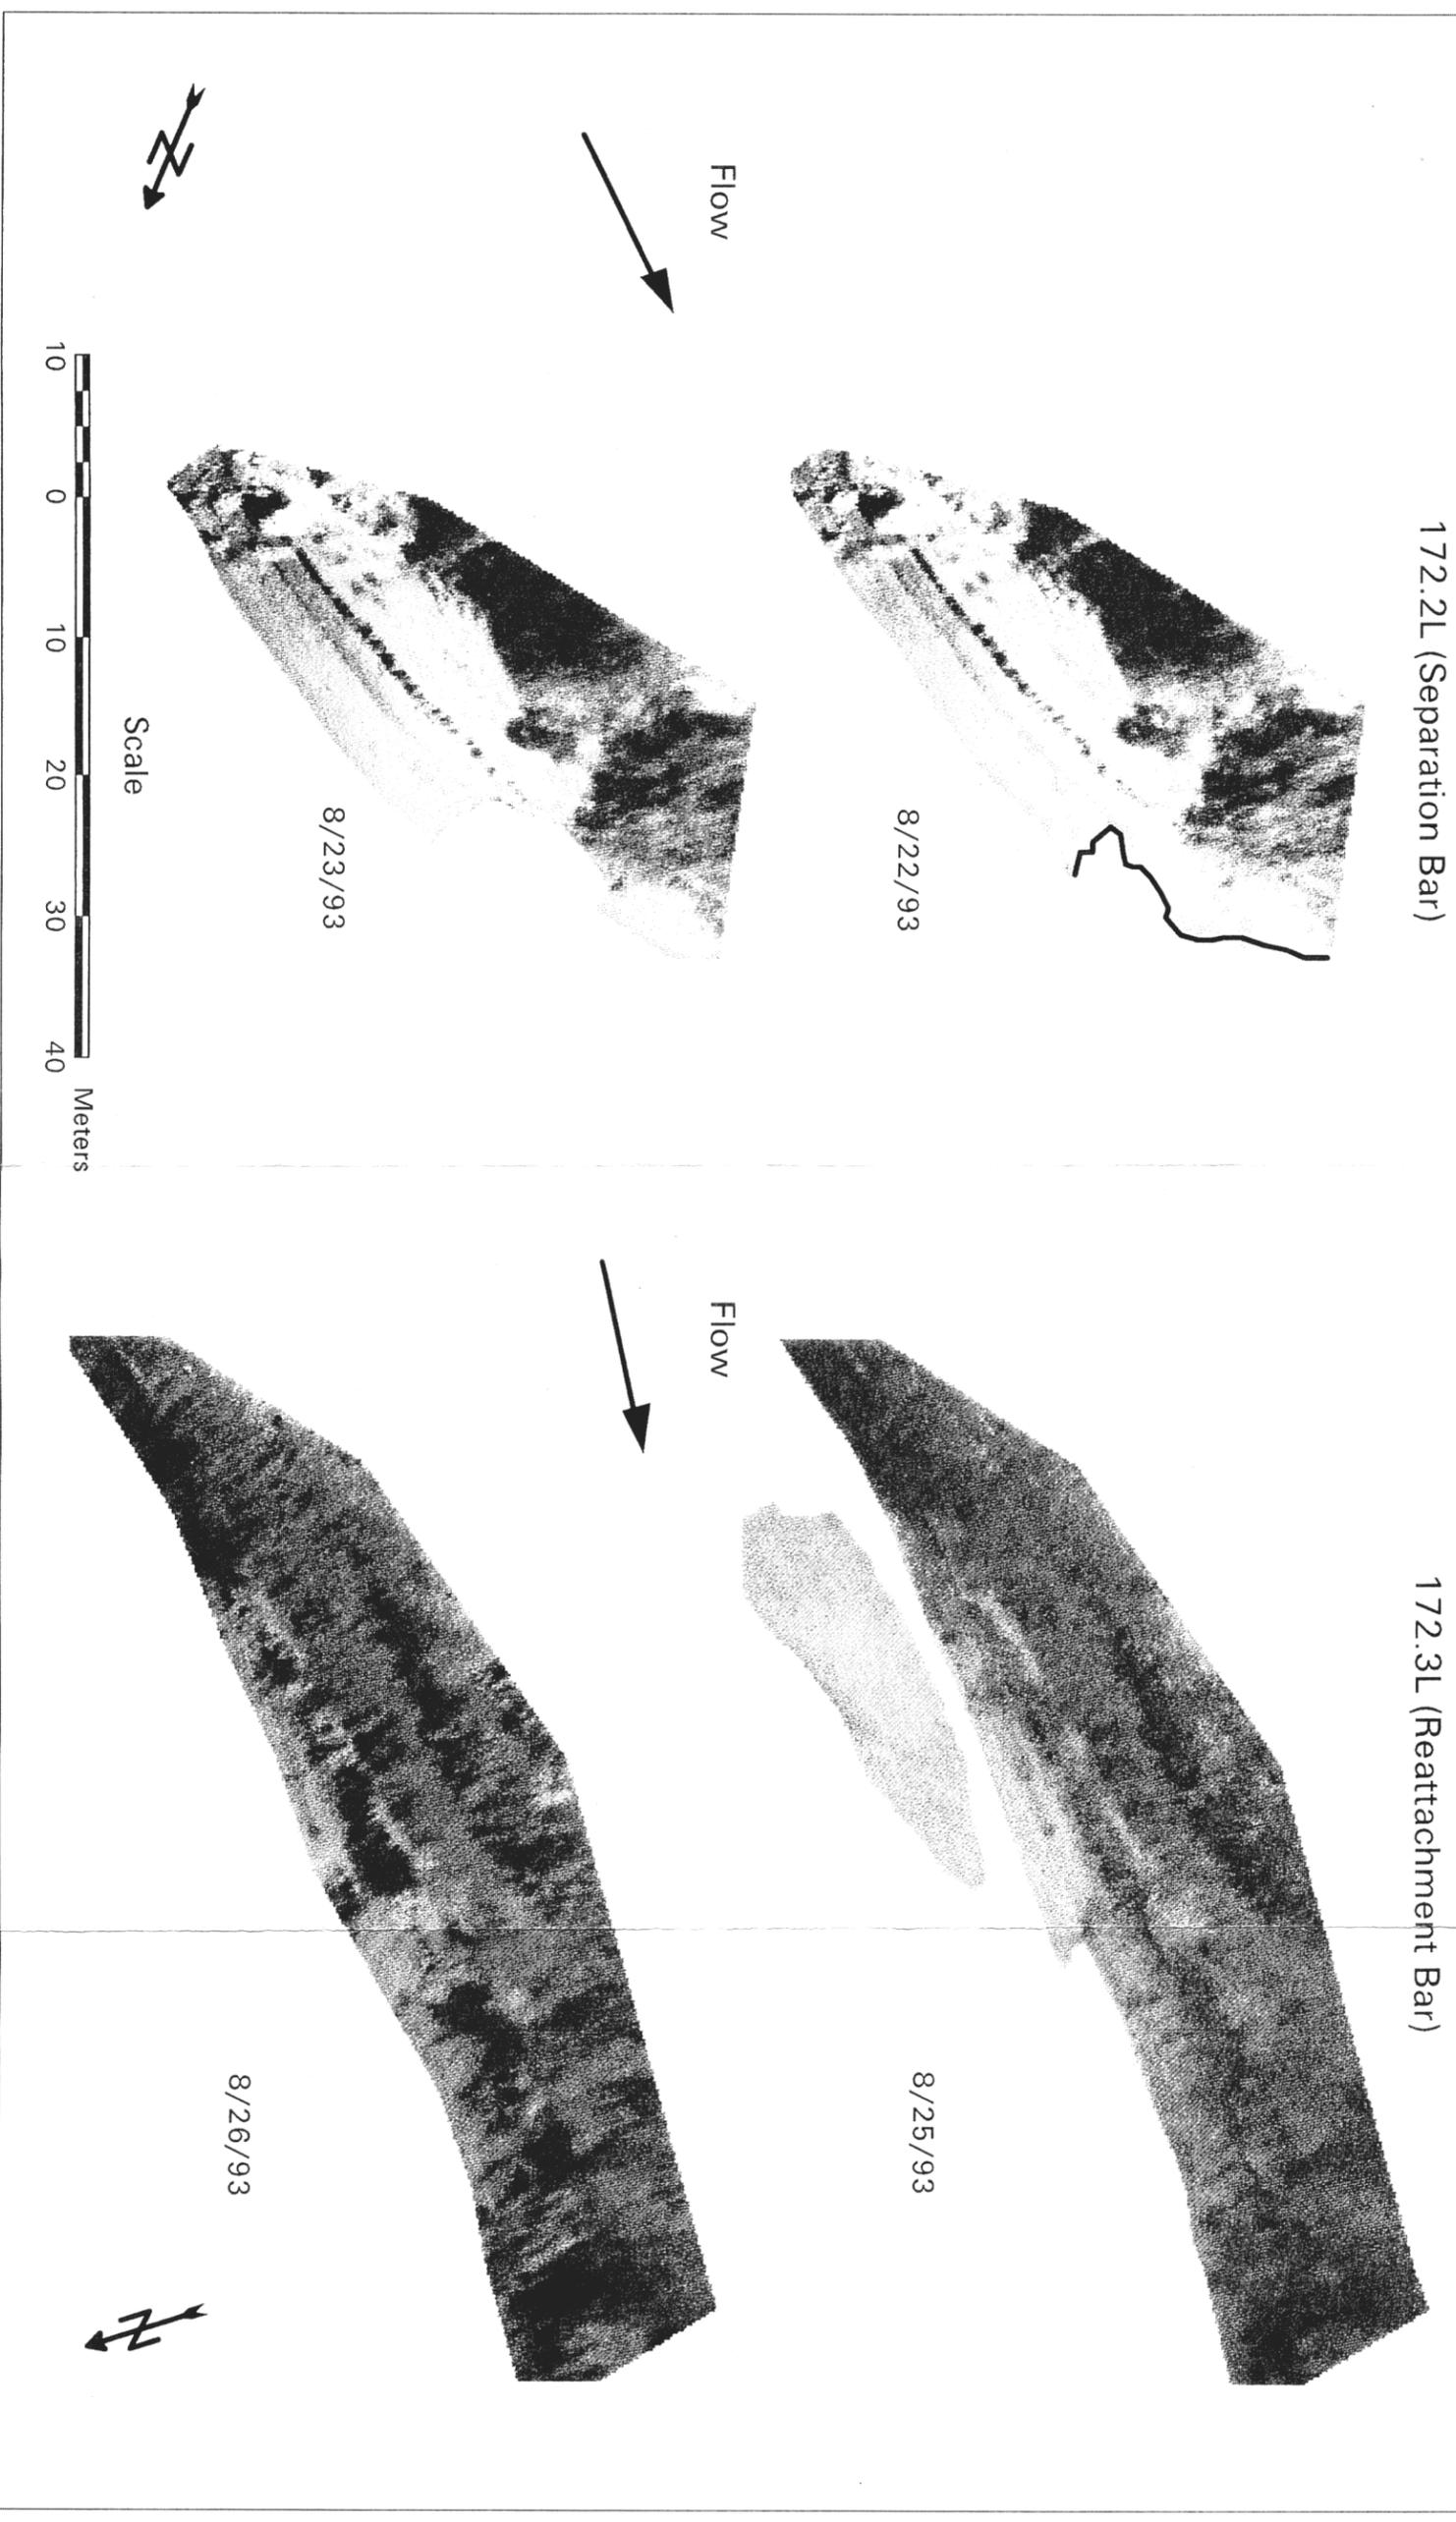
Sandbar Erosion Events in August, 1993 for Separation and Eddy/Reattachment Complex at 172.2L and 172.3L

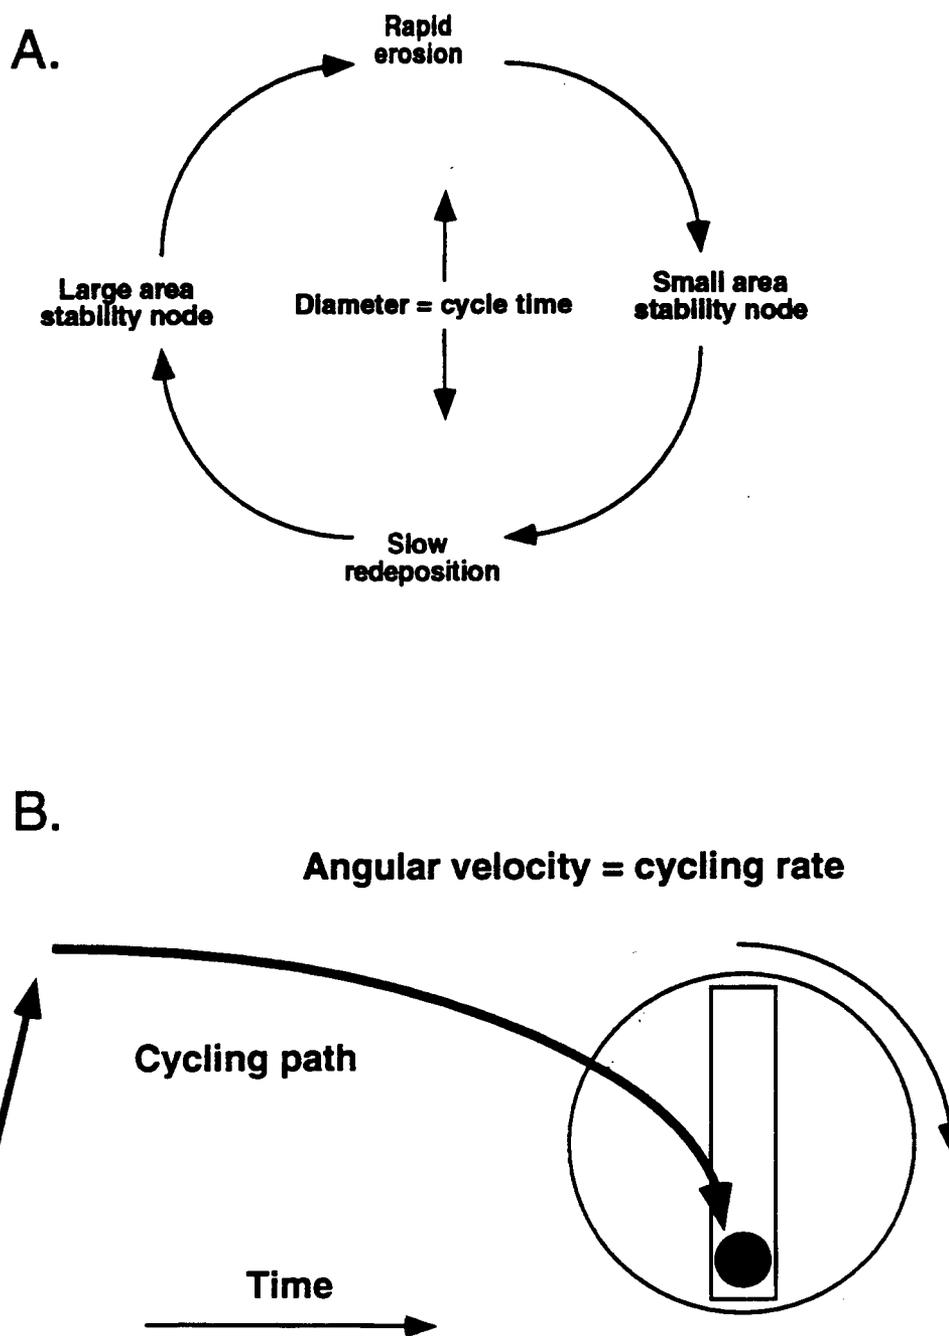
Fig. 96. Conceptual analog models of sandbar dynamics principles as suggested by this research. Panel A illustrates rapid erosion cycling and slow redeposition separated by quasi-stable area nodes. Panel B is a mechanical analog simulating erosional cycling by the path described by an axle moving within the slot of a rolling wheel (see text for details).

During periods of degradation, rates similar to aggradation were measured in many instances. However, the major difference between aggradation and degradation rates is that many periods of erosion were actually very short periods of time typically less than 24 h - thus the usage 'events' in this report (see Figures 81 through 88 for examples). Degradation was typically a punctuated event while aggradation was prolonged. This characteristic has been incorporated in an overall sandbar cycle model presented later (Figure 96).
