EFFECTS OF GLEN CANYON DAM ON COLORADO RIVER SAND DEPOSITS USED AS CAMPSITES IN GRAND CANYON NATIONAL PARK, USA

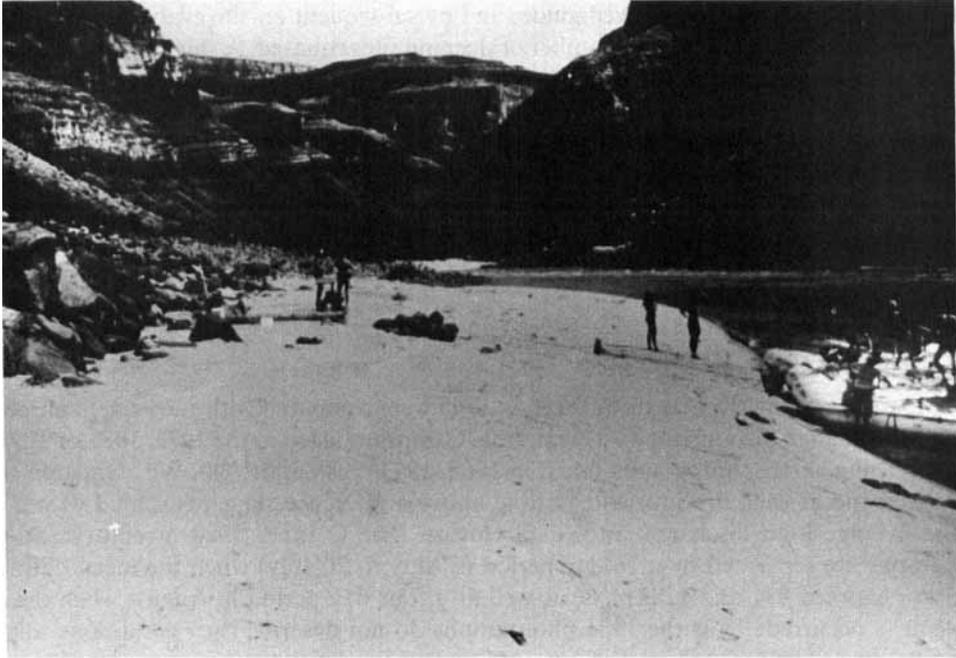
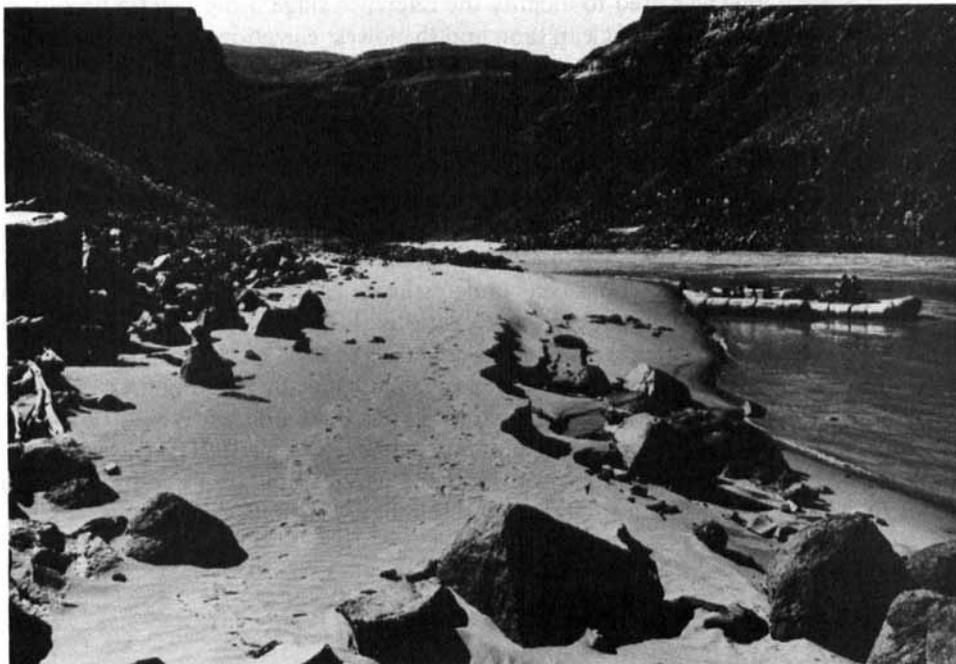
Figure 3. Photographs showing decreased campsite size over time due to erosion, but which are regarded as 'no change' in our inventory comparisons. The top photo was taken in May 1981 and the bottom photo, which shows much less sand and newly exposed rocks near the river, was taken in March 1992

Because of limitations in interpreting aerial photographs, we did not estimate differences in vegetation density, nor did we categorize the physical carrying capacity of sites; instead, changes in size above the reference stage were recorded as a substantial increase or decrease from the initial 1965 condition. Erosional change was noted when a deposit above the reference stage was completely eroded, was significantly smaller, or when substantially more rocks were visible at the site. We are confident that our estimates of sand bar change based on aerial photograph comparisons underestimate campsite erosion since 1965. We know of many specific sites where there was a loss of sand at elevations above the $708 \text{ m}^3/\text{s}$ reference stage, but where there was little to no change in area of exposed sand (Figure 3).
