**THE INFLUENCE OF VARIABLE DISCHARGE REGIMES ON
COLORADO RIVER SAND BARS BELOW GLEN CANYON DAM:
FINAL REPORT**

Northern Arizona University

NPS Cooperative Agreement Number: CA 8006-8-0002

**Sponsored by: The U.S. Department of Interior National Park Service Cooperative Parks Study Unit
Northern Arizona University Flagstaff, AZ 86011**

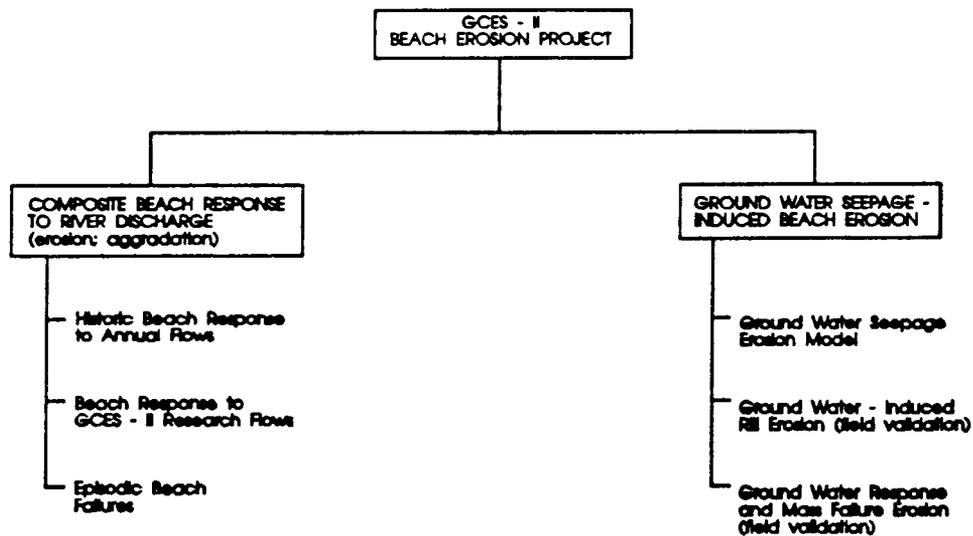
Figure 2. The major research components of the GCES Phase II Cooperative Beach Erosion Project.

The composite response of sand bars to alternative river discharge regimes was investigated using several approaches (Fig. 2). The investigation of seepage-induced beach erosion is keyed to the development and application of a finite element ground water seepage and sand bar slope failure model.

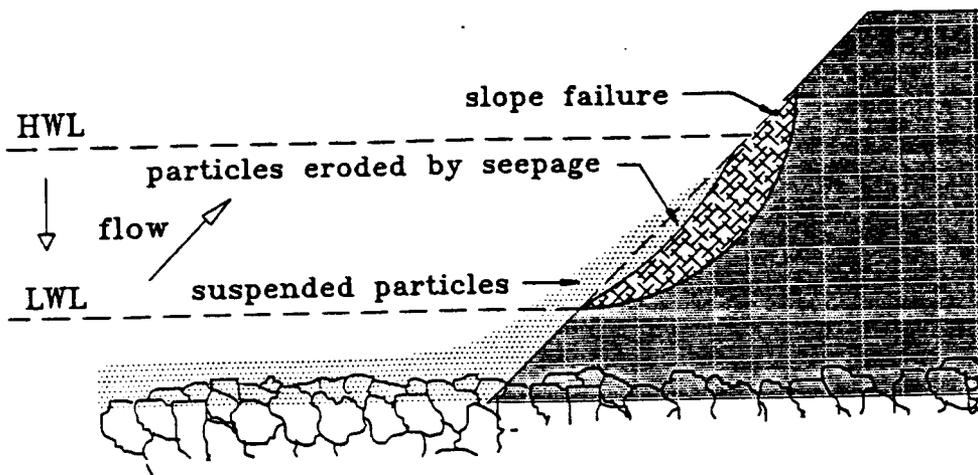
Fig. 1 Mechanism of seepage driven erosion.

Seepage driven erosion was observed in most of the sand bars downstream of the Glen Canyon Dam. When the river stage falls at a rate greater than the permeability of the soil, the volume of water stored during the rising stage must drain from the bank. The exit hydraulic gradient (i) may become greater than the critical hydraulic gradient [$i_{cr} = (G - 1)/(1 + e)$ where G is the specific gravity and e is the void ratio of the soil] during the falling river stage. The soil fluidizes (quicksand condition) and is then carried in suspension by the outflow of water (Fig. 1). Rivulets and gullies (rilling process) are formed below the exit point along the sand bar as the bank stored water with its sediments rushes down slope towards the river. These rivulets and gullies are scoured deeper as the water picks up sediments along its path to the river. Typical examples of these are shown in Figs. 2 and 3.

The permeability and porosity (or void ratio) of the soil are key factors in determining the extent of seepage driven erosion. For soils with low permeabilities, for example, the silty sand on some sand bars along the Colorado River, the water accumulated during the rising river stage cannot drain sufficiently fast. The resulting pore water pressures reduce the shear strength of the soils so that slope failures under undrained conditions occur. A typical example of this is shown in Fig. 6. The mass of material involved in the catastrophic undrained failure of sand bar slopes is often very large - several hundred tons. A substantial area of the sand bar can be lost in a few seconds. On occasions, incipient undrained slope failures may occur during the down ramping river stage. That is, the failure plane develops, but for complete failure a further reduction (by a very small amount) in shear strength is required. The next rising river stage could then easily precipitate complete failure because the shear strength of the soil mass is now reduced by the increase in pore water pressure. It is quite easy to confuse this seepage related failure to a tractive force induced failure or the failure is categorized as caused by a rising river stage. The condition that is predominant in provoking such failures is a rapid, high down ramping stage followed by a constant low stage over a day or more.

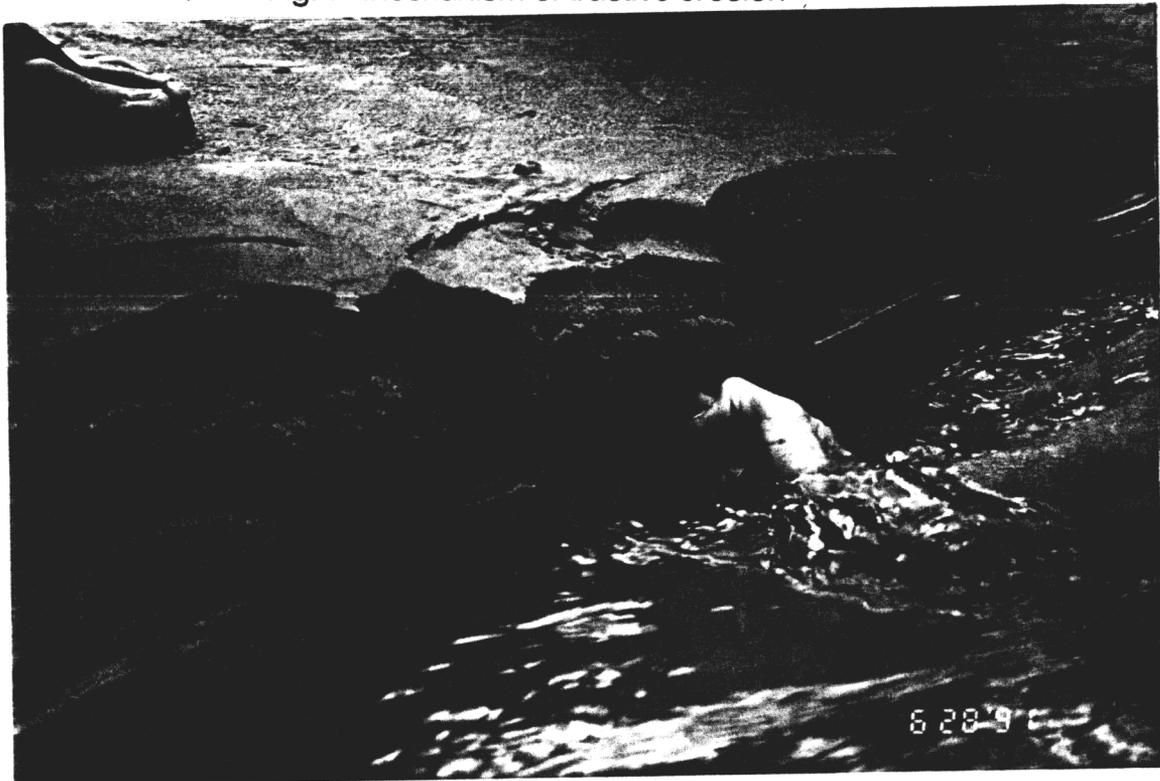
Fig. 8 Scouring and bank failure from tractive force

Tractive erosion is well described in the literature. Most of the reported work dealt with the scouring of river beds due to shearing forces in the direction of flow. Tractive forces erode river banks due to velocity gradients from changes in the geometry of the river system. Fig. 7 shows the predominant tractive force mechanism in the Colorado River downstream of the Glen Canyon Dam. Velocity gradients during rapid rising river stage undercut the bank slopes. The soil directly above collapses into the void of the undercut. If the soil has some cohesion, a tension crack develops at the surface and the soil mass above the undercut rotates about its lower corner at the end of the undercut towards the river. Most of this collapsed soil is then transported downstream with the rising river stage. A typical example of this type of erosion mechanism is shown in Fig. 8.

In some sections of the river where the sand bar slope is shallow, the tractive forces scour the soil in the direction of flow between low water level and high water level. The slope steepens and eventually exceeds its limiting value (the angle of repose of the soil) leading to a slope failure (mass wasting).

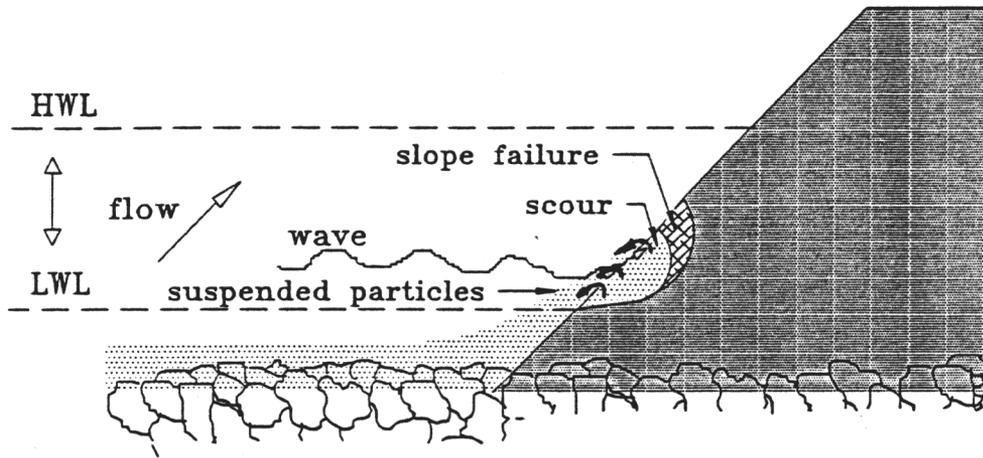
Fig. 9 Mechanism of wave induced erosion

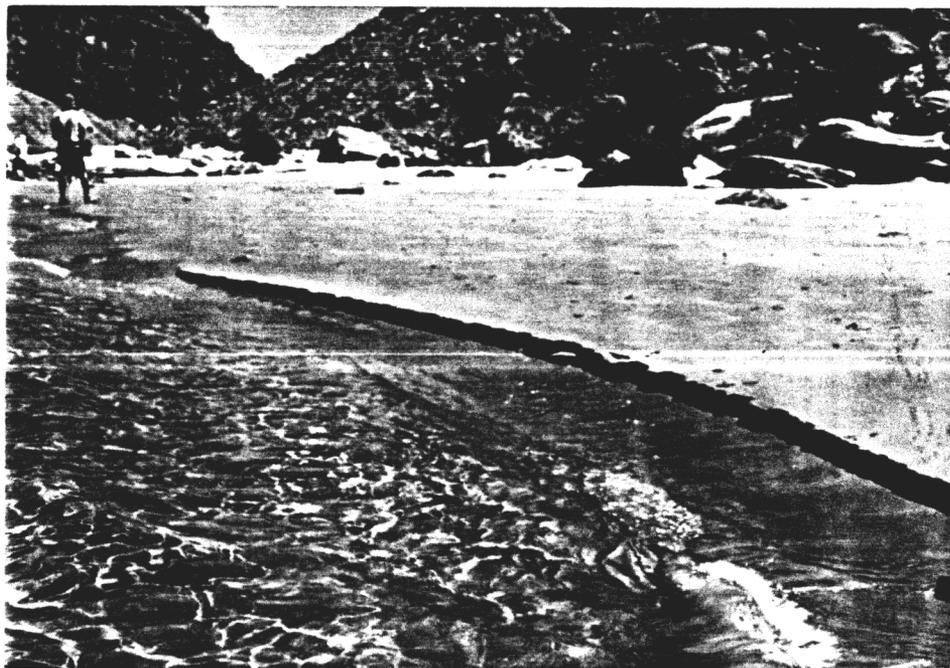
Fig. 10 Scouring and mini slope failures from waves

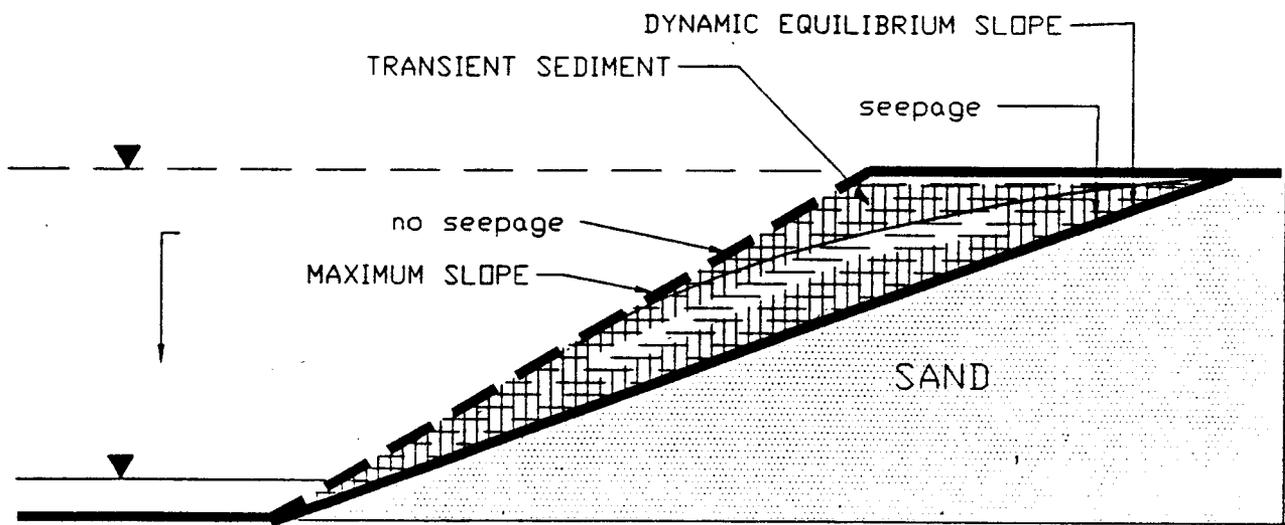
Fig. 11 Equilibrium slope and transient sediment zone.

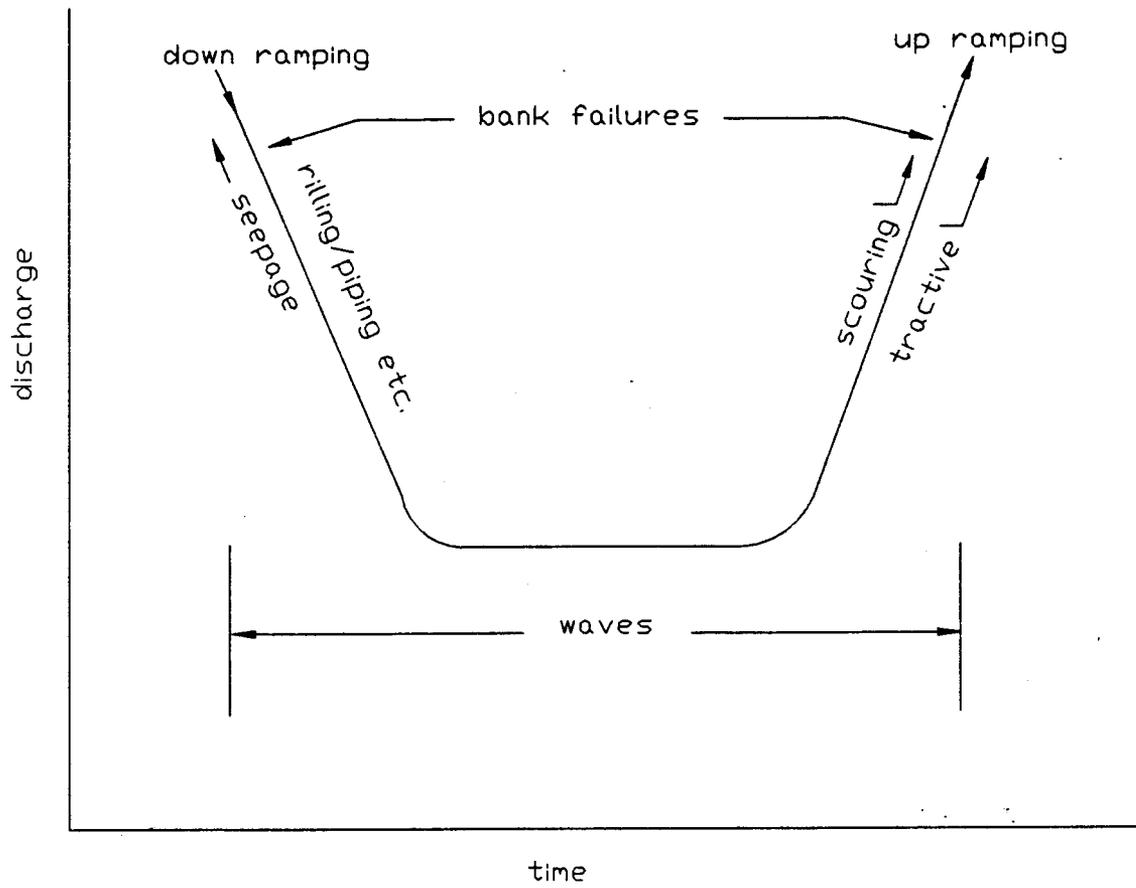
Fig. 22 Conceptual model illustrating erosion as a function of ramping rate.

The results from the model show that fast up ramping rates followed by a period of constant peak discharge or slow up ramping rates enable a greater amount of water to be stored in the sand bars than fast up ramping rates. Consequently, to reduce seepage driven erosion under these conditions, a slow down ramping rate is desirable.

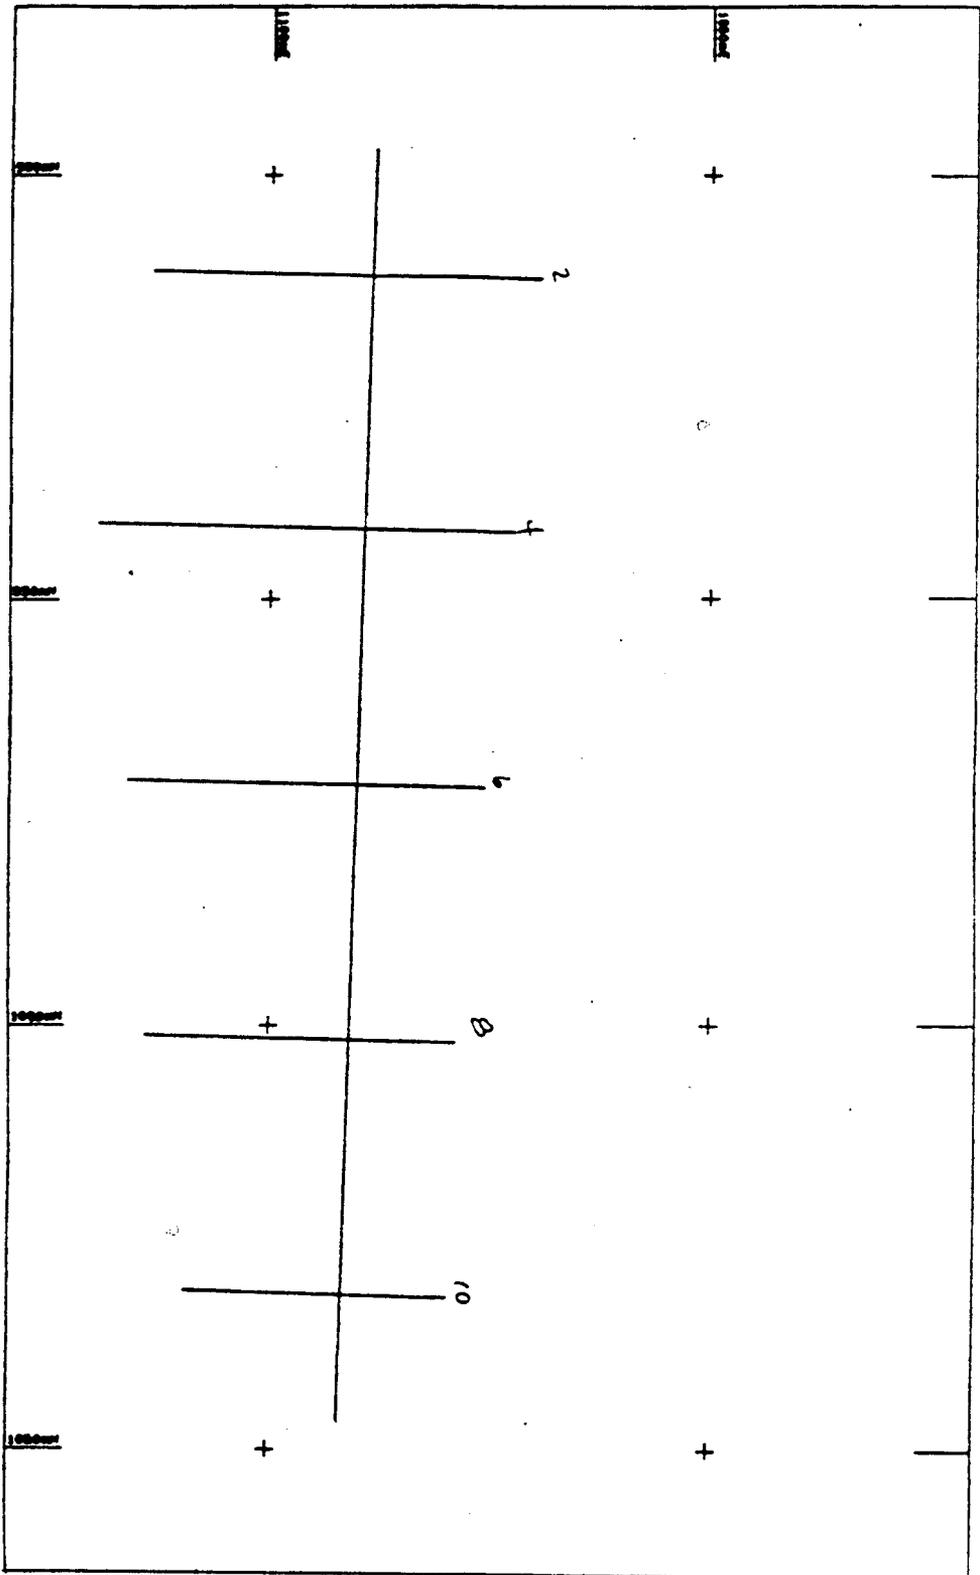
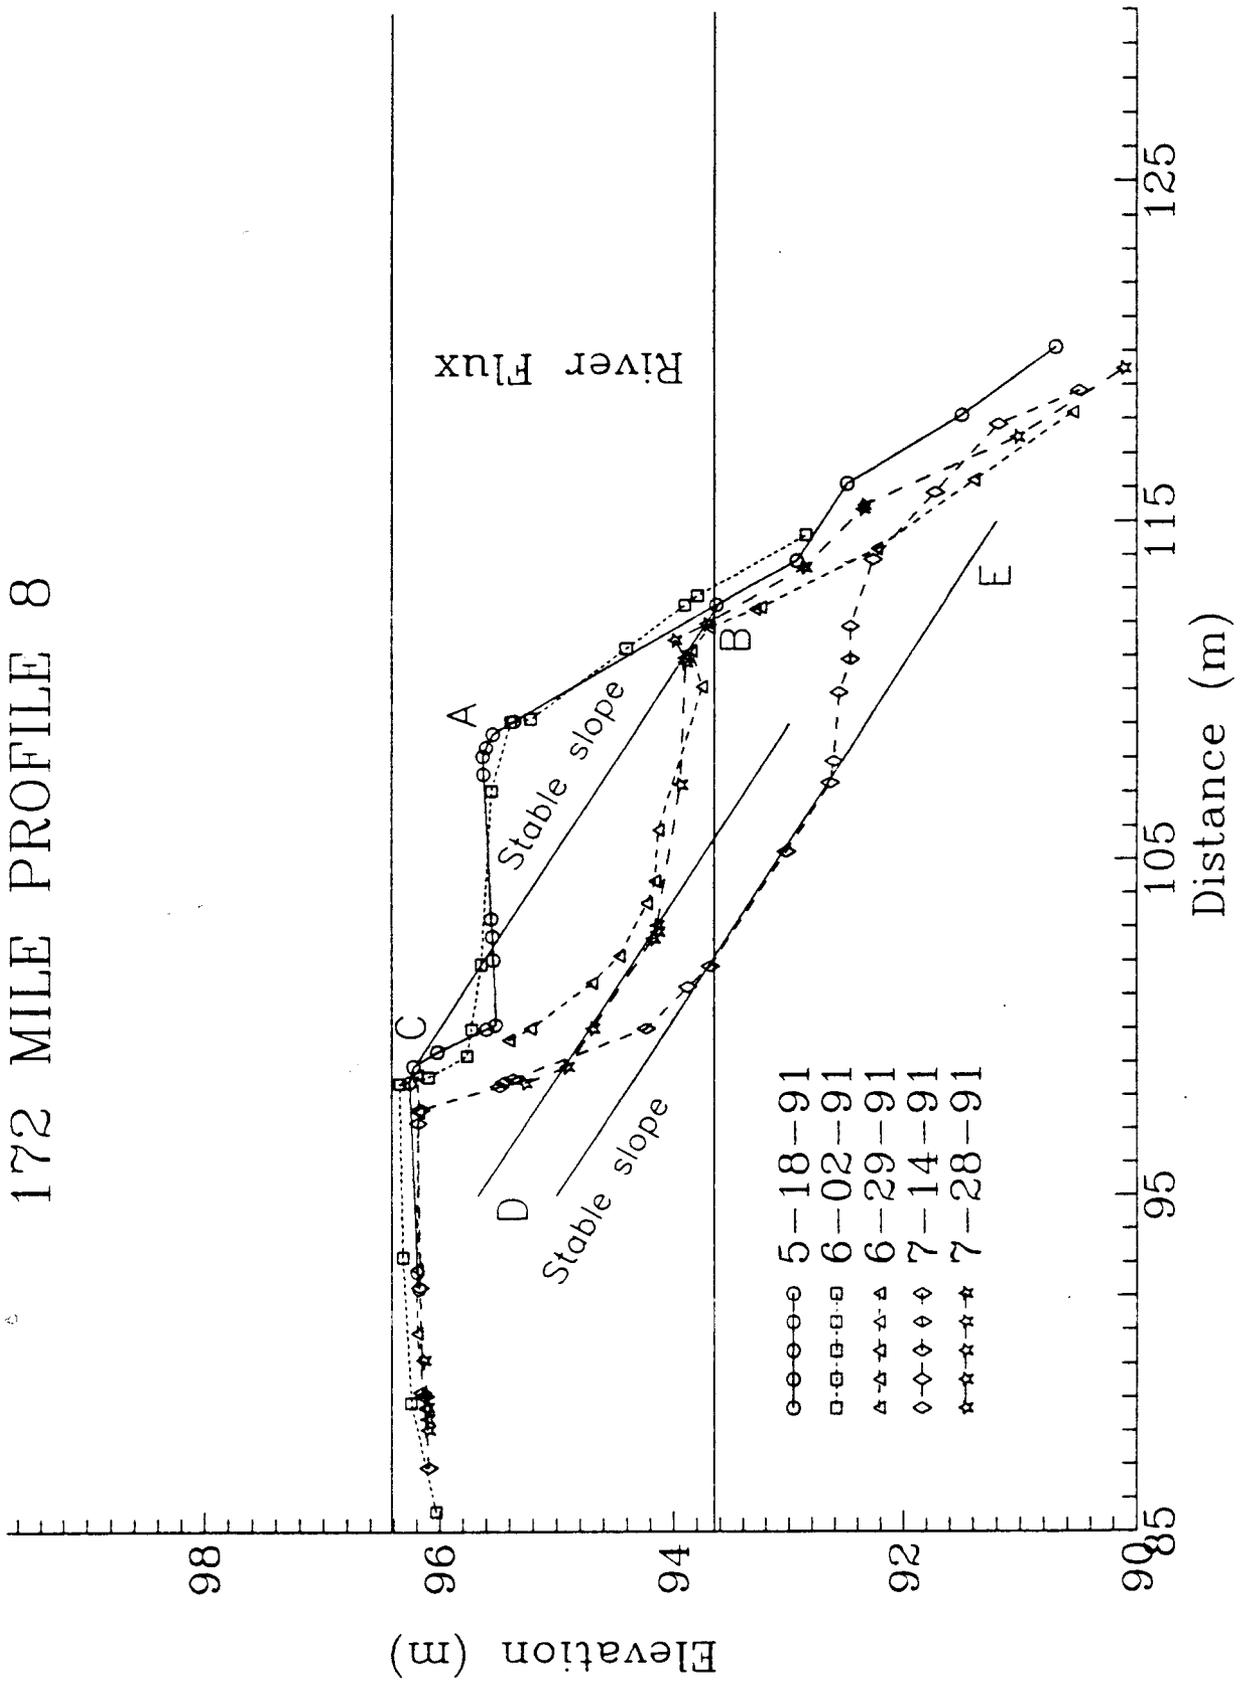
172 MILE PROFILE 8

Fig. 24 Topographic Profile 8 and t 72/ and e driu slope

Let us now examine this prediction with respect to the survey data of Profile 8 as reported by Beus et. al. (1992: this report Chapter 6) as shown in Fig. 24. The survey profile of May 18, 1991 shows that the maximum slope AB (Fig. 24) is 26° which indicates that the velocity at which deposition occurred was about 0.0034m/s (see Appendix III). This slope is unstable under seepage conditions. Using equation (1), the maximum slope angle for a stable slope under seepage within the hydraulically active zone is 11° for $\phi = 26^\circ$. That is, if the slope within the river flux zone of sand bar 172L were BC (Fig. 24), mass wasting due to seepage of ground water would be unlikely. On June 2, 1991, the slope AB reduced to 24°. It appears that rilling moved material from the top portions of the slope and deposited it at the toe.

On June 18, 1991 a slope failure was observed by Cluer (1992: this report Chapter 5). The survey of June 29, 1991 showed that a mass wasting event did occur. The failure surface recorded is consistent with a rotational failure mechanism

common in slopes. The survey of July 14 revealed a deeper failure surface that appears to be non-circular. A line drawn parallel to the slope BC (the stable slope under seepage conditions predicted by the simple model) lie exactly on the middle slope, DE, of the failure surface measured on July 14.

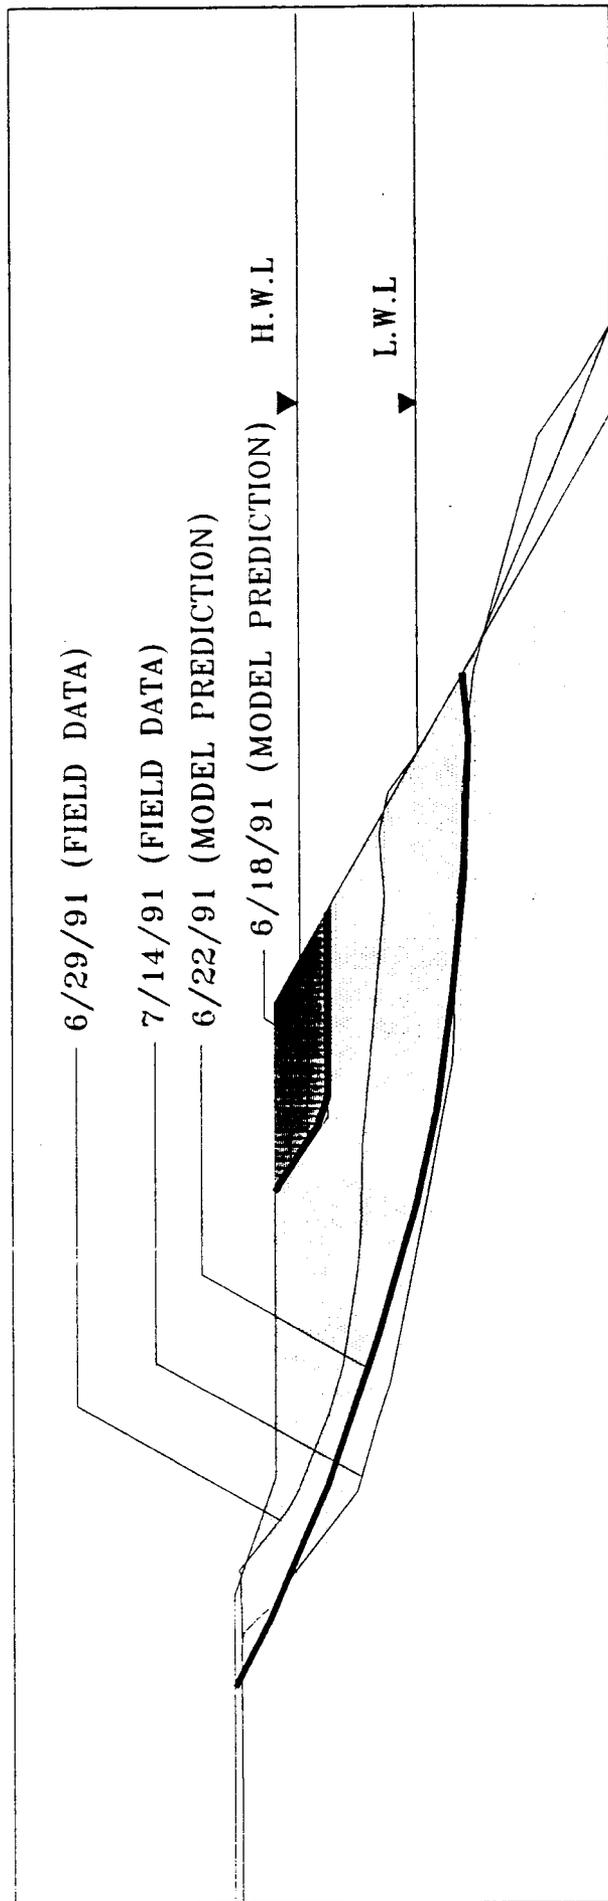
Fig. 28 Seepage-stress model prediction of mass wasting compared to field data for sand bar 172L.

the survey data can be made. However, the mass of material involved in the mass wasting event as predicted by the model is consistent with the photographs taken by Cluer (1992: this report Chapter 5) on June 18, 1991. The mass wasting predicted by the seepage-stress model on June 22, 1991 is much closer to the survey data of July 14 than June 29, 1991. The model did not predict any greater failure zone beyond June 22, 1991. Since no direct observations of events at sand bar 172L were made between June 20 and June 29, 1991, the exact timing of this mass wasting event is difficult to verify. All models, like the one described here, comprise assumptions which are not obeyed in the natural world. Differences between the model predictions and field data are expected. The overall trend and the quantitative predictions of the seepage-stress model developed here are very reasonable, at least, for practical purposes.

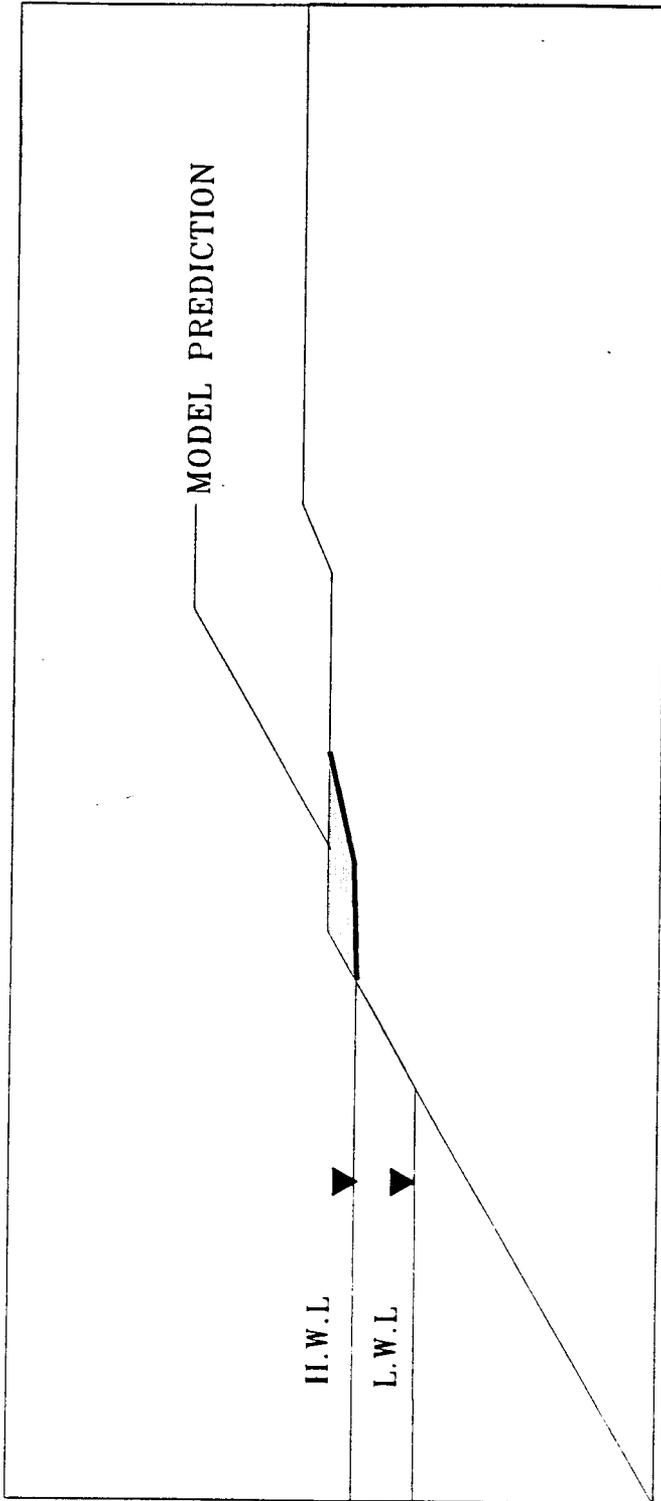
Fig. 29 Seepage-stress model prediction of mass wasting under EAS 4 for sand bar
172L.

We now explore the question, would mass wasting occur under the GCESEIS alternatives assuming the same initial cross section? We found from the measured river stage data at sand bar 172L, a river stage-discharge relationship of 0.3933m per 100m³/s for Profile 8. We introduced river stage variations approximating a 10 day regime each of alternatives 3, 4 and 5 on Profile 8. The model predicted no erosion for alternative 3. The erosion predicted for alternative 4 involves a zone of soil from the top of the slope to just below the high water level (Fig. 29). The model predicted massive mass wasting under alternative 5 as shown in Fig. 30.

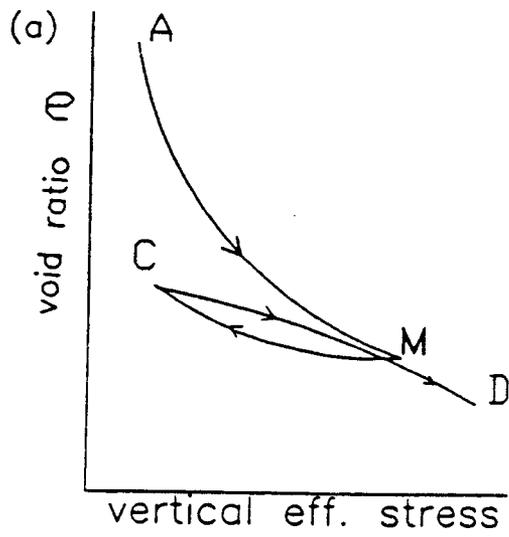
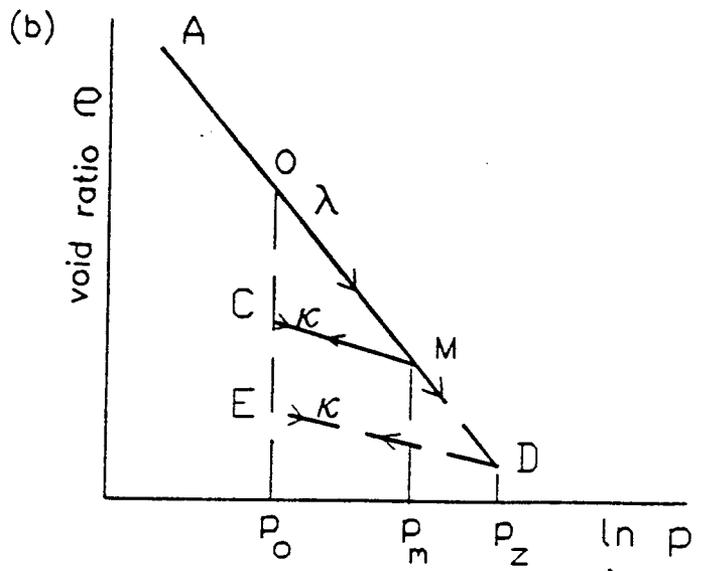
Fig. 1.1 (a) void ratio - vertical effective stress relationship.
 (b) void ratio - mean effective stress relationship.

In transient flow, the soil can undergo both elastic and plastic volumetric change. Let us consider the usual void ratio (e) - vertical effective stress consolidation diagram as shown in Fig. I-1a. The curve AM is the loading curve for a normally consolidated soil, MC is the unloading curve and CD is the reloading curve. These curves can be approximated by straight lines in $e - \ln p$ space (Schofield and Wroth, 1968) as shown in Fig. 1b. The hysteric unloading-reloading curves are replaced by a single straight line, MC, of slope κ while the loading curve has a slope of λ . Now consider a soil layer with the ground water level at time, t_0 , at a distance y from the ground surface (Fig. I-2). If the ground water level drops to a new position M, the mean effective stress on a typical element, X, located at a distance z from the surface will increase from say an initial value of p_0 to p_m . The soil consolidates and the total change in void ratio is

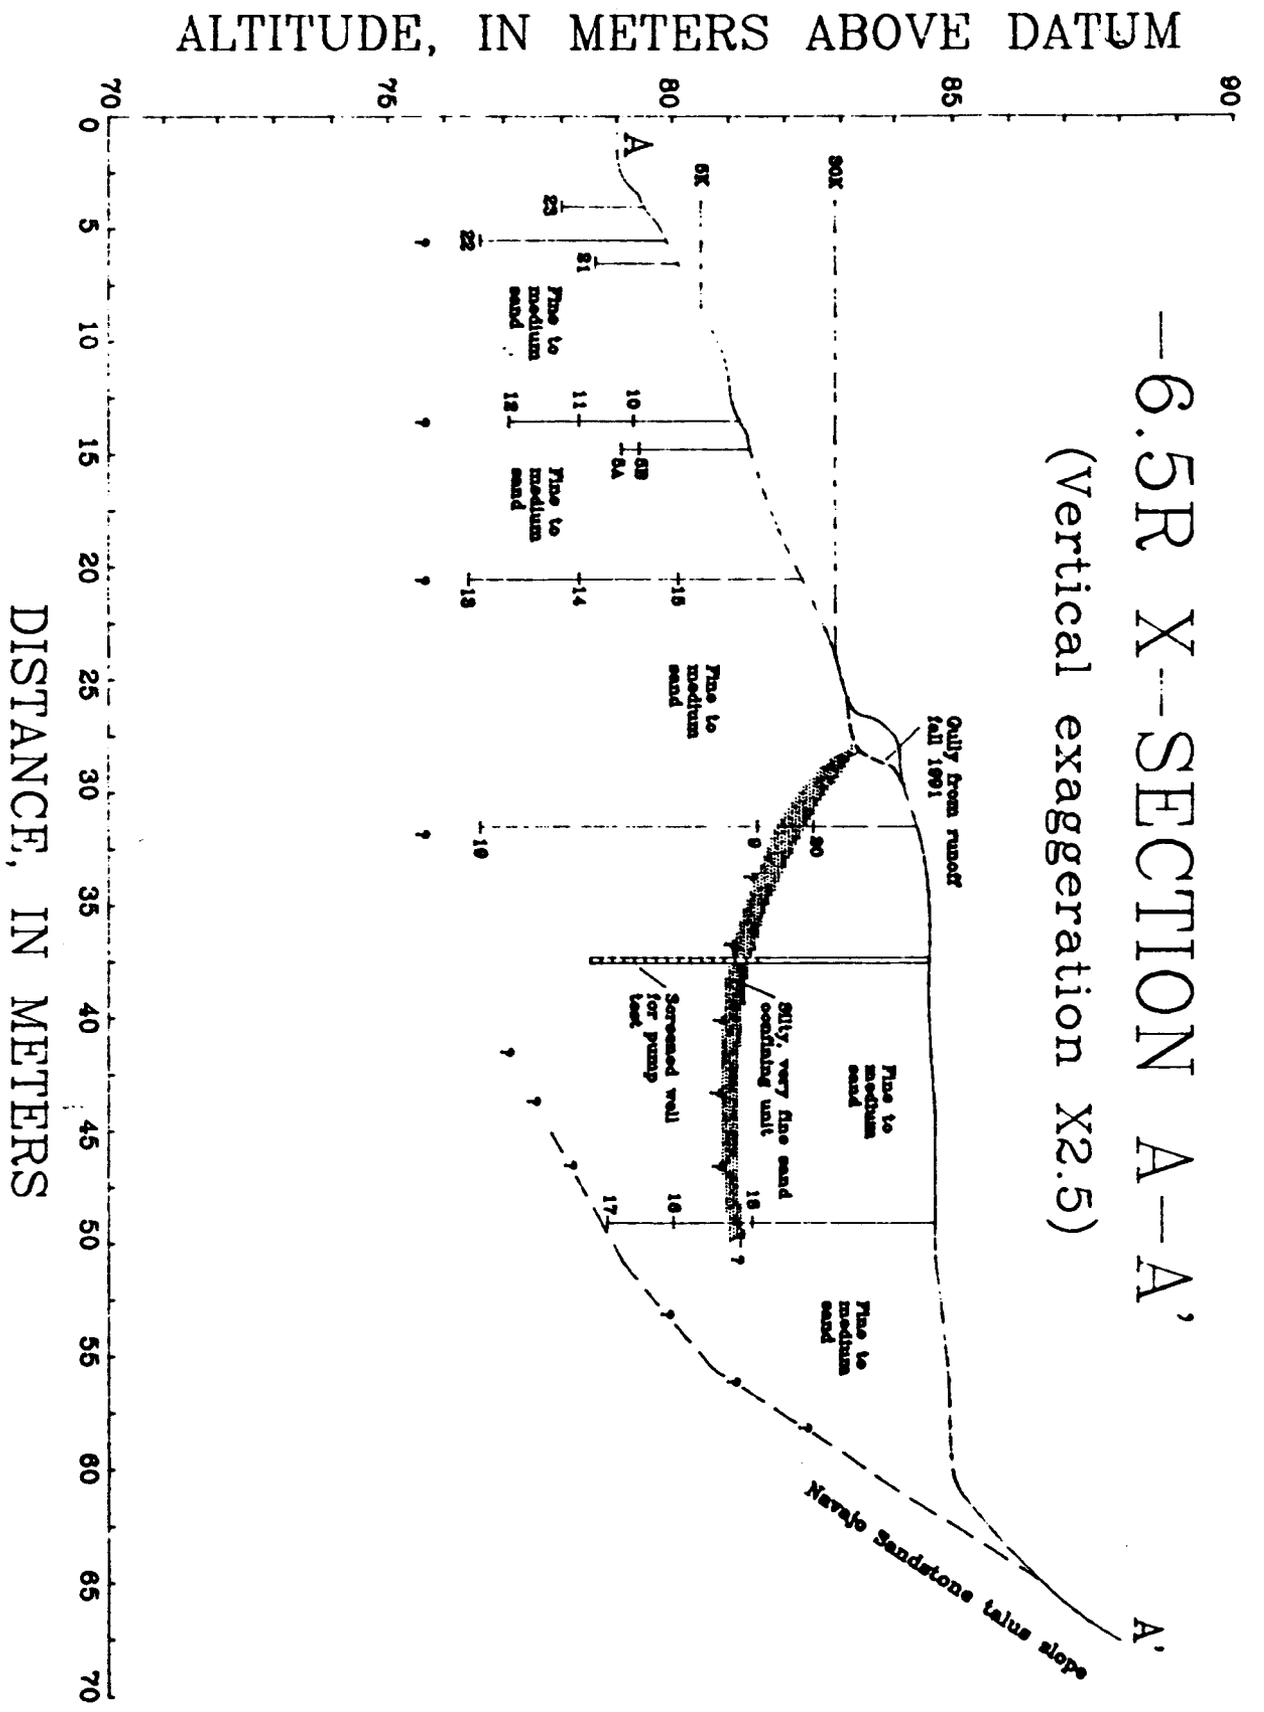
Figure 2.--Geologic section of sand bar -6.5R.

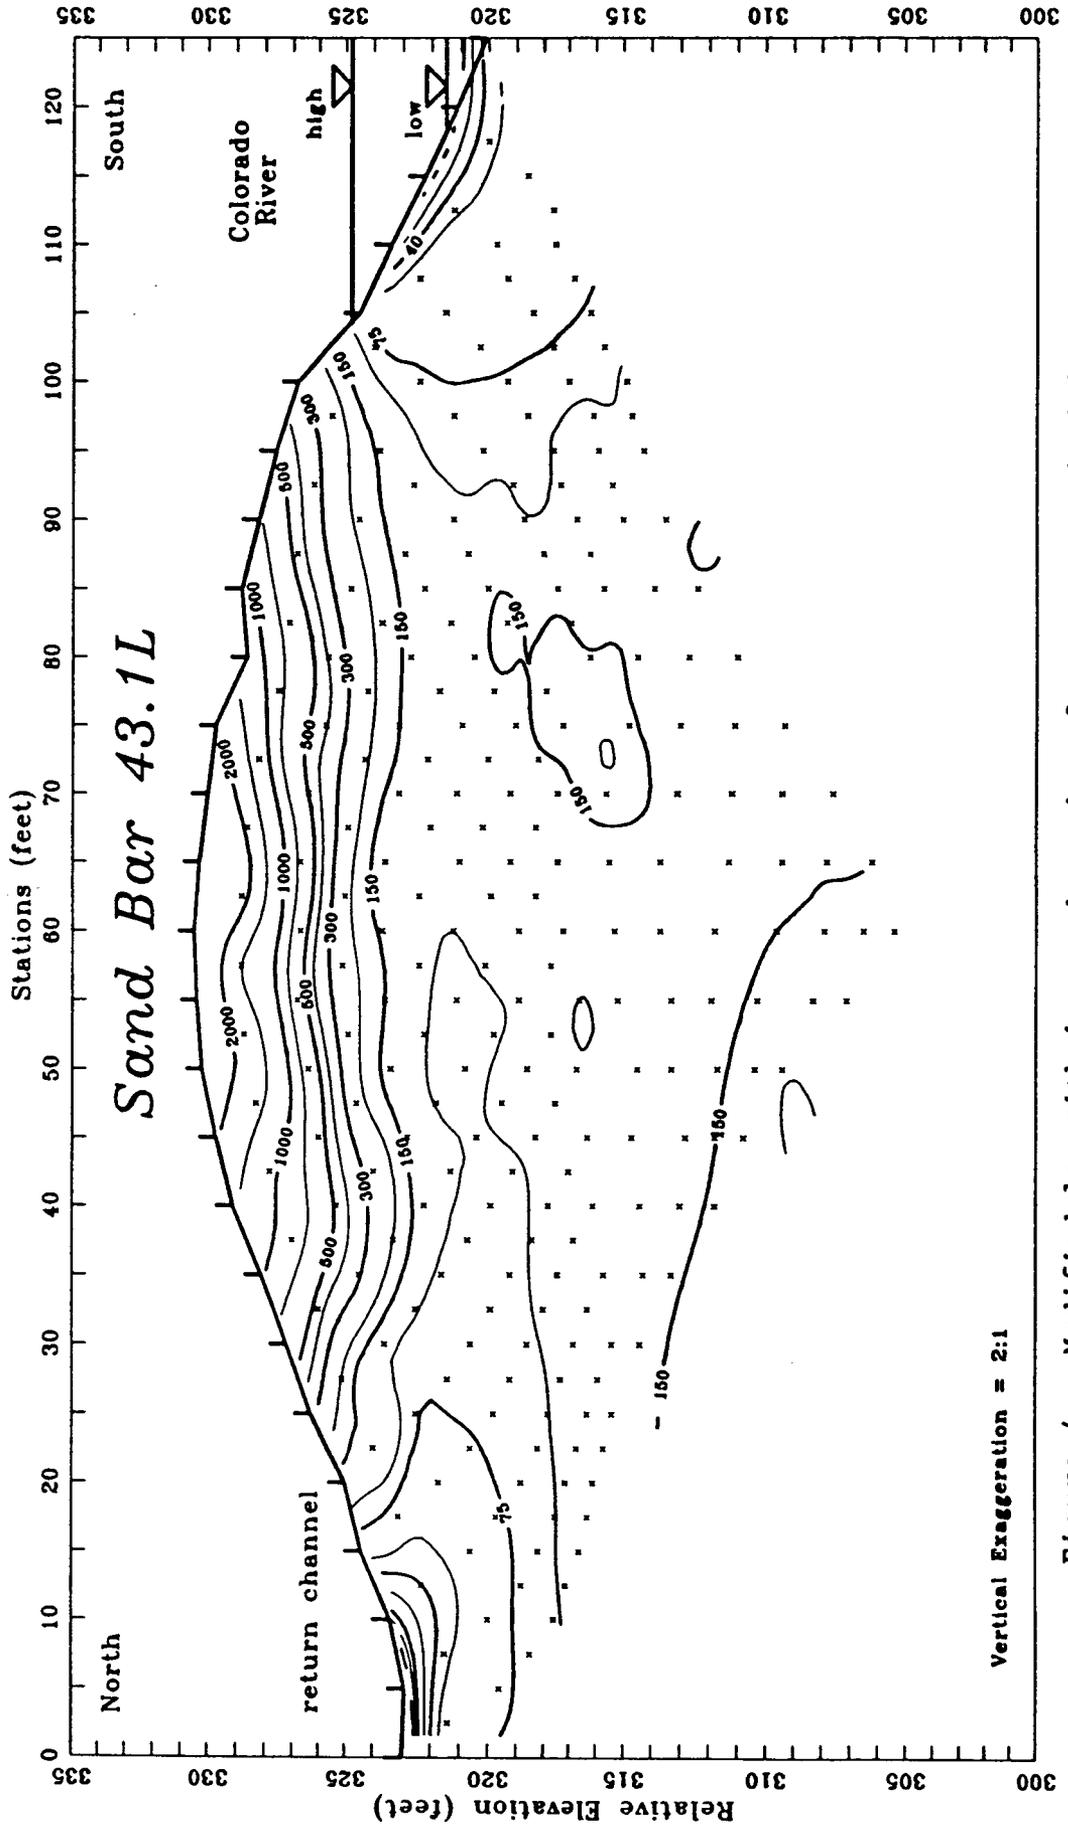
Figure 4.--Modified logarithmic pseudosection of apparent resistivity referred to land surface at sand bar 43.1L.

A single line of pole-pole DC resistivity was performed at sand bar 43.1L. The line was 36.5 m long and crossed the sand bar transversely, north to south, beginning at the base of the canyon wall next to outcrop and continuing across the elevated, dry-sand portion of the sand bar, and down

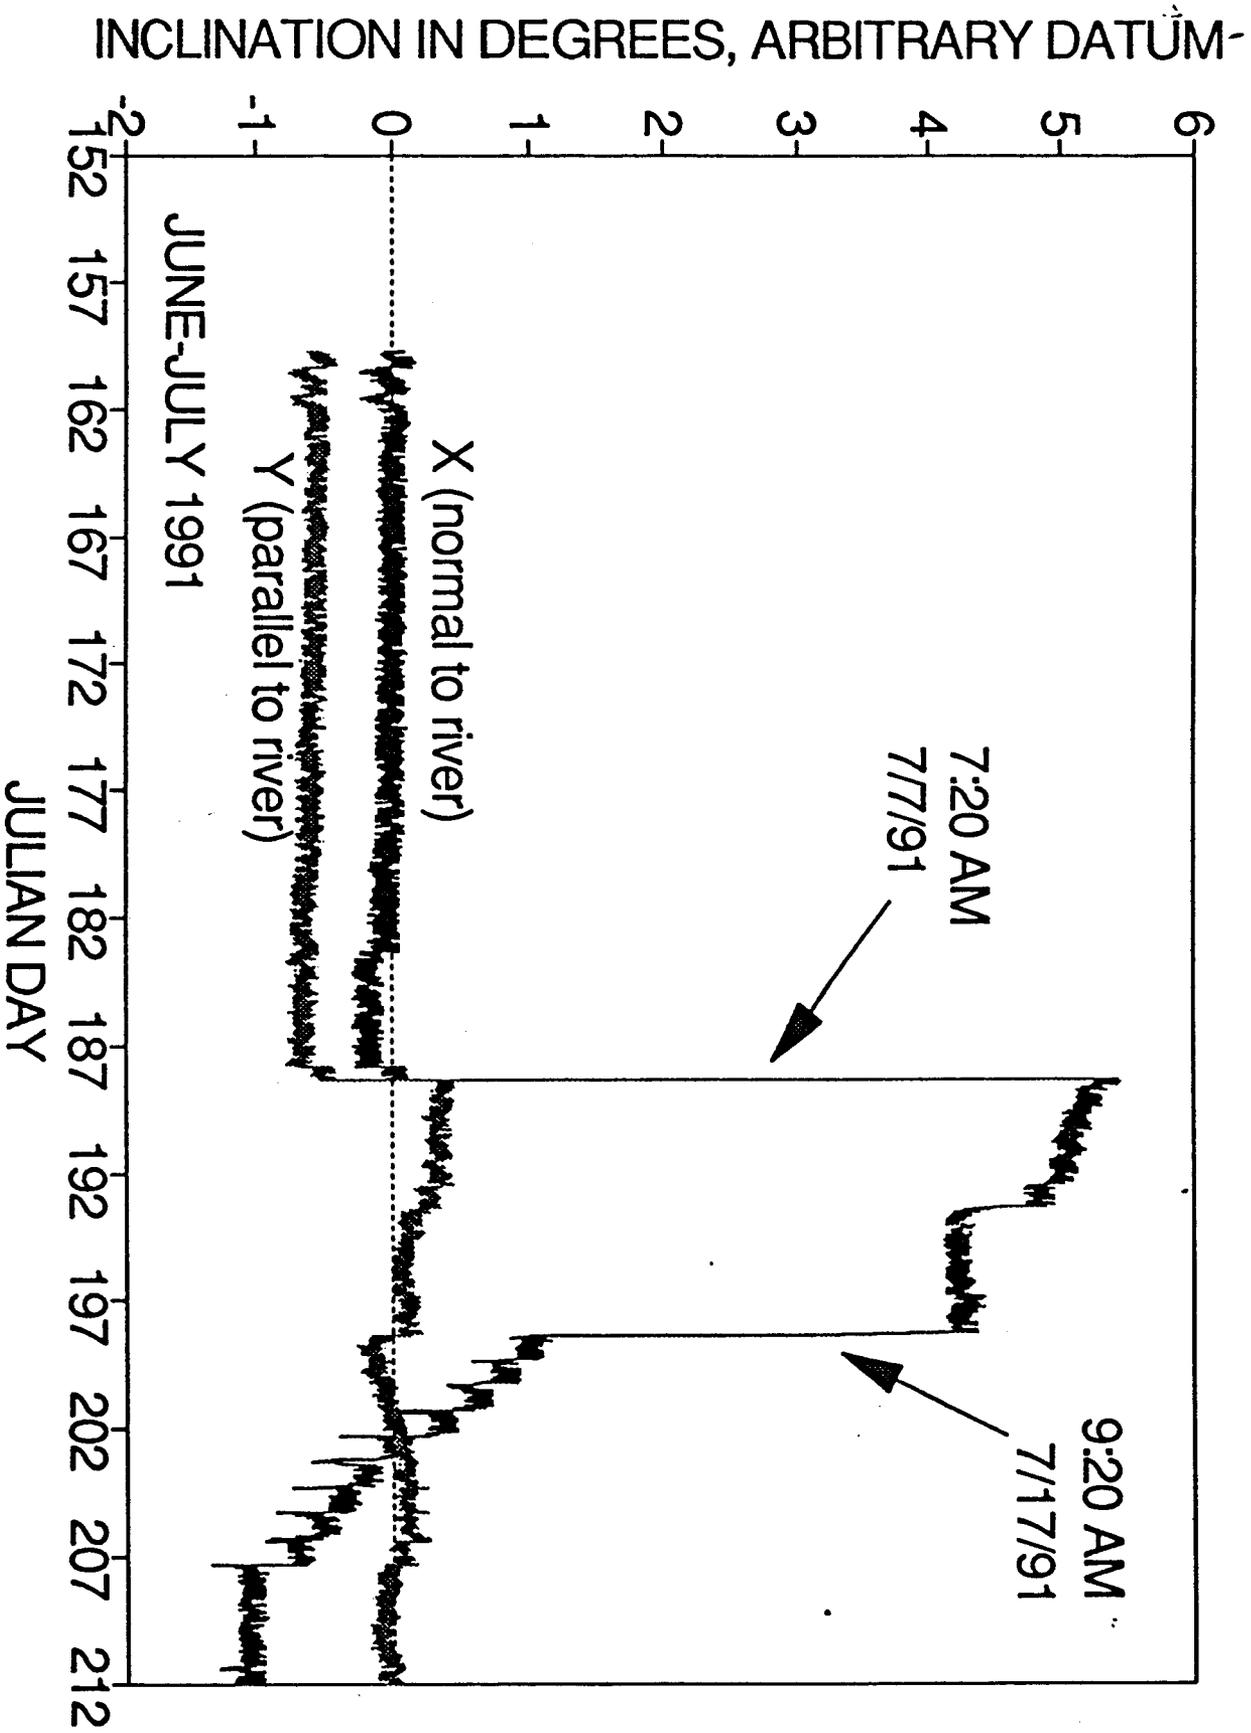
Figure 6.--Tilt for sensor 18 at sand bar 43.1L, June-July 1991.

At sand bar 43.1L, a sequence of tilts occurred from July 7, 1991, through July 17, 1991 (fig. 6). The tilts were at least five times greater in the x tilt sensor, which is oriented orthogonal to the river with the convention of increasing inclination being upward tilt toward the river than in the y tilt sensor. The y tilt sensor is oriented parallel to the river with the convention of increasing inclination being upward tilt facing down river. The events were preceded by downward tilt of -0.1° toward the river on the morning of July 2, and upward tilt of 0.1° the evening of July 6. At 7:20 a.m. on July 7, upward tilt of 5.5° occurred in the x sensor. In the morning of July 12, downward tilt of -0.5° occurred; and at 9:20 a.m. on July 17, an additional -3.3° of downward tilt occurred. These major events were followed by continued negative tilt in the x sensor from July 18 to July 26, punctuated with daily downward spikes of about 0.4° that occurred in the morning. With the single exception of the precursor upward tilt on July 6, all of the sudden tilts occurred on downward limbs of the hydrographs (figs. 7-12) when the effective stress (intergranular stress) in the sand-bar face

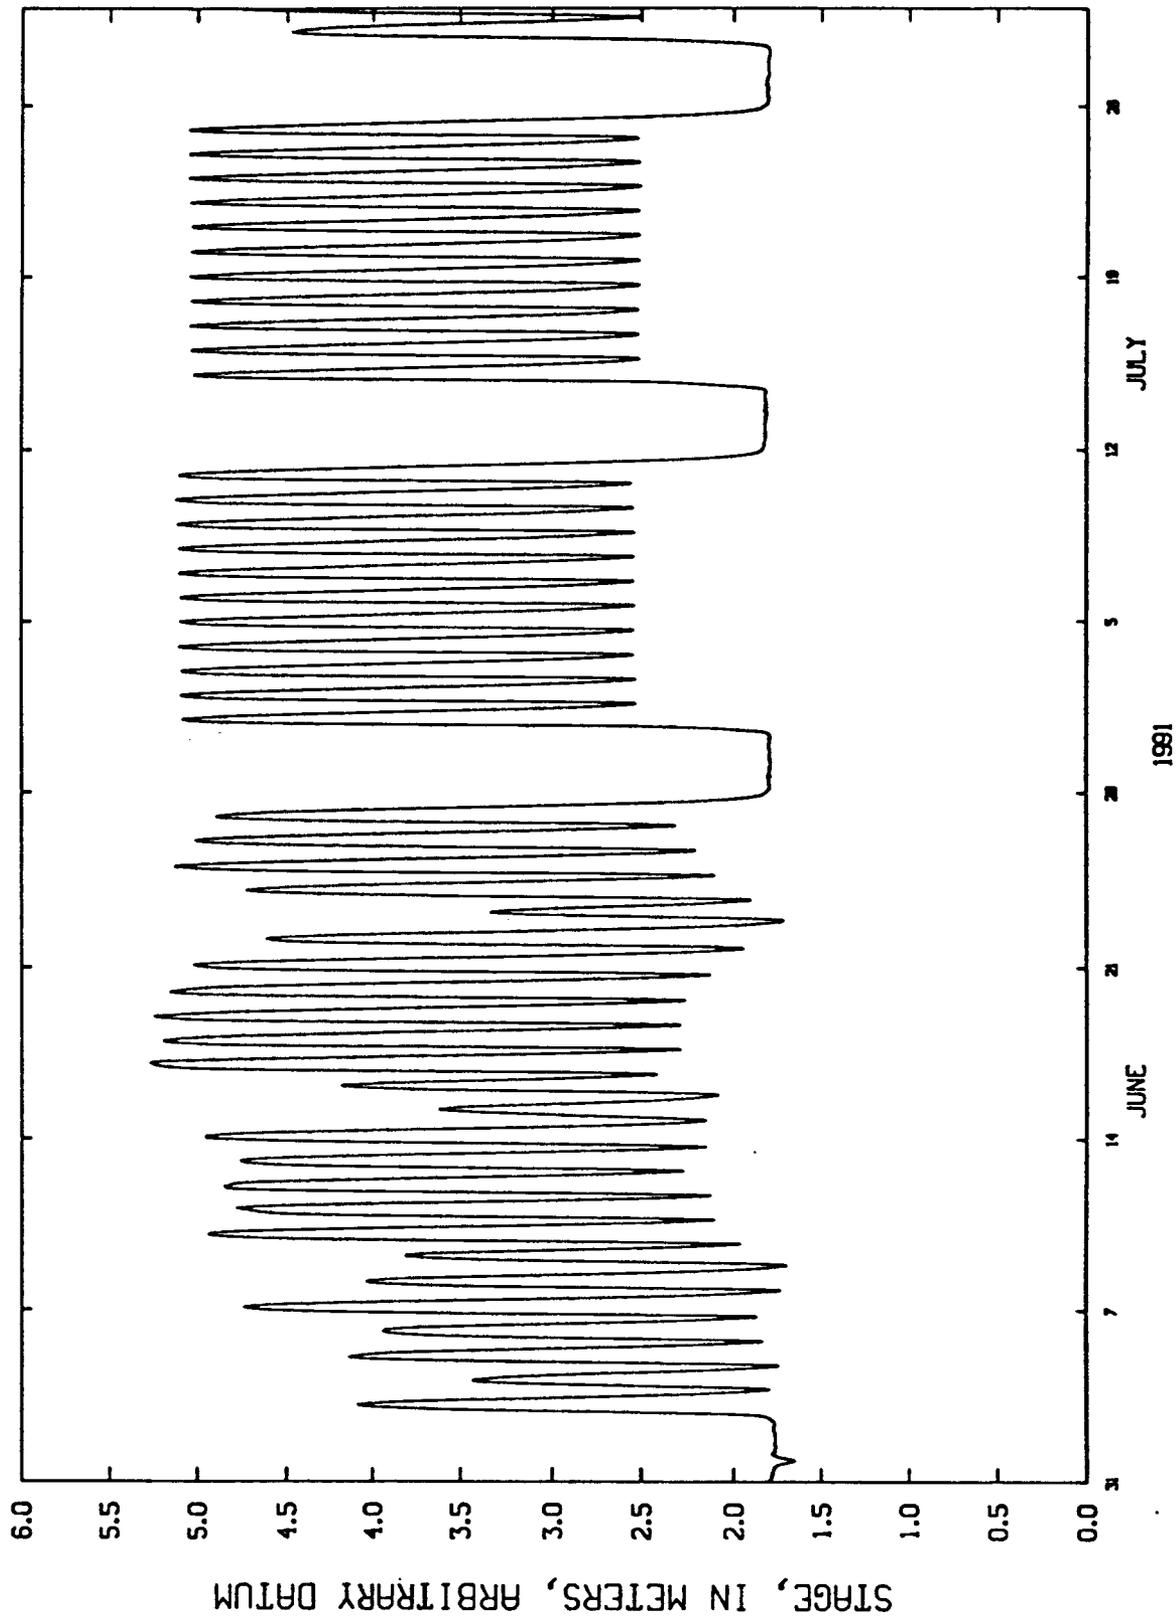
Figure 7.--River stage at river mile 40, June-July 1991.
