**THE INFLUENCE OF VARIABLE DISCHARGE REGIMES ON
COLORADO RIVER SAND BARS BELOW GLEN CANYON DAM:
FINAL REPORT**

Northern Arizona University

NPS Cooperative Agreement Number: CA 8006-8-0002

**Sponsored by: The U.S. Department of Interior National Park Service Cooperative Parks Study Unit
Northern Arizona University Flagstaff, AZ 86011**

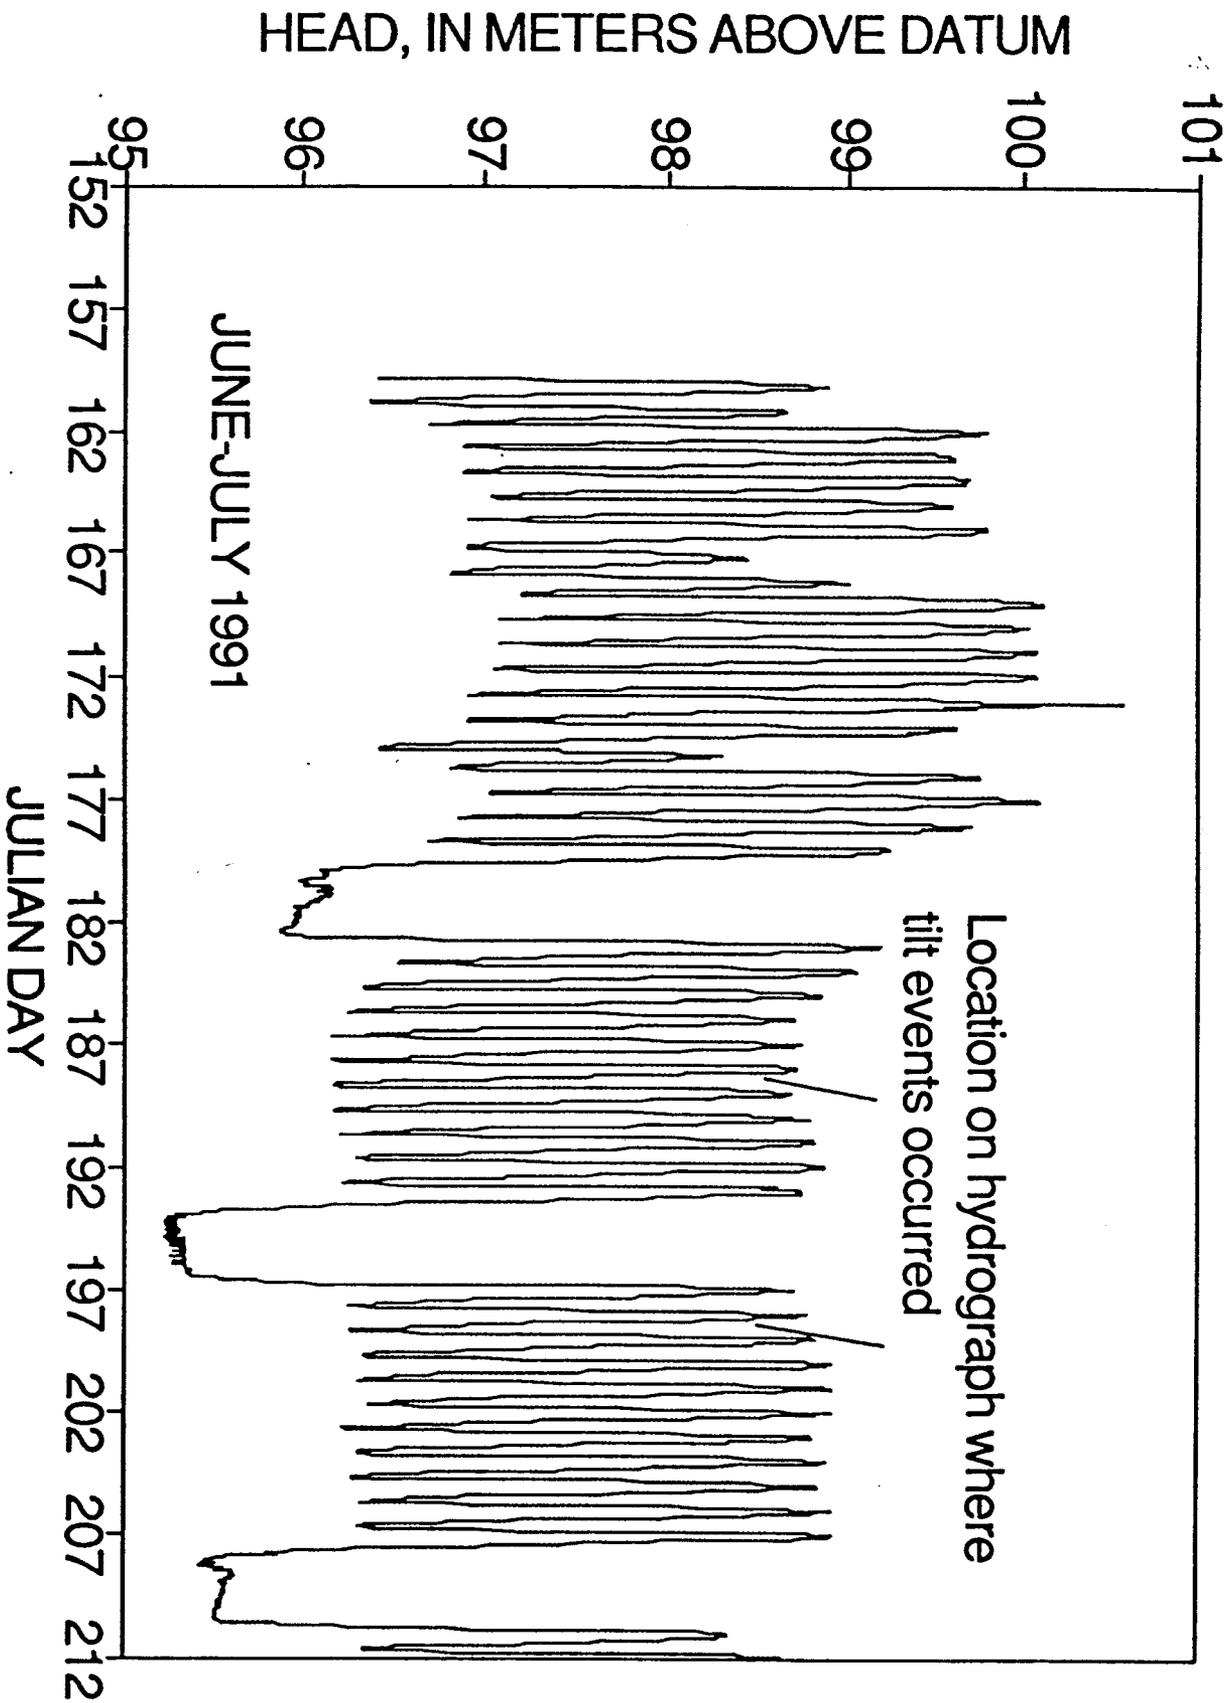
Figure 8.--River stage at sand bar 43.LL, June-July 1991.

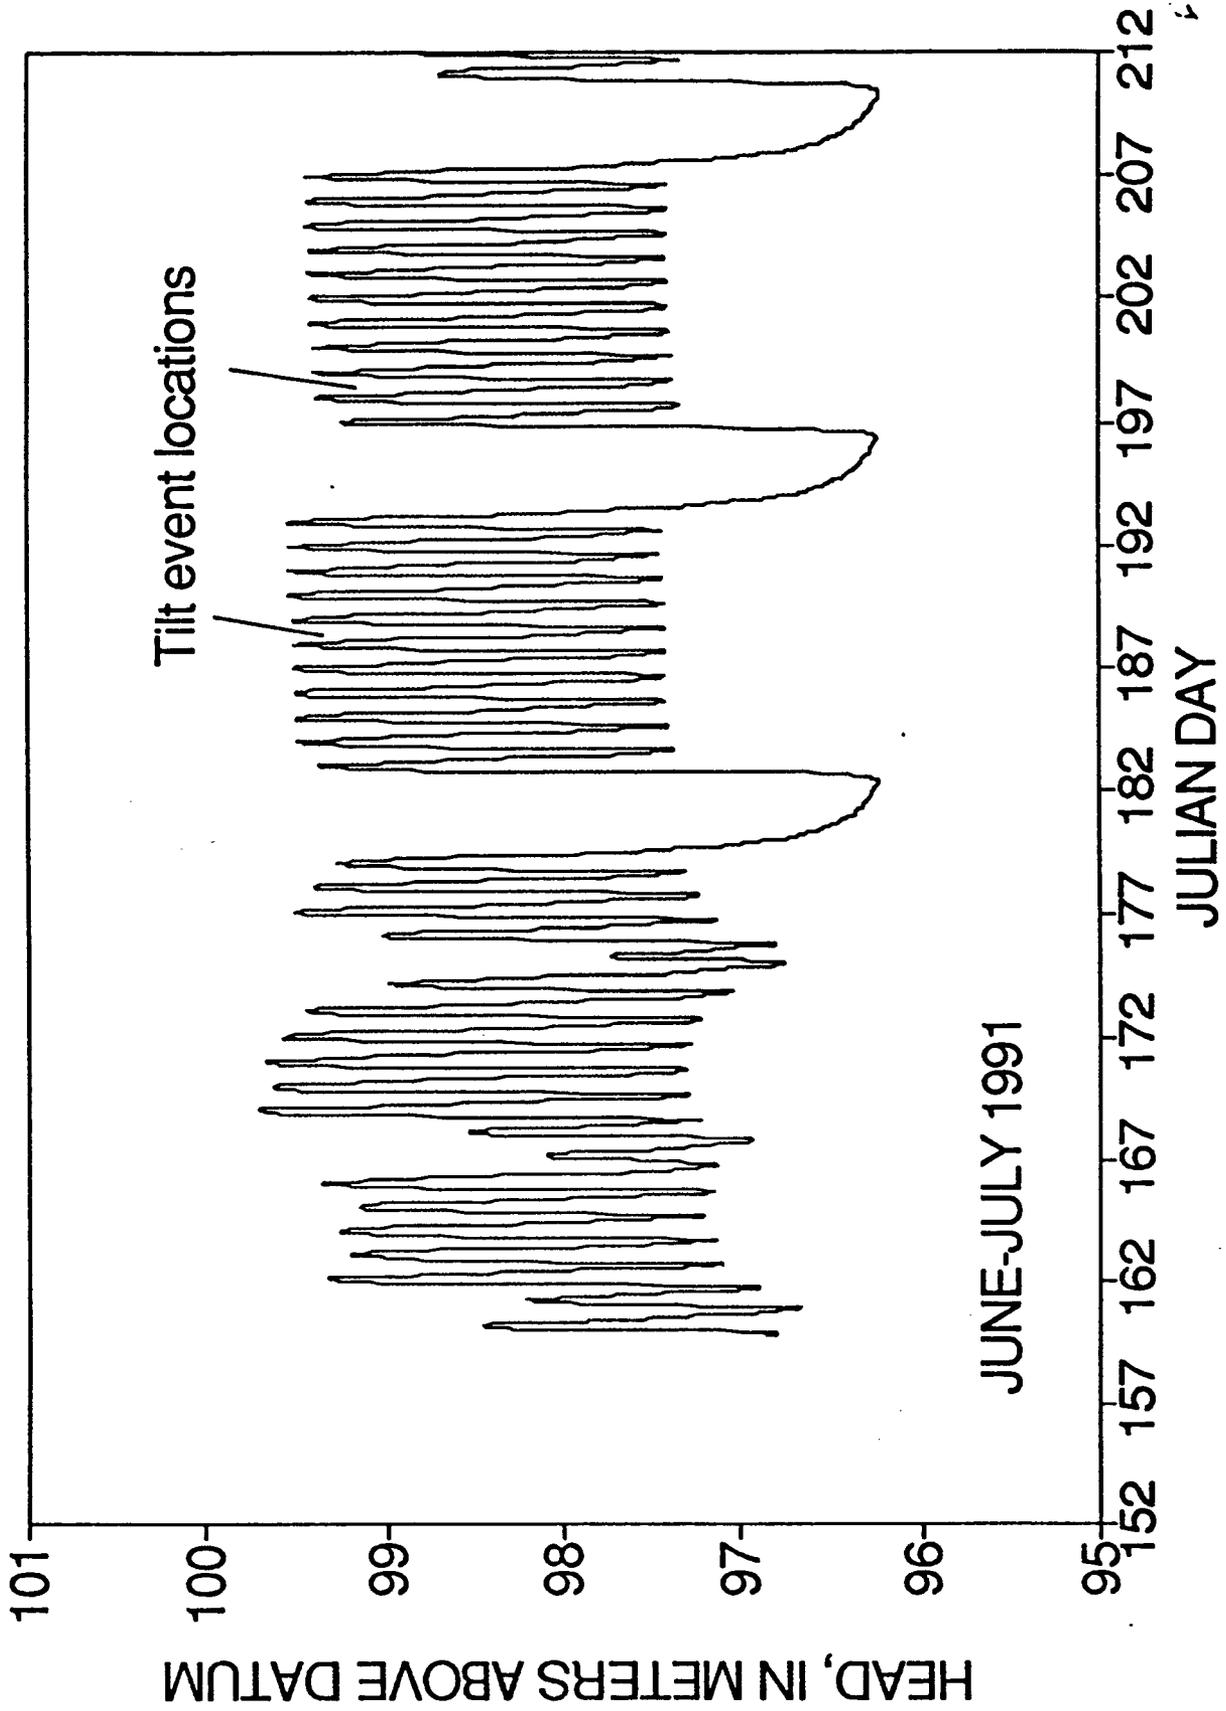
Figure 9. ---Water level in well 46 at sand bar 43.1L, June-July 1991.

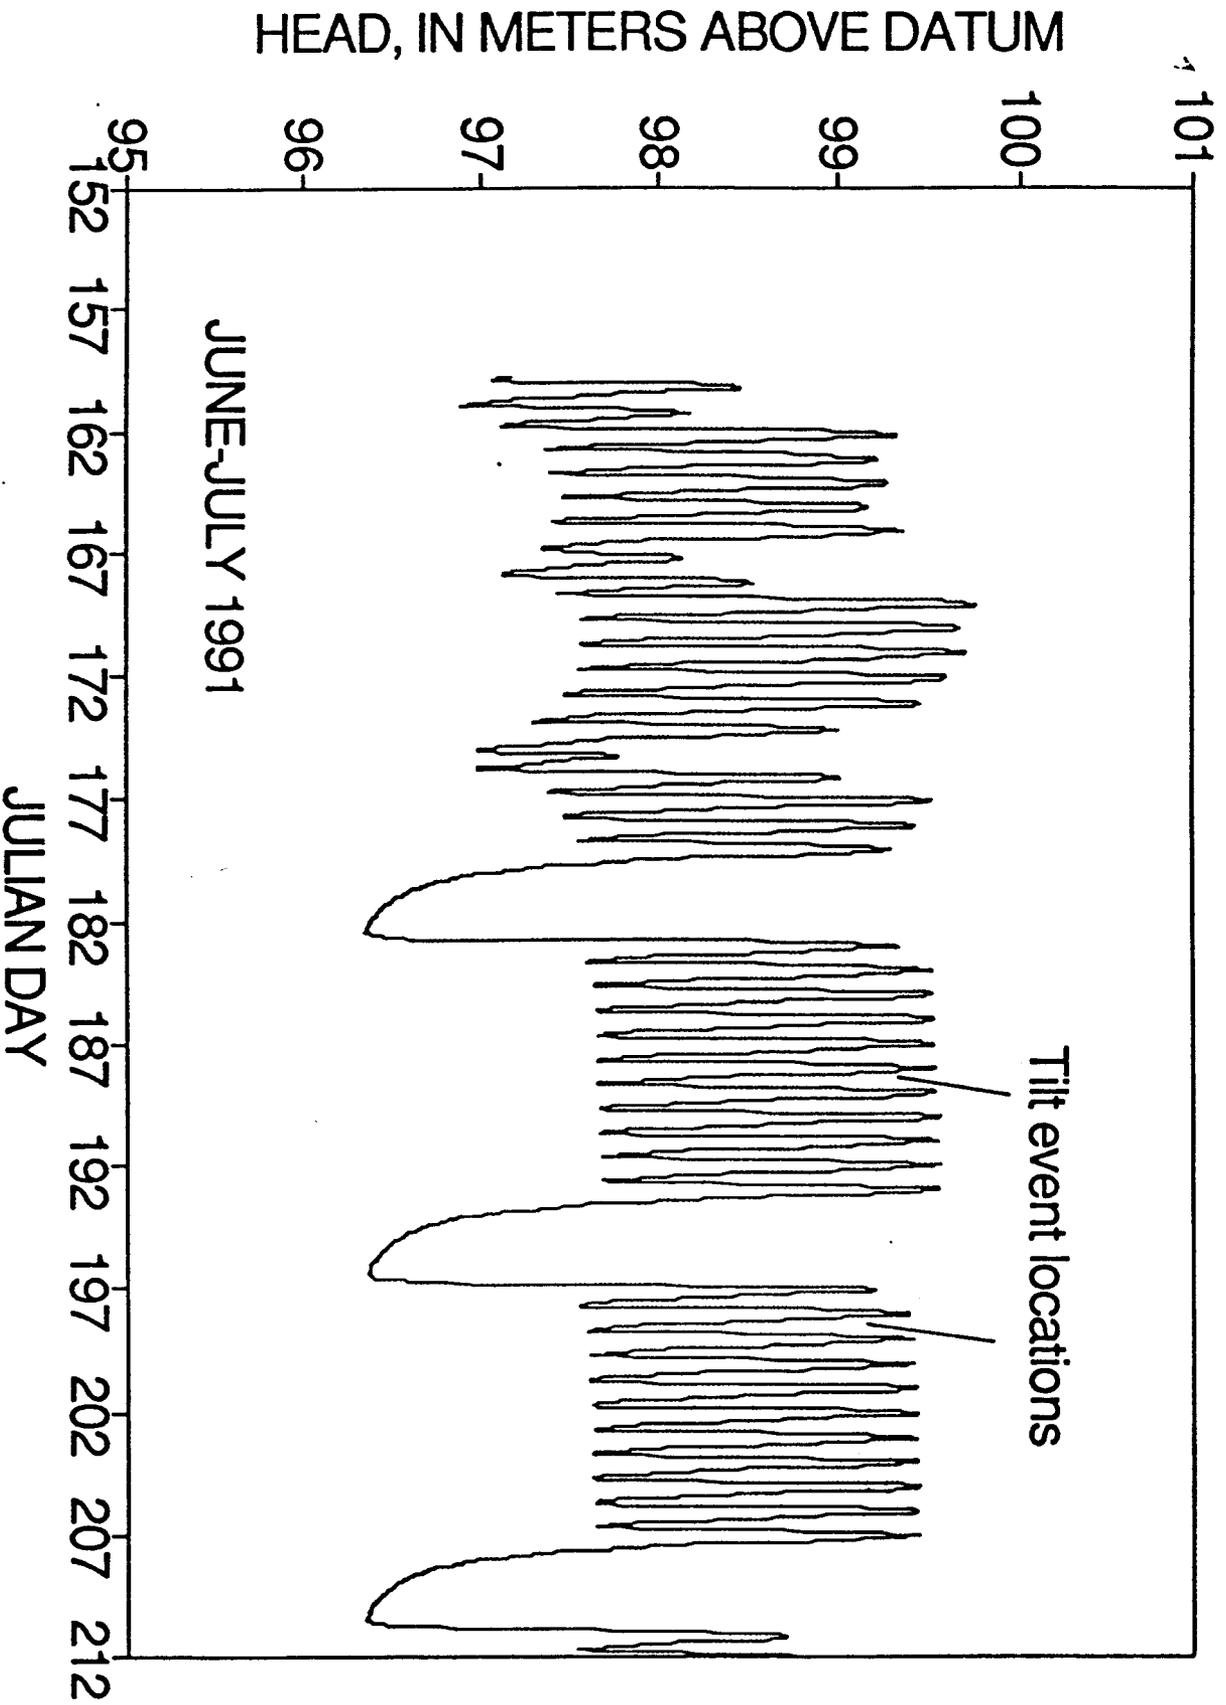
Figure 10.--Water level in well 40 at sand bar 43.1L, June-July 1991.

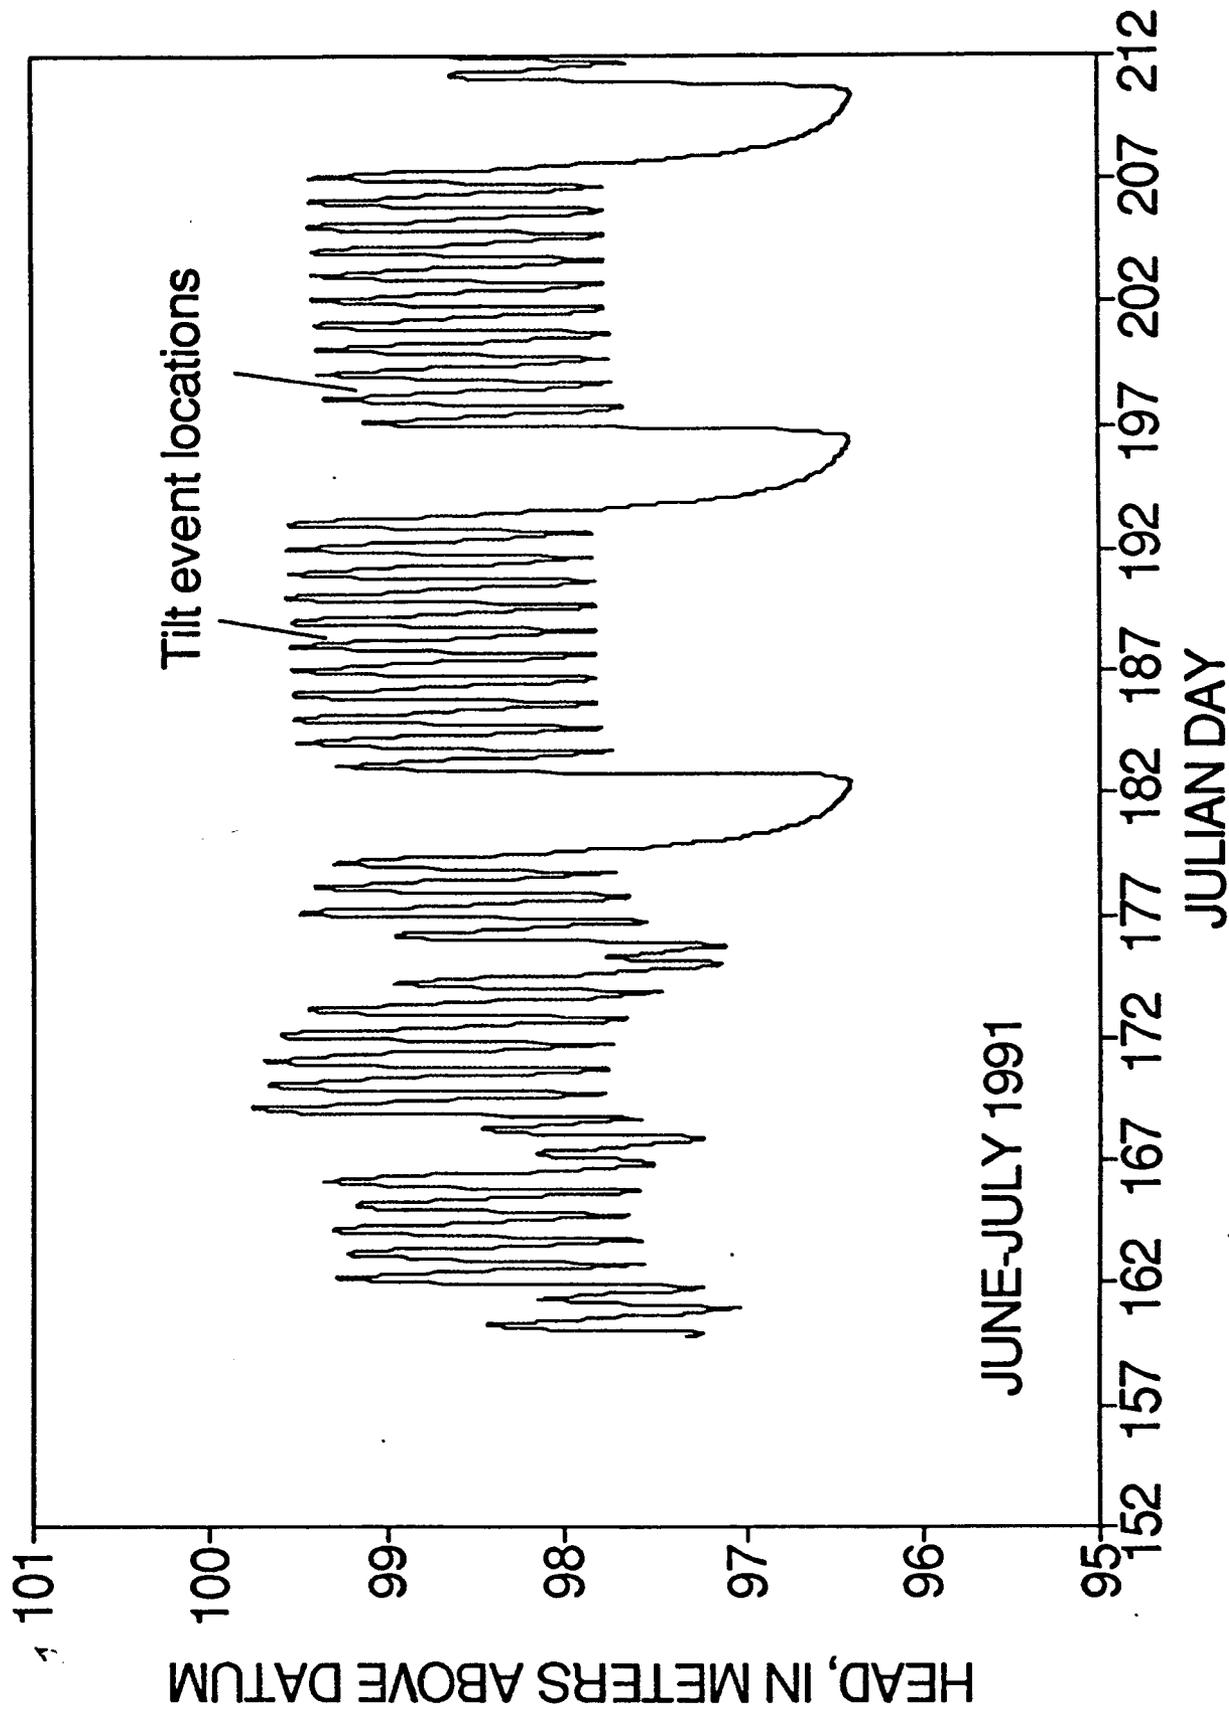
Figure 11.--Water level in well 37 at sand bar 43.1L, June-July 1991.

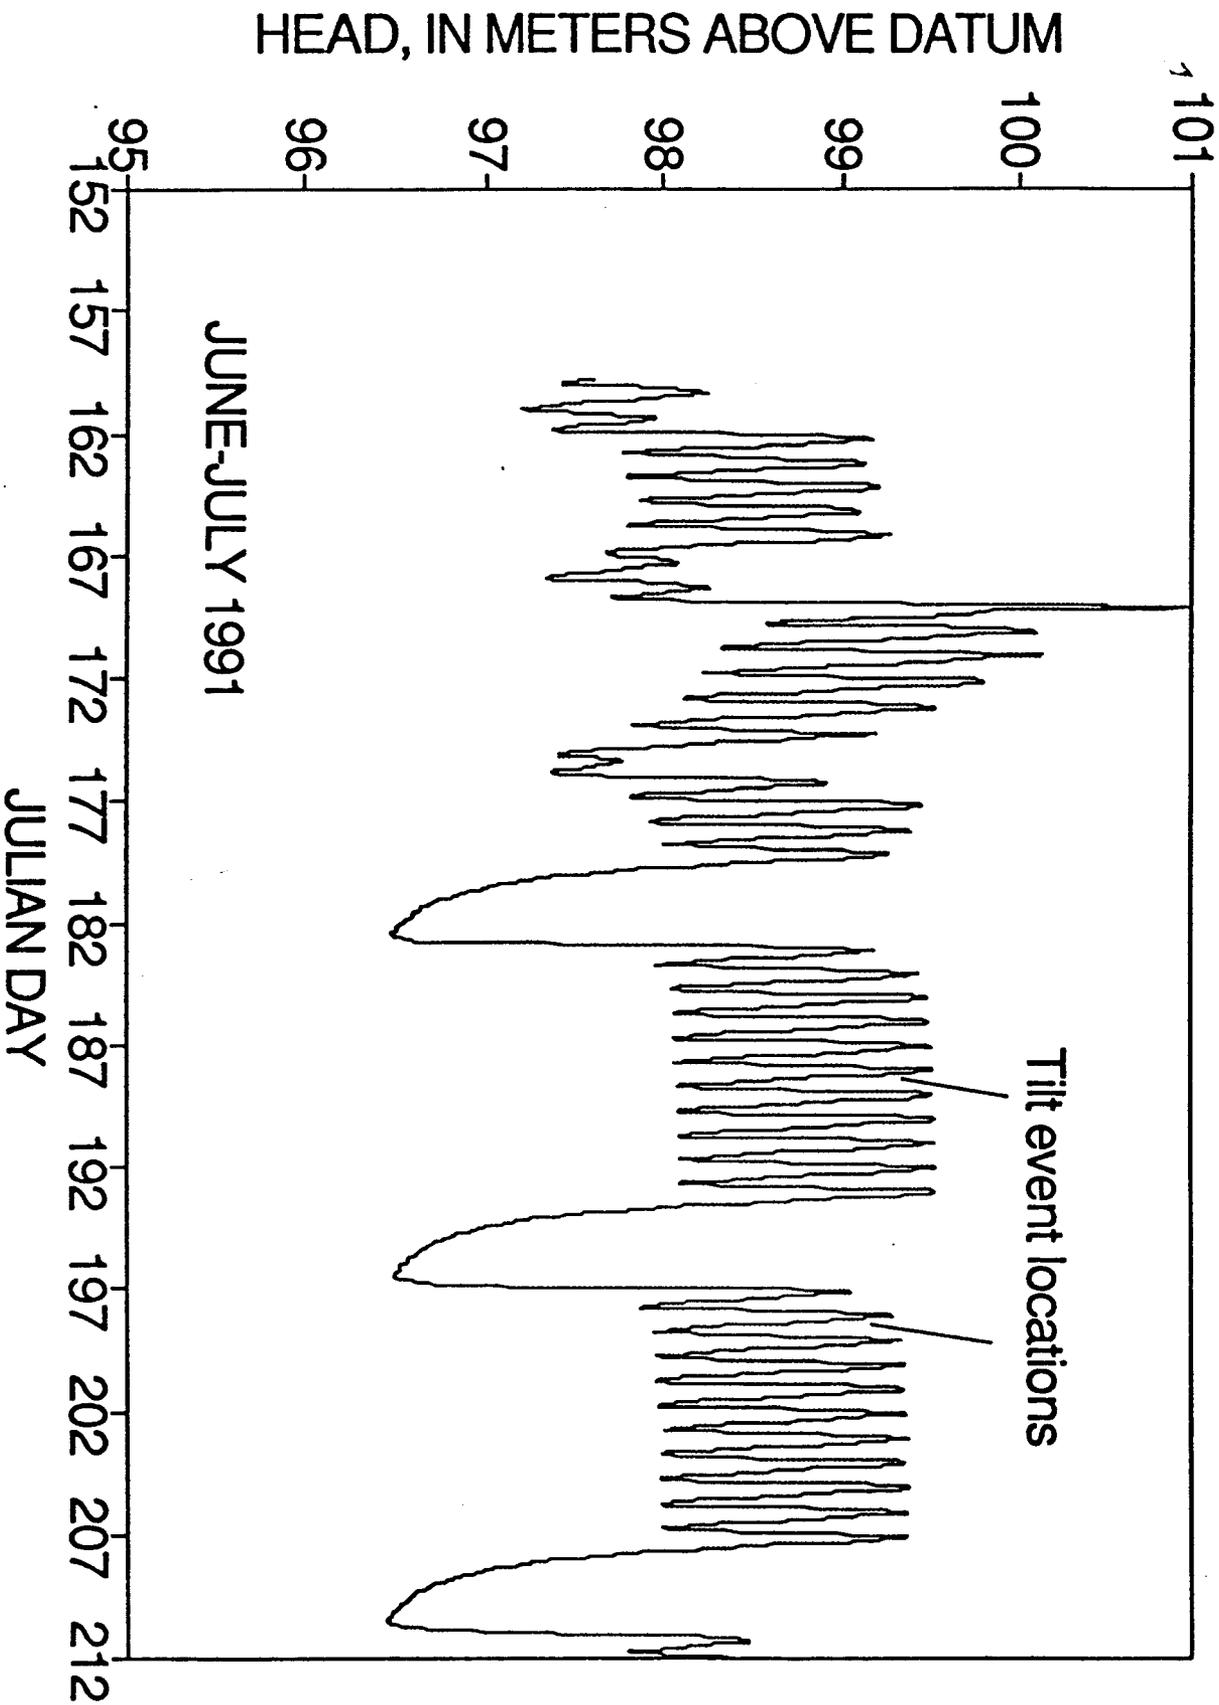
Figure 12.--Water level in well 42 at sand bar 43.1L, June-July 1991.

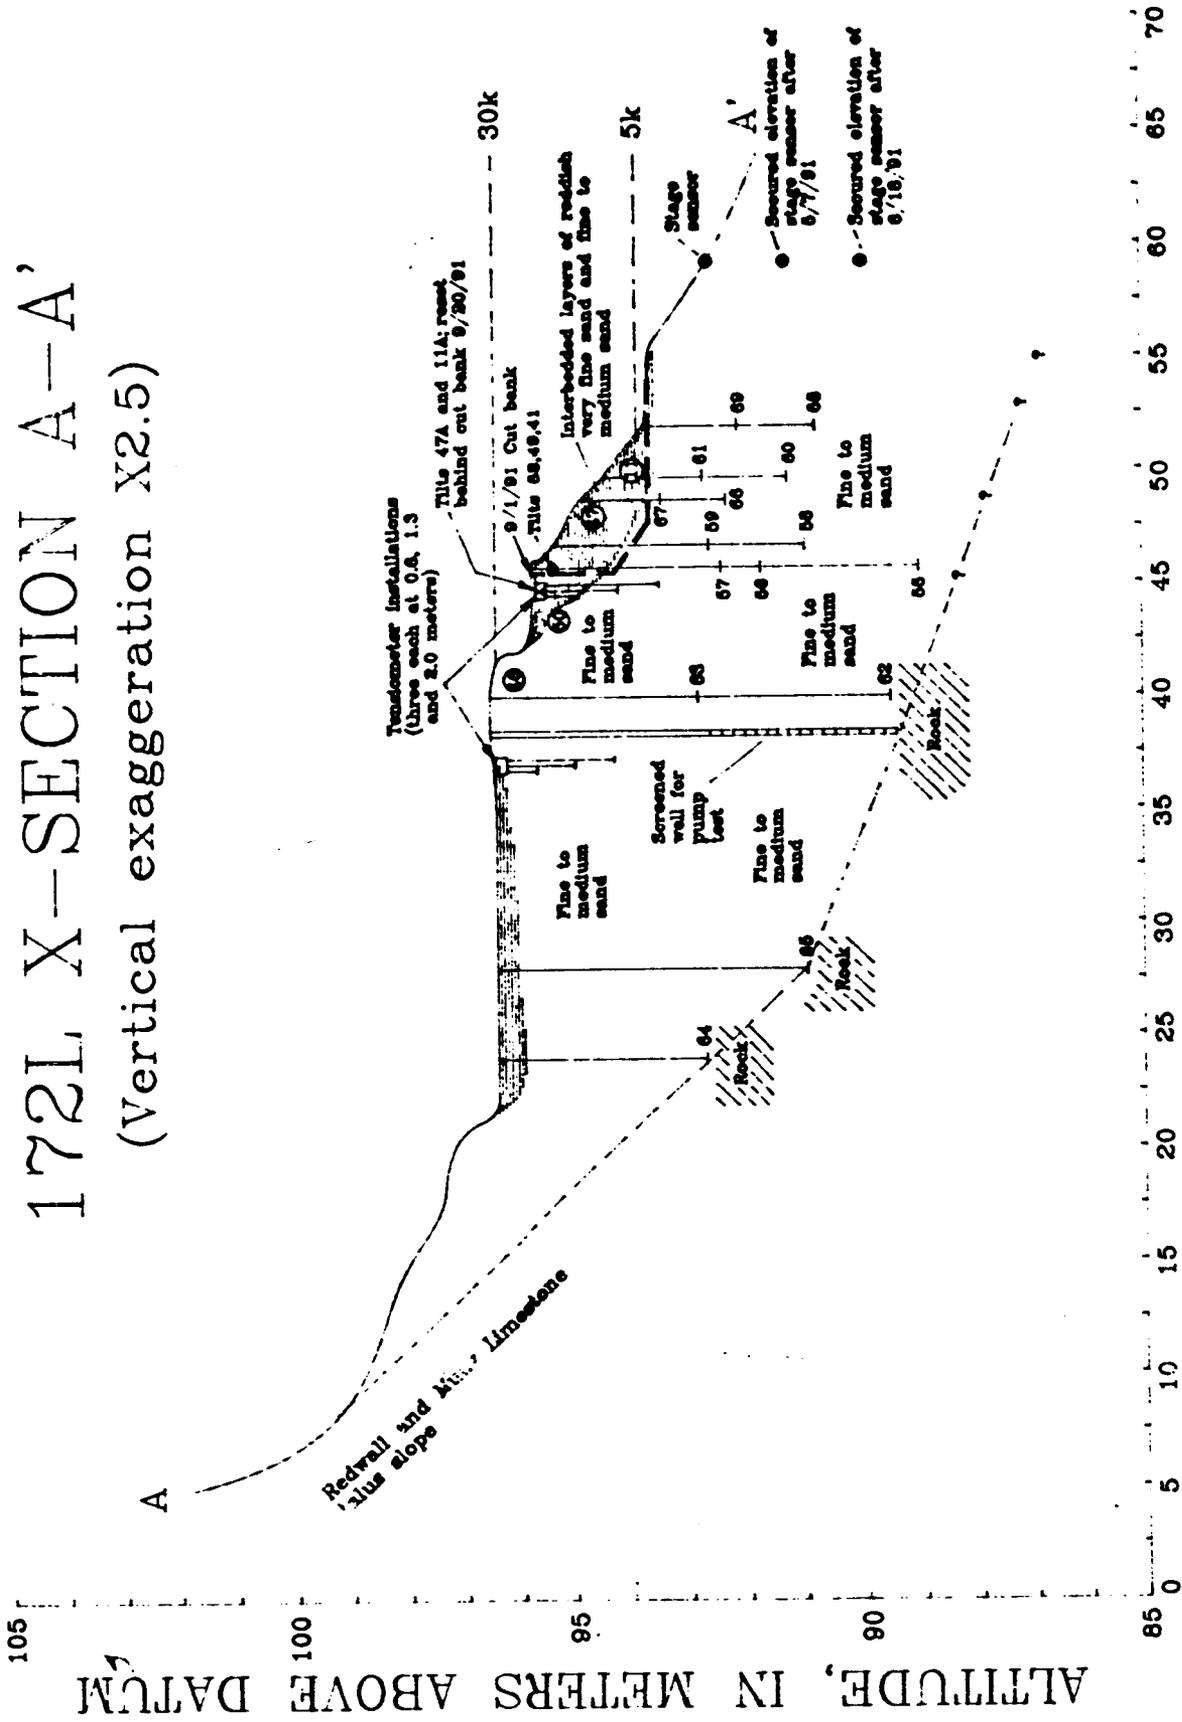
Figure 13.--Geologic section of sand bar 172.3L.

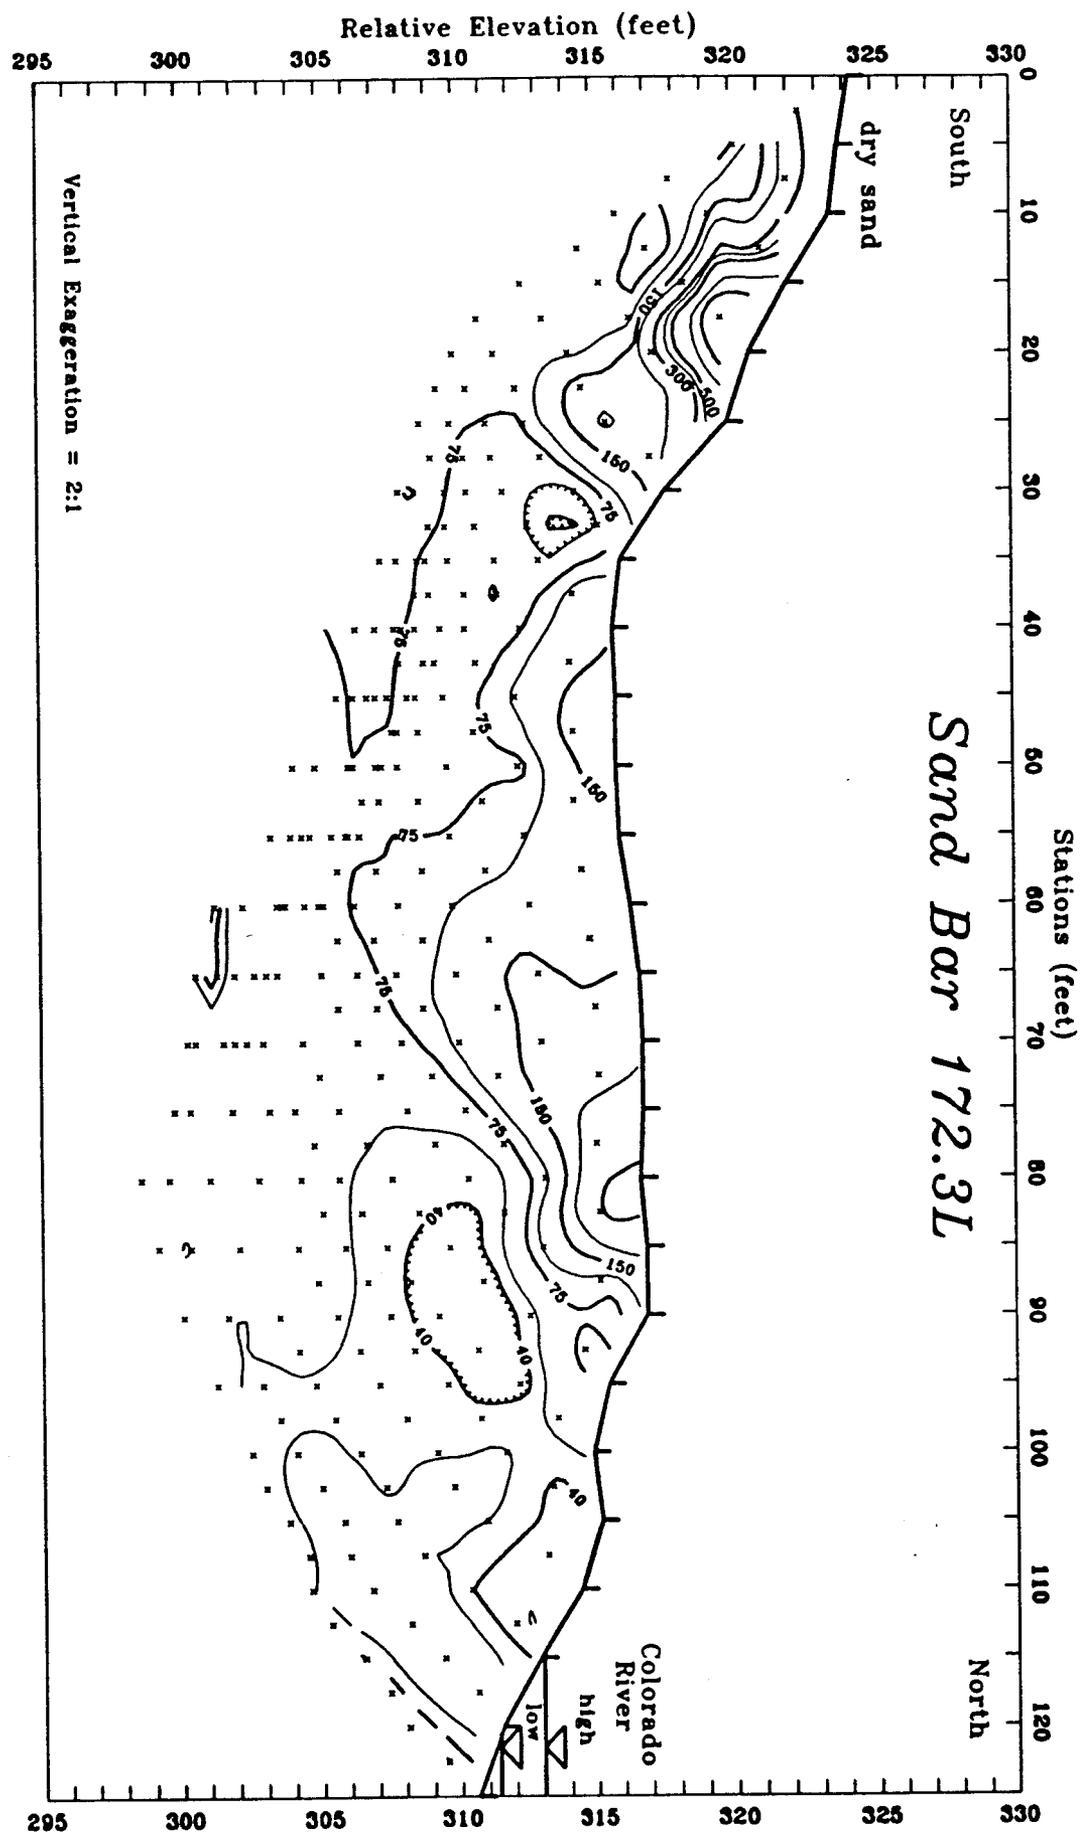
Figure 14--Modified logarithmic pseudosection of apparent resistivity referenced to land surface at sand bar 172.3L.

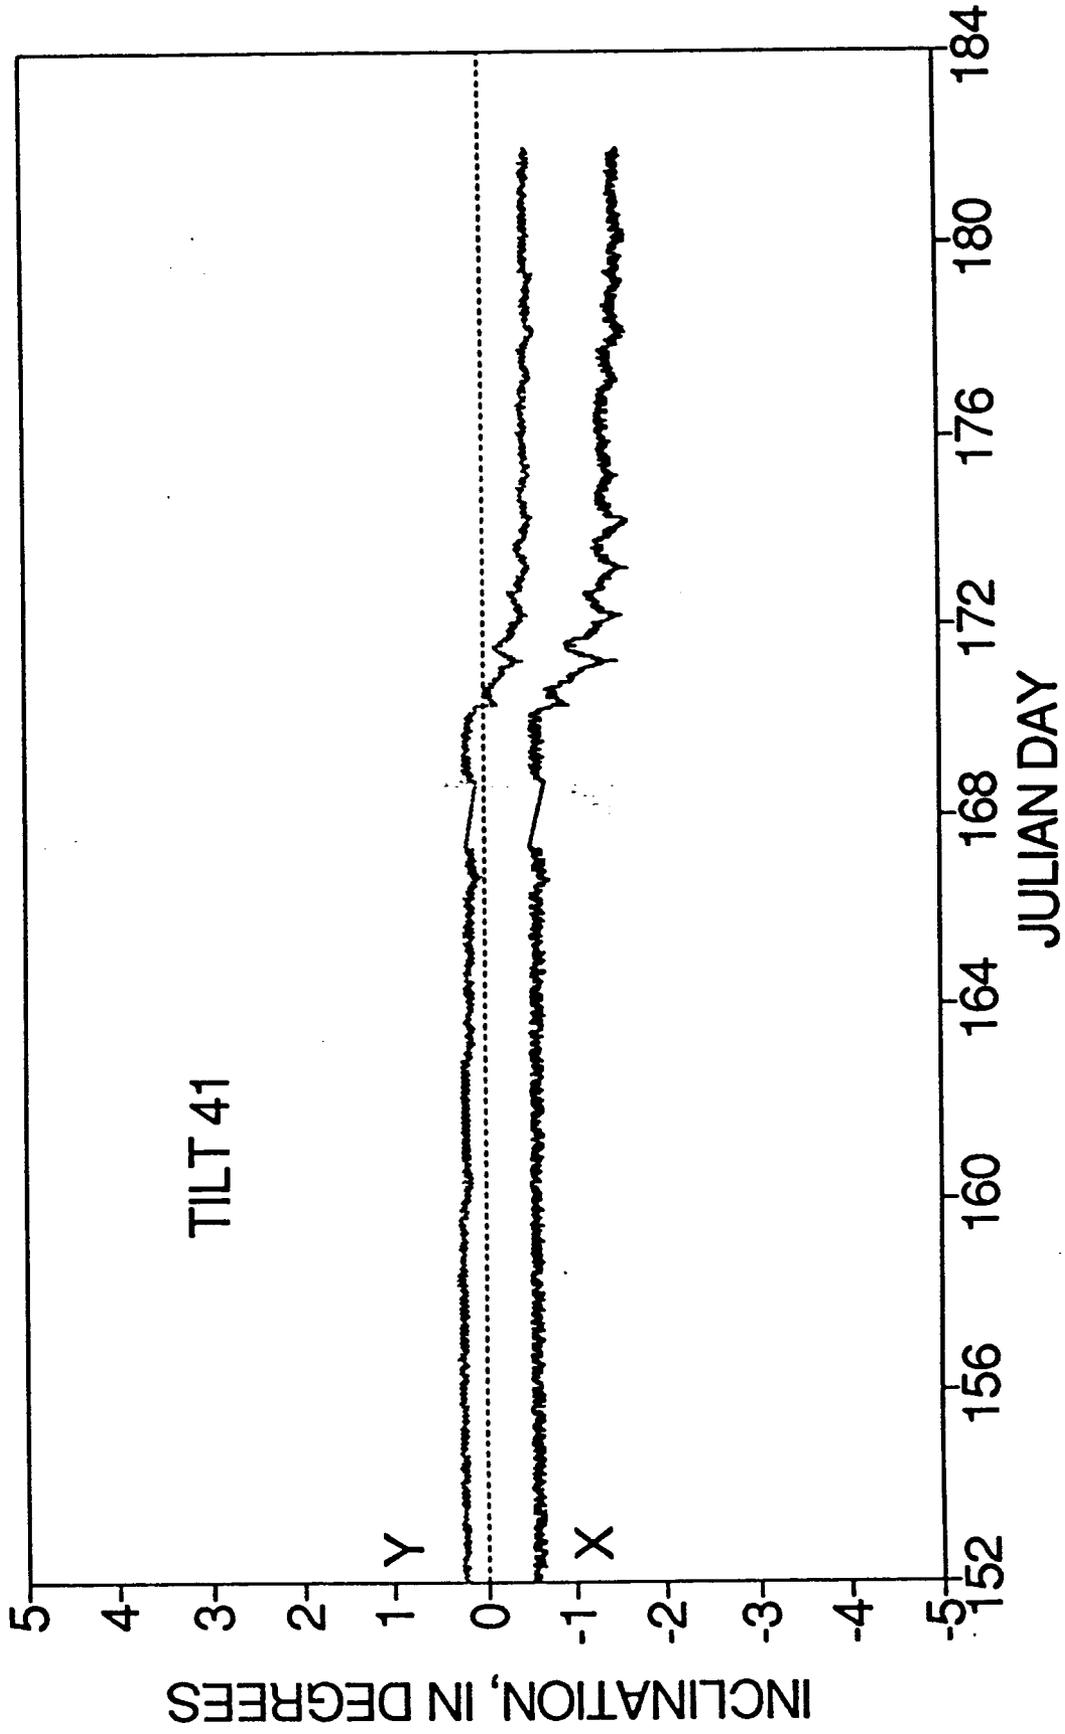
Figure 15. --Tilt for sensor 41 at sand bar 172.3L, June 1991.

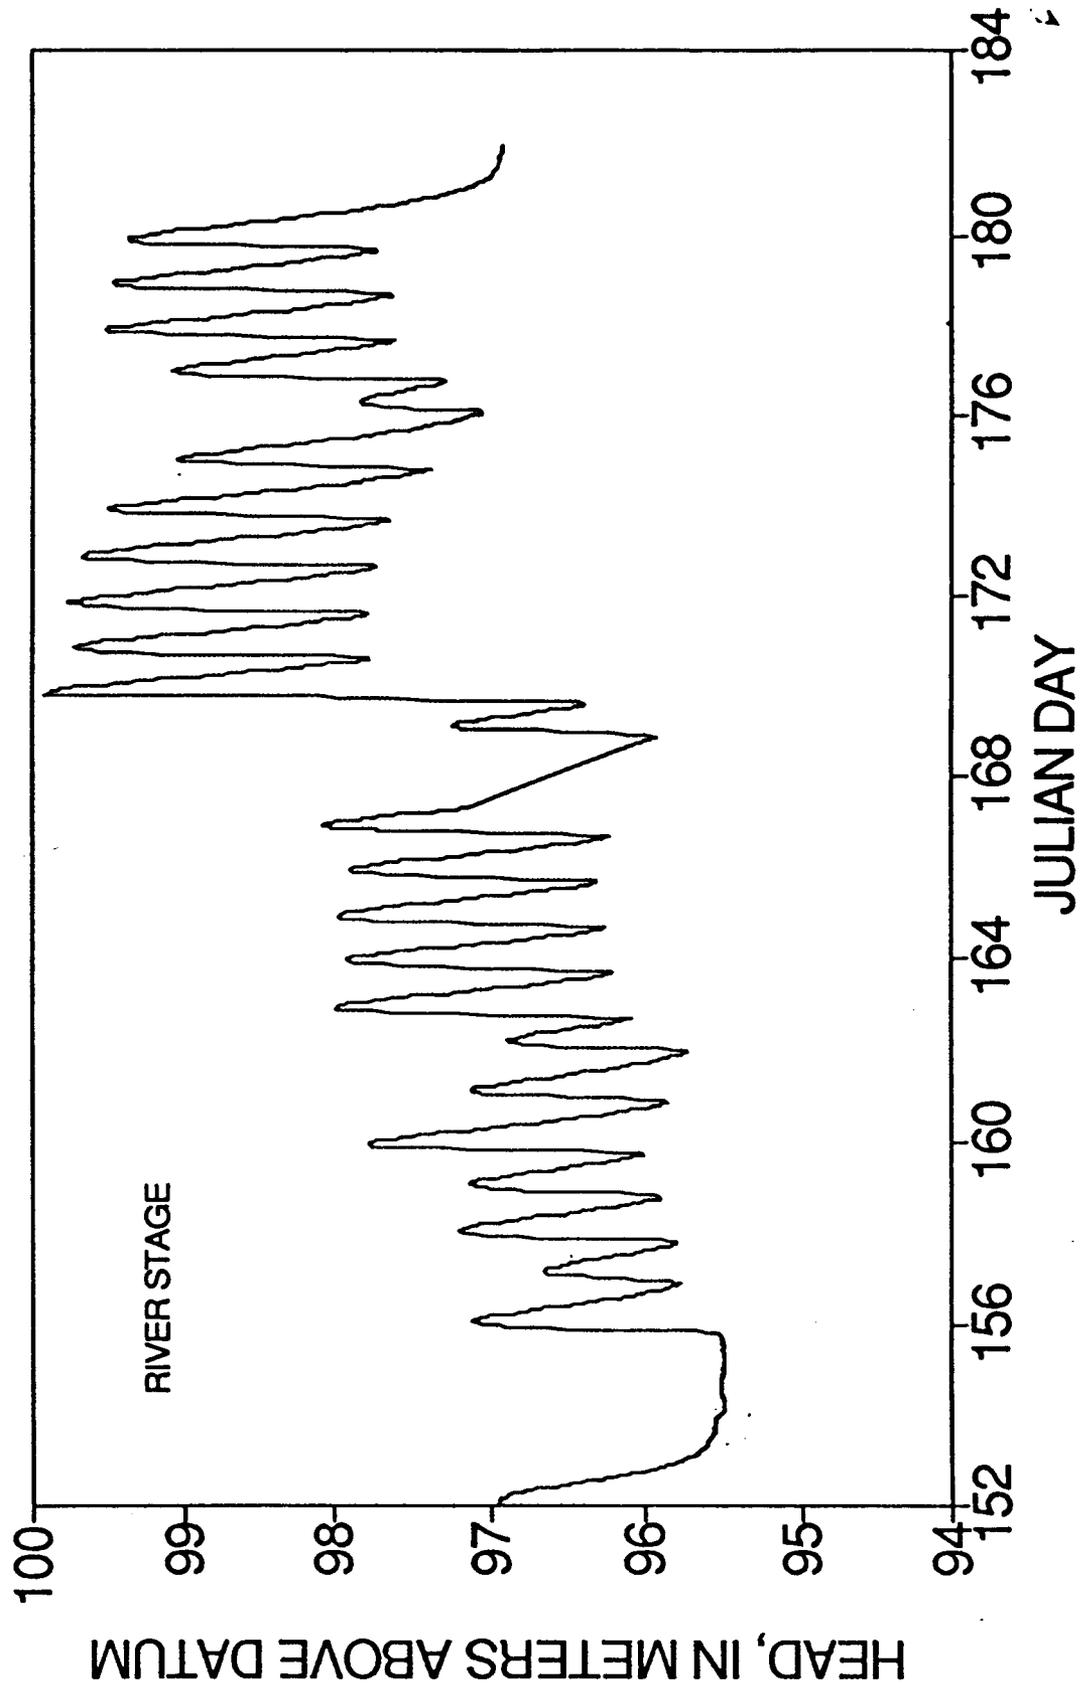
Figure 17. --River stage at sand bar 172.3L, June 1991.

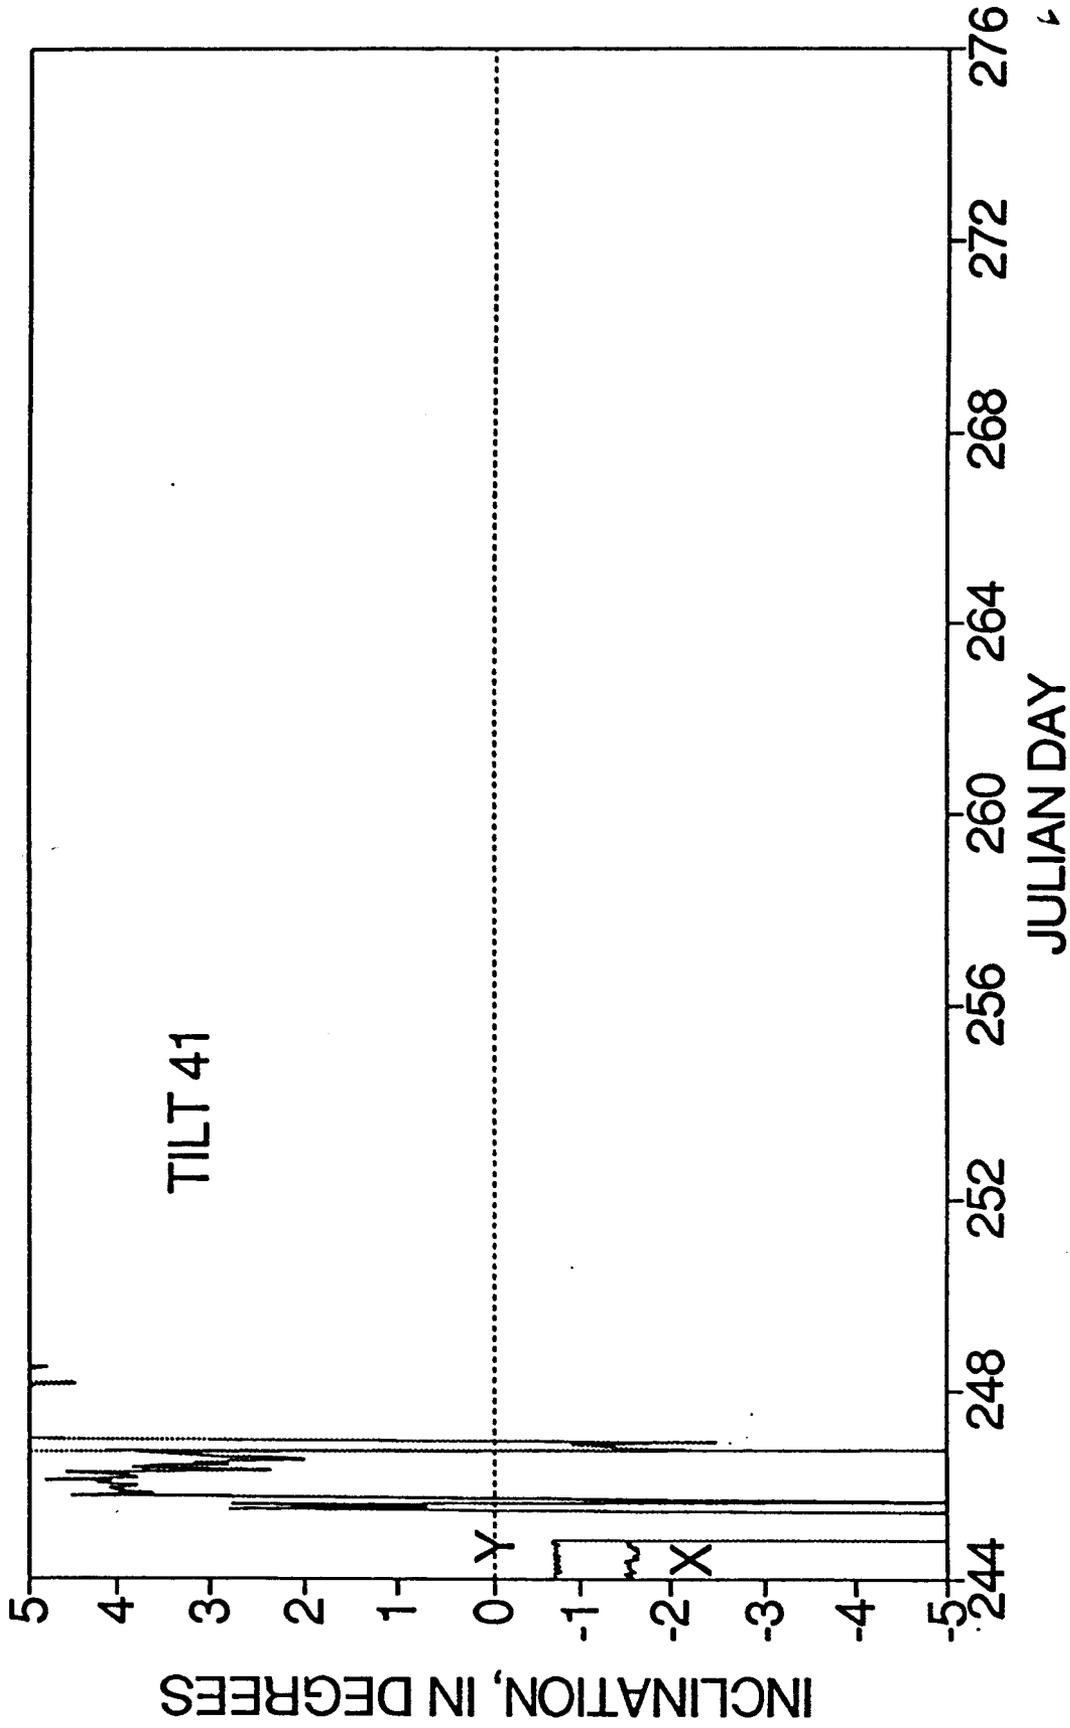
Figure 19.--Tilt for sensor 41 at sand bar 172.3L, September 1991.

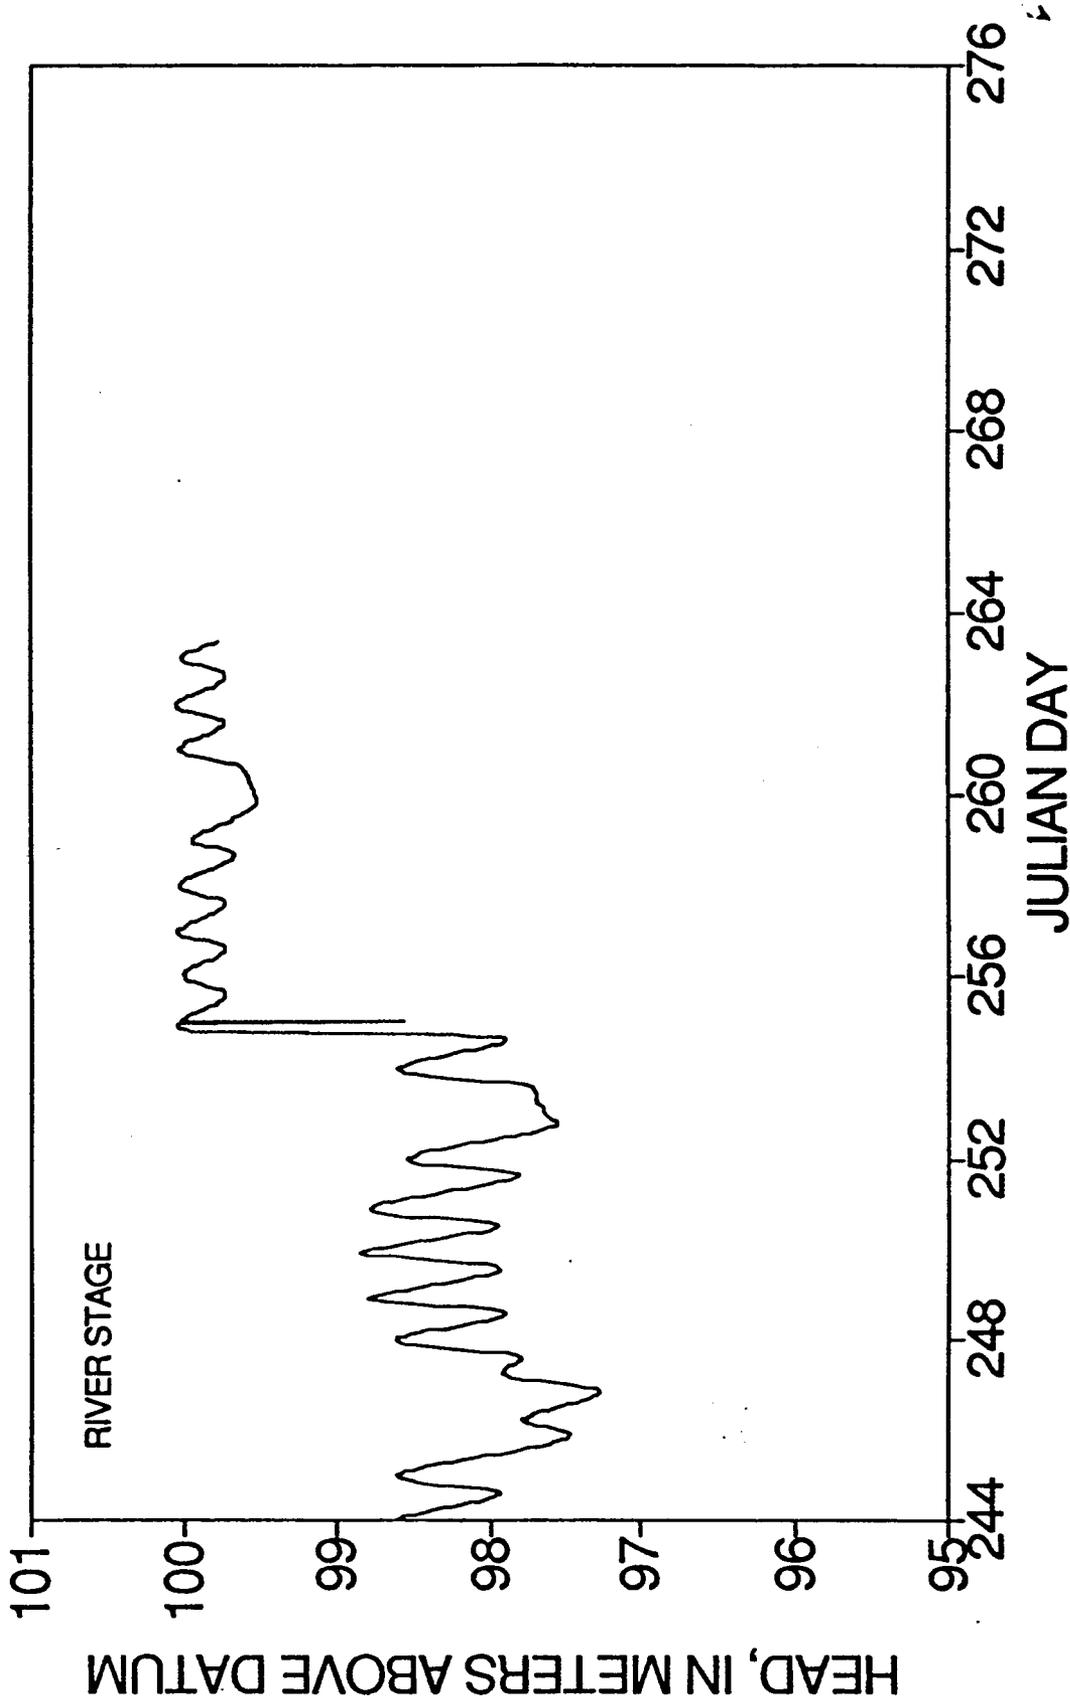
Figure 21. --River stage at sand bar 172.3L, September 1991.
