**THE INFLUENCE OF VARIABLE DISCHARGE REGIMES ON
COLORADO RIVER SAND BARS BELOW GLEN CANYON DAM:
FINAL REPORT**

Northern Arizona University

NPS Cooperative Agreement Number: CA 8006-8-0002

**Sponsored by: The U.S. Department of Interior National Park Service Cooperative Parks Study Unit
Northern Arizona University Flagstaff, AZ 86011**

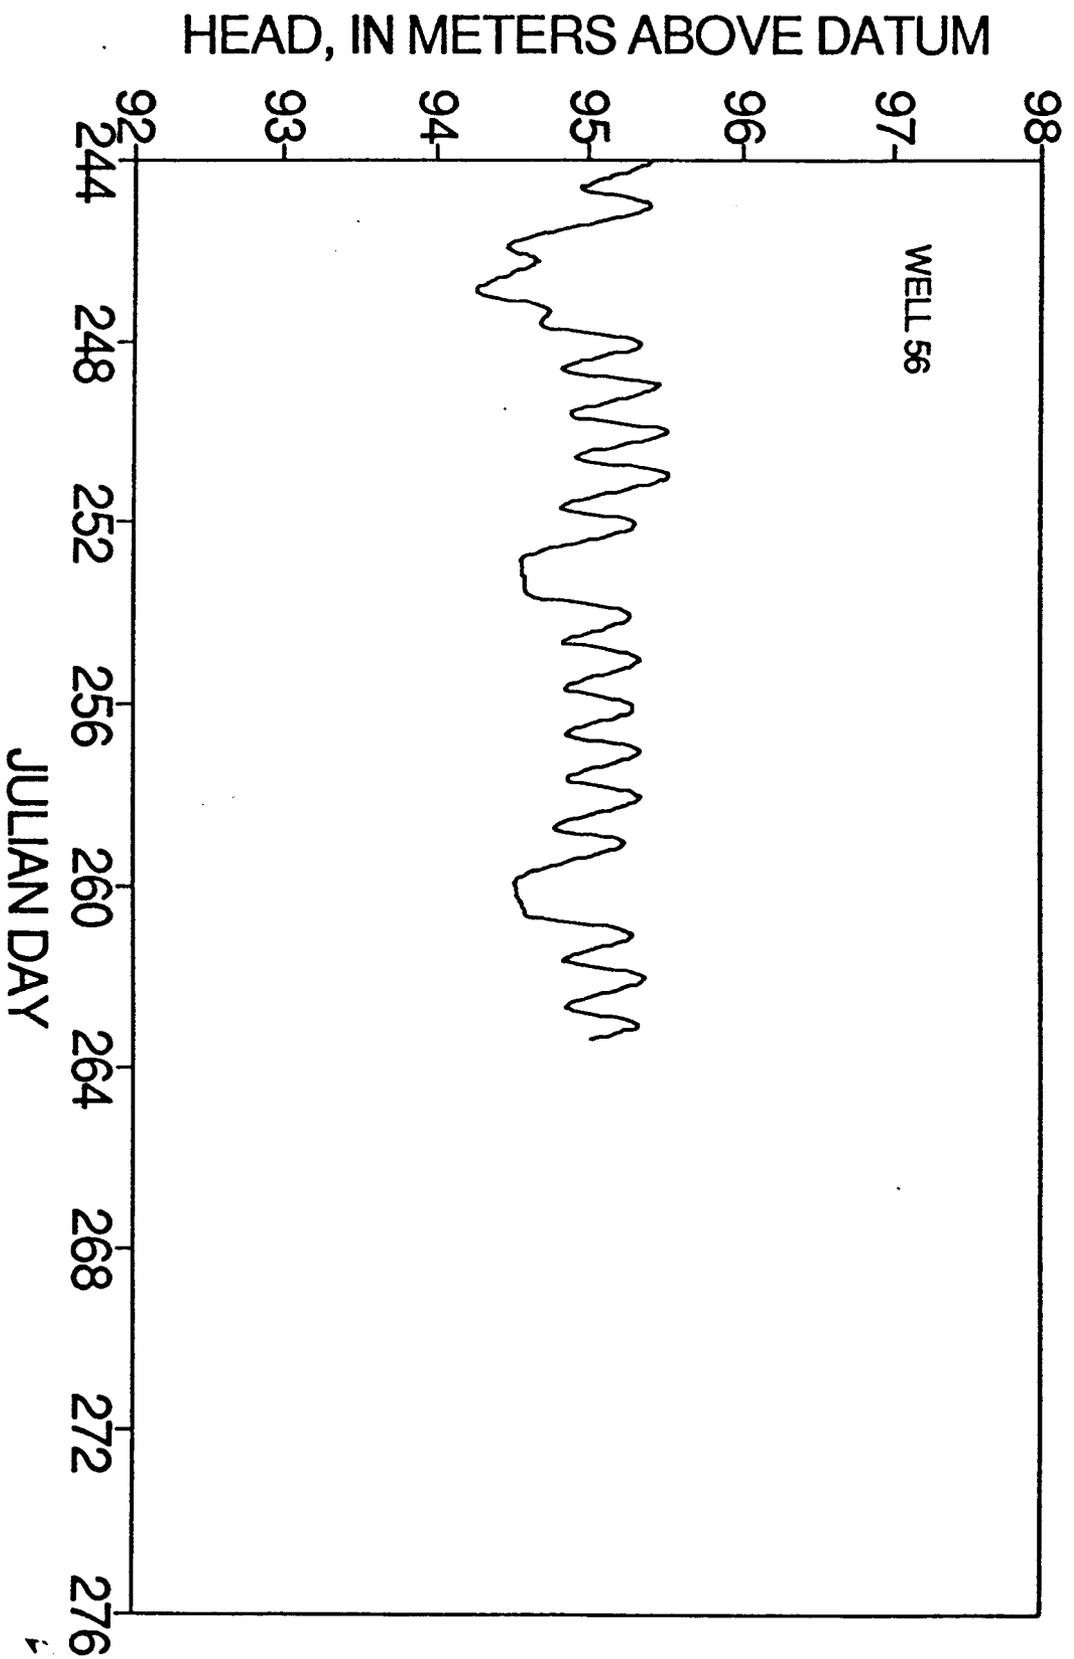
Figure 22.--Water level in well 56 at sand bar 172.3L, September 1991.

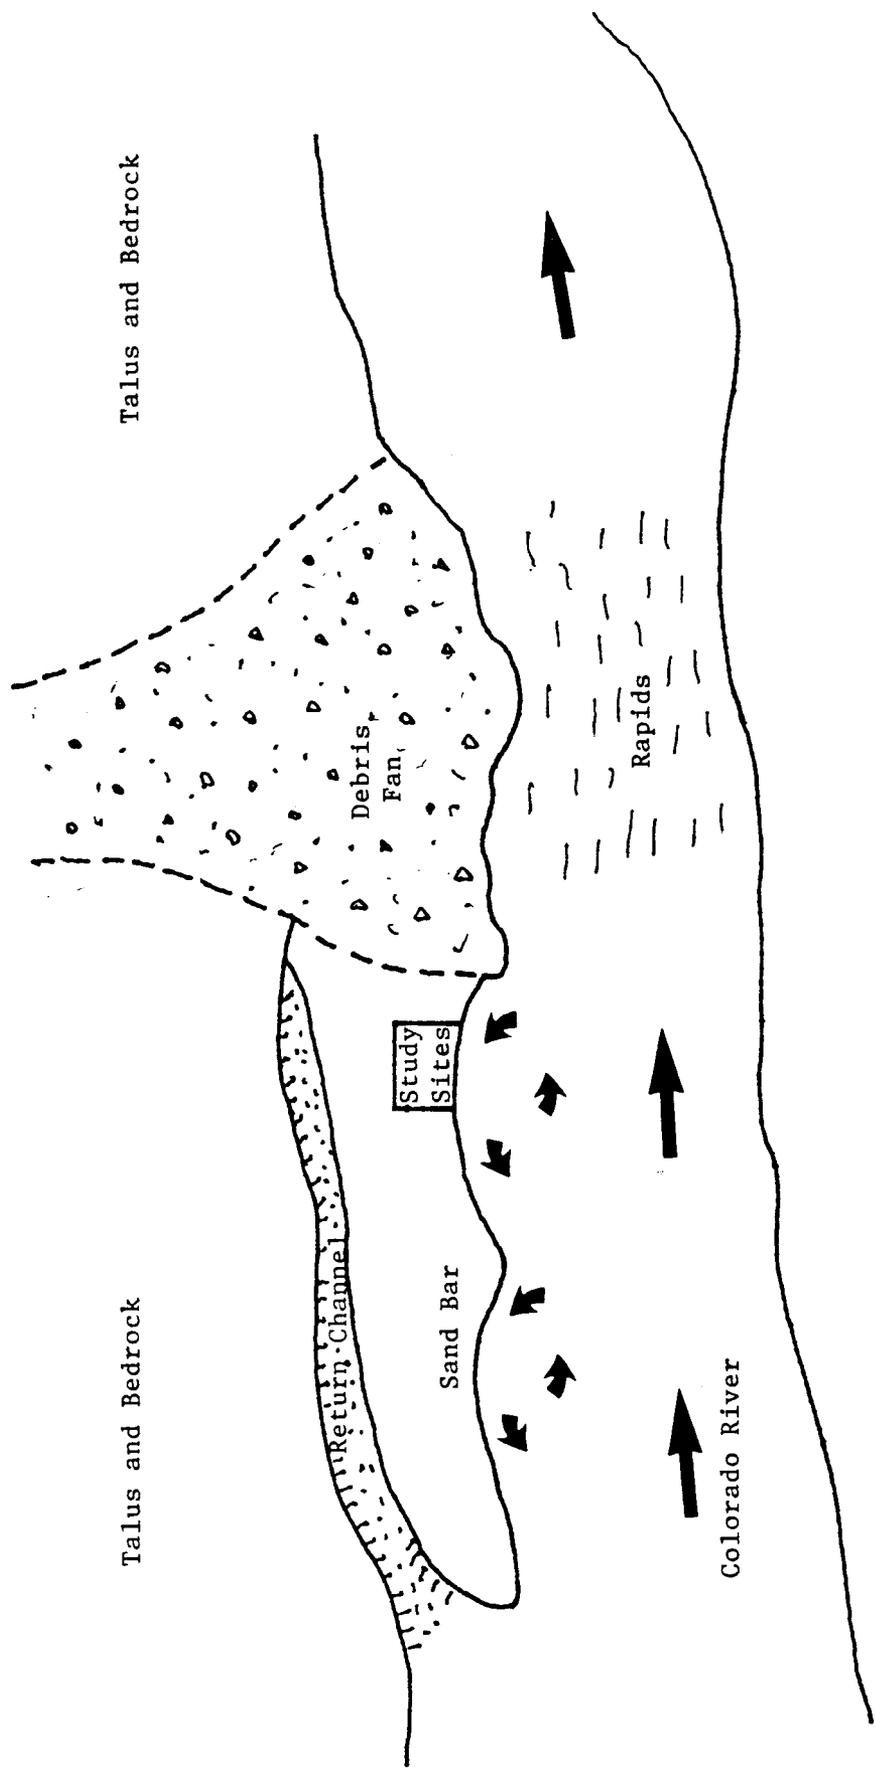
Figure 2. Major geomorphic features at Sand Bar 43.1L and location of study sites.

At the study site, the Colorado River flows from west to east, the sand bar being on the north side of the river. A return channel is present on the sand bar, beginning at the downstream end of the sand bar adjacent to the debris flow some 10 meters from shore and extending in an arc to the west adjacent to the talus/bedrock of the canyon wall for the majority of the sand bar length

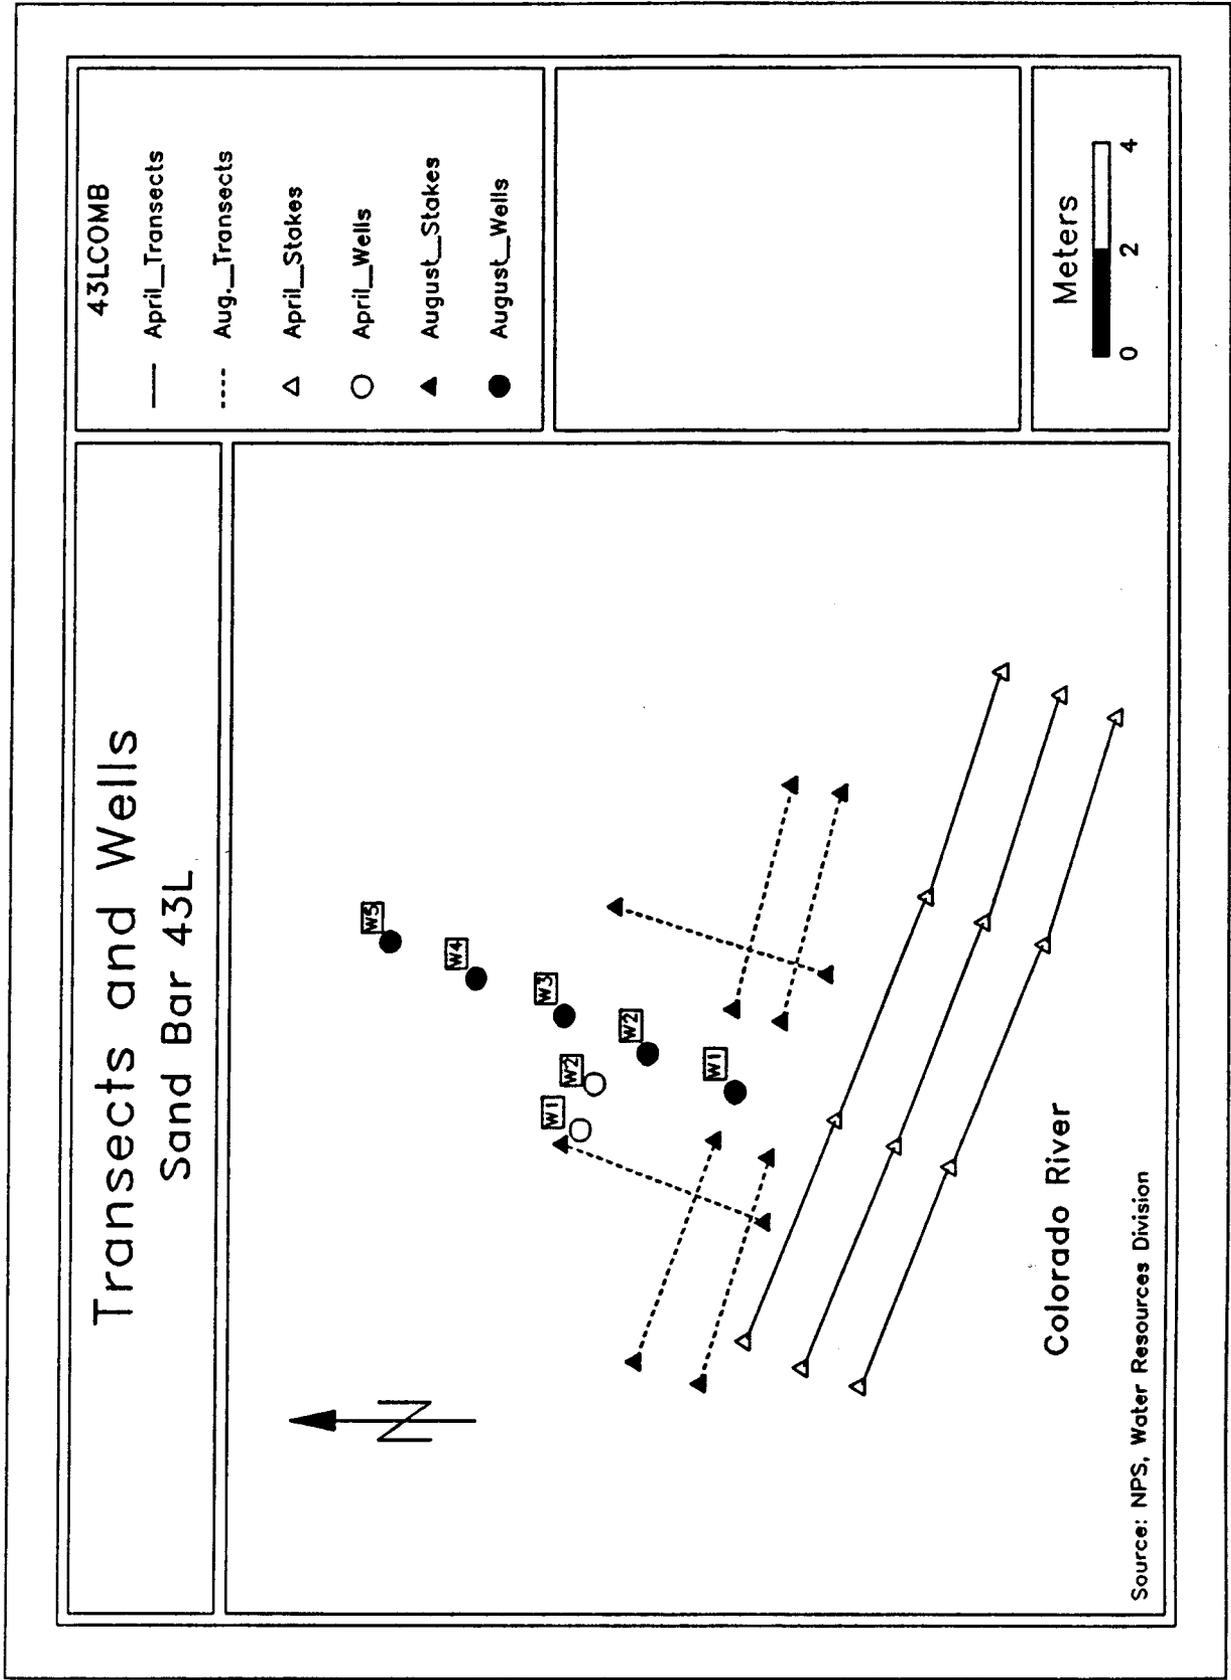
Figure 3. Relative locations of monitor wells and transects for the two study periods.

Changes in land surface elevation were measured with a surface profile gage which was designed to measure small changes in elevation without disturbing the surface (figure 4). The gage allows accurate measurement of erosion or deposition without trampling or other anthropogenic disturbances. Vertical support stakes (rebar) were installed at each end of a 4.5 meter transect to support the gage. The gage was positioned on the support stakes and the 58 vertical measuring rods, with ping-pong balls attached to the lower end, were allowed to drop to the ground surface. The ping-pong balls prevented the rods from penetrating the sand surface. The measuring rods were clamped in position with the balls resting on the sand surface and the gage was removed to measure and record the extended distance of each rod. Repeated measurements of a transect at different times allowed determination of ground

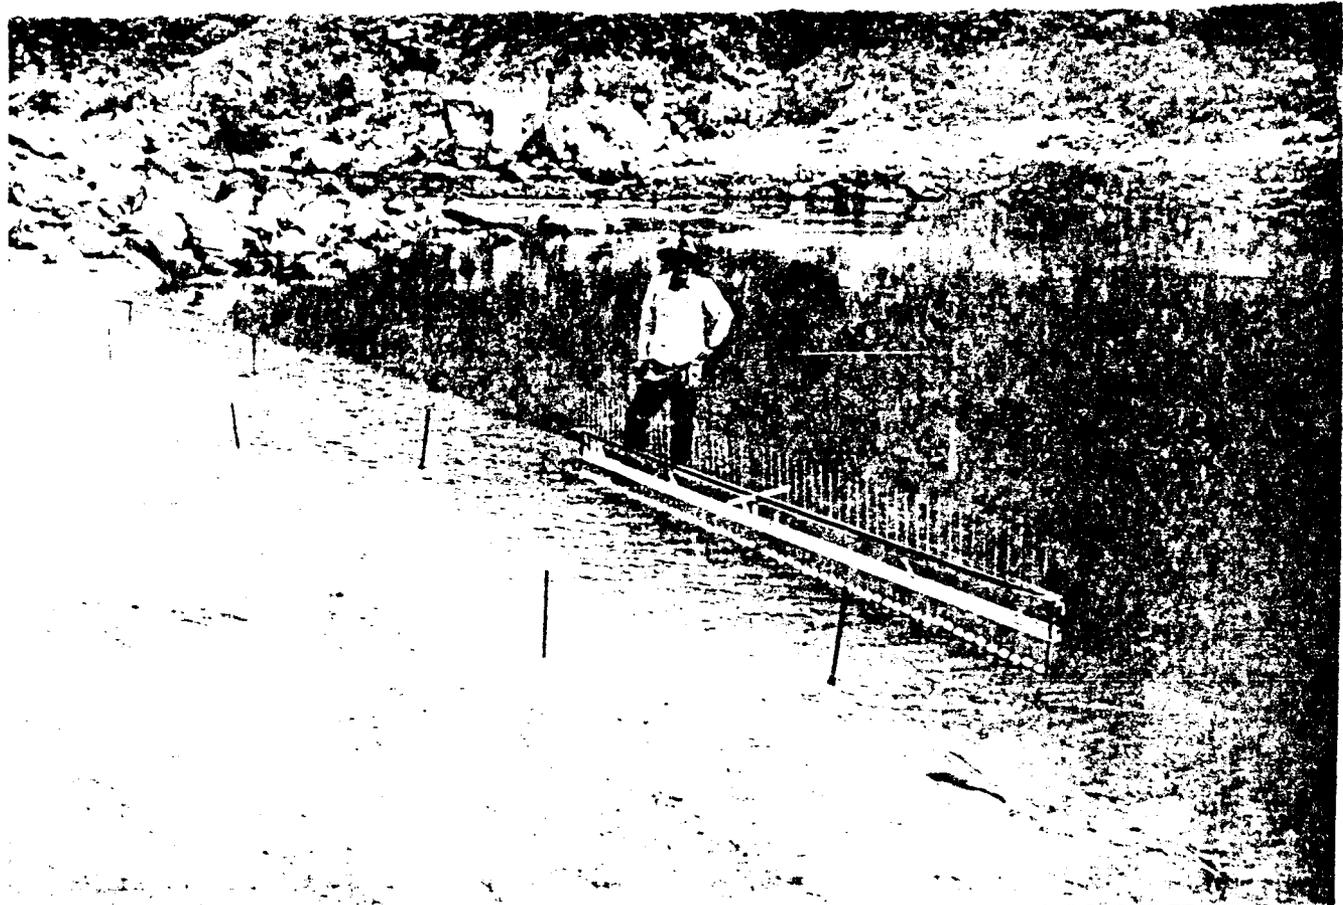
Figure 4. Photos of the Surface Profile Gage.

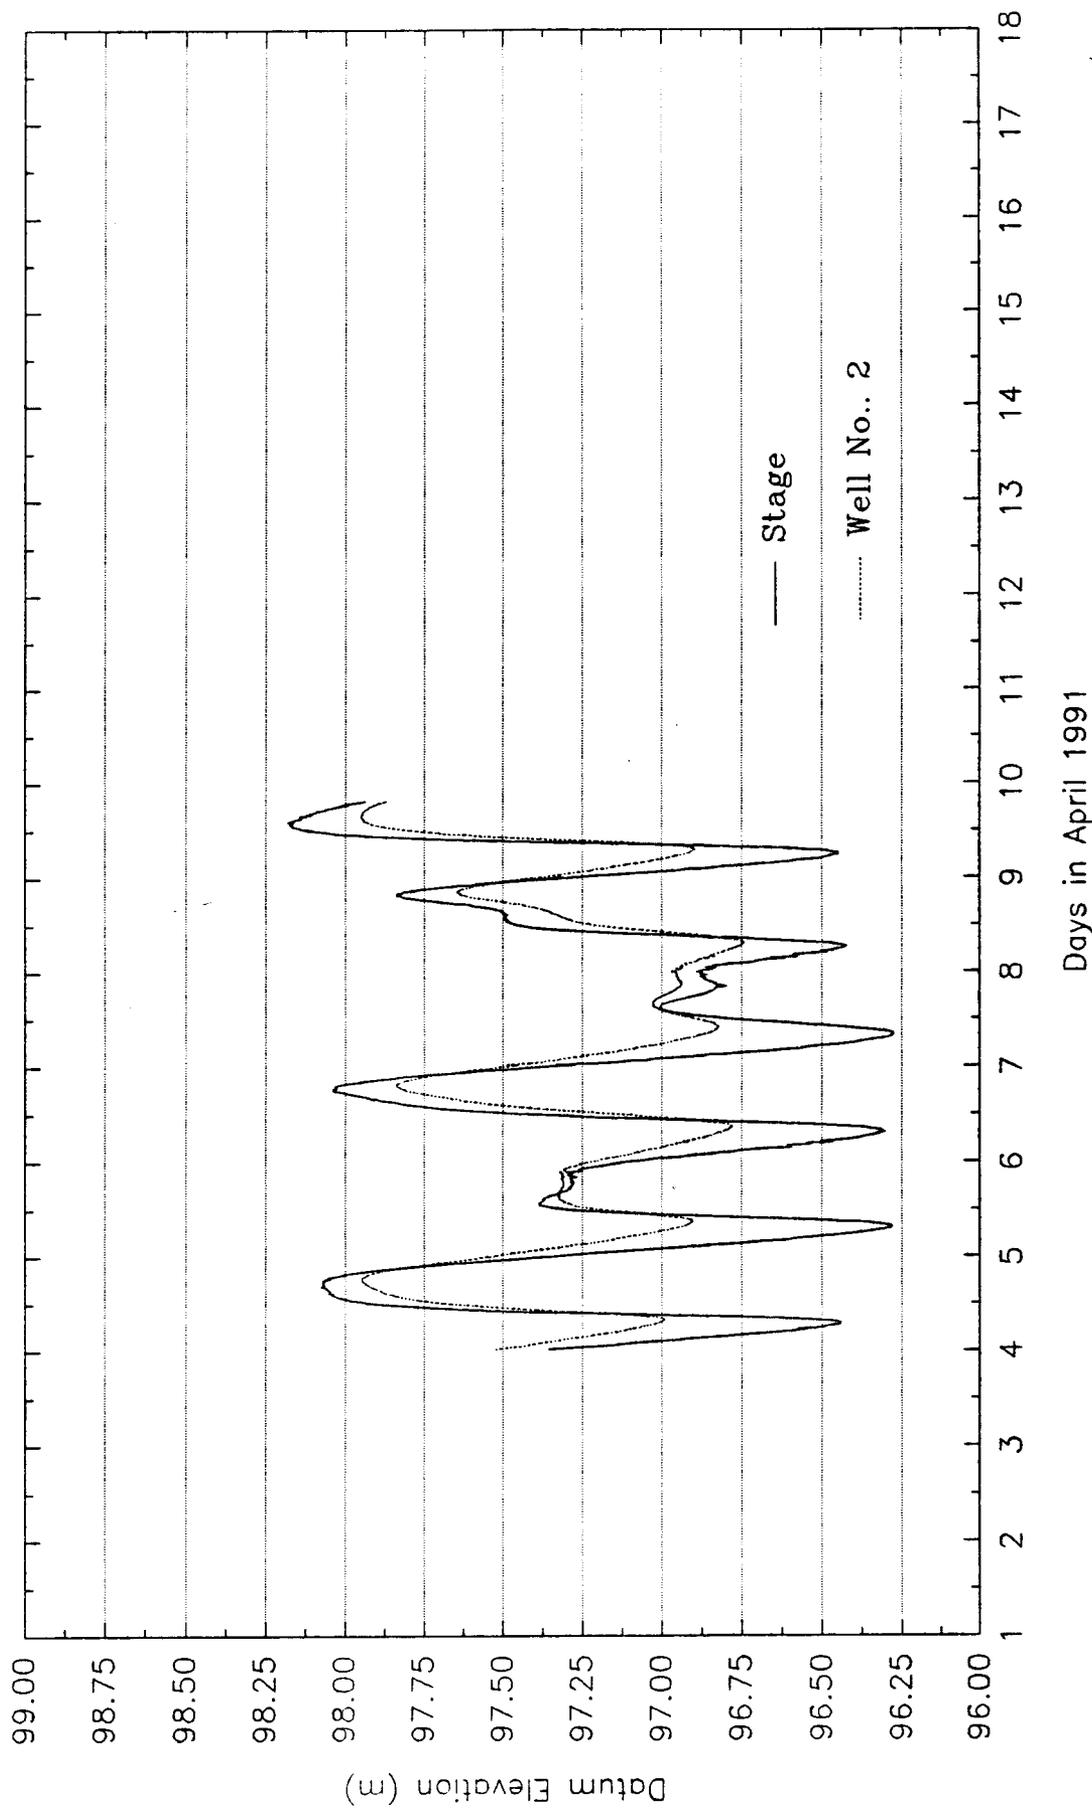
Figure 6. April hydrographs - River Stage and Monitor Well No. 2

River stage and water table fluctuations with associated lag times and daily differences of fluctuation for the study period are shown in figure 6. Well 1 was shallow and went dry each day at low river stage. Only data from Well 2 are shown on figure 6. Minimum river stage ranged from about 96.3 to 96.45 meters during the study, corresponding to minimum flow releases from the dam of 90 to 120 m³/s. Maximum river stage varied by more than a meter, from 97.0 to 98.2 meters, in response to differences in the maximum discharge from the dam and the length of time that the maximum discharge was maintained. Large discharges for a short duration are attenuated downstream to produce a maximum stage less than a smaller discharge of greater duration. For example, release of 450 m³/s from the dam for a short duration on April 9th produced a lower

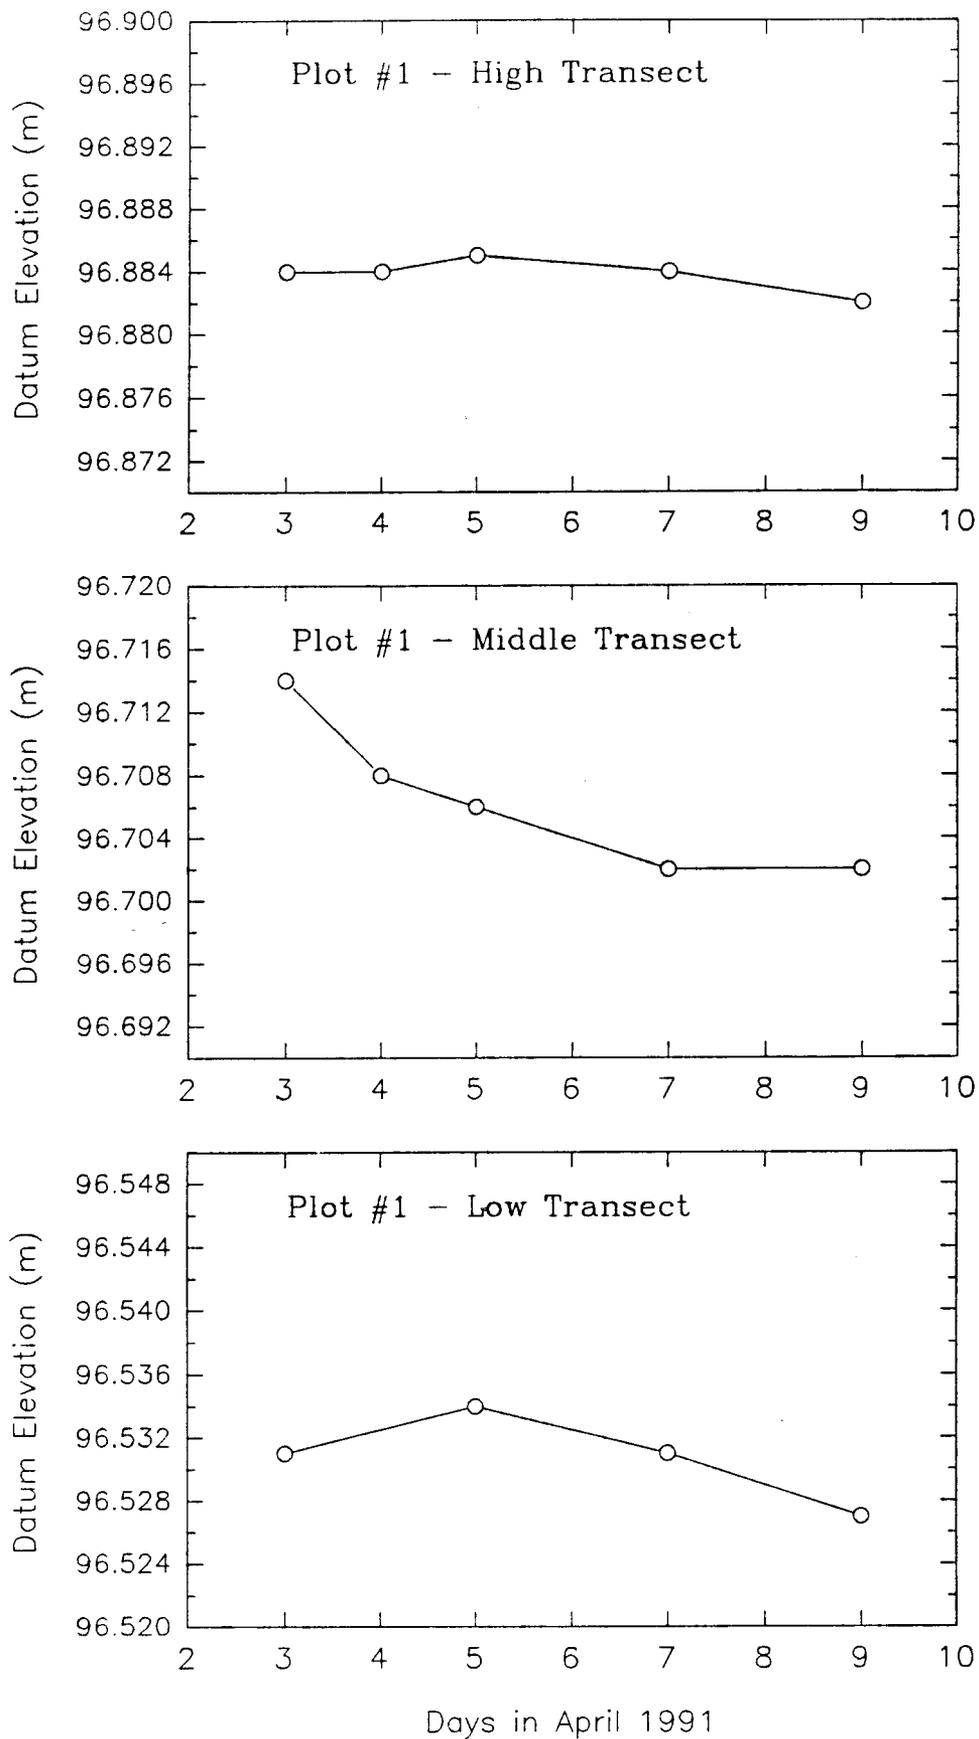
Figure 7. Mean Elevation of Transects in Plot #1, April 1991

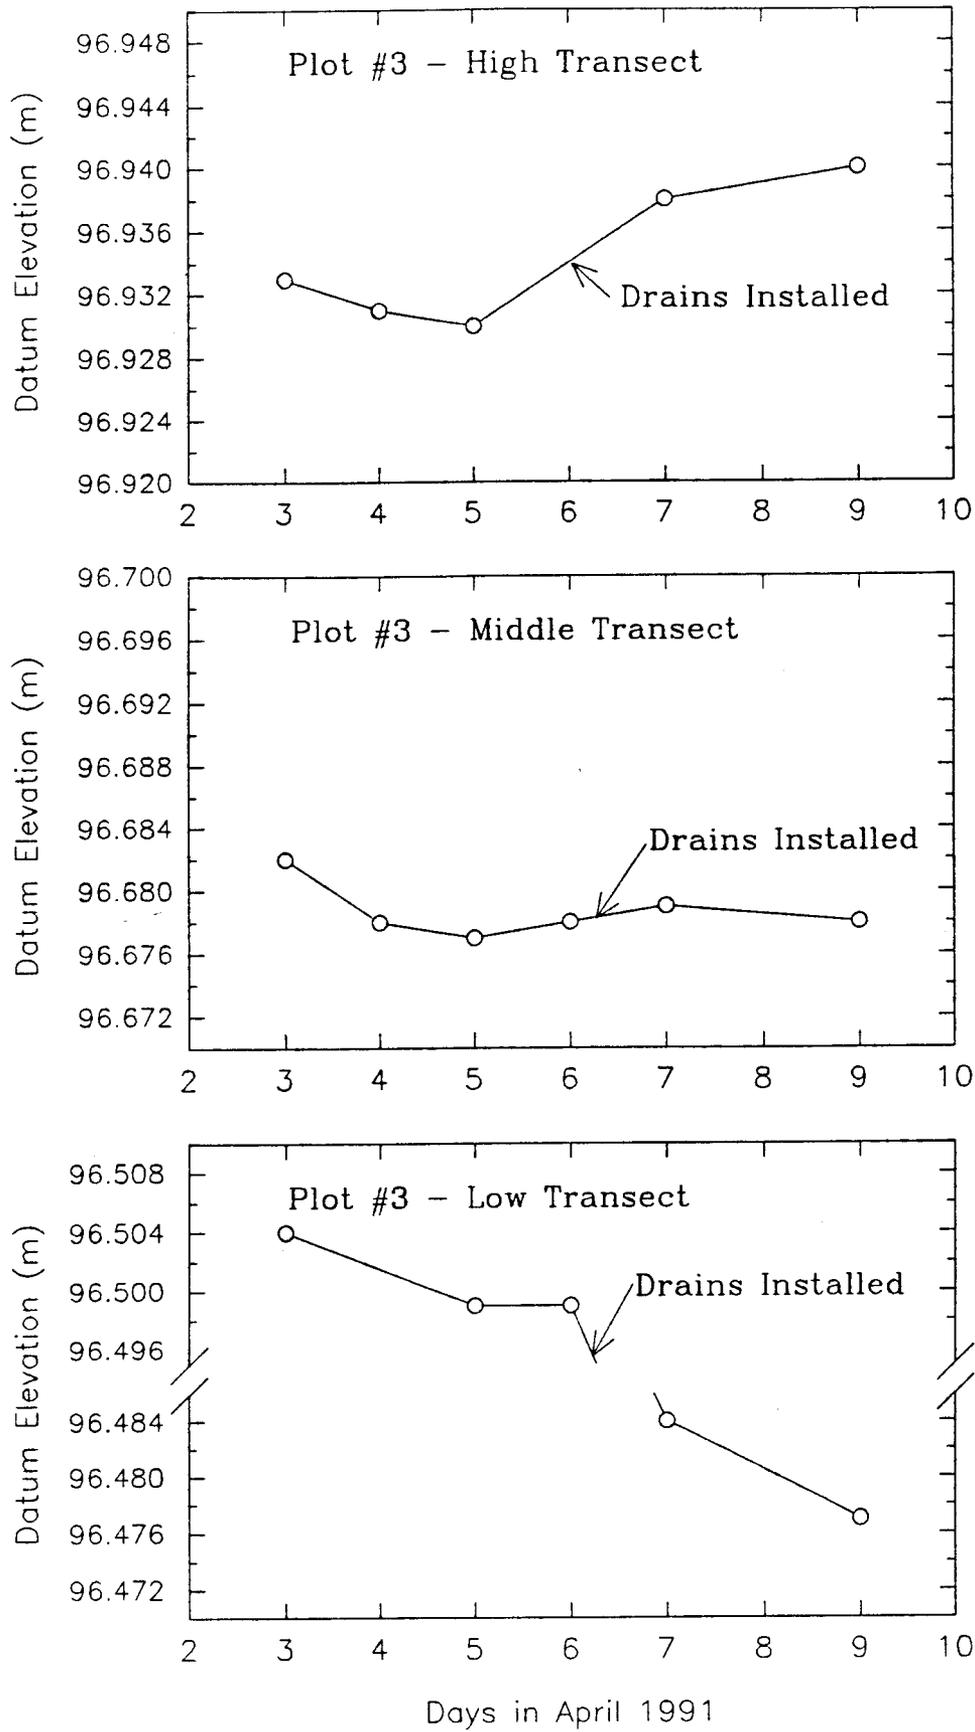
Figure 9. Mean Elevation of Transects in Plot #3, April 1991

Mean elevation changes for the transects in Plot 3 are shown in figure 9. The high transect had less than 1 mm elevation change prior to installation of the horizontal drains on April 6th. Mean elevation of this transect was higher (9 mm) on April 7th and 9th. Nearby foot traffic and/or soil creep may have disturbed this transect during this time period. The middle and low transects showed a gradual elevation decrease of about 6 mm from the start of the study on April 3rd until the horizontal drains were installed on April 6th. Following installation of the drains, the middle transect showed a slight elevation increase on April 7th and 9th due to disturbance from excavation for

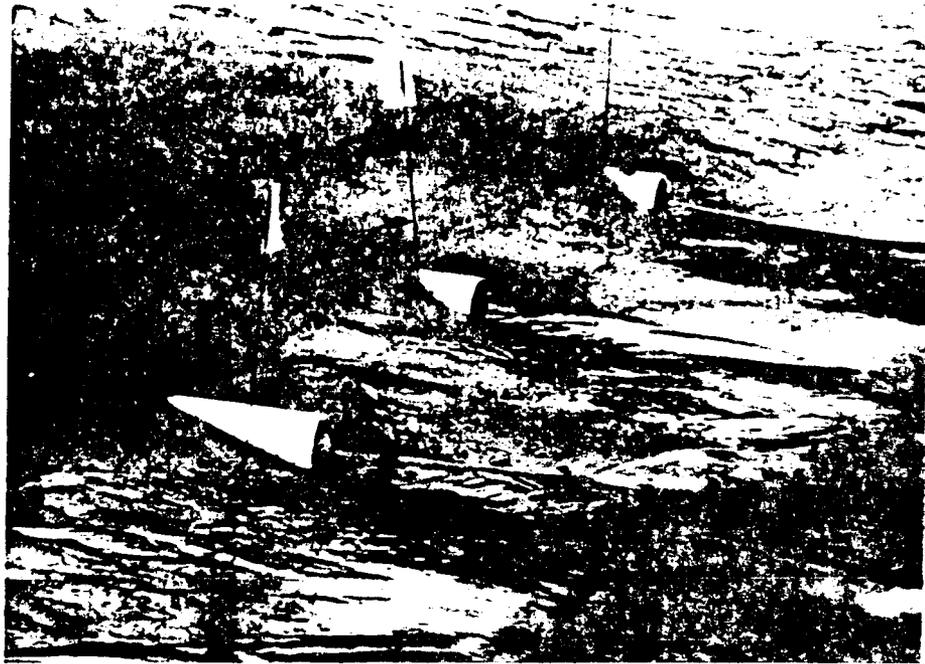
Downstream end of perforated lateral drains showing flow of intercepted groundwater at low stage of Colorado River.

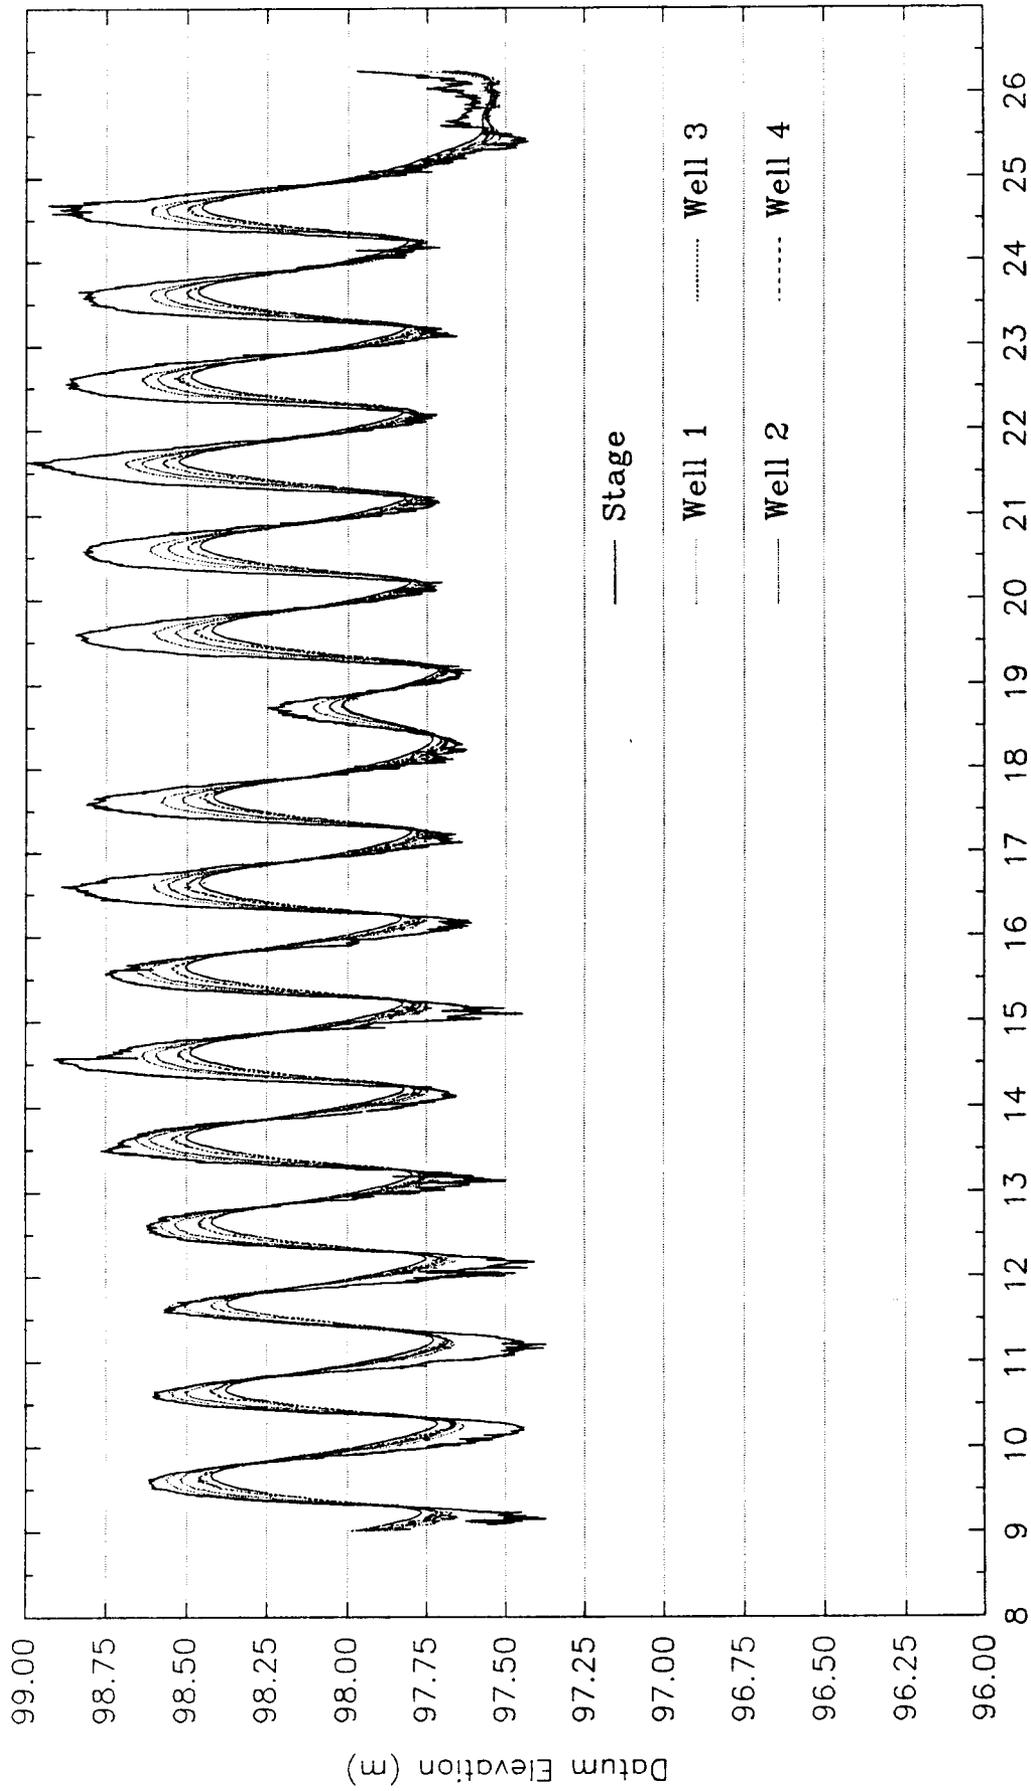
Figure 12. August Hydrographs - River Stage and Monitor Wells

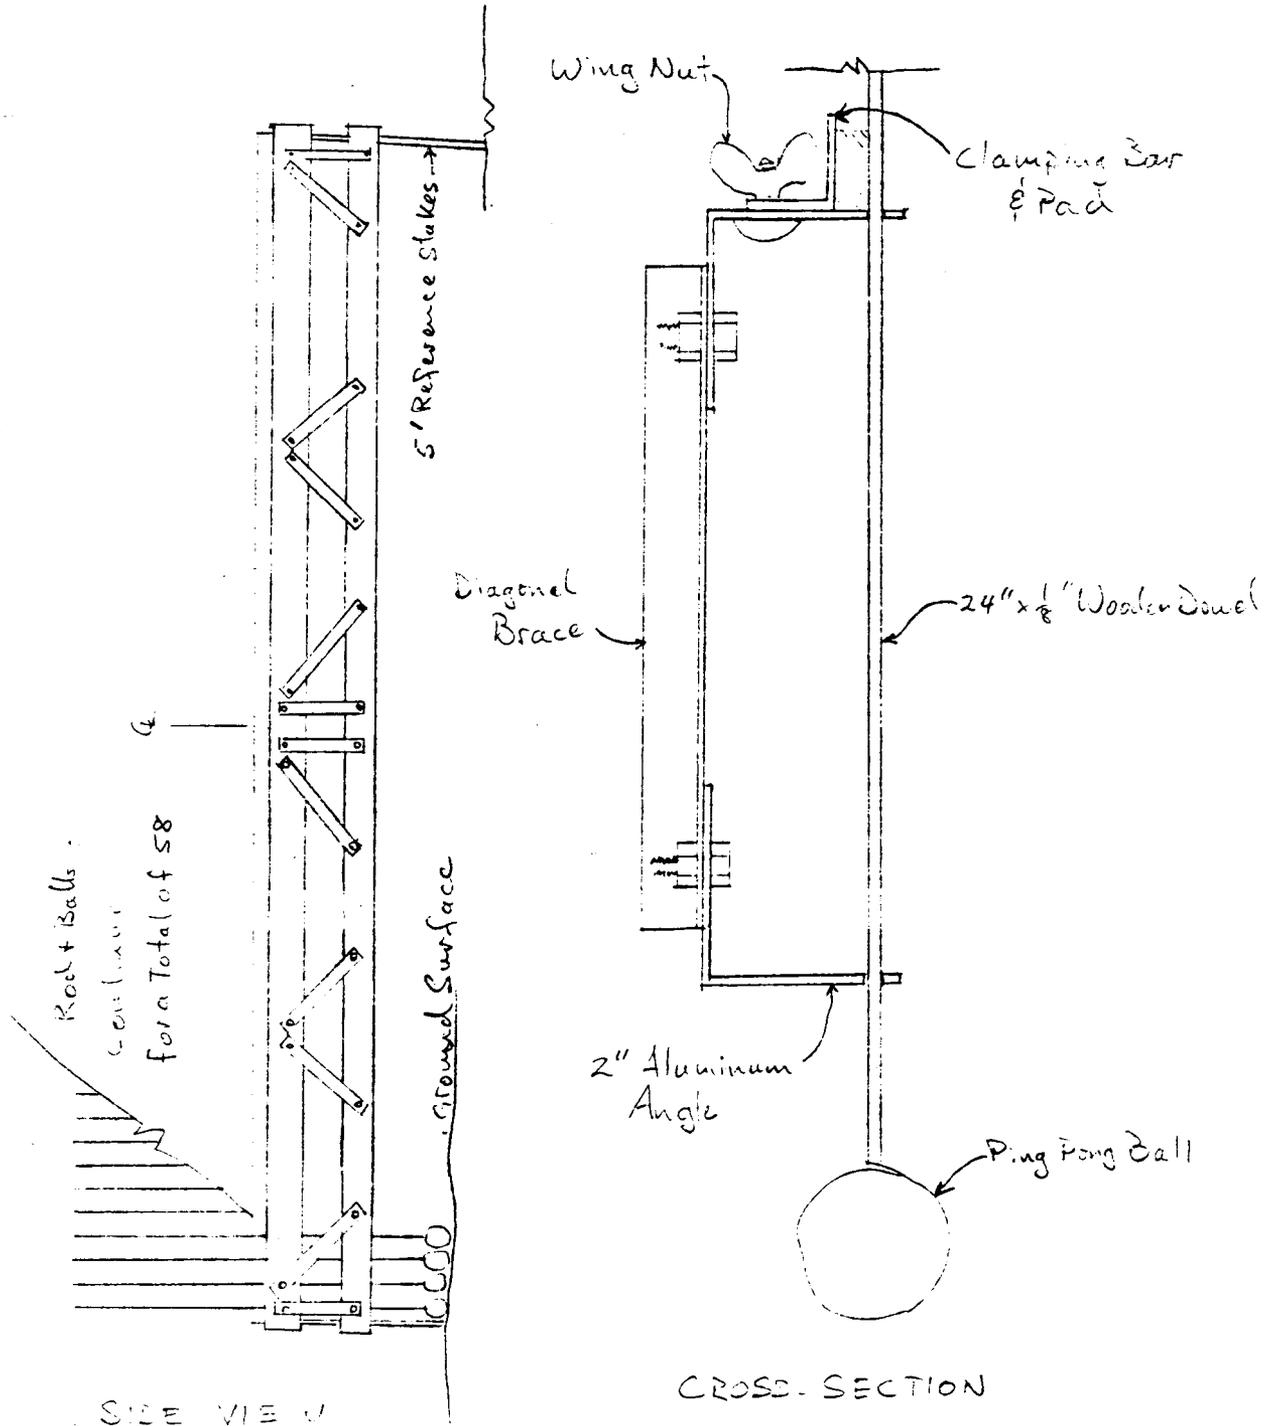
GROUND ELEVATION DIFFERENTIAL GAGE

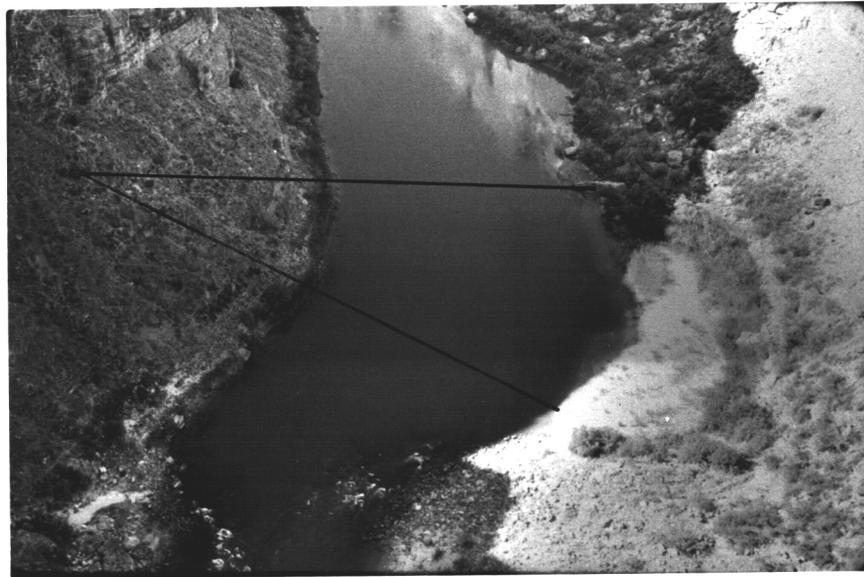
Figure 3. Aerial photograph of study site CR 43 L. River flows from top to bottom of image, note channel constricting debris fan downstream of deposit. Lines indicate location of camera and field of view. Photo taken at 5,000 ft³/s.

CR 43 L The sand deposit at this locale lies immediately upstream of a channel constriction (Fig 3). Consequently, it is classified as an upper pool deposit. There are typically two small recirculating eddies along the face of the deposit that shift and change size in response to changes in river stage. Current velocities at this site are relatively low because of its upper pool environment.

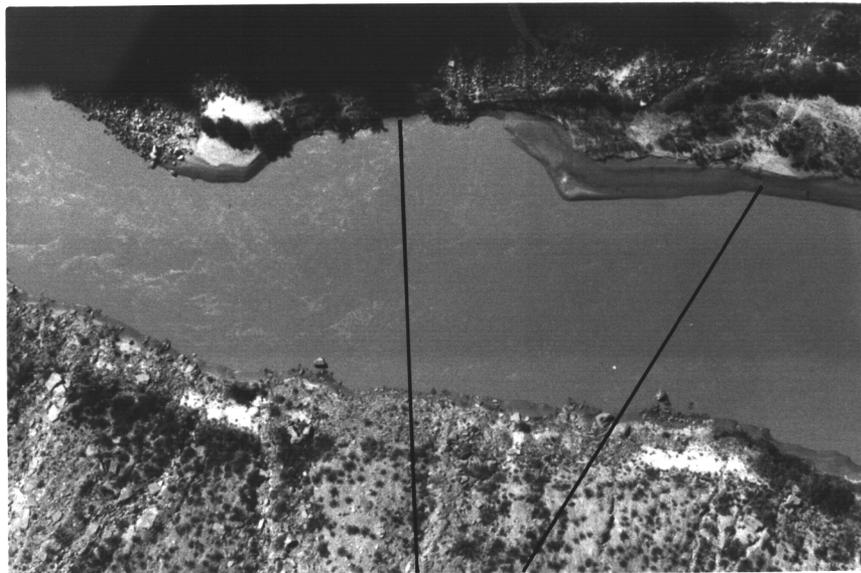
Figure 6. Aerial photograph of study site CR 172 L. River flows from left to right in image. Note separation deposit at flow constriction (upper left) and reattachment deposit in channel expansion (upper right and center). Lines indicate camera location and approximate field of view. Photo taken at 5,000 ft³/s.

CR 172 L About 104 miles downstream is the next study site, 1-mile downstream of Mohawk and Stairway canyons. This deposit is in a relatively narrow portion of the canyon, and consists of a narrow, flat reattachment deposit with a strong recirculating eddy.

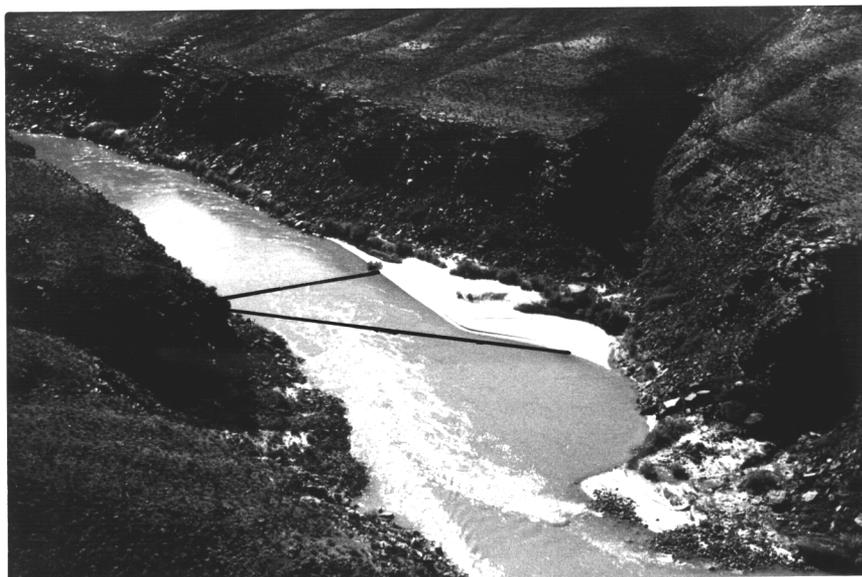
Figure 8. Aerial photograph of study site CR 216 R. River flows from lower right to upper left in image. Channel constriction appears in the lower right portion, associated with the separation deposit. Reattachment deposit at channel expansion is at right center. Lines indicate location of camera and approximate field of view. Photo taken during interim flows at approximately $10,000 \text{ ft}^3/\text{s}$.

CR 216 R The last study site is typical of Grand Canyon reattachment deposits, formed downstream of a channel constriction.

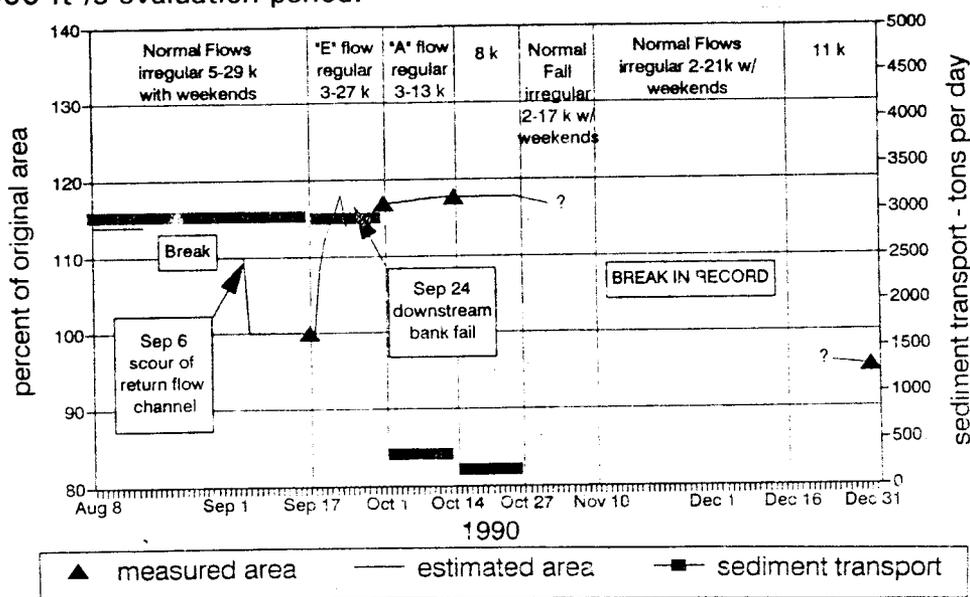
Figure 11a. Time series plot of daily deposit area at CR 68 R. Area is expressed as a percentage of area measured in original photograph. Test flow details are described along the top, and sediment transport capacities are shown as the heavy horizontal lines.

Normal Flow August 8-September 17, 1990 The first time-lapse camera was installed on August 8, 1990, at CR 68 R. Using a standard roll of film with 36 exposures, and programming the intervalometer for 6 hours between photos, 9 days of record were obtained (Fig. 11a). Film was replaced on September 2, 1990, and the intervalometer was programmed for 1 photo each day at estimated low stage, about 5:30 PM. The photographs of September 5 and 6, 1990 show that approximately 10% area of sediment in the return flow channel was eroded in the previous 24 hours (Fig 12a-b). This occurred on the second day of fluctuation following 2 days of low fluctuating "weekend" flows (see Appendix I, hydrograph of September, 1990). The CR 68 R deposits remained constant in size through the remainder of the **Normal Flow** and deposit areas were measured on September 17, during the 5,000 ft³/s evaluation period.

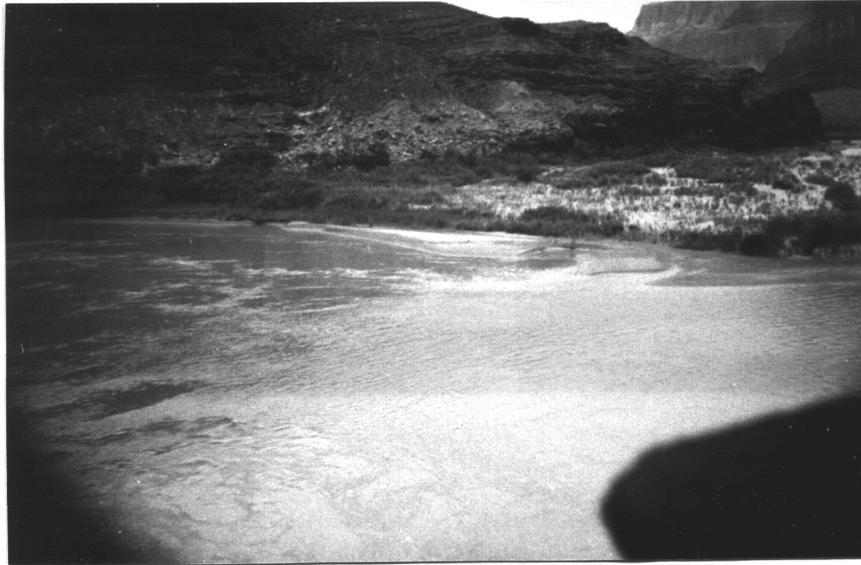
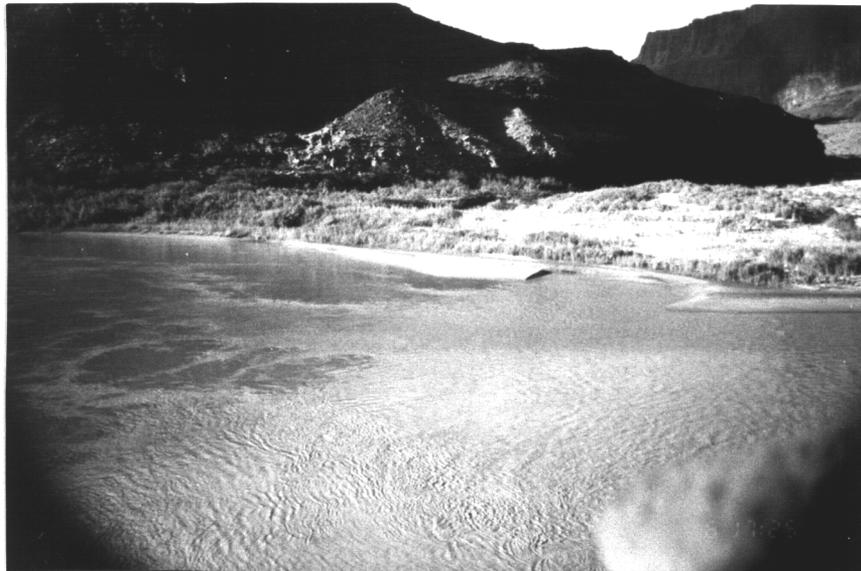
Figure 12a-b. Photographs of September 5 (a) and September 6 (b), 1990, at CR 68 R. Note erosion of return flow channel area (right center) in lower photograph.

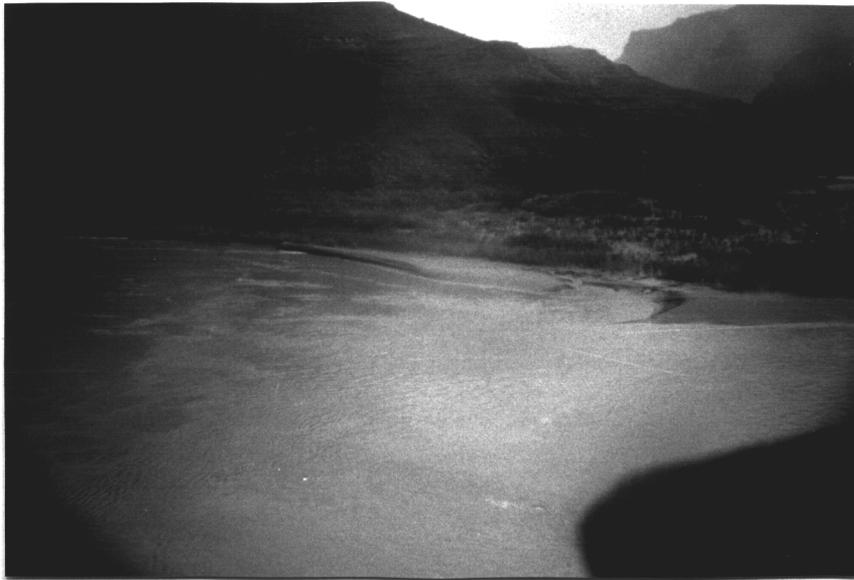
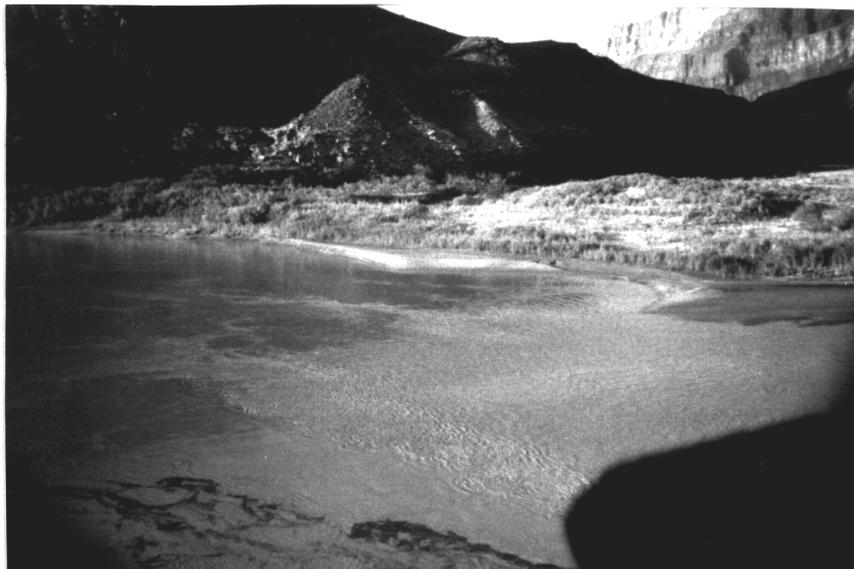
Figure 12c-d. Photographs taken on September 23 (c) and September 24 (d) at CR 68 R. Note enlarged return flow channel (right center) and cut-bank formation (left center) in lower photograph.

"E" Flow September 17-October 1, 1990 The **"E" flow** immediately began depositing sediments along the separation deposit, and the area of CR 68 R was increased 10% by September 20 (Fig. 11a). The deposits continued to increase in size until sometime between September 23 and 24, when the return flow area was eroded, reducing area about 4% in the past 24 hours. This erosion event occurred in the middle of the regularly fluctuating test flow (see Appendix I). The downstream portion of the reattachment deposit was also being eroded during this period of test flow (Fig. 12c-d) even though the overall area was increasing.
