**THE INFLUENCE OF VARIABLE DISCHARGE REGIMES ON
COLORADO RIVER SAND BARS BELOW GLEN CANYON DAM:
FINAL REPORT**

Northern Arizona University

NPS Cooperative Agreement Number: CA 8006-8-0002

**Sponsored by: The U.S. Department of Interior National Park Service Cooperative Parks Study Unit
Northern Arizona University Flagstaff, AZ 86011**

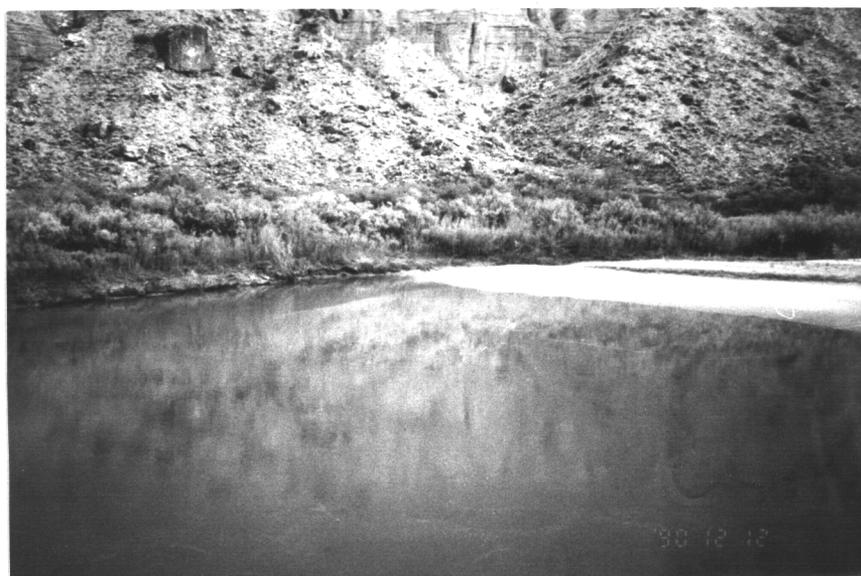
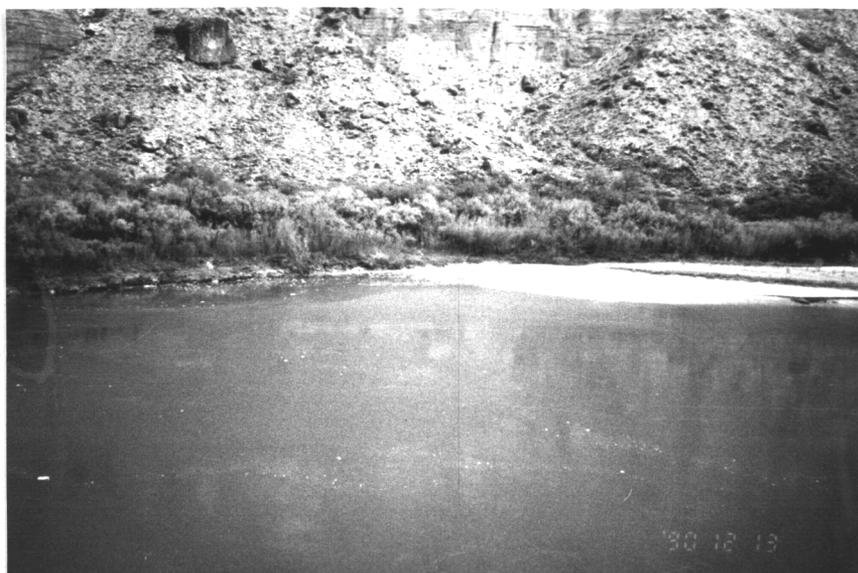
Figure 15a-b. Photographs taken on December 12(a) and 13(b), 1990, at CR 51 L. Note eroded area at right edge of lower photograph.

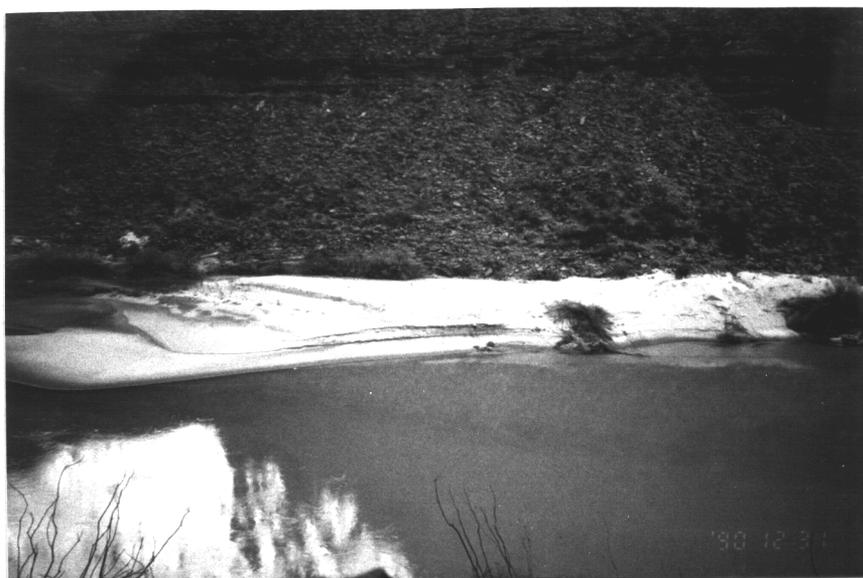
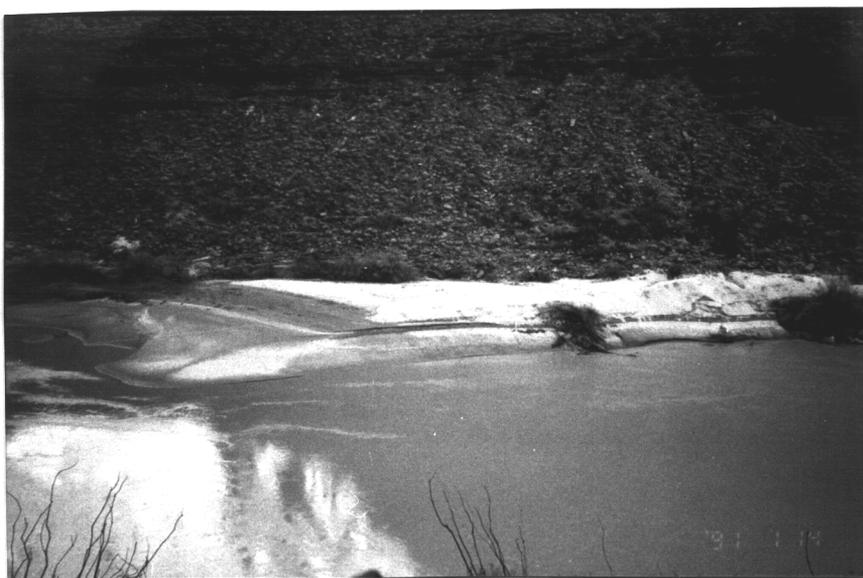
Figure 18a-b. Photographs taken on December 31, 1990(a) and January 14, 1991(b) at CR 211 L. Note erosion of reattachment platform (left center) in lower photograph.

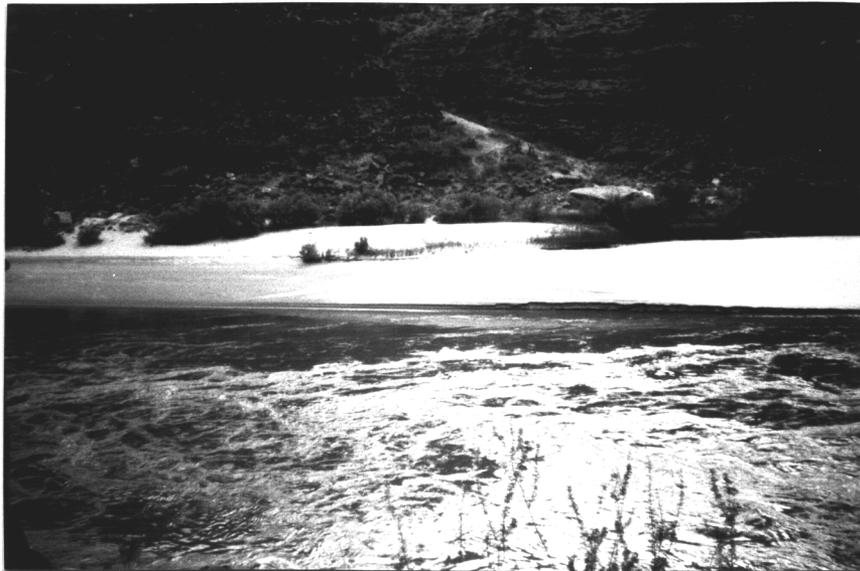
Figure 19. Photograph taken on January 14, 1991, at CR 216 R. Note cut-bank formation along reattachment deposit (right center).

Normal Winter Flow January 14-January 28, 1991 Approximately 1% area reduction was recorded at CR 43 L (Fig. 13a). At CR 51 L, erosion of about 16% area was documented (Fig. 14a). About 2% increased area was measured at CR 68 R for this test (Fig. 11b). Camera malfunction still affected CR 172 L. CR 211 L eroded approximately 17% over the two-week test period (Fig. 16a). CR 216 R eroded about 3% during the last day of the prior evaluation flow (Fig. 19 18?), but rebuilt and gained about 1% area over two-weeks (Fig. 17a).

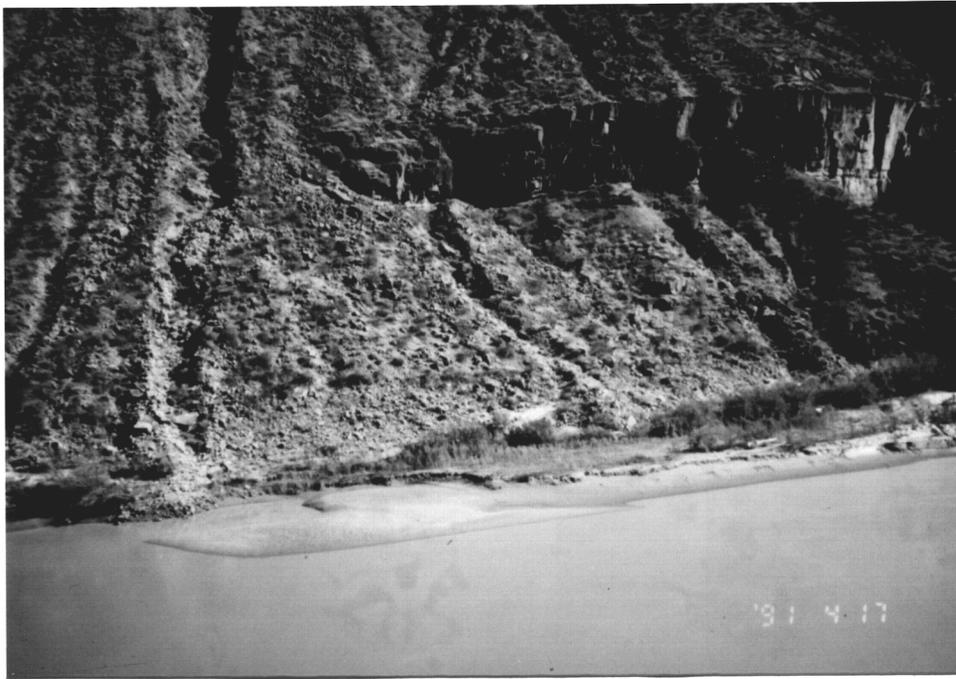
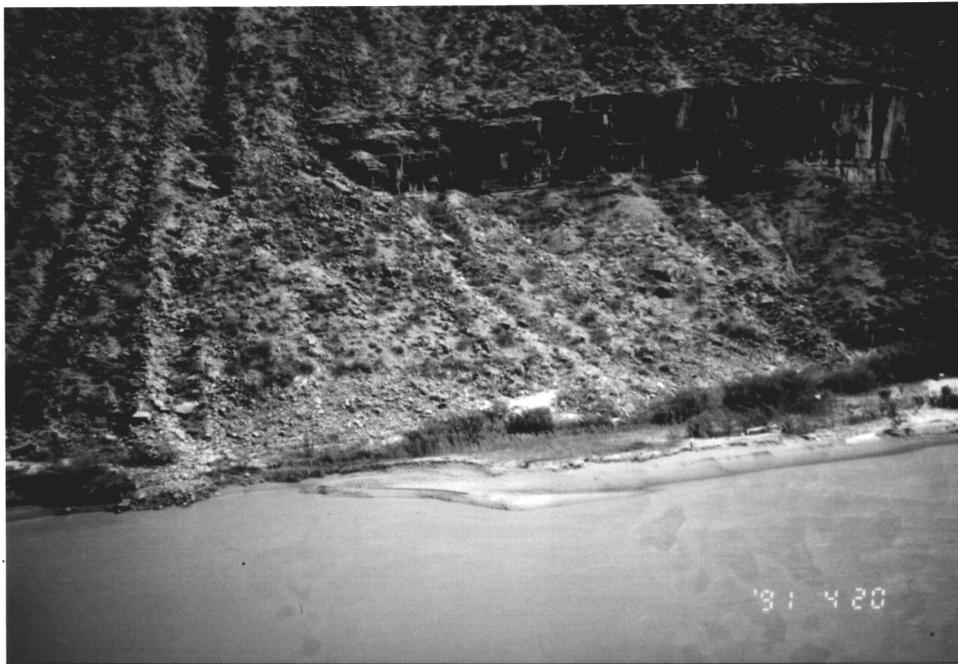
Figure 21a-b. Photographs taken on April 17(a) and April 20(b), 1991, at CR 172 L. Note erosion of reattachment platform area in lower photograph.

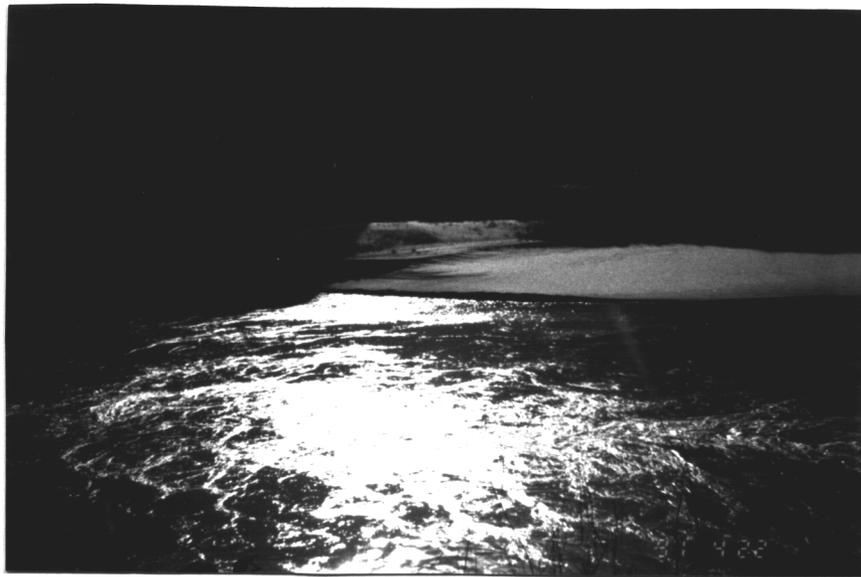
Figure 22a-b. Photographs taken on March 12 and April 22, 1991, at CR 216 R. Note reduction of area along water line in lower photograph.

Normal Flow February 10-April 20, 1991 Gradual deposition occurred at CR 43 L over the lengthy test flow period, resulting in 2% increased area (Fig. 13a). Erosion continued at CR 51 L for the first month of the test period, and record was not obtained for the remainder of the test (Fig. 14a). At CR 68 R, deposition was continuous at rates similar to those of the prior two tests. A break in record between April 13-22 however, apparently missed documenting rapid erosion of about 12% during that period (Fig. 11b). CR 172 L also aggraded during the *Normal Flow* period until on the evening of April 17, during rising river stage, about 30% of the deposit was eroded in 5-6 hours (Fig. 21a-b). This dramatic erosion event was witnessed by the author and others who had been working at the site for 4-days prior. Erosion occurred on the first stage increase following a 3-day low fluctuation "weekend" period (see Appendix I). At CR 211 L, there was a gradual 3% increase in area over the test period (Fig. 16a). CR 216 R was eroding at a high but steady rate for the first half of the test period (Fig. 17a). A break in record occurred during the second half due to battery failure, but the deposit was about 25% smaller at the end of the *Normal* test flow (Fig. 22a-b).

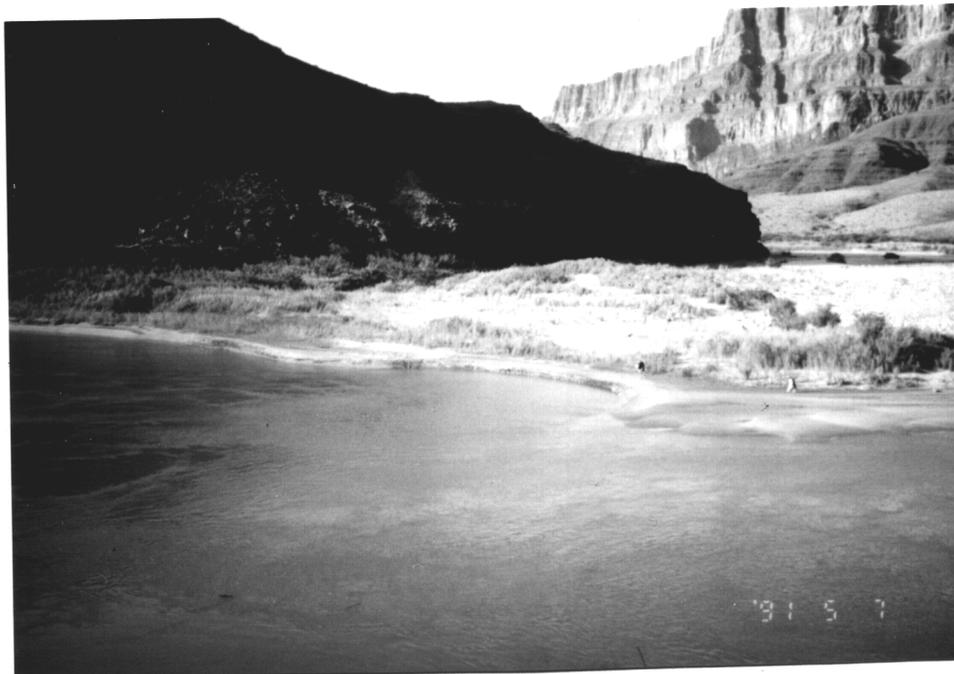
Figure 23a-b. Photographs taken on May 6(a) and 7(b), 1991, at CR 68 R. Note enlargement of return flow area in lower photograph.

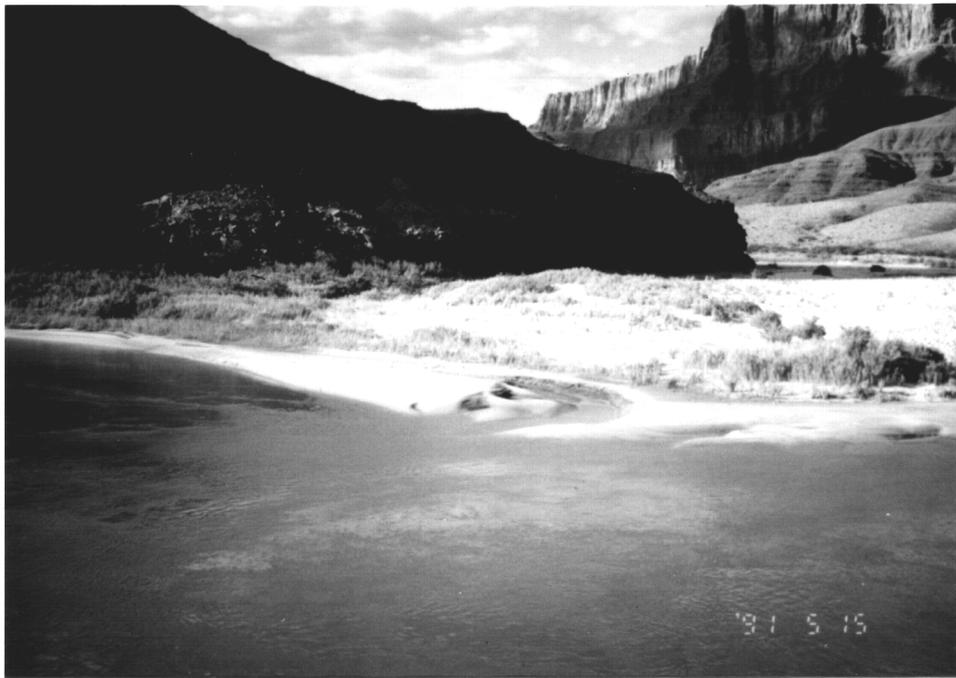
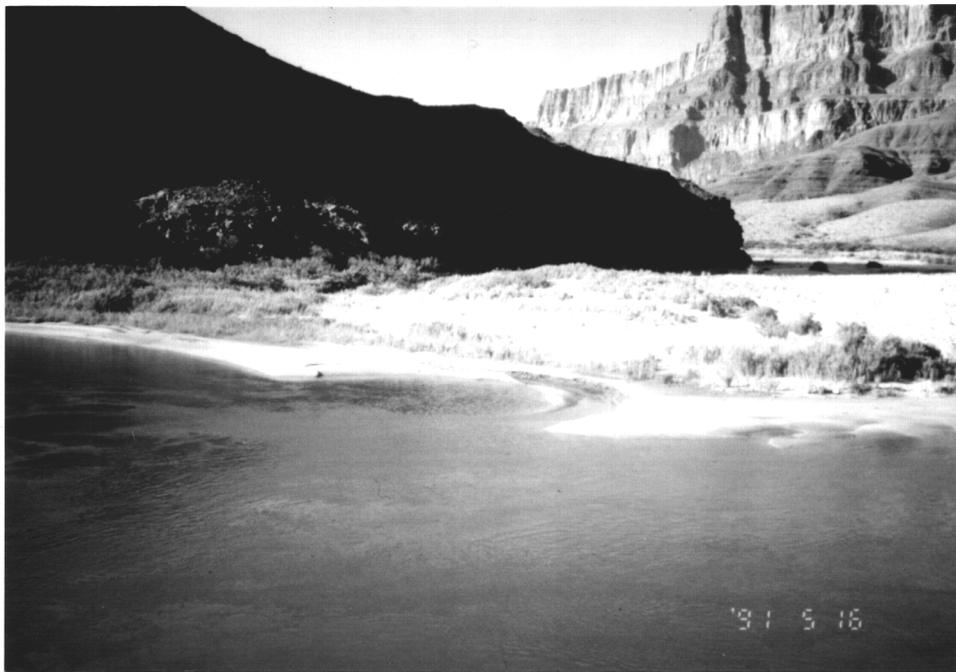
Figure 24a-b. Photographs taken on May 15(a) and 16(b), 1991, at CR 68 R. Note enlarged return flow area in lower photograph.

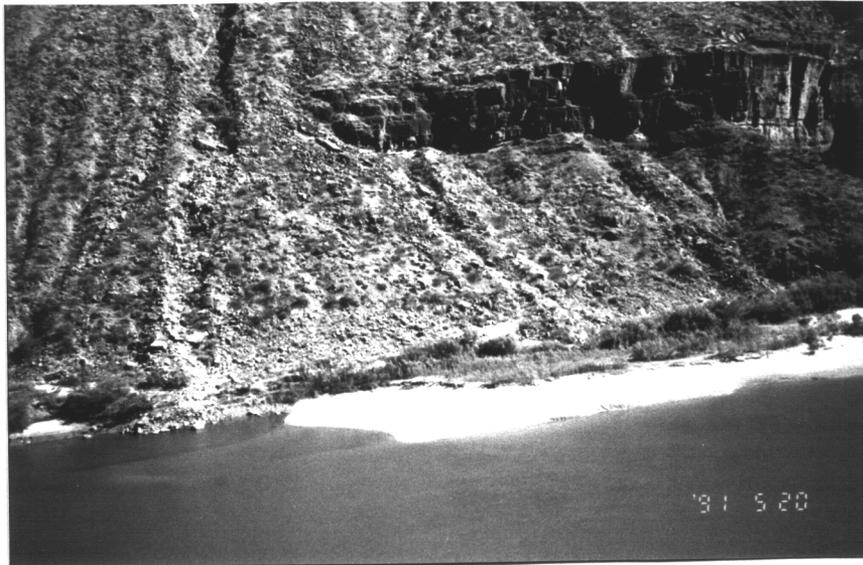
Figure 25a-b. Photographs taken on May 20 and June 2, 1991, at CR 172 L. Note elongated reattachment deposit in lower photograph.

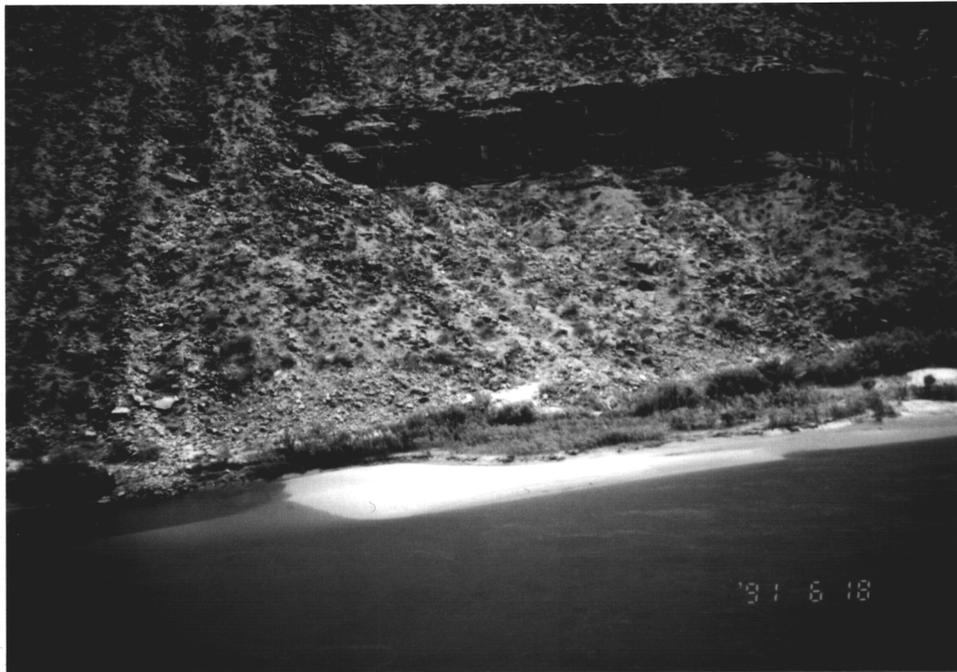
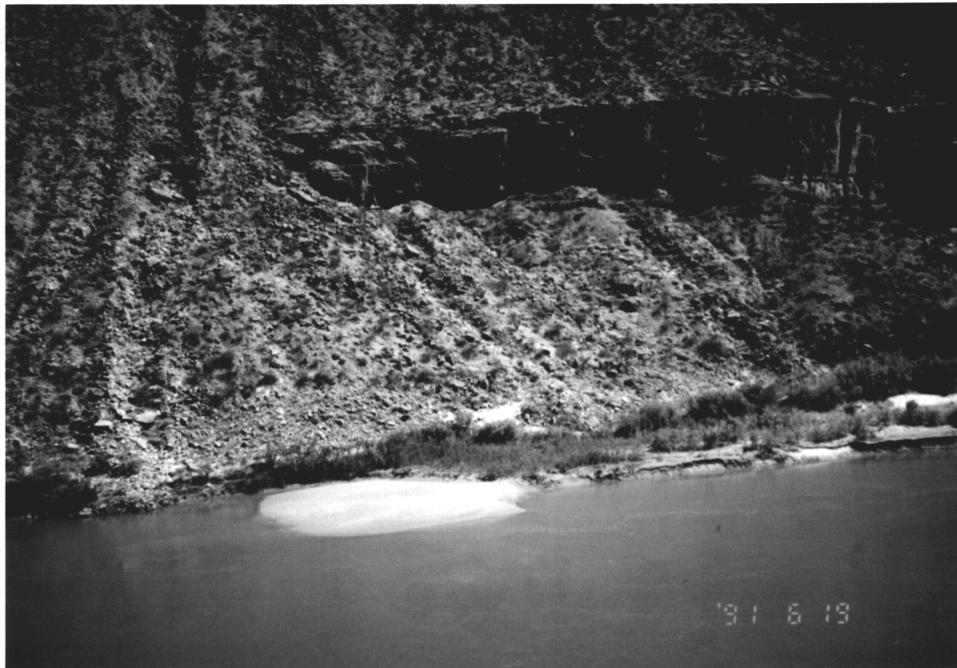
Figure 26a-b. Photographs taken on June 18(a) and 19(b), 1991, at CR 172 L. Note erosion of deposit face in lower photograph (right center).

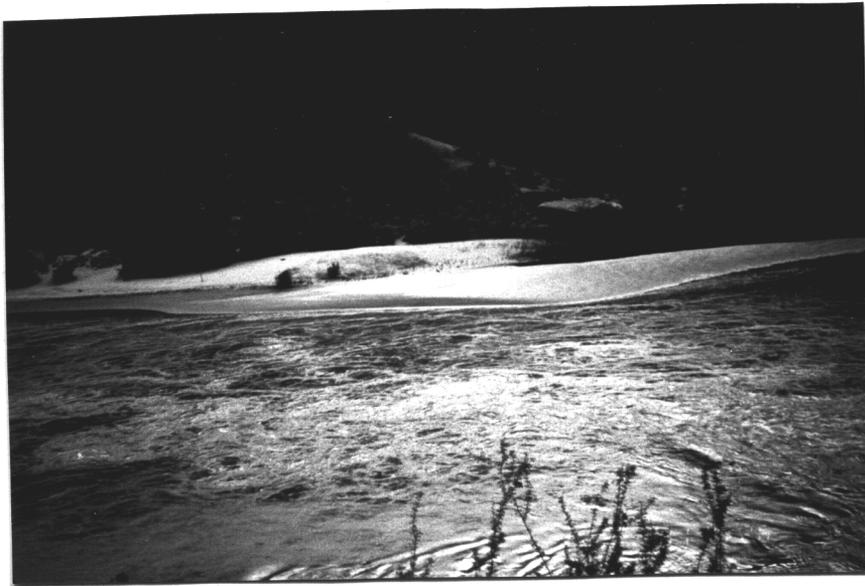
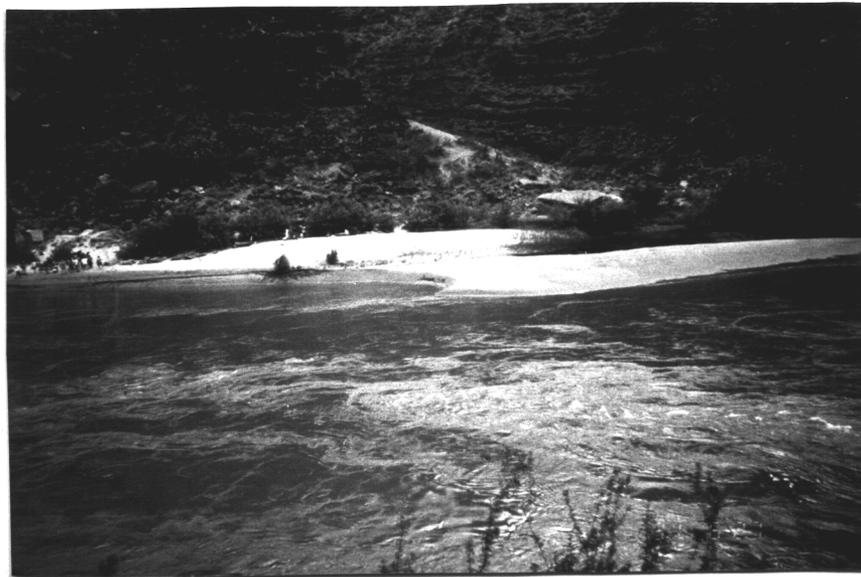
Figure 27a-b. Photographs taken on June 26 and 27, 1991, at CR 216 R. Note erosion of downstream portion of reattachment deposit in lower photograph.

Normal Summer Flow June 1-29, 1991 The *Summer* test flow eroded the deposit at CR 43 L about 7% over the test period (Fig. 13b). This was the highest erosion rate documented at CR 43 L. CR 51 L also eroded at a high rate during the test flow, but a secondary sand wave came into view on June 18, and the deposit increased in area for the remainder of the test as the sand wave migrated further into the recirculation zone (Fig. 14b). Area increased at CR 68 R about 2% (Fig. 11c). The *Summer* test flow produced more dynamic results at the three down river sites. CR 172 L began rapid deposition, about 18% area increase in 16 days, but on June 18, massive erosion reduced the area about 25% (Fig. 26a-b). Rapid deposition resumed at CR 172 L for the remainder of the test flow. At CR 211 L, area increased gradually about 3% over the test period. CR 216 R responded to the test similarly to CR 172 L. Following erosion of the lower deposit toe during the evaluation flow, rapid deposition began. Area increased about 8% in the first 25 days, but between photographs taken on June 26 and 27 (Fig. 27a-b), 20% of the downstream portion of the reattachment deposit had been eroded (Fig. 17b).

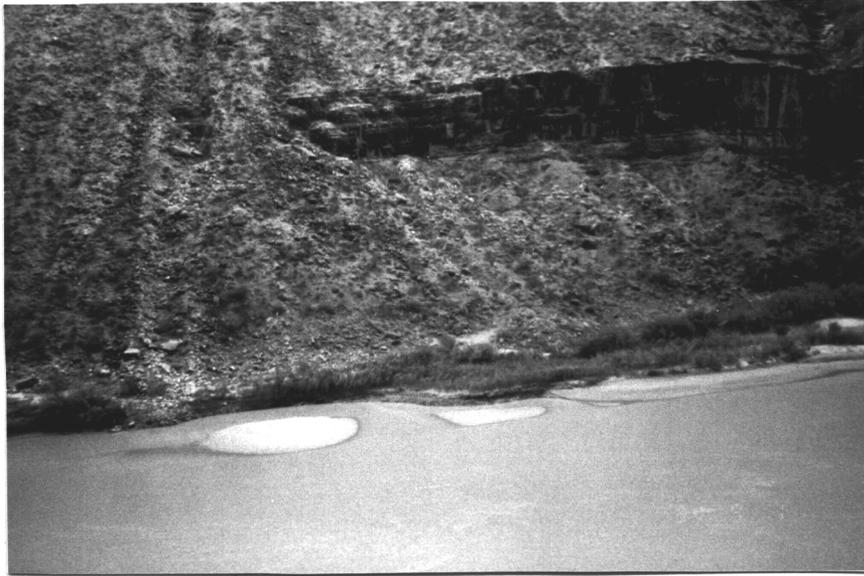
Figure 28a-b. Photographs taken on September 1 and 2, 1991, at CR 172 L. Note erosion of entire reworked portion of deposit in lower photograph.

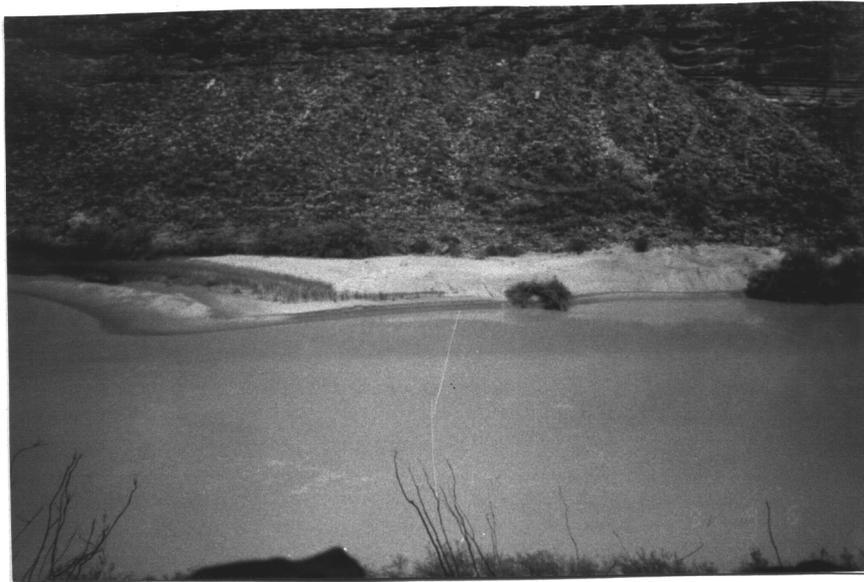
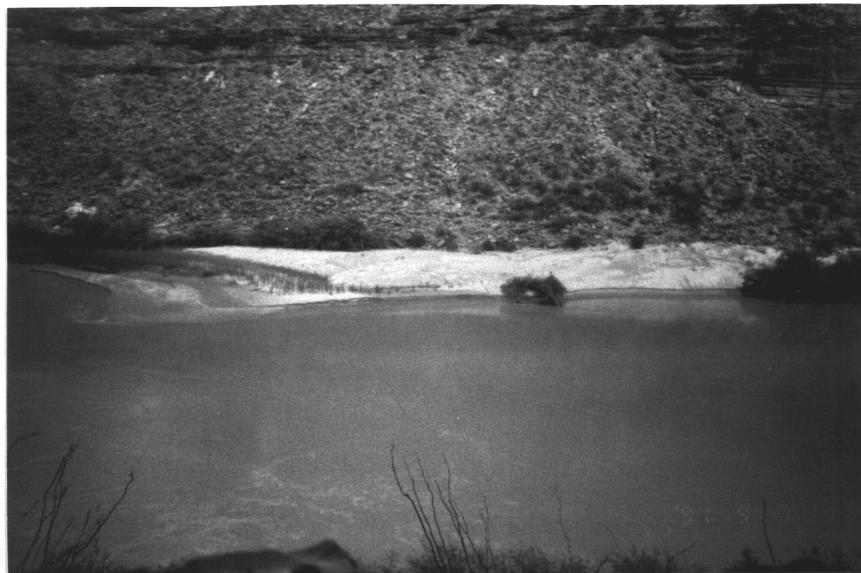
Figure 29a-b. Photographs taken on September 6 and 7, 1991, at CR 211 L. Note erosion of reattachment deposit platform in lower photograph.

latter at CR 211 L between photographs taken on September 6 and 7 (Fig. 29a-b). Approximately 10% of the deposit area was eroded within the 24-hour period (Fig. 16b). Gradual erosion continued at CR 216 R (Fig. 17b).

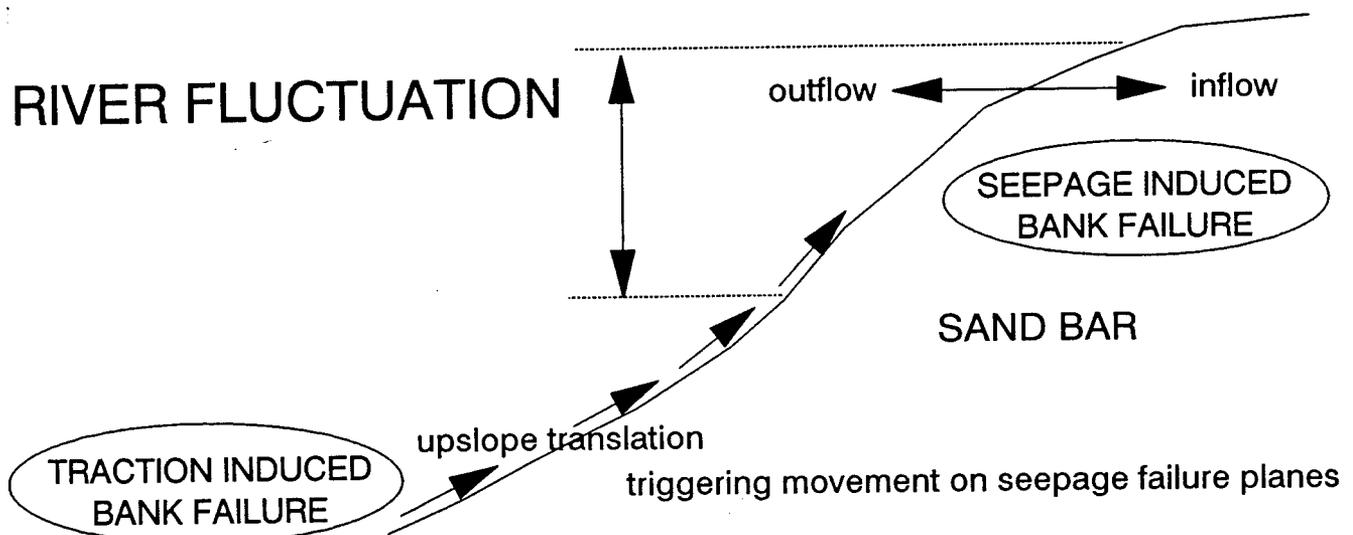
Figure 31. Model of two-process bank failure system. River stage fluctuations drive bank failure processes that result from rising stage and from descending stage. Rising and peak river stages are associated with the greatest hydraulic gradient in the typical daily river fluctuation, resulting in increased turbulence and current velocity. Dynamic activity of channel and eddy-stored sediments would be expected during rising and peak river stage. This is when traction induced bank failure would occur, and translate upslope. As river stage recedes and bottoms out, bank water outflow increases, sometimes resulting in bank failure or development of incipient failure planes (Budhu, this report).

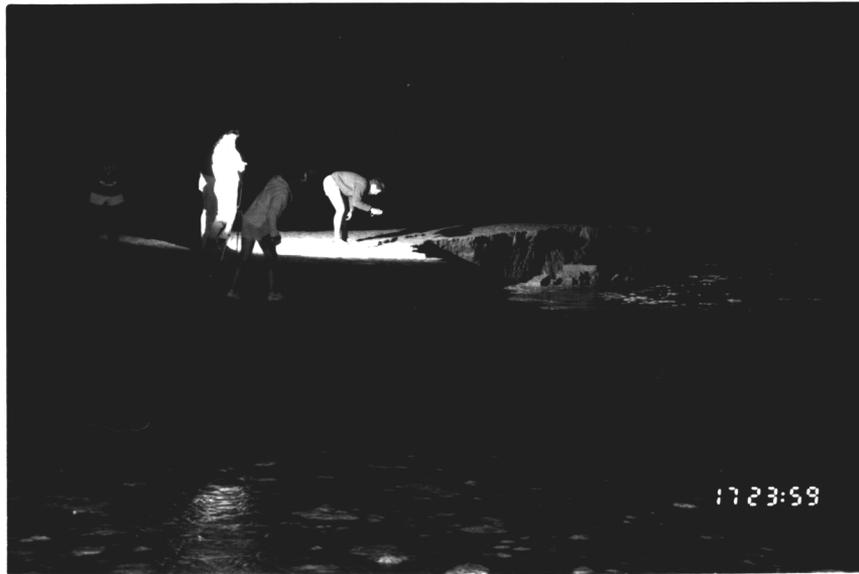
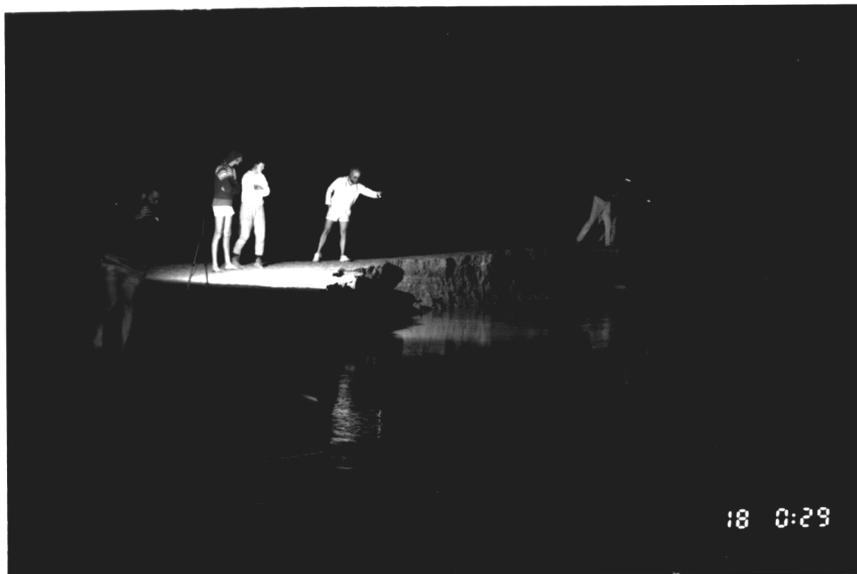
Figure 32. *Time-lapse images of April 17, 1991, bank failure event at the reattachment platform on CR 172 L. First image was taken at 23:59, on April 17, and the second image was taken at 0:29, on April 18.*

Examples of both types of bank failure were documented during this study. The first traction induced bank failure was observed on April 17, 1991, at CR 172 L (Fig. 21). The author and a team of NPS and USGS scientists were instrumenting the site for seepage monitoring when the failure occurred. During the rising stage, about 10 PM on April 17, loud splashing noises were heard coming from upstream. Inspection of the reattachment bar platform area revealed that the deposit was eroding at an alarming rate. Swift current was transporting the eroded material away from the bar as rapidly as the bank collapsed. The current velocity affecting the collapsing bank was estimated to be in excess of 1 meter per second, and was the primary recirculating flow pattern. However, the pattern was directed at a high angle to the deposit, unlike the pattern observed during the prior 4 days. Progressive erosion of the later stages of this bank failure was documented using time-lapse photography (Fig. 32). The event lasted about 4 hours, and approximately 30% of the sand bar was eroded.

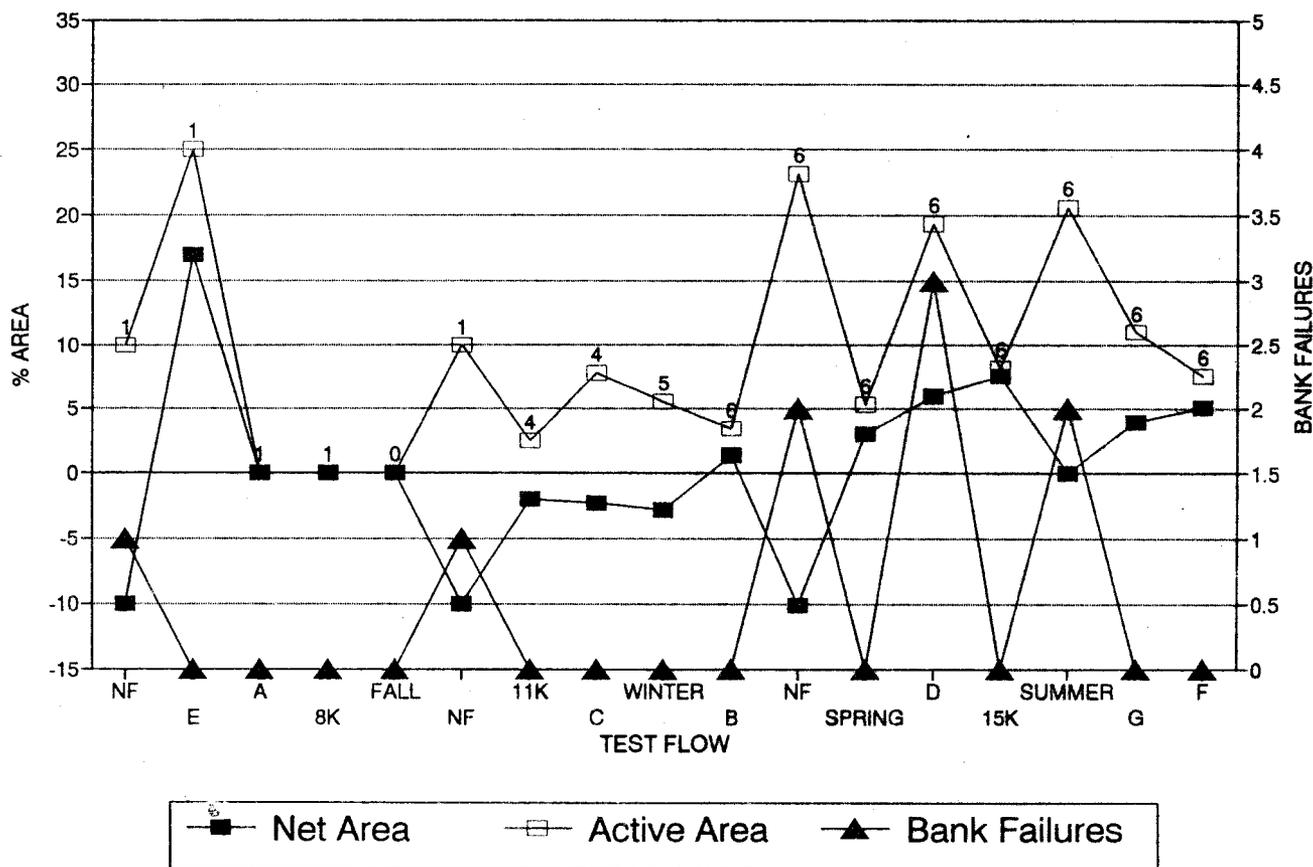
Figure 33. Test flow-series plot of three variables; net area, active area, and number of bank failures. Net area is average resulting area at the end of each test flow. Active area is the average sum of eroded and deposited area during each test flow. Number of bank failures is the average number per test flow.

The responses of sand bars to the "normal" flows and the imitation "seasonal" flows (i.e., Normal Summer) were distinctive. For example, there was a marked divergence between the amount of active sand bar area and the net or resulting area during the "normal" flows. Conversely, there was a demonstrated convergence of active area and net area during the regularly fluctuating test flows (Fig. 33). Plots of discharge time-series for each of the GCES-II test releases reveal the basic hydraulic differences between "normal" and regular test flows (Appendix I, this report). The most basic difference is the "weekend" 2-3 day low fluctuation period that was an integral element of each of the "normal" test flows. Figure 33 shows that the number of bank failures increased during periods of "normal" flow and that the active and net area curves diverge simultaneously. This indicates that bank failures were most often observed during "normal" flow periods, in fact "normal" flows resulted in 72% of the bank failures that involved more than 5% area. Regular test flows resulted in 28% of the bank failures that eroded more than 5% area. During the 17 test flows studied, 7 were "normal" and 10 fluctuated regularly. The "normal" flows accounted for 69% of the total erosion and 27% of the total deposition. The regularly fluctuating test flows resulted in 31% of the total erosion and 73% of the total deposition (Fig. 34). During the course of the study, the overall area of the six sand bars increased about 7%.

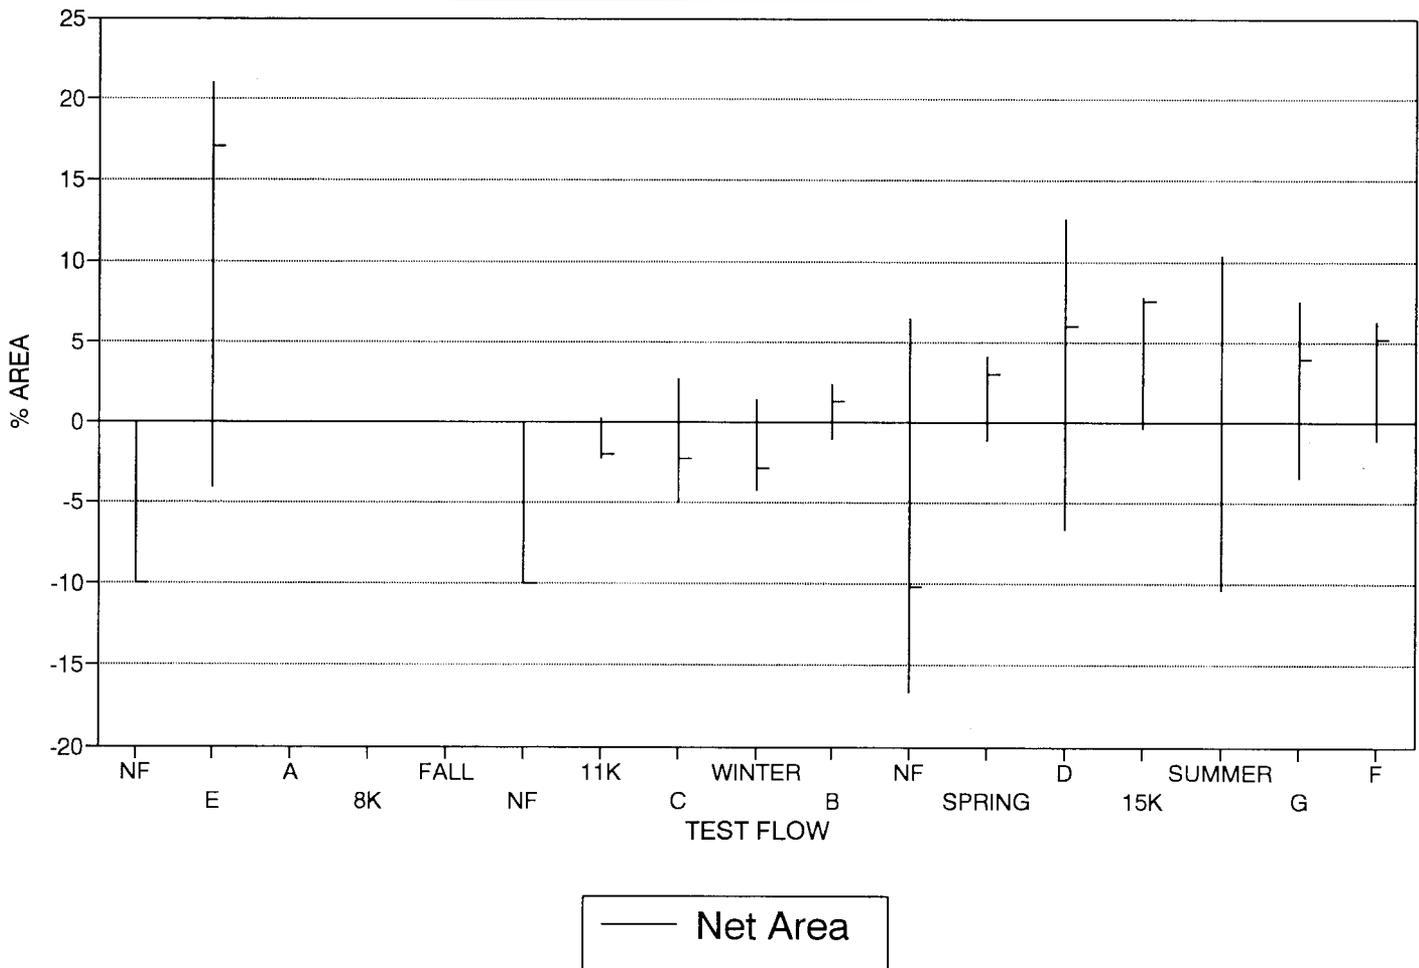
Figure 34. Test flow-series plot of average final (net) area at the end of each test flow and the range of erosion and deposition during the test.

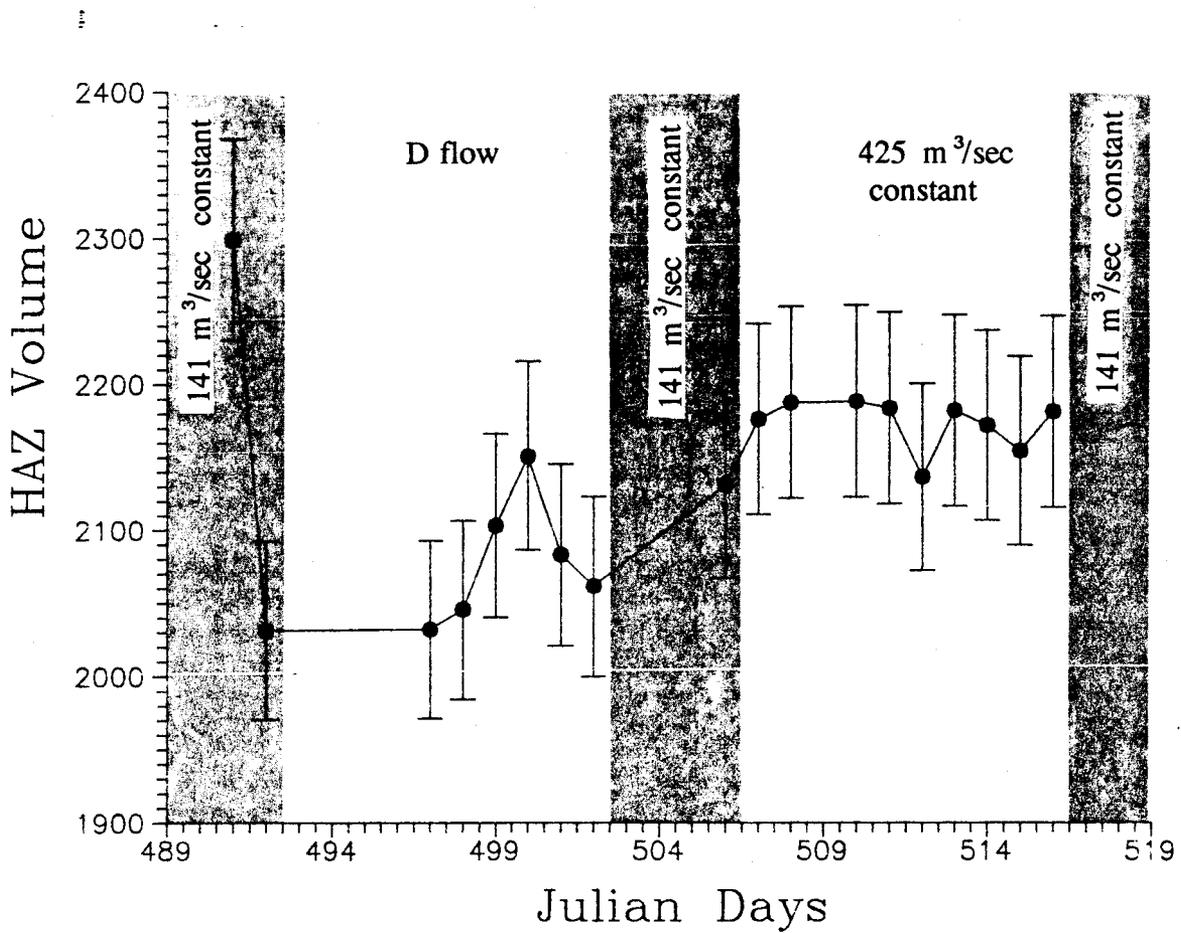
Figure 5. Daily repeated surveys of the Mile 45 reattachment sand bar during May, 1991 (adjusted Julian day 489 = May4). Note the bank failure event during the initial "constant 5,000 cfs" (141.5 m³/sec) test flow.

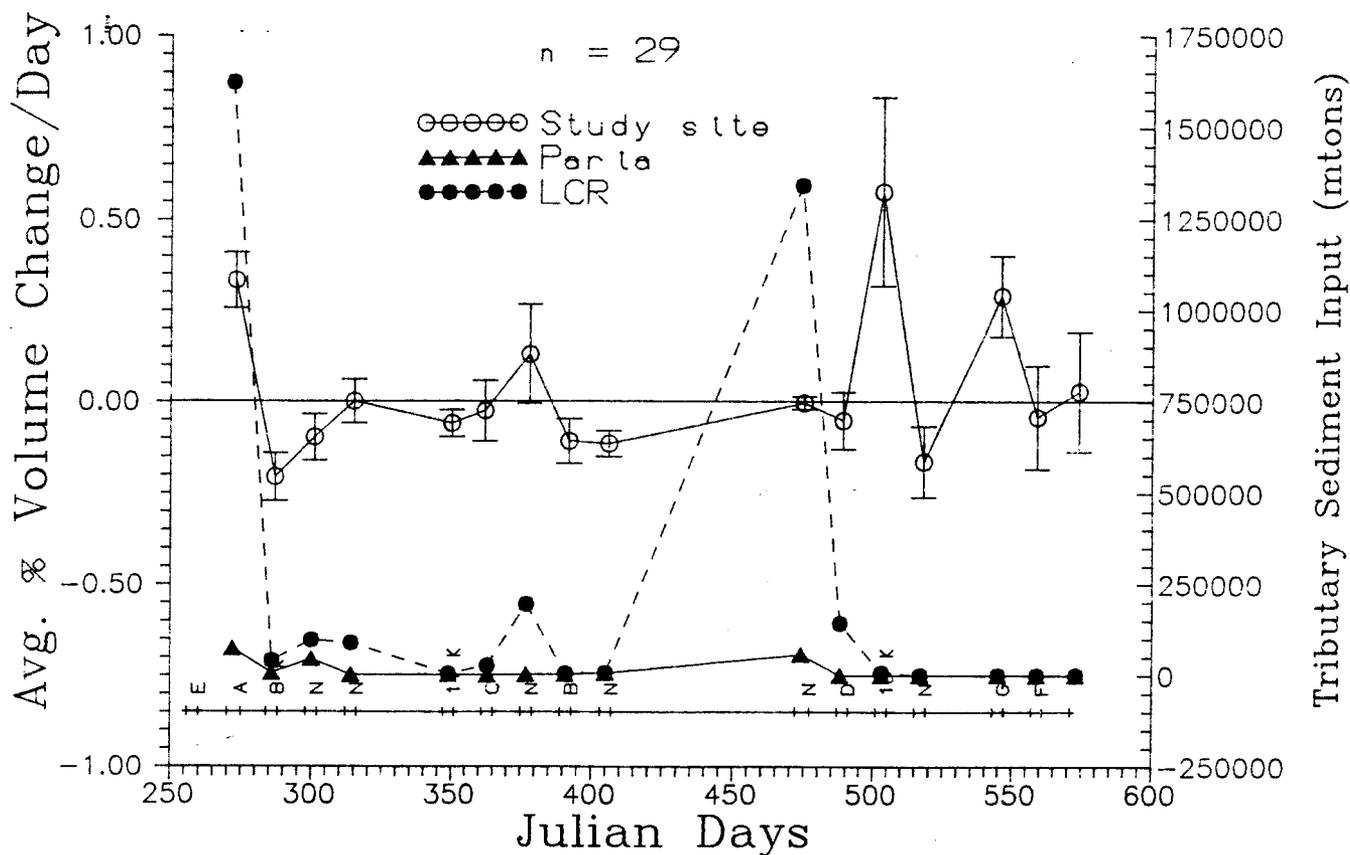
Figure 8. Average percent HAZ volume change/day for 29 Colorado River study sites, and average daily tributary sediment input (mt/d) from the Paria and Little Colorado Rivers from September, 1990 through July, 1991 (Julian Day 250 = Sept. 7, 1990; Julian Day 577 = July 31, 1991). The mean %VCR (open circles) and one standard error are presented for all sand bars surveyed during each test flow, and represents %VCR for the previous flow. For example, the mean %VCR during flow "E" was 0.34, as measured just prior to the beginning of the "A" flow.

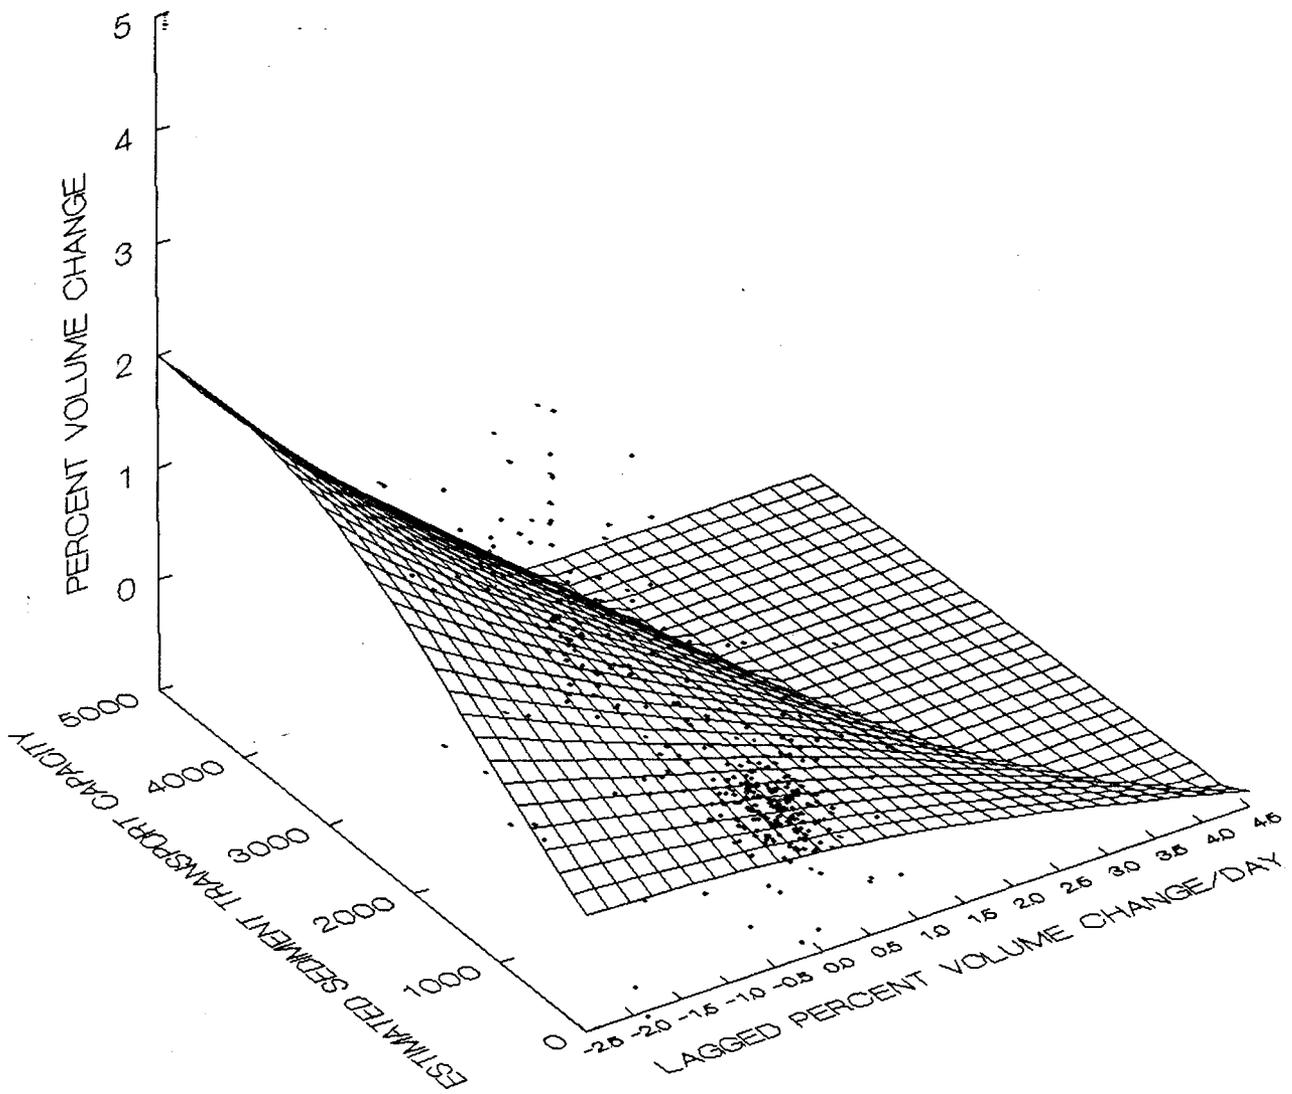
Figure 12. Relationship between HAZ percent volume change rate/d (%VCR), lagged %VCR and estimated sediment transport capacity for 29 sand bars from September, 1990 through July, 1991.

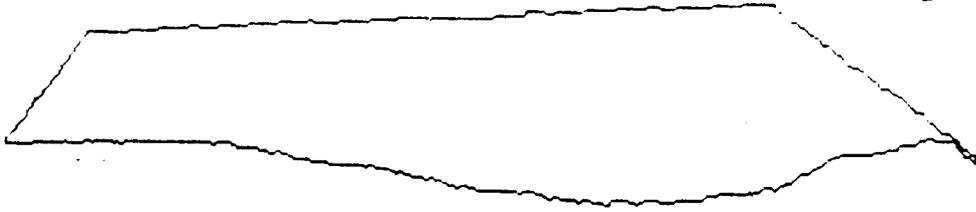
A1a

Figures A1a-A1l. Original planimetric outlines and subsequent comparisons of bracketing outlines. Dark shaded areas were eroded. Light shaded areas were aggraded.

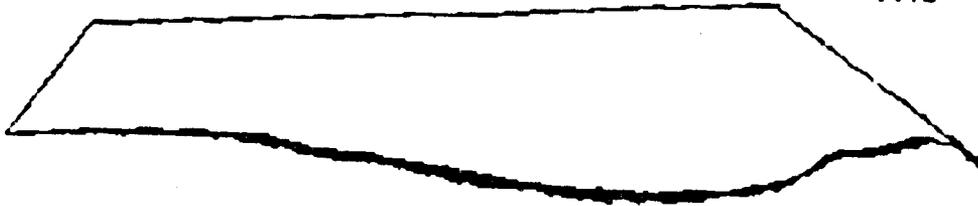
A1b

12/17/90 12/30/90 11,000 cf

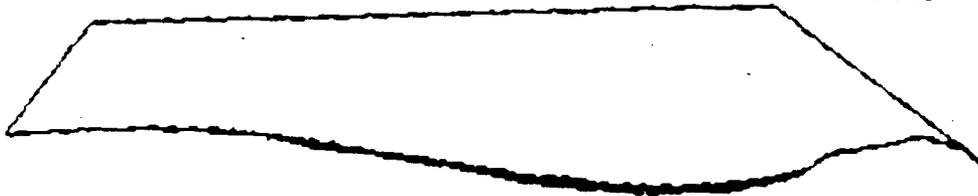
A1c

12/30/90 01/12/91 "C"

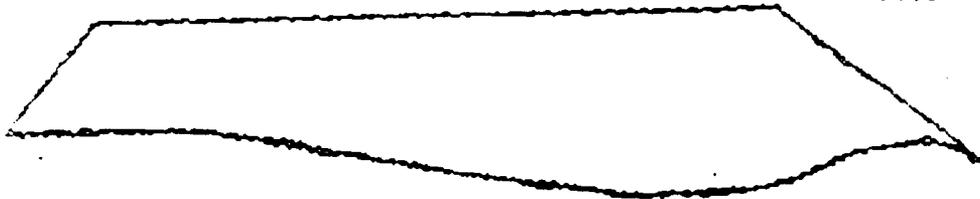
A1e

01/26/91 02/09/91 "B"

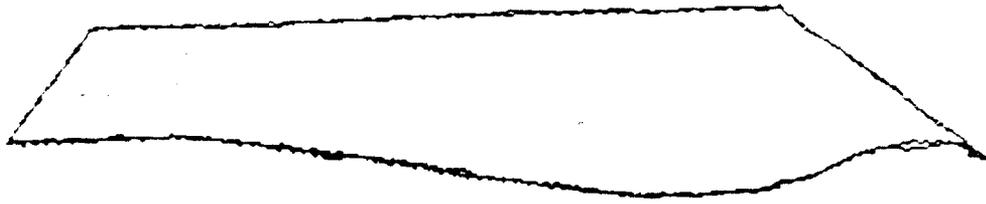
A1f

02/09/91 04/20/91 NORMAL

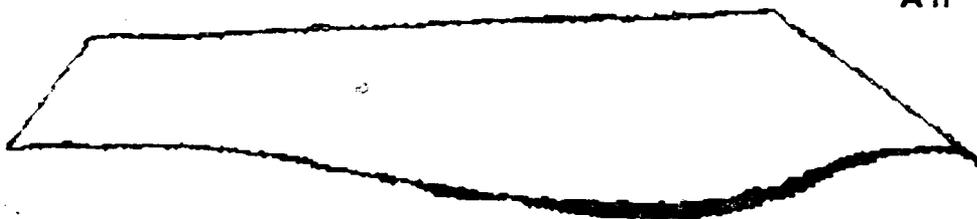
A1i

05/19/91 06/02/91 15,000 cf

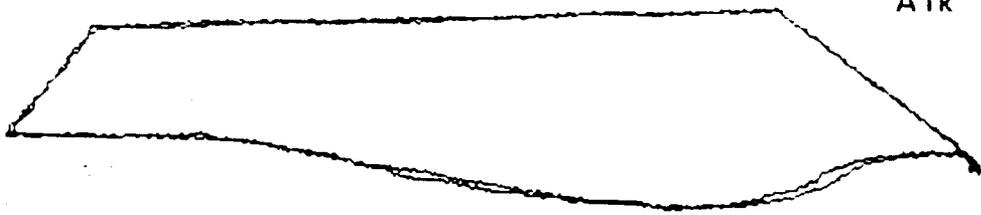
A1k

06/30/91 07/14/91 "G"

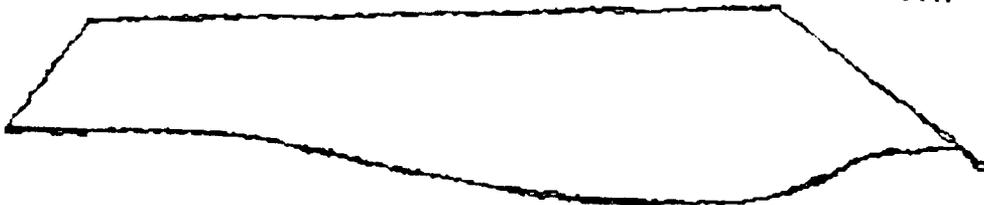
A1l

07/14/91 07/27/91 "F"
