**THE INFLUENCE OF VARIABLE DISCHARGE REGIMES ON
COLORADO RIVER SAND BARS BELOW GLEN CANYON DAM:
FINAL REPORT**

Northern Arizona University

NPS Cooperative Agreement Number: CA 8006-8-0002

**Sponsored by: The U.S. Department of Interior National Park Service Cooperative Parks Study Unit
Northern Arizona University Flagstaff, AZ 86011**

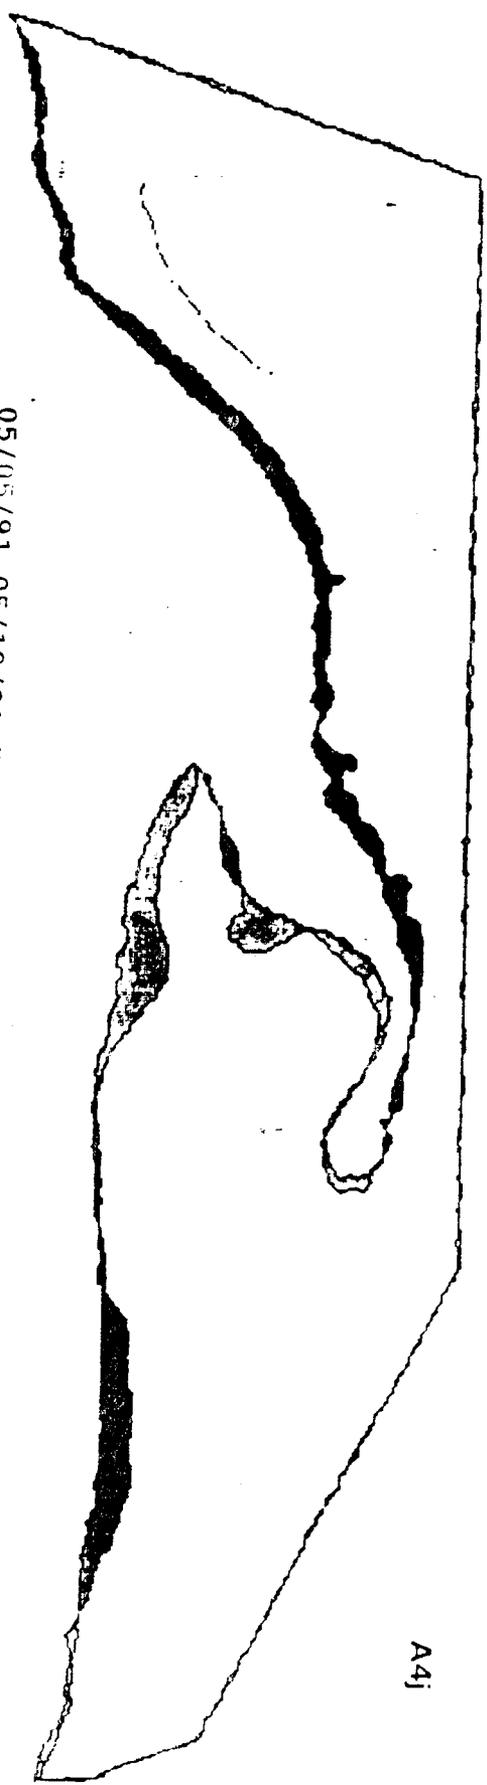
A4i

05/05/91 05/19/91 "D"

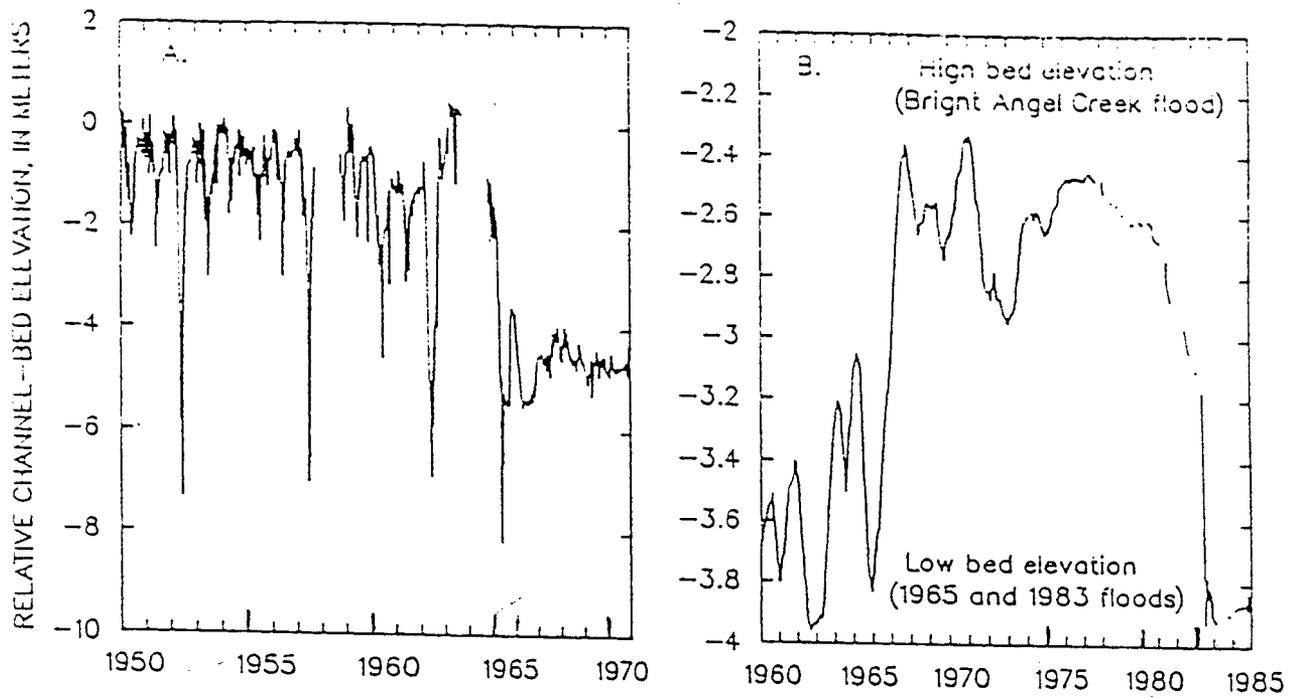
FIGURE 17 Bed elevation at (a) the U.S. Geological Survey gaging station, Colorado River at Lees Ferry (river mile 0), 1950-1970, and (b) at the U.S. Geological Survey gaging station, Colorado River near Grand Canyon (river mile 87.2, 139 km), 1960-1985. (From Kieffer and others, 1989)

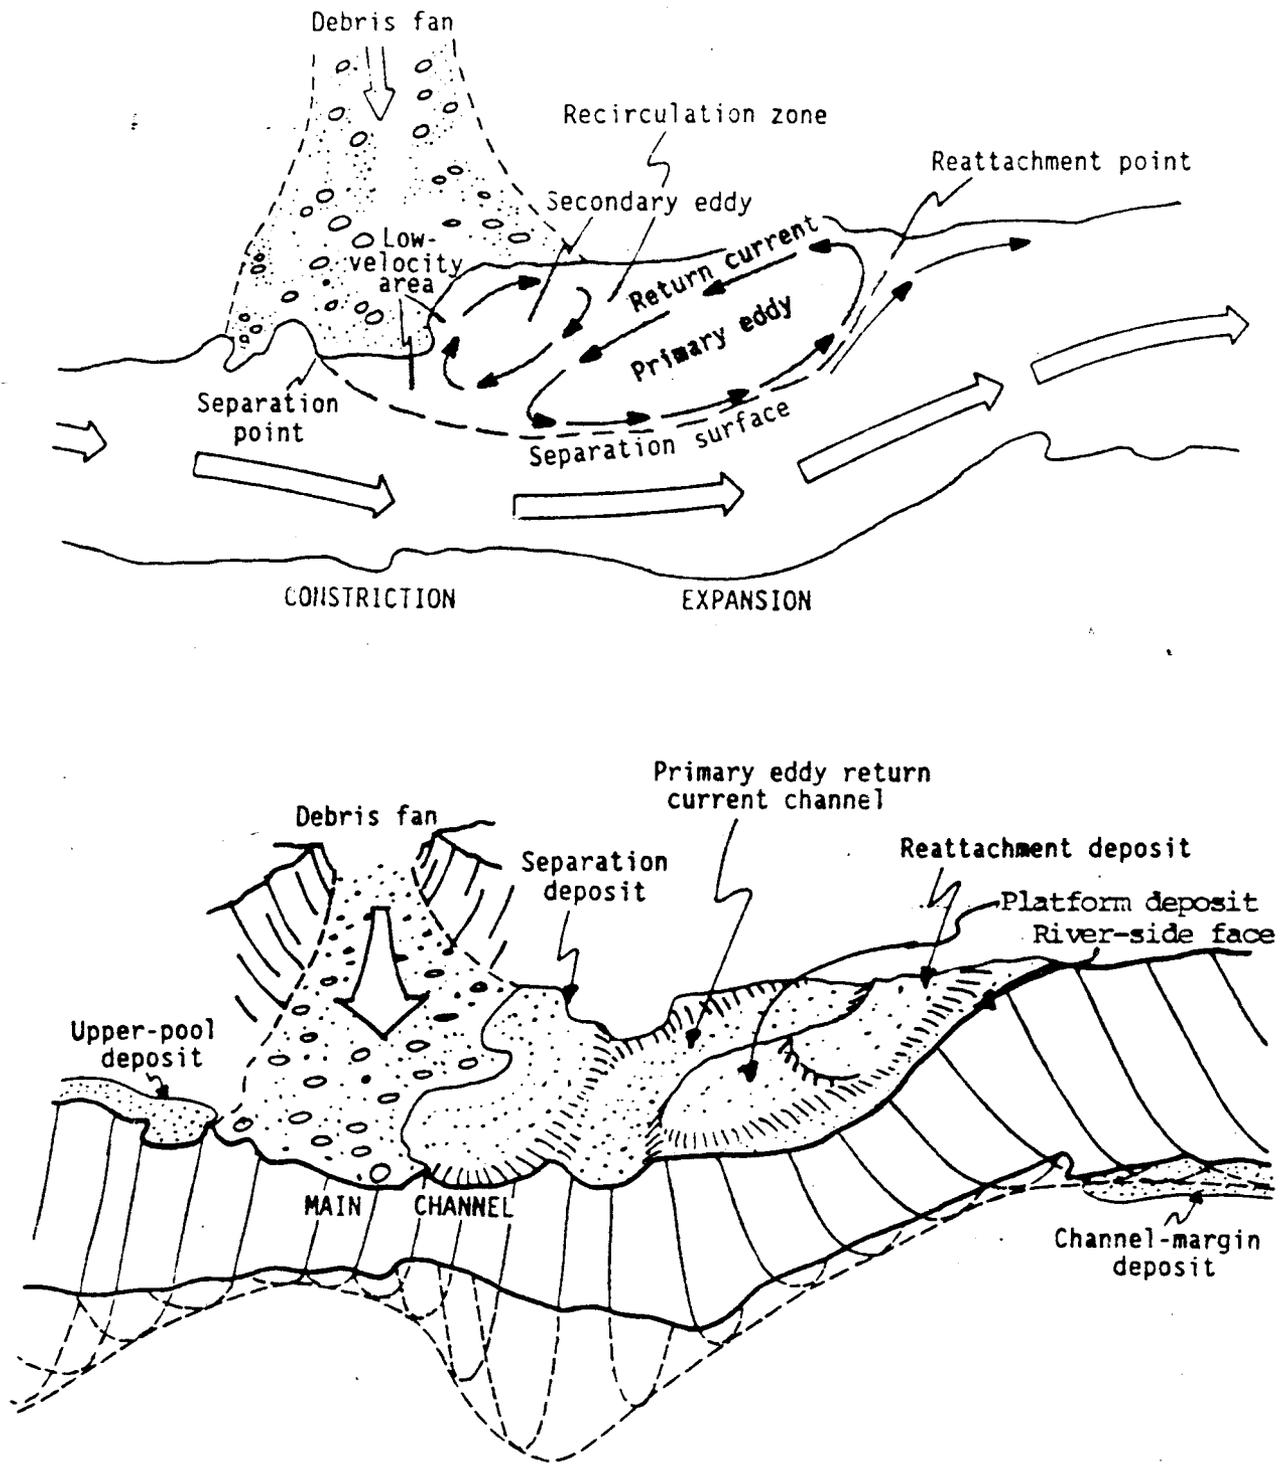
Figure 2. Diagram of deposit types and sedimentary environments in the Grand Canyon, with nomenclature used in this report. Modified from Schmidt and Graf, 1988 (Fig. 3).

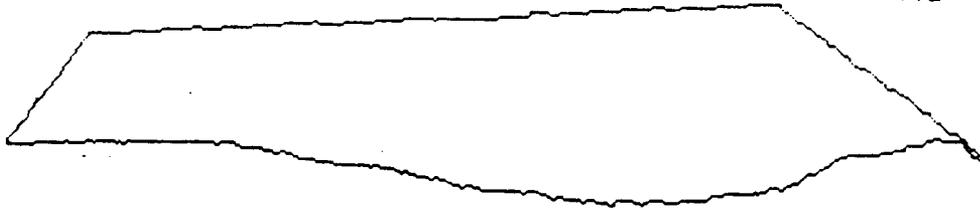
A1a

Figures A1a-A1i. Original planimetric outlines and subsequent comparisons of bracketing outlines. Dark shaded areas were eroded. Light shaded areas were aggraded.

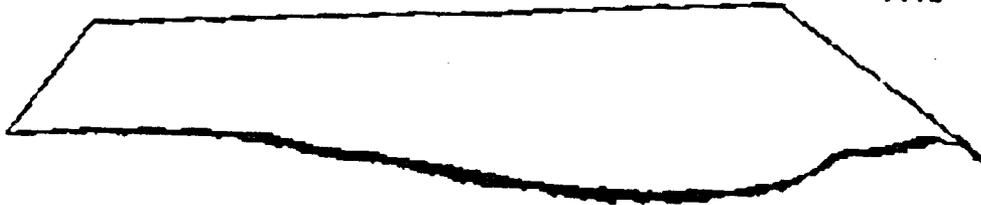
A1b

12/17/90 12/30/90 11,000 cf

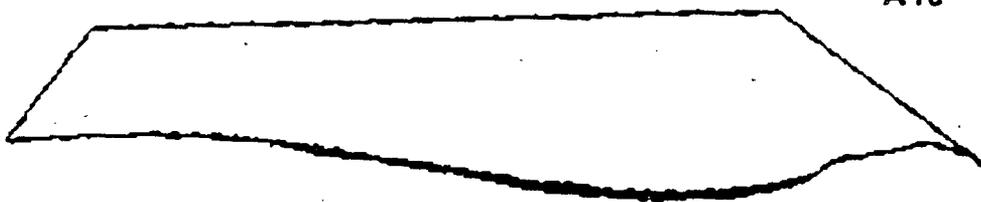
A1c

12/30/90 01/12/91 "C"

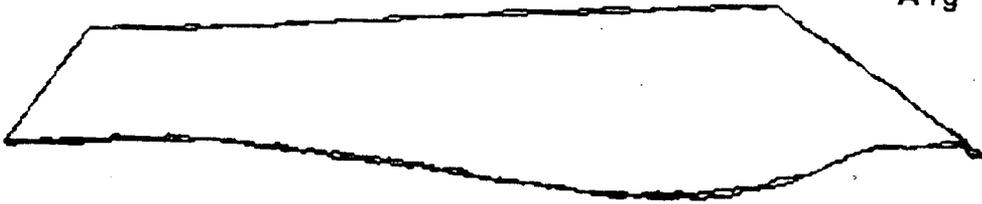
A1g

04/20/91 05/05/91 SPRING

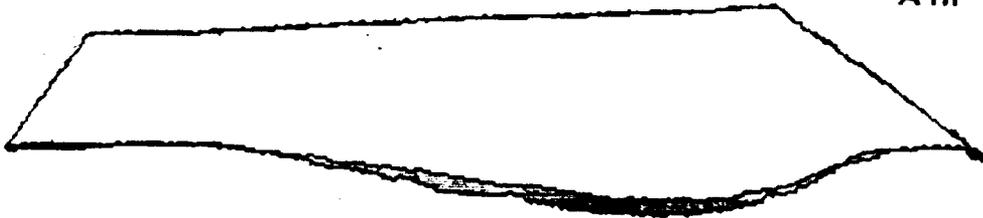
A1h

05/05/91 05/19/91 "D"

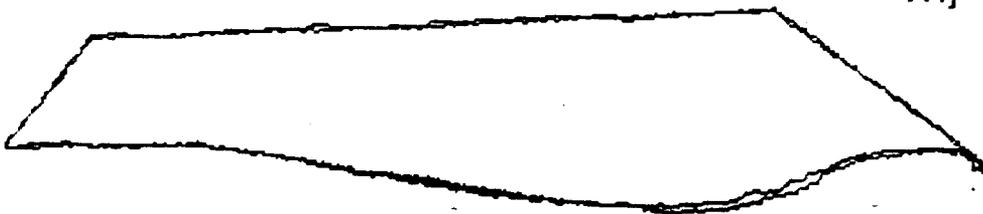
A1j

06/02/91 06/30/91 SUMMER

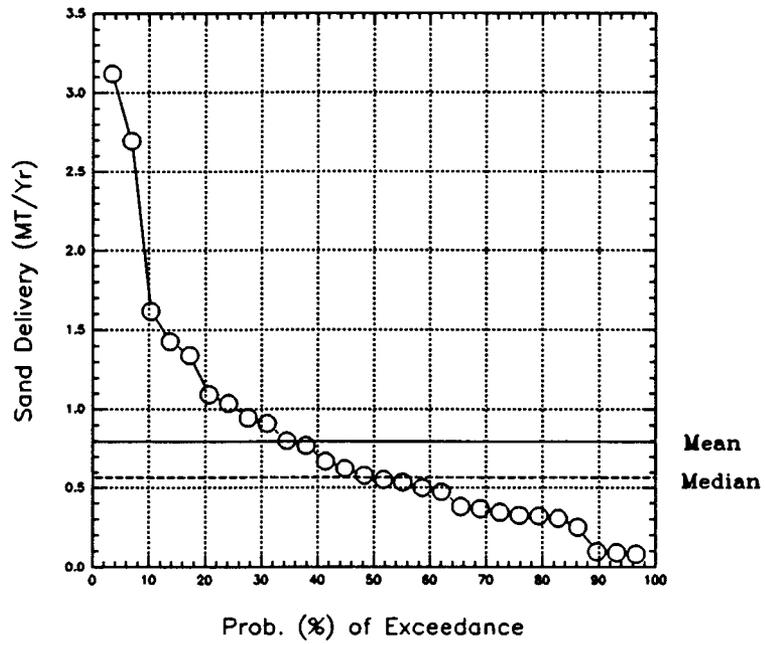
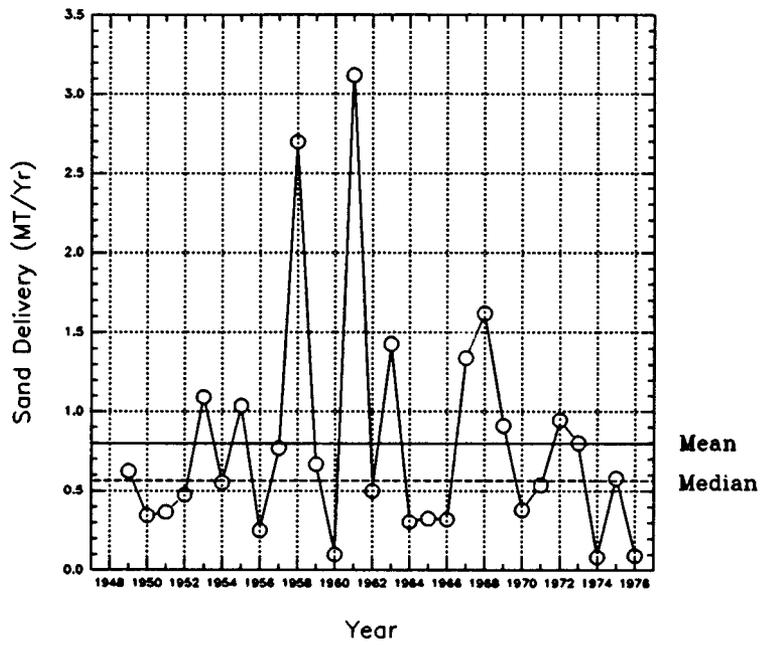
FIGURES 1 and 2 (respectively). Sand delivery (million tons/yr) from the Paria River into the Colorado River (1948 - 1975).

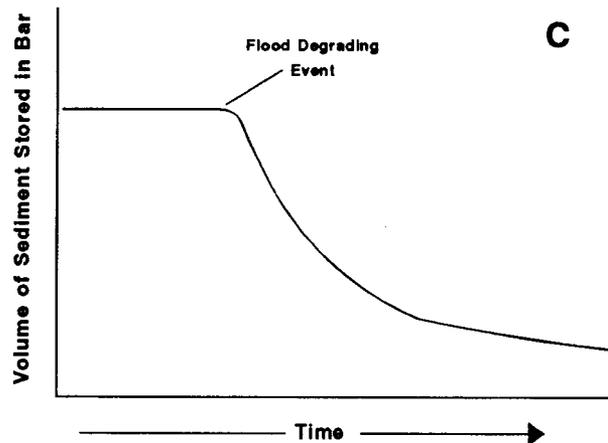
Figure 4. A conceptual model of sand bar responses to flood perturbation under different flow regimes.
