COLORADO RIVER INVESTIGATIONS VII

July - August, 1988

By
Students and Staff of Geology 538-626
Northern Arizona University

TOPOGRAPHIC CHANGES ON SELECTED BEACHES IN THE GRAND CANYON, 1987-1988

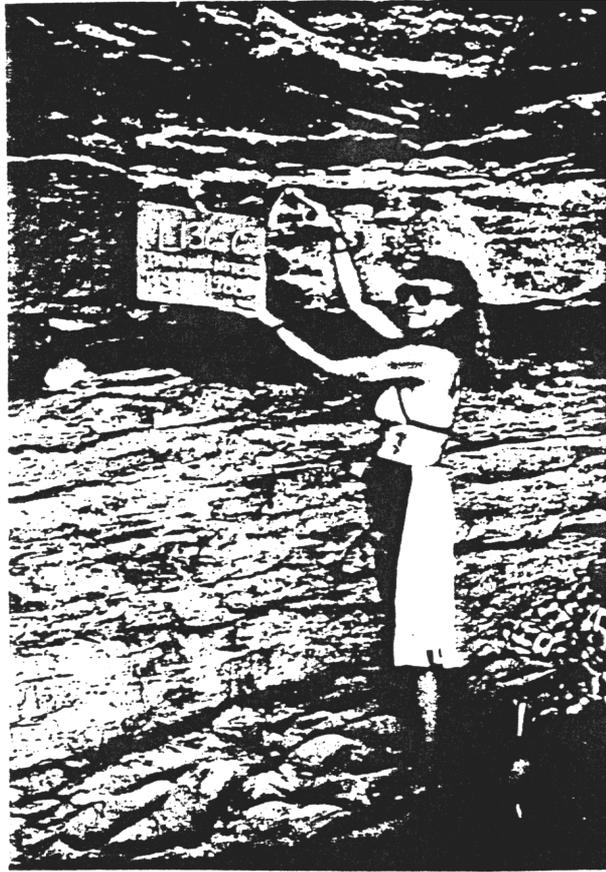
Figure I-21. BS 1 at Ponchos Kitchen. L 136-6.

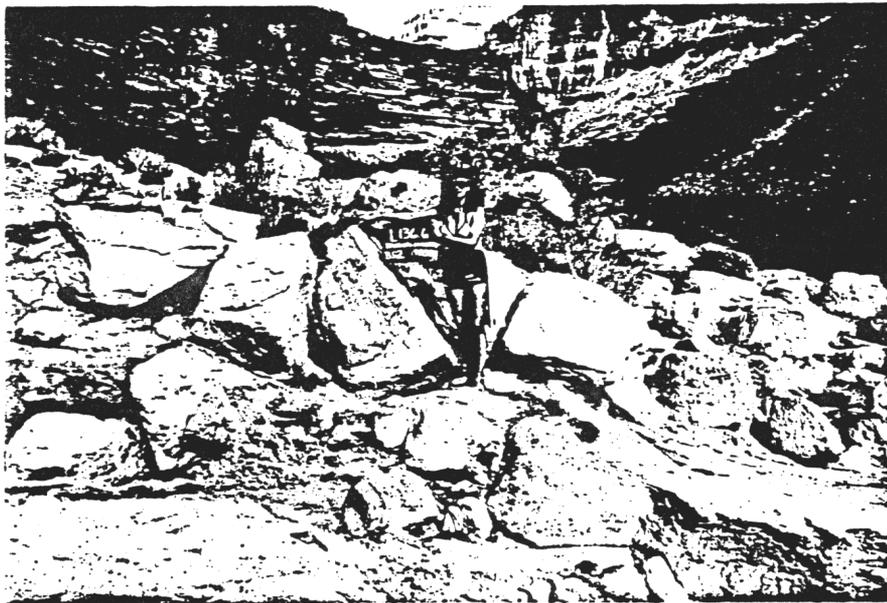
Figure I-22. BS 2 at Ponchos Kitchen. L 136.6.
