COLORADO RIVER INVESTIGATIONS #9
July - August, 1990

By
Students and Staff of Geology 601 - Biology 680
Northern Arizona University

January 1991

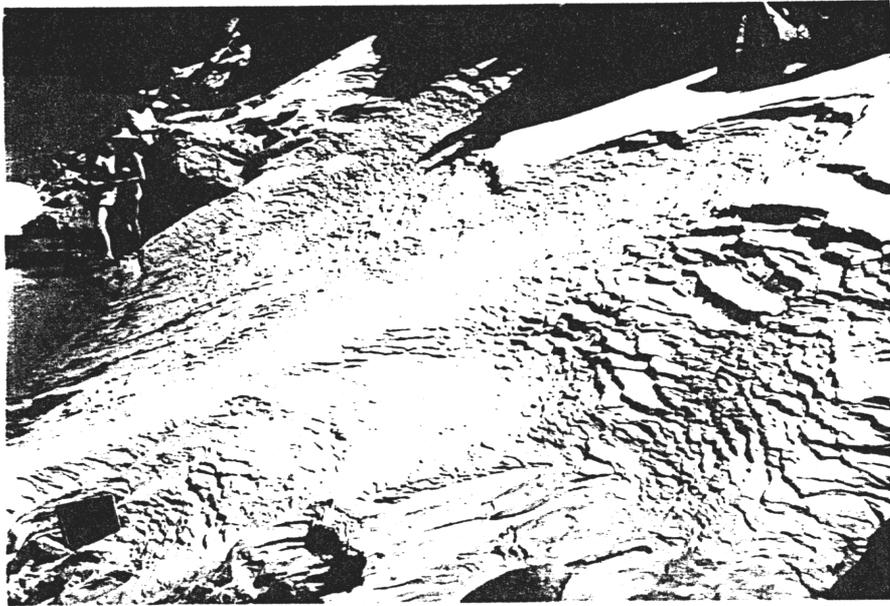
Figure 4 Microfailure on beach surface

When possible, underlying sedimentary structures were observed for possible correlation to the overlying beach surface. Photographs were taken whenever possible. In several cases, trenches dug by another investigative team were available for observation (Figures 4,5).

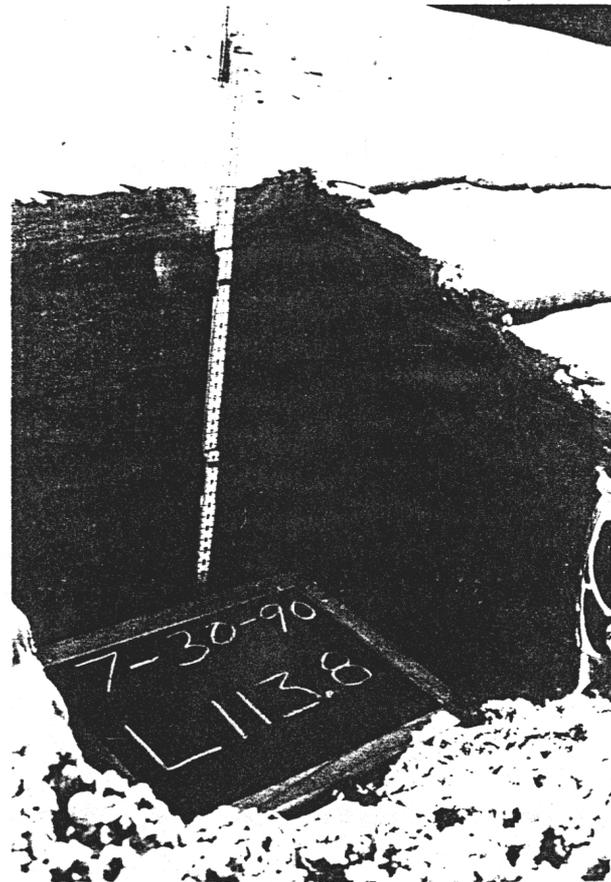
Figure 5 Trench dug below microfailure in figure 4 showing slippage planes between alternating silt and sand layers.

When beach trenches were dug on microfailing slopes, slippage planes were observed. These planes did not appear when macrofailure was present.

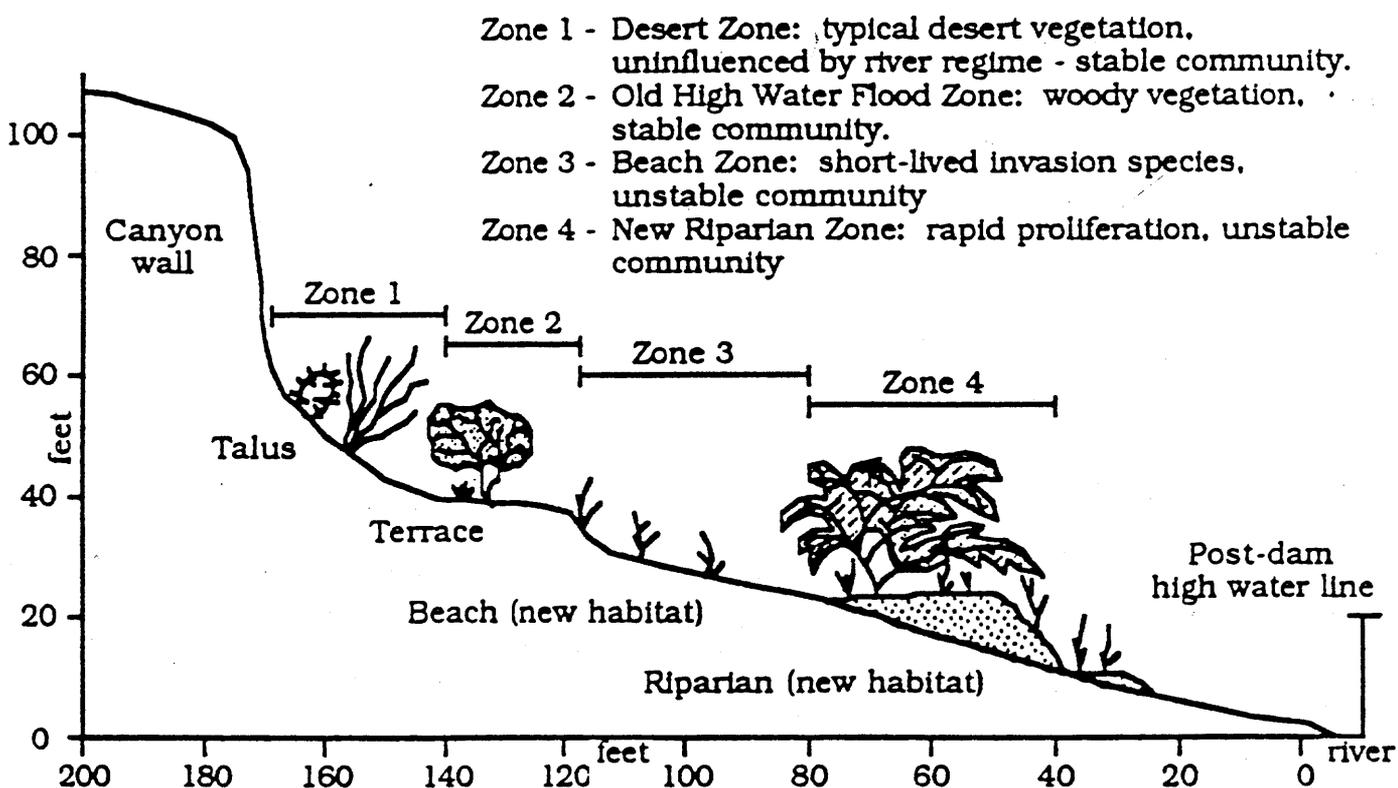
Figure IV-1: Diagrammatic cross-section of vegetation zones in the Inner Gorge of the Colorado River in Grand Canyon after construction of Glen Canyon Dam (adapted from Carothers et al. 1979).

Three zones were identified using plant species and terraces. Zone 4, the New High Water Zone (NHWZ), was found near the water's edge and was marked by the presence of tamarix (*Tamarix ramosissima*), spiny aster (*Aster spinosus*), and camelthorn (*Alhagi camelorum*). Zone 2, the Old High Water Zone (OHWZ) was found on a terrace above the river and was inhabited by acacia (*Acacia greggii*), mesquite (*Prosopis glandulosa*), and fourwing salt bush (*Atriplex canescens*). The desert zone (Zone 1) which was typically located on a talus slope near canyon walls is characterized by brittlebush (*Encelia farinosa*), barrel cactus (*Ferocactus acanthodes*), and mormon tea (*Ephedra* spp.); Figure IV-1.

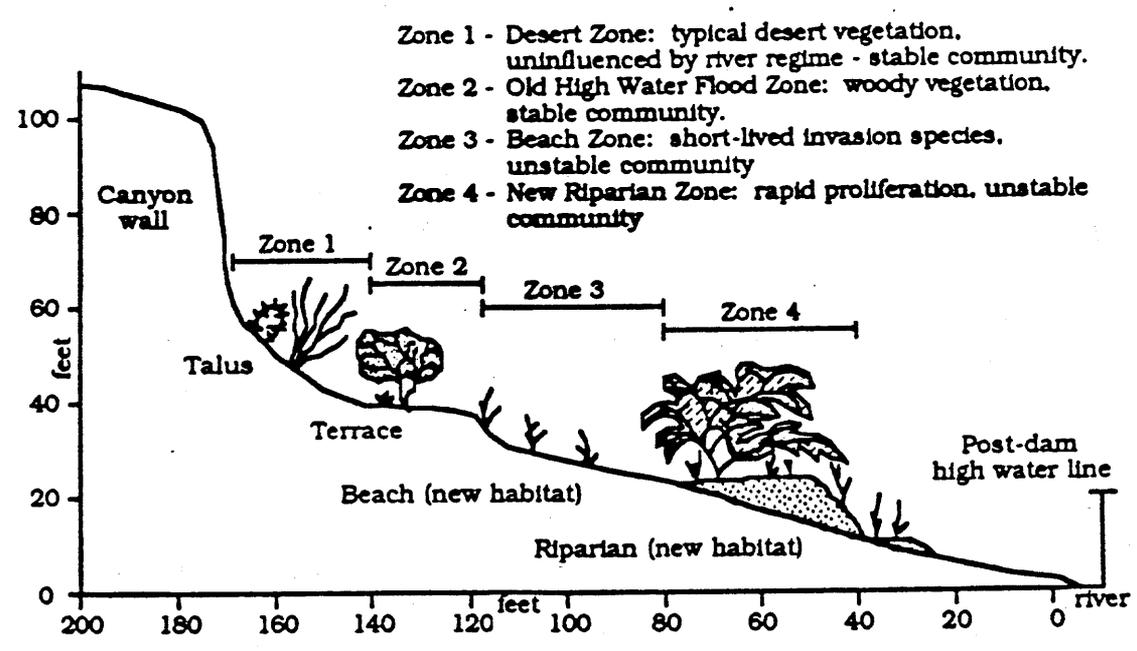
Figure V -1. Diagrammatic cross-section of vegetation zones in the Inner Gorge of the Colorado River in Grand Canyon after construction of Glen Canyon Dam (adapted from Carothers, et. al., 1979).

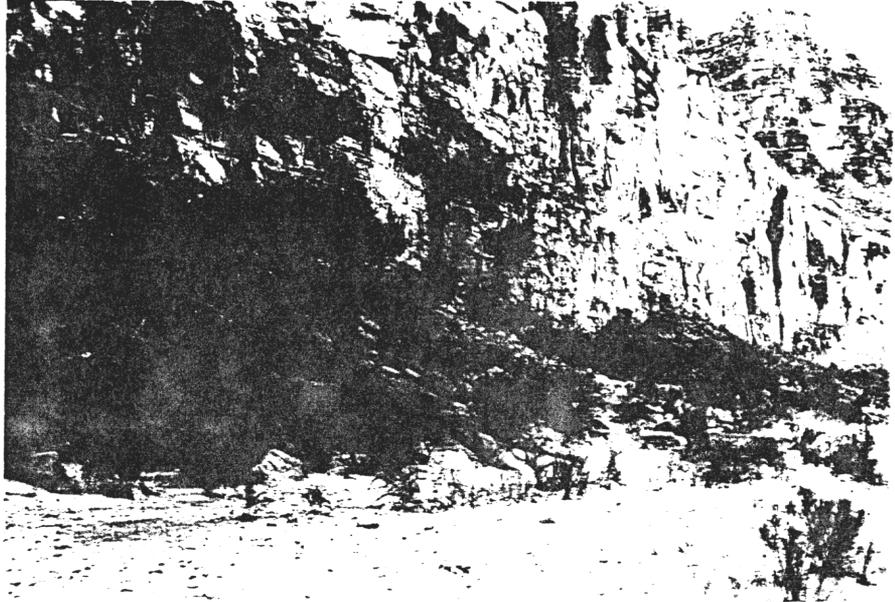
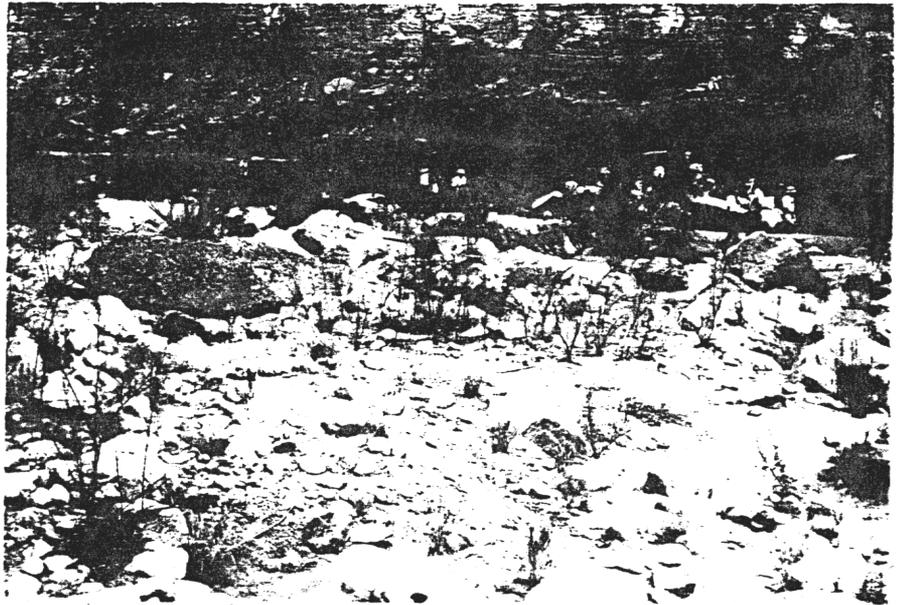
Figure A-4. National Canyon (RM 166.5) showing the old high water zone and alluvial deposits in the new high water zone.

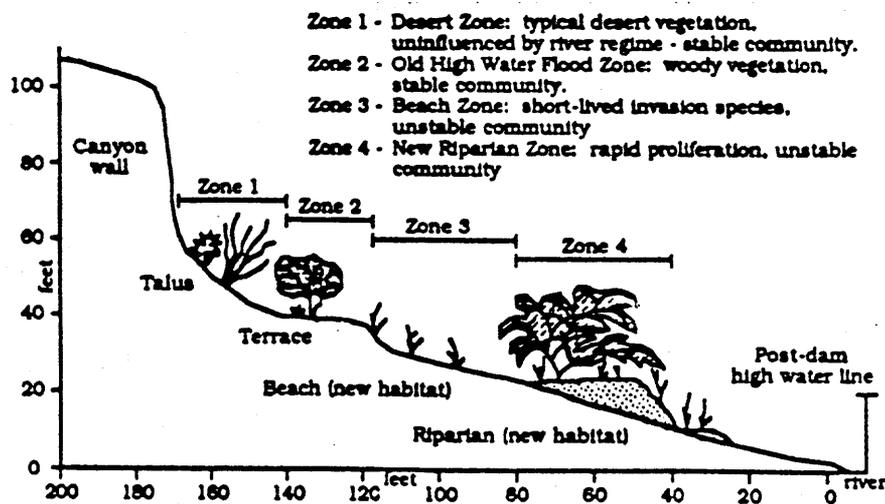
Figure VII-1. Diagrammatic cross-section of vegetation zones in the Inner Gorge of the Colorado River in Grand Canyon after construction of Glen Canyon Dam (adapted from Carothers, et al., 1979).

Several authors studied the river corridor flora intensively. Carothers et al. (1979) identified four zones along the river. Zone I was the area farthest from the river, characterized by desert vegetation. Zone II was the Old High Water Zone, representing the highest level of flooding prior to the construction of Glen Canyon Dam. Zone III was poorly vegetated and "back beach" area lying just below the Old High Water Line II. Zone IV was the New High Water Zone, which is established by the current high water level as determined by the controlled flows released from Glen Canyon Dam.

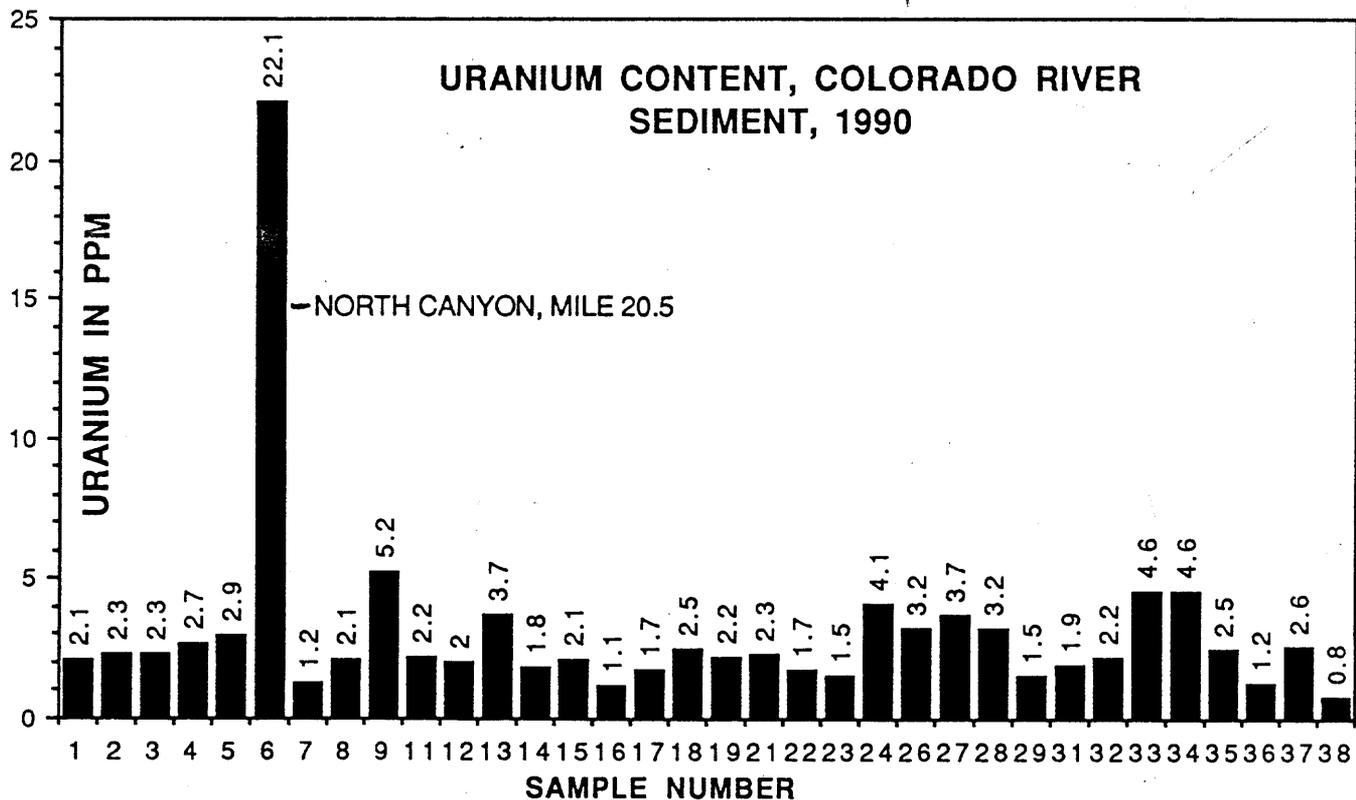
Figure 8-1: Graph of Uranium content.

The results are reported in ppm for uranium and thorium. The elemental analyses were evaluated both in terms of absolute abundance and concentration ratio of uranium and thorium. Results are summarized in Tables 1 and 2. and Figure 8-1.

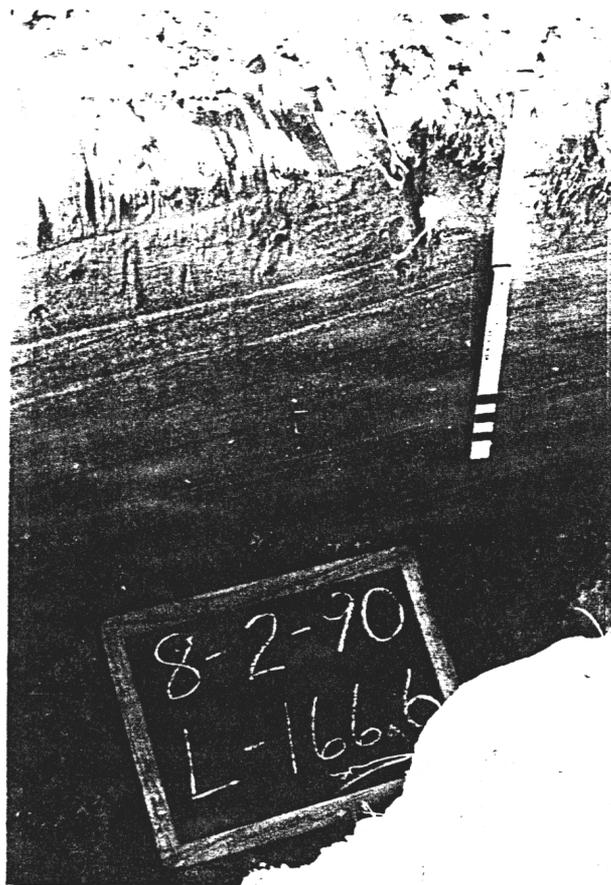
Figure IX-2 Laminar bedding (cm scale)

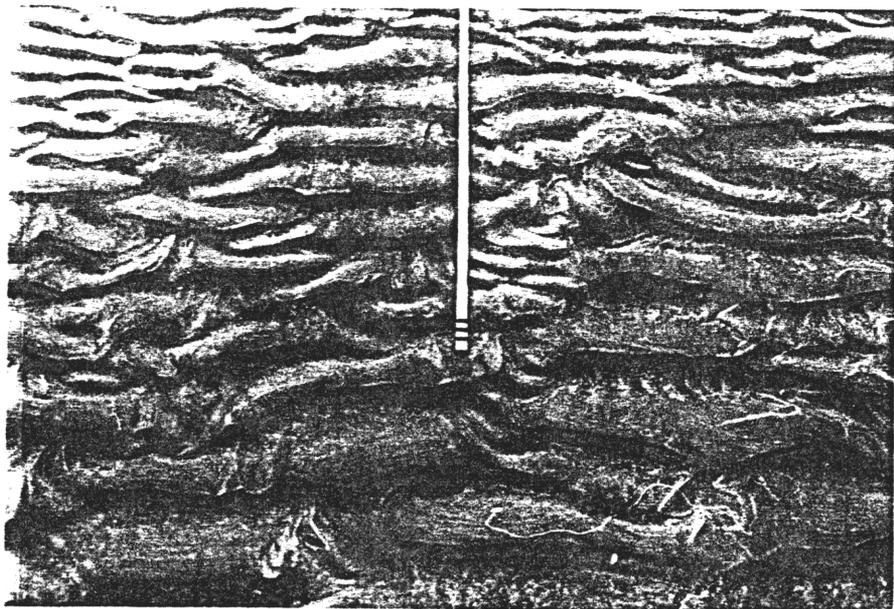
Figure IX-4 Undulatory ripples (cm scale)

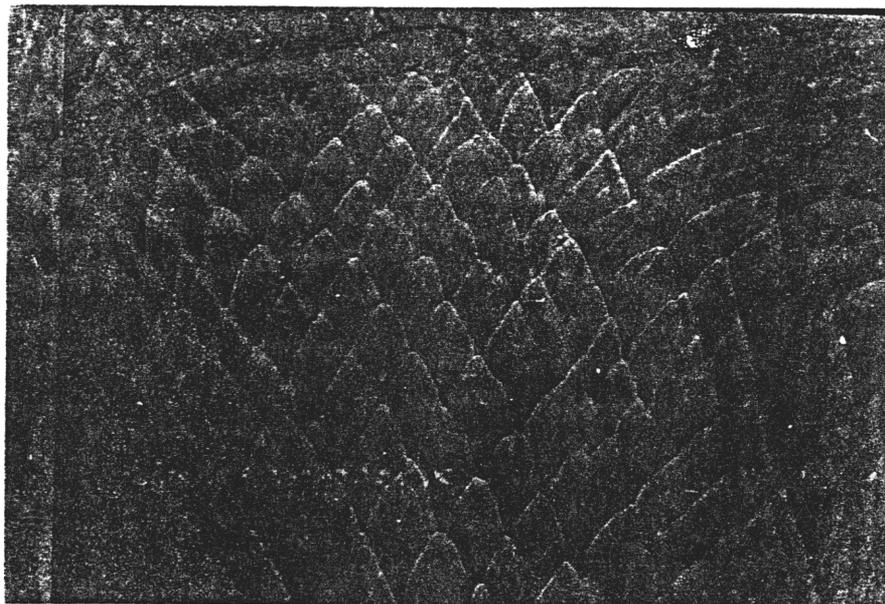
Figure IX-6 Rhomboid ripples

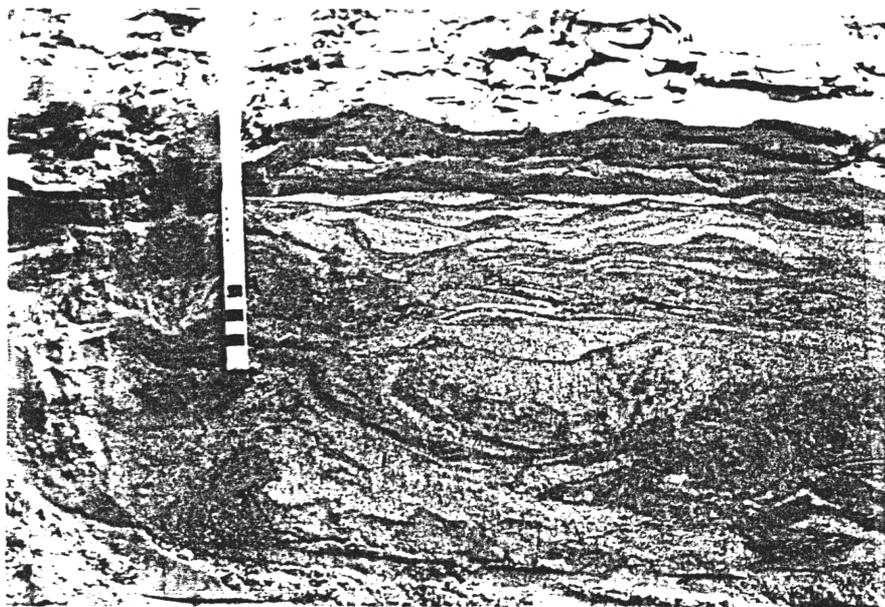
Figure IX-9 Convoluted bedding (cm scale)

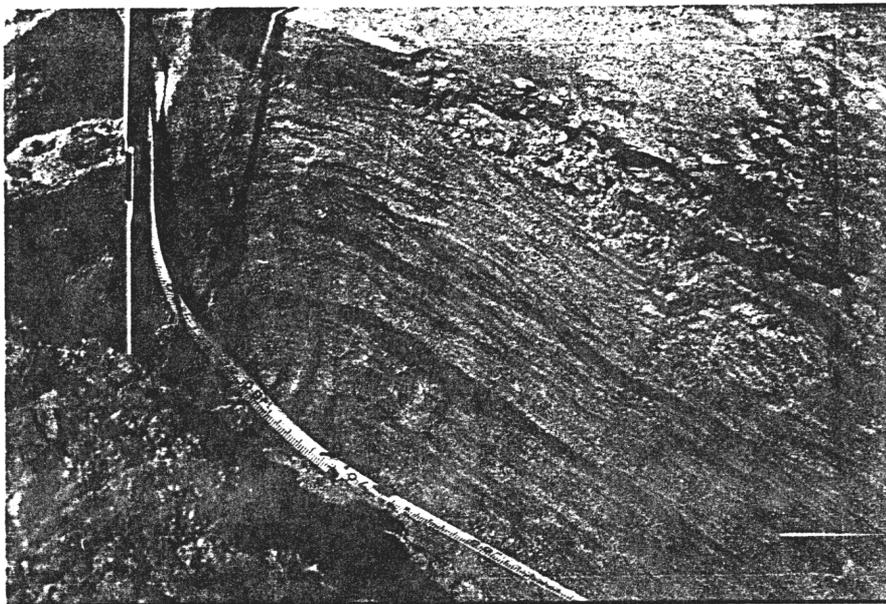
Figure IX-11 Lenticular bedding

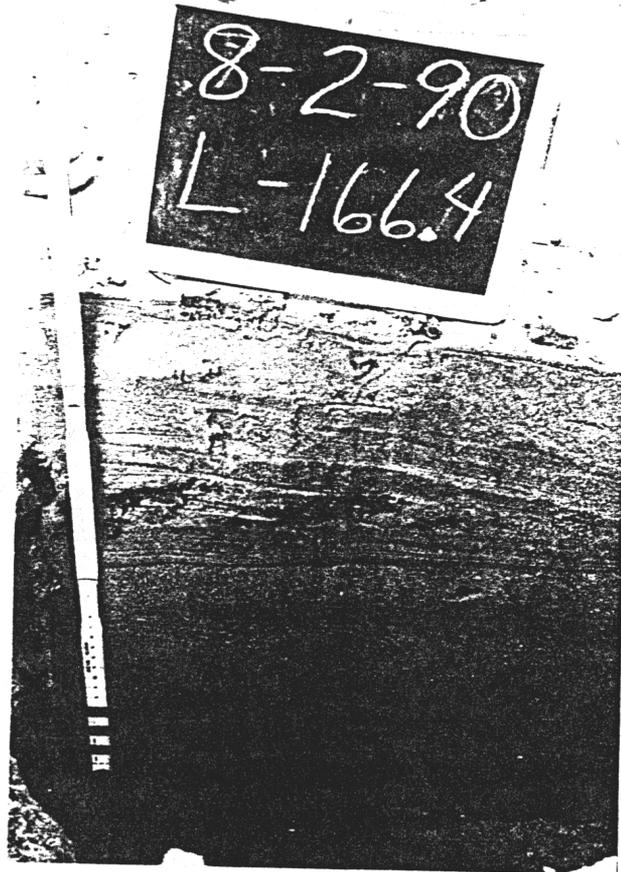
Figure IX-14 National beach trench

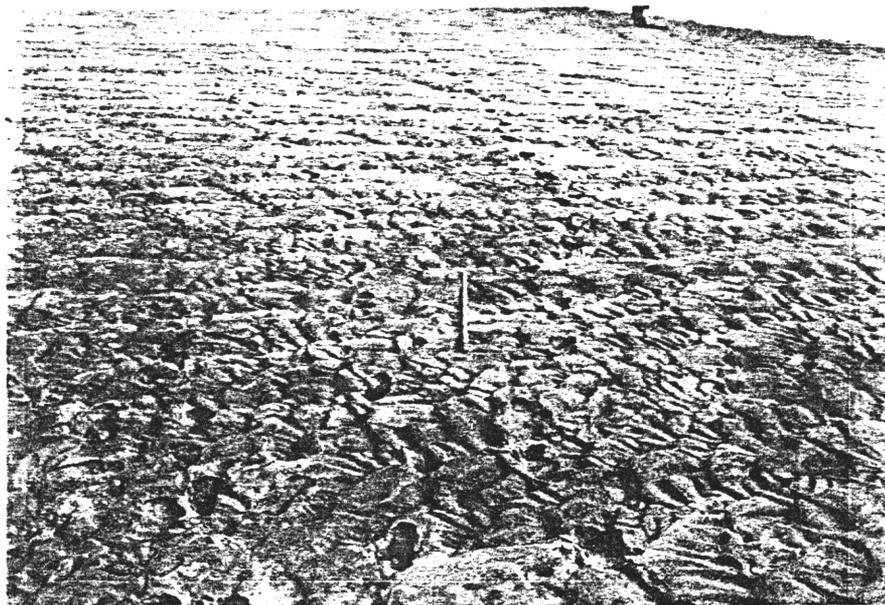
Figure IX-16 Megaripples
