EDDY BAR RESPONSES TO THE
SEDIMENT DYNAMICS OF POOL-RIFFLE ENVIRONMENTS
- FINAL REPORT -

BRIAN L. CLUER, HYDROLOGIST

NATIONAL PARK SERVICE

PROJECT NAME: [A PROPOSAL TO] DETERMINE THE PROCESSES OF RAPID EROSION AND
THE EFFECTS ON EVOLUTION AND LONGEVITY OF CHANNEL MARGIN
DEPOSITS

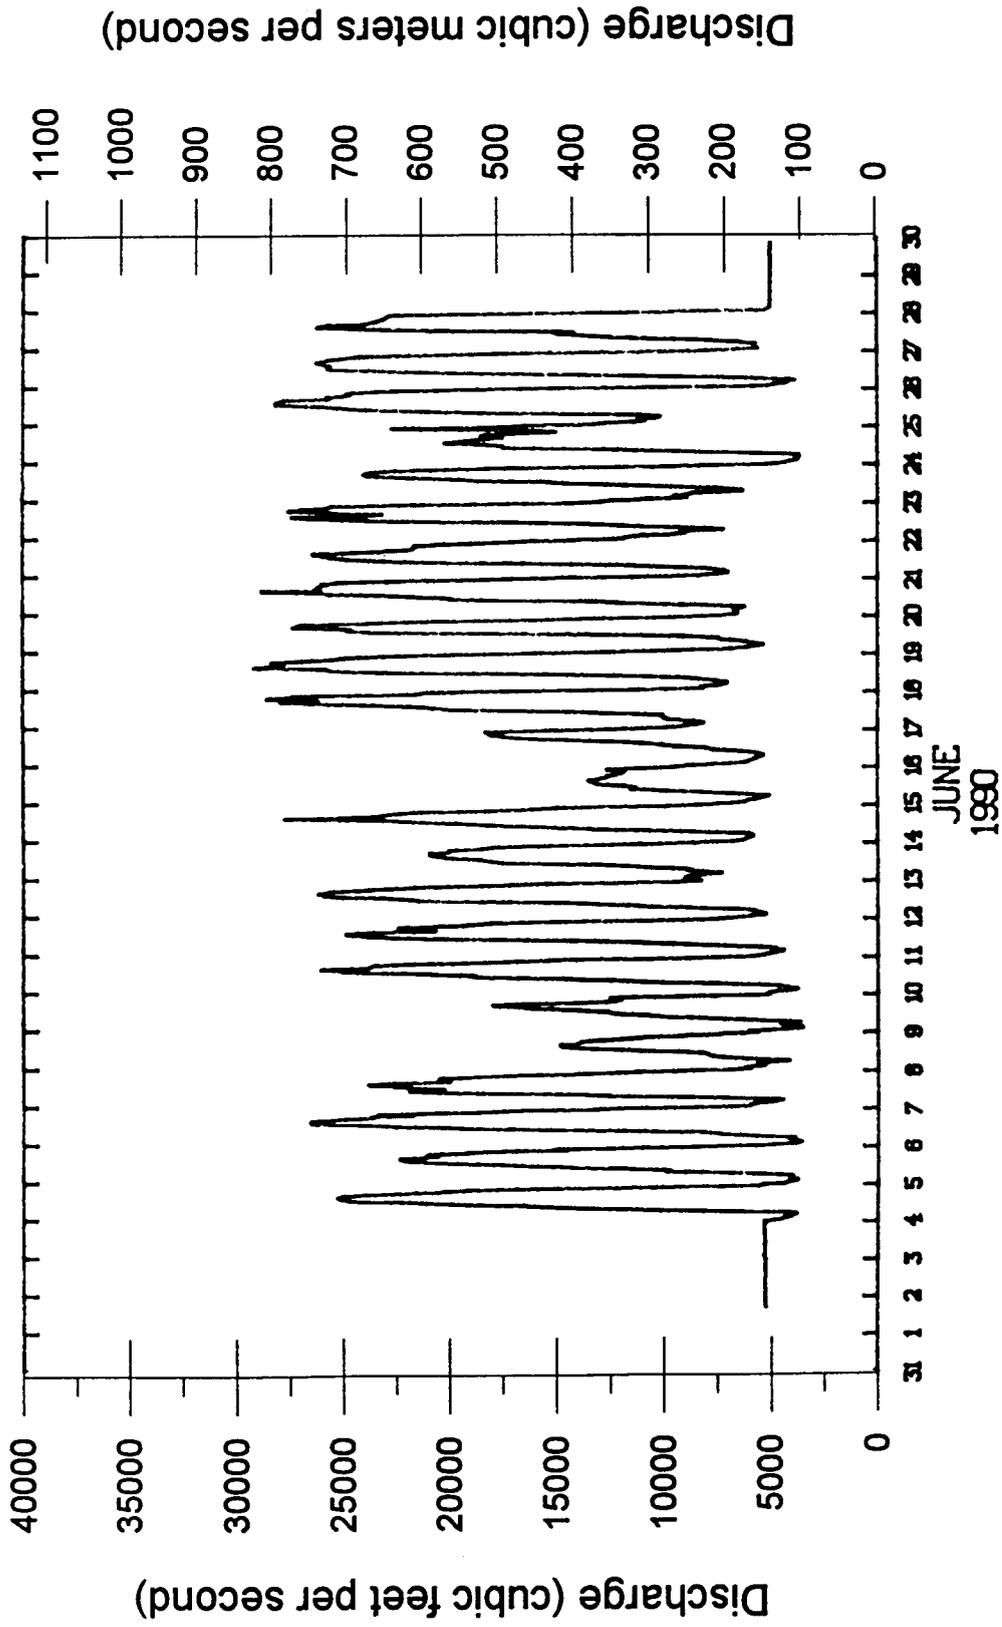
Figure 1. Example of post-dam hydrograph for peaking hydroelectric power production. Five days of large flow fluctuations (Monday-Friday) are typically followed by two days of lower flow fluctuations (Saturday-Sunday).

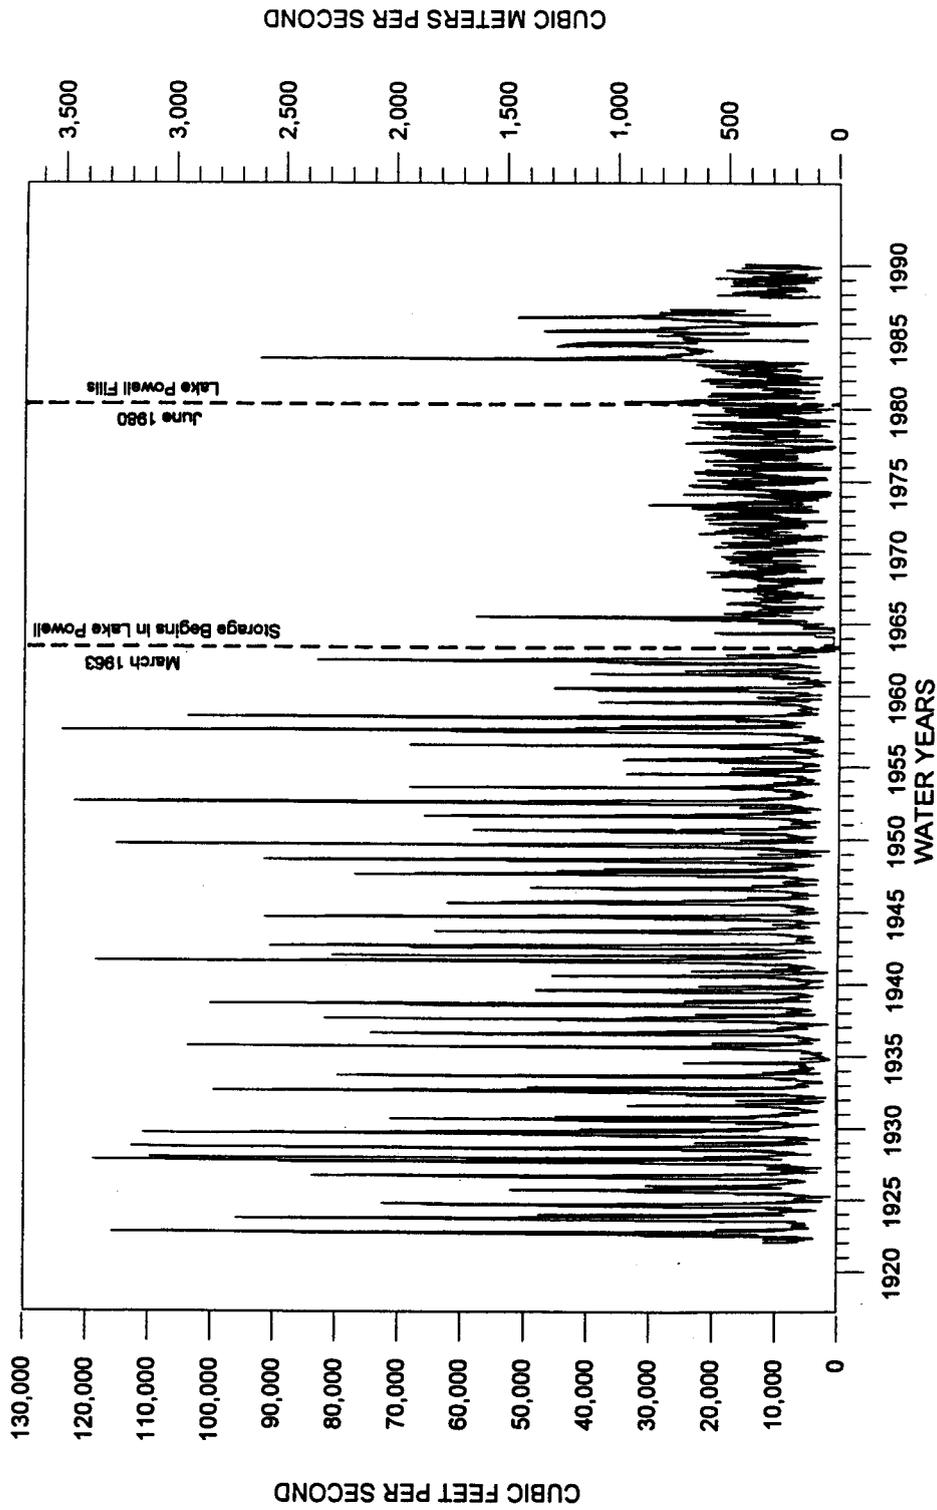
Figure 2. Daily mean discharge of Colorado River at Lees Ferry gage for water years 1922-90. Notice annual flood pattern in the pre-dam period, post-dam bypass flows 1983-1986, and regulated fluctuation patterns in the post-dam filling and post-dam full periods for hydropower production.

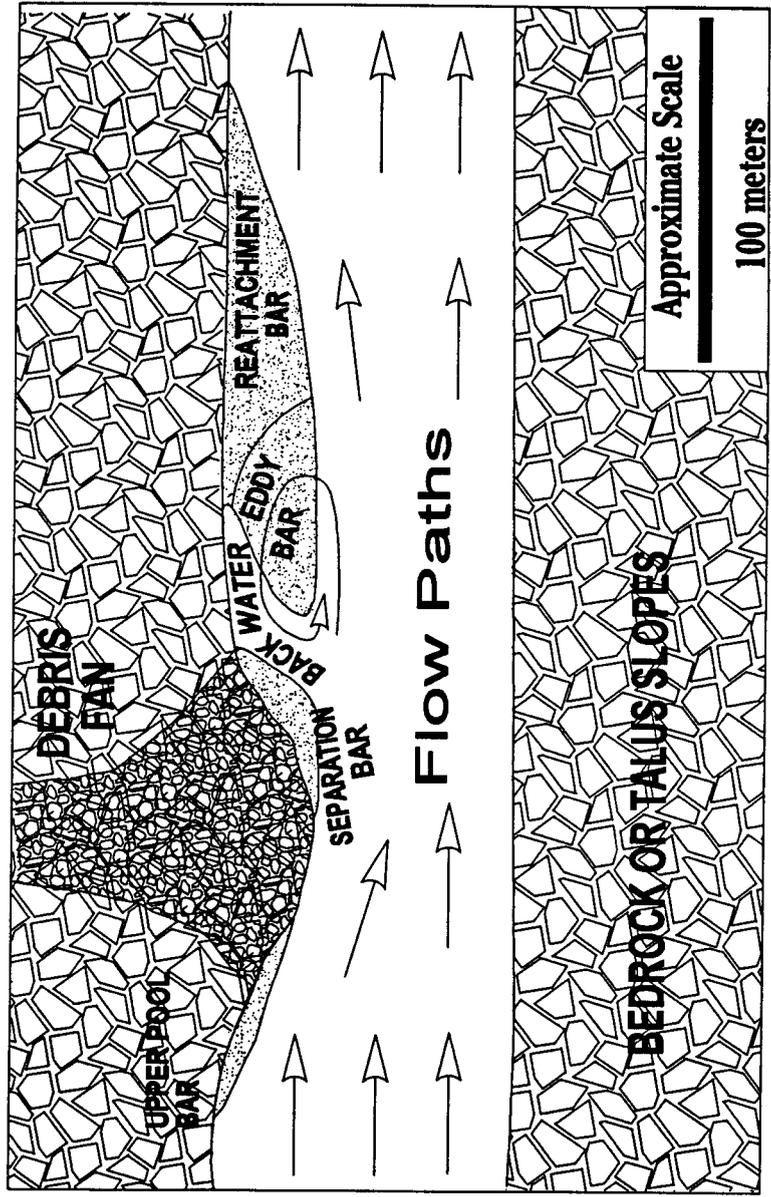
Figure 3. Sketch map and nomenclature used to describe sand bars commonly found in the Grand Canyon and other incised rivers with debris fan channel constrictions.

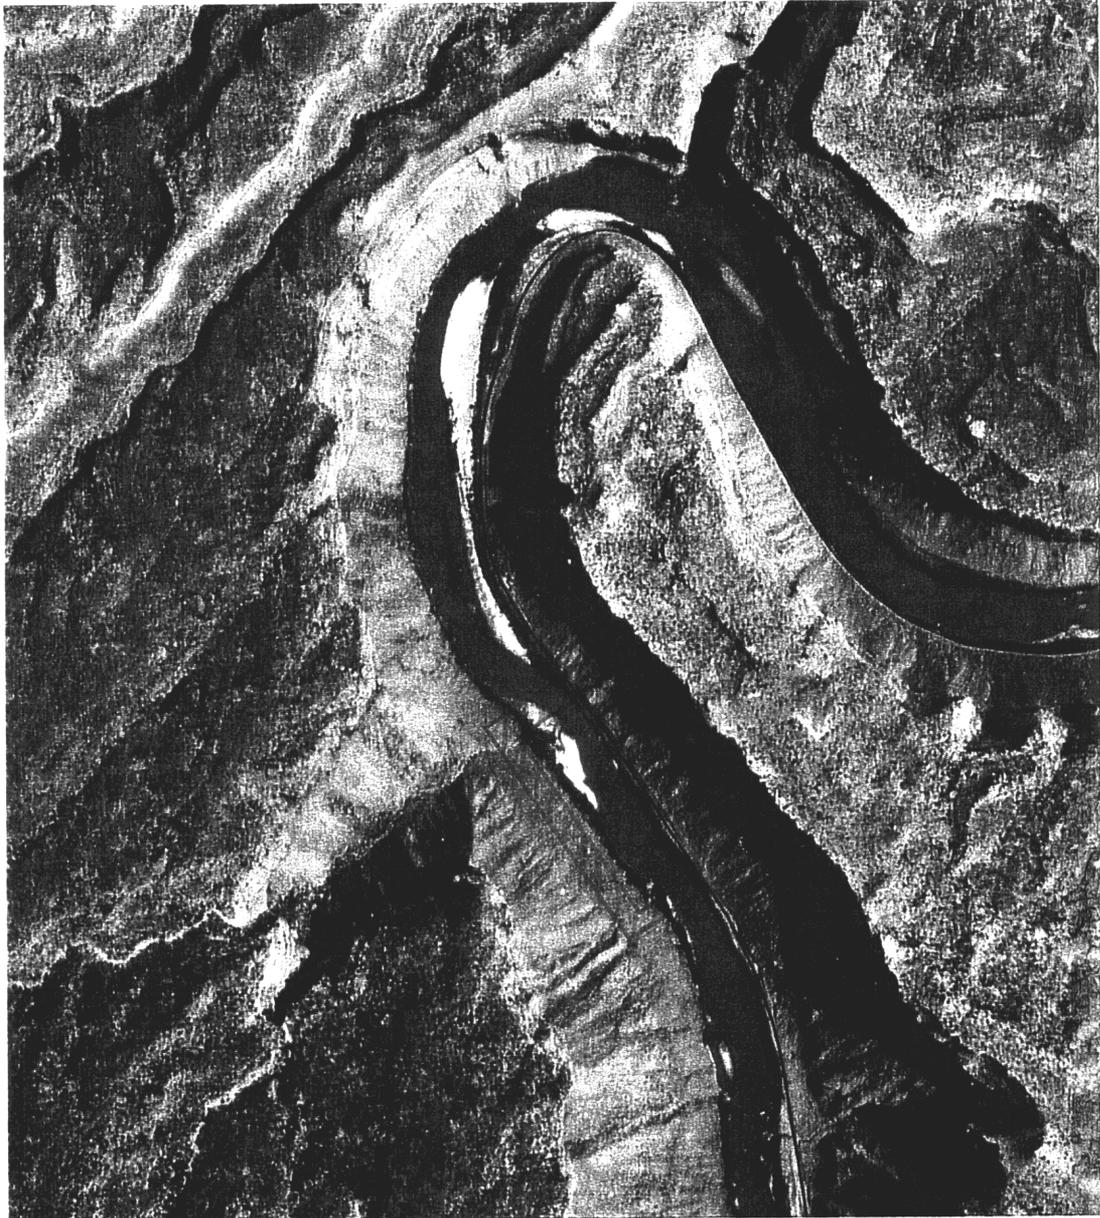
Figure 5. Aerial photograph of Moab study reach (outlined in red hatched box). Flow is from right to bottom, study sand bar is white area within box, the gray shaded debris fan is from the side-canyon entering from lower left corner. Photo width covers approximately 2 km.

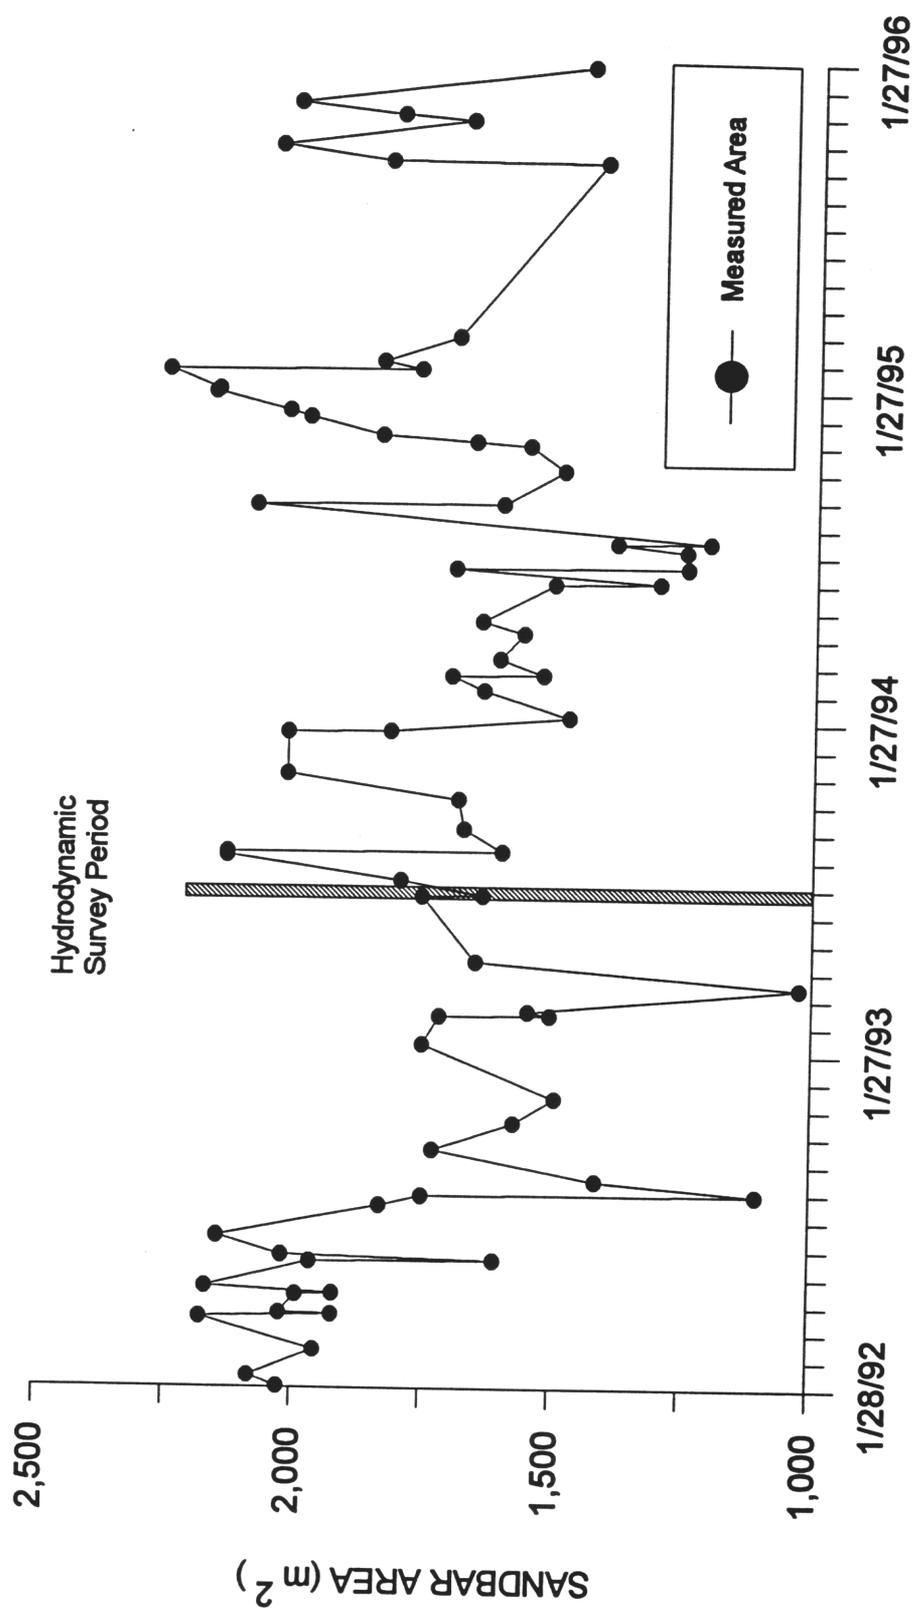
Figure 6. Time-series plot showing scour and fill history during powerplant discharges for the Mohawk eddy deposit in Grand Canyon. Data are from daily photographs (Cluer and Dexter, 1994). Shaded bar indicates period of field studies and rapid erosion event described in this report.

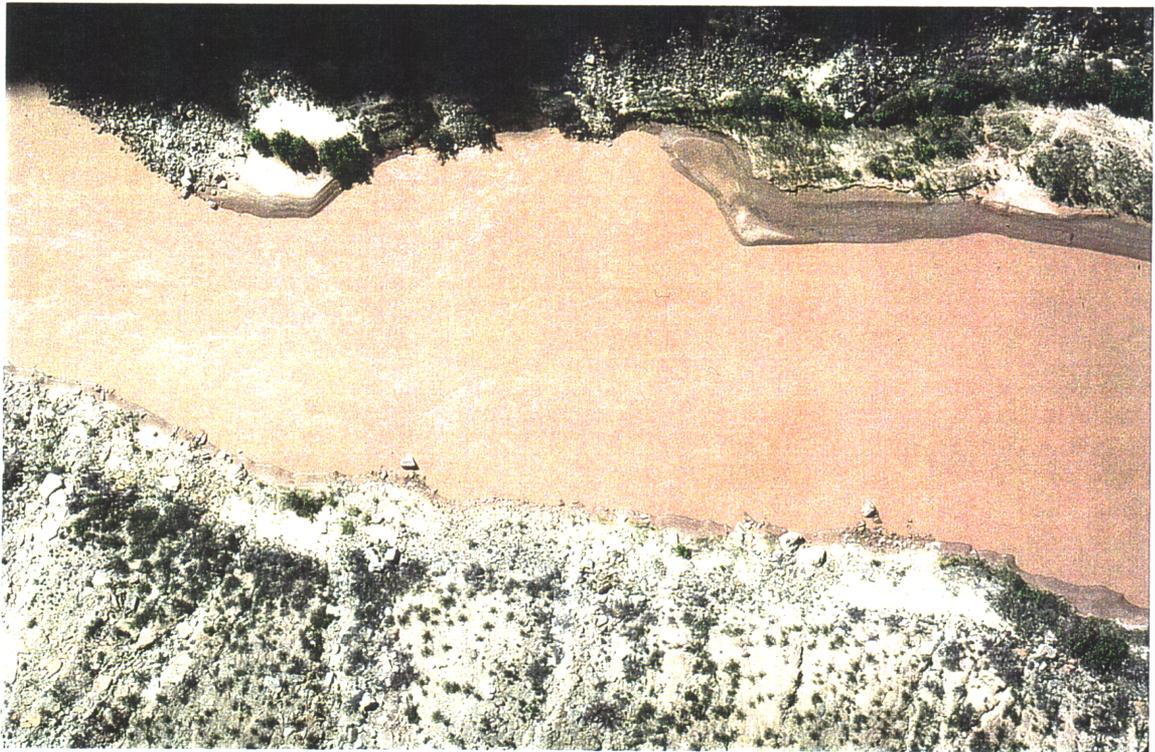
Figure 8. Aerial photograph of Mohawk study reach in Grand Canyon. Flow is from left to right. Debris-fan channel constriction is in upper left, unvegetated eddy bar and vegetated reattachment bar in upper middle and extending to right. Eddy bar was scoured three days prior to this photograph. Width of photograph is approximately 300 meters.

The Mohawk site is 303 kilometers downstream from Glen Canyon Dam and 1.6 kilometers downstream from Mohawk Canyon and Stairway Rapid (figure 7). The mean channel width is approximately 90 meters and Cambrian Bright Angel Shale (Breed, 1974) is exposed at river level. Talus slopes along the river are covered primarily with blocks from the overlying Cambrian Muav Limestone.

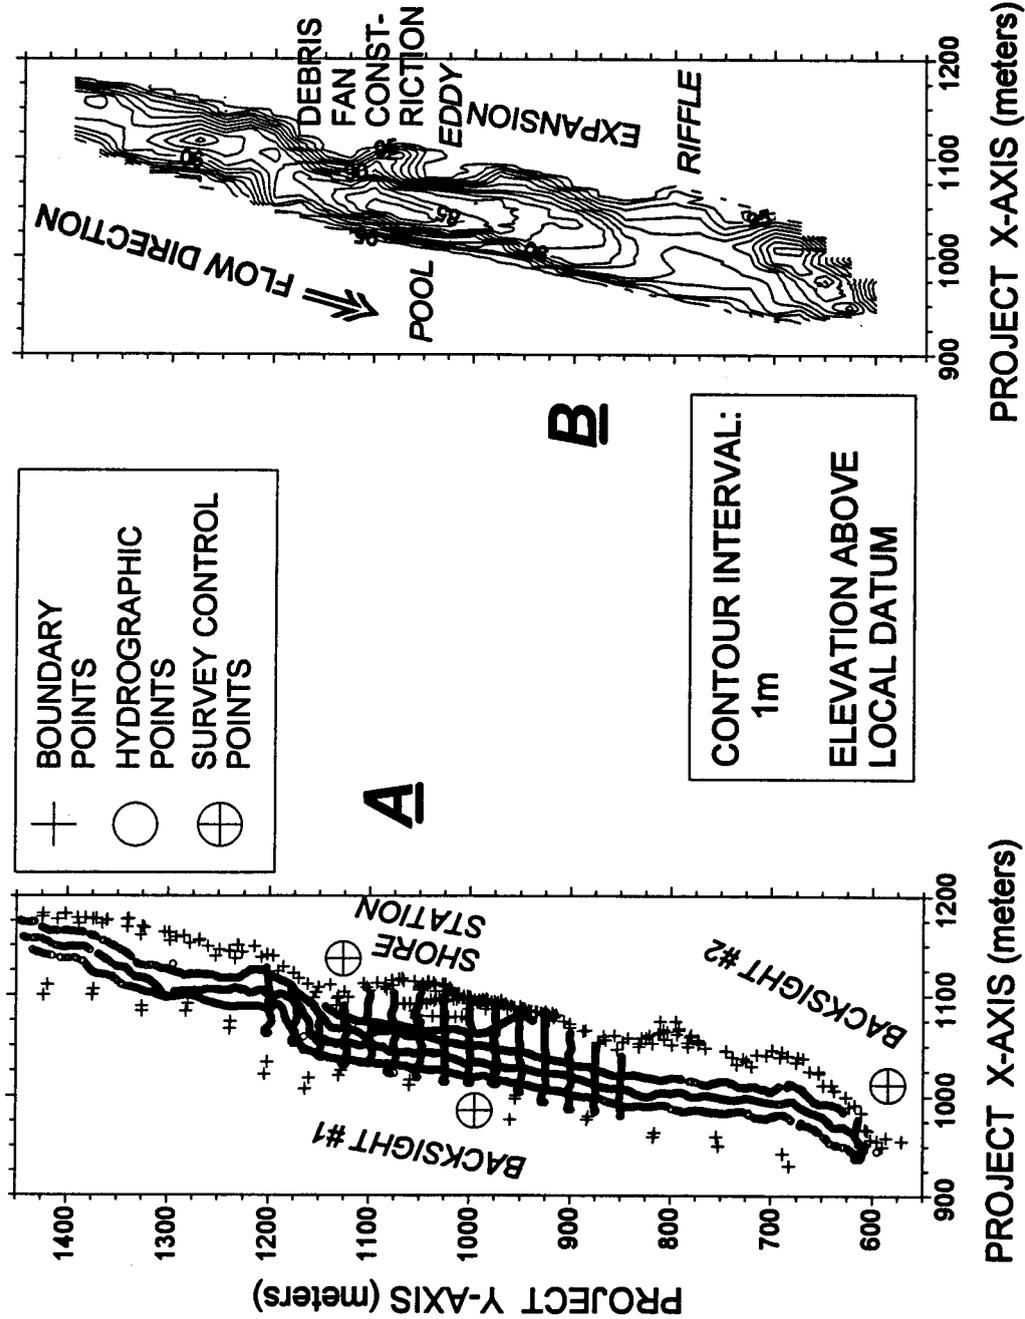
Figure 9. Data collection definition diagram and site description for the Mohawk study reach. (A) typical data coverage and survey control, and (B) resulting bathymetric contour map. All units are in meters.

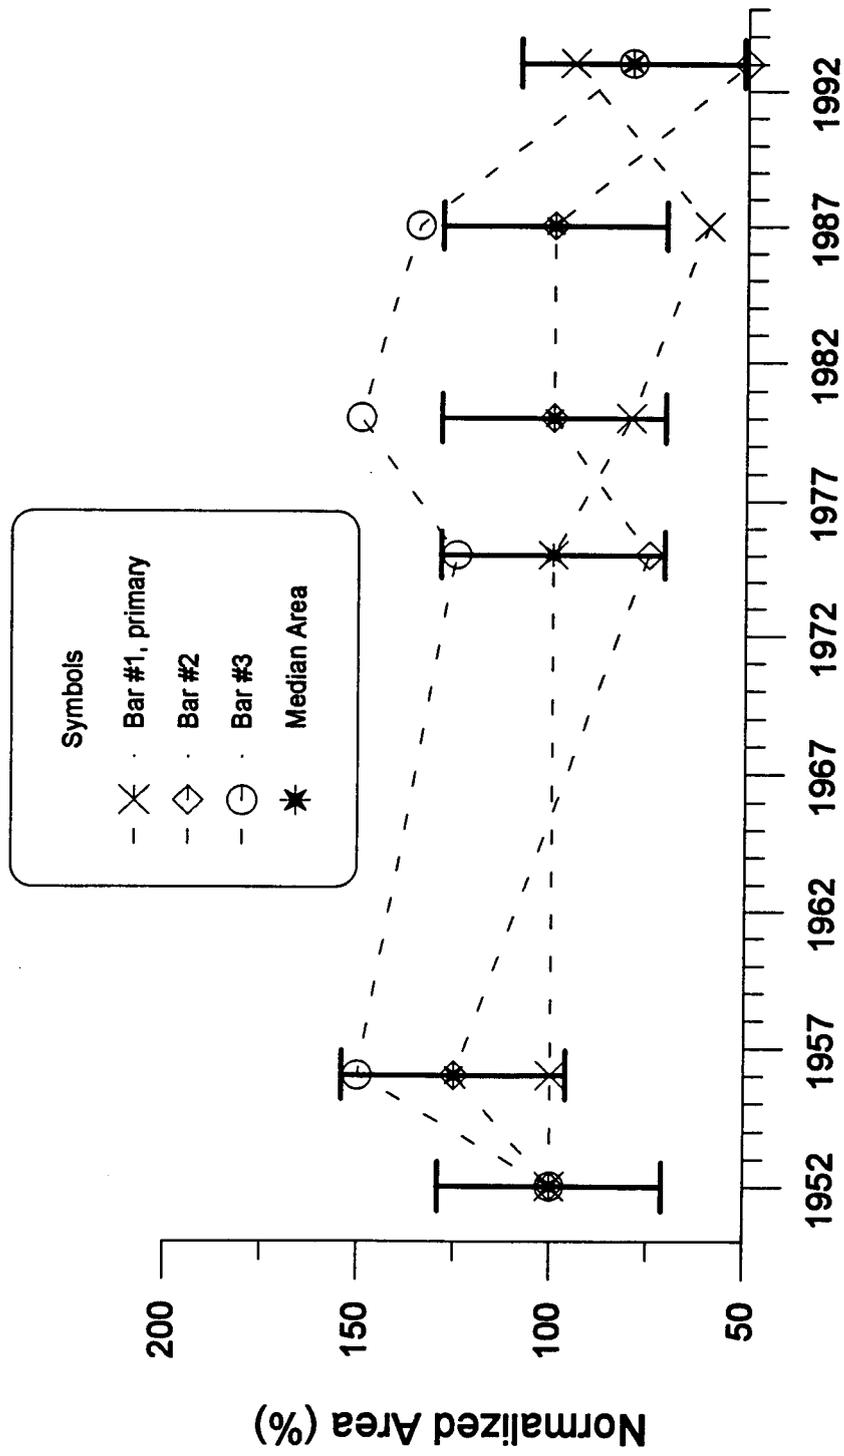
Figure 11. Results from aerial photography analysis for Moab study reaches. Bar #1 is the primary study bar and bars #2 and #3 are from the secondary study reach. See legend for explanation of symbols. Error bars were determined from one standard deviation from short time interval sampling.

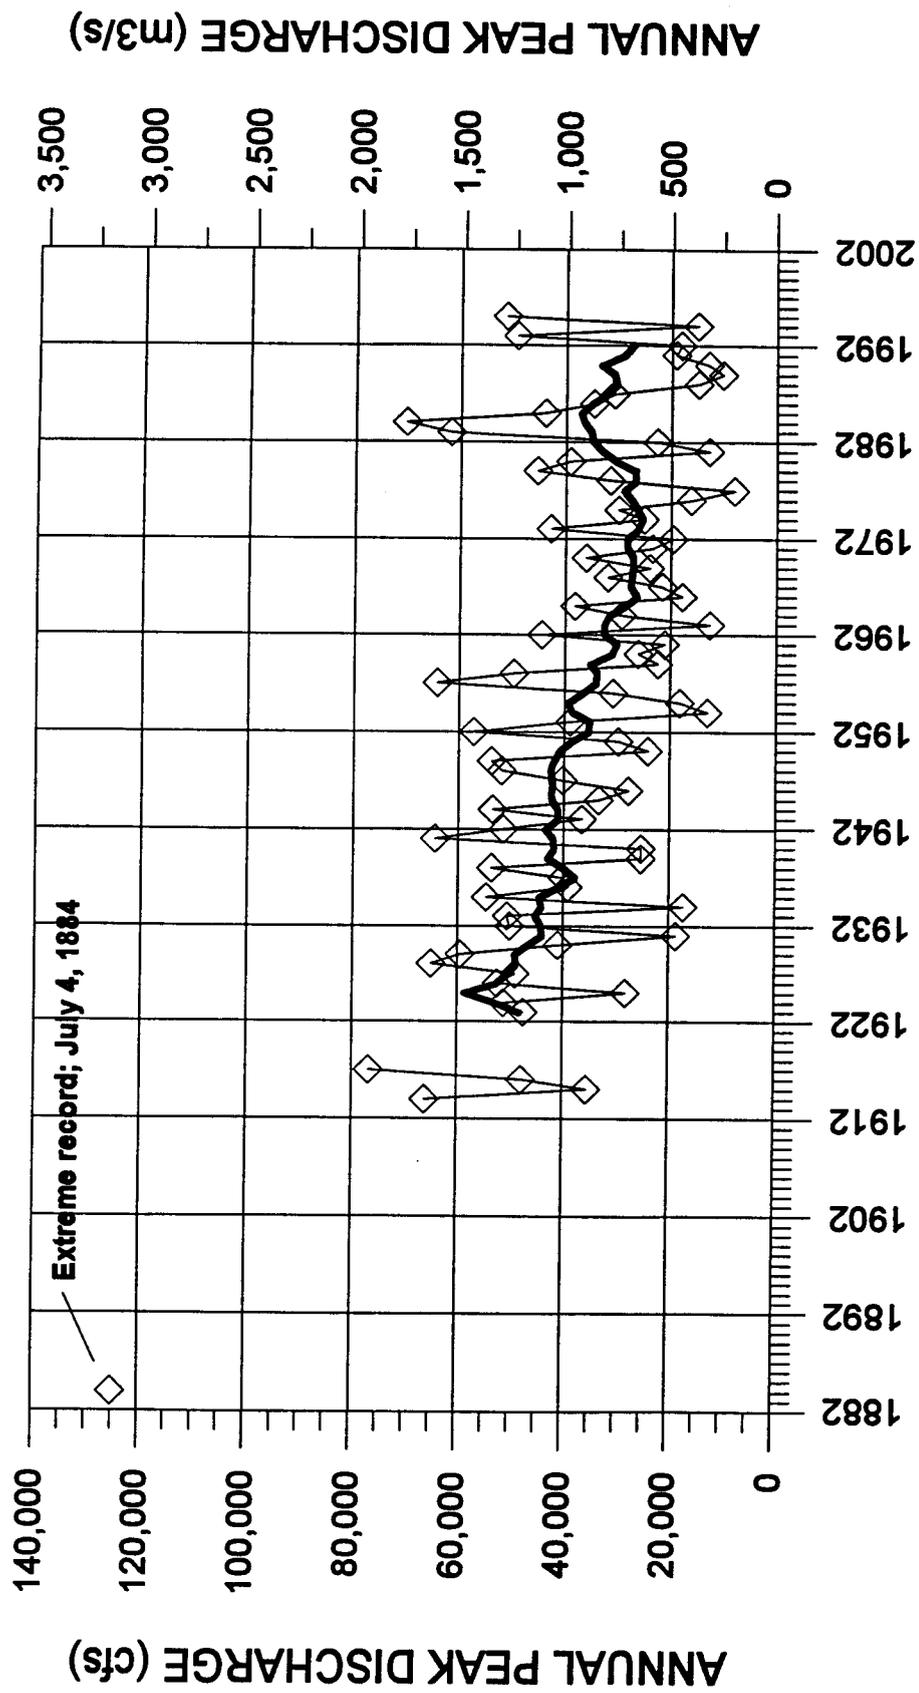
Figure 12. Annual peak discharge record for Colorado River near Cisco, UT. Heavy line is the 11-year running average. Note the outlying record from 1884.

The annual floods that occurred during this research/monitoring project are placed in perspective by graphs of the annual peak flow time series (figure 12) and the ranked return period (figure 13). Peak discharges in the range 280 to $1,000 \text{ m}^3\text{s}^{-1}$ have return periods of 1-2 years and the 1992 and 1994 floods were in this range. The 1993 and 1995 floods were in the range of 3-5 year return period flows. The highest flow recorded at the Cisco gage, $3,540 \text{ m}^3\text{s}^{-1}$, occurred on July 4, 1884. This flow record is an extreme outlier

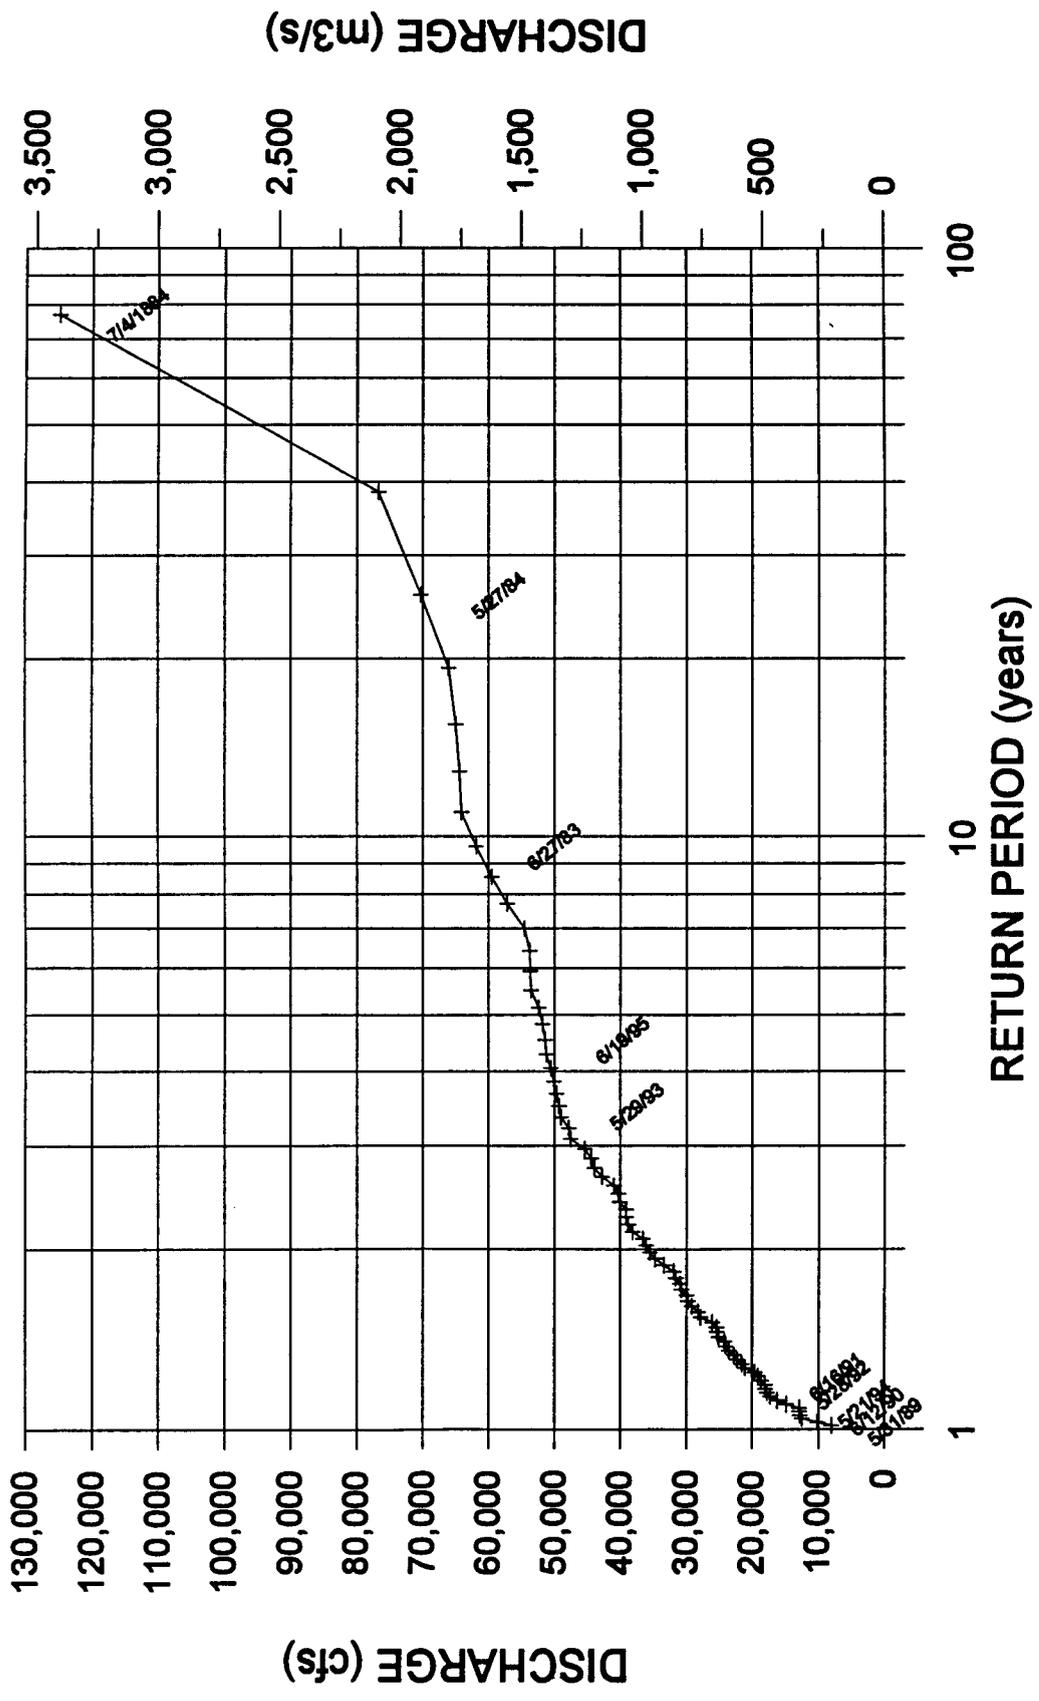
Figure 13. Return period graph for peak flows at the Colorado River near Cisco, UT stream gage.

Systematic measurements of the sand bars began with the first topographic survey in July 1992. Photographs show that the bar was elongated, elevated and covered greater area as a result of the spring 1992 flood (from approximately $1,800 \text{ m}^2$, estimated from photographs, to $2,700 \text{ m}^2$, surveyed). Maps from topographic surveys indicated that the volume of sand temporarily stored in the 1992 eddy deposit was approximately $5,100 \text{ m}^3$ above the late July low flow level. At $484 \text{ m}^3\text{s}^{-1}$ peak discharge, the Spring 1992 flood was in the range of 1-2 year recurrence (figure 13). No information exists to describe if

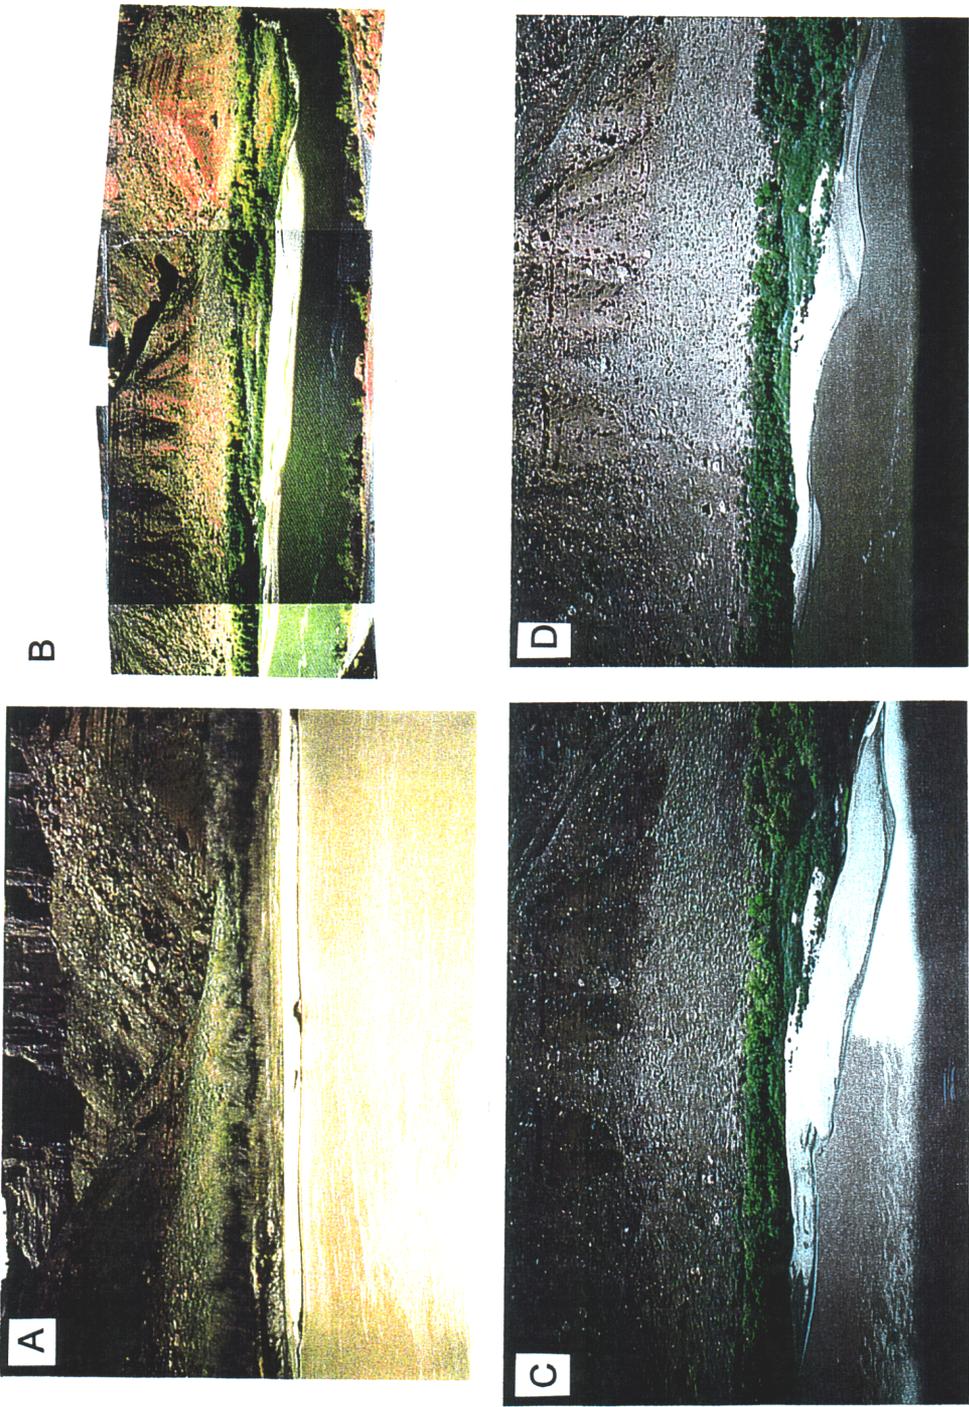
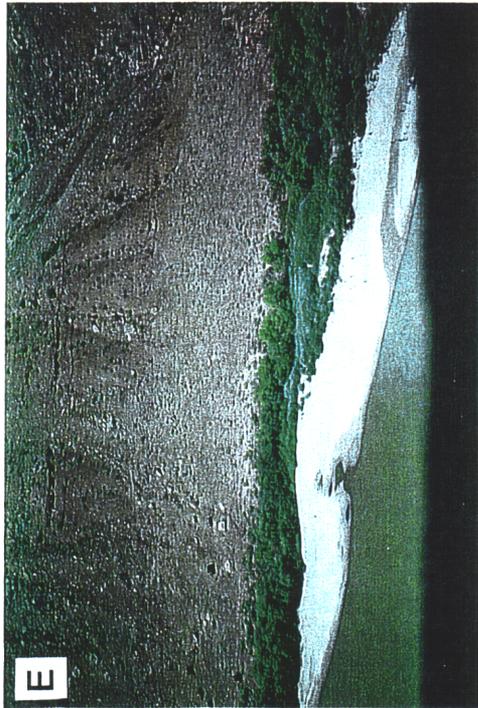
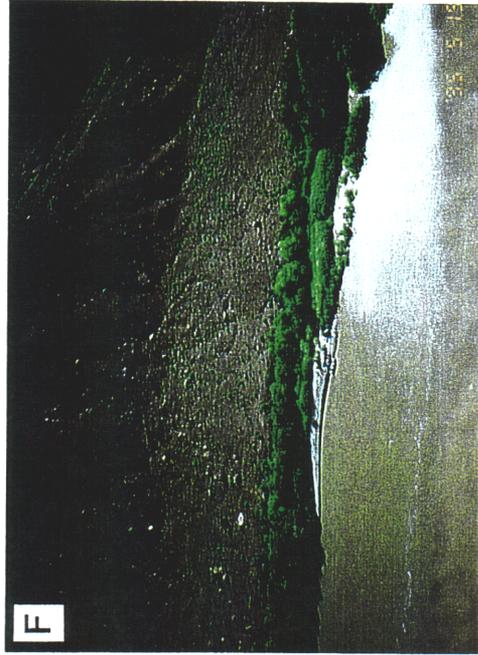
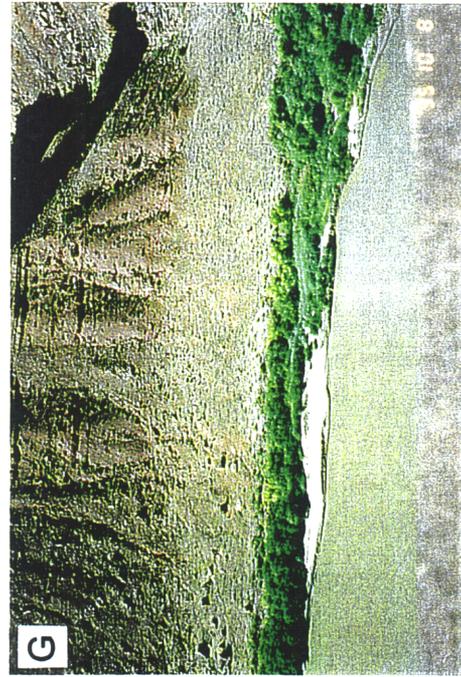
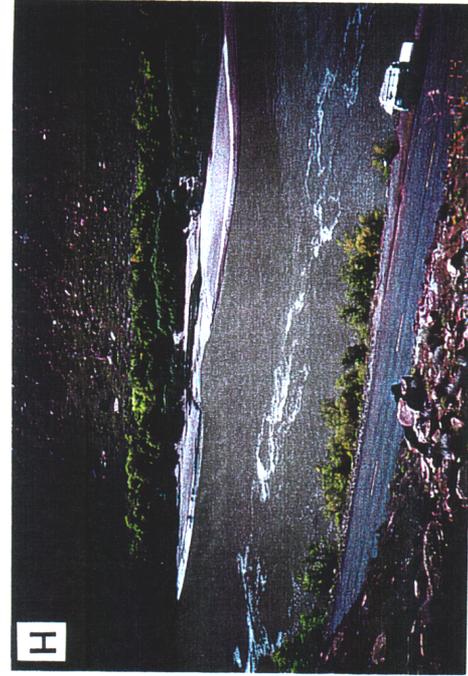
Figure 14. Photographs of the unregulated river sand bars at the primary study reach 50 km upstream from Moab, UT. Flow is to left. Images are approximately 300 m wide. (A) 3/30/1992, (B) 10/15/1992, (C) 10/11/1993, (D) 6/8/1994.

Figure 14, continued. Photographs of the unregulated river sand bars at the primary study reach 50 km upstream from Moab, UT. Flow is to left. Images are approximately 300 m wide. (E) 7/14/1994, (F) 5/19/1995, (G) 10/8/1995, (H) 10/14/1996.

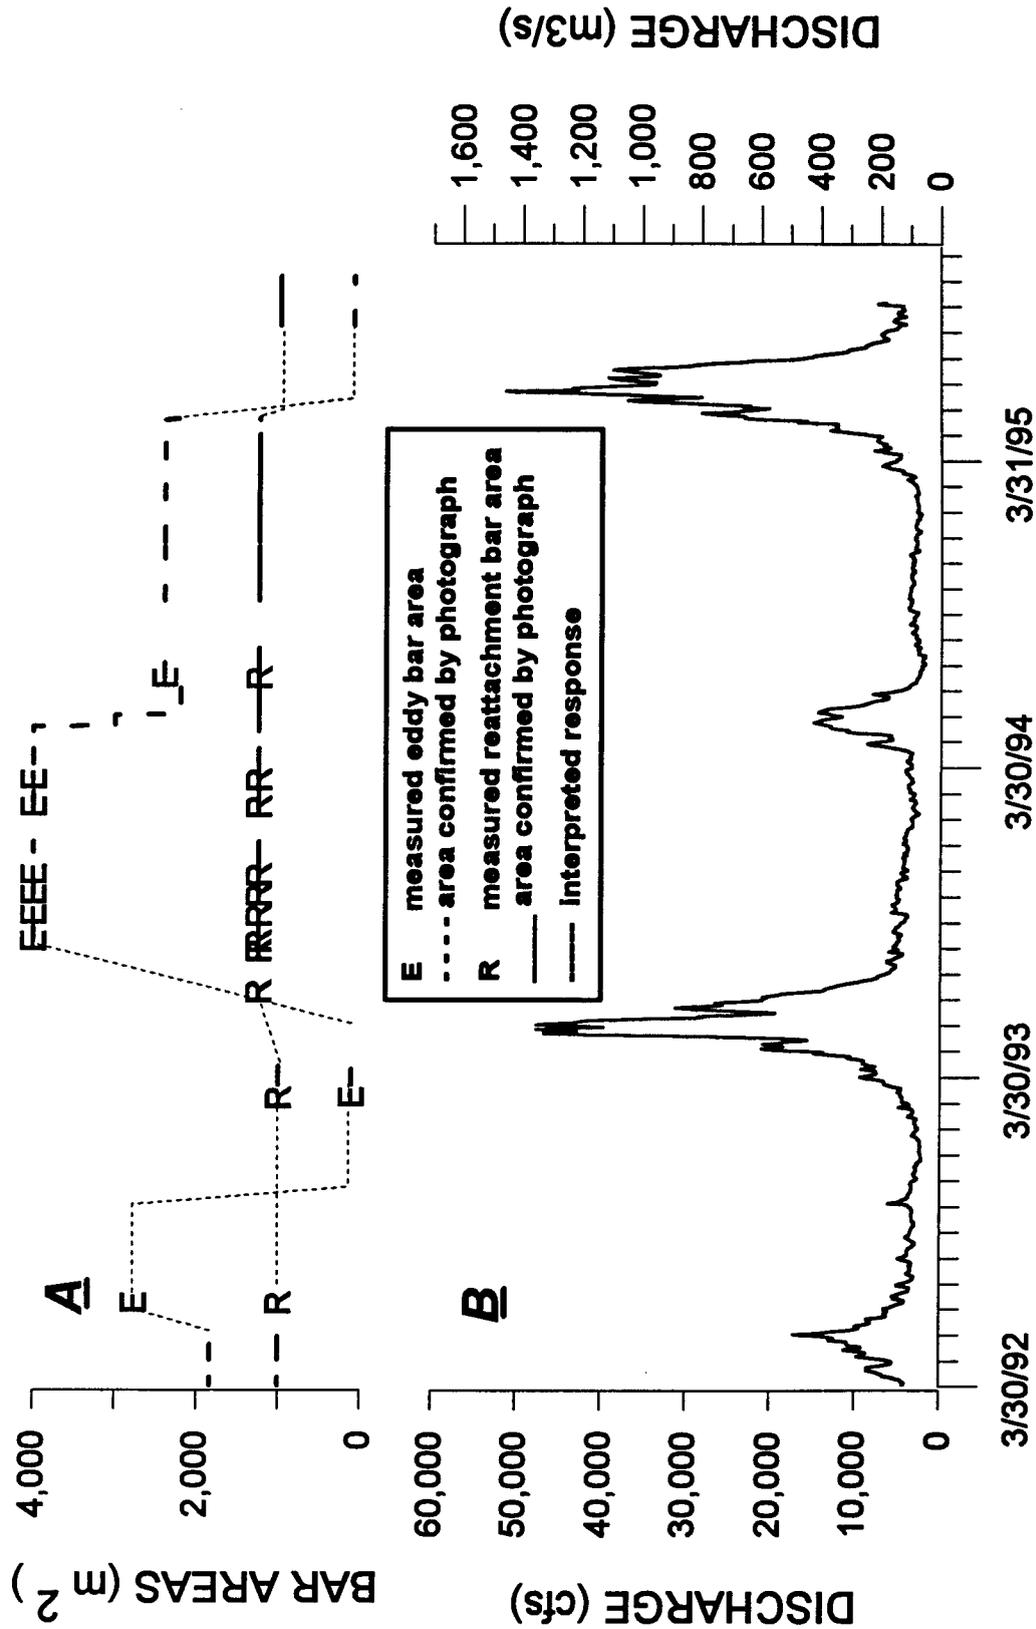
Figure 15. Time series of data collection and results for sand bars at the Moab study reach (A). Mean daily discharge for the study period (B).

the eddy bar was scoured and re-deposited by the 1992 flood. Figure 15 shows the results and corresponding flow conditions in time-series from April 1992 to October 1995.

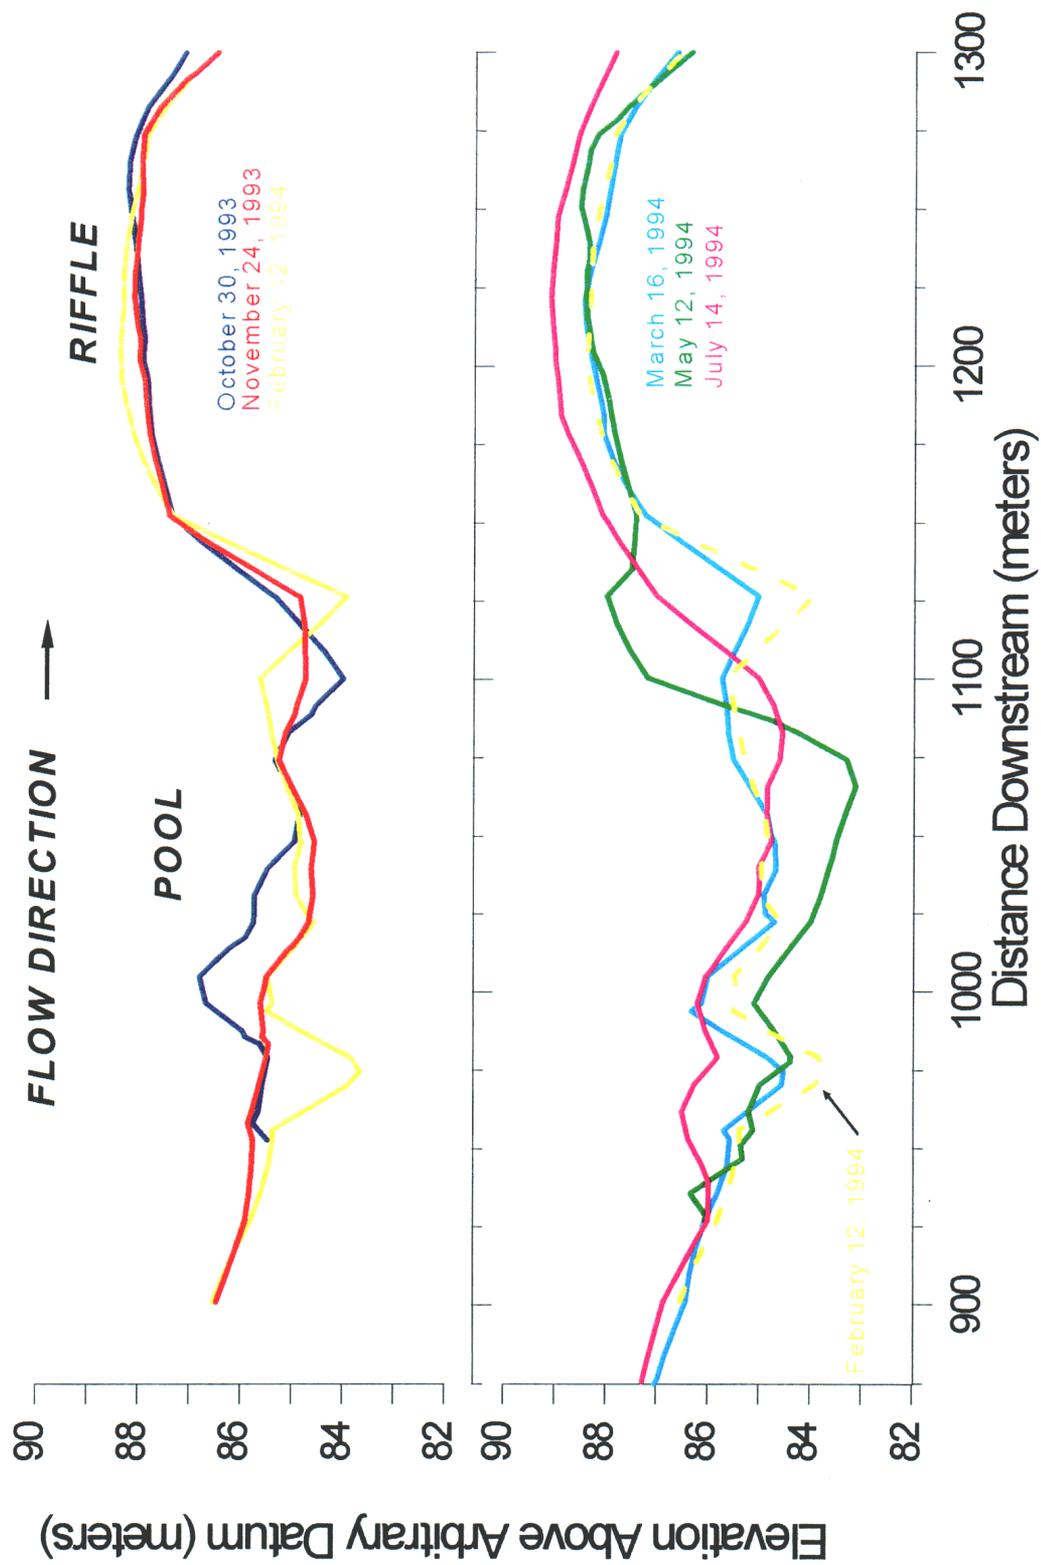
Figure 16. Thalweg profiles from Moab study reach for dates shown in legend, showing changes in the pool downstream from the debris fan riffle.

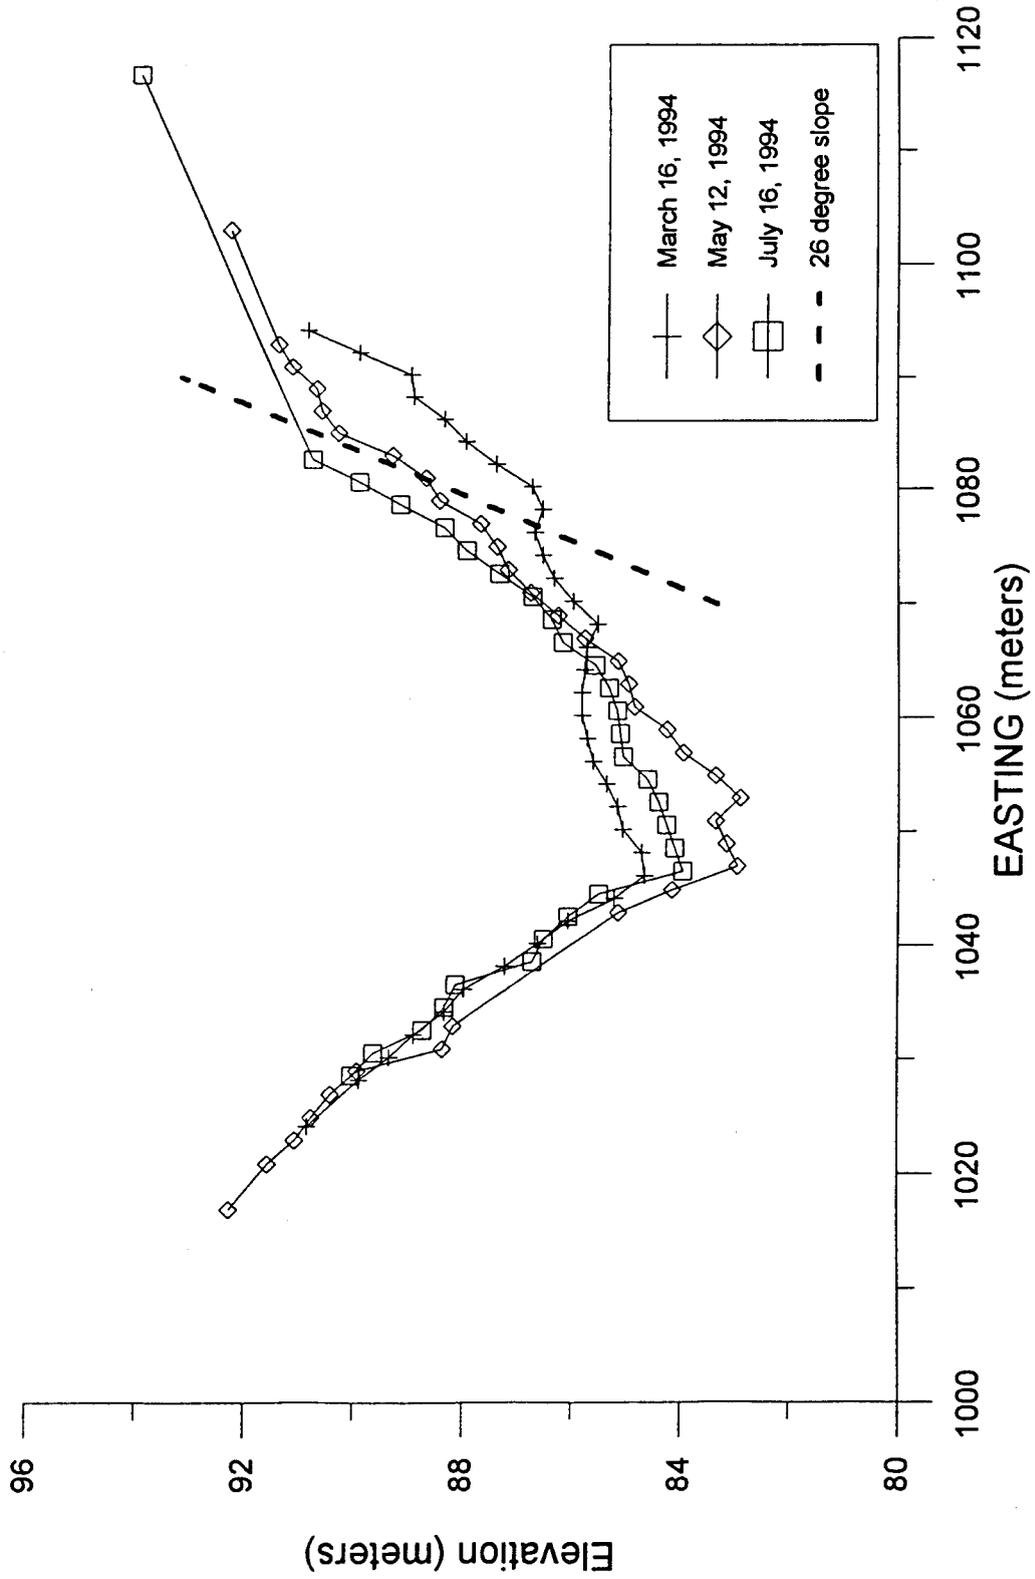
Figure 17. Cross sections at the Moab study reach for dates shown in legend. View is looking downstream across the pool and eddy bar. Heavy dashed line indicates slope at angle of repose.

The eddy bar face obtained a maximum angle of 26 degrees near its crest (figure 17). This angle was maintained as minor deposition occurred along the face between March 16, 1994 and May 12, 1994. The eddy bar was scoured shortly after the May 12 survey and a new eddy bar was deposited at an angle of approximately 24 degrees, as measured on July 16, 1994.

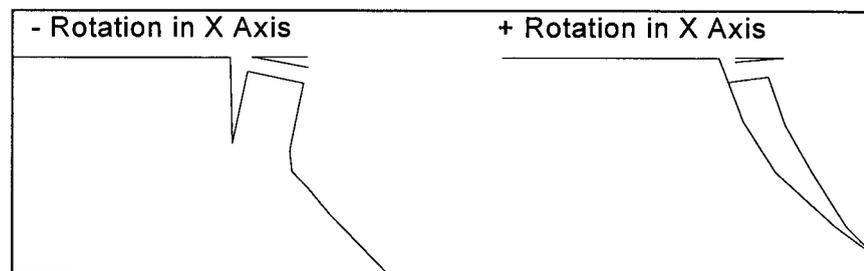
Figure 19. Definition sketch of tilt sensor axis conventions, in the X-axis, looking downstream at the left bank.

The sign and axis conventions of inclination assigned to the biaxial tilt sensors were: positive X axis is perpendicular to the river and +X is rotation toward the river when viewed from upstream; the Y axis is parallel with the river and +Y is when the sensor rotates downstream. A sensor within a slump block or rotational failure will tilt first in the +X direction. A sensor within a zone undergoing creep or within a zone on the riverward side of a fissure during early stages of a process similar to glacial calving will first tilt in the -X direction (figure 19).
