EDDY BAR RESPONSES TO THE
SEDIMENT DYNAMICS OF POOL-RIFFLE ENVIRONMENTS
- FINAL REPORT -

BRIAN L. CLUER, HYDROLOGIST

NATIONAL PARK SERVICE

PROJECT NAME: [A PROPOSAL TO] DETERMINE THE PROCESSES OF RAPID EROSION AND
THE EFFECTS ON EVOLUTION AND LONGEVITY OF CHANNEL MARGIN
DEPOSITS

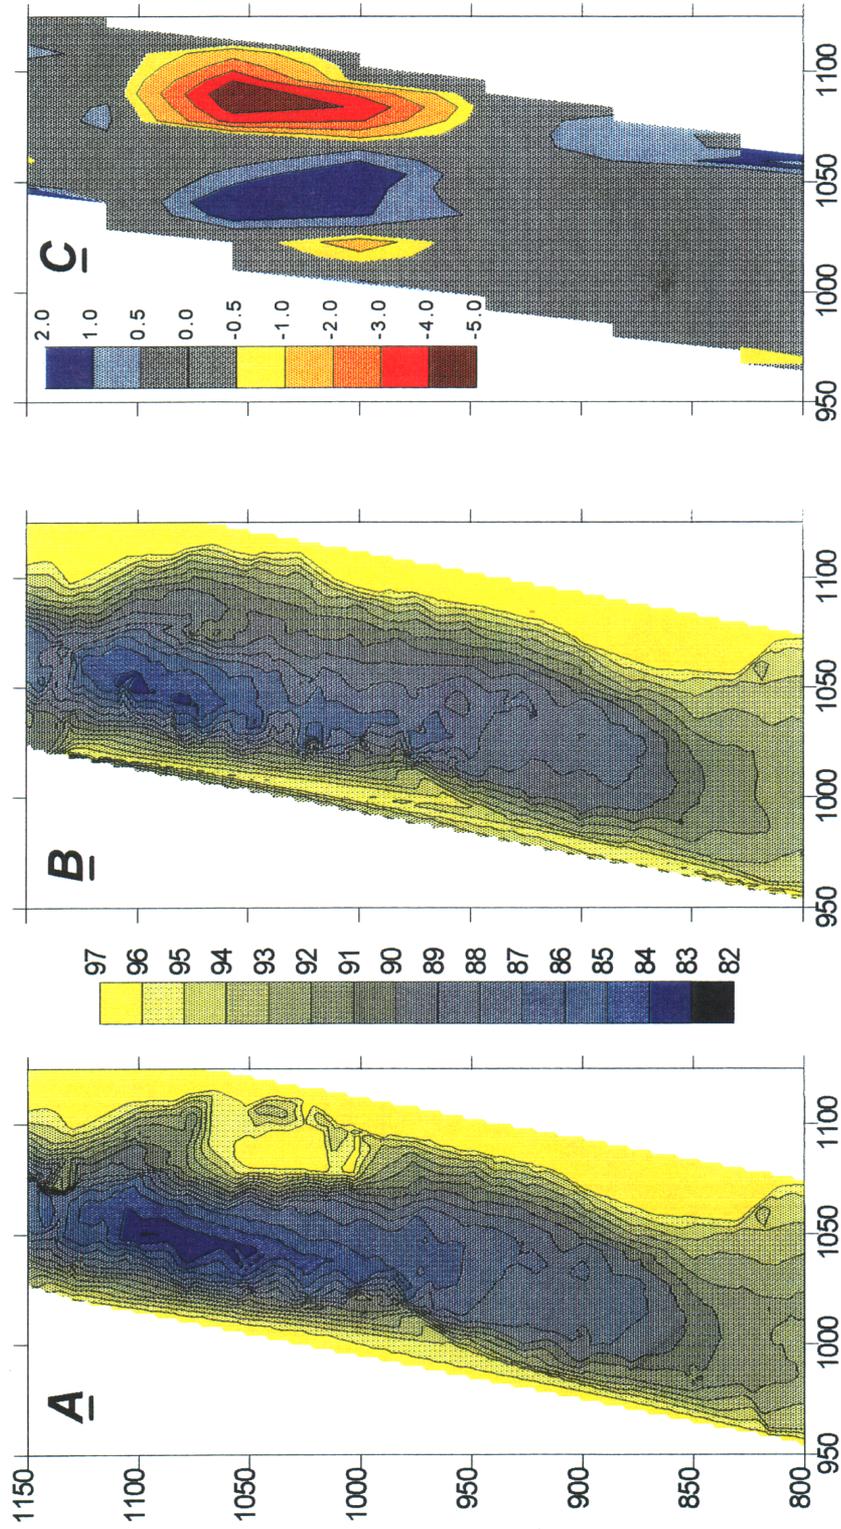
Figure 20. Topographic maps of Mohawk channel and sand bars from surveys MOE (A) and MOF (B), and residual surface topographic map (C) showing scour and fill pattern between surveys MOE and MOF.

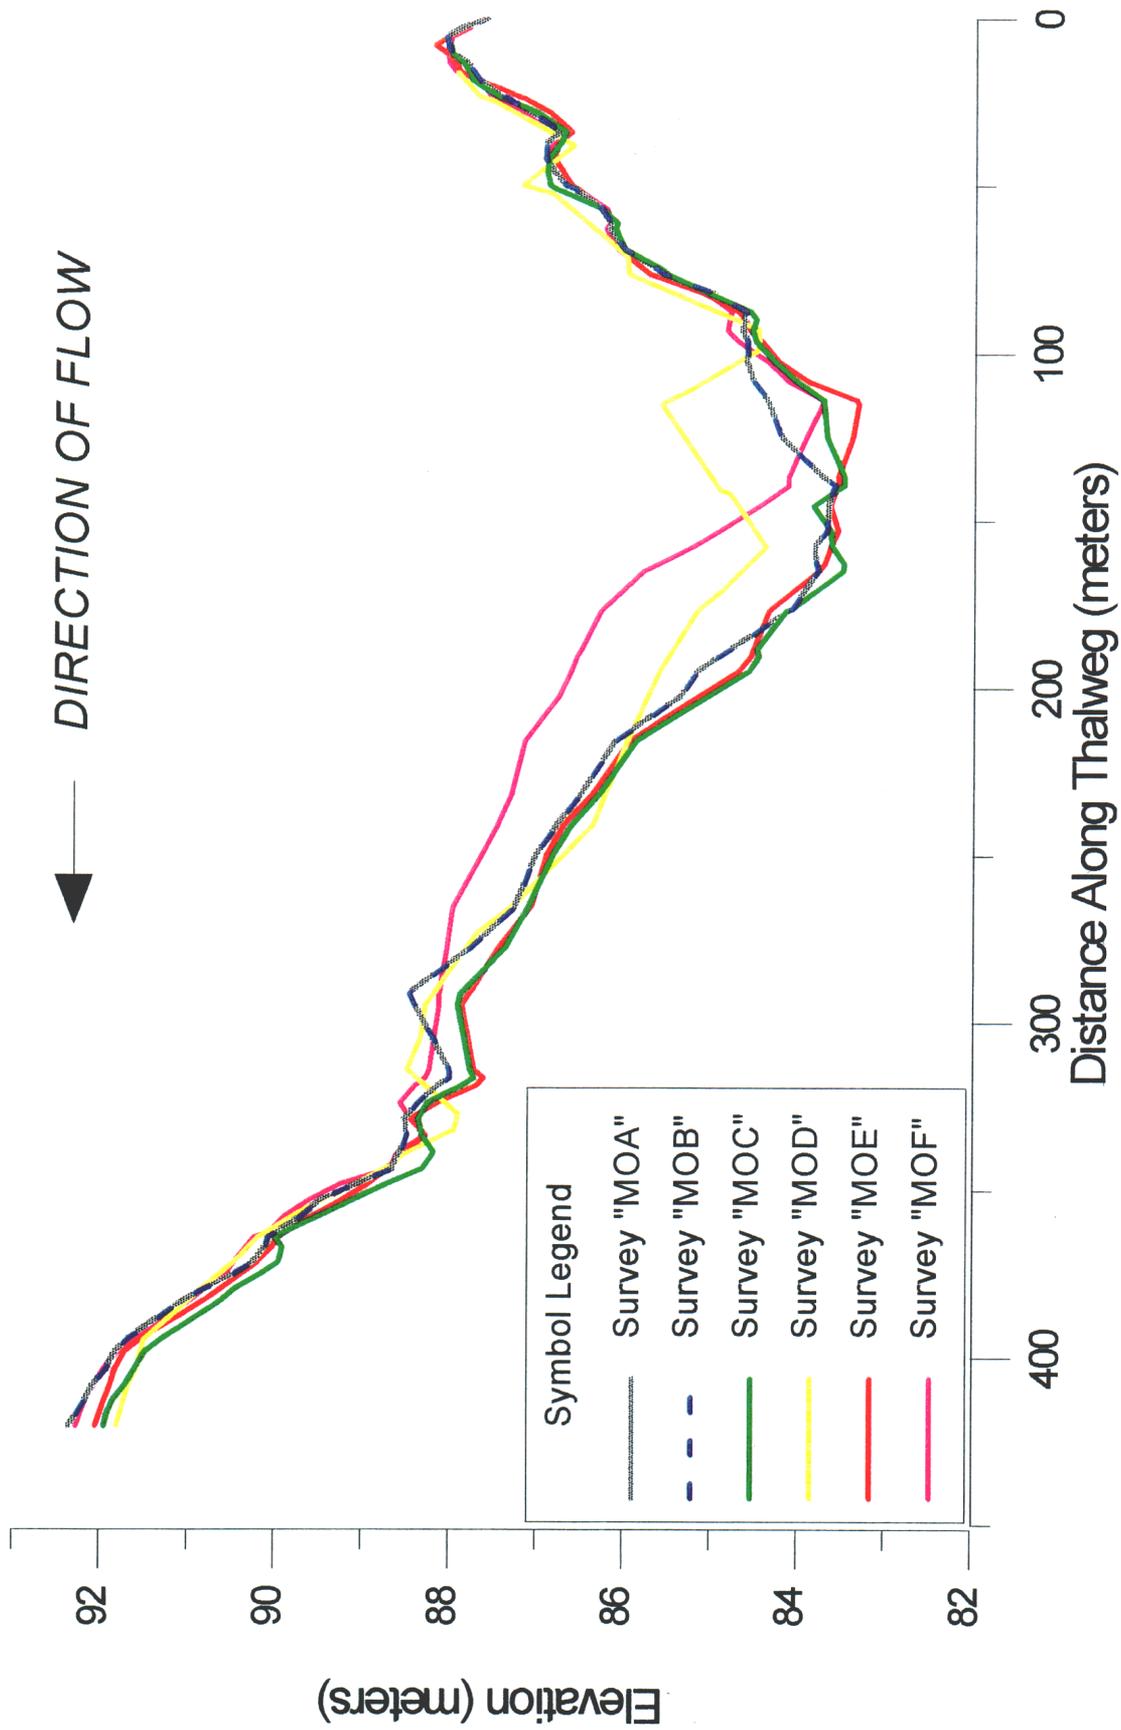
Figure 21. Thalweg profiles from Mohawk surveys MOA-MOF, as distinguished in legend.

The thalweg profile during MOD differed considerably from MOC. The pool area was filled up to one meter deep over a length of approximately 175 meters. Also, the exit slope dune returned in much the same location and shape as during MOA and MOB. Between MOD and MOE the pool was scoured and closely resembled the MOC profile overall. The pool was unchanged in the upstream area but the downstream area and pool exit slope aggraded between 0.5 and 1 meters over 250 meters length. The aggradation was the result of erosion of the eddy bar which occurred shortly after survey MOD was completed. Topographic residual calculations indicate that of 11,500 m³ sand scoured from the eddy, approximately 5,000 m³ were deposited in the pool and pool-exit slope area (figure 20). Aggradation in the range 0.1-0.3 meters was mapped over the entire survey area downstream from the eddy, totaling approximately 8,000 m³ of sand redistributed on the channel bed from the eddy scour event. The remaining 3,500 m³ of sand were probably transported downstream from the survey reach before survey MOF was completed.

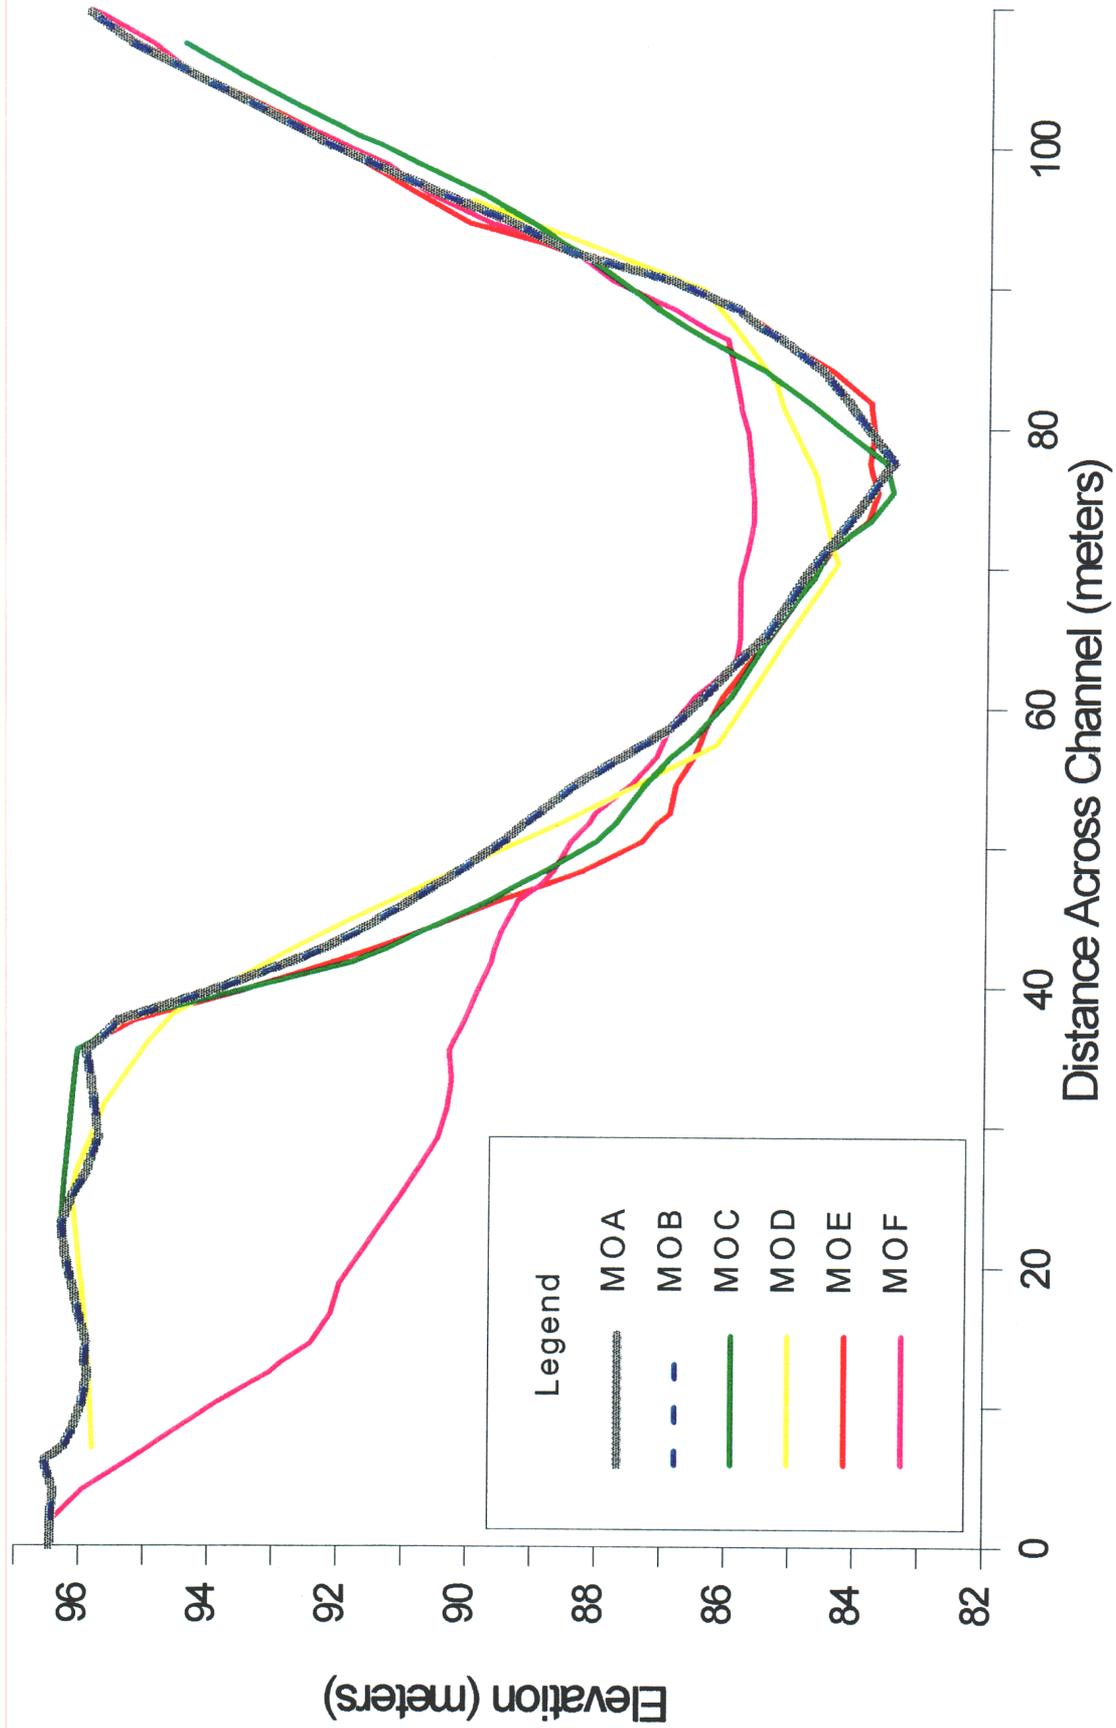
Figure 22. Cross sections from Mohawk across the pool and eddy bar for surveys shown in legend. View is looking downstream.

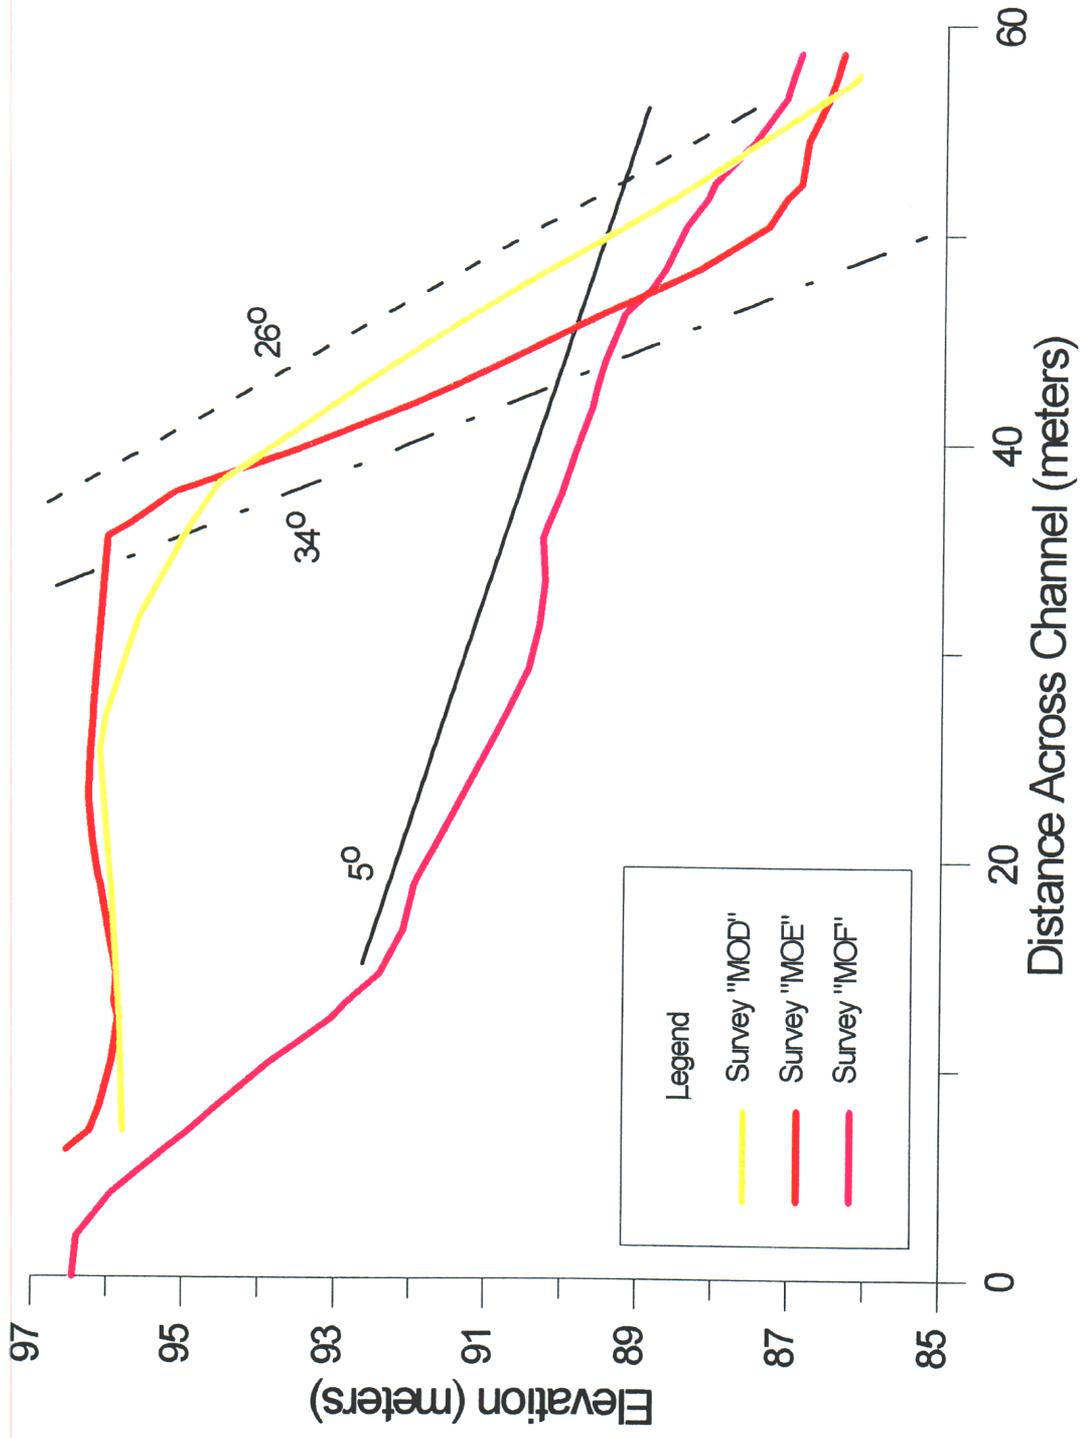
Figure 23. Cross sections from the Mohawk eddy bar for surveys shown in legend, and average slopes of the bar face.

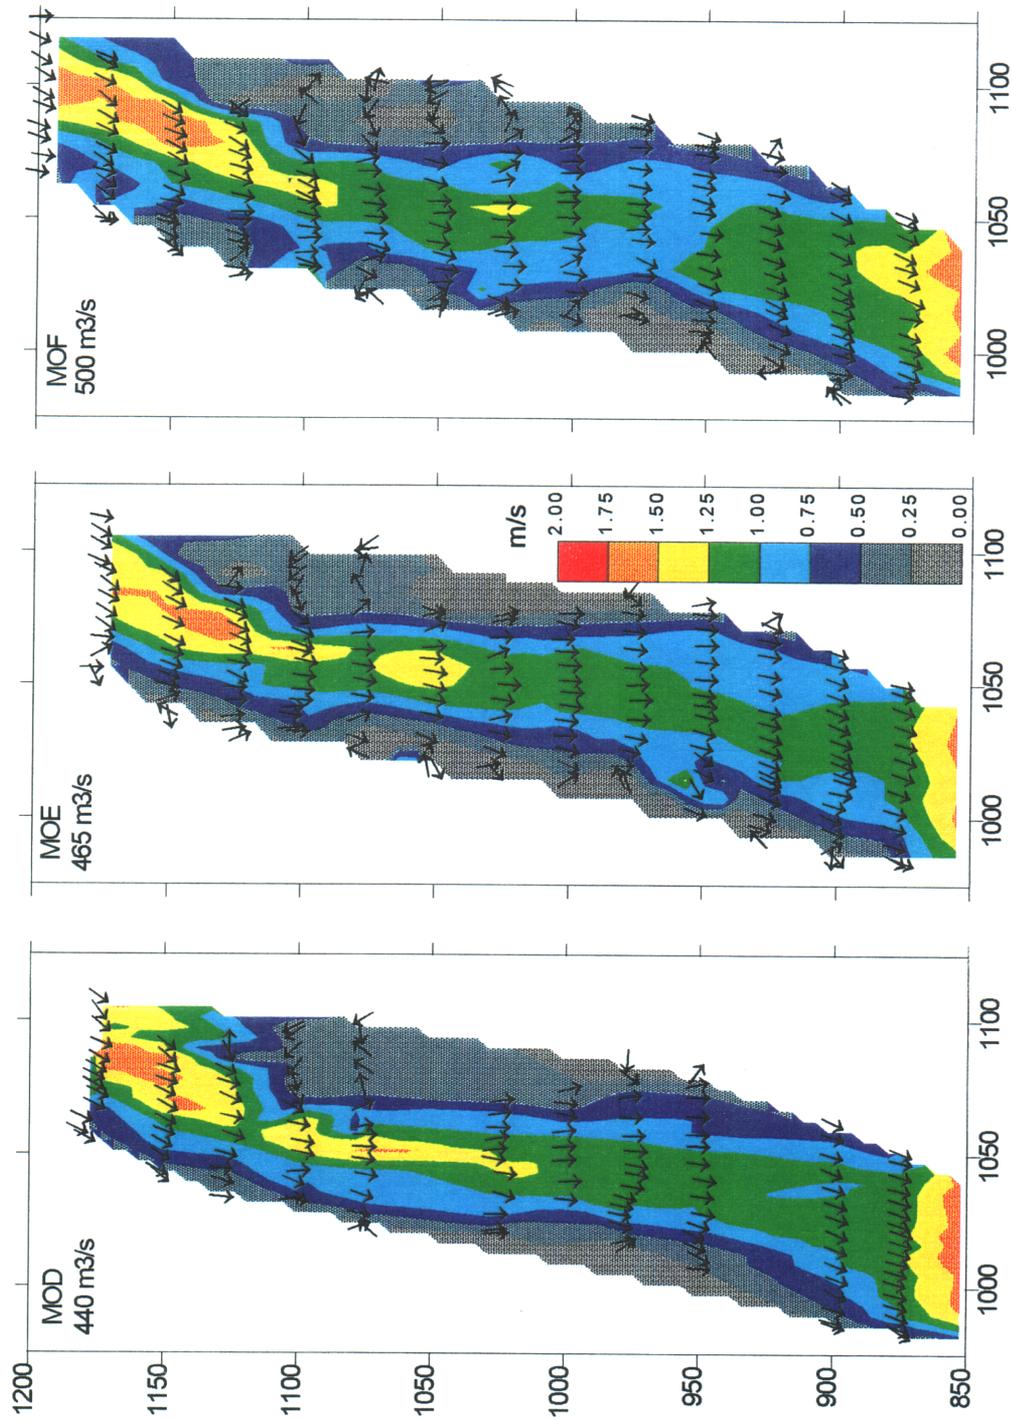
Figure 24. Depth-averaged velocity field maps from Mohawk for surveys indicated. Data from the BB-ADCP current velocity profiler, positioned with the bathymetric mapping system.

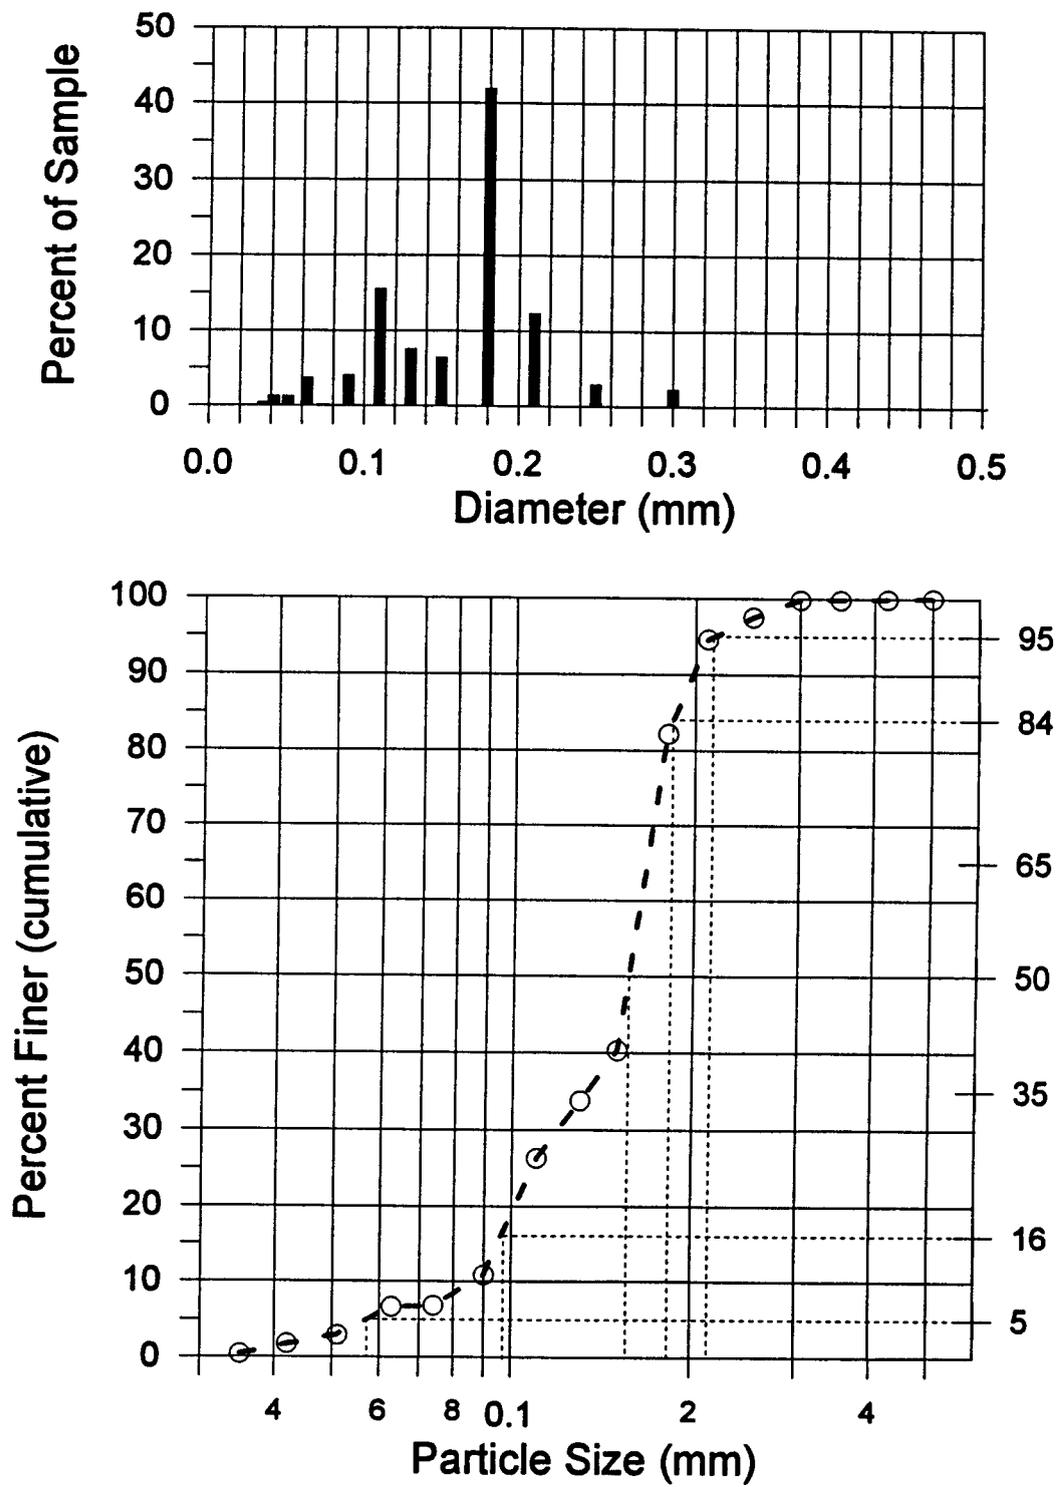
Figure 25. Sieve analysis for sediment sampled in Mohawk eddy.

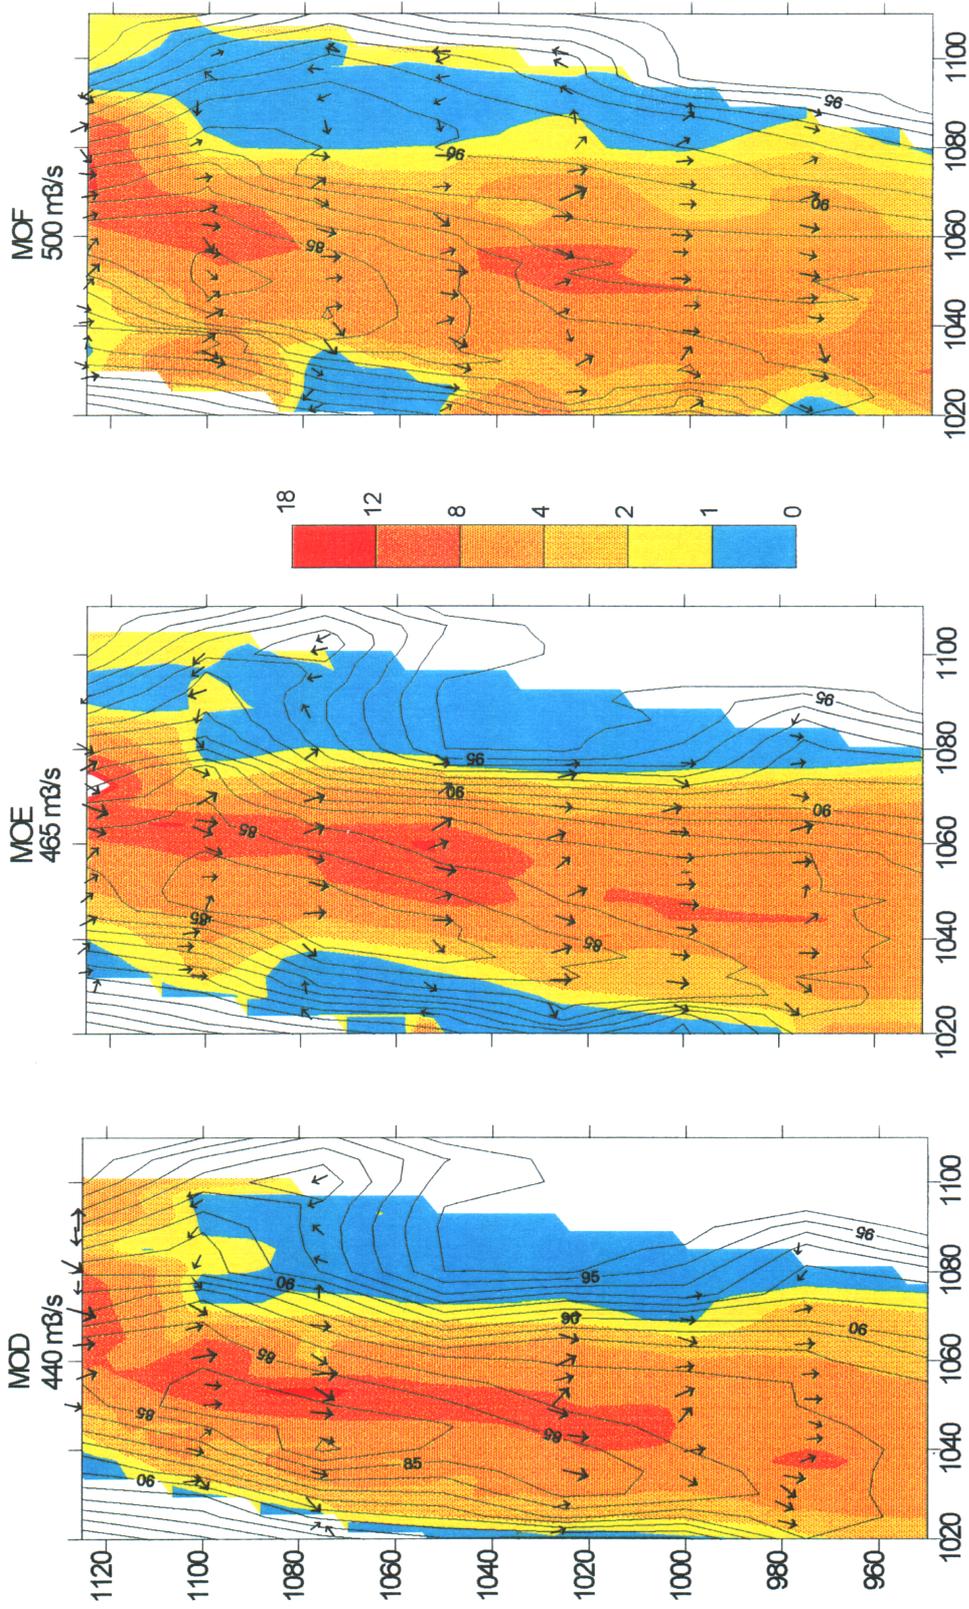
Figure 26. Maps of particle stability (color contours) and near-bed velocity vectors (scaled by magnitude) overlaid on channel topography contours (solid lines) for Mohawk surveys indicated. Particle stability values less than one show stable or depositional areas. Values greater than one are unstable or erosional.

Map plots of particle stability show significant variation in hydrodynamic patterns between surveys prior to and after the erosion event (figure 26). These relatively easy to understand maps are made up of channel topography maps overlaid by particle stability color contour maps, which are overlaid by scaled vector plots of near-bottom velocities.

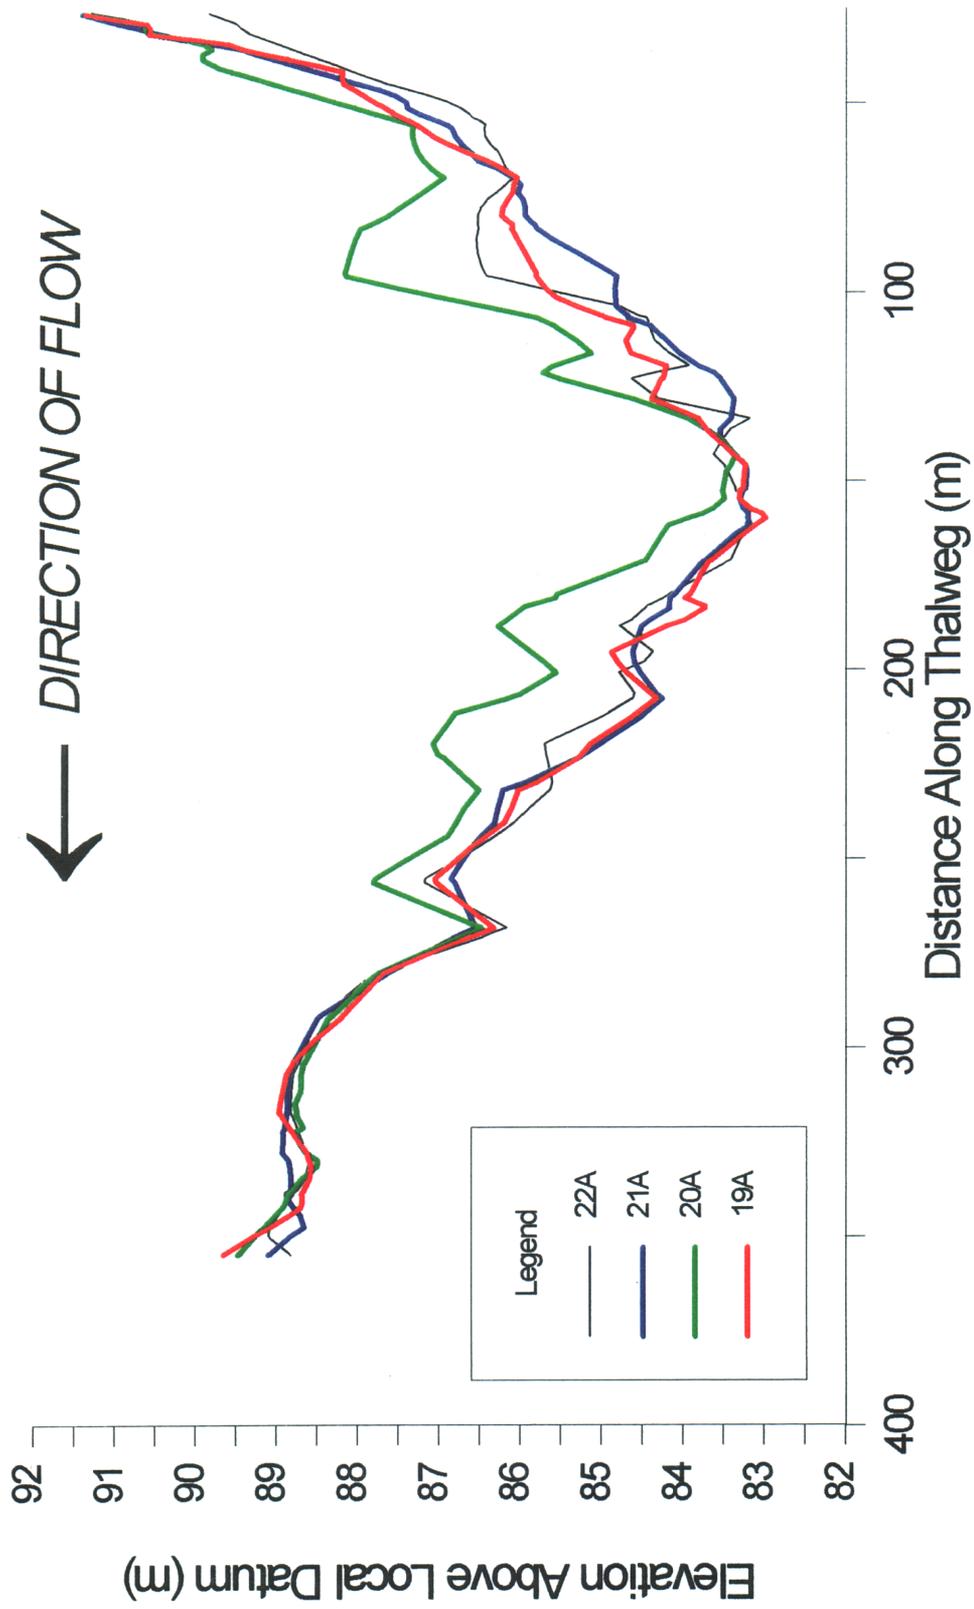
Figure 27. Thalweg profiles sliced from maps from Mohawk, for surveys shown in legend.

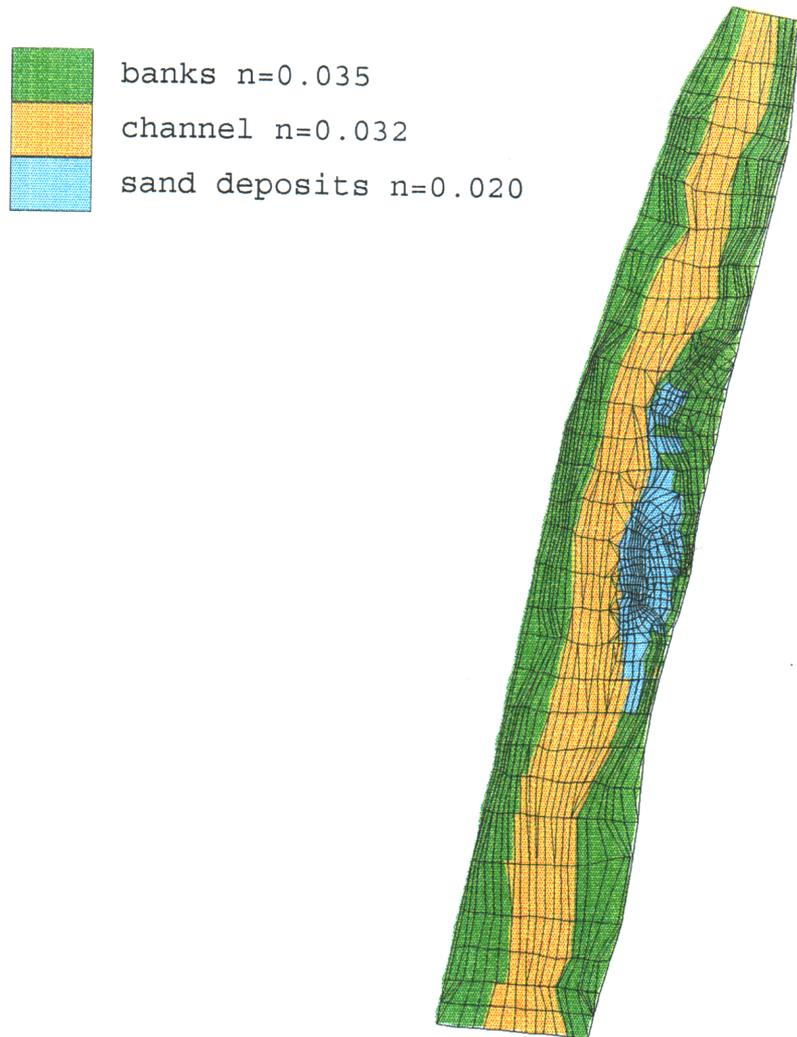
Figure 28. Layout of finite element mesh and material properties used in two-dimensional flow model.

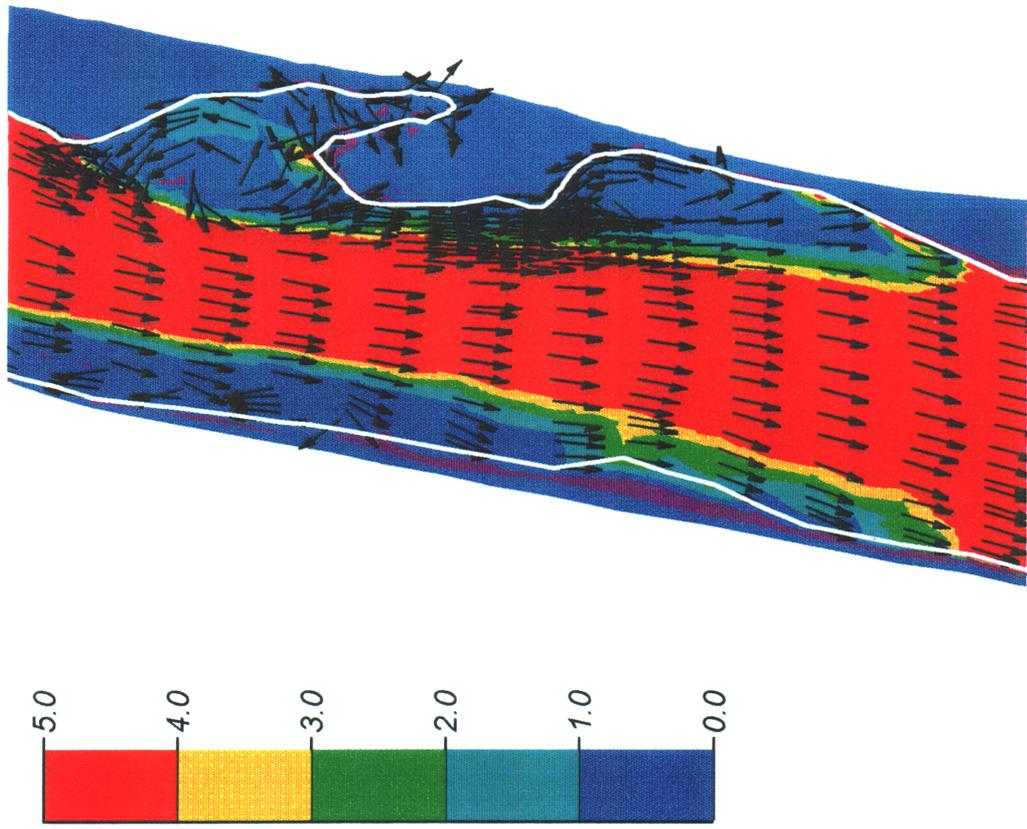
Figure 29. Particle stability and flow vector plot for initial condition of experiments listed in table 4. White lines show location of wetted boundary and information outside the boundaries should be ignored.

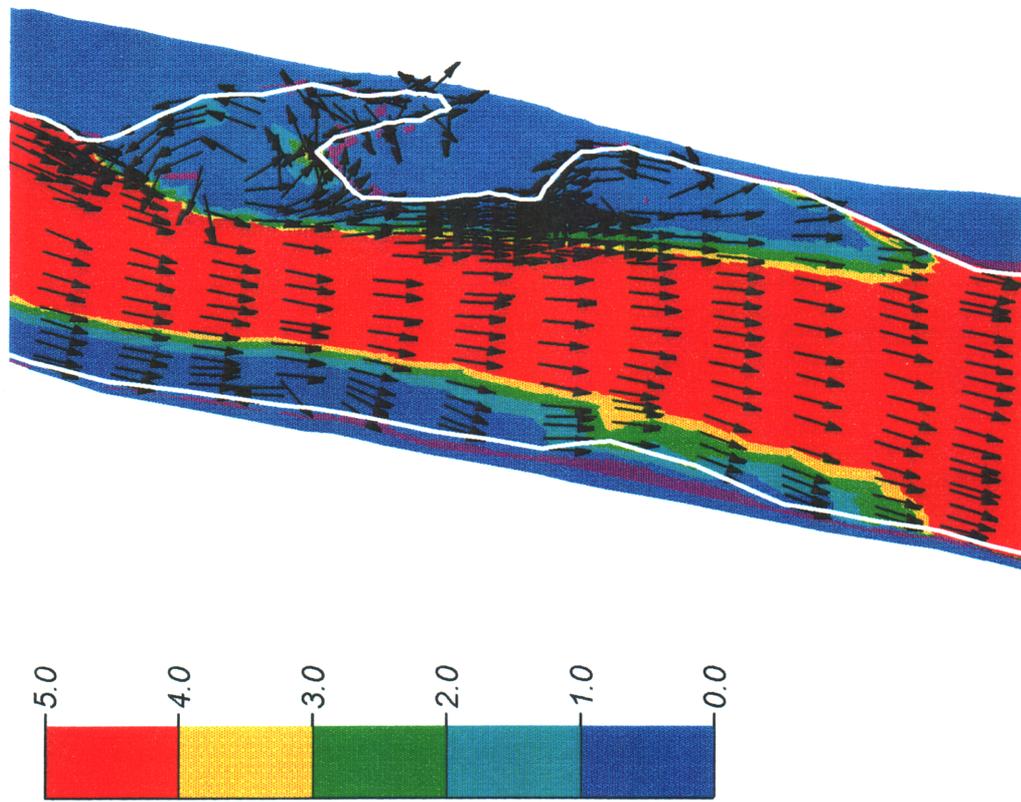
Figure 30. Particle stability and flow vector plot for entry slope filled condition of experiments listed in table 4. White lines show location of wetted boundary and information outside the boundaries should be ignored.

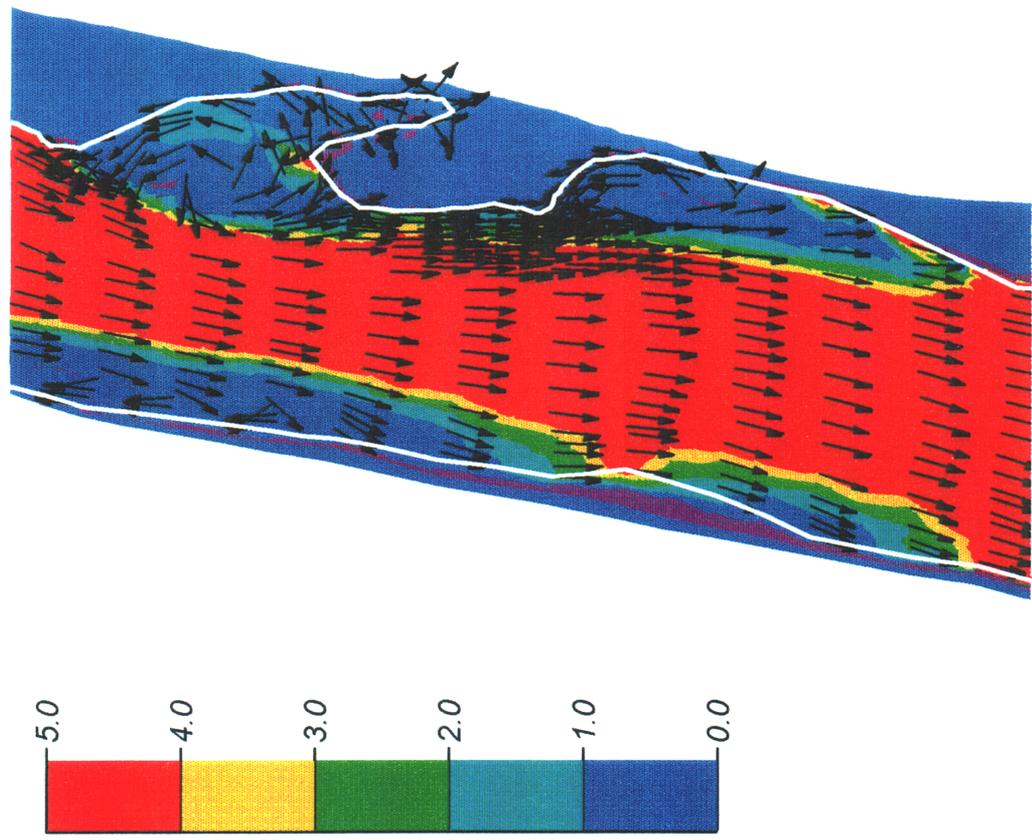
Figure 31. Particle stability and flow vector plot for exit slope filled condition of experiments listed in table 4. White lines show location of wetted boundary and information outside the boundaries should be ignored.

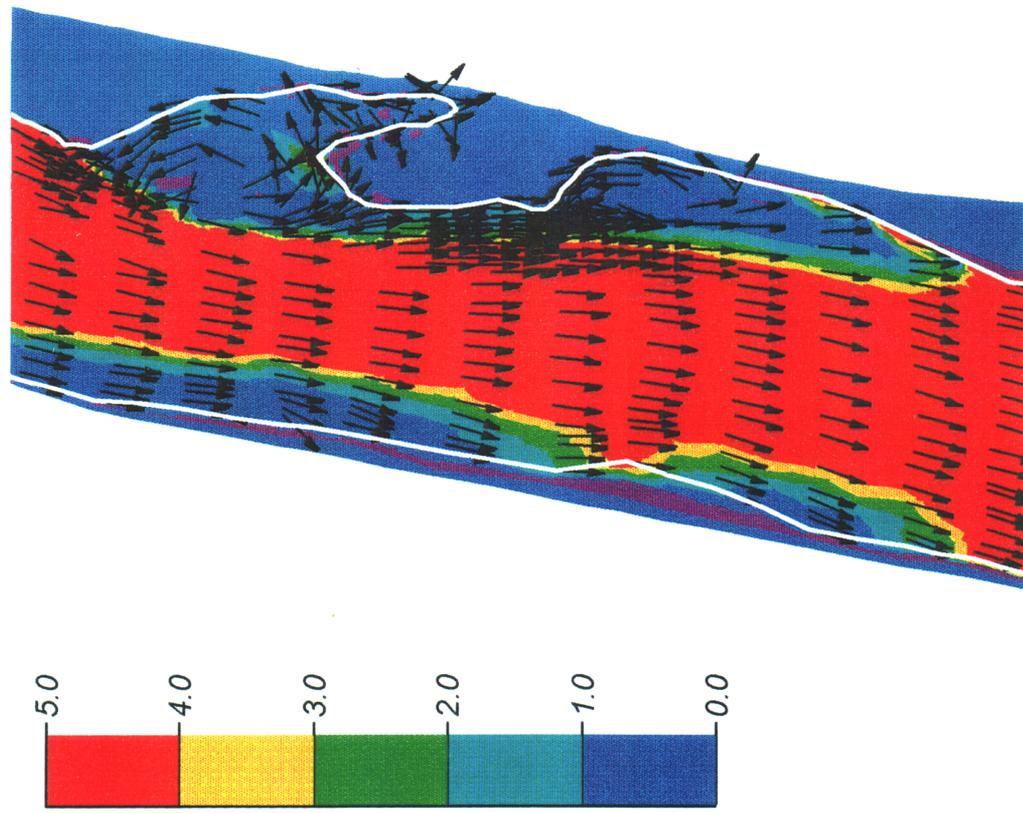
Figure 32. Particle stability and flow vector plot for entry and exit slopes filled condition of experiments listed in table 4. White lines show location of wetted boundary and information outside the boundaries should be ignored.

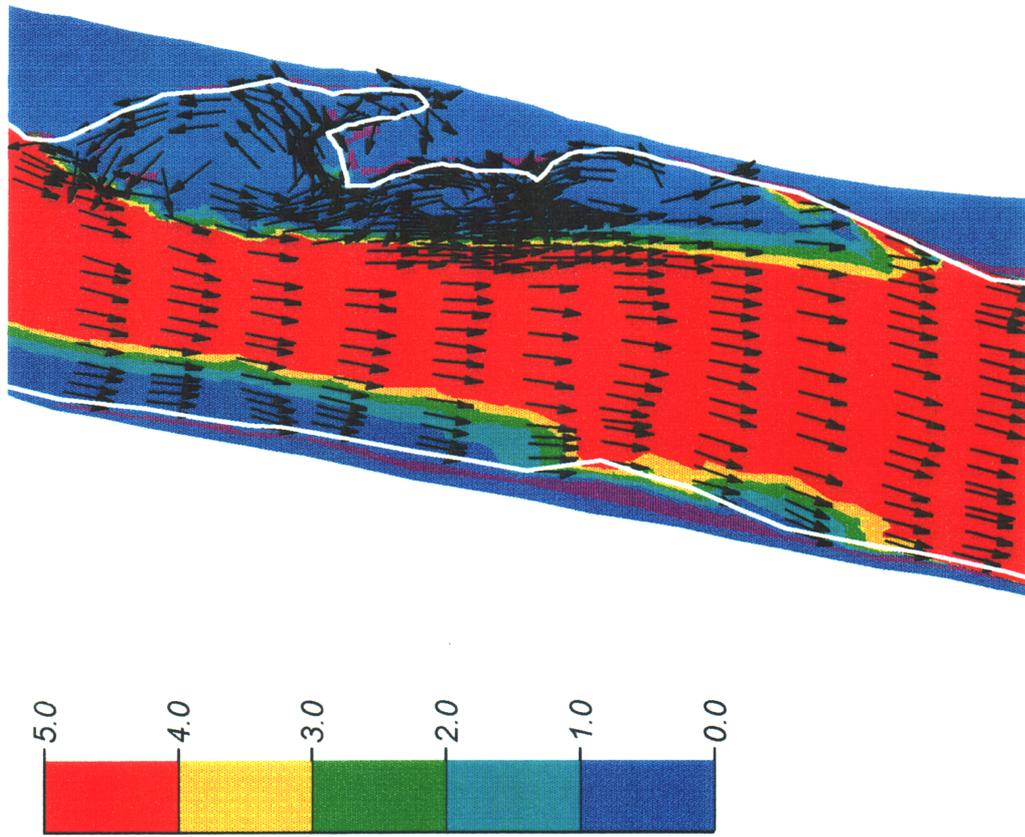
Figure 33. Particle stability and flow vector plot for initial condition of experiments listed in table 5. White lines show location of wetted boundary and information outside the boundaries should be ignored.

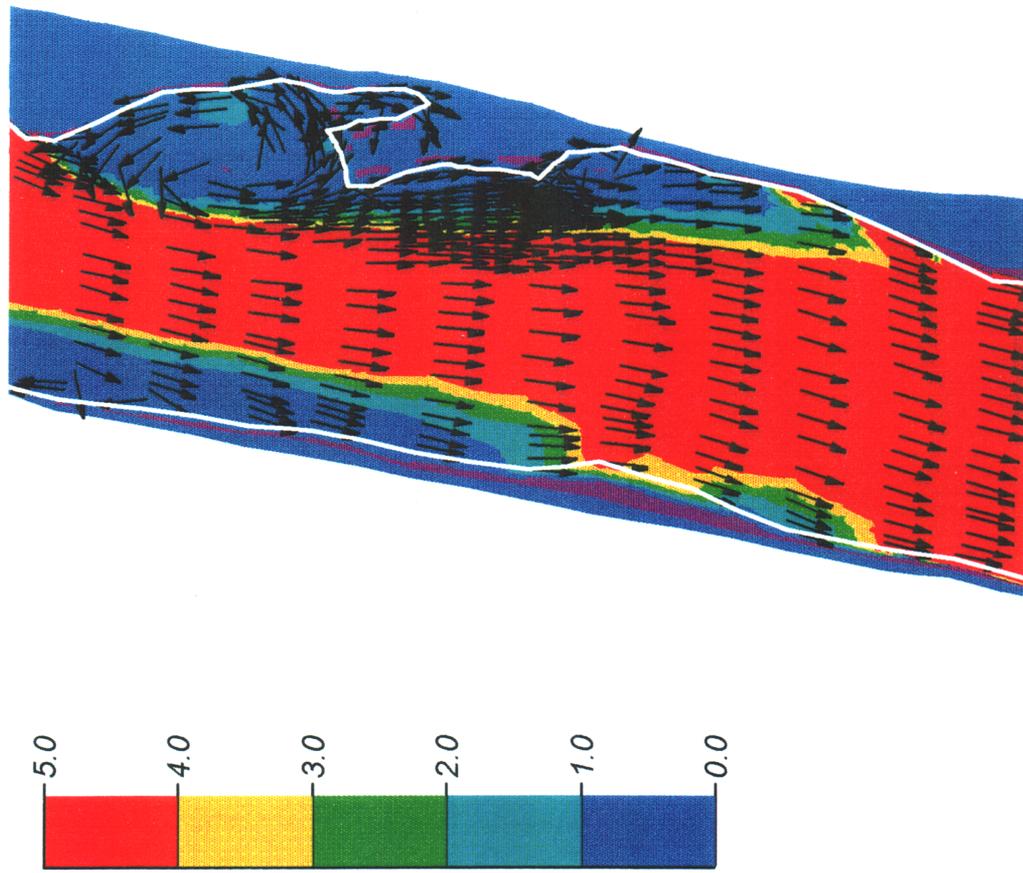
Figure 34. Particle stability and flow vector plot for exit slope filled condition of experiments listed in table 5. White lines show location of wetted boundary and information outside the boundaries should be ignored.

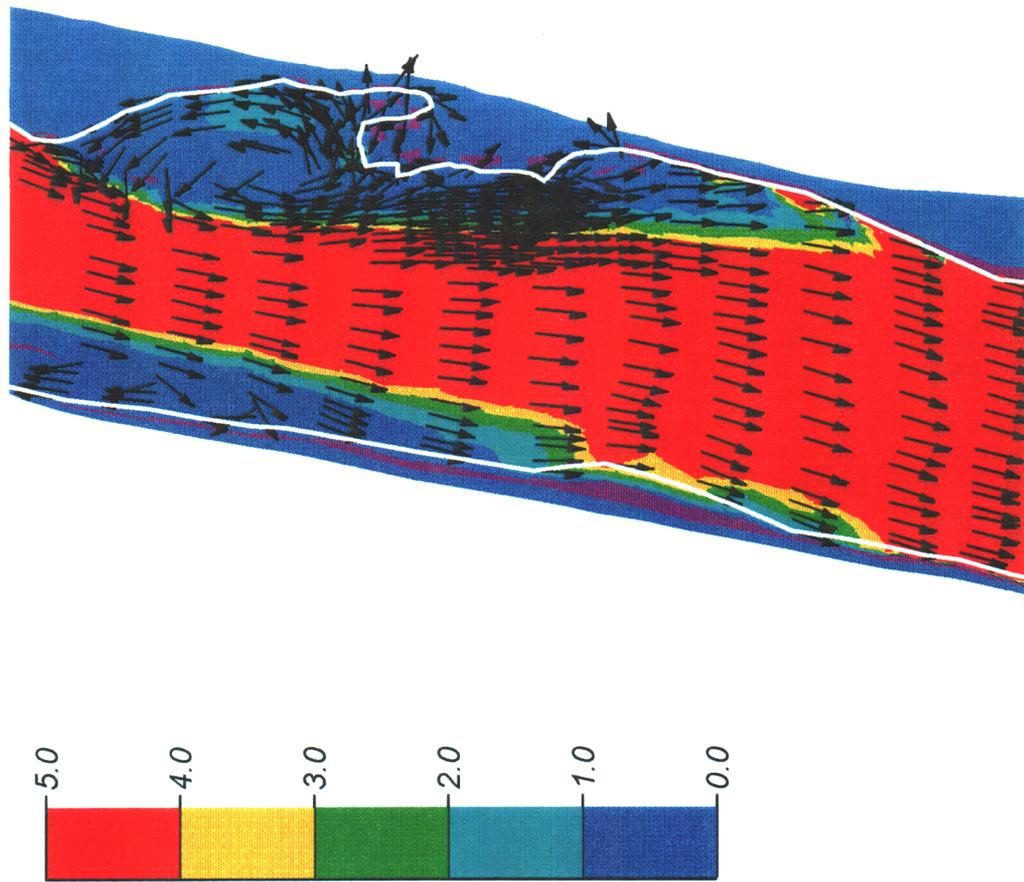
Figure 35. Particle stability and flow vector plot for entry and exit slopes filled condition of experiments listed in table 5. White lines show location of wetted boundary and information outside the boundaries should be ignored.

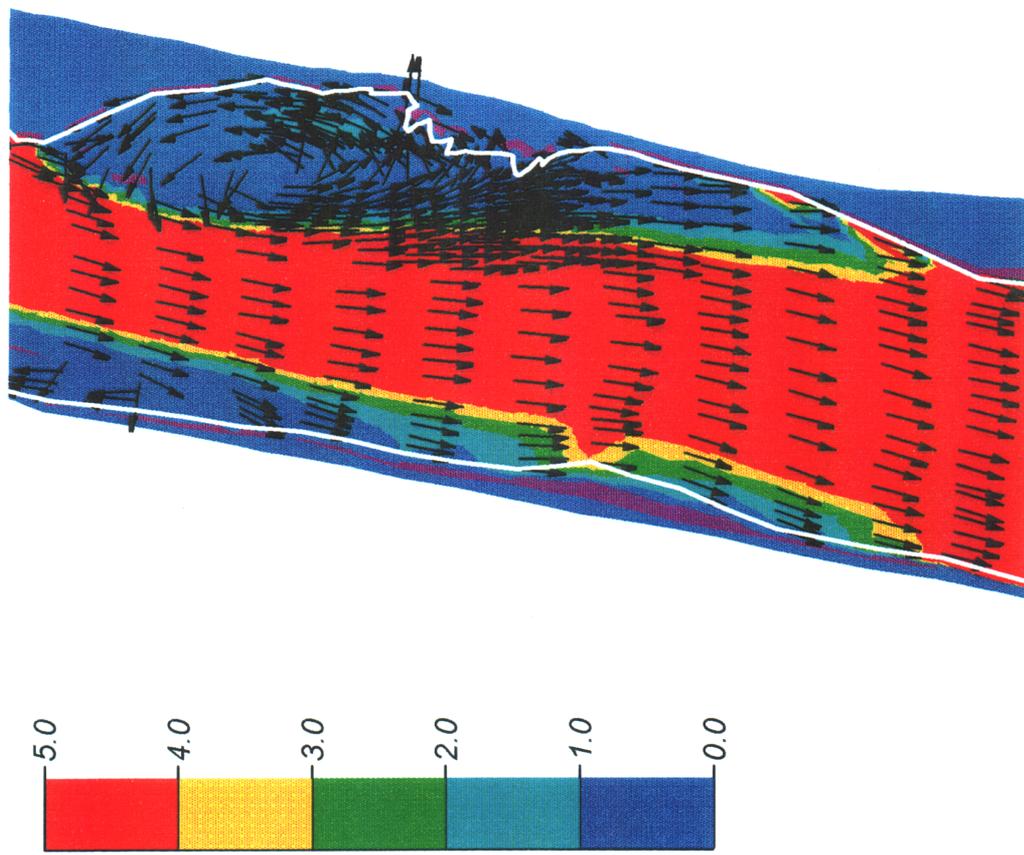
Figure 36. Particle stability and flow vector plot for exit slope filled and entry slope scoured condition of experiments listed in table 6. White lines show location of wetted boundary and information outside the boundaries should be ignored.

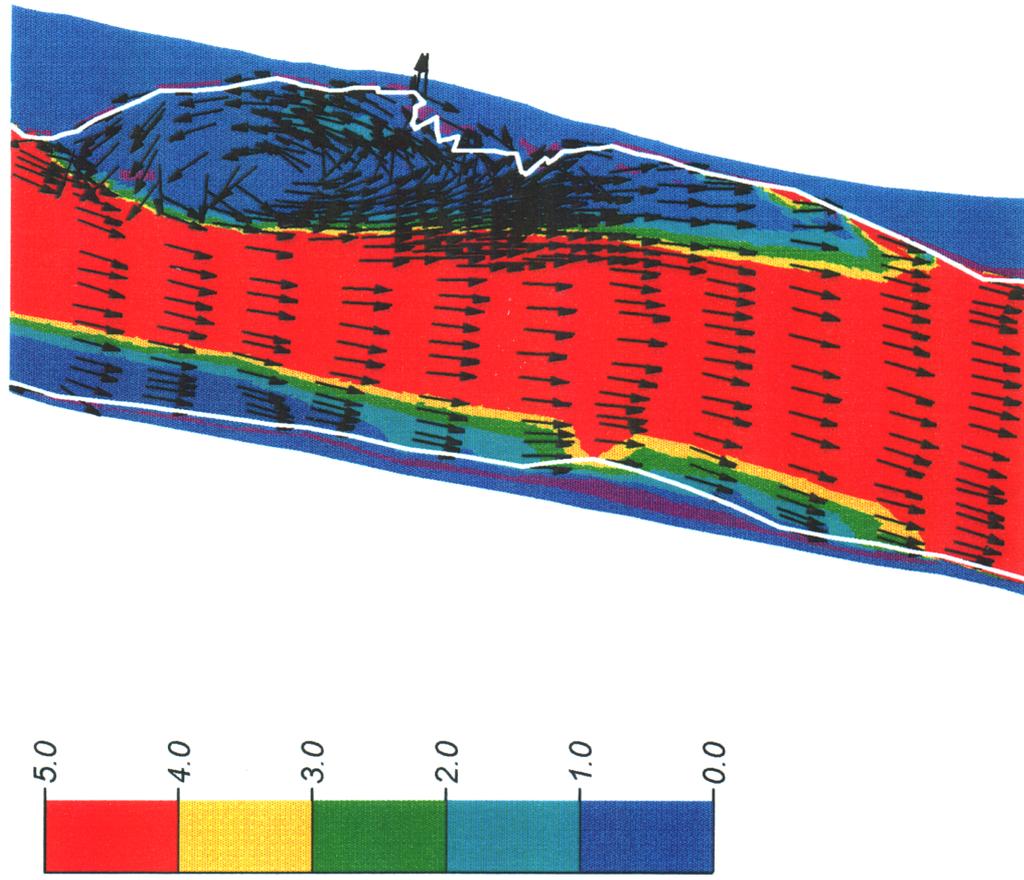
Figure 37. Particle stability and flow vector plot for entry and exit slopes filled condition of experiments listed in table 6. White lines show location of wetted boundary and information outside the boundaries should be ignored.
