EDDY BAR RESPONSES TO THE
SEDIMENT DYNAMICS OF POOL-RIFFLE ENVIRONMENTS
- FINAL REPORT -

BRIAN L. CLUER, HYDROLOGIST

NATIONAL PARK SERVICE

PROJECT NAME: [A PROPOSAL TO] DETERMINE THE PROCESSES OF RAPID EROSION AND
THE EFFECTS ON EVOLUTION AND LONGEVITY OF CHANNEL MARGIN
DEPOSITS

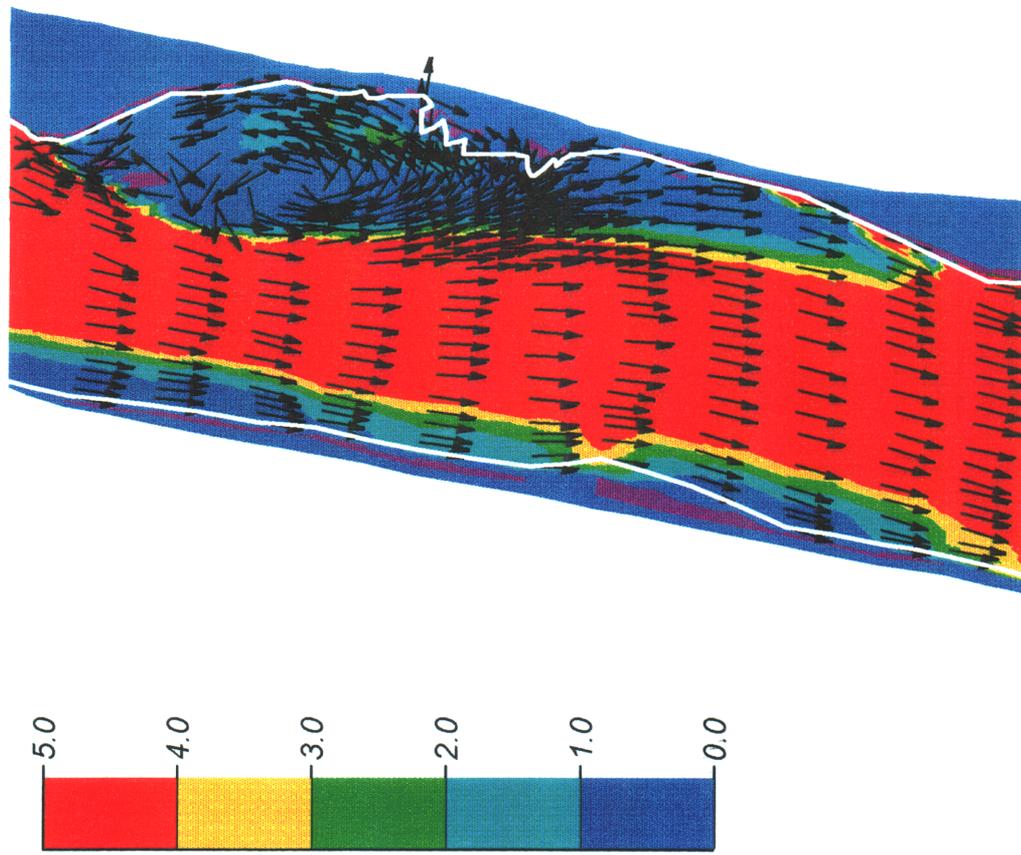
Figure 38. Particle stability and flow vector plot for entry slope filled and exit slope scoured condition of experiments listed in table 6. White lines show location of wetted boundary and information outside the boundaries should be ignored.

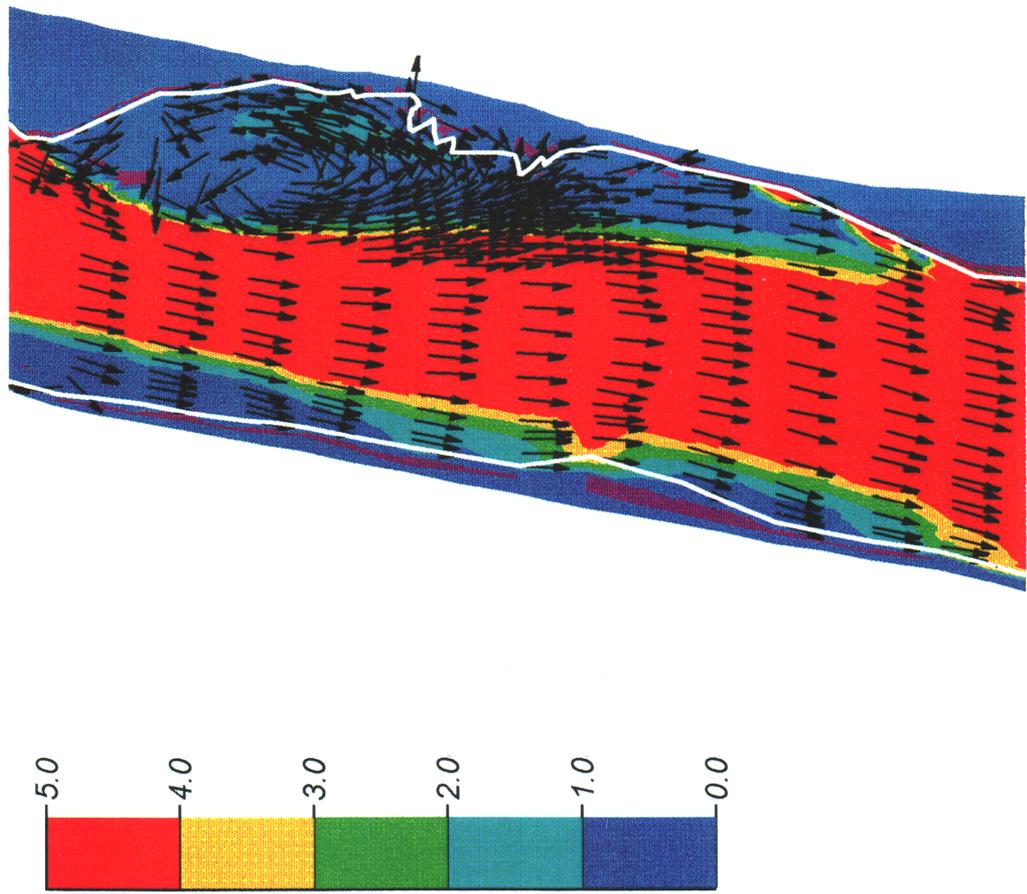
Figure 39. Particle stability and flow vector plot for entry and exit slopes scoured condition of experiments listed in table 6. White lines show location of wetted boundary and information outside the boundaries should be ignored.

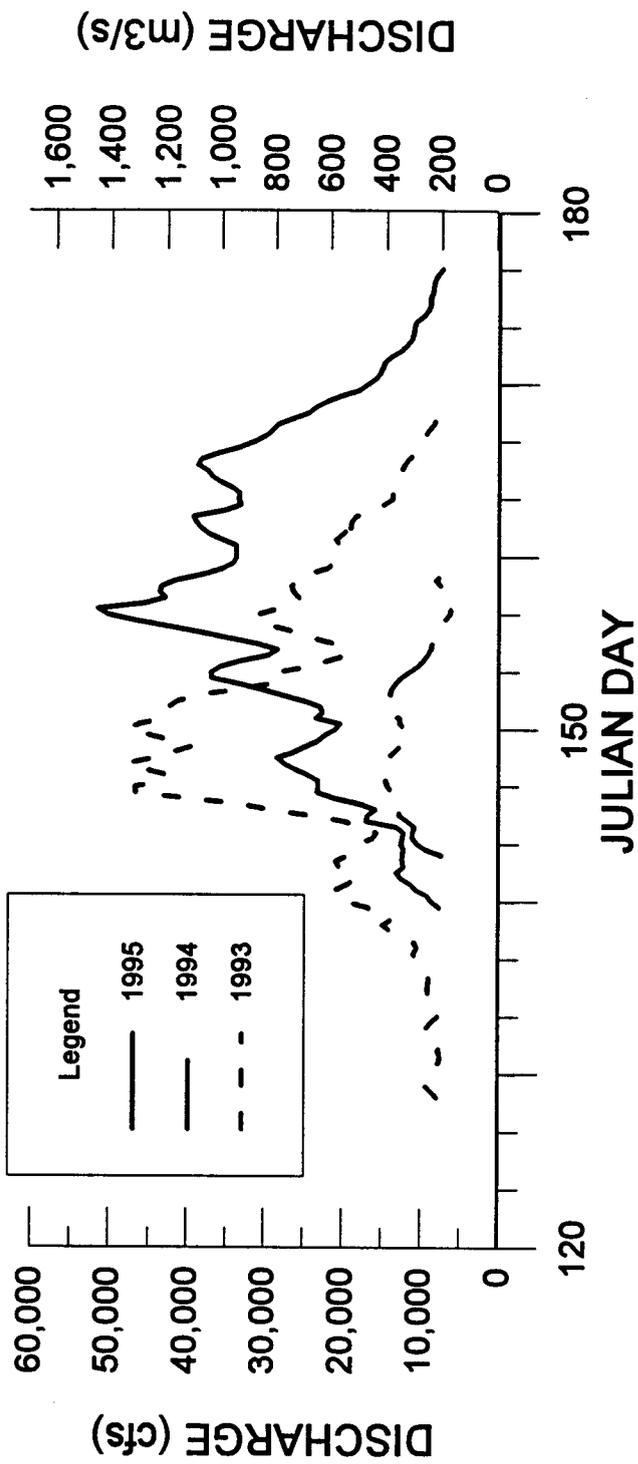
Figure 40. Hydrographs for the 1993-1995 floods for flows greater than $227 \text{ m}^3 \text{ s}^{-1}$.

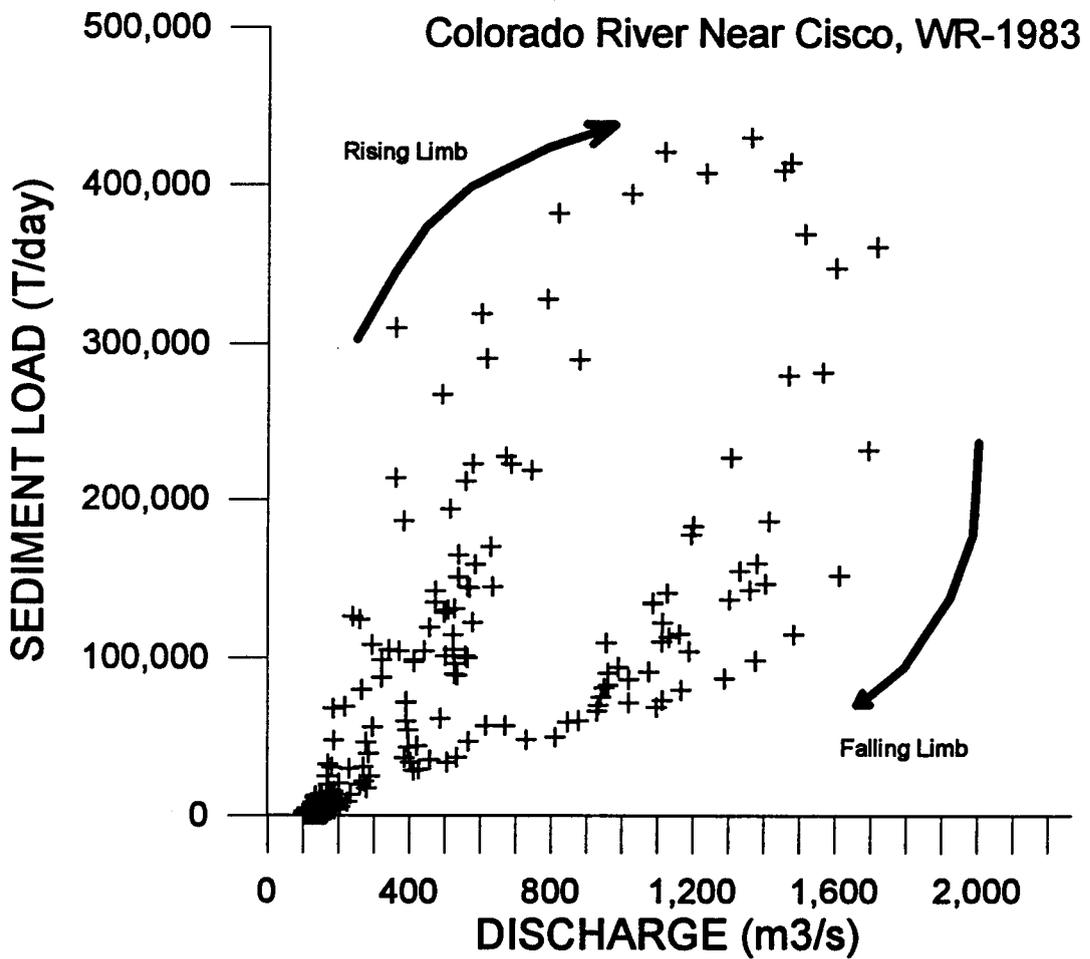
Figure 41. Sediment rating curve showing pronounced hysteresis for the 1983 flow, Colorado River near Cisco, UT.

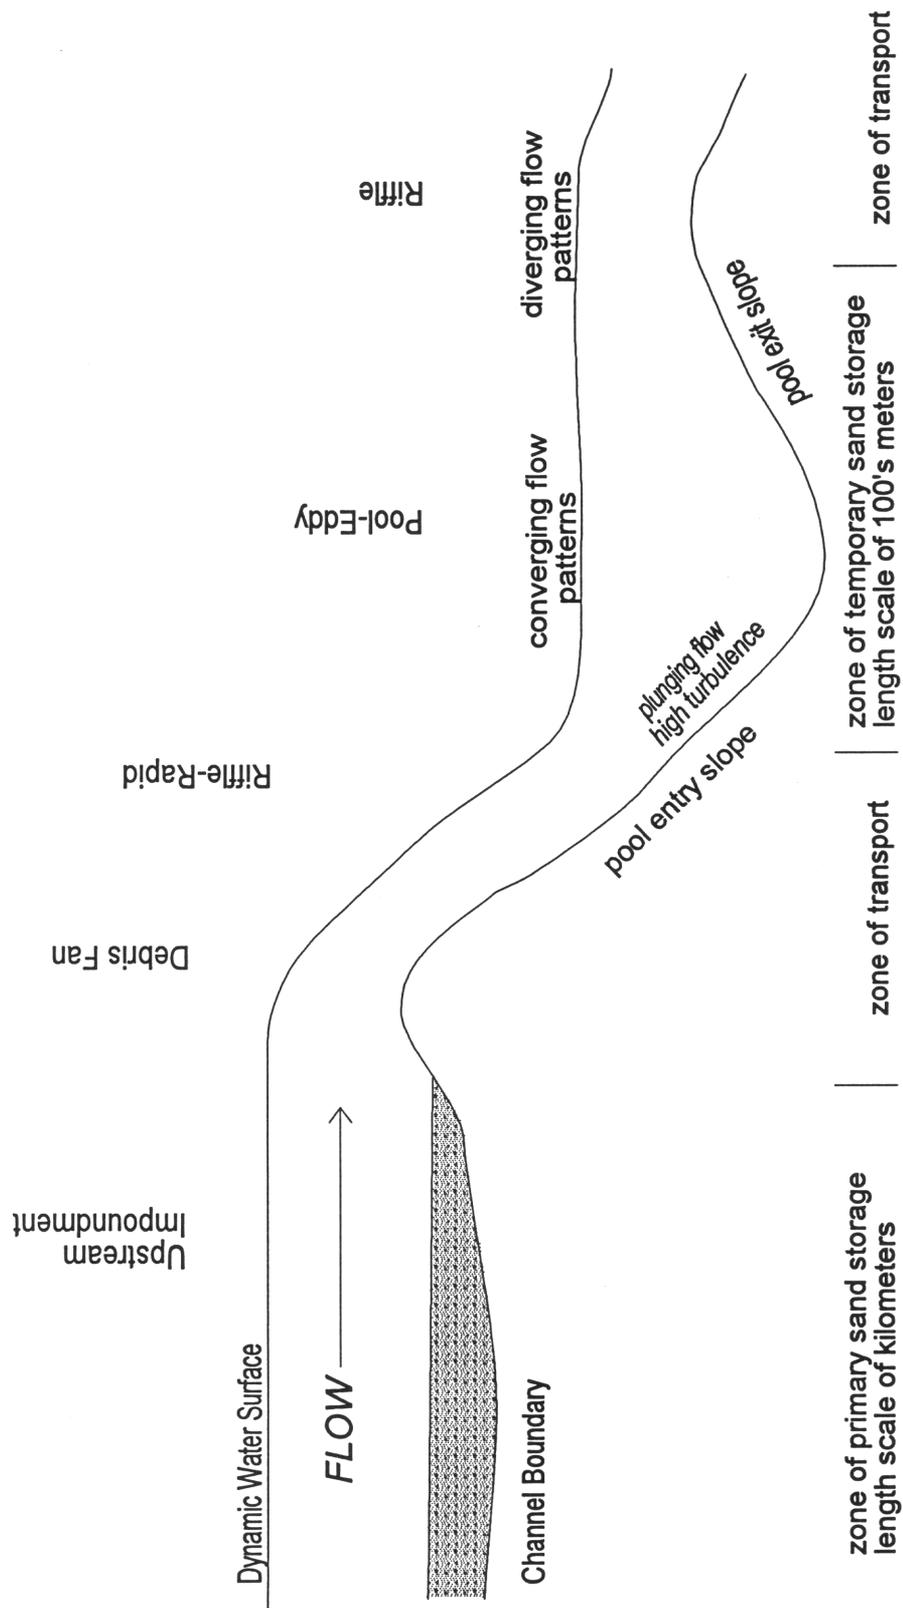
Figure 42. Explanatory river profile diagram for conceptual model of non-uniform sediment transport and episodic eddy bar scour. Sediment storage reservoir is shaded region on left.
