Changes in Debris Fans and Rapids: 21 Years of Monitoring Debris-Flows in Grand Canyon

Peter Griffiths, Robert Webb,
Christopher Magirl, and Brian Yanites
U.S. Geological Survey - Tucson

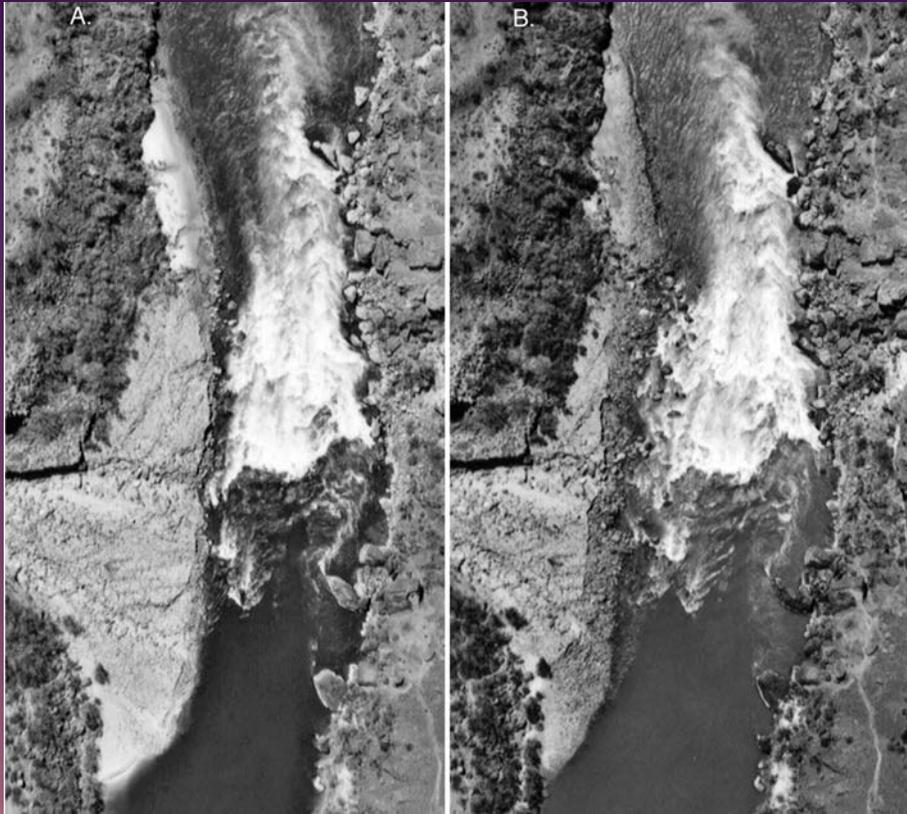
Lava Falls Rapid. A. March 25, 1996. B. April 6, 1996. The river reworked the 1995 debris-flow deposit and widened the rapid by about 20 m.

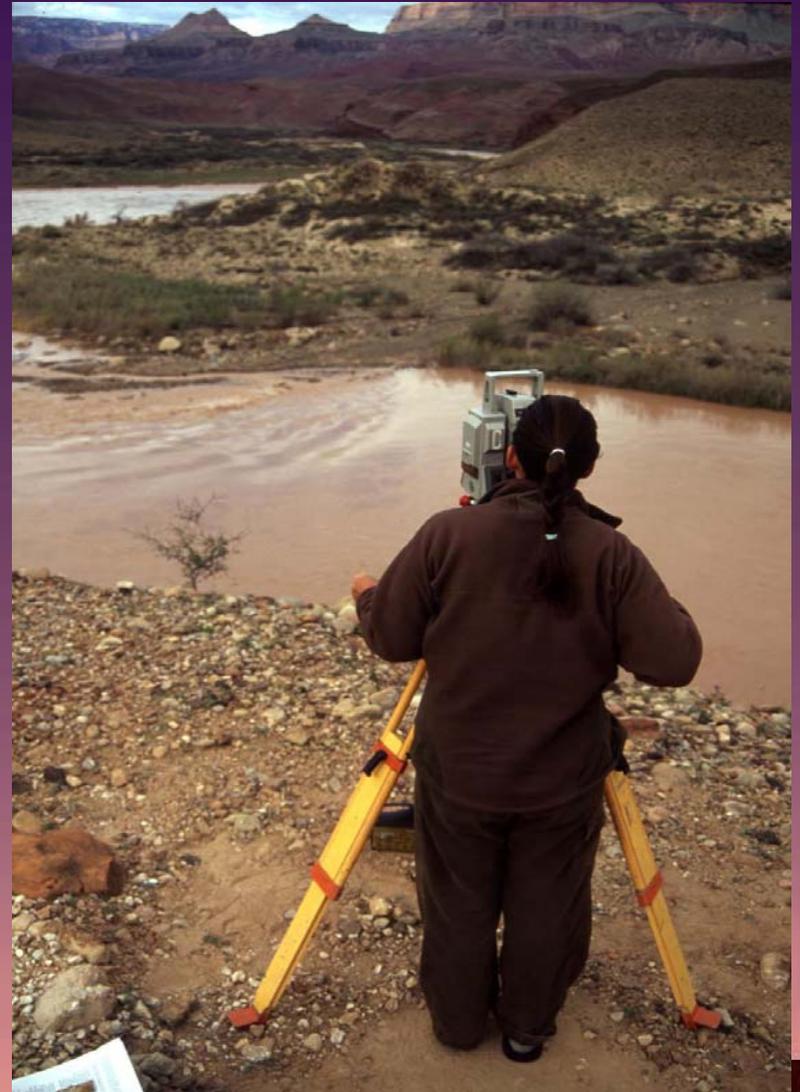
Since 1984, we have collected:

- 234 topographic surveys
- 225 particle-size samples
- 289 point count surveys

To provide information about:

- area and volume
- particle-size distribution
- fan reworking
- channel constriction and rapid fall

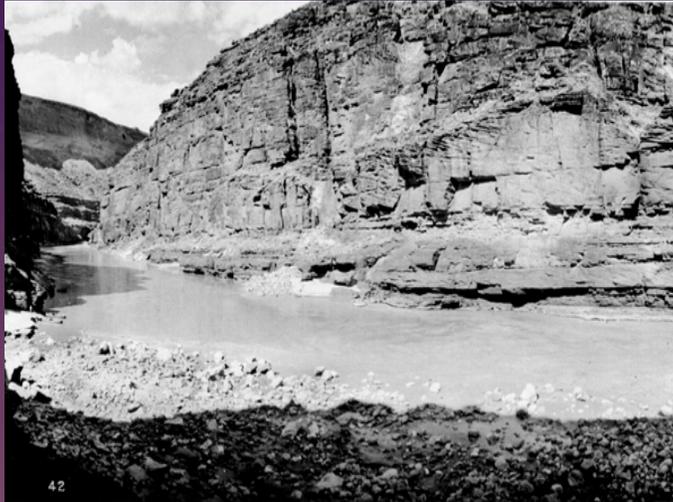
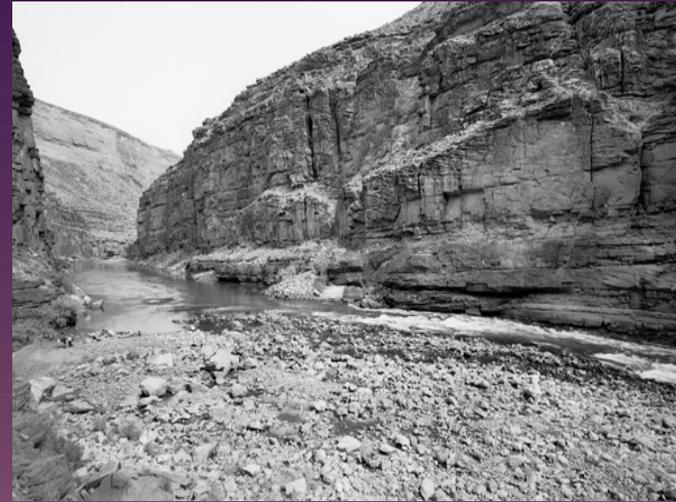
House Rock Rapid, mile 16.8

Largest Rise at Head of a Rapid

Net Rise: 1.83 m

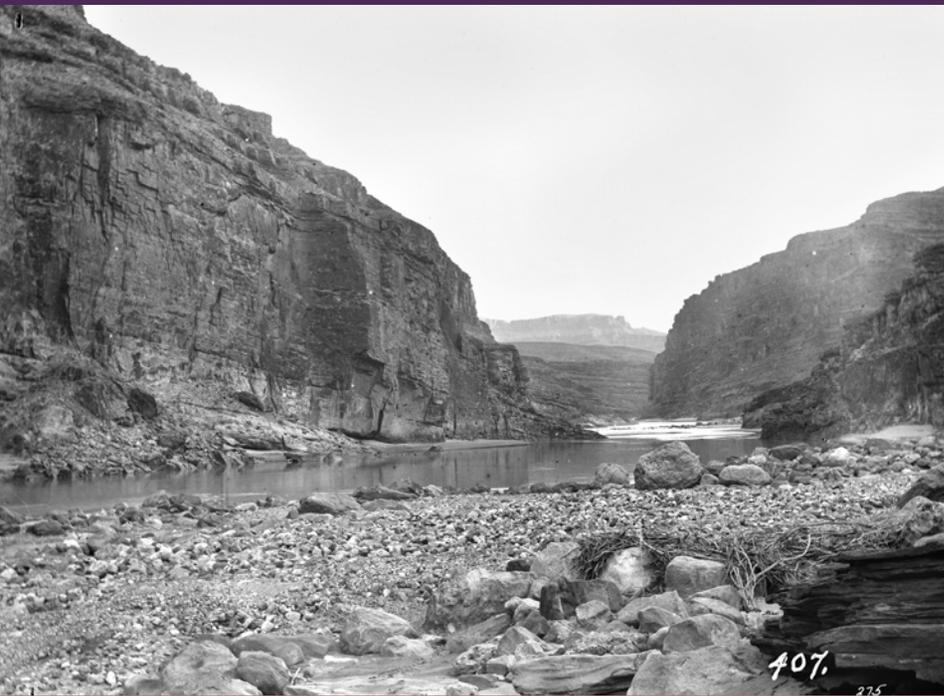
1890 (R.B. Stanton)

Nevills Rapid at 75-Mile Wash: Debris Fan Aggradation
