Sandbars in historical context: Comparison of images following the March 2008 high flow with images from the 1980s and earlier.

March 3, 2009

USGS cooperators Jack Schmidt and Milada Majerova of Utah State University are currently compiling historical photographs of selected study sites and comparing those images with photos taken during and following the 2008 high-flow experiment. These photographs will help scientists, managers, and stakeholders evaluate the present condition of sandbars and vegetation relative to the condition prior to the onset of regular monitoring, which began in the early 1990s.

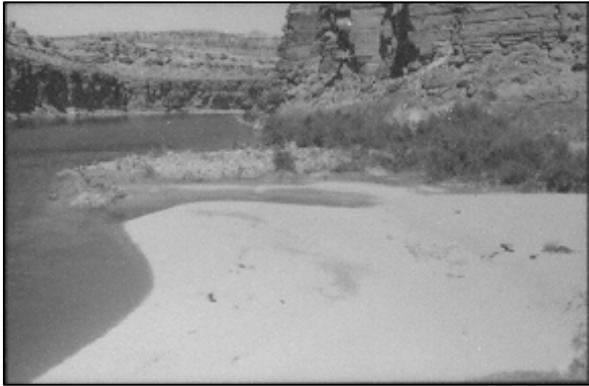
1230 October 4, 1985 (~12,500 ft³/s)

October 4, 1985 and May 10, 2008:
Cobble bar and sand bar is covered with vegetation in May 2008.

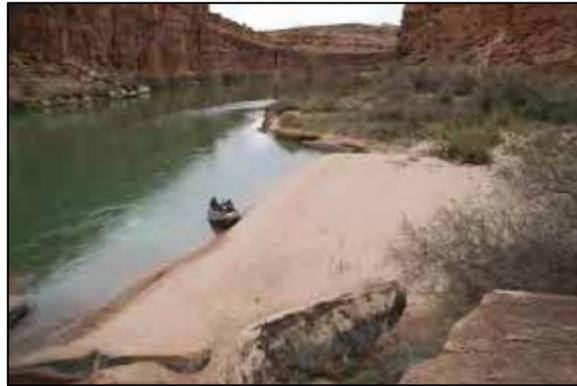
March 2008 and May 10, 2008:
Sand bar deposit contains sprouting vegetation in May. There was none in March.

1645 March 28, 2008
(~9,800 ft³/s)

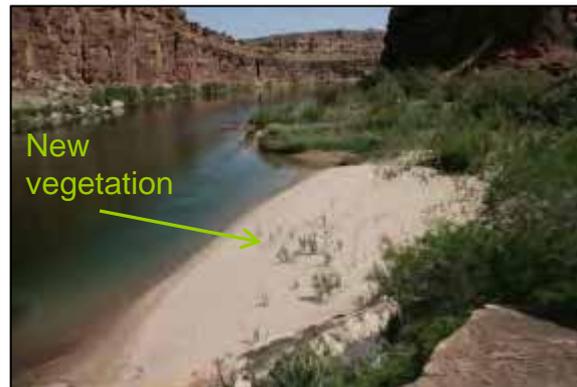
1020 May 10, 2008
(~10,300 ft³/s)

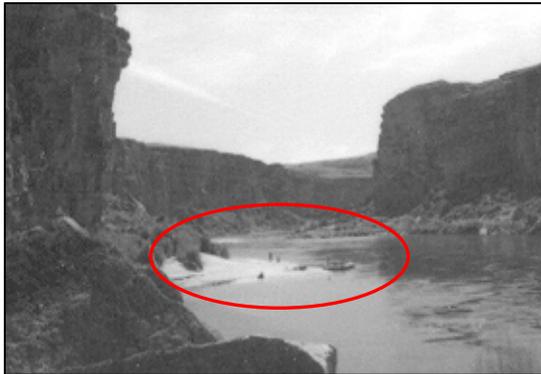
1230 October 4, 1985
(~12,500 ft³/s)

October 4, 1985 and May 10, 2008:

Negligible change in volume of sand, however, in 1985 there is more sand on downstream portion of bar that extends further out into the river. Bar in May has approximately 1.5m platform at upper end of bar which has been eroded by a cut bank.

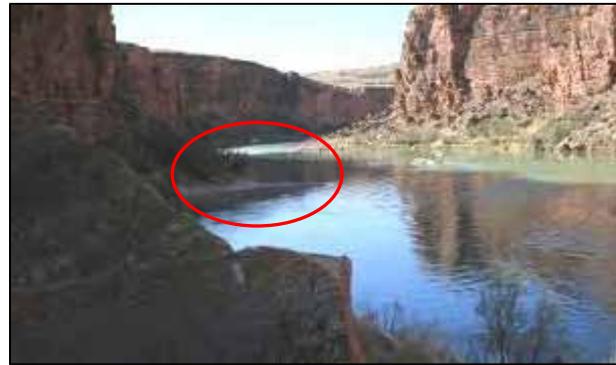
0950 March 29, 2008
(~9,600 ft³/s*)

March 29, 2008 and May 10, 2008:

5% loss of sand. Loss appears to have occurred near reattachment point.

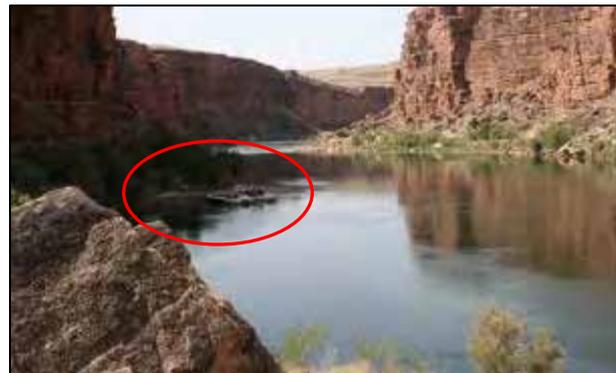
0945 May 10, 2008
(~10,000 ft³/s*)

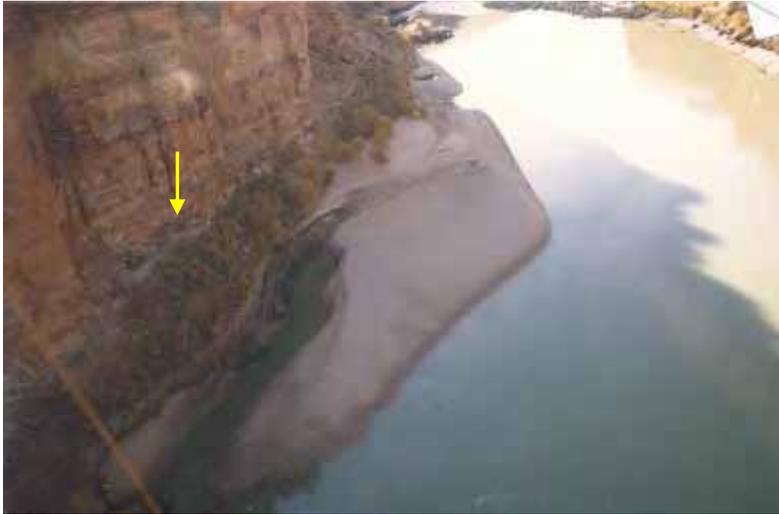
Photo from helicopter
December 1985

Sand bar seems bigger in March 2008 before HFE; although, 1985 photo is showing sand in higher elevations and farther downstream. Since discharge is unknown for 1985 it is difficult to compare.

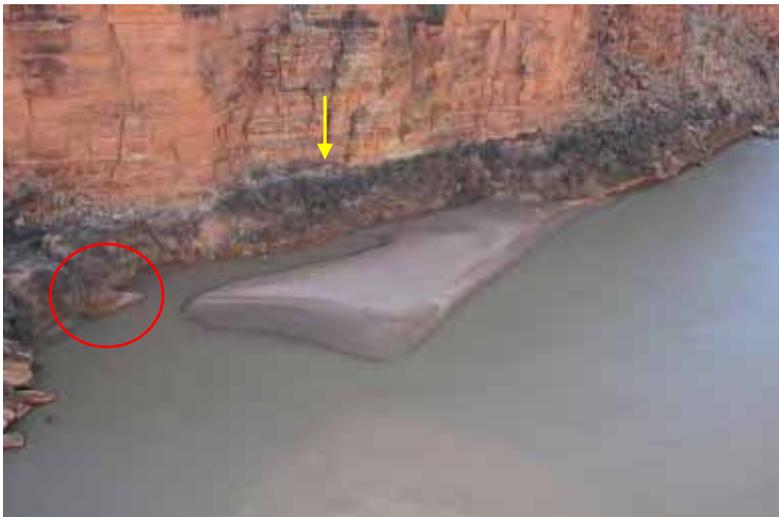
0930 March 2, 2008, before HFE

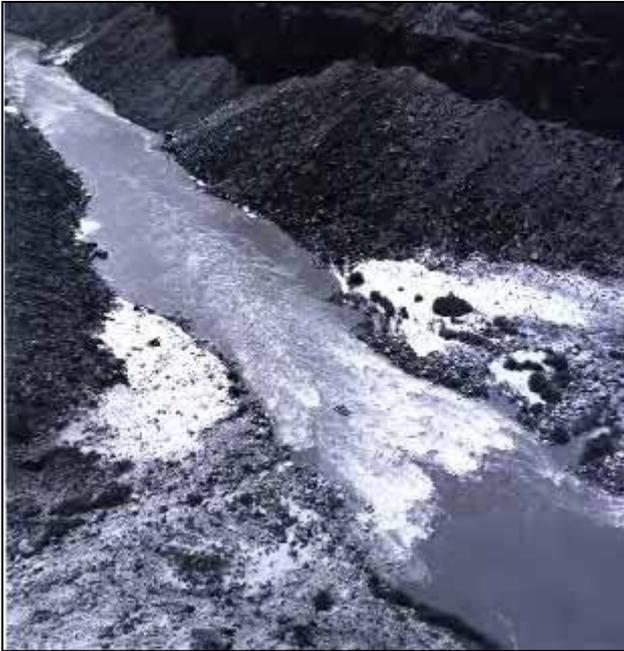
August 21, 1972 (daily mean
18,700 ft³/s; taken by R. M. Turner,
USGS; boat in the rapid is 6.7 m
long)

For pages 6-8: Note the extensive areas of bare sand on the separation bars on river left and river right in pre-dam photographs. Some talus blocks on the separation bar on river left were exposed in 1972 and more were exposed in 1991. Reattachment bars were more extensive in pre-dam photographs and did not exist in 1991. (John C. Schmidt, David J. Topping, Paul E. Grams, and Joseph E. Hazel. System-Wide Changes in the Distribution of Fine Sediment in the Colorado River Corridor Between Glen Canyon Dam and Bright Angel Creek, Arizona, 2004)

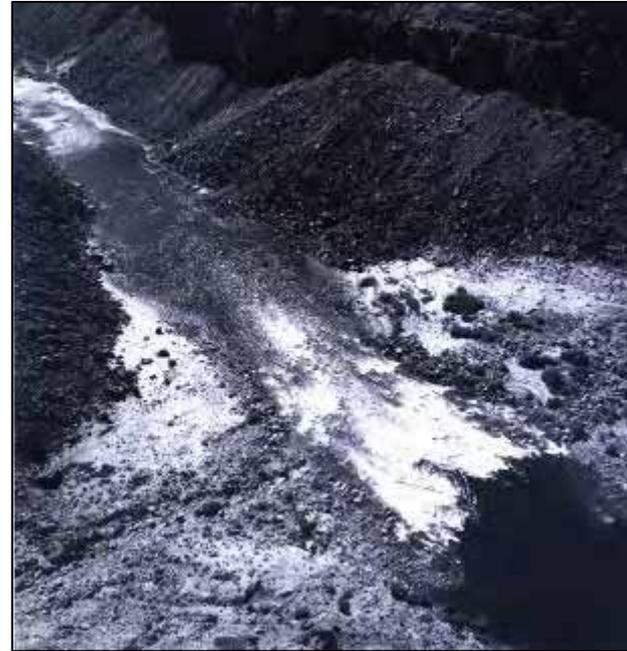
October 4, 1991
(daily max 1,800 ft³/s,
daily min 6,100 ft³/s,
daily mean 9,300 ft³/s;
taken by R. H. Webb)

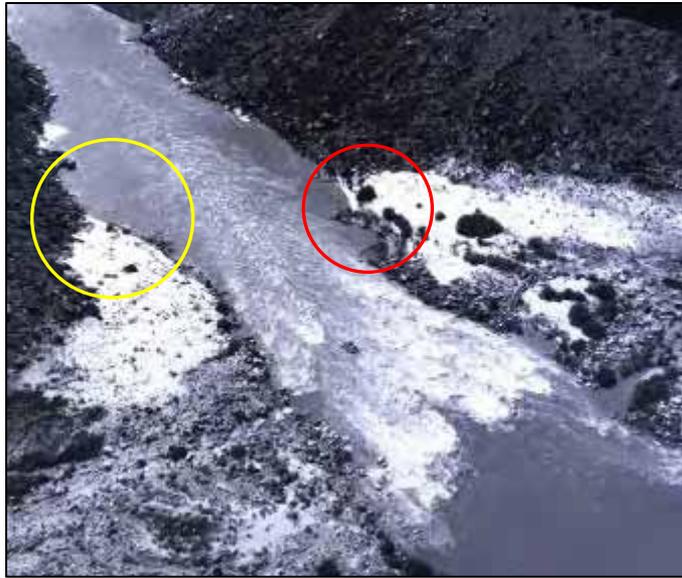
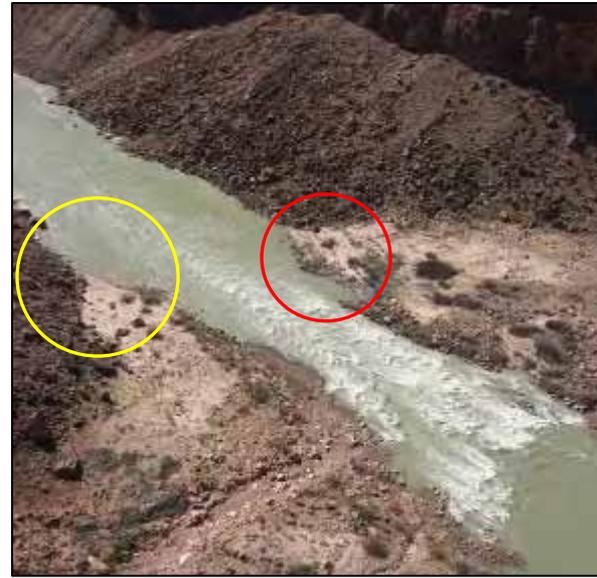
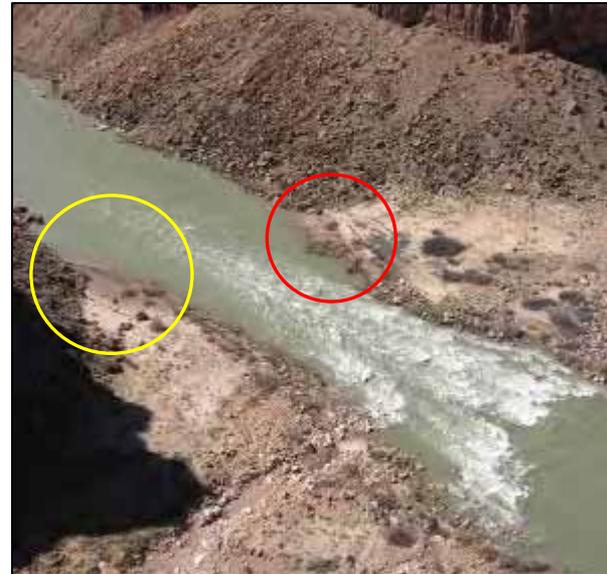
Badger Creek Rapid RM 8.10: 1972 – 2008 comparison

August 21,
1972
(daily mean
18,700 ft³/s)

1400 - 1500
March 4, 2008
(~11,700 ft³/s)

1230 March 9,
2008
(~17,600 ft³/s)

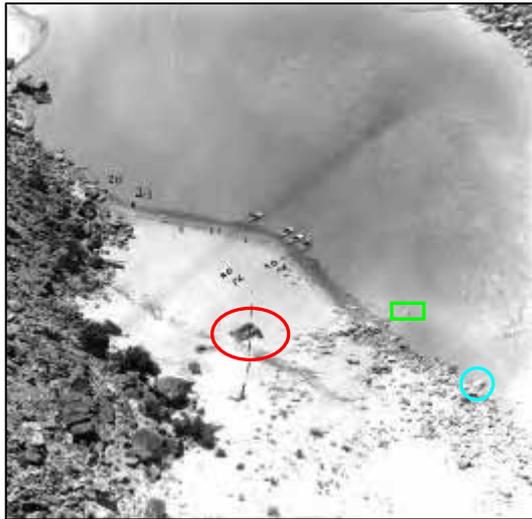
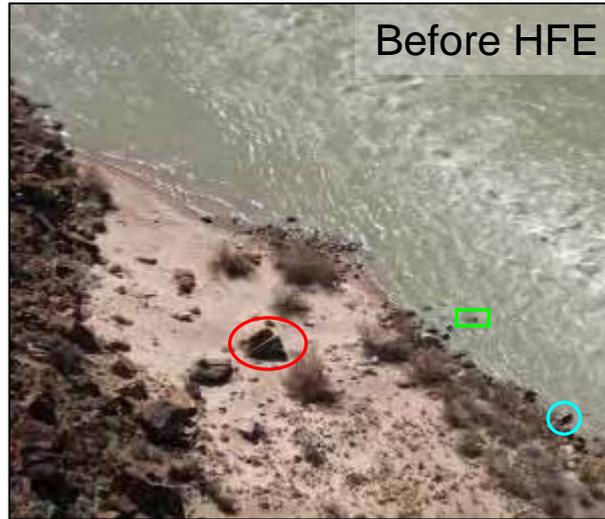
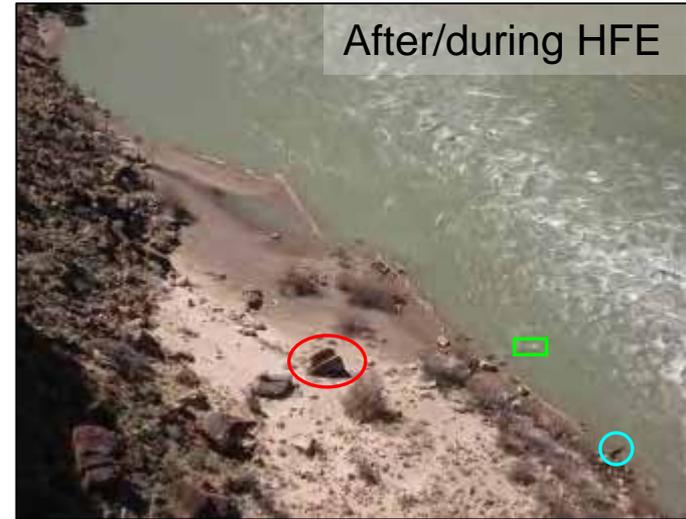
RM 8.15L: Detailed comparison of Jackass beach before, after HFE 2008 and 1956

July 1956

1400 - 1500 March 4, 2008
(~11,700 ft³/s)

1230 March 9, 2008
(~17,600 ft³/s)

Rocks on the beach are more exposed in 2008. Generally more sand (on both upper and lower bar) in 1956. No vegetation on the beach in 1956.

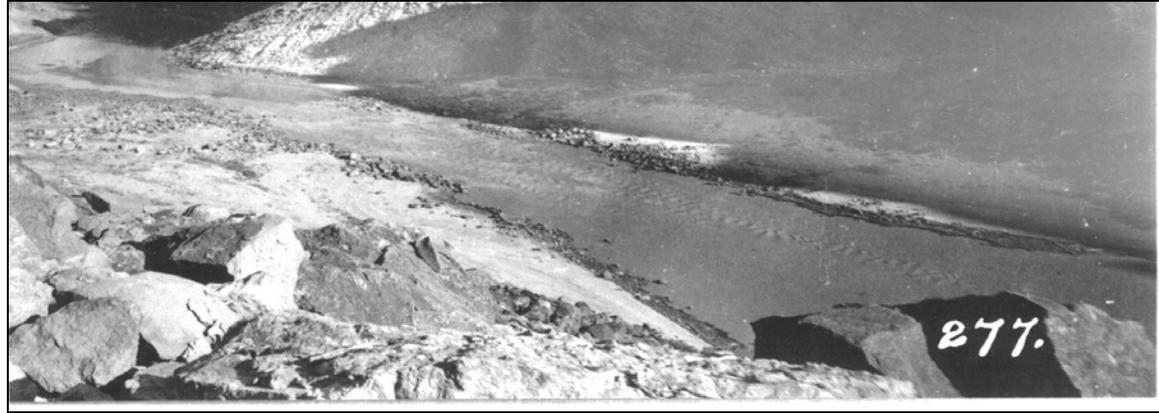
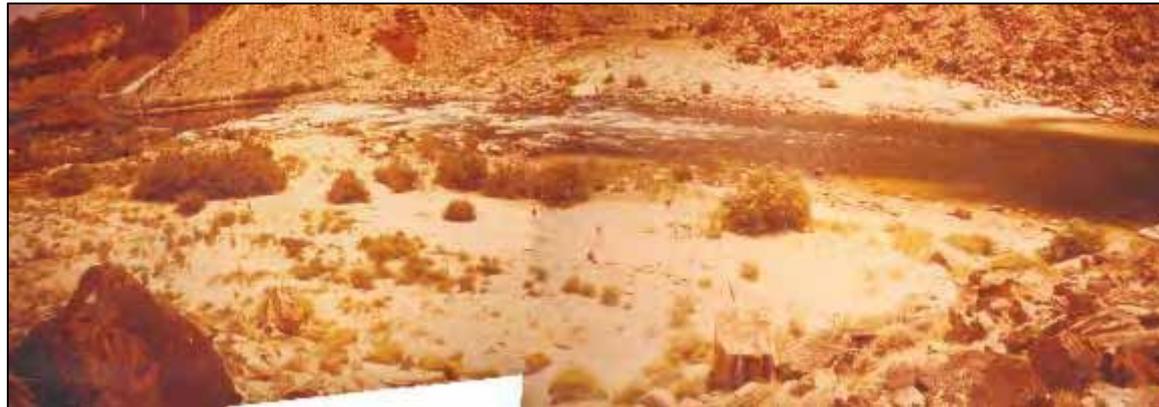
Badger Creek Rapid RM 8.10: 1890 – 1973 photo match

1890

1973 (~3,000 - 5,000 ft³/s)

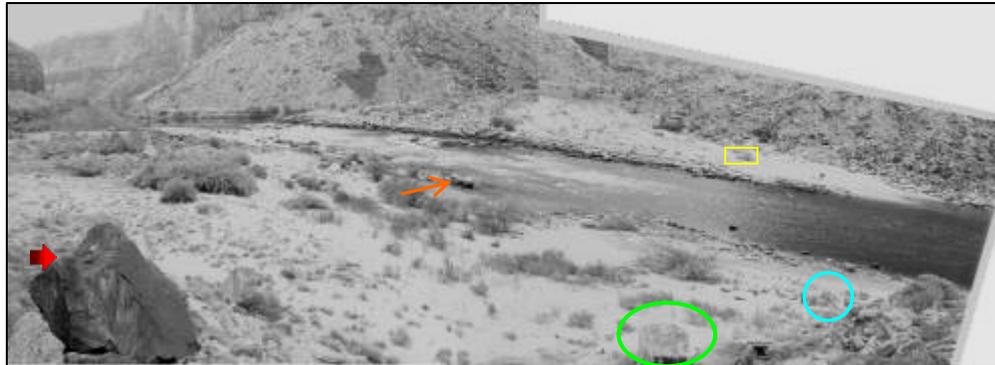
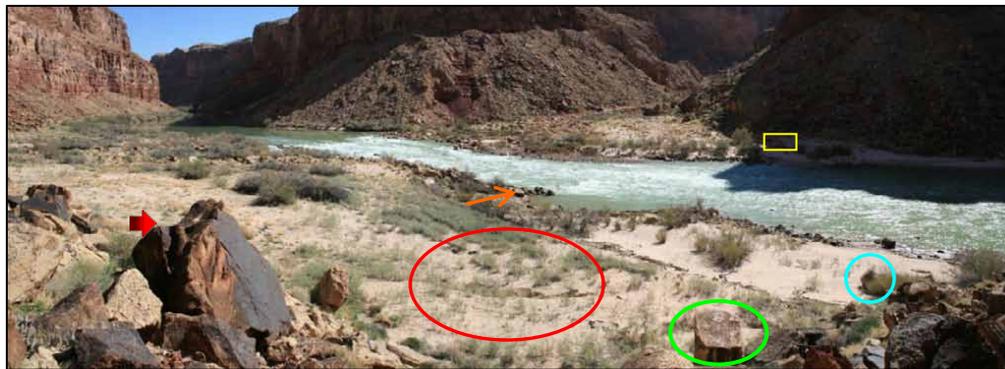
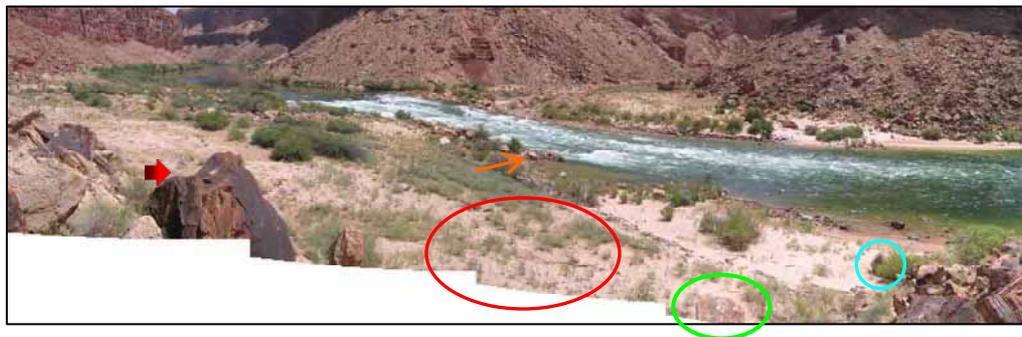
Badger Creek Rapid RM 8.10: 1985 – 2008 comparison

0830 October 6, 1985 (~3,000 ft³/s)

1020 March 29, 2008 (~9,100 ft³/s)

1145 May 10, 2008 (~10,300 ft³/s)

There appears to be increase in vegetation on 1983 and 1984/86 deposits. Higher sand of 1983 now partially deflated and has some new gullies in it. It seems there is less sand around 2008 water line. Small dune formed on the lower surface since 1985. Overall, it appears that the amount of sand is about the same on the lower surface. There is a starting gully formation in red ellipse on the higher surface.

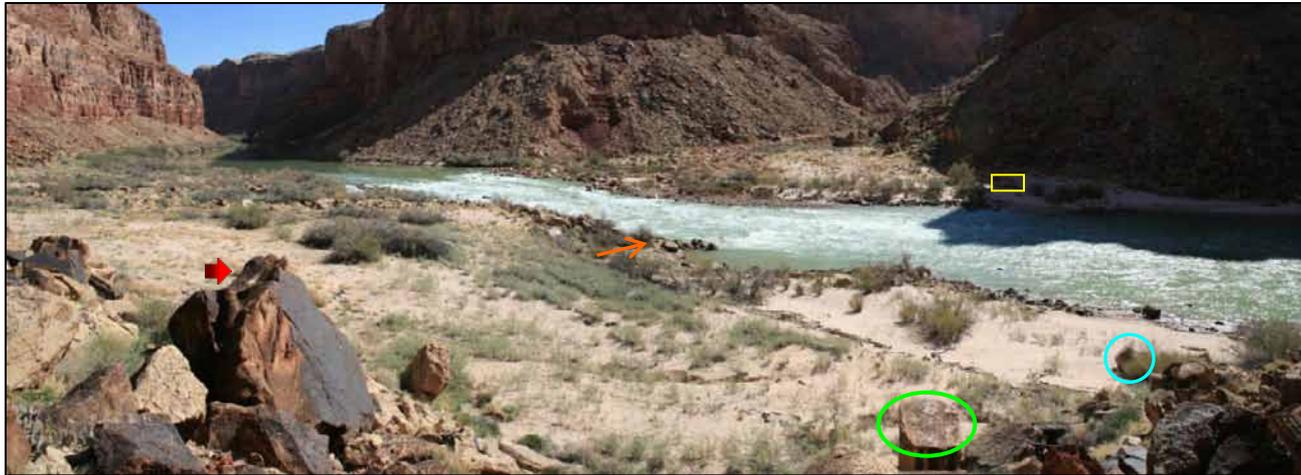
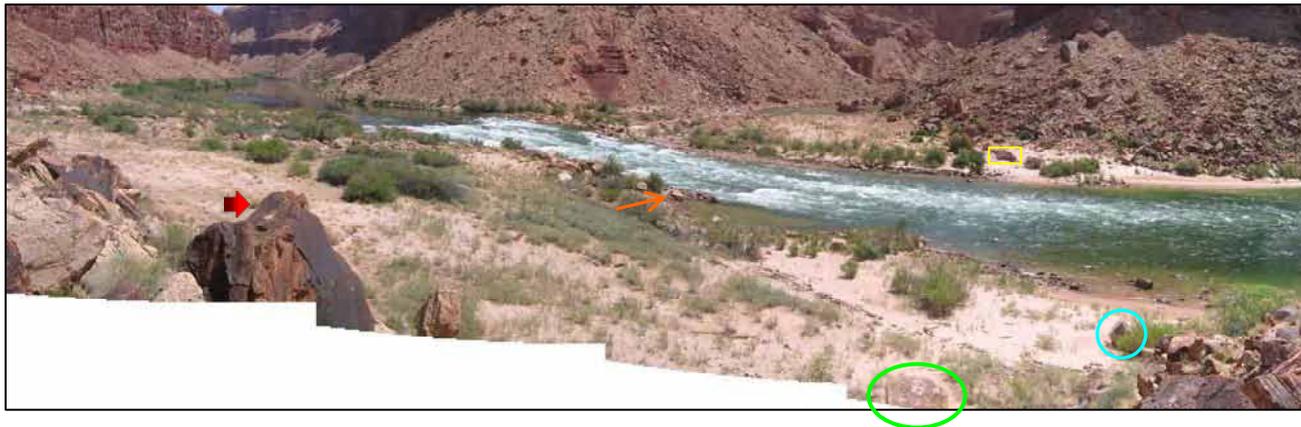
Badger Creek Rapid RM 8.10: March and May 2008 comparison

There appears to be less sand below 25,000 ft³/s line and above 50,000 ft³/s line in May. More sand accumulated around the drift wood line in May. Vegetation appears to be about same except little more sprouting vegetation right below drift wood line in May.

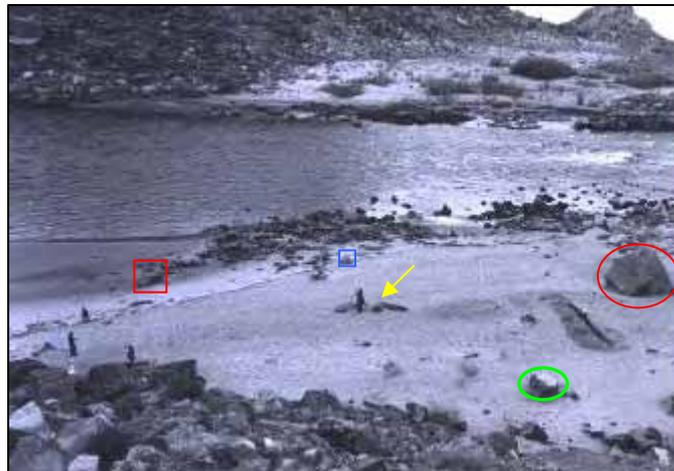
Jackass Canyon RM 8.15: 1985 – 1986 comparison

0945 January 12, 1986
(~2,100 ft³/s)

Rocks are more exposed on 1/1986 photo. Cluster of rocks upstream from red square not exposed in 10/1985. More obvious breaks in slope along waters edge and on beach in 1/1986. Generally there appears to be more sand in 10/1985 on the beach. Upstream beach has more changes in slope, large scours, and ravine formation.

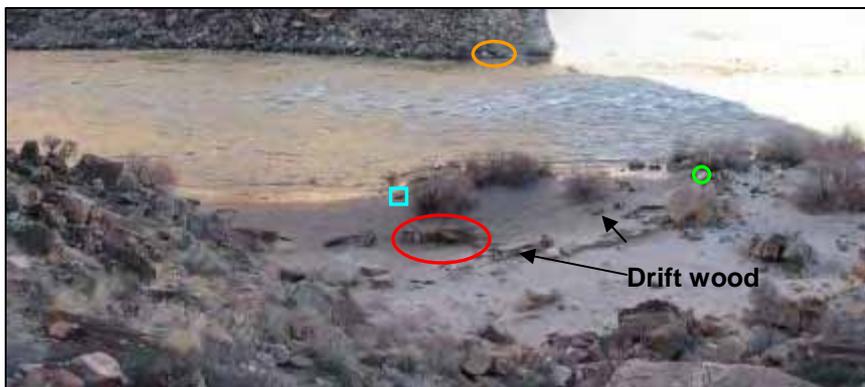
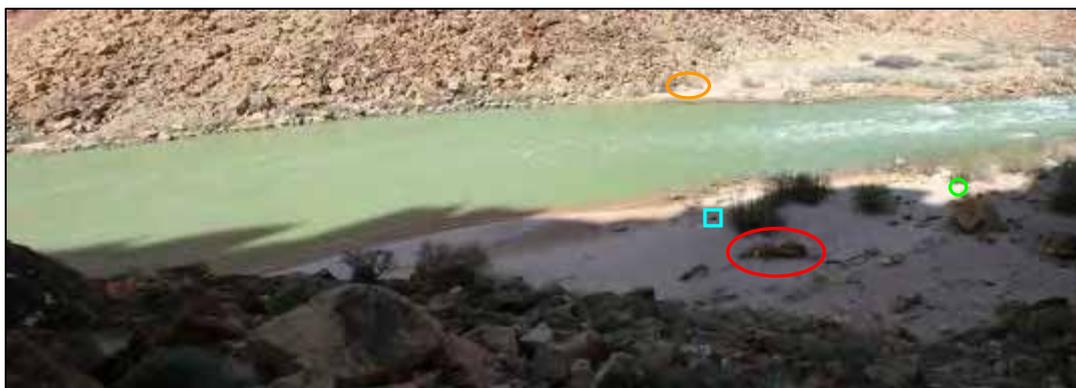
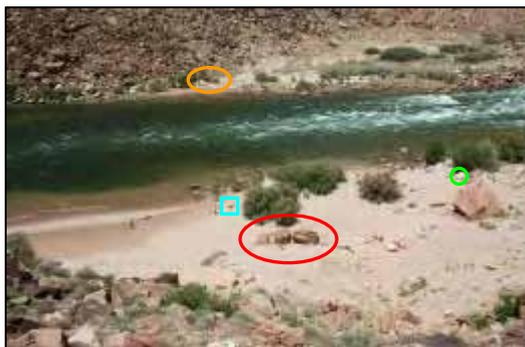
Jackass Canyon RM 8.15: March and May 2008 comparison

0930 March 8, 2008,
after HFE (~42,200 ft³/s)

1100 March 29, 2008
(~9,500 ft³/s)

1145 May 10, 2008
(~10,300 ft³/s)

There appears to be some burial of the drift wood present in March, probably by wind, at the edge of boulder line.

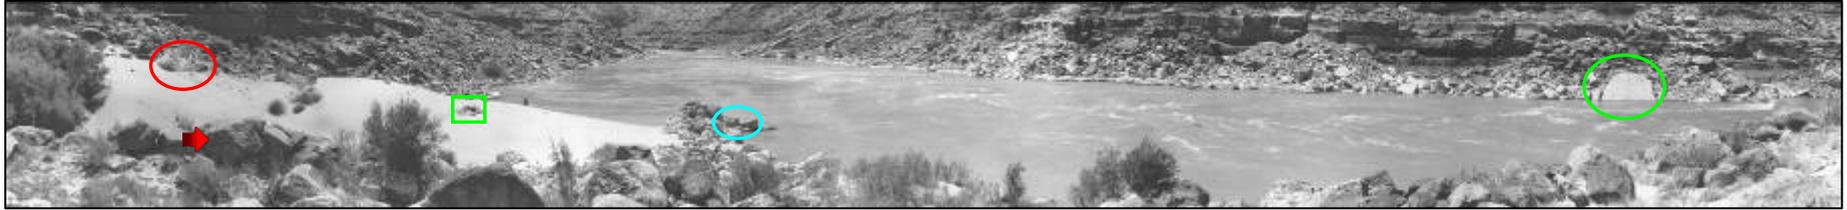
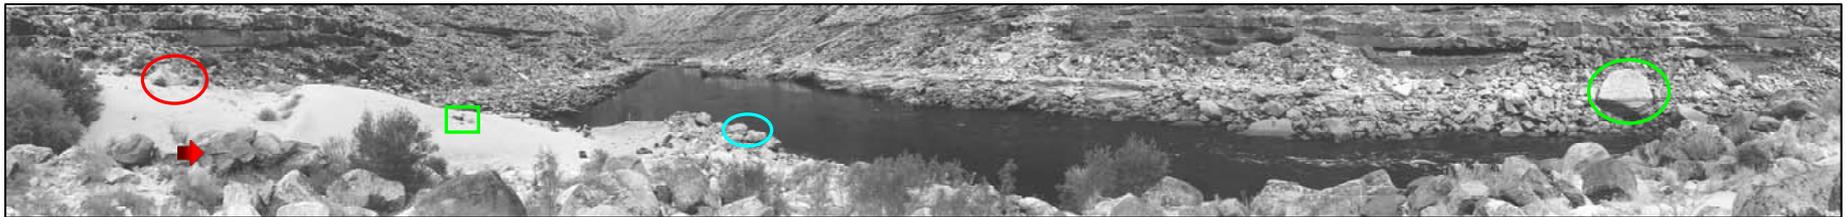
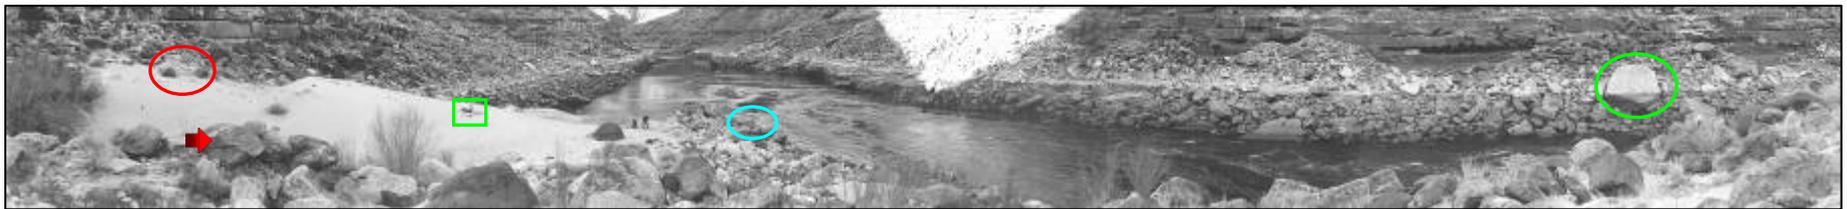
Below Salt Wash RM 12.4L: 1986-1986 comparison

1500 August 1, 1985 (~30,100 ft³/s)

0900 October 8, 1985 (~4,200 ft³/s)

0915 January 13, 1986 (~ 2,500 ft³/s)

January 1986 photo is showing sand removal from sand dune. Compare the reference middle rock (green rectangle), and size and shape of dune to both sides of the rock. Comparing to 2008, there is a margin sand bar on river right about 100 m downstream from eddy that did not exist in 1985 (p. 3).

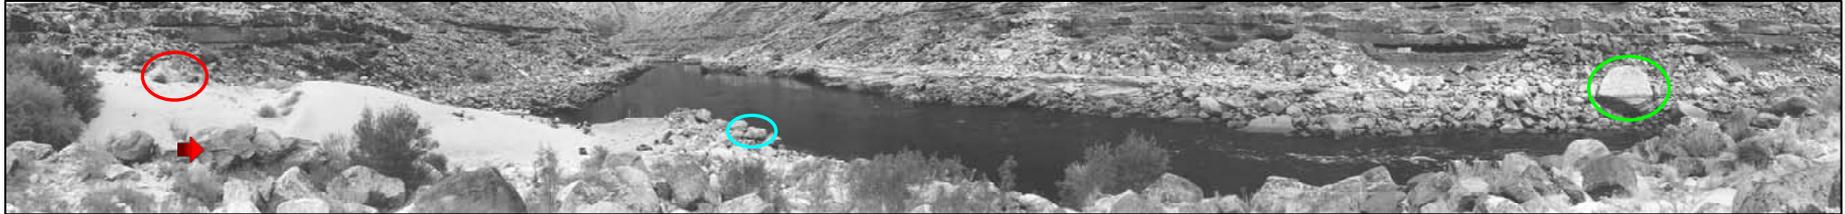
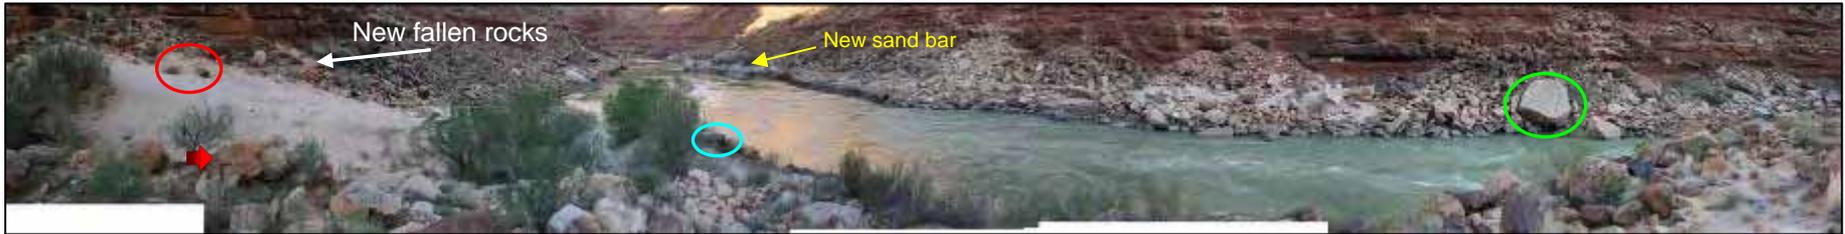
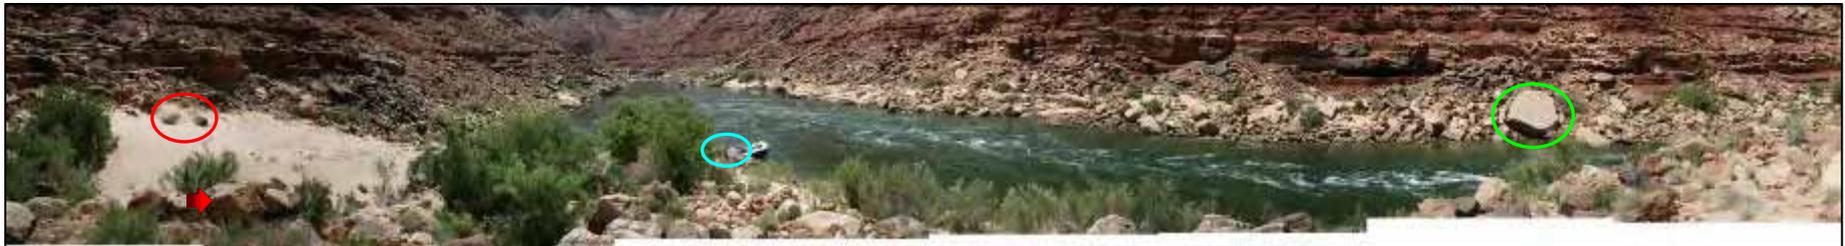
Below Salt Wash RM 12.40L: 1985-2008 comparison

0900 October 8, 1985 (~4,200 ft³/s)

0720 March 30, 2008 (~8,400 ft³/s)

1345 May 10, 2008 (~11,900 ft³/s)

Very little change in both upper surface sands and sand along the river margins for March and May 2008. Notable is the sidewalk of sand along both river margins. Comparing to 1985, there is a margin sand bar on river right about 100 m downstream from eddy that did not exist in 1985 (p. 2). Upper sand surface is extremely deflated along left wall.

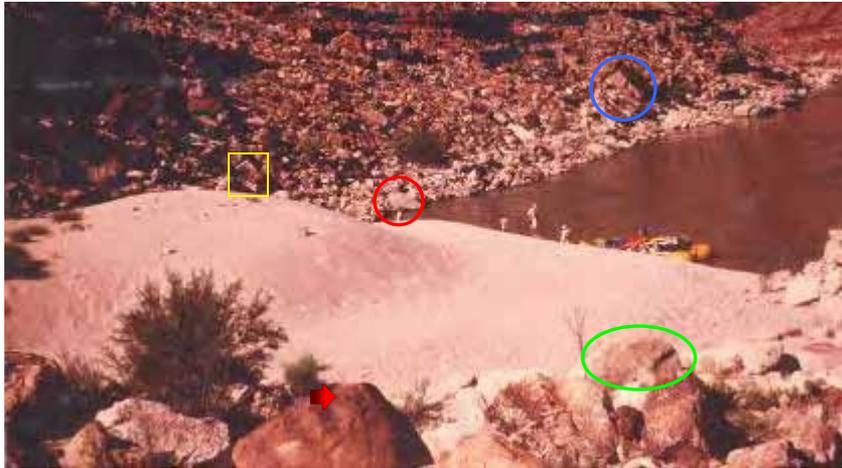
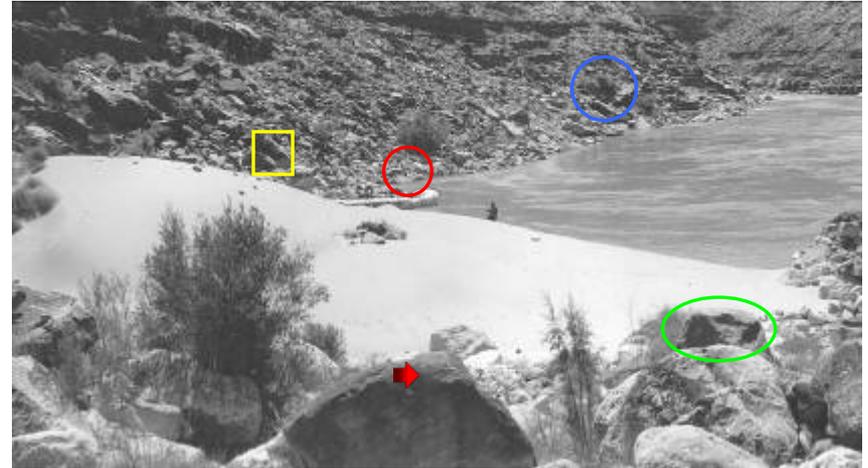
Below Salt Wash RM 12.40L: 1984-2008 comparison

August 10, 1984 (daily mean $\sim 24,200$ ft³/s)

1400 August 1, 1985 ($\sim 29,500$ ft³/s)

Upper sand surface is extremely deflated along left wall. There does not appear to be a sidewalk of sand in 1984-1985. Also for 2008, there is a margin sand bar on river right about 100 m downstream from eddy that did not exist in 1985.

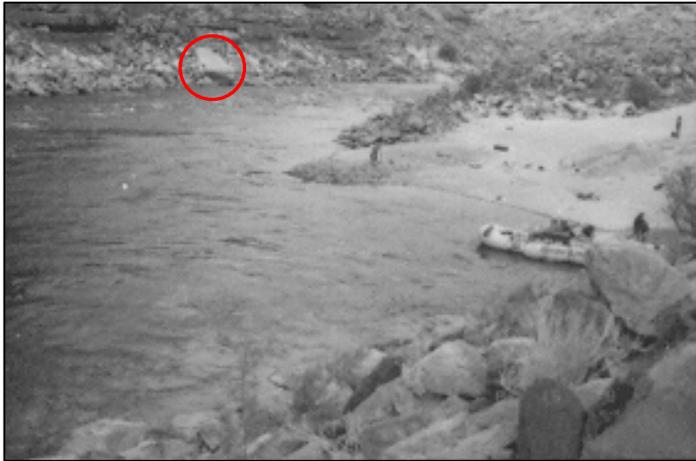
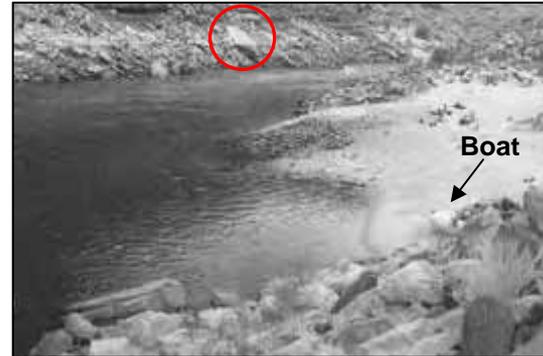
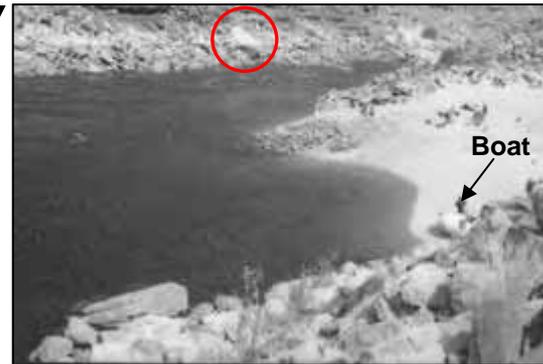
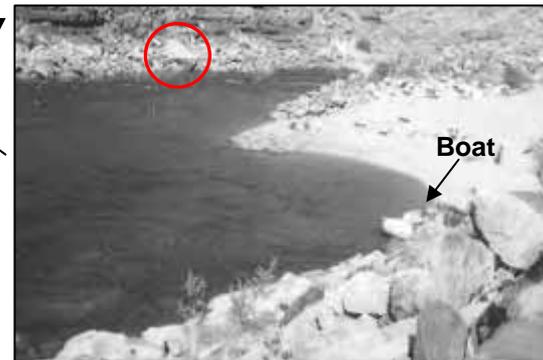
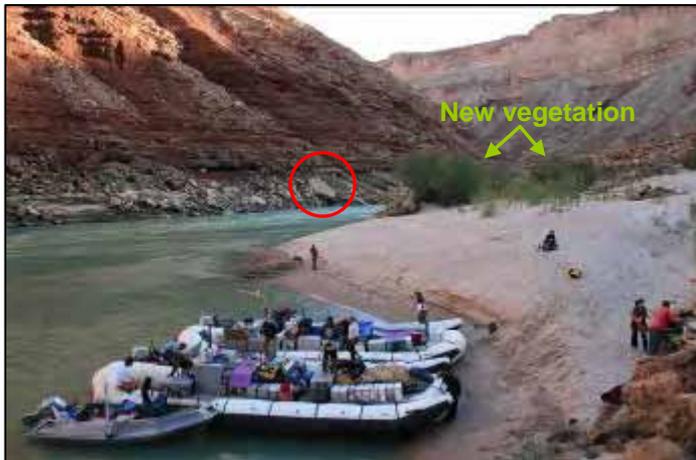
Below Salt Wash RM 12.40L: View from downstream 1985-2008 comparison

0900 October 8, 1985 (~4,200 ft³/s)

January 13, 1986
Photos showing
fluctuating flow
during the day
(~1000 – 2,100 ft³/s,
1200 – 4,000 ft³/s,
1400 – 13,200 ft³/s,
1600 – 17,700 ft³/s,
1800 – 18,700 ft³/s)

0730 March 30, 2008 (~7,700 ft³/s)

**** New vegetation in 2008 is obstructing the view of the lower portion of the sand bar when looking downstream. From upstream view photo, (p.5) there appears to be more sand below 25,000 ft³/s.

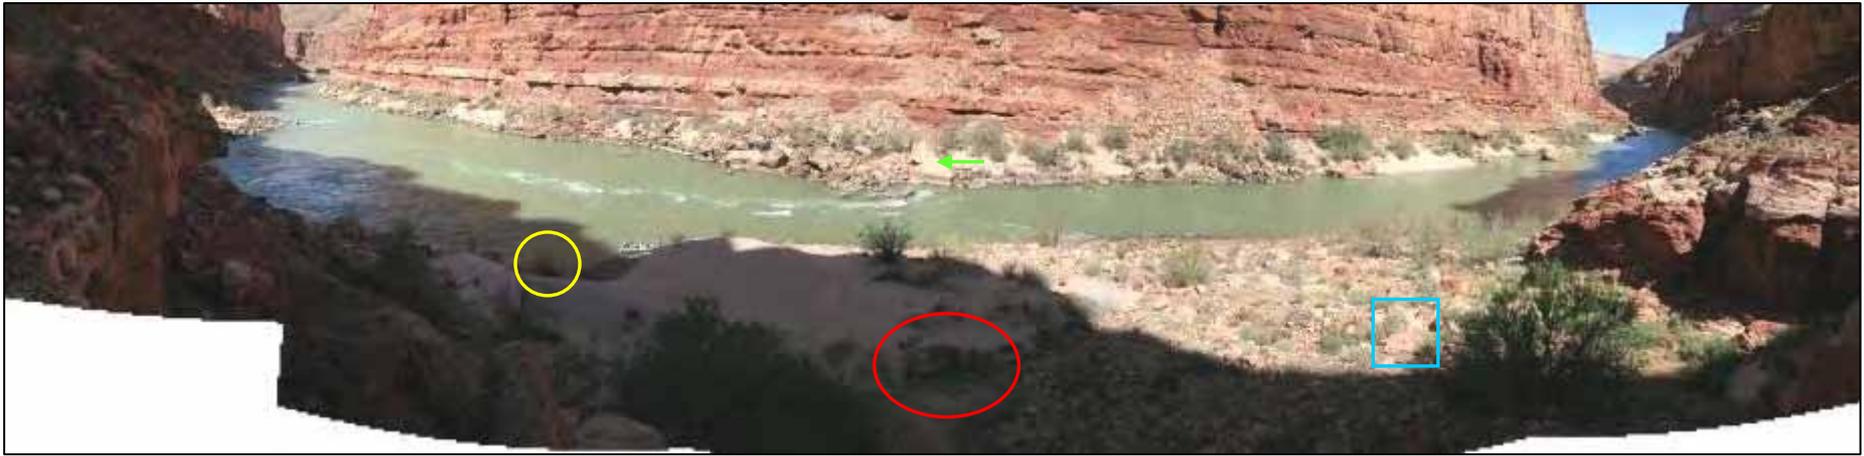
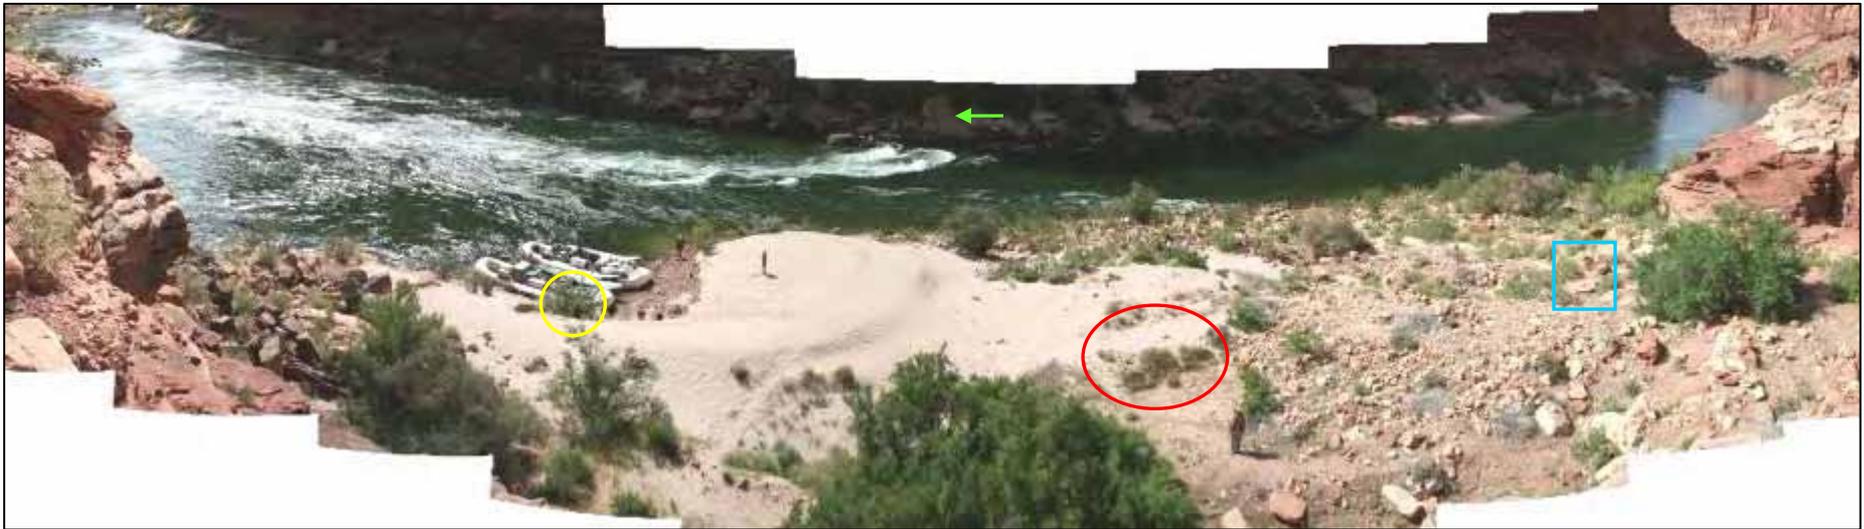
18 Mile Wash RM 18.35L : March and May 2008 (after HFE) comparison

There appears to be more sand on the sand bar in March. Bar leveled by May probably by wind and sand got distributed
Sat upstream on 1/3 of the sand bar.

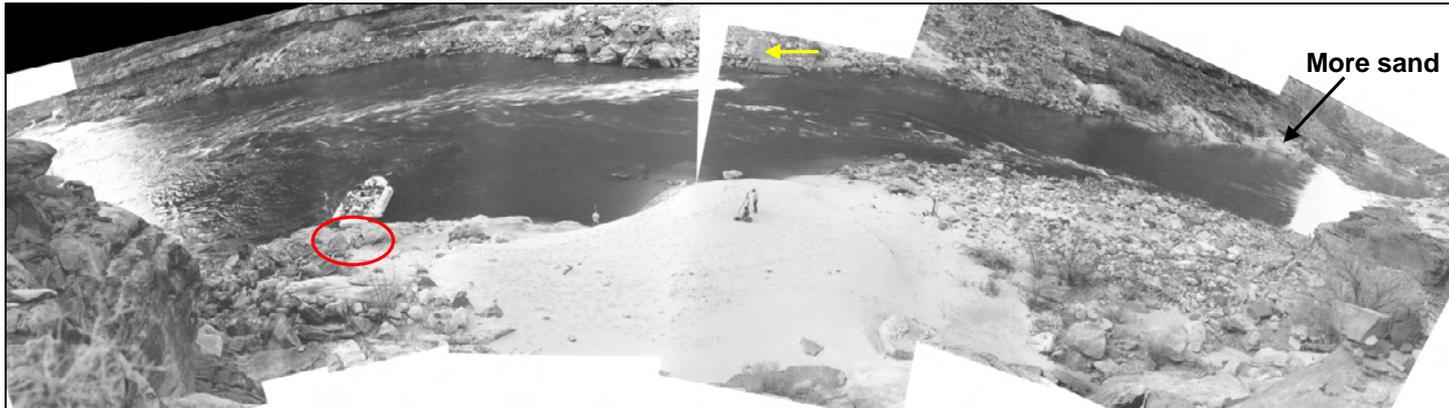
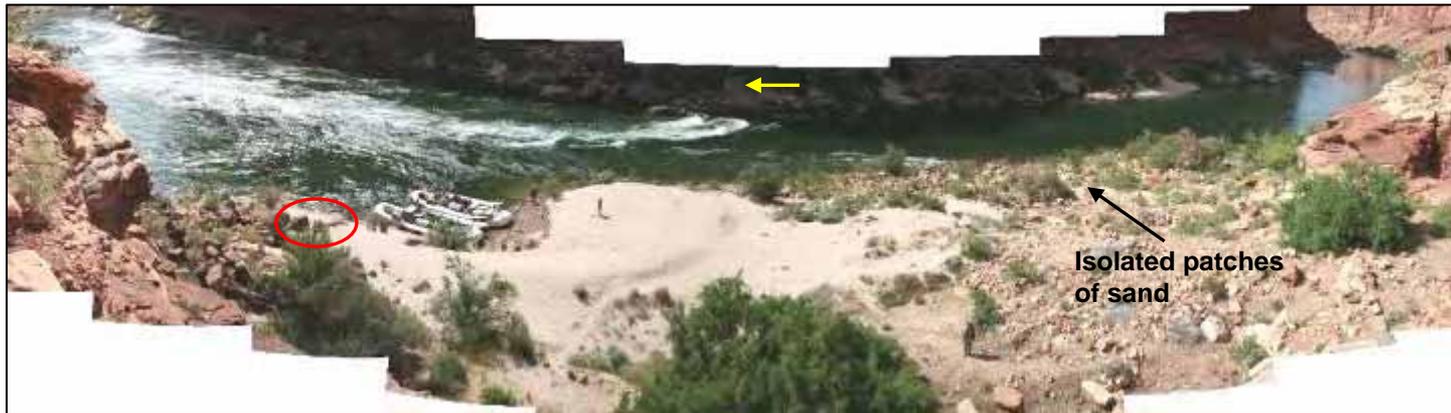
18 Mile Wash RM 18.35L : 1986-2008 comparison

Rocks are more exposed at the upstream end of the site in year 1986. More vegetation in this part in 2008. The sand bar seems to be bigger in 1986. There is more sand in between 25,000 and 50,000 ft³/s - compare two boulders in the red ellipse.

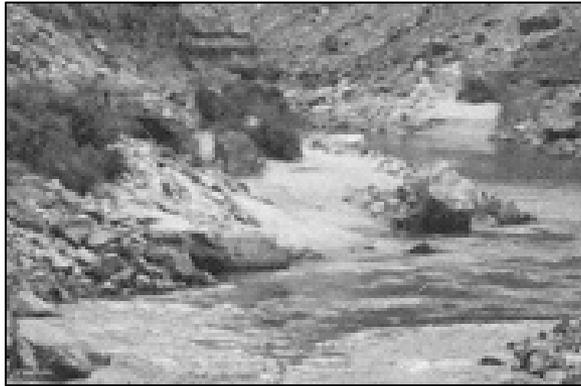
Margin bar upstream from 18 Mile Wash, RR
Photo taken from downstream (18.5L beach)

0930 October 9, 1985 (~4,200 ft³/s)

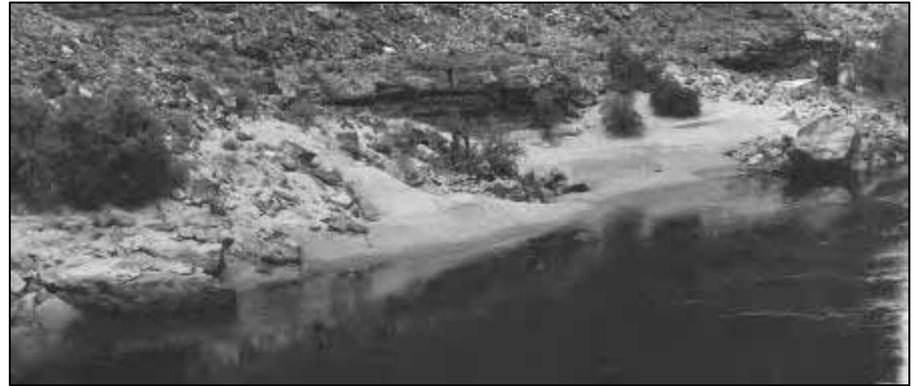
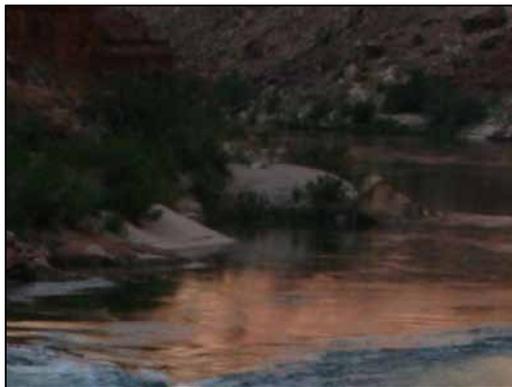
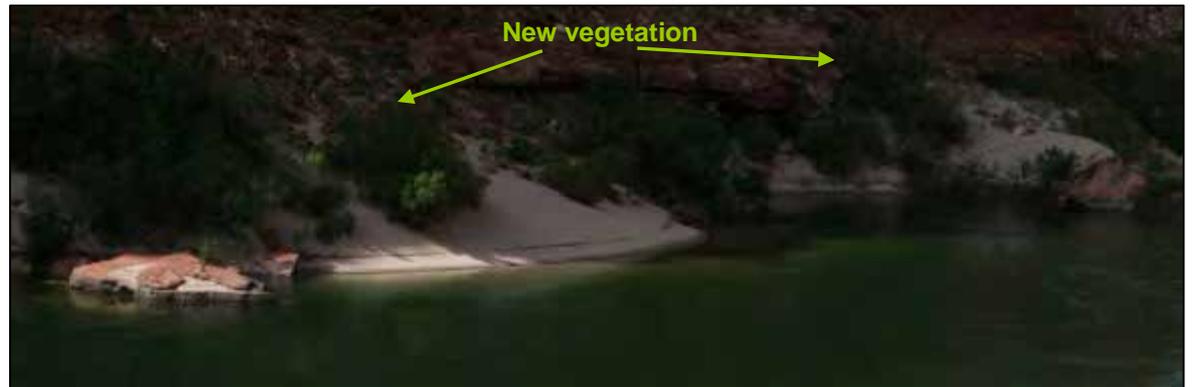
Margin bar upstream from 18 Mile Wash, RR
Photo taken from 18 Mile Wash Beach

0920 May 10, 2008 (~9,600 ft³/s)

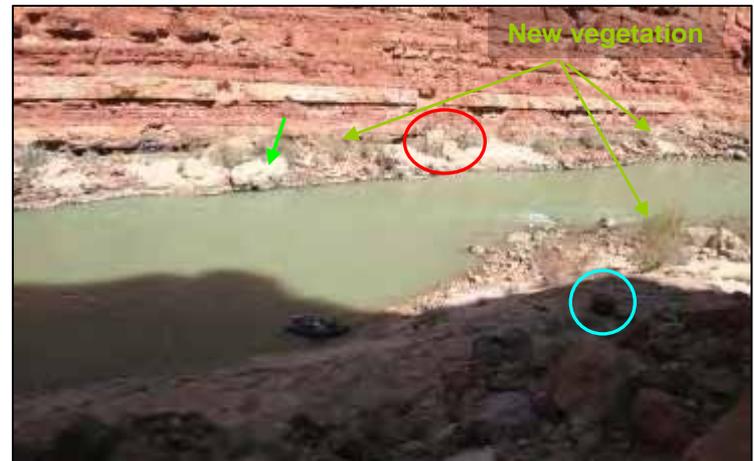
1030 March 30, 2008 (~7,600 ft³/s)

There appears to be more sand on river right, as well as new vegetation in 2008. When comparing 1985 and 2008 upper sand bar seems to have more sand, lower sand bar has more exposed rocks – less sand in 2008; although, part of it is under water. New vegetation on river left as well.

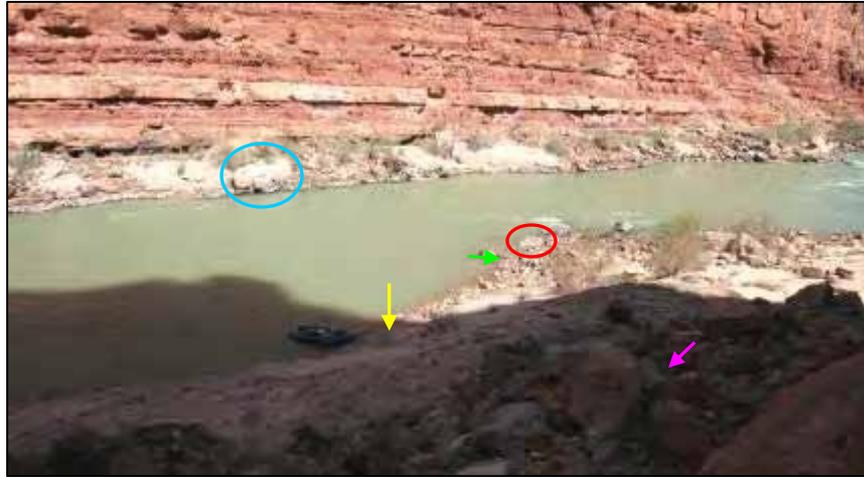
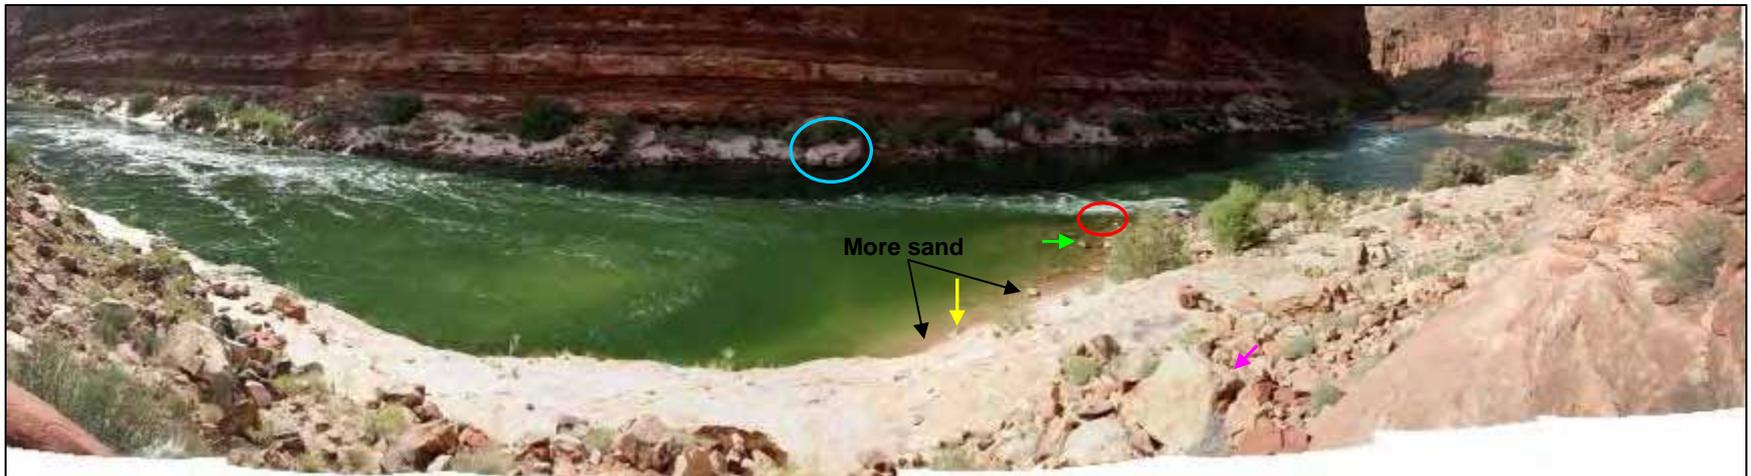
Below 18 Mile Wash RM 18.5L: Changes caused by 2008 HFE

There appears to be more sand on river left in May; although, can't see the upstream end of the site with the rocks because of the vegetation.
Amount of sand on river right (between river and wall) appears to be smaller in May; probably result of cut bank and wind erosion.
