Sandbars in historical context: Comparison of images following the March 2008 high flow with images from the 1980s and earlier.

March 3, 2009

USGS cooperators Jack Schmidt and Milada Majerova of Utah State University are currently compiling historical photographs of selected study sites and comparing those images with photos taken during and following the 2008 high-flow experiment. These photographs will help scientists, managers, and stakeholders evaluate the present condition of sandbars and vegetation relative to the condition prior to the onset of regular monitoring, which began in the early 1990s.

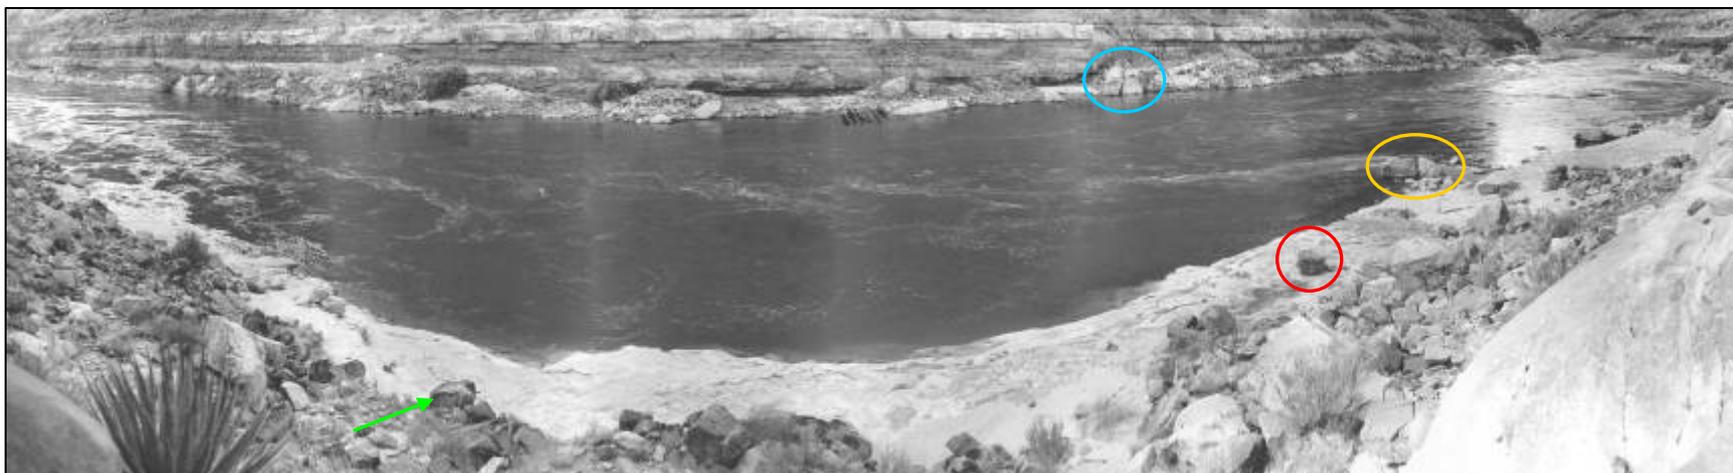
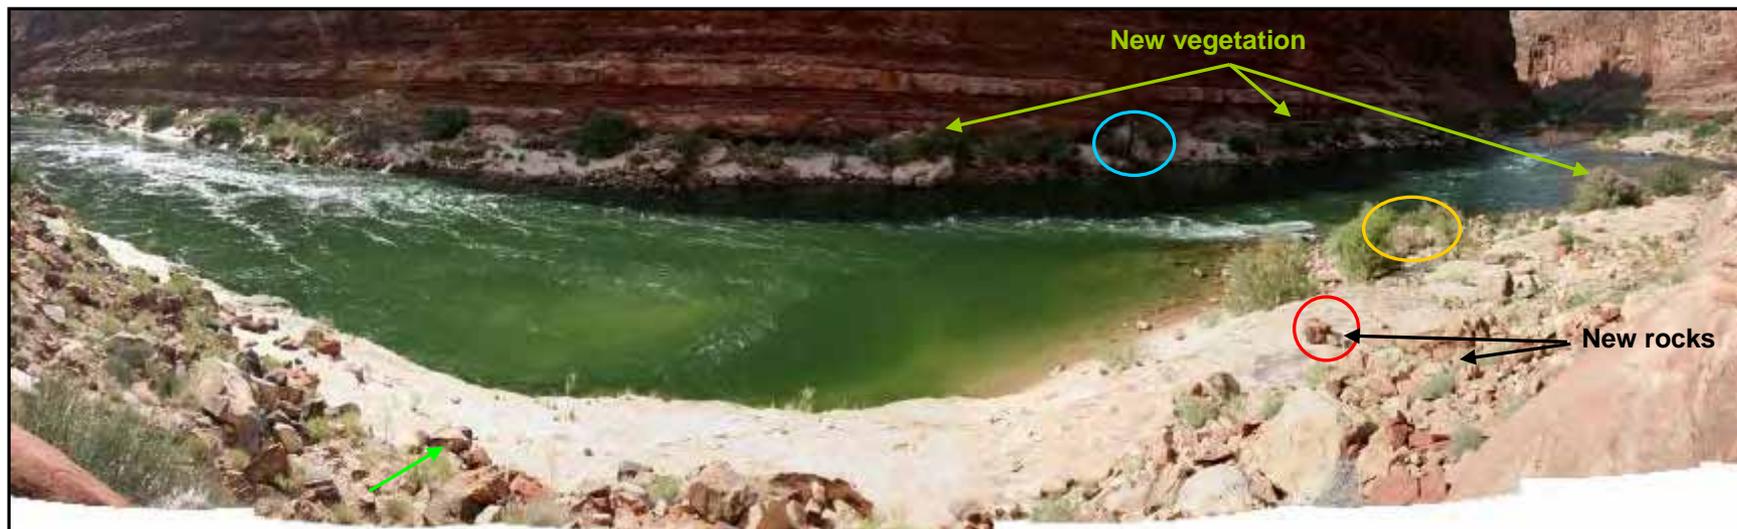
Below 18 Mile Wash RM 18.5L: 1985-2008 comparison

1630 August 2, 1985 (~29,100 ft³/s)

1550 May 10, 2008 (~10,100 ft³/s)

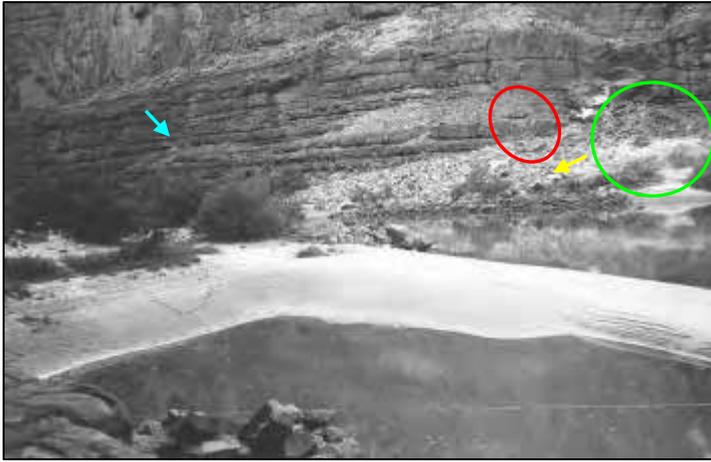
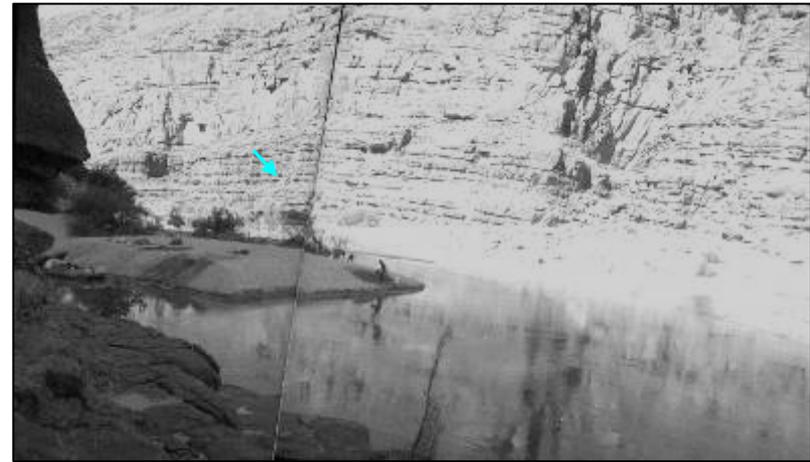
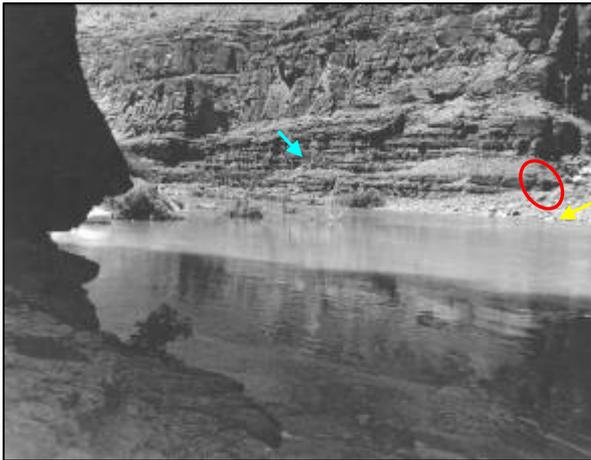
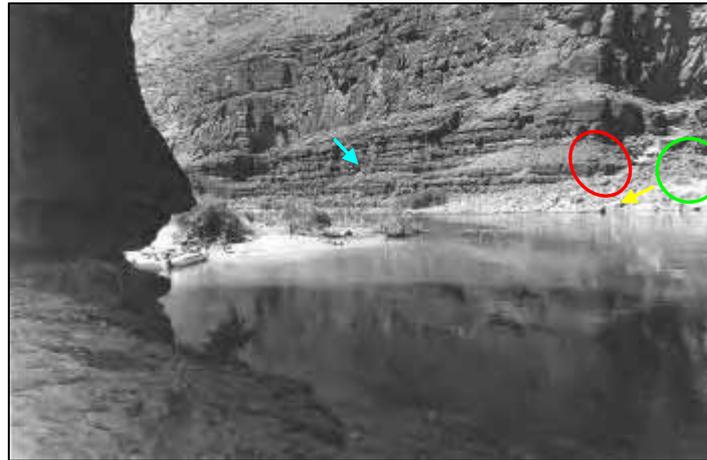
19 Mile Wash RM 19.41L: 1976-1984/1985 comparison

Sand bar on river left more exposed due to the low water level in 1976. There is more vegetation in the green circle area in 1976. There appears to be more sand in that same area (above the vegetation line) in 1985. Less sand at inside bend of left sand bar in 1984 than 1976. Vegetation seems reduced (can see the dead branches) in 1984 and 1985.

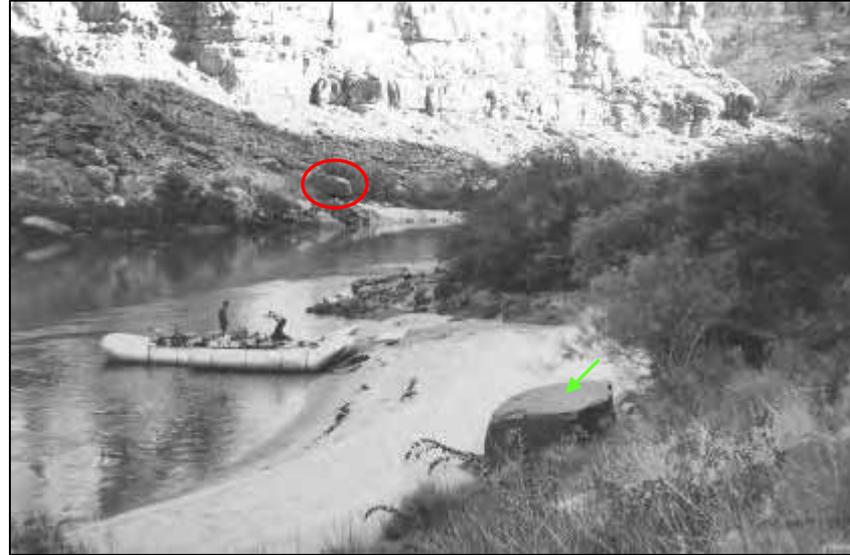
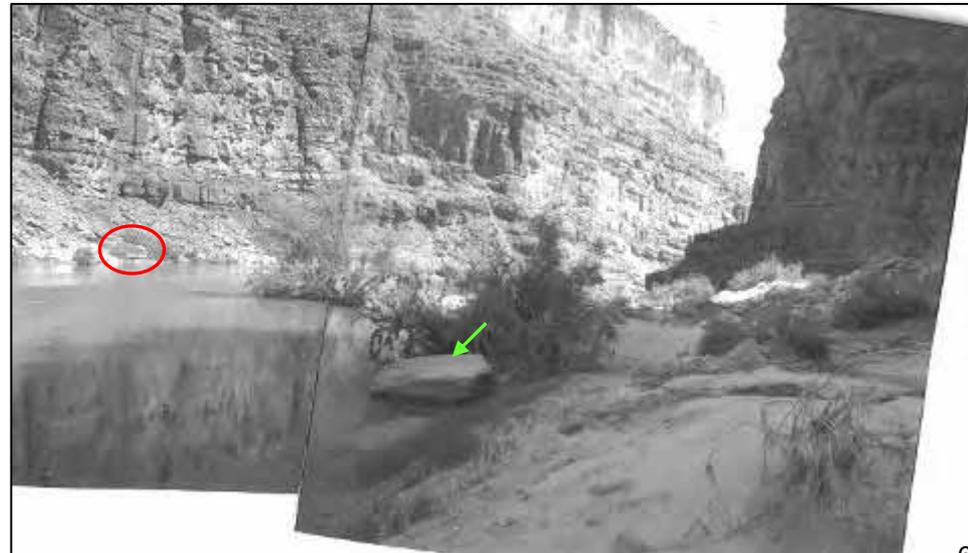
19 Mile Wash RM 19.41L: View from downstream end 1976-1984 comparison

Vegetation reduced by 1984. Beach doesn't exist in the 1984 water level. Debris fan that separates upper and lower beach very low. There appears to be erosion of the beach due to lack of eddy at high flow.

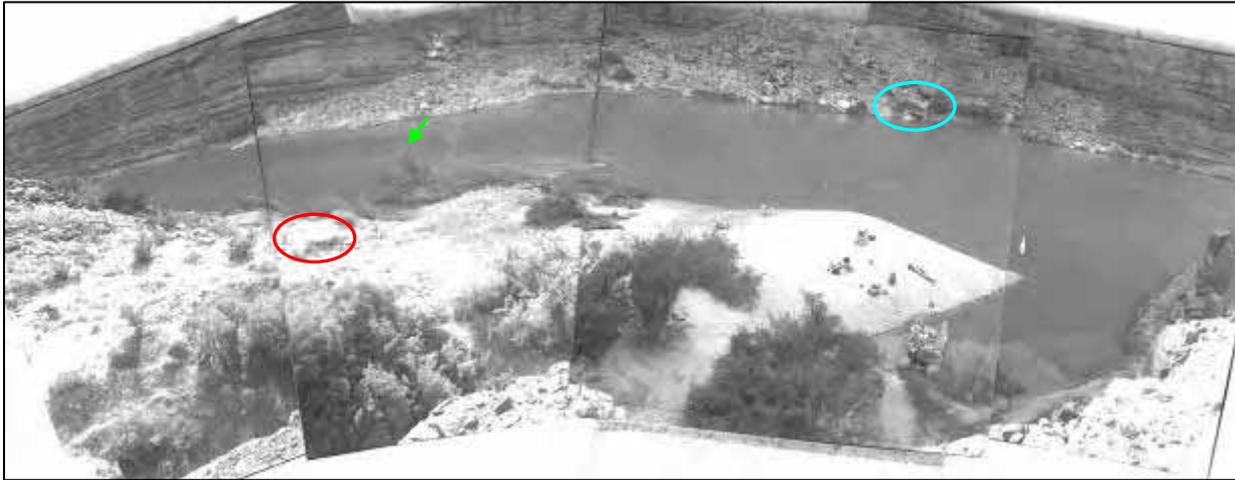
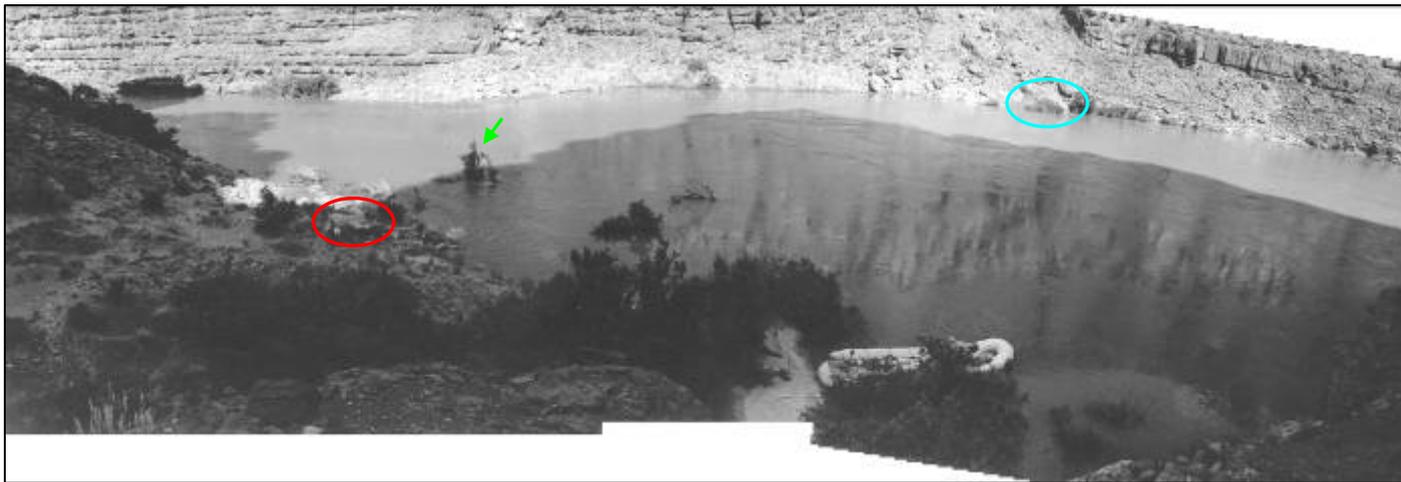
19 Mile Wash RM 19.41L: 1984-1985 comparison

August 11, 1984
(~24,300 ft³/s)

0945 May 23, 1985
(~41,800 ft³/s)

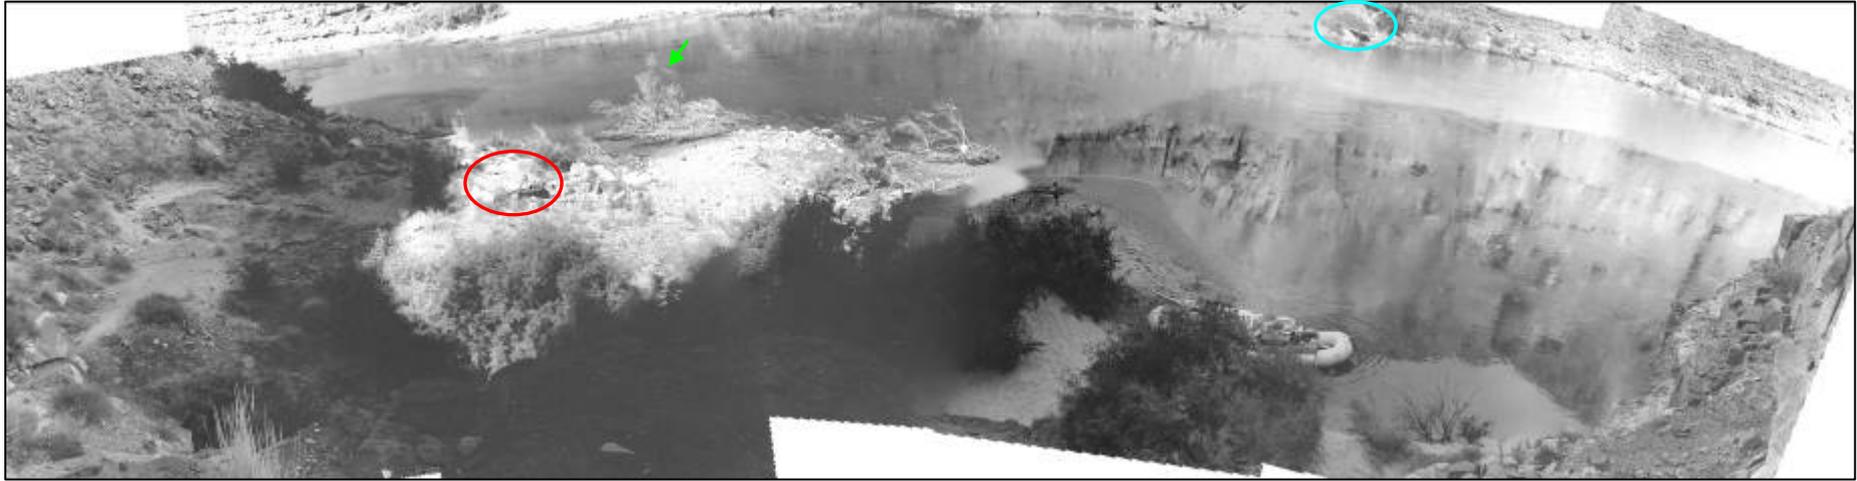
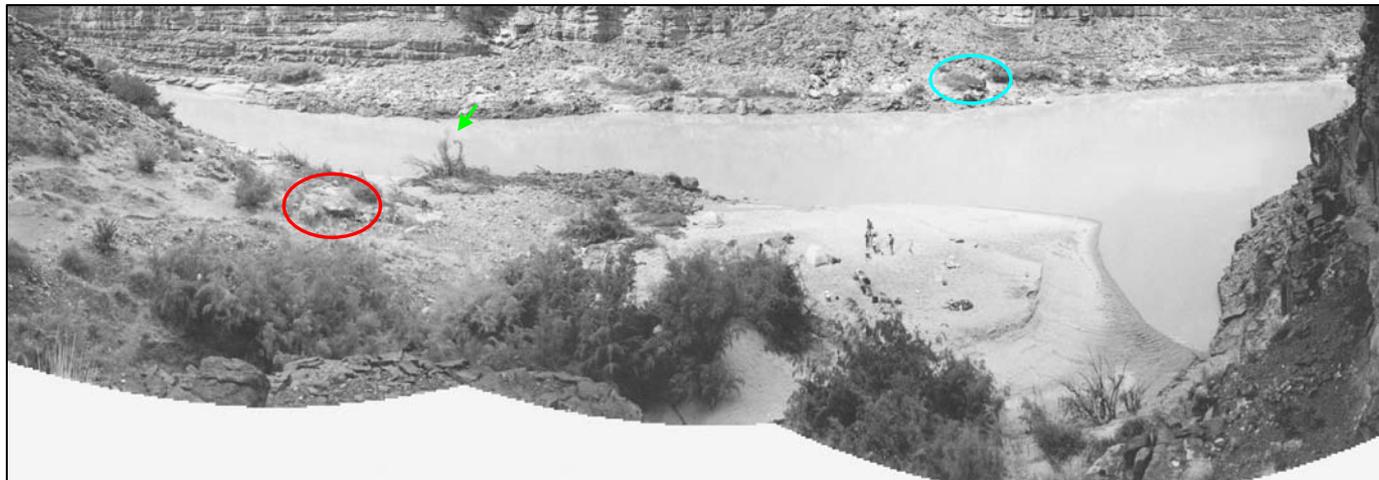
19 Mile Wash RM 19.41L: August and October 1985 comparison

0930 August 3, 1985 (~23,800 ft³/s)

1115 October 10, 1985 (~4,100 ft³/s)

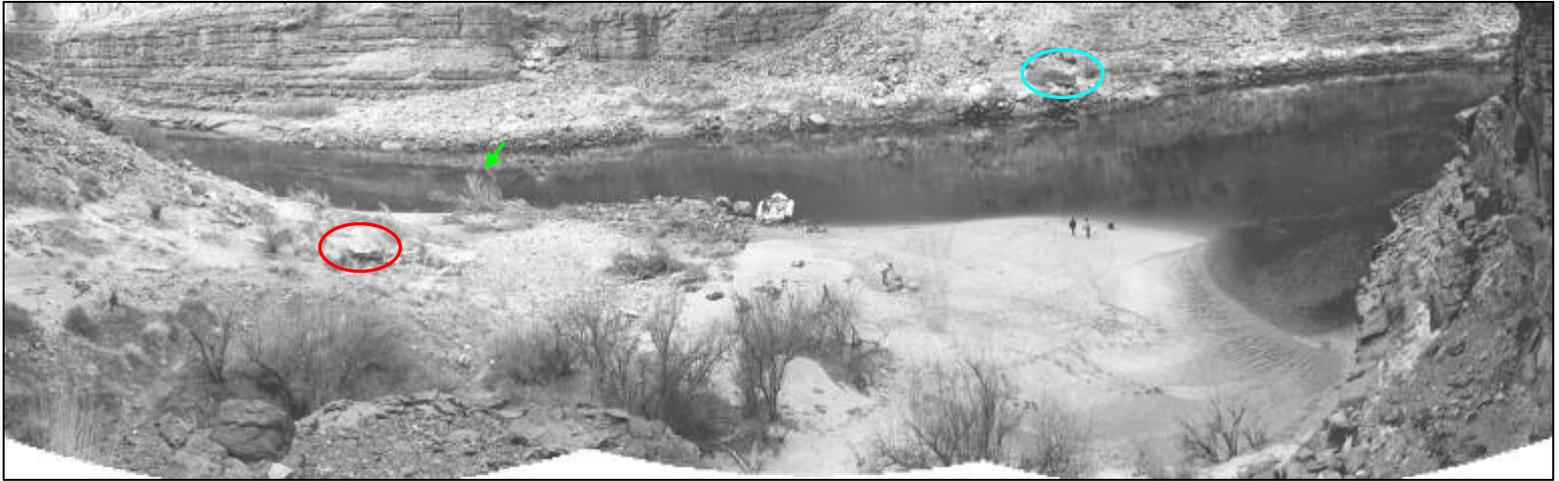
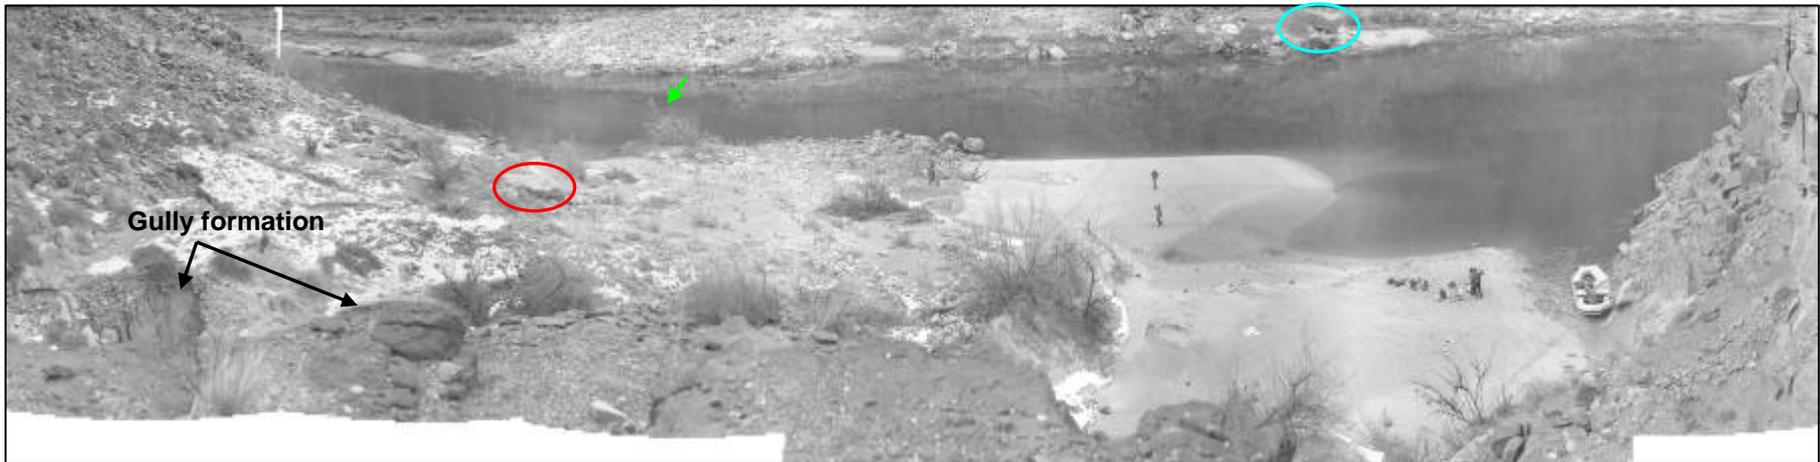
19 Mile Wash RM 19.41L: 1986-1989 comparison

0930 January 14, 1986 (~5,900 ft³/s)

1530 January 15, 1989 (~7,500 ft³/s)

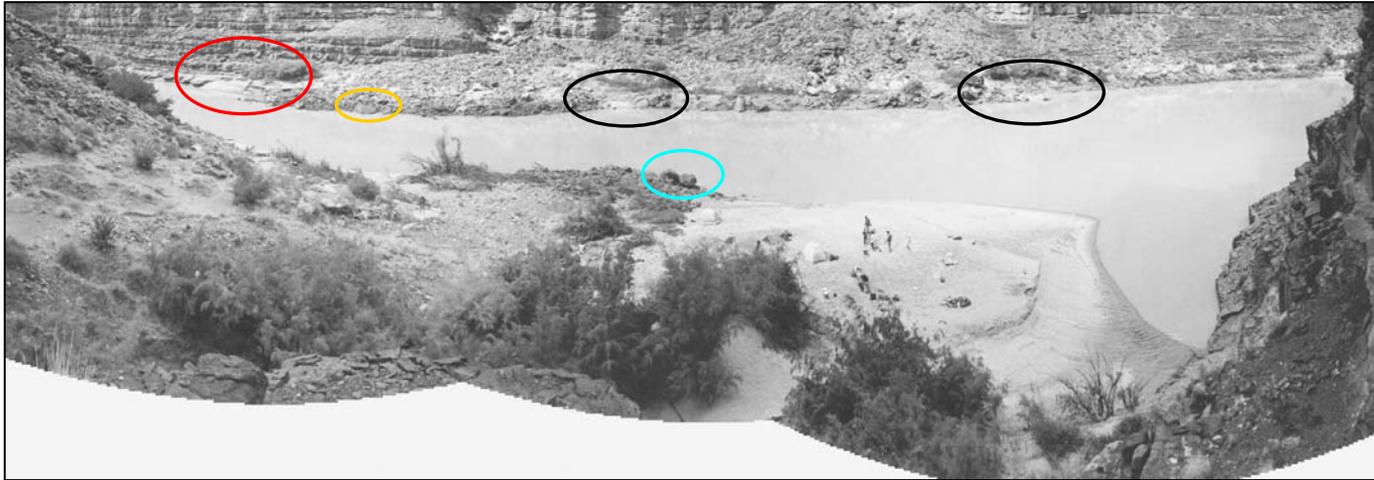
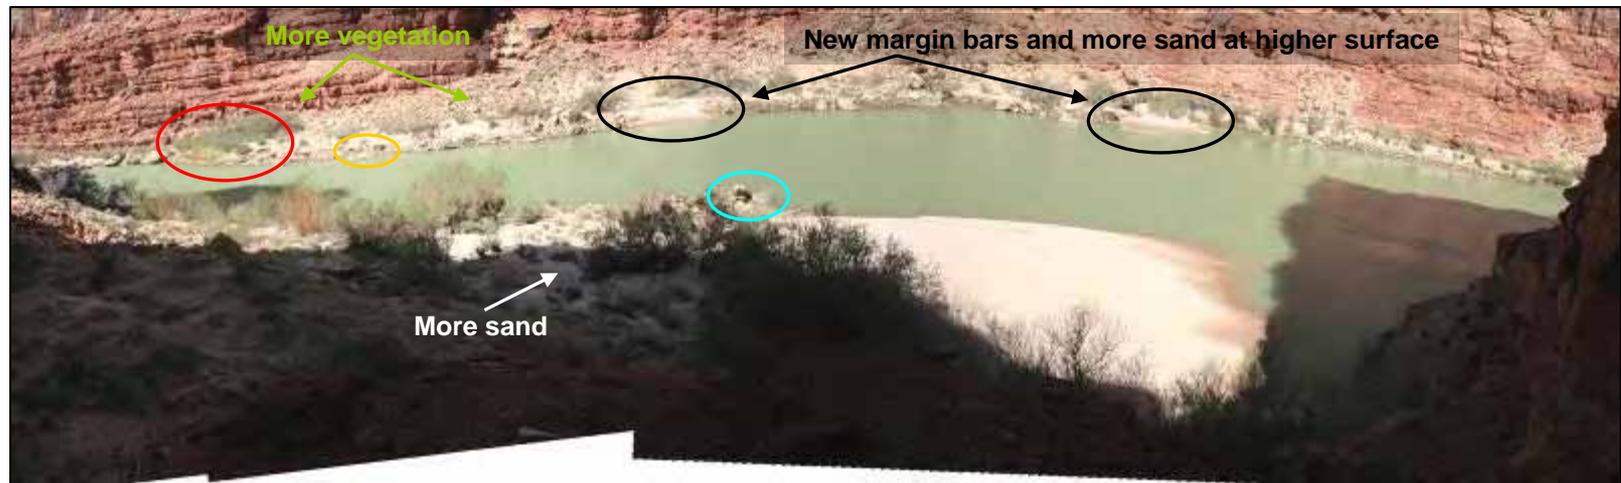
19 Mile Wash RM 19.41L: 1985-2008 comparison

The sand bar on river left has some new vegetation and there appears to be more upper surface sand (between 25,000 and 40,000 ft³/s). There are new margin bars on river right (black ellipses) in 2008. The most upstream one existed in 1973 and 1976 (see the sketch – page 3). Bar that is downstream from them (red ellipse) got more vegetated over time. There is noticeable sidewalk of sand on river right with some new vegetation in 2008.

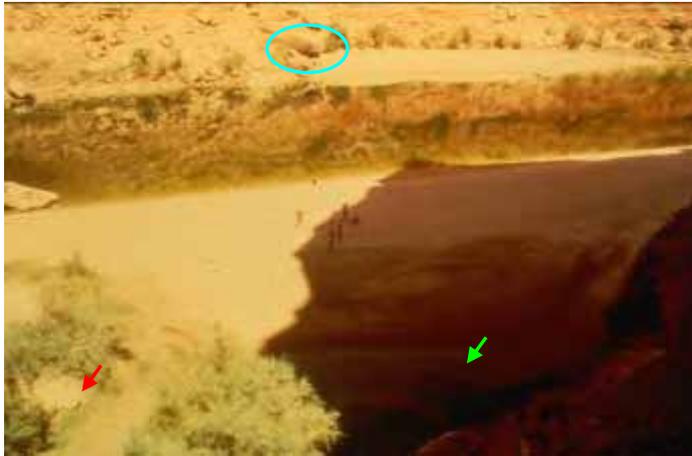
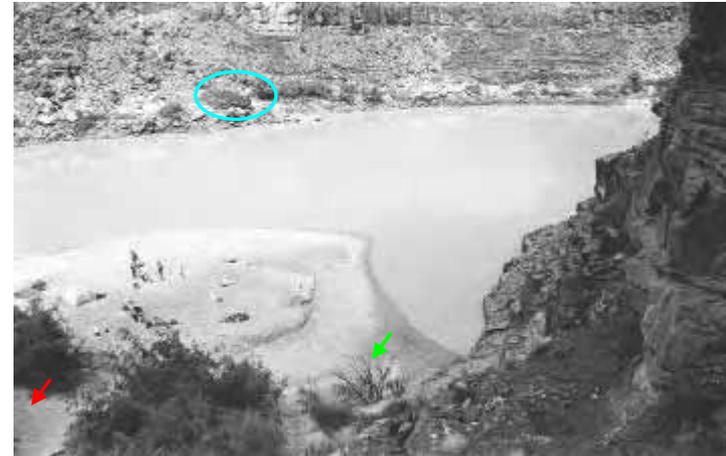
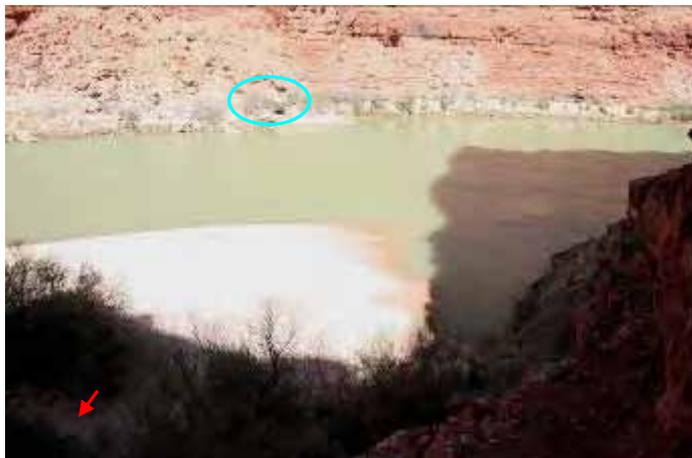
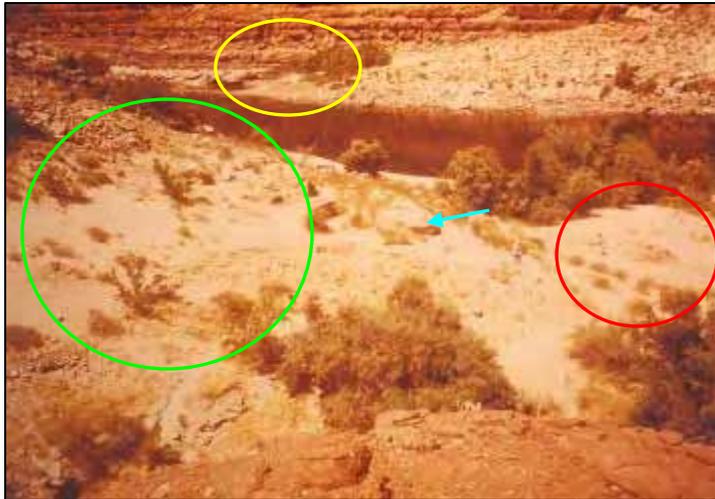
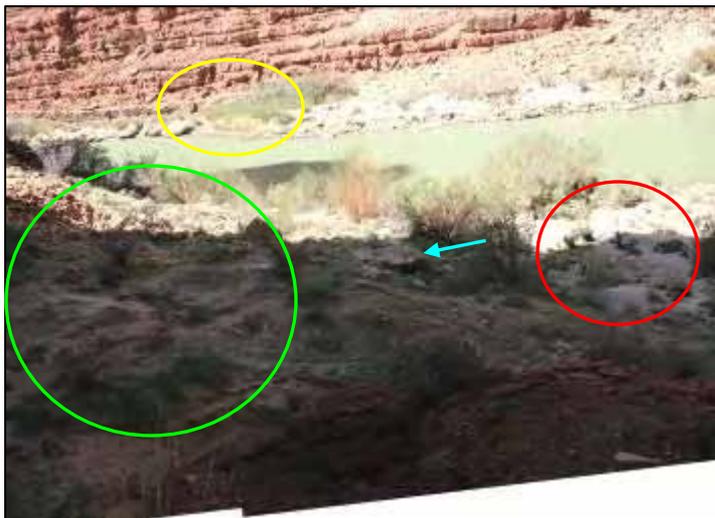
19 Mile Wash RM 19.41L: 1973-1985-2008 comparison

There appears to be more sand in the area of green circle in 1973 comparing to 1985 and 2008. The sand bar area between 25,000 and 45,000 ft³/s (red circle) has more sand in 1973 than 1985. 2008 photo shows small sand dunes formed in the same area. Sidewalk of sand along the river right (around 43,000 ft³/s) is visible in 2008. Small margin bar on river right seems smallest in 1973, showing more vegetation growth in 2008 (yellow ellipse).

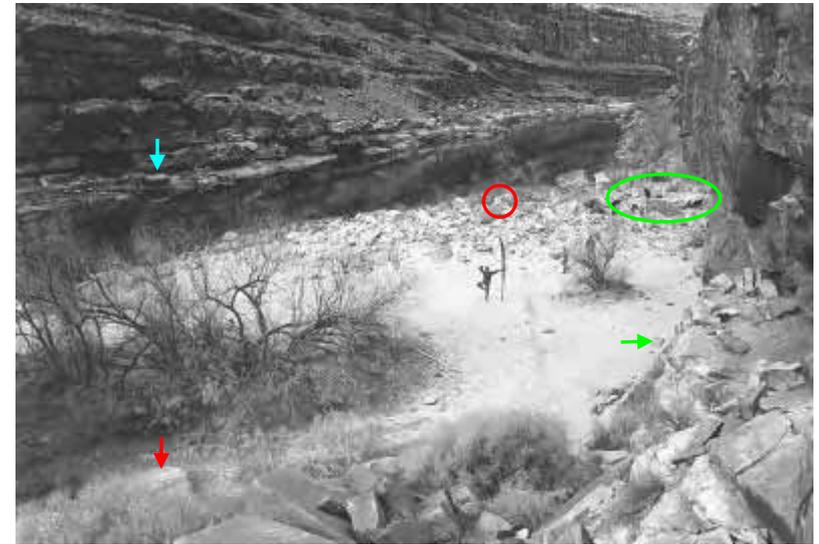
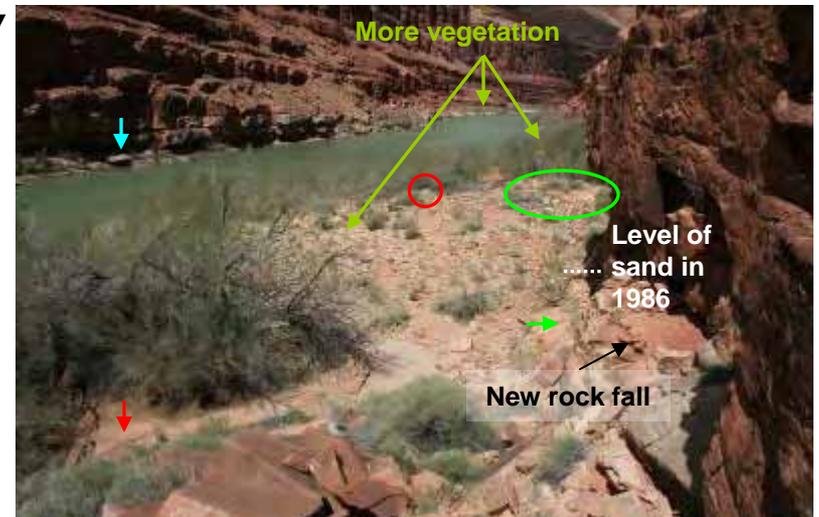
20 Mile Camp RM 20.20L: 1973, 1986 and 2008 comparison

There appears to be more sand in 1973 on bar itself and on margin bars as well. There is more vegetation in 1973, especially by waters edge. New vegetation growth since 1986 in 2008 photo. Much less sand on the sand bar itself; although, boulders seem more buried in the finer material at the upstream end of the bar (see green ellipse) in 2008. Margin bars seem to have more sand on the upper surfaces in 1986. There is some new rock fall on the rock ledge in 2008.

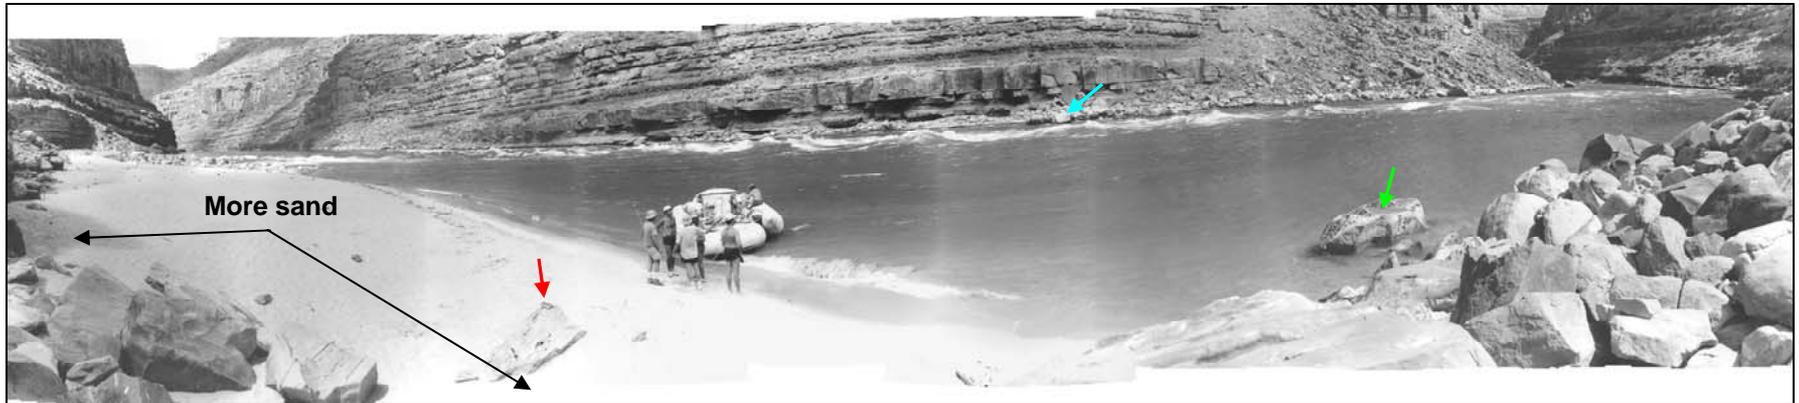
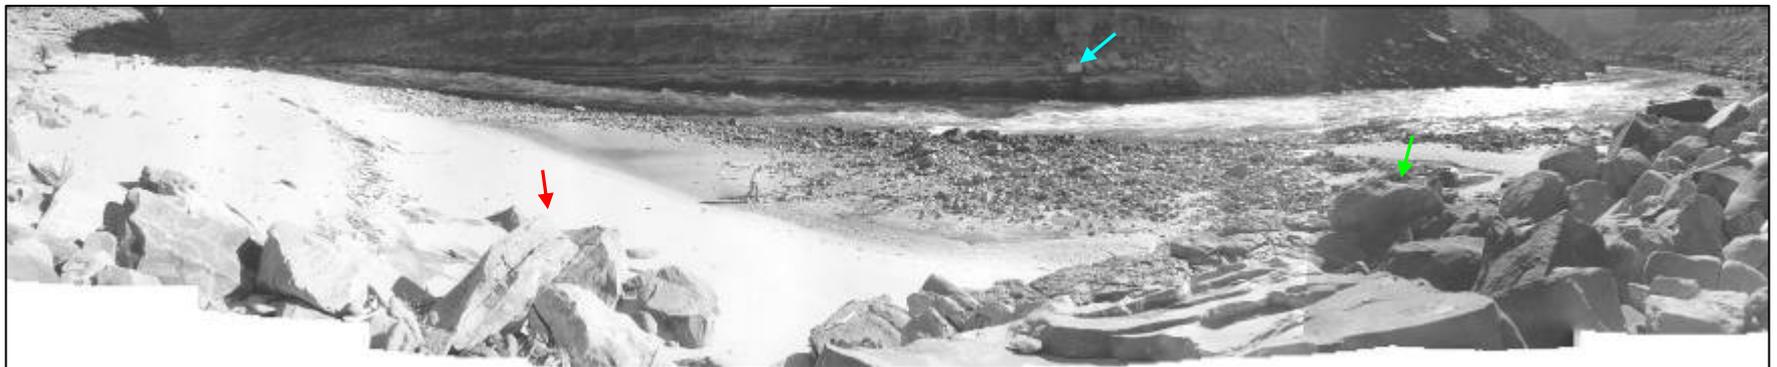
North Canyon RM 20.85R: 1985-1990 comparison

There appears to be more sand below 25,000 ft³/s, between 25,000 and 50,000 ft³/s, and above 50,000 ft³/s line in 1985. The front boulder (red arrow) seems almost completely buried in sand in 1985.

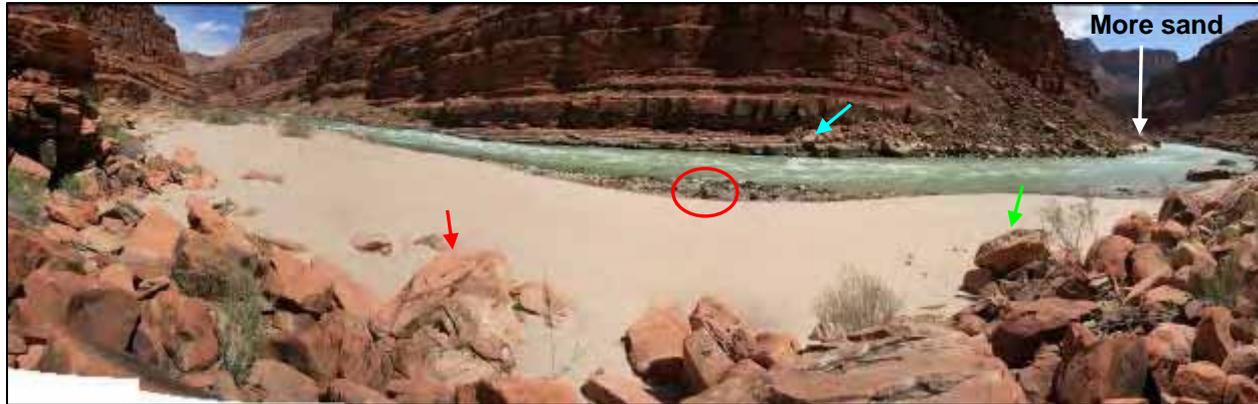
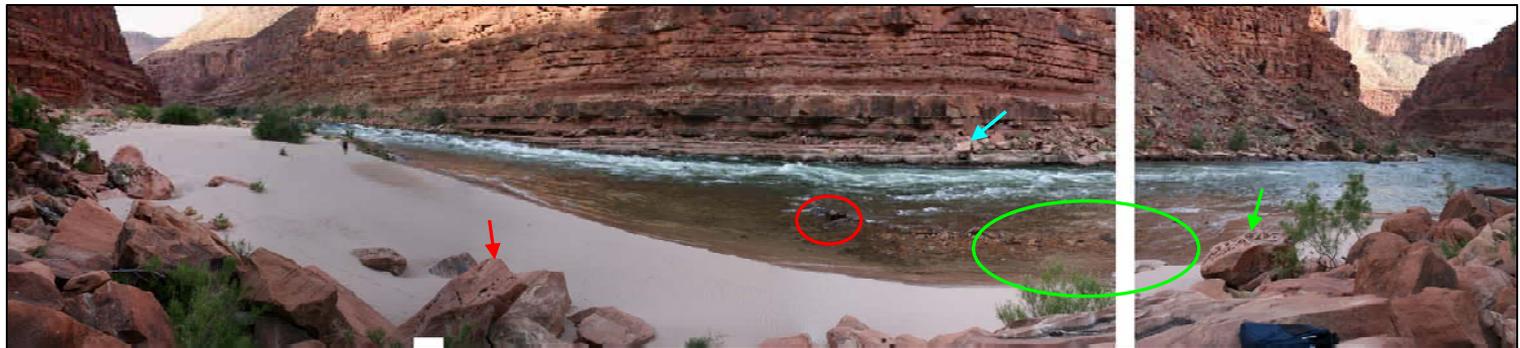
North Canyon RM 20.85R: March and May 2008 comparison

Large sand pile was eroded by fluctuating flows at the downstream end of the bar (green ellipse). Amount of sand above 50,000 ft³/s seems same just little different distribution by wind. There is some new vegetation sprouting below May water line (green ellipse). There seems to be more sand on margin bars on river left above 25,000 ft³/s line in March.

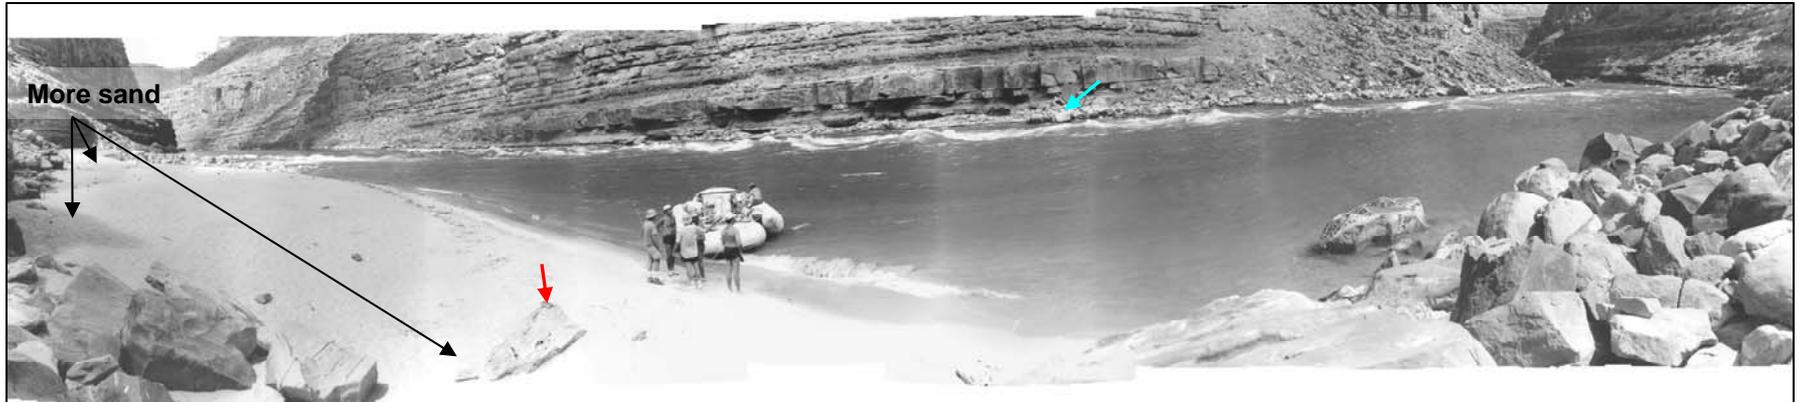
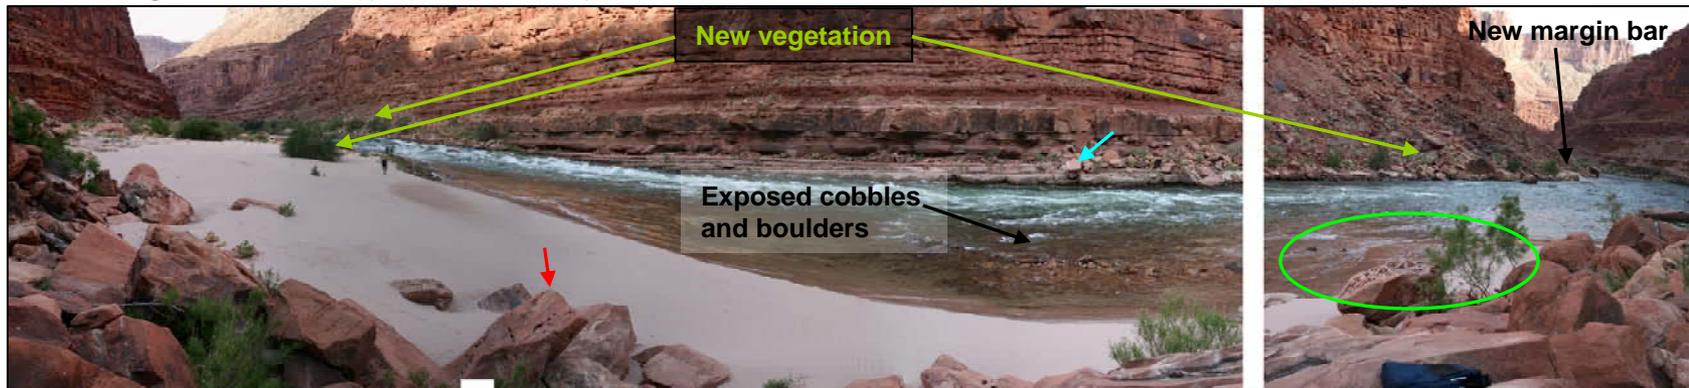
North Canyon RM 20.85R: 1985-2008 comparison

The line of drift wood in 1985 represents flow around 45,000 – 47,000 ft³/s. Sand has been evacuated around this line in mid and downstream part of sand bar. There is no sand in the area of downstream end (green ellipse) near 2008 water line in 1985. There are some new sand deposits above May 2008 water line. Sand has been eroded away showing cobbles and boulders below the 2008 water line. Additionally, fluctuating flow has eroded a cut bank at water's edge leaving ~2 ft scarp. There appears to be more sand above 50,000 ft³/s line along the boulders in 1985. There is new vegetation on the bar and river margins on river left.

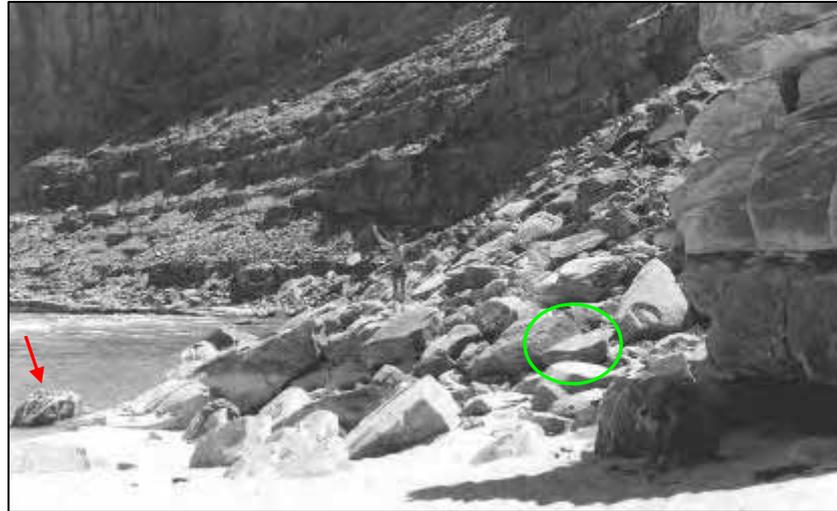
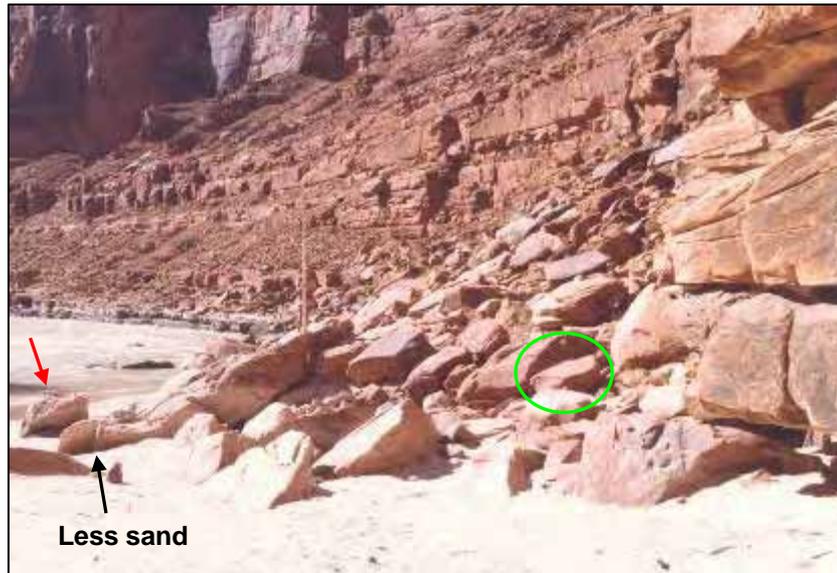
North Canyon RM 20.85R: Downstream view

Amount of sand seems about the same, except around the left lower corner of photo (between 25,000 and 50,000 ft³/s)

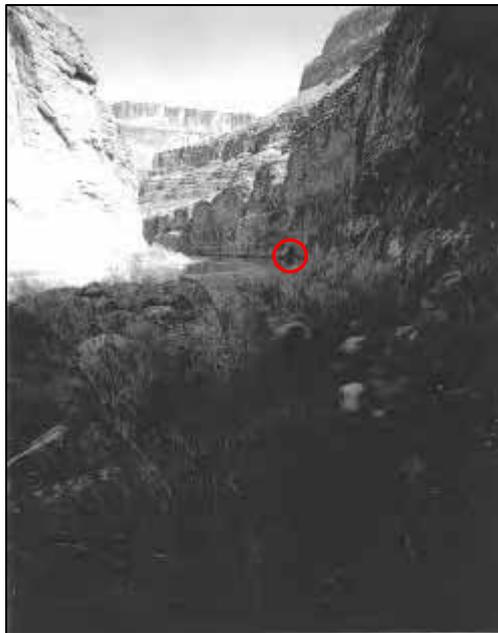
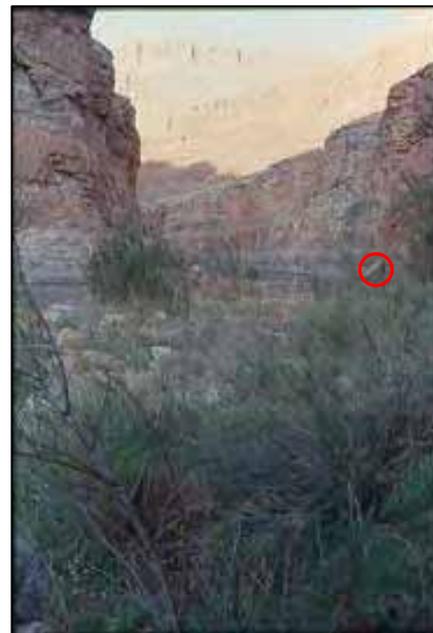
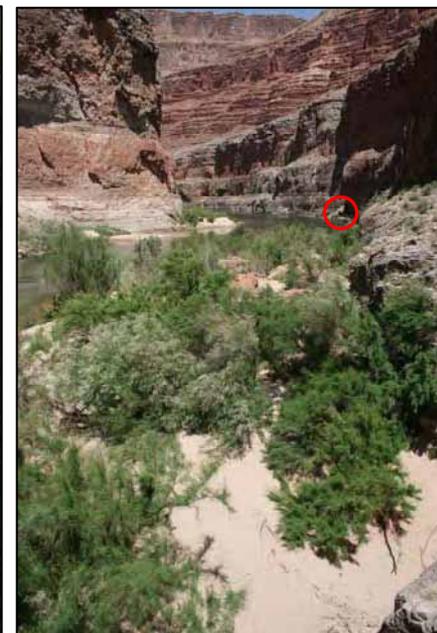
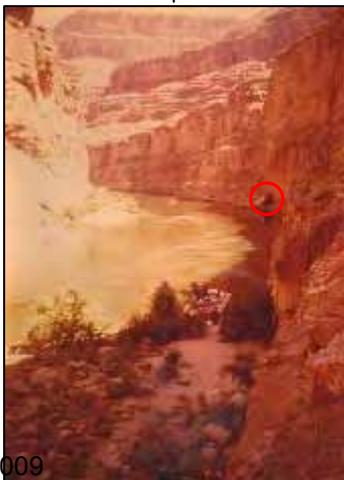
Silver Grotto, Upstream View RM 29.50L: 1889-2008 comparison

The vegetation growth is the most significant change in about 100 years. There is new sand deposition as well. 1974 photo is included here for better illustration; although, the view is slightly different. Three more photos that fall in this period (between 1889 and 1993) are compared on the next page.

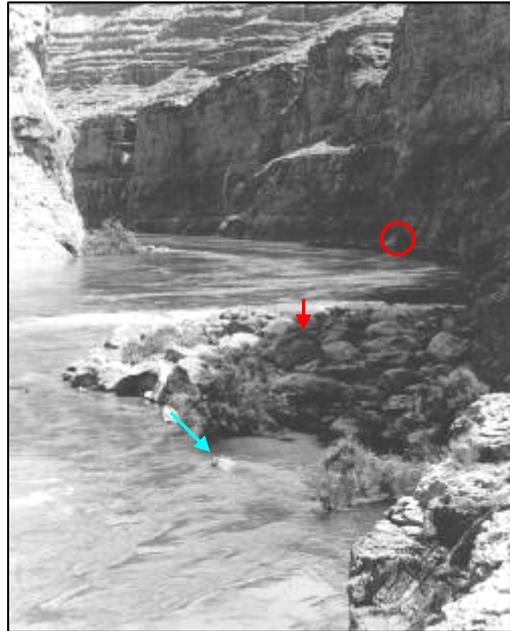
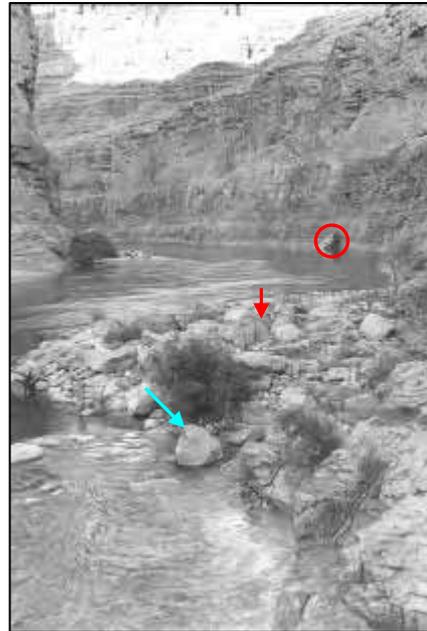
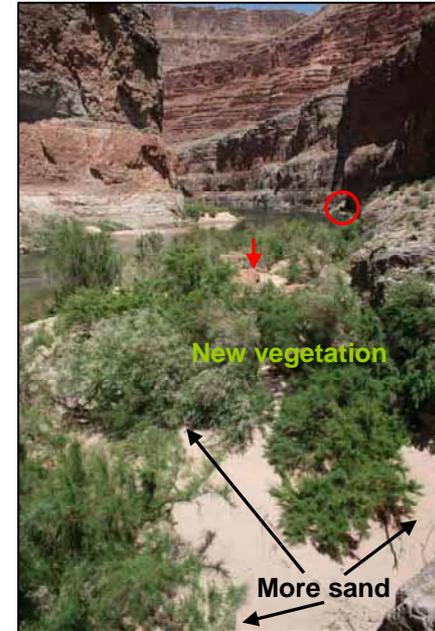
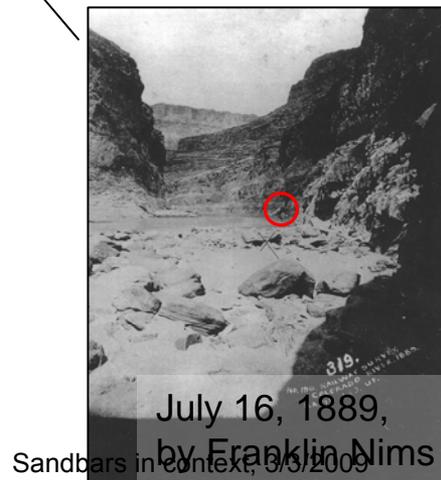
Silver Grotto, Upstream View RM 29.50L: 1889-1985-2008 comparison

There is new vegetation growth since 1889 till 1985 and the same from 1985 to present. There seems to be more vegetation in 1974 photo (p. 2) than in 1985. Much more sand in 2008 than in 1985.

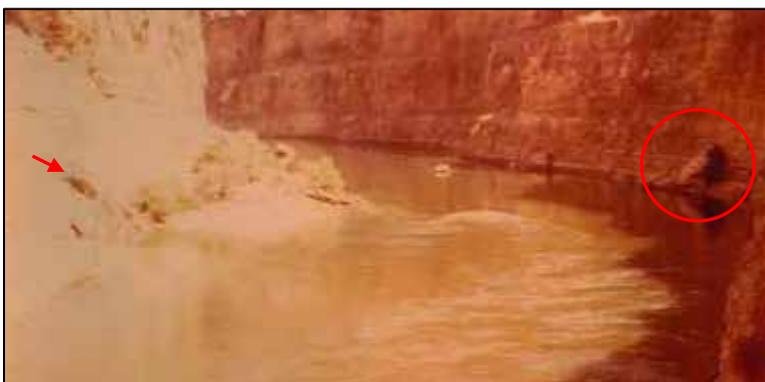
Silver Grotto RM 29.50L: Margin Bar 1974-1989 comparison

Upstream sand bar seems bigger in 1889 with sand in higher elevation. There appears to be more sand 1974 as well; although, hard to compare due to bad picture quality. When comparing 1985 and 1989 photos, there appears to be less sand on downstream end (black ellipse) and more sand on upper surface of the bar in 1989. New vegetation on the sand bar in 1989.

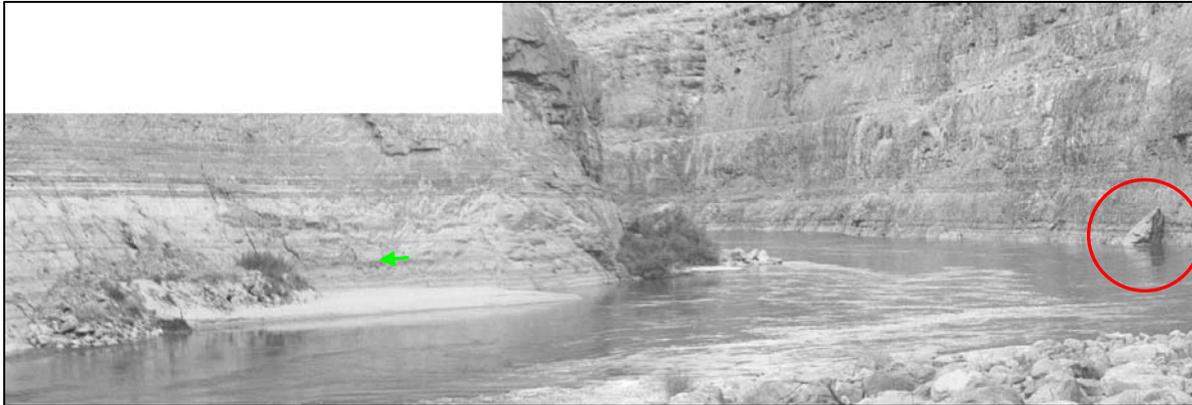
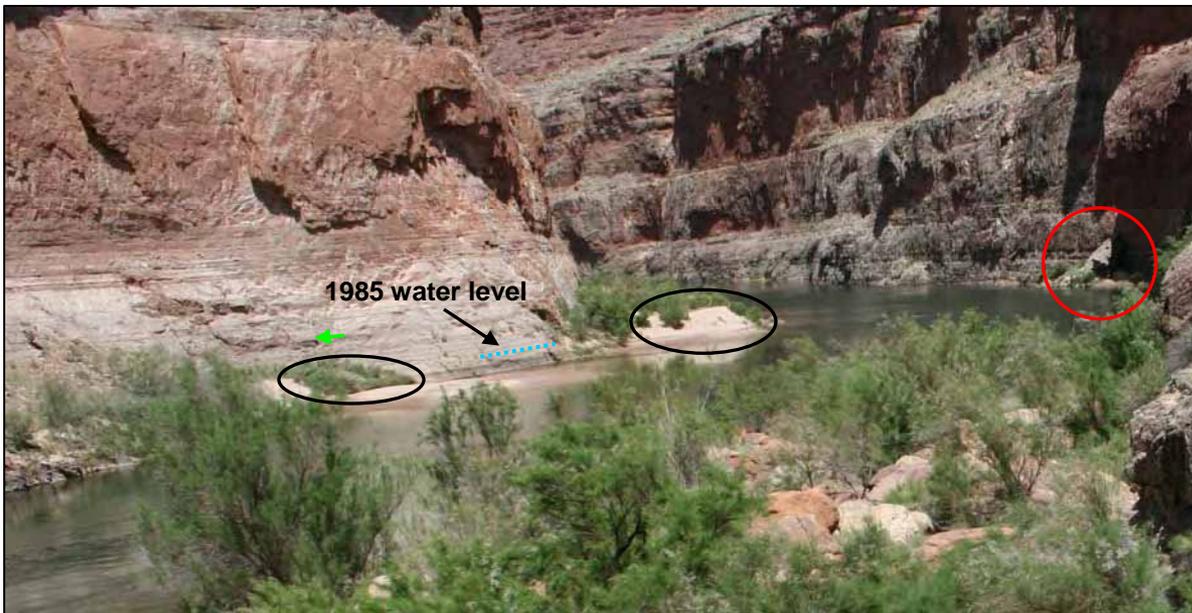
Silver Grotto RM 29.50L: Margin Bar 1985-1999-2008 comparison

There appears to be new sand depositions in 2008 (black ellipses); although, the top of the bar itself seems at lower elevation. Also, bar in 1985 stretches little more downstream than in 2008. Sand around the big boulder on river right has some new deposits and vegetation in 2008. 1985 water level is marked in 2008 photo for better illustration.
