Sandbars in historical context: Comparison of images following the March 2008 high flow with images from the 1980s and earlier.

March 3, 2009

USGS cooperators Jack Schmidt and Milada Majerova of Utah State University are currently compiling historical photographs of selected study sites and comparing those images with photos taken during and following the 2008 high-flow experiment. These photographs will help scientists, managers, and stakeholders evaluate the present condition of sandbars and vegetation relative to the condition prior to the onset of regular monitoring, which began in the early 1990s.

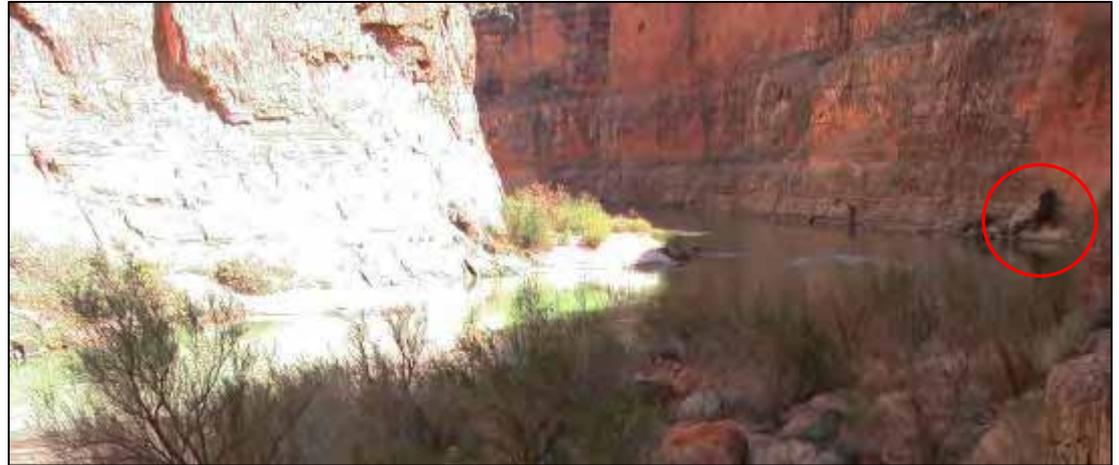
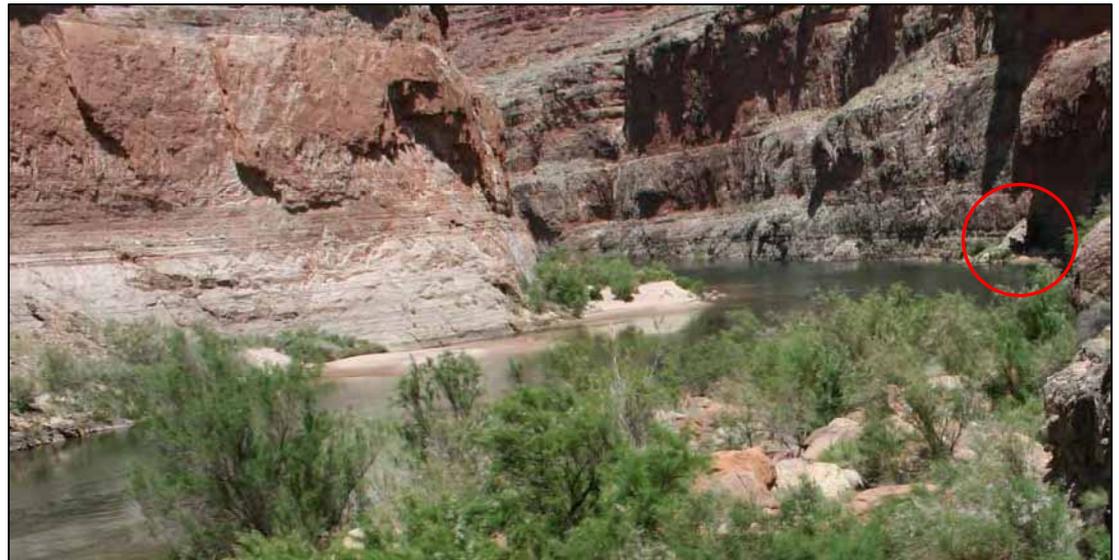
Silver Grotto RM 29.50L: Margin Bar March 2008-May 2008 comparison

There appears to be about the same amount of sand on margin bar. Same applies to the sand around the big boulder on river left (red circle).

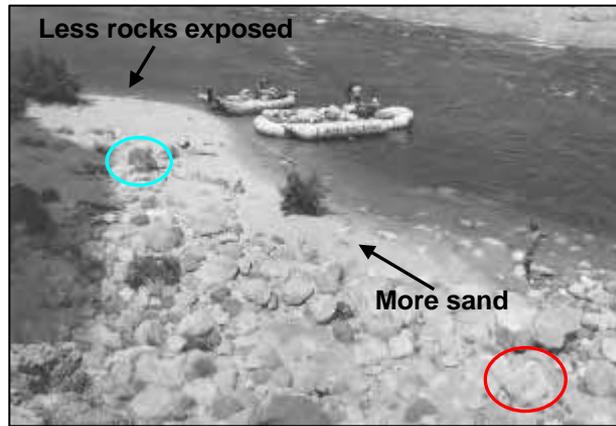
1045 May 24, 1985 (~43,500 ft³/s)

Flow from right to left. Generally, there is more sand in 1974 except the downstream end of the photo. There is more vegetation, mainly grass, in 1974 as well.

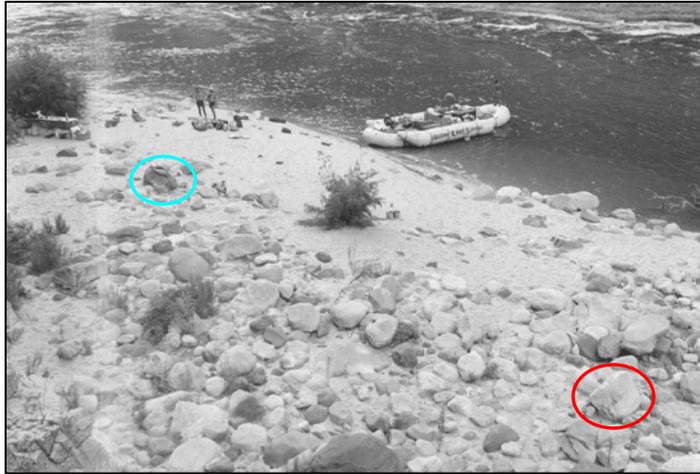
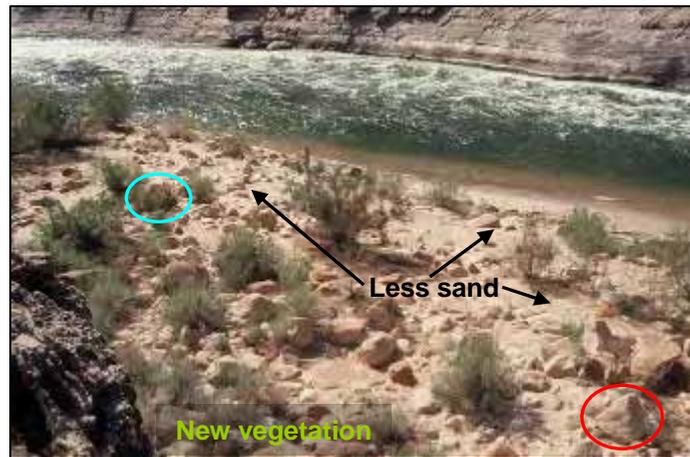
Silver Grotto RM 29.50L: 1985-1986-1989-1999 comparison

Flow from right to left. 1986 and 1989 photos show less sand below 15,000 ft³/s and about the same amount of sand above this line. There is less sand on entire sand bar and some new vegetation growing in 1999.

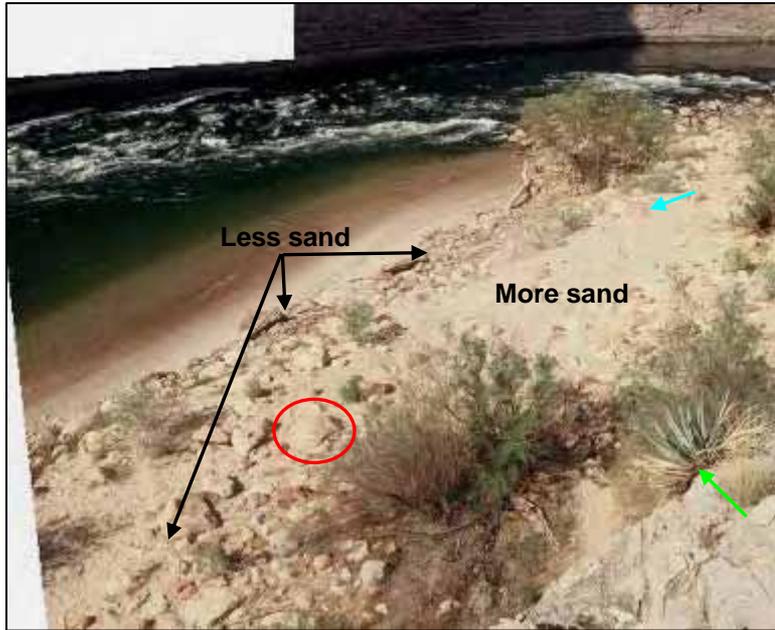
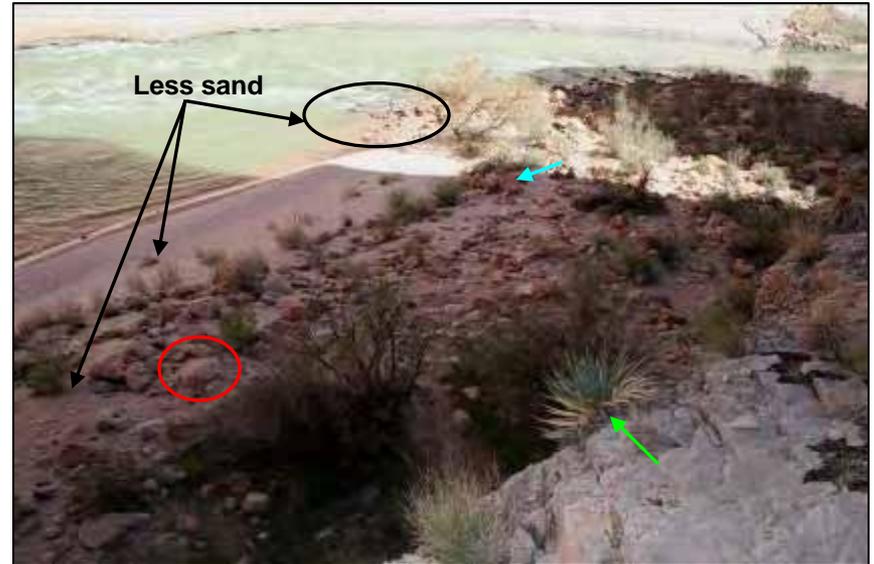
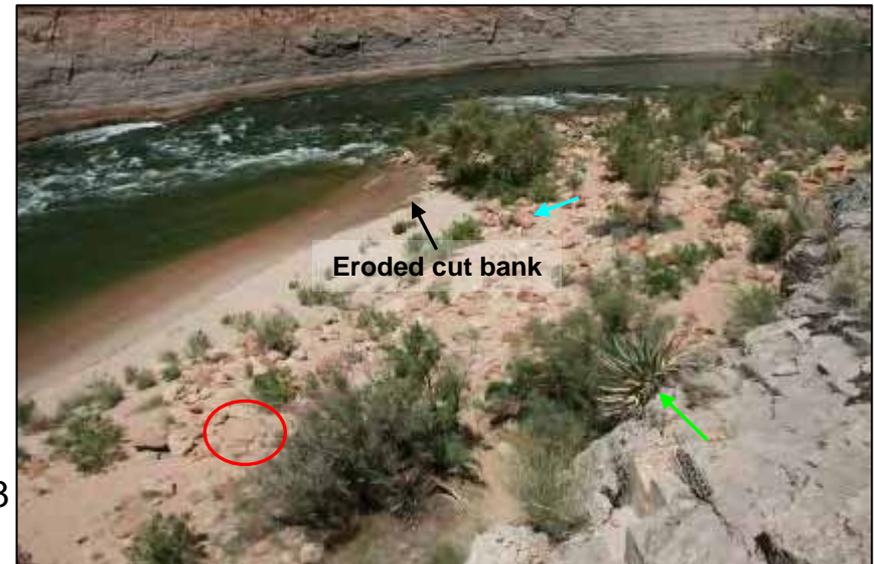
Silver Grotto RM 29.50L: 1999-2008 comparison

All photos are compared to May 2008:

There is less sand below 20,000 ft³/s line in 1999 and in the left bottom corner of the photo. Upper surface of the bar has more sand in 1999. There is new vegetation growth after 1999. When comparing March and May 2008 photos, there is generally less sand in March. Rocks are more exposed at the waters edge in March 2008 (black ellipse).

Fluctuating flow eroded cut bank at the upstream end of the beach in May 2008.

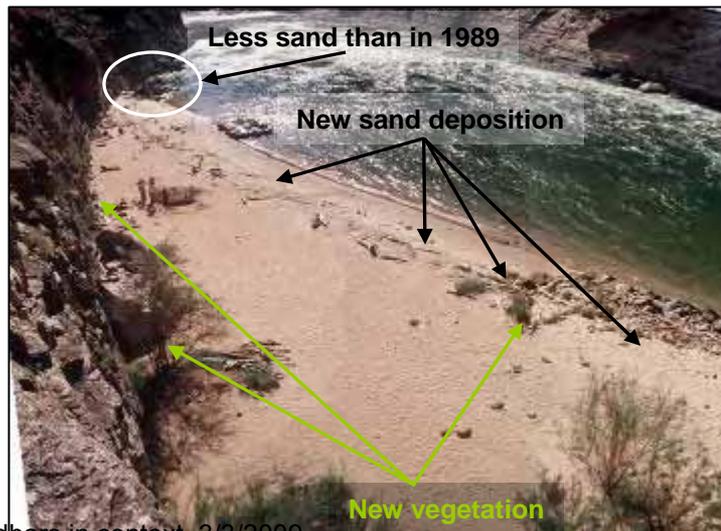
March 28, 1999 (~11,000 ft³/s)

When comparing to 1985 photo, there appears to be more sand on the upper sand bar surface with new vegetation growing in 1989 and established trees in 1999. Some grasses are spreading along the wall as well. Lower surface was eroded between 1985 and 1989, and some new sand was deposited around 25,000 ft³/s line after 1989 which is visible in 1999 photo. The far downstream end has less sand in 1999.

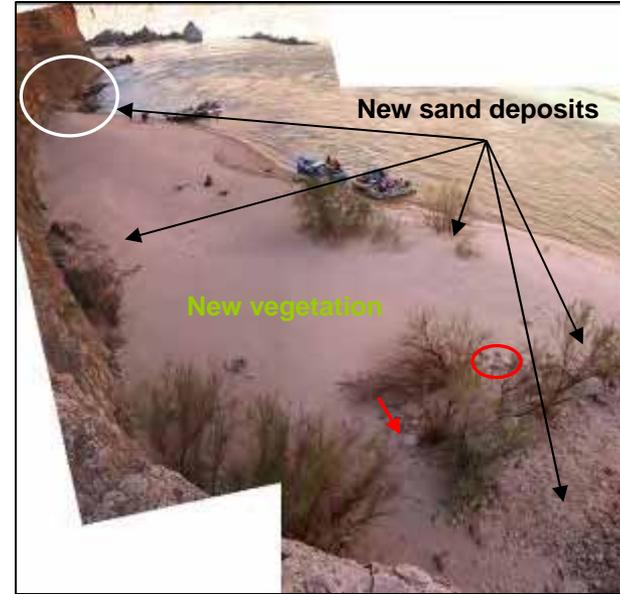
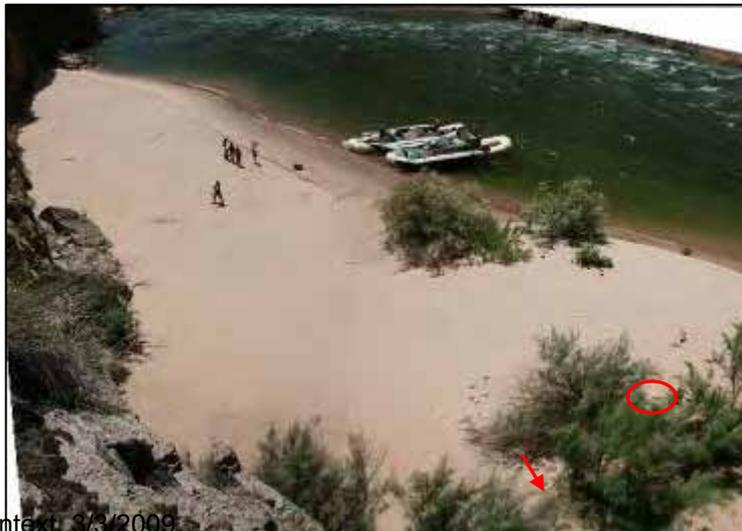
Silver Grotto, Lower Beach RM 29.50L: 1999-2008 comparison

There appears to be new sand deposition on entire sand bar. Sand bar is higher in elevation. The far downstream end of the bar has sand deposition in higher elevation as well, with some new vegetation (white circle). Overall, there is more established trees in 2008. The tree existing in 1999 (p. 10) died. Vegetation visible along the wall in 1999 is gone as well.

When comparing March and May 2008, the sand was eroded little bit below 15,000 ft³/s, which can be seen at the far downstream end (white circle) and behind the trees at the waters edge (see boulders) in May. The upper surface was leveled probably by wind.

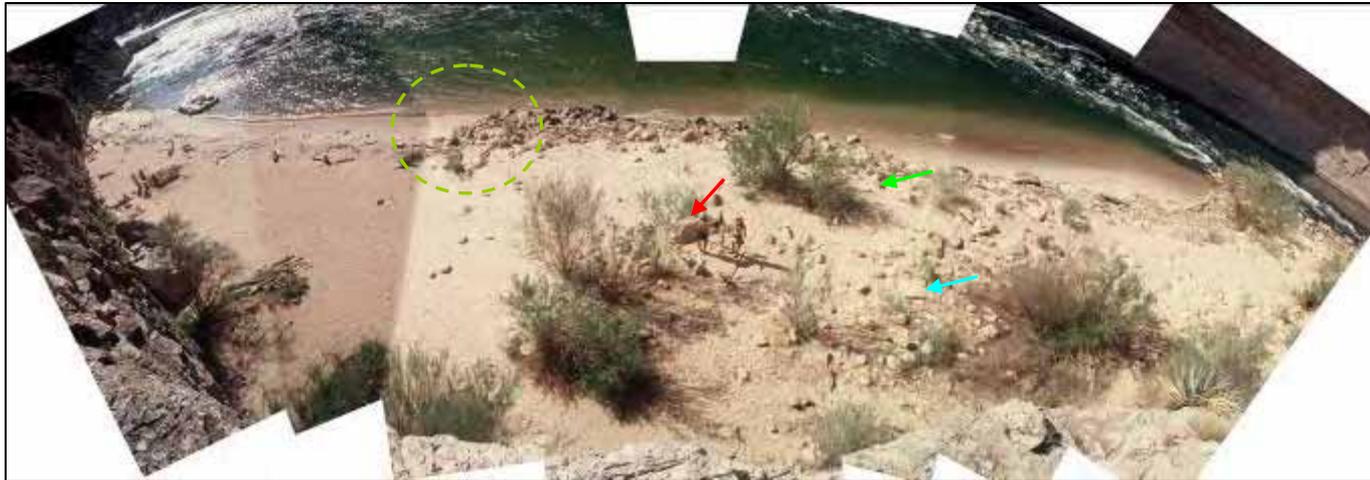
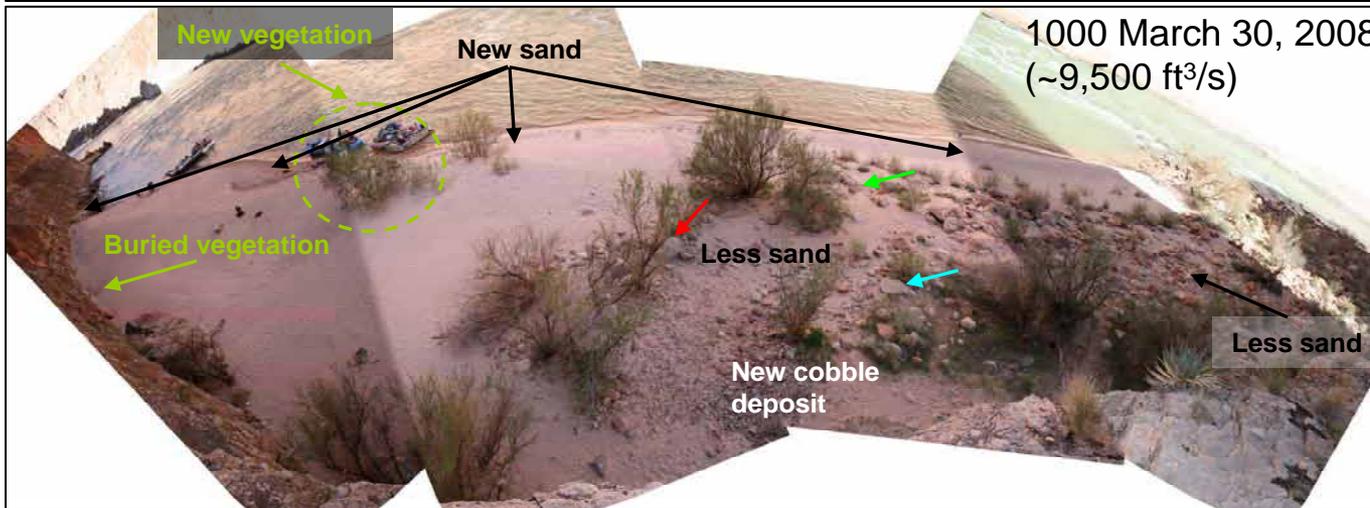
Silver Grotto, RM 29.5L: 1999-2008 comparison

There appears to be new sand deposition on entire sand bar. Sand bar is higher in elevation. The far downstream end of the bar has sand deposition in higher elevation as well, with some new vegetation. Upper surface of the upstream end of the bar has more sand in 1999. Overall, there is more established trees in 2008. The tree growing by the wall in 1999 died. Vegetation visible along the wall in 1999 is gone as well.

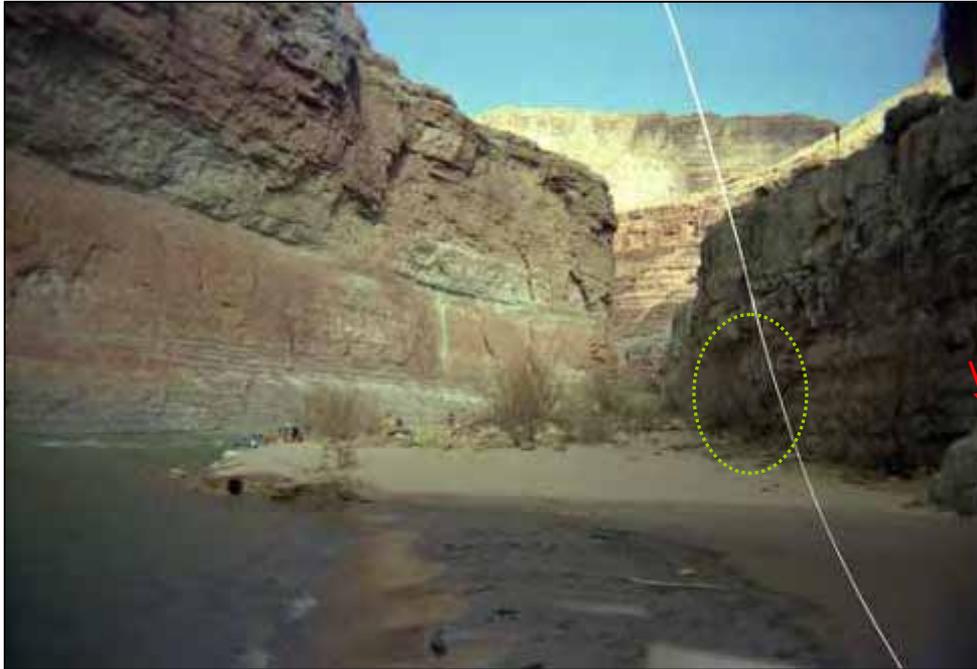
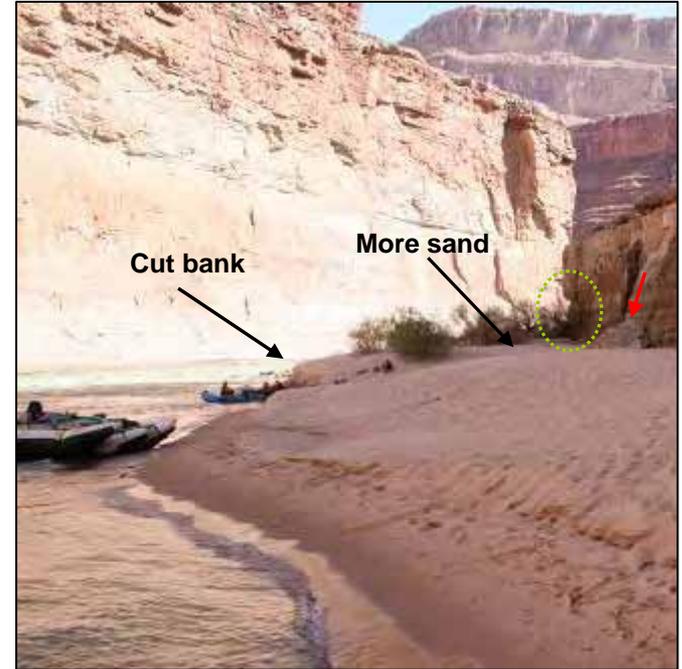
Silver Grotto, Looking upstream, RM 29.5L: 1997-2008 comparison

There appears to be more sand on the upper surface of the bar in 2008. Some new vegetation growing in 2008 as well. Cut bank caused by fluctuating flow is visible (behind the blue boat) in 2008 photo.

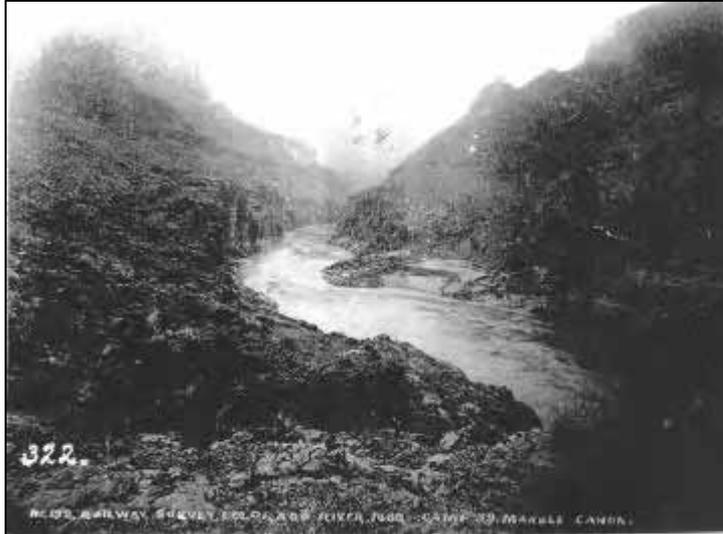
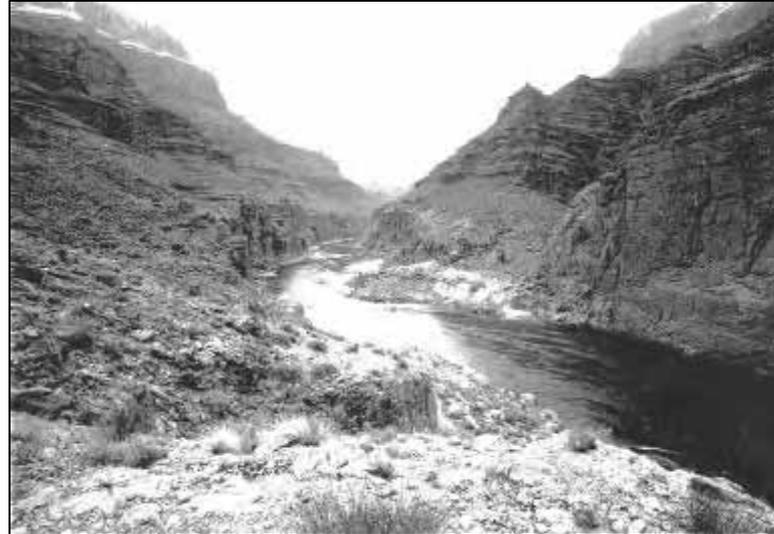
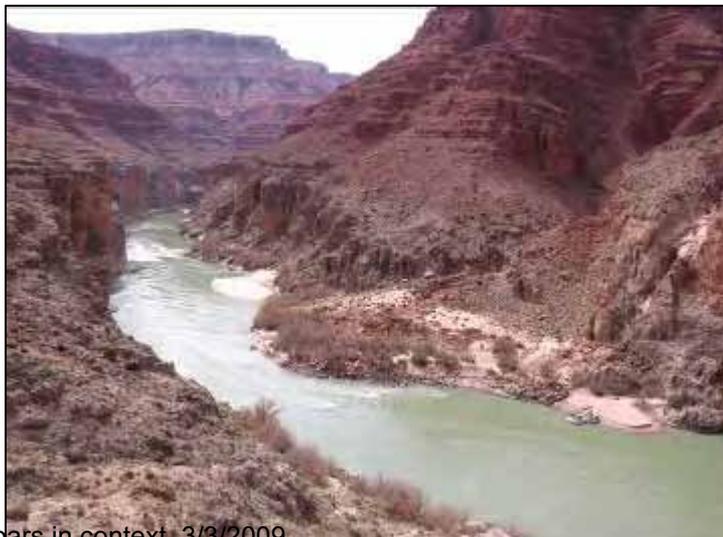
RM 30.55R: Looking downstream from RL at the bar 1889-1992-2008 comparison

There seems to be less sand in 1992 than in 1889 on the main beach itself. The new vegetation is starting to be visible. There is a small reattachment bar visible on 1992 photo (red ellipse); although, flow is smaller so it is hard to compare the existence of this bar.

There is new sand on the main beach in 2008. It seems that sand is in higher elevation, now being eroded and forming cut bank (downstream end of black ellipse). New vegetation, with more established trees, is growing on the entire site. Downstream reattachment bar looks bigger in 2008.

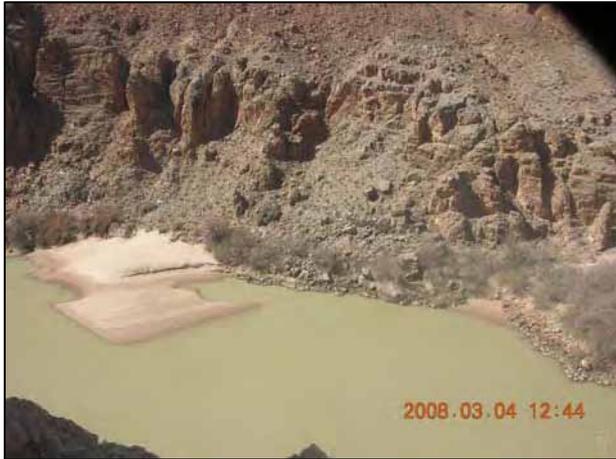
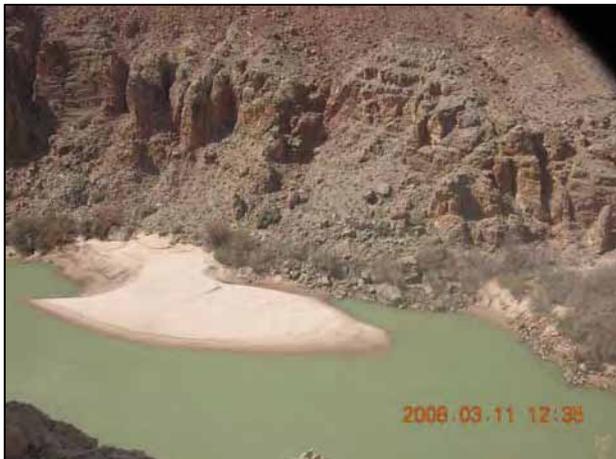
Reattachment Bar at RM 30.75R: View from river left Before and after HFE 2008

1244 March 4, 2008 (~8,200 ft³/s)

1235 March 11, 2008 (~8,300 ft³/s)

Lines in June 2008 photo represent the size of the sand bar before and right after the HFE. Red dotted line represents conditions before HFE and black dashed line represents conditions right after HFE. Lines are following the water level line - ~8,300 ft³/s for both days.

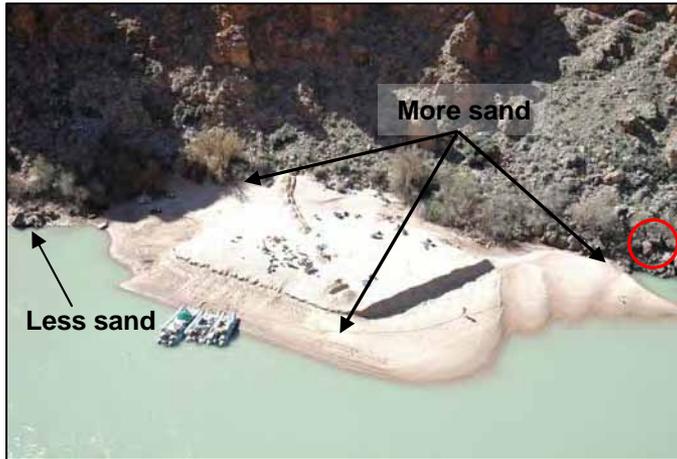
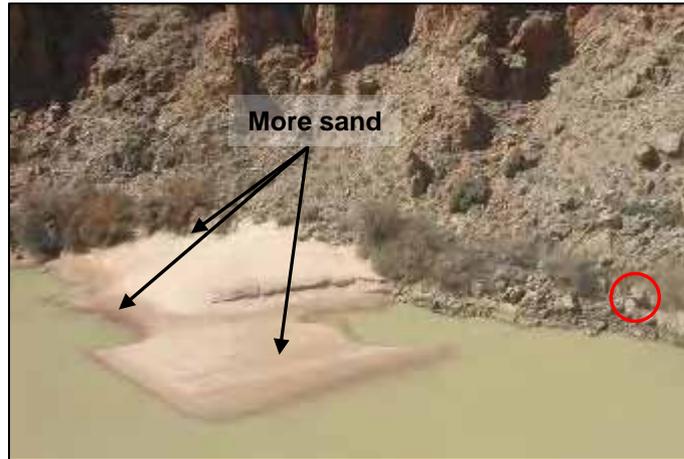
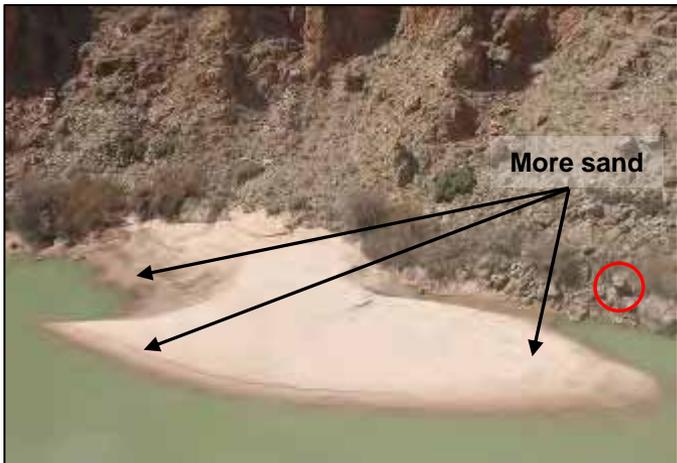
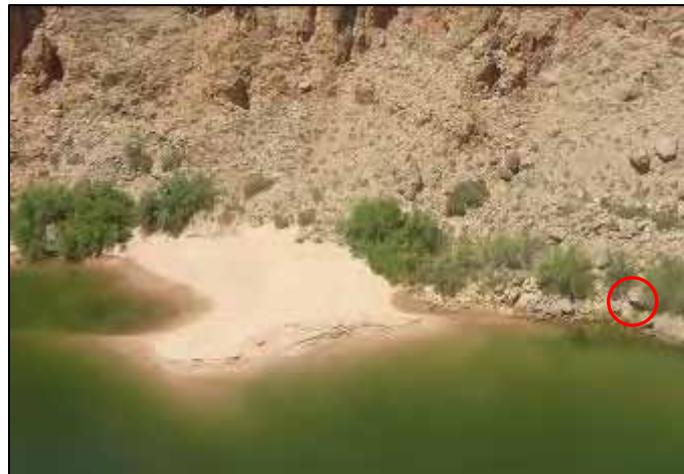
Reattachment Bar at RM 30.75R: View from river left 2005 and before-after HFE 2008

March 9, 2005 (~6,000-10,000 ft³/s)

1244 March 4, 2008 (~8,200 ft³/s)

1235 March 11, 2008 (~8,300 ft³/s)

1046 June 16, 2008 (~11,400 ft³/s)

Photos are compared to June 2008 photo.

Sand bar looks bigger and higher in elevation in 2005. Sand bar was re-built during 2008 HFE but portion of it was eroded by fluctuating flow later in 2008. Vegetation is about the same for both years.

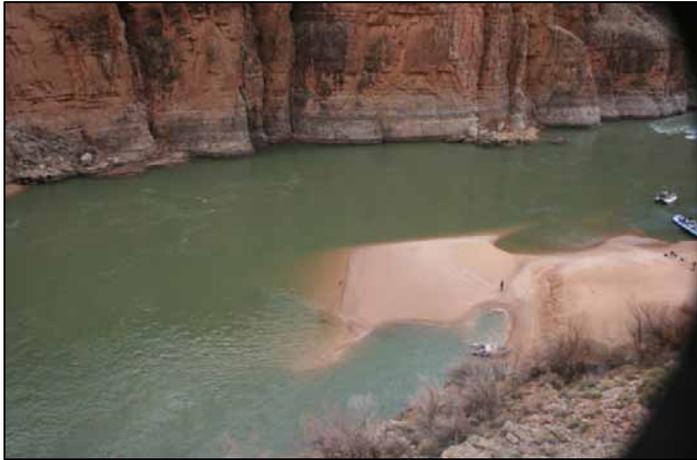
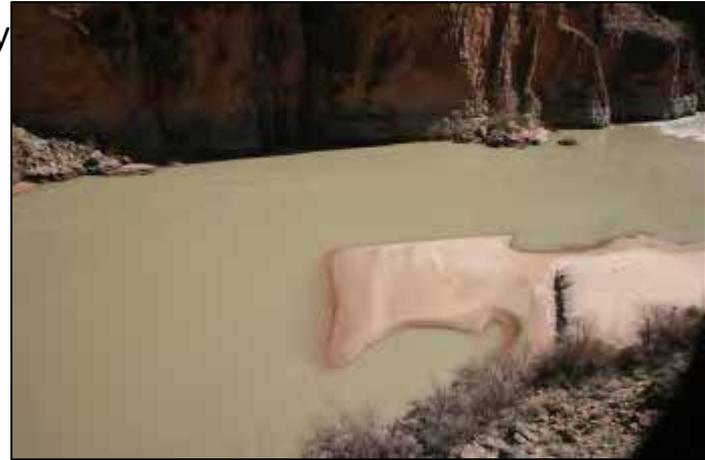
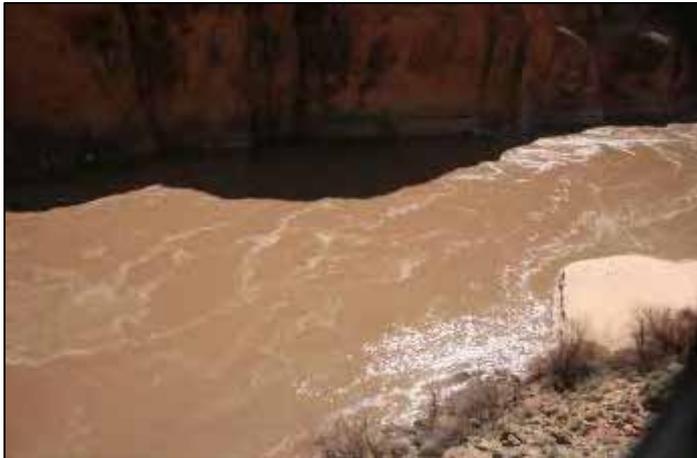
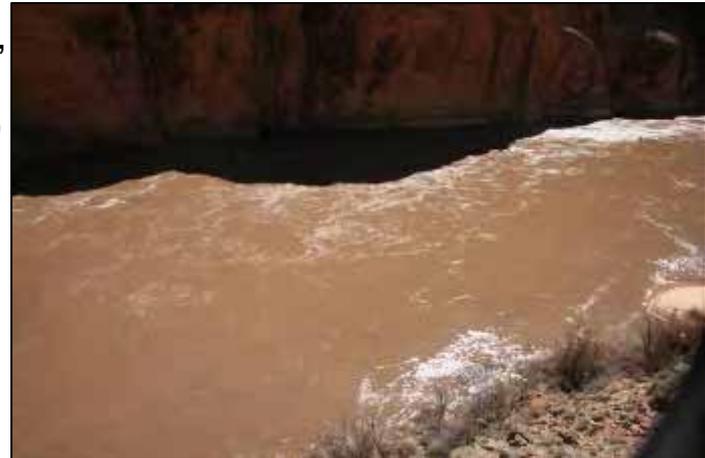
View from river right Before and during HFE

1428 February
4, 2008
(~9,500 ft³/s)

1356
March 4,
2008
(~8,400
ft³/s)

1156 March 5,
2008
(~22,100 ft³/s)

1155
March 6,
2008
(~42,600
ft³/s)

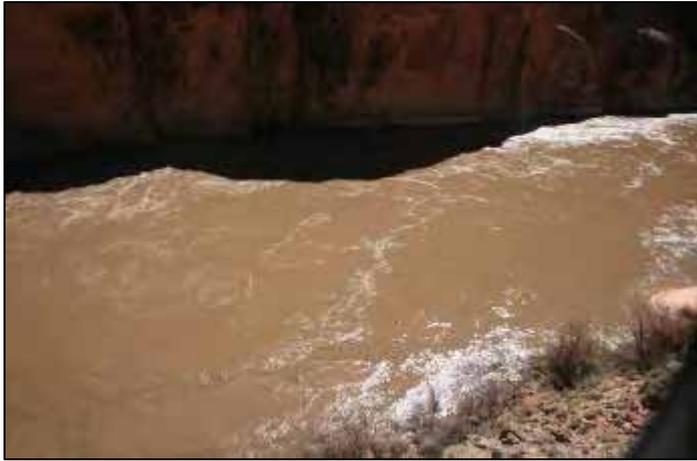
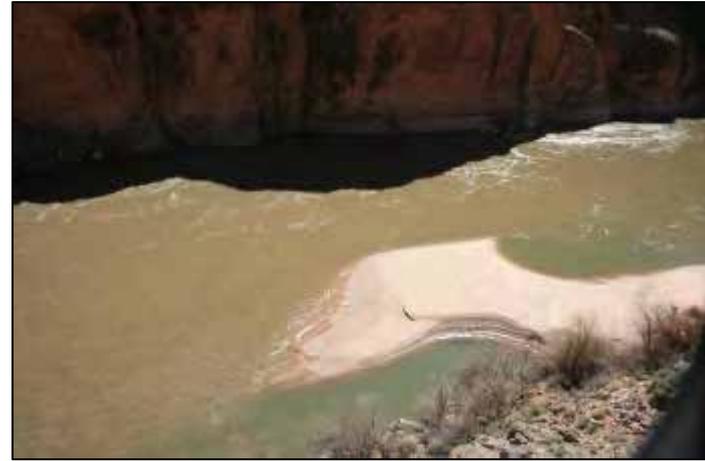
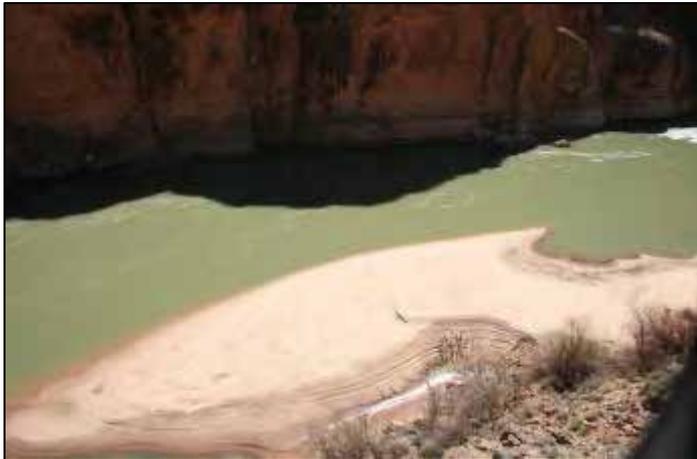
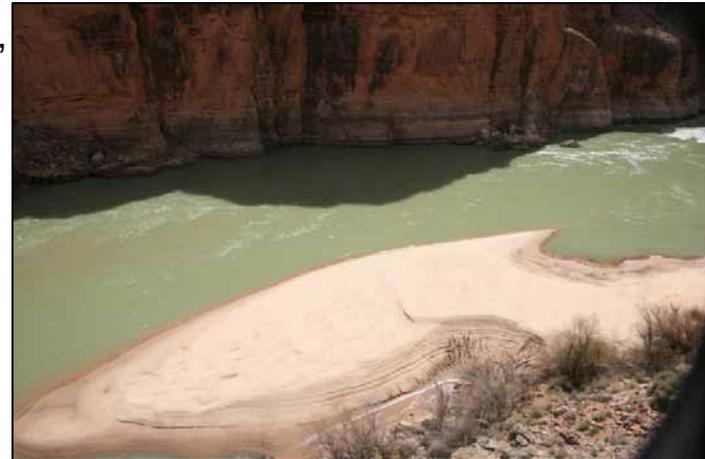
View from river right During and after HFE

1155 March 7,
2008
(~42,800 ft³/s)

1155
March 9,
2008
(~22,800
ft³/s)

1155 March 10,
2008
(~8,400 ft³/s)

1155
March 11,
2008
(~8,400
ft³/s)

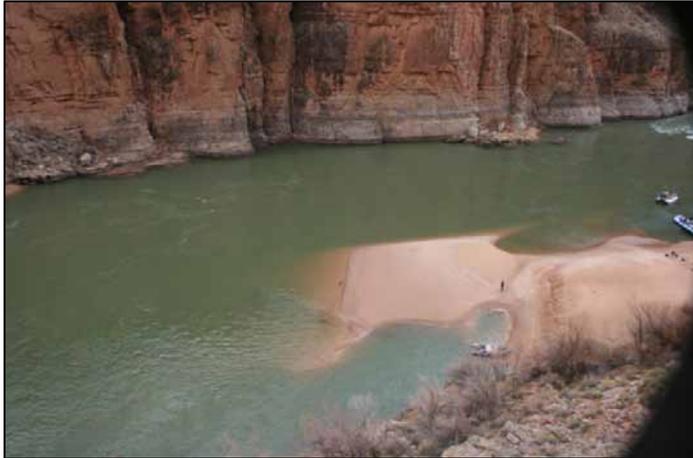
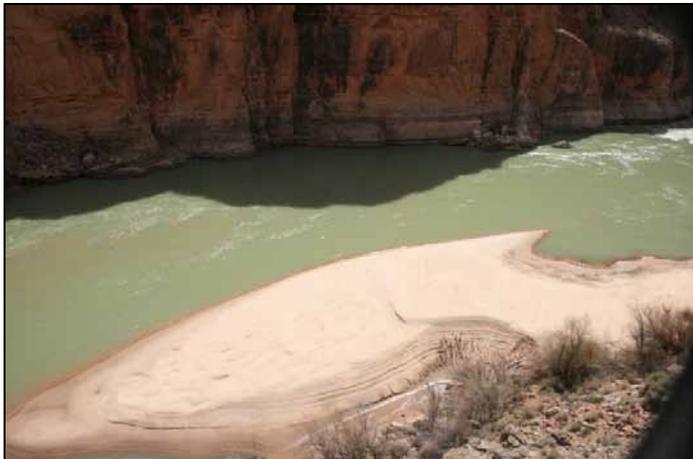
Reattachment Bar at RM 30.75R: View from river right Before and after HFE 2008

1428 February 4, 2008 (~9,500 ft³/s)

1155 March 11, 2008 (~8,400 ft³/s)

Lines in August 2008 photo represent the size of the sand bar before and right after the HFE. Red dotted line represents conditions before HFE and black dashed line represents conditions right after HFE. Lines are following the water level line - ~8,400-9,500 ft³/s for both days.

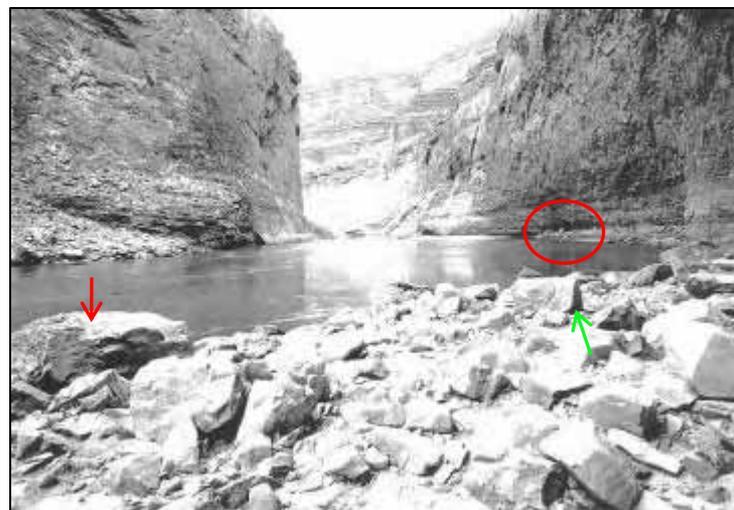
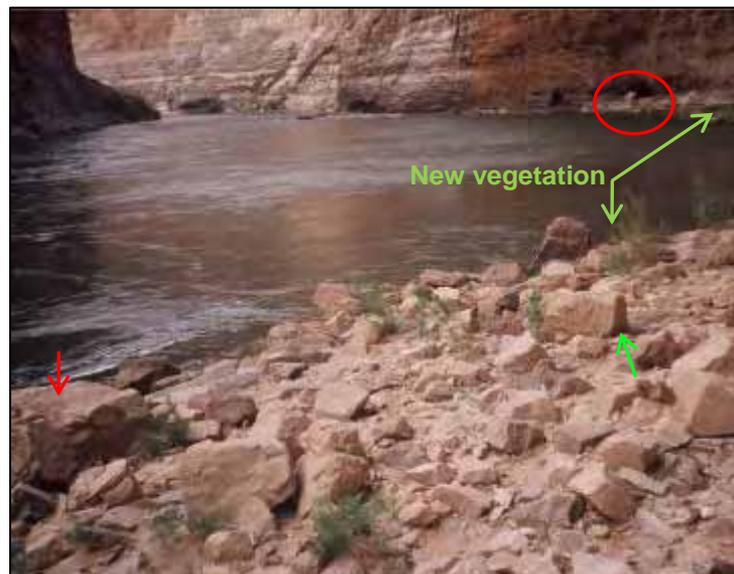
Redwall Cavern RM 33.30L

January 3, 1992; Robert H. Webb (~daily max
↓ 16,000 ft³/s, min 10,000 ft³/s, mean 13,400 ft³/s)

There is more sand in 1890 than 1999 (~0.5 ft). Sand on upper terrace between boulders has presence of ripples. There is more sand in far background as well. Amount of sand is about the same for 1992 and 1999 photos. There is less vegetation in 1890 and 1992 than in 1999.

March 30, 1999 (~daily max 16,000 ft³/s,
min 10,300 ft³/s, mean 13,600 ft³/s)

Wind ripples and dunes were present in some of the old photos and have been observed in the field at Redwall Cavern. It is possible that some or much of the variation in bar elevation is due to eolian processes in addition to fluvial processes.

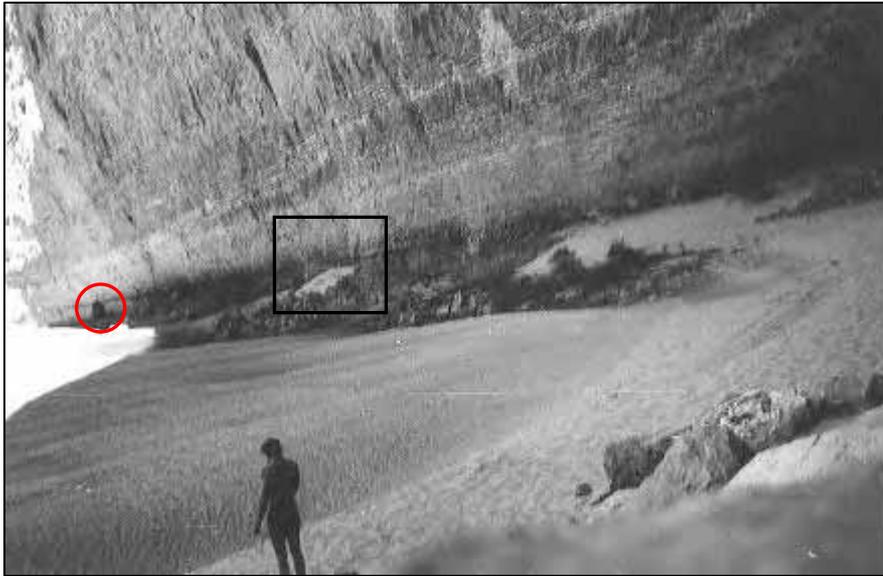
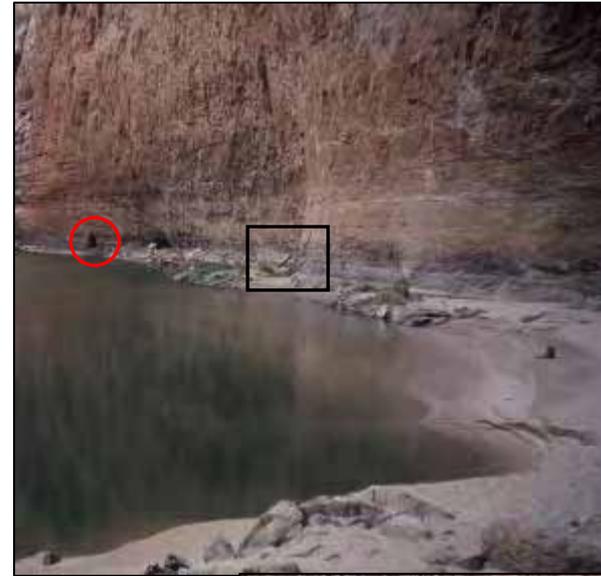
Redwall Cavern RM 33.30L

August 6, 1976; E. M. Laursen (~daily mean 8,500 ft³/s)

March 30, 1999
 (~daily max
 16,000 ft³/s,
 min 10,300 ft³/s,
 mean 13,600 ft³/s)

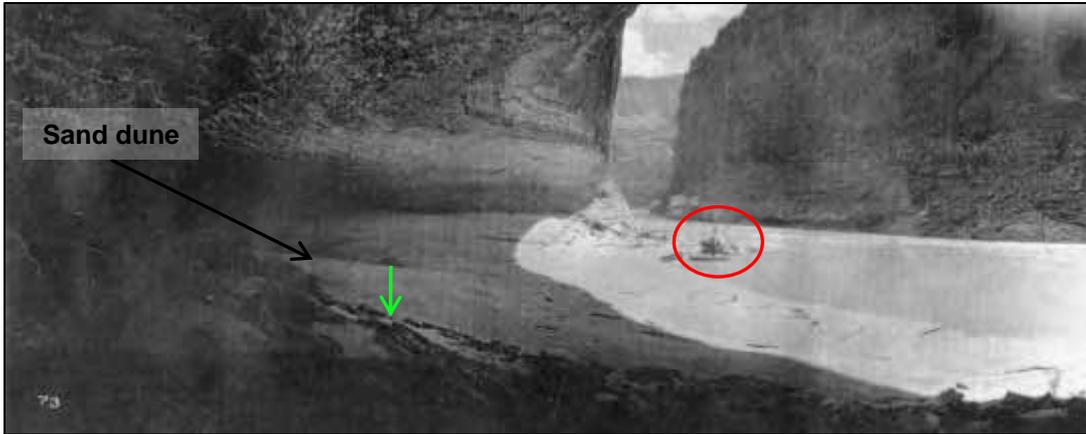
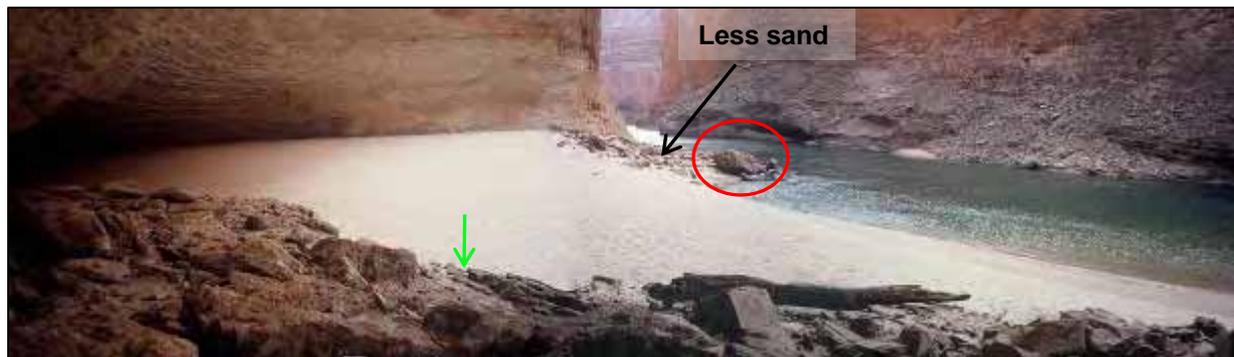
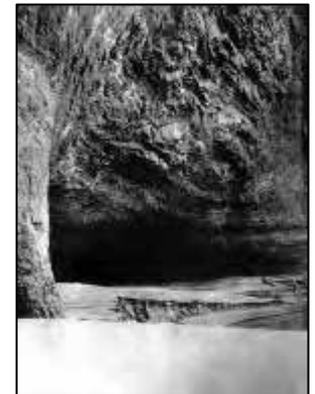
Redwall Cavern RM 33.30L

August 8, 1923; E. C. LaRue (~daily mean 19,000 ft³/s)

The 1923 photo shows less sand at higher elevation than the 1911 photo. Rocks at both the downstream and upstream ends of the bar are exposed about the same amount in the 1923 photo as they were in 1999. The thickness of low-elevation sand has been more variable. There was between 0.6 and 1.5 m more in 1923 than in 1999.

March 30, 1999 (~daily max 16,000 ft³/s, min 10,300 ft³/s, mean 13,600 ft³/s)

November 13, 1911; Kolb

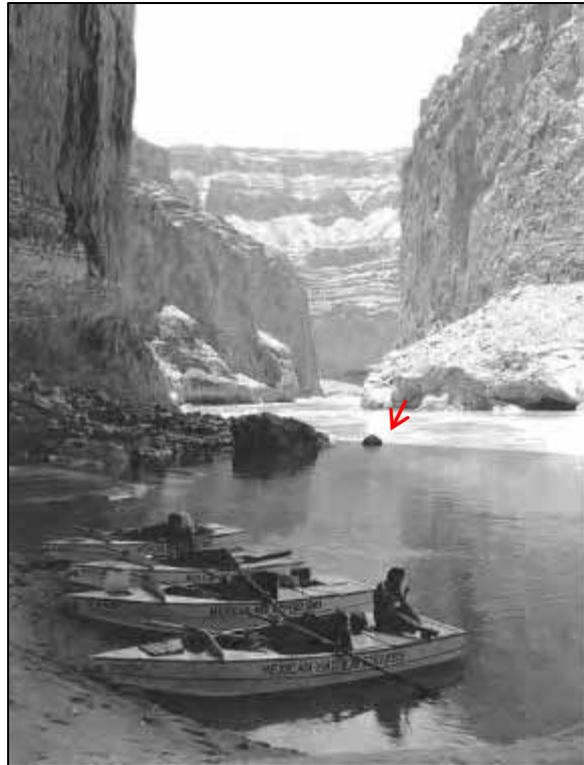
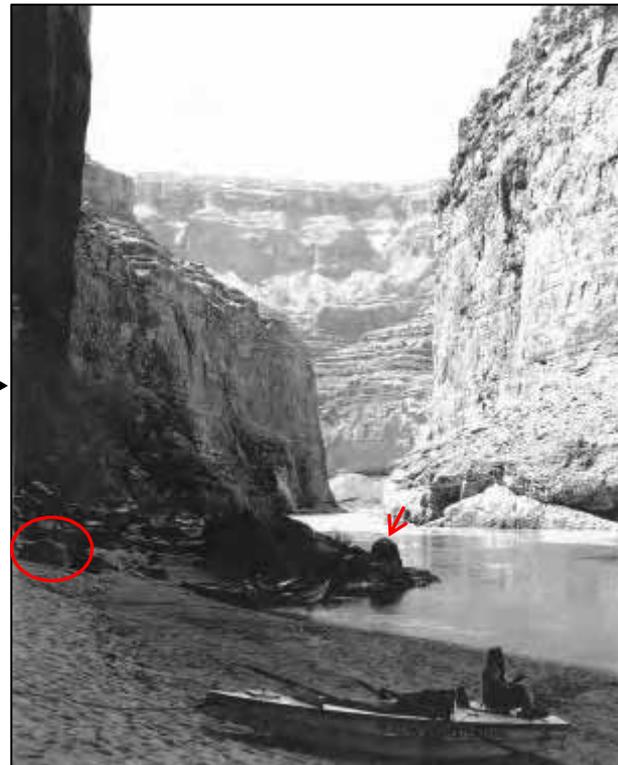
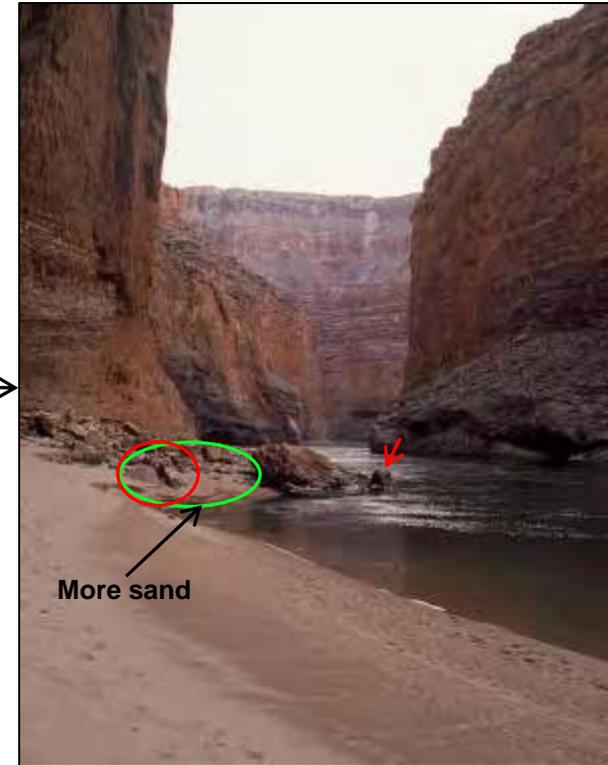
Redwall Cavern RM 33.30L

July 1951; Tad Nichols

September 10, 1994; Robert H. Webb
 (~daily max 12,600 ft³/s,
 min 8,100 ft³/s, mean 10,000 ft³/s)

March 30, 1999 (~daily max 16,000
 ft³/s, min 10,300 ft³/s, mean 13,600 ft³/s)

There is slightly less sand in higher elevation in 1951 than 1999. Sand slopes more gently towards the river in 1951. There is less vegetation in 1951 than in 1994 but about the same as for 1999. When comparing 1994 and 1999, there is more high elevation sand and more vegetation in 1994. Sand slopes more gently towards the river in 1994. Amount of low elevated sand is about the same for both years with little bit more sand in the green ellipse.

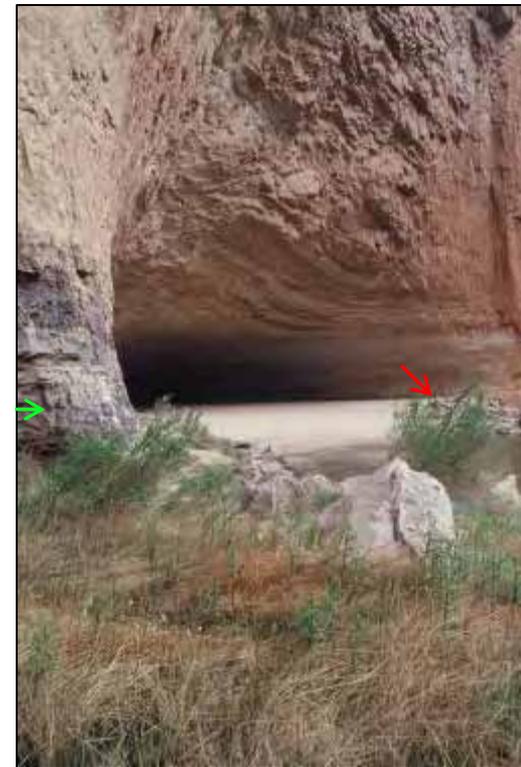
→ March 30, 1999
(~daily max 16,000 ft³/s,
min 10,300 ft³/s,
mean 13,600 ft³/s)

There is sand covering rocks in 1911 photo at the higher elevation parts of the bar. These rocks are exposed (~0.5m above the surface of the sand bar) in 1995 and 1999 photos. Vegetation growth occurred after 1911 and became more established by 1999.
