**SUMMARY REPORT FOR 1992 GCES MONITORING
OF ARCHAEOLOGICAL SITES FROM LEES
FERRY TO SEPARATION CANYON,
GRAND CANYON NATIONAL PARK**

February 1994

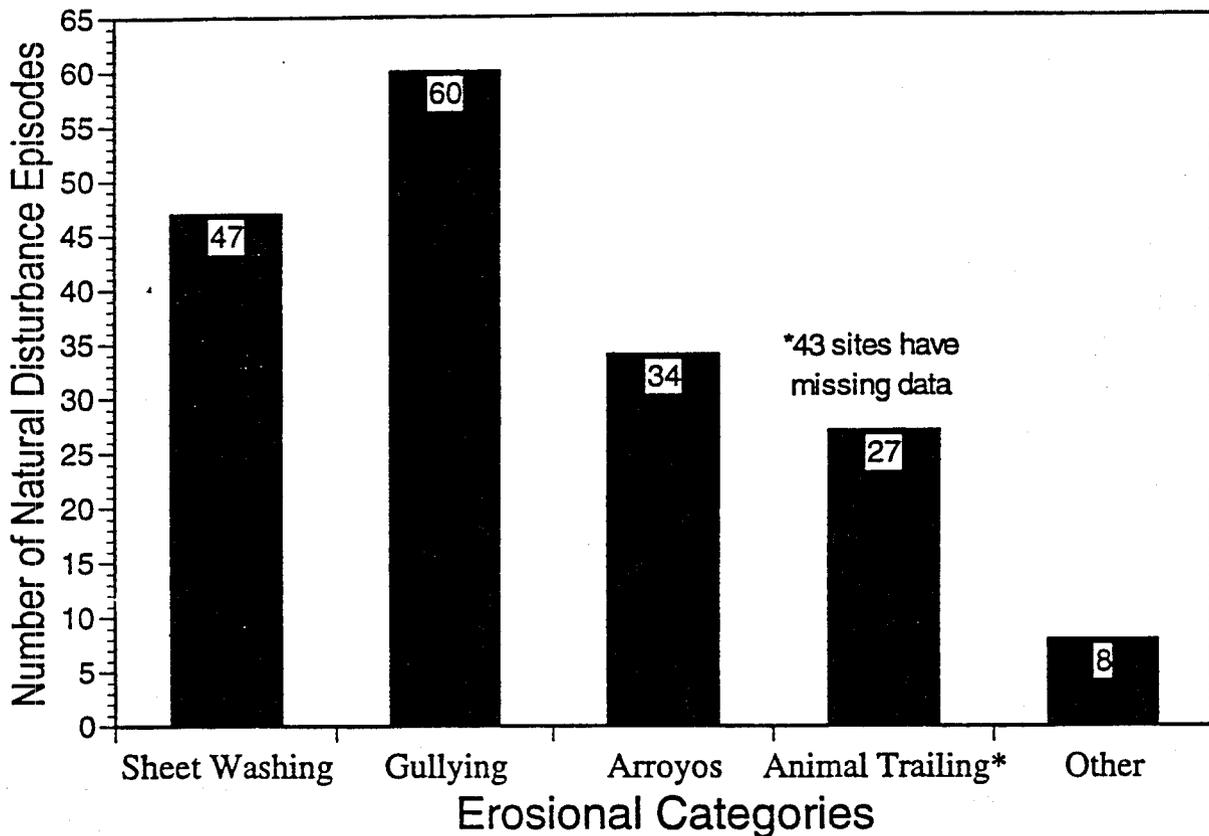
The main form of erosion was gullying, which was recorded 60 times. Sheet washing was observed 47 times, and arroyo cutting was noted 34 times. Animal trailing occurred 27 times; however, this may not represent the actual occurrence because 43 sites had missing data for this variable. The erosional categories and their frequencies are in Figure 1.

Figure 1. Erosional categories and frequencies for fiscal 1992 monitoring.

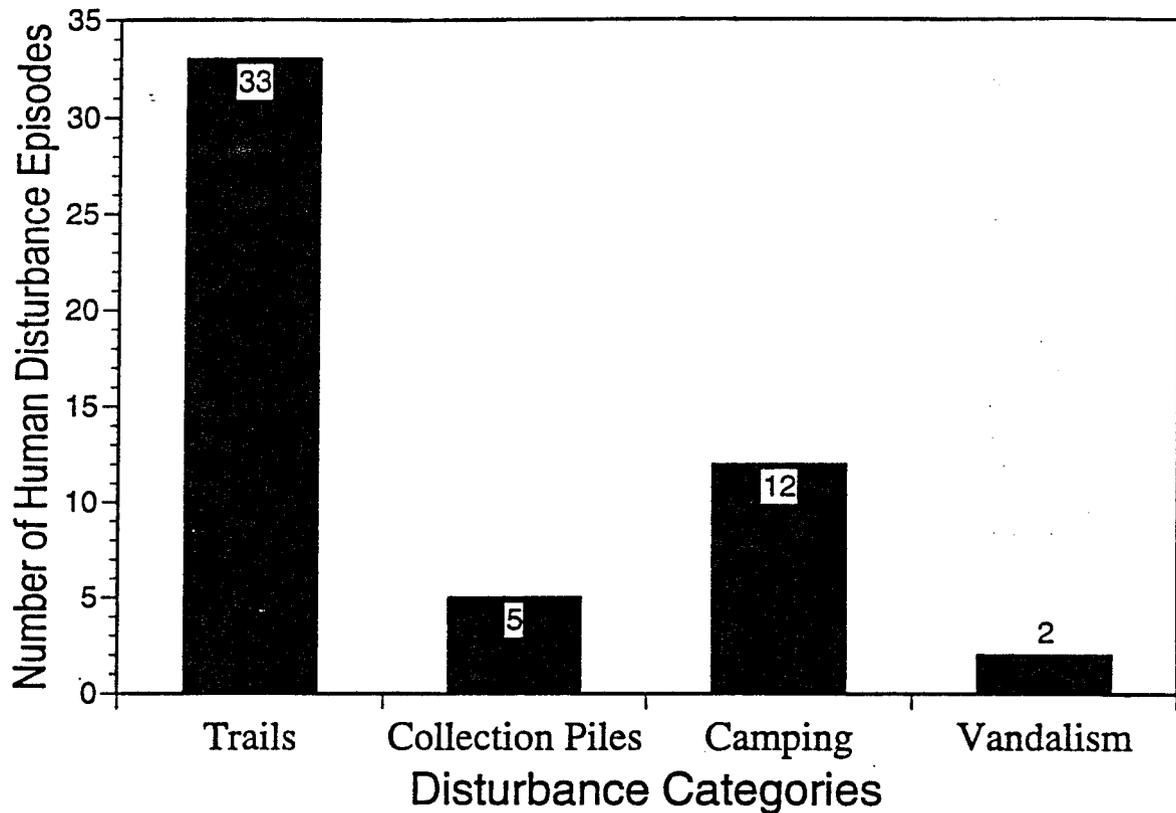
The leading cause of site damage by humans is trailing, which was noted at 33 sites, and on-site camping was observed at 12 sites. Deliberate site vandalism was only noted twice. See Figure 2 for the categories and frequencies of human disturbances.

Figure 2. Human disturbance categories and frequencies for fiscal 1992 monitoring.

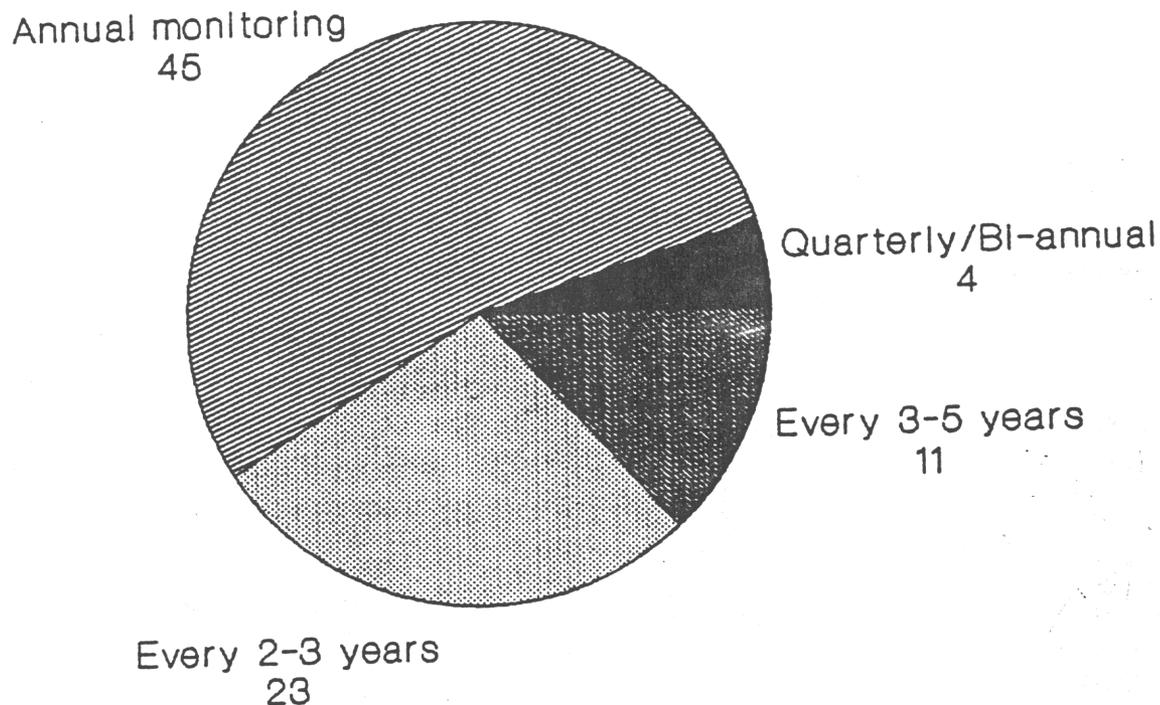
Question No. 45 of the 1992 monitor form refers to the monitoring priority of each site. Sites are ranked according to four values: 1 = highest priority (quarterly or bi-annual monitoring); 2 = annual monitoring; 3 = monitor every 2-3 years; and 4 = monitor every 3-5 years. The results are summarized in the pie chart (Figure 1), and Table 1 lists the monitor priority rankings given for each site by field crews. These recommendations may be slightly different from the final recommendations presented in the following section.

Figure 11. Pie chart summarizing the priority ranks of each site.
