Erosion Control Project at Palisades
Delta along the Colorado River Corridor
Grand Canyon National Park

Prepared by
GCES Project Archaeologists
Lisa M. Leap
Christopher M. Coder
Cultural Resource Management
Grand Canyon National Park

December, 1995

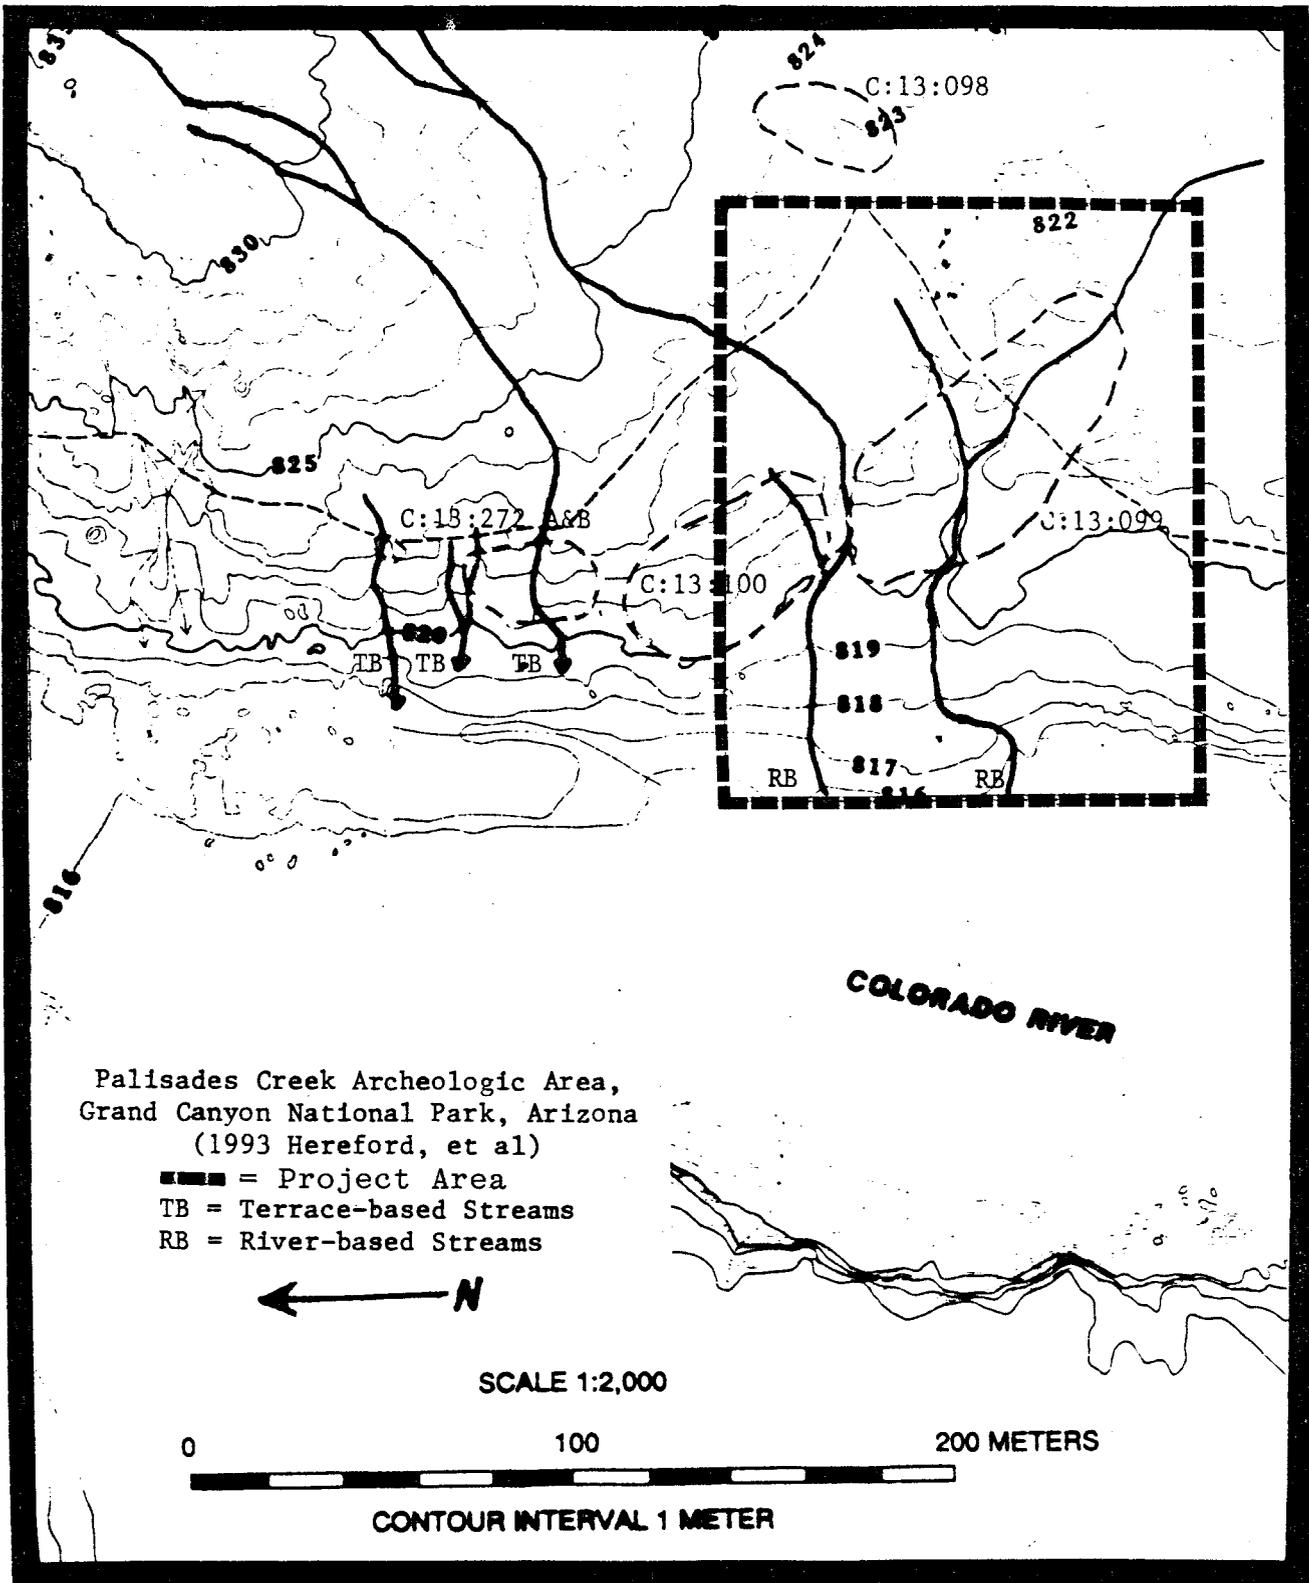
There are three river-based streams of concern at Palisades. These streams, referred to as RB1, RB2 and RB3, intersect two sites, C:13:099 and C:13:100. RB1 has seven known features that are either adjacent to or in the drainage. RB2 has two known features in the drainage, and RB3, which connects to RB2, contains three features. These drainages were the focal areas of erosion control, while several active tributaries to these streams were also used for opportune sediment catchment locations. See Figure 1 for site locations and the drainage systems where remedial action occurred.

Figure 1. Locational map of C:13:099 and C:13:100 and the river-based streams where erosion control was implemented.
