**Archaeological Site Monitoring and Management
Activities along the Colorado River in Grand
Canyon National Park**

LISA M. LEAP AND JENNIFER L. DIERKER
Grand Canyon National Park

RCMP Report No. 89
Flagstaff, Arizona

December 2003

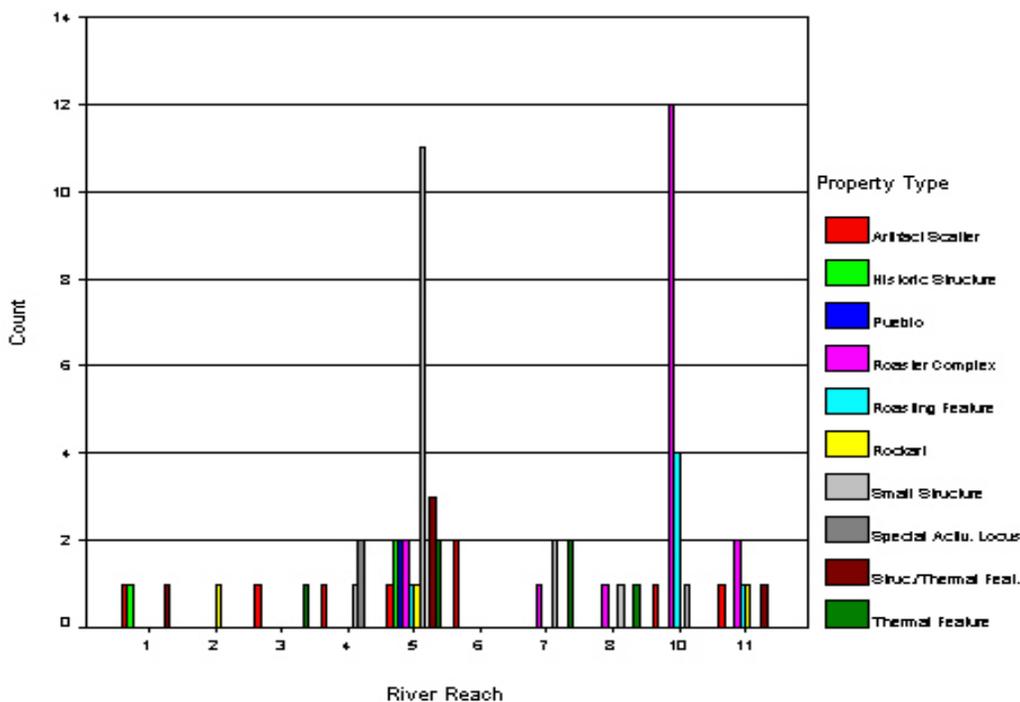
The site types within this year’s sample comprise of a variety of property types (see Figure 1). Roasting features and small structures comprise almost half the sample (34 or 49.3%). Small structures predominate in Reach 5 (mile 61.5 to 77.4). Roaster complexes predominate in Reach 10 (mile 159.9 to 213.8).

Figure 1. Sites monitored in FY03 by river reach and property type (N = 69 Sites).

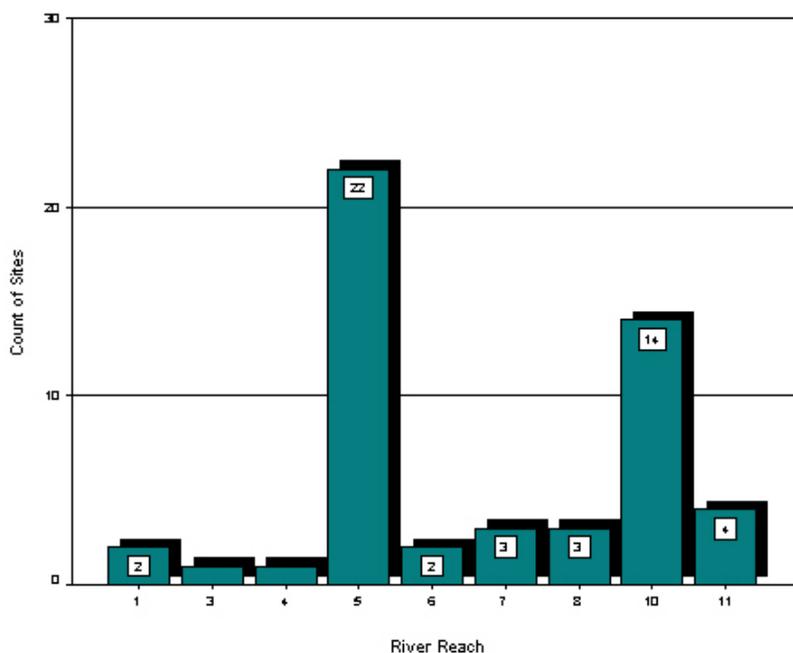
Most of the sites (36 or 69%) with active erosion are in Reaches 5 and 10 (Figure 2). Reaches 3 and 4 have the fewest number of sites with impacts (1 each). There is active erosion in 9 of the 13 river reaches along the river corridor.

Figure 2. Actively eroding archaeological sites by river reach, FY03 (N = 52 Sites).

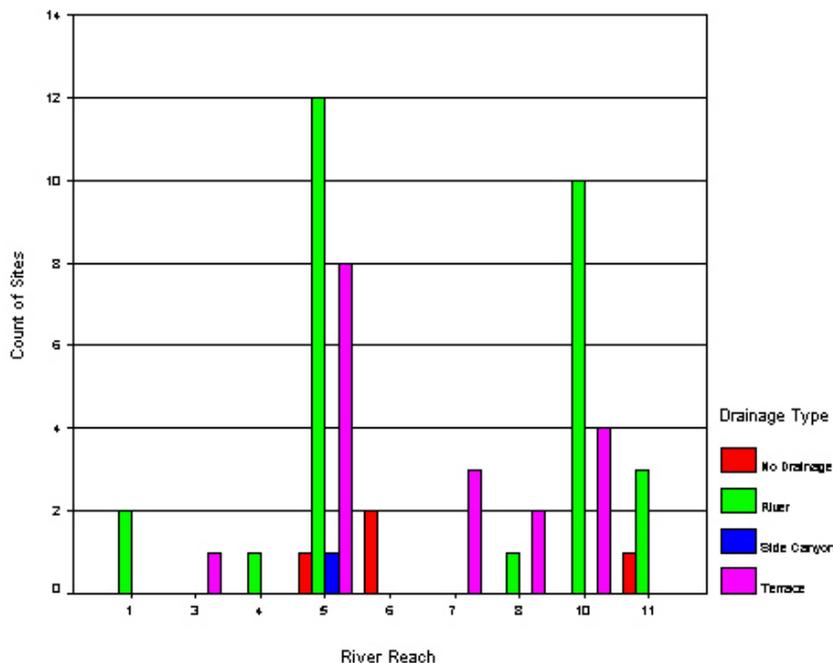
Sites with river and terrace-based drainages have been recorded as sustaining the greatest amount of damage due to actively occurring erosional processes (Figure 3). Sites with river-based drainages comprise 29 or 56% of the sample, while sites with terrace-based drainages comprise 35% (18). For this reason, RCMP archaeologists prioritize remedial actions based upon whether sites have river or terrace-based drainages. Most sites with river-based drainages are a top priority and many are recommended for data recovery. RCMP archaeologists have observed that sites with terrace-based drainages can often be successfully treated with a variety of preservation measures that do not require removal or destruction of cultural resources. These preservation measures include planting vegetation, installing checkdams or reseeding the areas with grasses.

Figure 3. Actively eroding archaeological sites by river reach and drainage type, FY03 (N = 52 Sites).

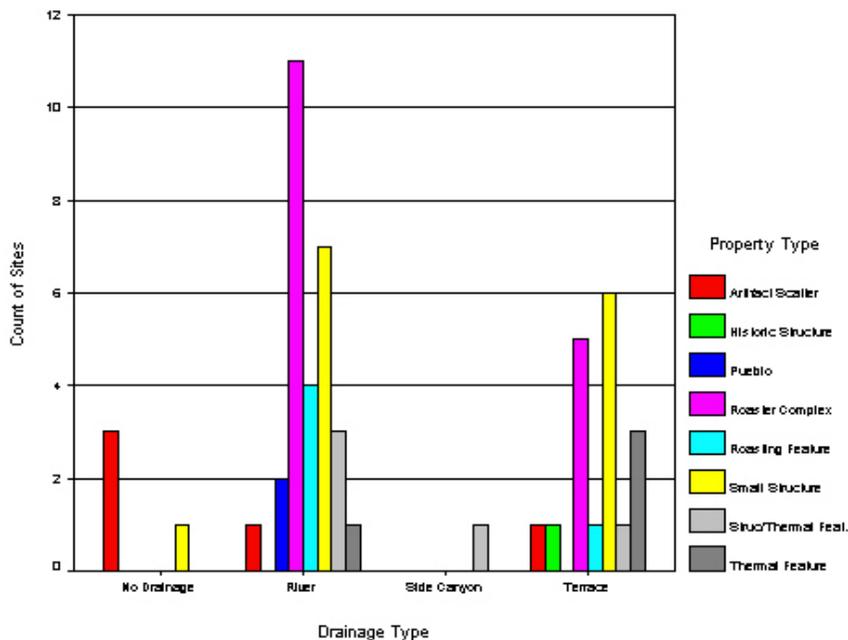
A variety of property types are sustaining loss of cultural material or site integrity along the river corridor (Figure 4 below). At most of the sites monitored in FY03 the physical impacts were recent (53 or 77% of sites). These impacts had occurred since the last monitoring visit. Sites actively eroding via river-based drainages include artifact scatters, roasting or thermal features and complexes, small structures, and pueblos. Sites actively eroding via terrace-based drainages include artifact scatters, historic structures, roasting or thermal features, and small structures.

Figure 4. Actively Eroding Archaeological Sites by Drainage and Property Type, FY03 (N = 52 Sites).

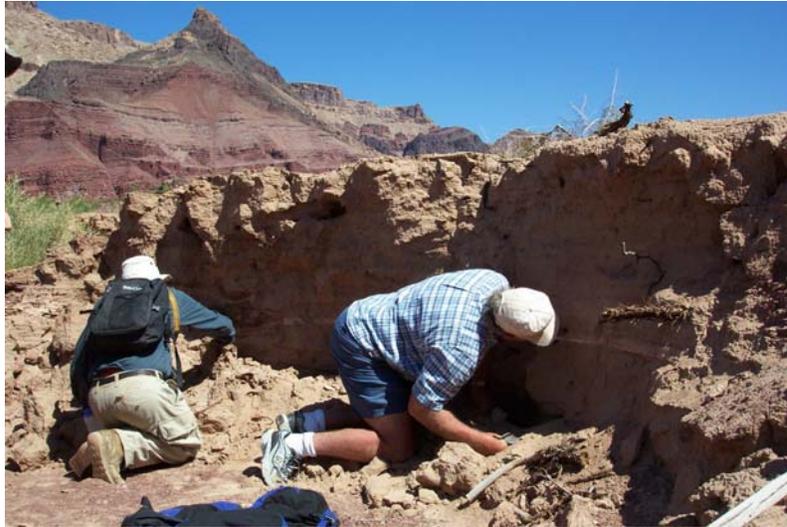
An ash-like, non-cultural sample was collected at C:13:273 on the eolian transport trip. This sample came from an extensive lens located near Feature 3 and extending toward the river's edge. Sedimentologists thought this lens could be volcanic. See Figure 13 for the location of the exposed white ash. USGS will analyze the sample. Table 9 lists the sites where samples were taken in FY03.

Figure 13. Dave Rubin, USGS sedimentologist and Fred Nials, geoarchaeologist prepare to collect samples for the eolian transport research (May 2003).
