Bridge Canyon Project, Arizona

Geology of the

UPPER GNEISS DAM SITE

March 1943

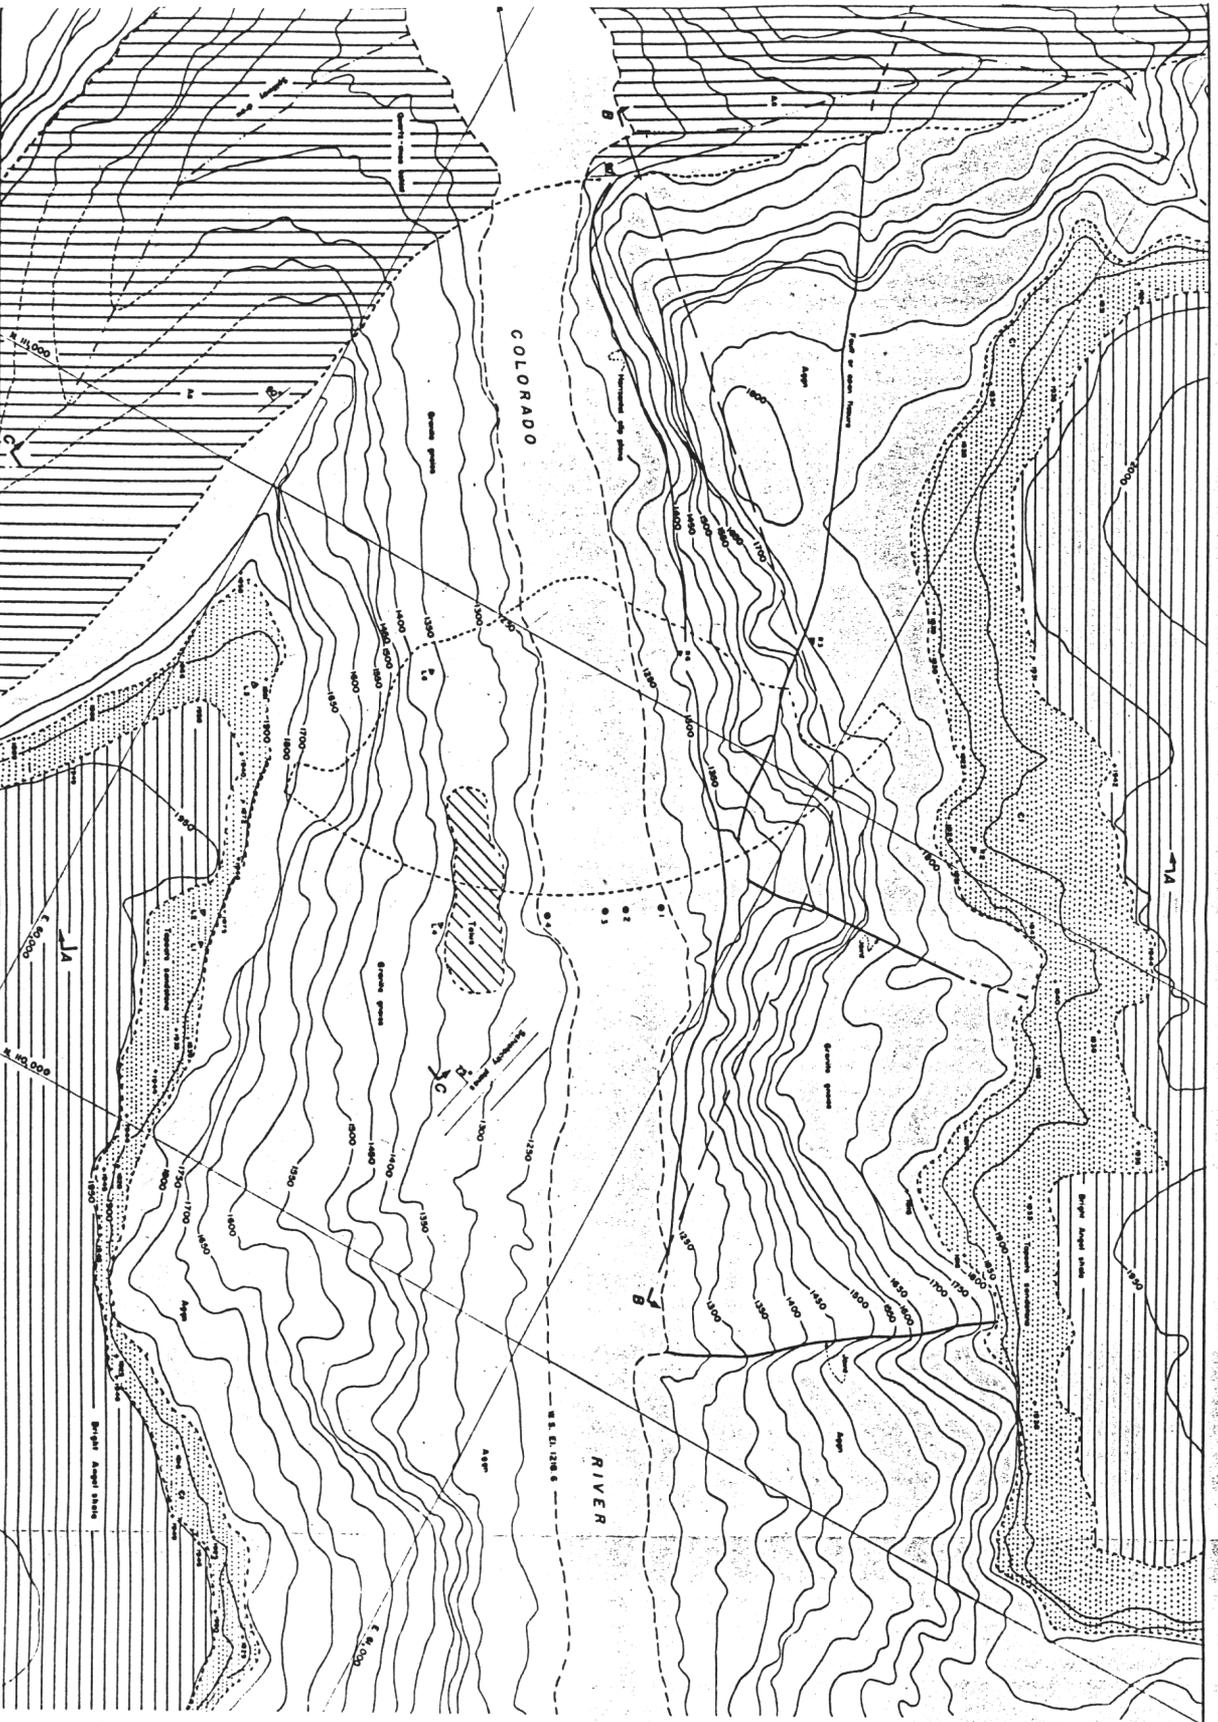
Prepared from field sketches and maps  
UNITED STATES  
DEPARTMENT OF THE INTERIOR  
BUREAU OF RECLAMATION  
BRIDGE CANYON INVESTIGATIONS, ARIZONA  
Geologic Map of the  
**UPPER GNEISS DAM SITE**  
Designed and Drawn by  
JAMES H. HARRIS  
Checked by  
W. H. HARRIS  
Project, Arizona, August, 1942

One is the fault or open fissure which is shown on the right abutment. See map and photographs. Although the affected zone is only 6" wide it has a marked topographic expression which shows up as a cleft in the hard gneiss. An exploratory drift is needed to completely evaluate conditions along this fault but from surface exposures it seems serious enough to require extensive special treatment, perhaps removal of the crushed material and backfilling with concrete. This area could be avoided by moving the axis upstream but the section is much wider here. The fault can not be traced to the river and it evidently does not extend beyond the point shown on the map.

The second defect is the horizontal slip or shear plane at about elevation 1300 which extends the full length of the right abutment and may be present on the left although it is not prominently exposed on the left abutment. This fracture is filled with a diabase sill downstream 1000 feet from the axis but the intrusive sill evidently is not continuous as it is not present where the fracture is exposed near the axis. This fracture is probably the result of horizontal thrusting during Pre-Cambrian
