# Hydrogeology and Deformation of Sandbars in Response to Fluctuations in Flow of the Colorado River in the Grand Canyon, Arizona

U.S. GEOLOGICAL SURVEY  
Water-Resources Investigations Report 95—4010

By MICHAEL C. CARPENTER, ROBERT L. CARRUTH,  
JAMES B. FINK, JAMES K. BOLING, and  
BRIAN L. CLUER

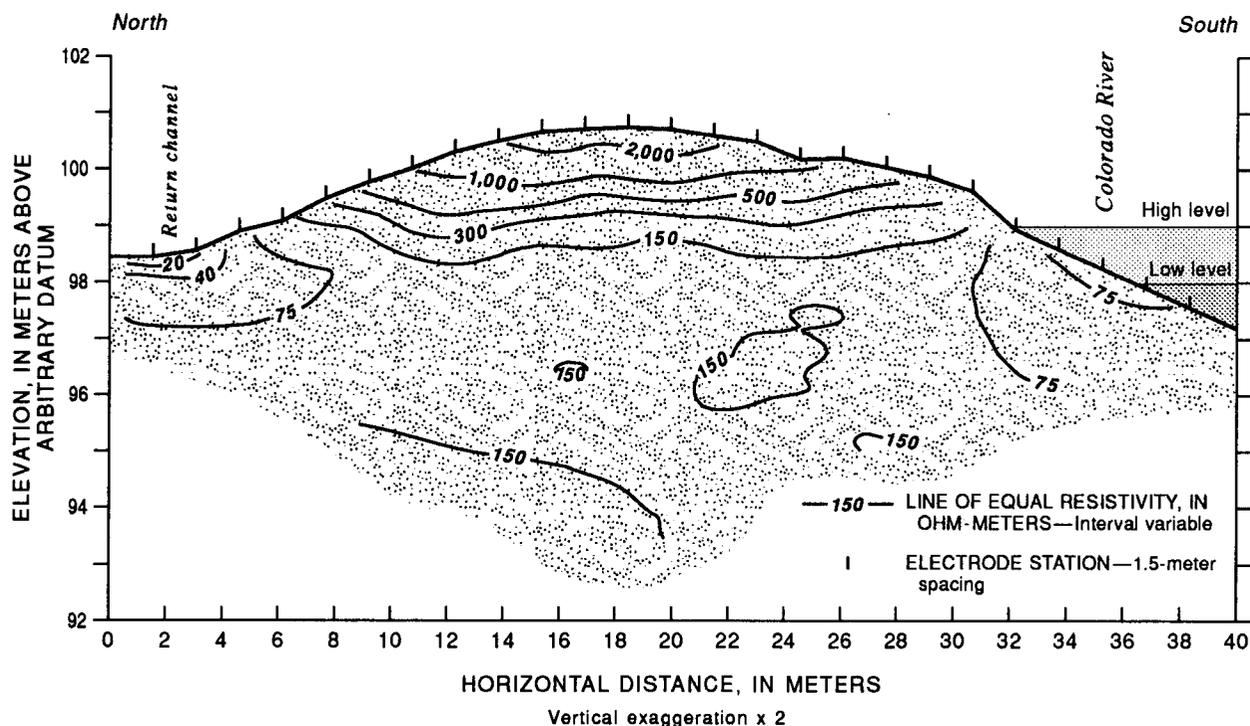
A single line of pole-pole DC resistivity was performed at sandbar 43.1L. The line was 36.5 m long and crossed the sandbar transversely, north to south, beginning at the base of the canyon wall next to outcrop and continuing across the elevated, dry-sand part of the sandbar, and down the sandbar face into the Colorado River approximately 1.5 m (fig. 4). The first 5 m of the line was in a return channel adjacent to the cliff base.

Apparent resistivities ranged from 50 to more than 2,000 ohm-meters ( $\Omega$ -m). The high apparent

resistivities were related to the dry-sand part of the sandbar that underlay approximately 18 m of the line. Data from the central part of the line were block-averaged and modeled using one-dimensional methods. Modeling results indicated that the dry sand had a true resistivity of about 3,800  $\Omega$ -m and a thickness of about 1.6 m (fig. 5, table 1). This thickness correlated well with the elevation of the dry-sand part of the sandbar above the average stage of the river during the measurement period. Low apparent resistivities occurred on both ends of the line where electrodes were either occasionally submerged in the river or in the return channel. Apparent resistivities in these areas ranged from 40 to 50  $\Omega$ -m, suggesting that the river-water resistivity was not any greater than

**Figure 4.** Modified logarithmic pseudosection of apparent resistivity referenced to land surface at sandbar 43.1L, opposite Anasazi Bridge, August 1991.

50  $\Omega$ -m. (A resistivity of 50  $\Omega$ -m is equivalent to an electrical conductivity of 200  $\mu$ S/cm.) Resistivity values of about 40  $\Omega$ -m occurred in the return channel. These resistivity values probably were lower than the river water because of the clay content in the sediments underlying the return channel or greater dissolved solids in the stagnant return-channel water.

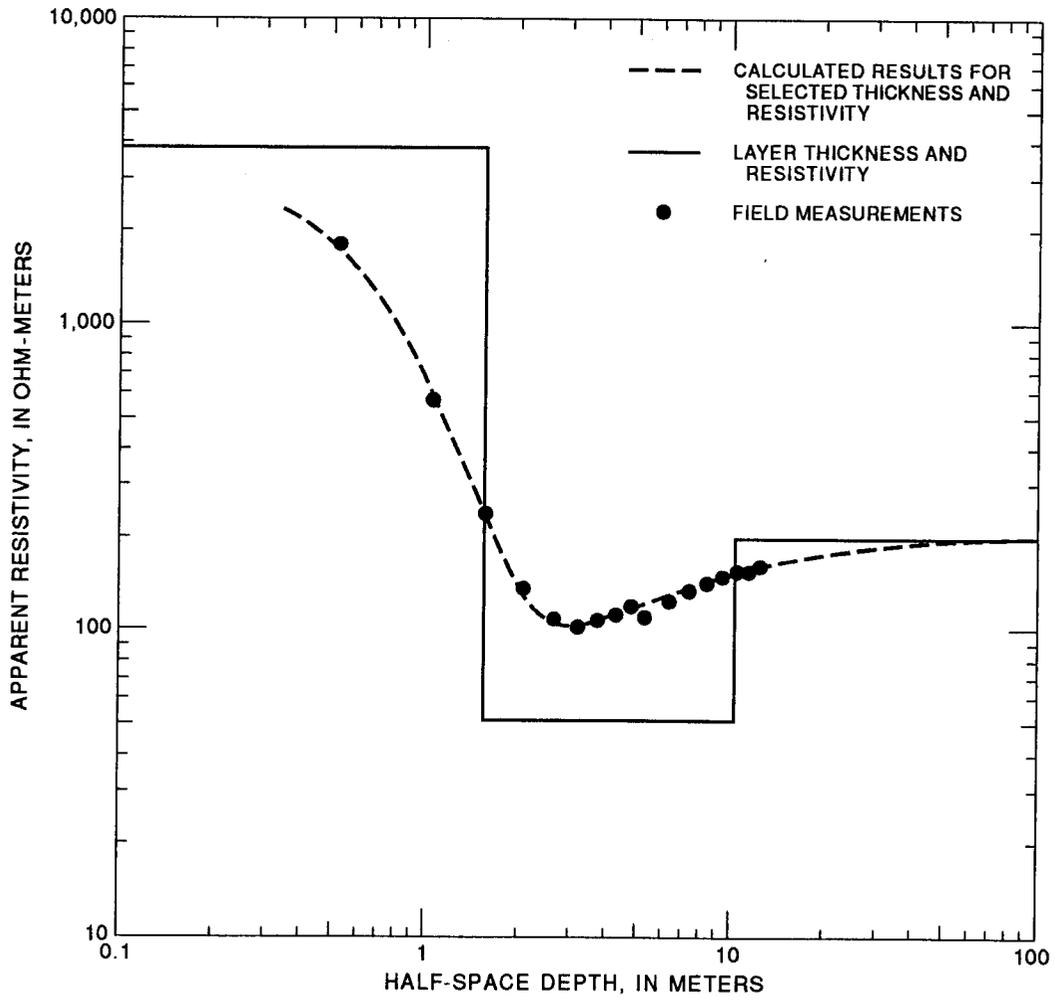
Modeling yielded a higher true resistivity for the third layer that may represent electrical bedrock. The maximum depth penetrated by any of the piezometers was approximately 10 m. Bedrock was not encountered nor was there any significant change observed in grain size that might indicate penetration of a basal gravel or talus. On the basis of the resistivity data, bedrock may have been just

**Figure 5.** Block-averaged, apparent resistivity from sandbar 43.1L, opposite Anasazi Bridge, in relation to theoretical half-space depth of investigation.

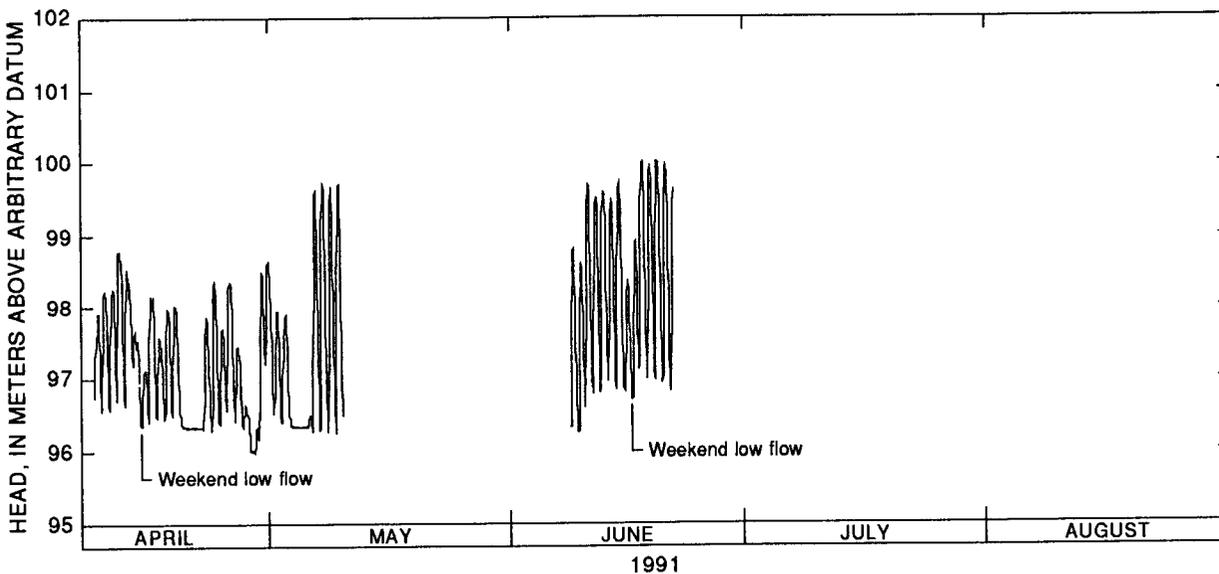
Figure 7. River stage at sandbar 43.1L, opposite Anasazi Bridge, April 8 through June 21, 1991.

failure on this sandbar was oversteepening of the lower part of the slope in the zone of fluctuating river stage. This conclusion was supported by evidence of rill erosion in daily photographs taken automatically from the opposite bank (Cluer, 1991). Rilling was enhanced during fluctuating weekend low flows (fig. 7). Rilling was intense after about 1.5 days during research steady low flows.

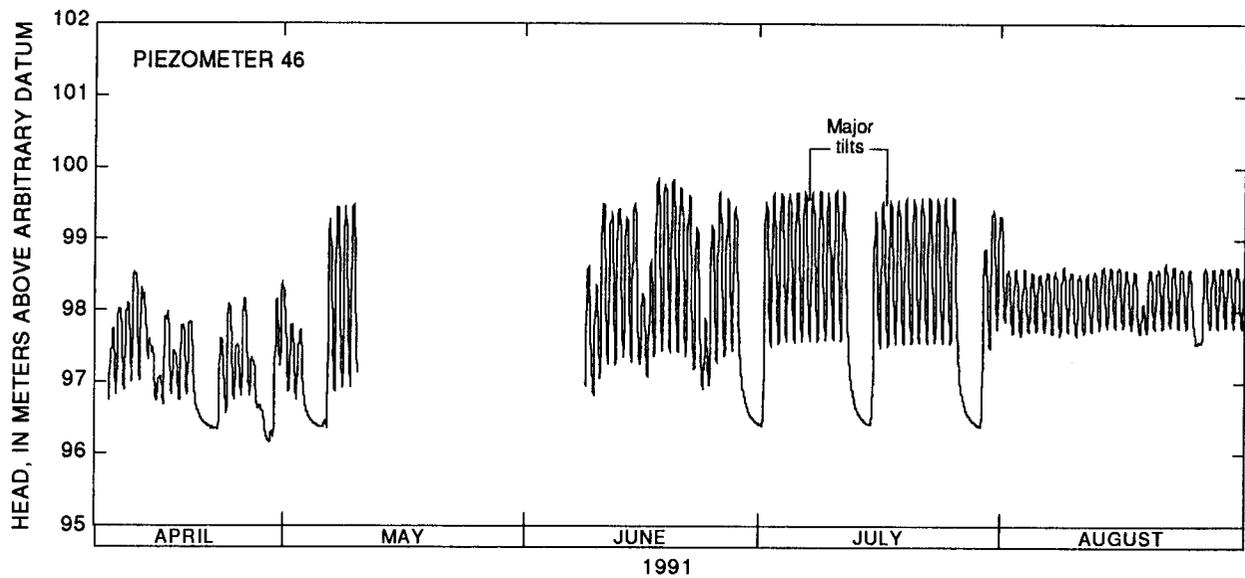
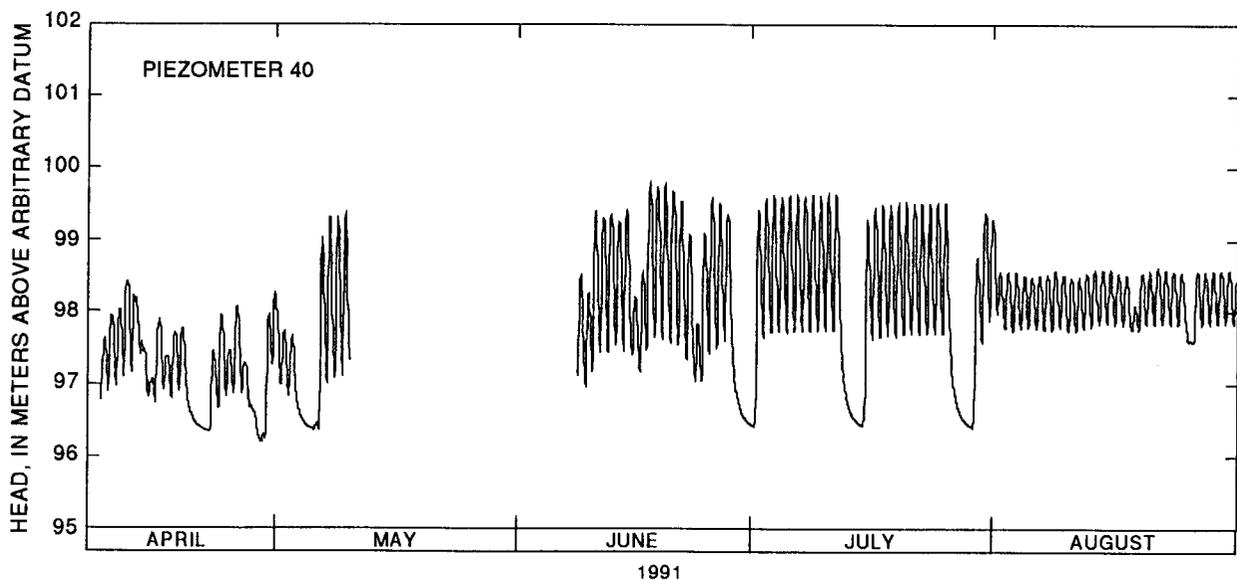
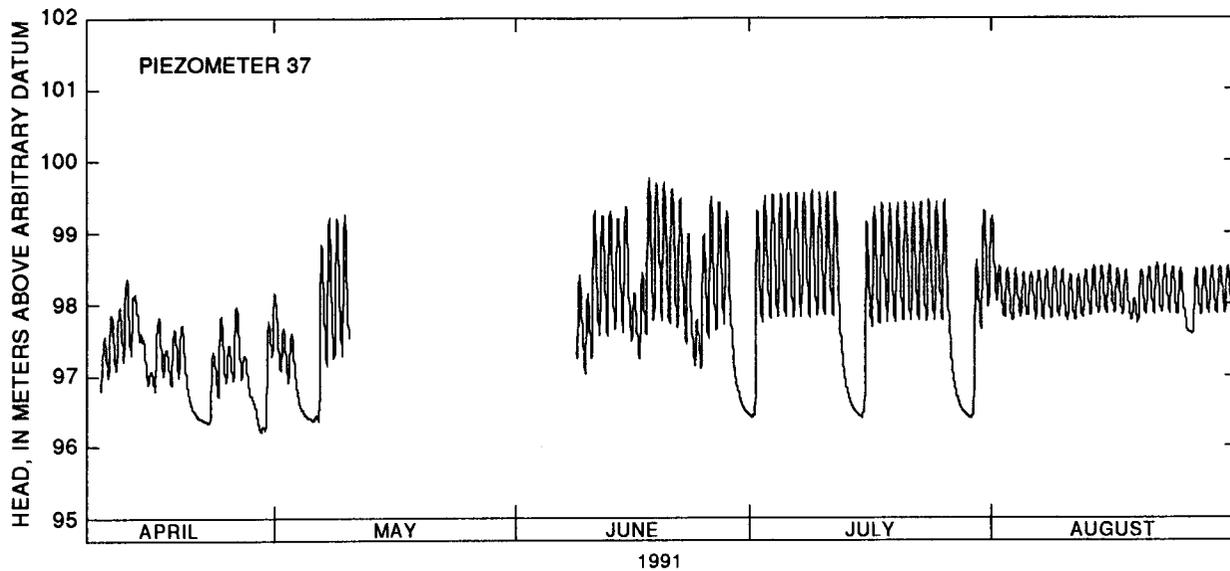
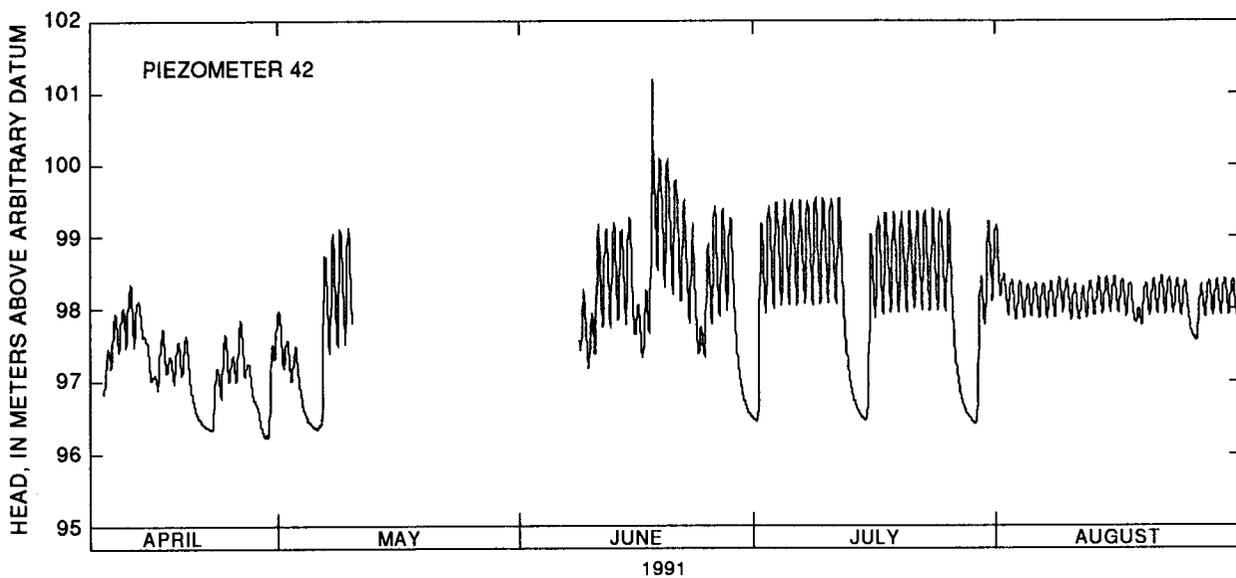
**Figure 8.** Water level in piezometer 46 at sandbar 43.1L, opposite Anasazi Bridge, April 8 through August 31, 1991.

**Figure 9.** Water level in piezometer 40 at sandbar 43.1L, opposite Anasazi Bridge, April 8 through August 31, 1991.

**Figure 10.** Water level in piezometer 37 at sandbar 43.1L, opposite Anasazi Bridge, April 8 through August 31, 1991.

**Figure 11.** Water level in piezometer 42 at sandbar 43.1L, opposite Anasazi Bridge, April 8 through August 31, 1991.

Attenuation of water-level fluctuation from the front to the back of sandbar 43.1L was evident at piezometers 46, 40, 37, and 42 (figs. 9–11). From piezometer 46 to piezometer 42, the attenuation of fluctuating July flows was 30 percent over a distance of 30 m. The particularly high water level in piezometer 42 beginning on June 17, 1991, (fig. 11) may have been caused by hydraulic

connection to an upstream part of the return channel or overpressurization by a process such as temporary sealing of a zone accompanied by swelling of clays. Piezometer 42 exhibited no evidence for movement or failure throughout its record.

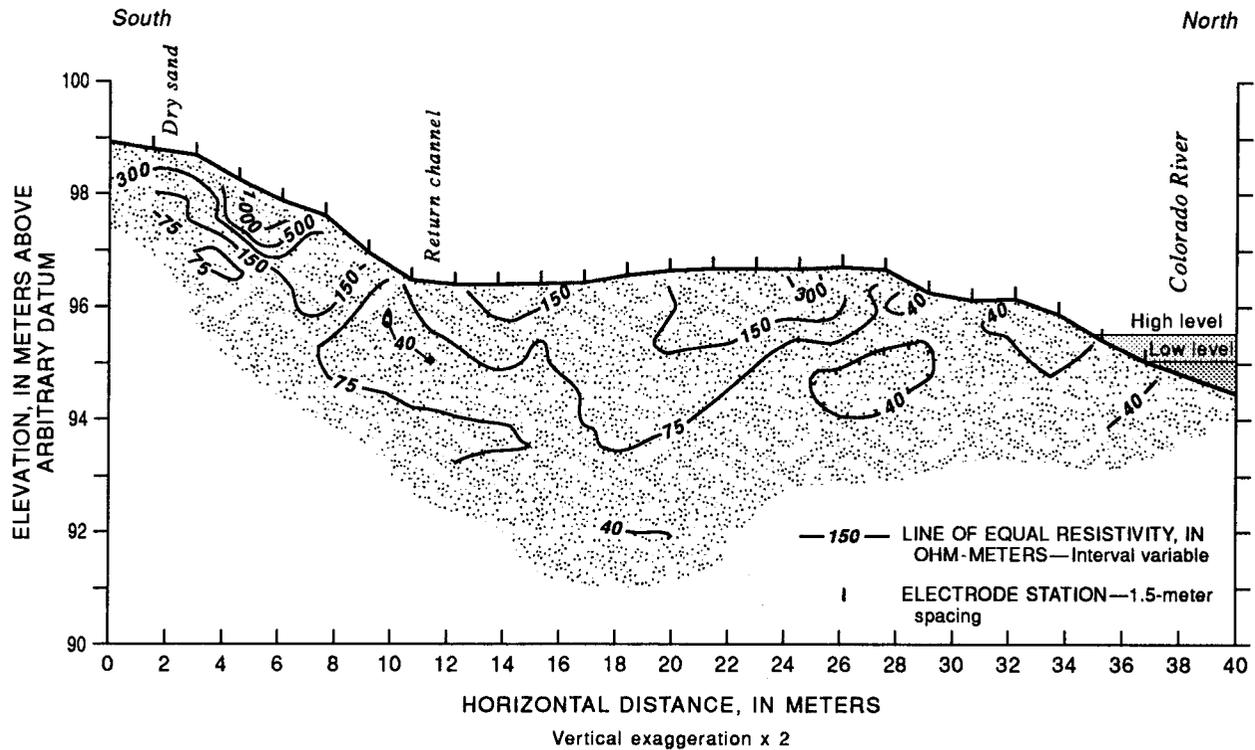
A single line of pole-pole DC resistivity was performed at sandbar 172.3L. The line was 38 m long and crossed the sandbar transversely, south to north, beginning at the base of the talus slope and continuing across the elevated, dry-sand part of the sandbar down the sandbar face into the Colorado River (fig. 13). The first 9 m of the line was in an elevated, dry-sand part of the sandbar. The central part of the line crossed a silty, very fine sand bench for approximately 17 m before dropping off the sandbar face. The north end of the line terminated 3 m into the river. The topography of this survey line was more irregular than the line at sandbar 43.1L and resulted in greater localized variations in the observed apparent resistivities. Well-defined layered-earth responses were not evident in the data, and one-dimensional modeling was not applied.

Apparent resistivities ranged from 25  $\Omega$ -m to greater than 1,000  $\Omega$ -m. The highest values were associated with dry sand at the south end of the line and near the top of the sandbar. Although the central part of the line was well vegetated and had a higher percentage of silt and clay, the associated apparent resistivities were greater than 100  $\Omega$ -m. A decrease in apparent resistivity with increasing spacing in the central part of the line suggested a more conductive lower horizon, but effects caused by surface topography or perhaps lateral changes in porosity or permeability masked the deeper effects. Drilling encountered obstacles at depths ranging

The two most salient features in the apparent resistivity pseudosection were the two lows associated with sharp changes in topography. The low near the return channel was likely restricted to changes in topography. The low beneath the bench on the sandbar face appeared to be related to a combination of changes in topography and subsurface lithology. The inferred subsurface change may have been caused by a facies change or a zone of increased porosity.

**Figure 13.** Modified logarithmic pseudosection of apparent resistivity referenced to land surface at sandbar 172.3L, downstream from the mouth of National Canyon, August 1991.

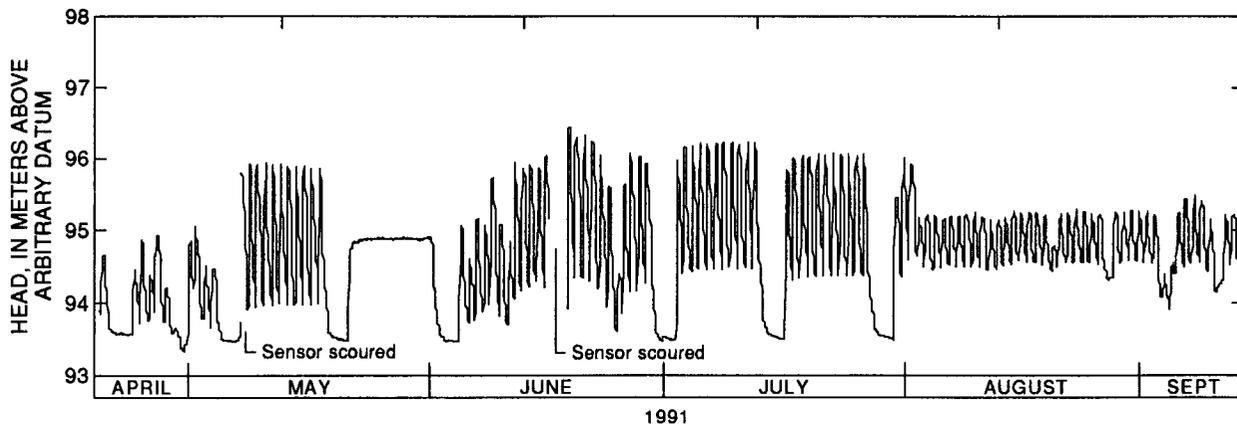
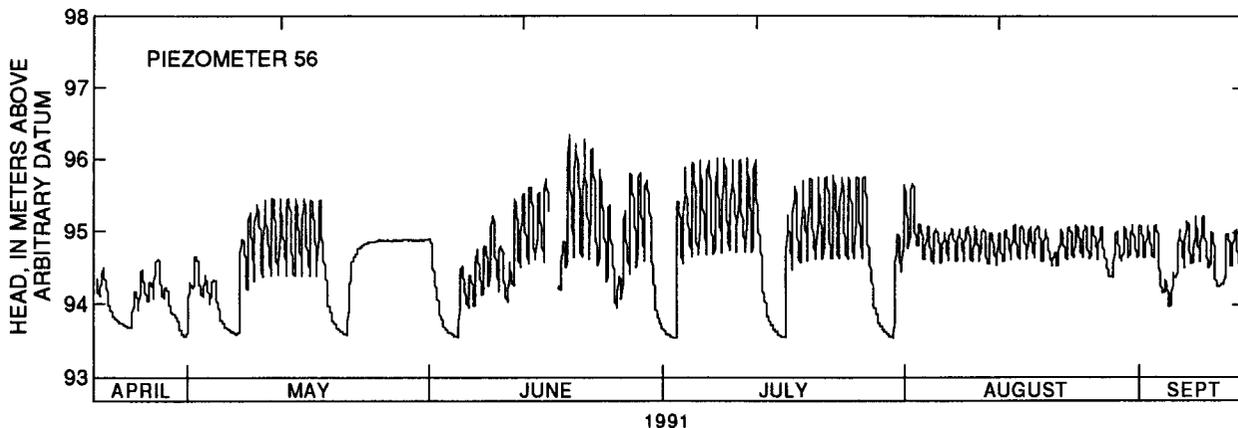
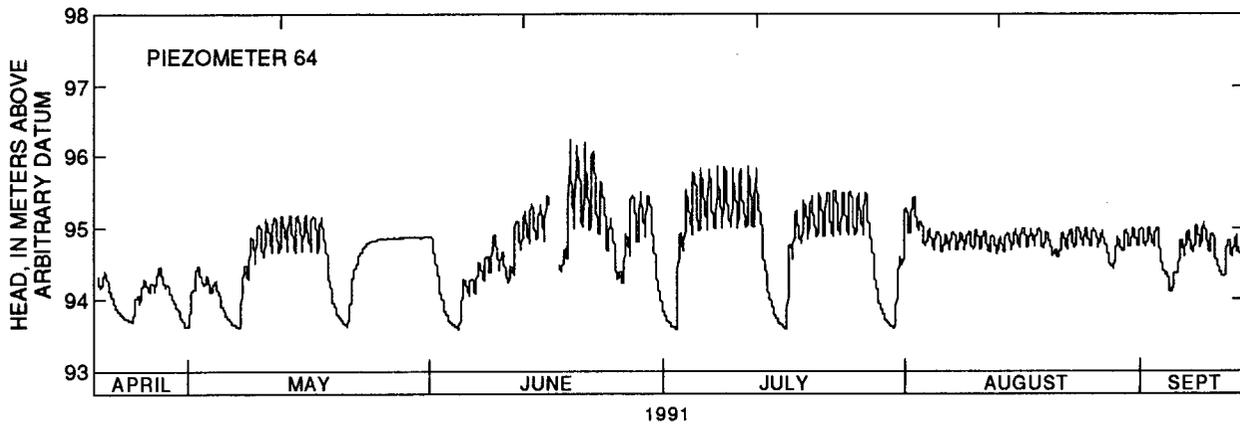
At sandbar 172.3L, attenuation of water-level fluctuation was about 30 percent from the stage sensor to piezometer 56 and 65 percent from the stage sensor to piezometer 64 over a distance of 35 m (figs. 15–17). Water-level fluctuations were less attenuated at piezometer 56 after the June 18, 1991, scour that deepened the stage sensor. The stage sensor was scoured and buried successively 1.3 m and 1.8 m on May 7 and June 18, 1991. The change in attenuation from the stage sensor to piezometer 56 probably was caused by the

**Figure 15.** River stage at sandbar 172.3L, downstream from the mouth of National Canyon, April 19 through September 12, 1991.

**Figure 16.** Water level in piezometer 56 at sandbar 172.3L, downstream from the mouth of National Canyon, April 19 through September 12, 1991.

**Figure 17.** Water level in piezometer 64 at sandbar 172.3L, downstream from the mouth of National Canyon, April 19 through September 12, 1991.
