Sonar Patterns of the
Colorado Riverbed in the Grand Canyon

SONAR PATTERNS
OF THE COLORADO RIVERBED IN
THE GRAND CANYON

Distinctive patterns on side-scan sonar charts and depth-finder charts were used to delineate smooth bottom, sediment waves, and boulders and bedrock outcrops on the bed of the Colorado River in the Grand Canyon, Arizona.

By Richard P. Wilson
Water Resources Division
U.S. Geological Survey
Tucson, Arizona

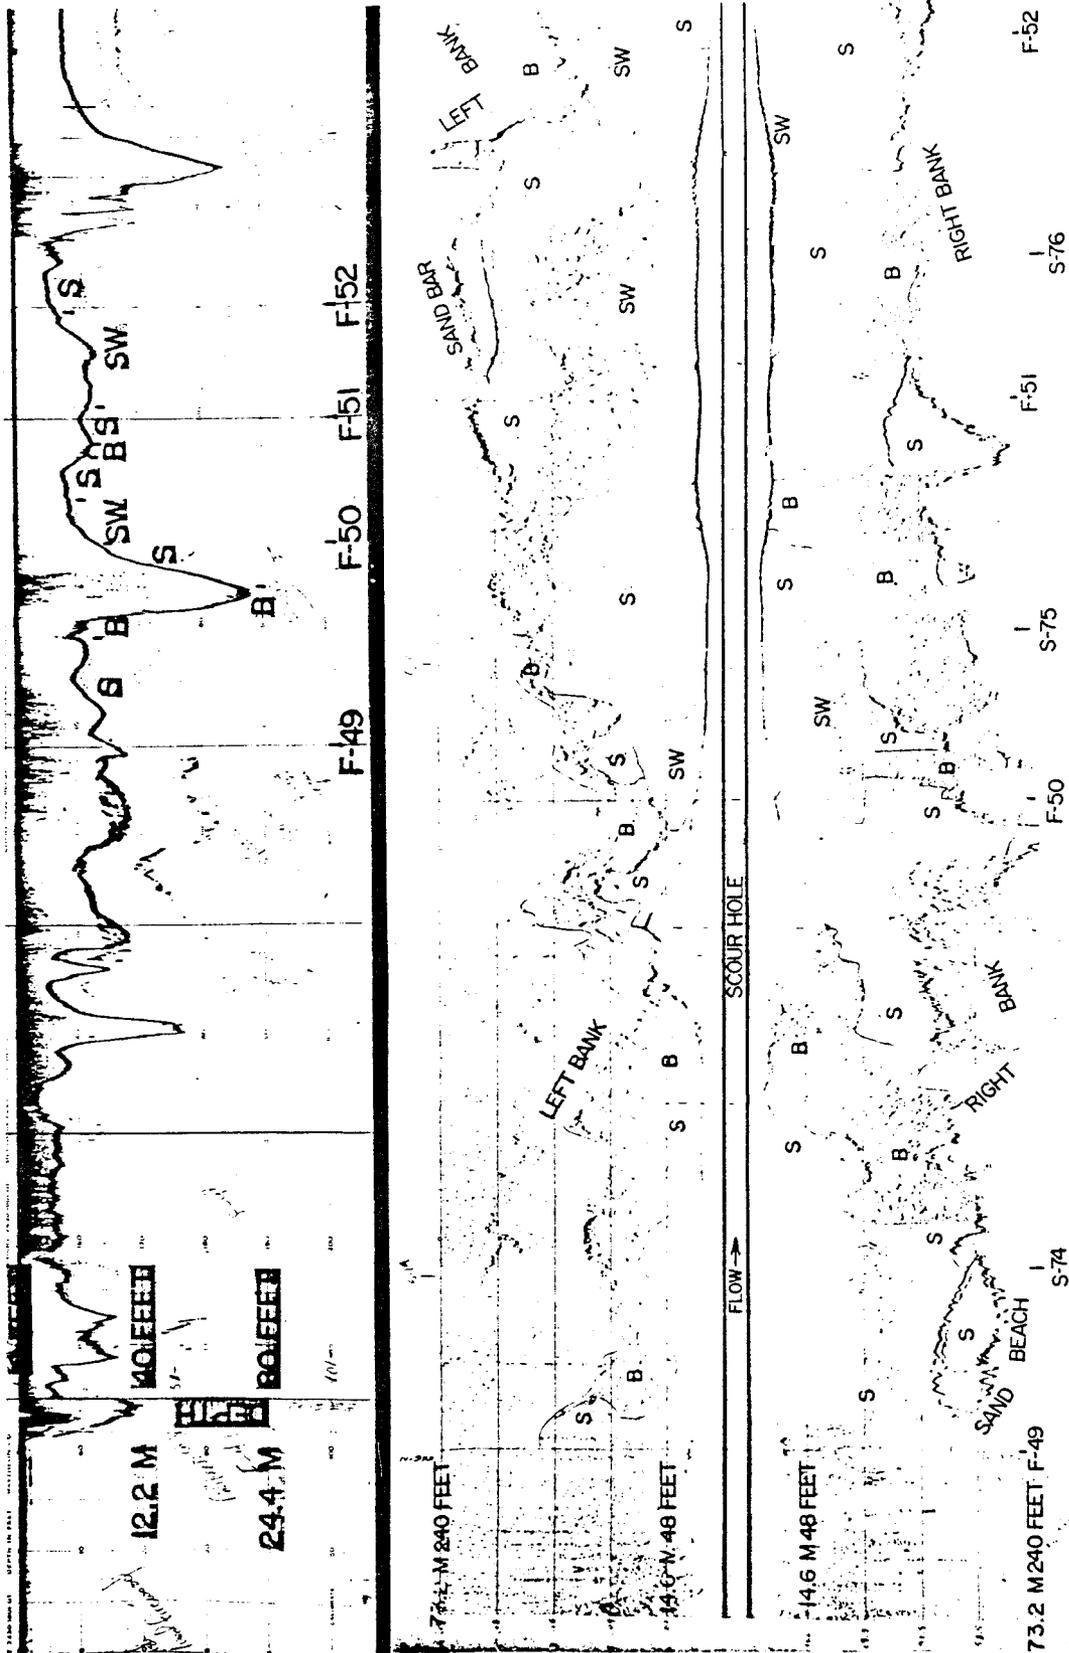
Figure 2. Uncorrected side-scan sonar and Fathometer charts.

SIDE-SCAN SONAR PATTERNS. A side-scan sonar pattern is produced by multiple sonic reflections from particles and surface features of an area of riverbed. The location and shape of accumulations of movable sediment on the riverbed that produce side-scan sonar patterns are a function of sediment particle size, current-velocity pattern, and length of time a particular velocity pattern has existed. The particles are stored and distributed in an organized way in the sediment accumulations as a result of the variations in local current velocity. Side-scan sonar images on the chart are divided visually into three patterns: B = boulders and bedrock; S = smooth bottom; and SW = sediment waves. See Figure 2 for an example of a side-scan sonar pattern.

ANALYSIS AND DISPLAY OF PATTERN DATA. The sonar patterns contain three distortions that must be corrected in order to make geometrically correct maps. A sonar-pattern map derived from part of the uncorrected chart in Figure 2 is shown in Figure 4. The distance axis is traced out by the fish as the boat travels down the river. The plotting position of the distance-coordinate values (miles below Lees Ferry) vary because of changes in boat speed and flow velocity. The digitized distance coordinates were corrected by linear interpolation between navigation points using assigned mileages interpreted from the 1923 USGS maps. Bottom reflections on each side of the fish appear on the range axis of the chart at a point farther than their true position from the distance axis (Figure 5). The range-coordinate value is decreased by an amount that varies from 0 near the river banks to the distance of the fish above the bottom for reflections directly beneath the fish. The corrections are determined from the depth profile and the bottom and bank slopes. Data from the 224 cross sections are used to estimate the slopes. Generalized cross section geometry and range-correction equations are shown in Wilson (1986). The third correction required is to bend the distance axis to conform to the actual curving course followed by the boat as it traveled down the river. The river generally is narrow with respect to bend radii, and only a few miles of wide meandering channel are present in the canyon. The error in computation of pattern areas caused by this distortion is probably small compared to the errors of range and distance. This third correction was not made and the patterns are plotted and areas are computed using the distance axis as a straight line.

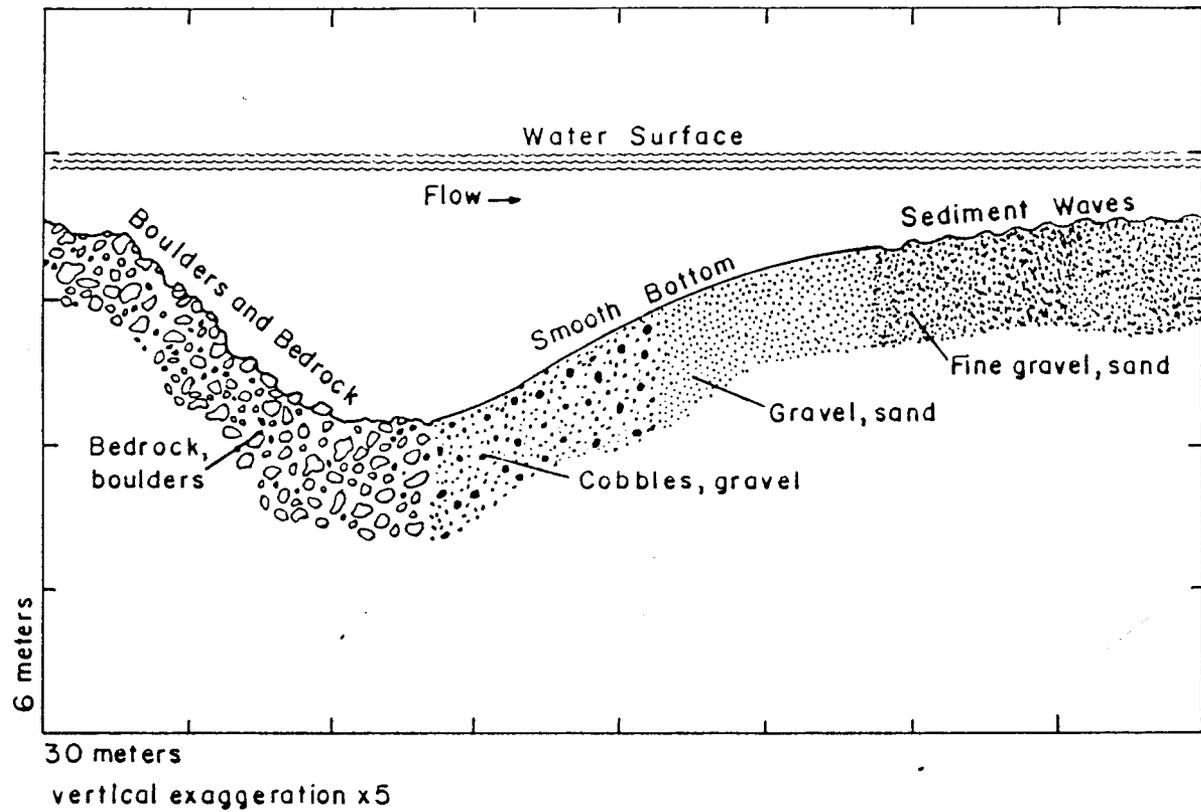
Figure 3. Generalized scour-hole profile, location of side-scan sonar patterns, and bed material.

Scour holes more than 1.5 times deeper than the local mean depth occur below many rapids and riffles. The scour holes are a local feature that owe their location to the high-energy level generated by fall through rapids. Scour is displaced and concentrated below the rapids because the boulder bed of the rapids is resistant (Howard and Dolan 1981). Many of the holes display a characteristic pattern on the depth profile. Rough bottom of boulders and bedrock slopes downward to the scour-hole bottom on the upstream side. Smooth bottom begins in the bottom of the hole or at the base of the downstream side and continues downstream as depths decrease until sediment waves appear. The slope of the downstream side changes smoothly from about one-half the upstream value to 0 (Figure 3). Bed material samples suggest that the bottoms of the holes consist of cobbles and gravel that become finer downstream and change to fine gravel and sand that form sediment waves. Only a small amount of sand is stored in the holes during a sustained discharge of 25,000 cfs. Current velocity in the holes remains greater than in the pools downstream and prevents significant accumulation of sand. The sediment deposited in the hole by a previous flood probably coarsens downward to the point of maximum scour because the particles that accumulate on the bottom become smaller as velocity and discharge decrease during the flood recession.

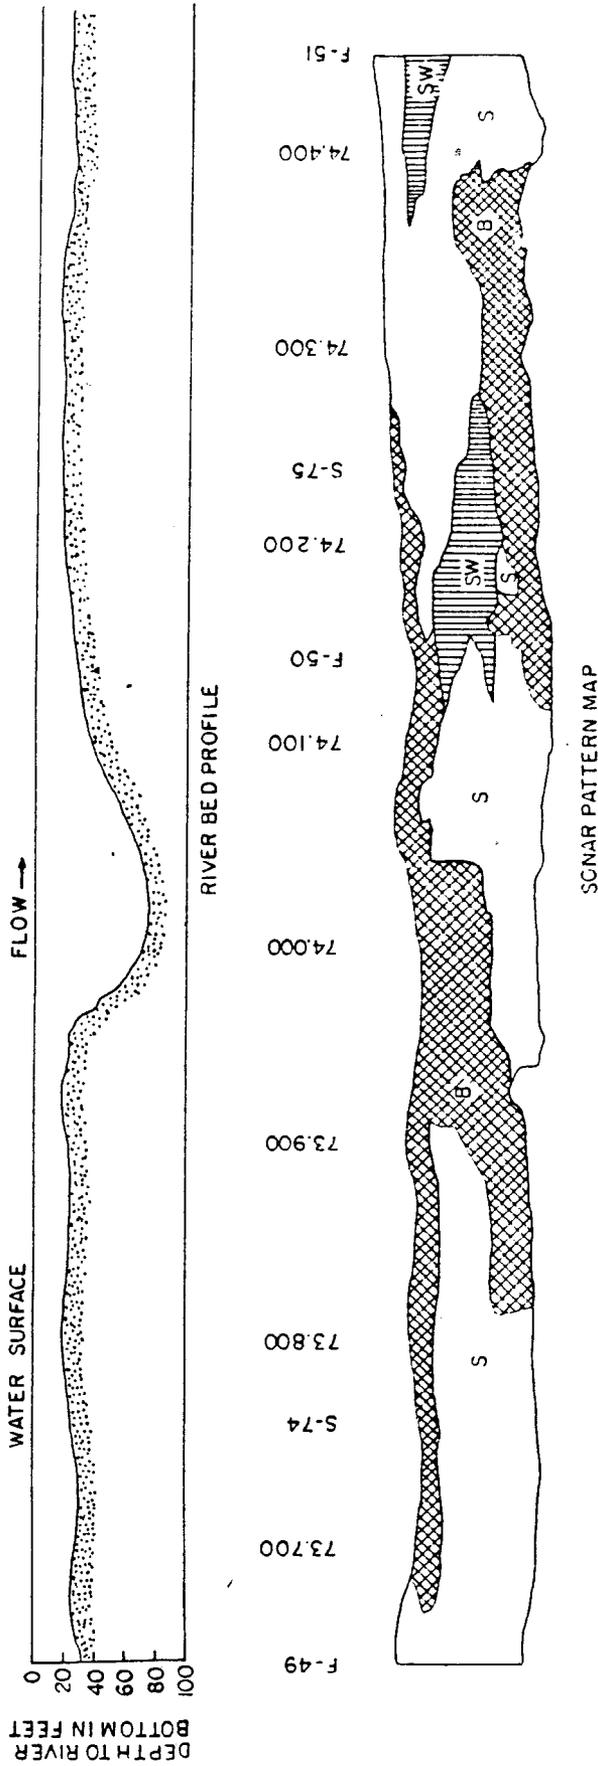
Figure 4. Example of a sonar-pattern map of reach F49F51.

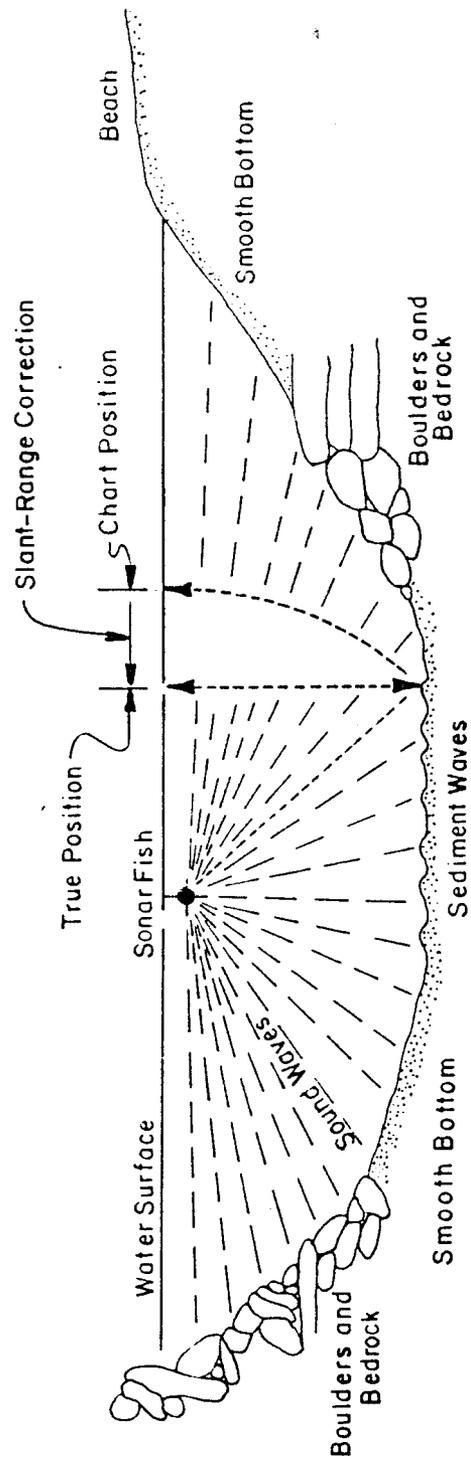
Figure 5. Sonar slant-range correction.
