**DEBRIS FLOWS FROM TRIBUTARIES OF THE COLORADO RIVER,  
GRAND CANYON NATIONAL PARK, ARIZONA**

Open-File Report 87-118

By Robert H. Webb, Patrick T. Pringle, and Glen R. Rink

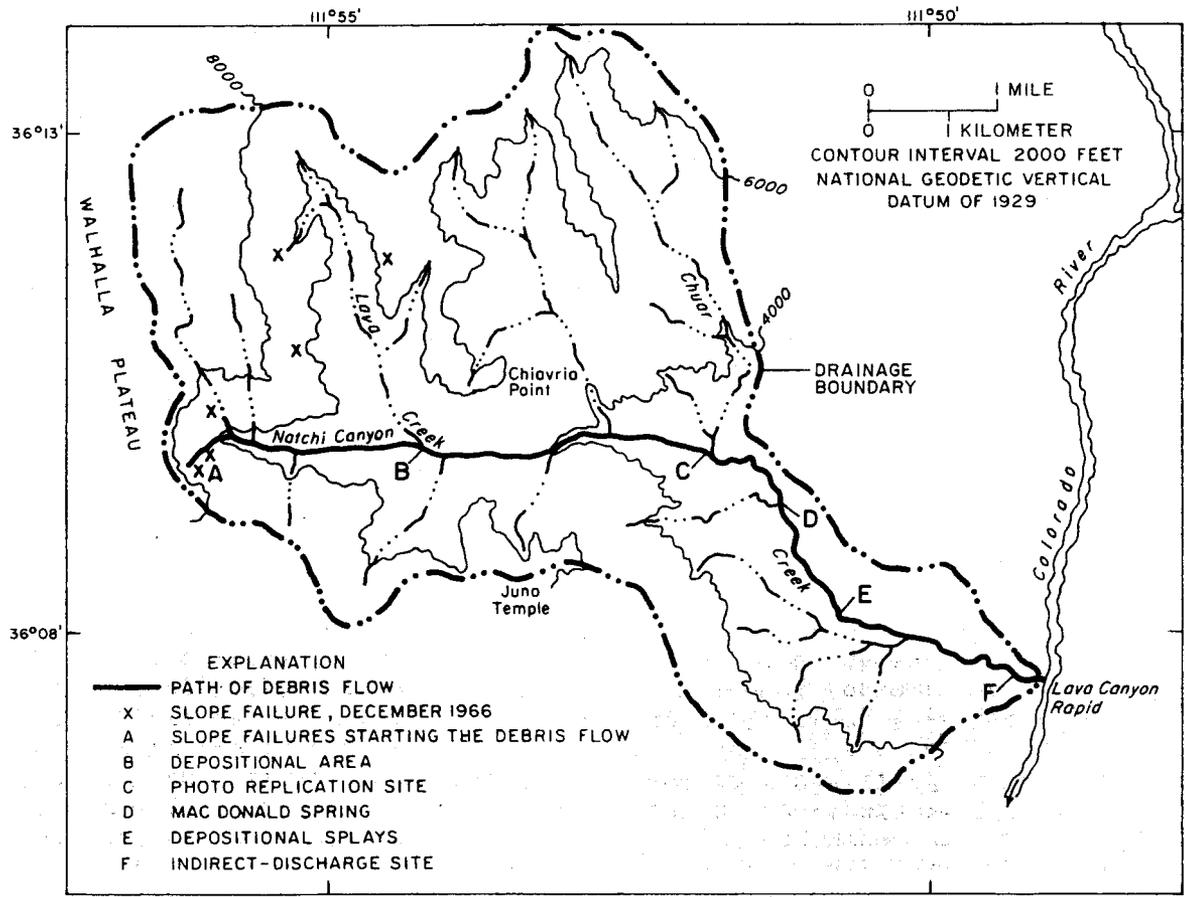
Figure 2.--The Lava-Chuar Creek drainage at mile 65.5 on the Colorado River.

Evidence for at least five prehistoric debris flows is preserved in prominent terraces along Lava Creek (fig. 4). Hyperconcentrated-flow deposits and possible channel-fill facies of additional debris flows also were found. Sediments are preserved as much as 12 ft above the channel bed of 1986 near the Colorado River and as much as 20 ft above the channel bed in the narrow reaches near the headwaters. Driftwood lodged in a debris-flow deposit (symbol Z; fig. 4) 12 ft above the channel bed of 1986 had a radiocarbon date of  $250 \pm 80$  yrs BP (years before present) (sample number A-4543). This deposit could not be traced downstream from site B (fig. 2). Radiocarbon dating of entrained wood in debris-flow deposits X and W (fig. 4) indicate maximum dates of  $625 \pm 65$  (AA-1787) and  $1,460 \pm 60$  (AA-1788) yrs BP for these debris flows, respectively. The youngest of these events (X) had a hyperconcentrated-flow facies associated with the deposit. On the basis of deposit thickness and height above the channel, the debris flows W, X, and Y had little attenuation in stage in the 3-mi reach between sites E and F (fig. 2) and reached the Colorado River.

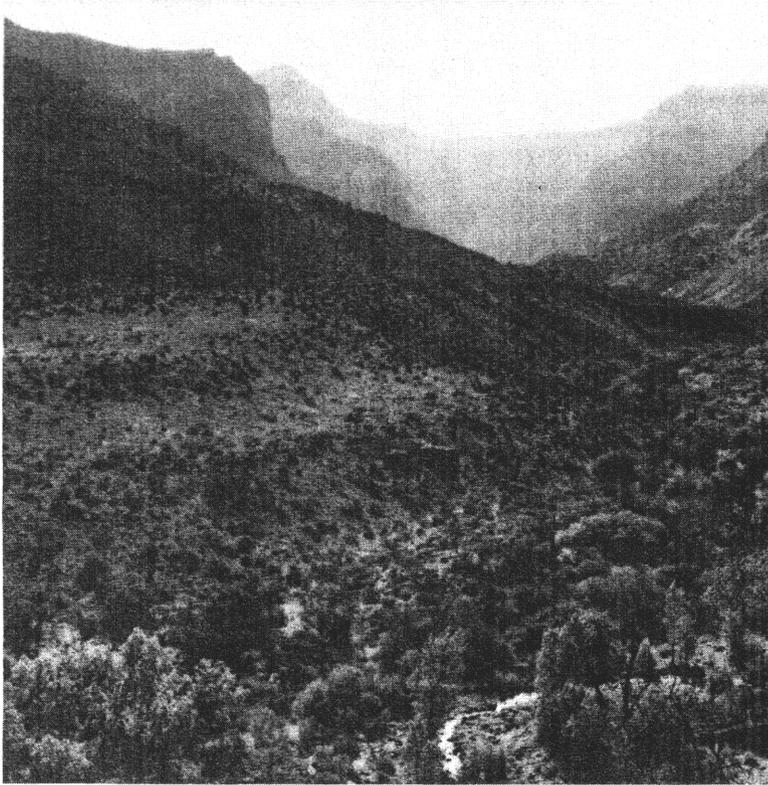
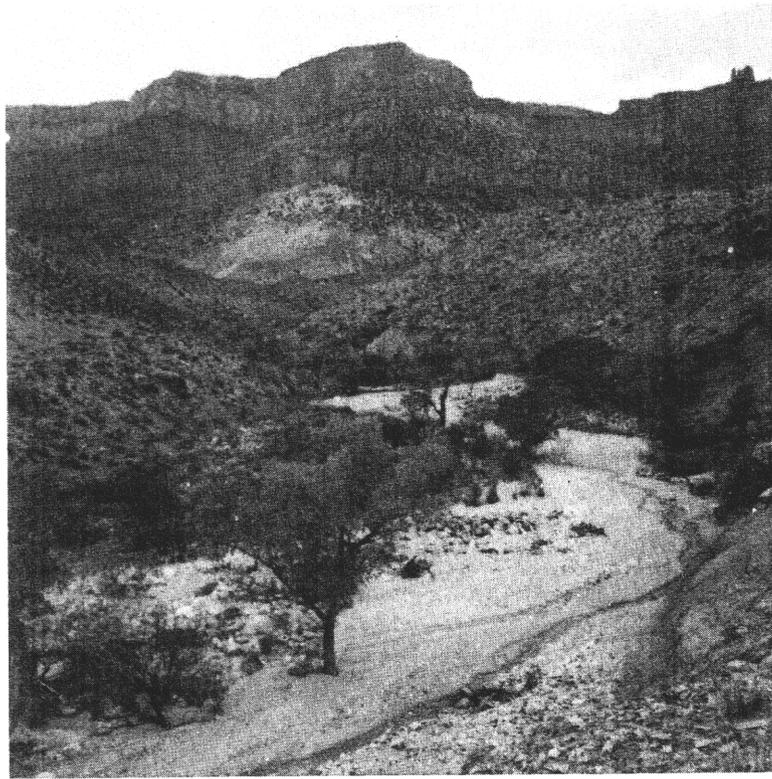
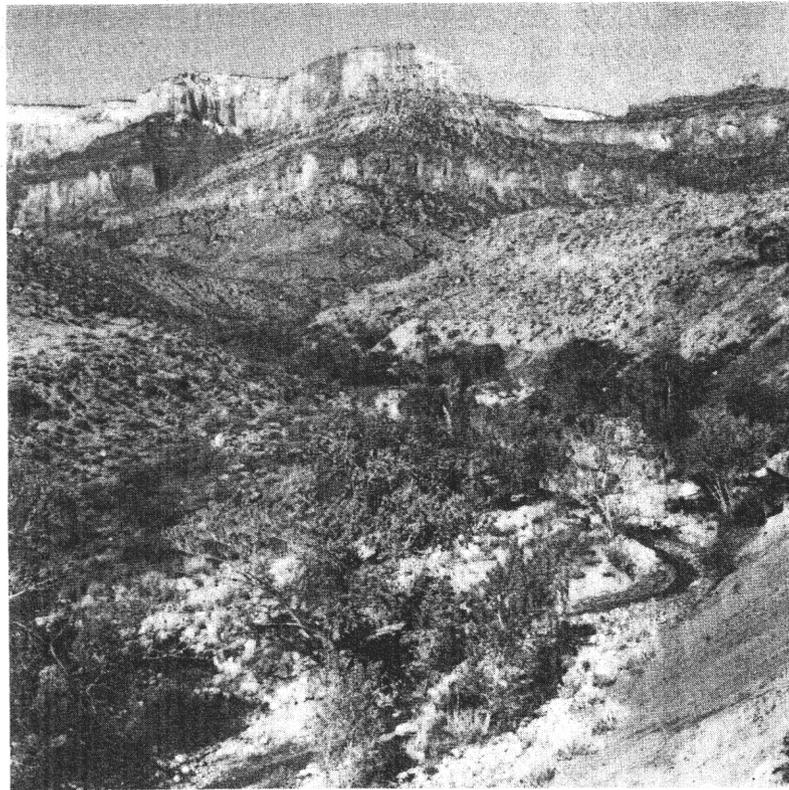
Figure 3.--Lava Creek at the confluence with Chuar Creek, 3.8 miles upstream from the Colorado River. View B is slightly different from A and shows significant channel alteration following the 1966 debris flow. View C matches B and shows revegetation and entrenchment of the channel after the 1966 and subsequent debris flows.

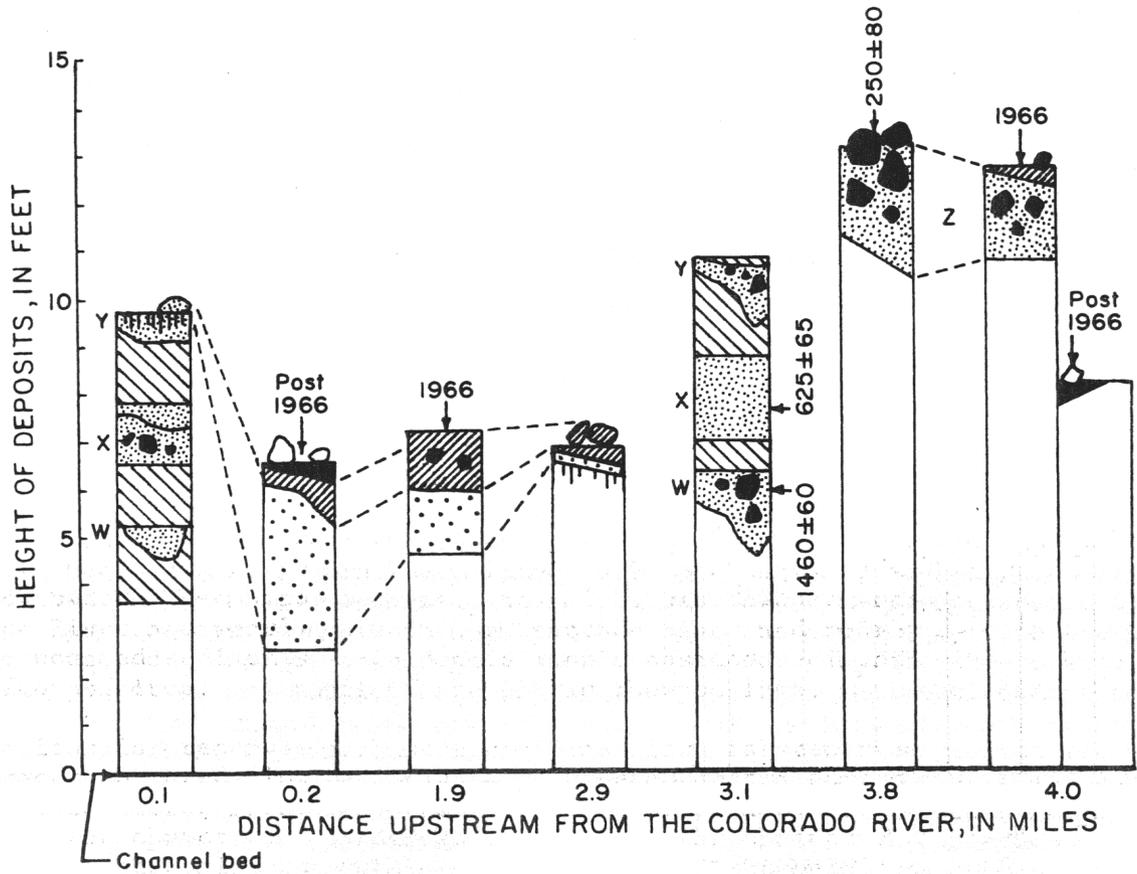
Figure 4.--Stratigraphy of debris-flow deposits in the Lava-Chuar Creek drainage.

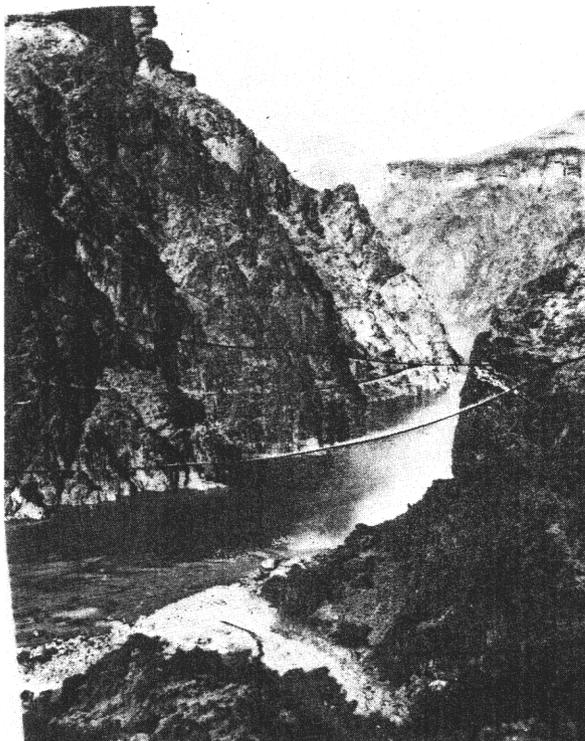
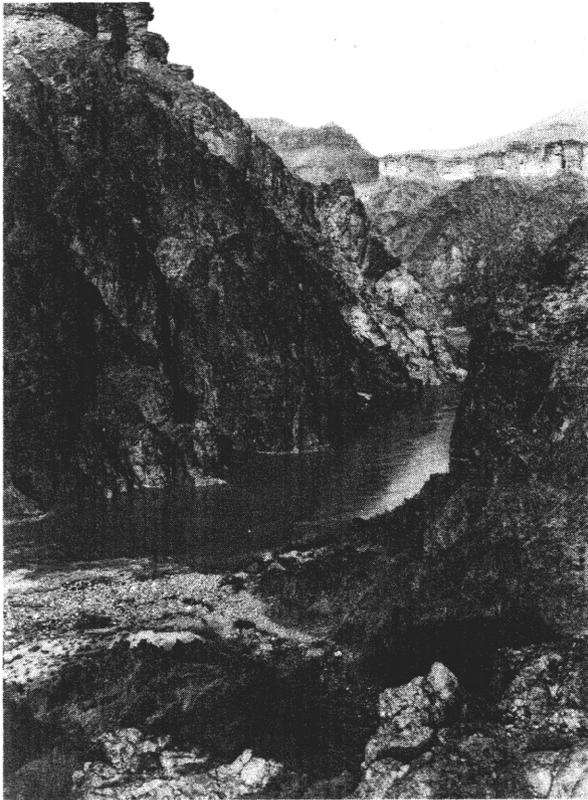
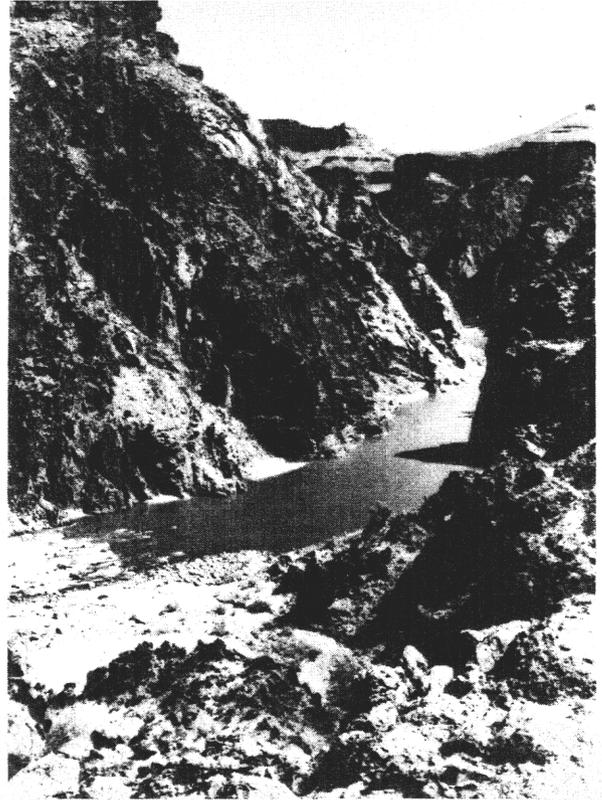
Figure 8.--The mouth of Monument Creek. In view A, the discharge in the Colorado River apparently is between 20,000 and 25,000 cubic feet per second. Curved lines in the center of the photograph are cracks in the original glass-plate negatives. In view B, the discharge in the Colorado River is about 8,000 cubic feet per second. The river appears to be more constricted than in 1872 despite differences in discharge, and a debris flow that occurred 2 to 7 years prior to the photograph date may have contributed to the constriction. In view C, the discharge in the Colorado River is 28,500 cubic feet per second. The 1984 debris flow has constricted the river significantly, especially in comparison with 1872 conditions.

Photographs B and C are reversed. Photograph on left was taken April 1986; photograph on right was taken September 1968.

Near the Colorado River, the deposits in the center of the channel abruptly change to well-sorted and imbricated boulder bars (fig. 8C) superficially resembling sieve deposits (Hooke, 1967). The debris flow at this point was confined and deposition occurred to an average depth of 5 ft. At locally unconfined sites, the critical thickness of the debris flow was 3 ft. The particle-size distribution (fig. 10D) shows a well-sorted cobble deposit with a median diameter of 32 mm, although poorly sorted matrix was found on the channel margin. We speculate that either recessional or post-event streamflow, dewatering of the deposit after deposition, or positive pore pressures from springs in the channel bed caused the nearly complete removal of the debris-flow matrix from the boulders and its subsequent transport into the Colorado River.

The new debris fan at the Colorado River (fig. 8) was surveyed to estimate the volume of material deposited during the debris flow of 1984. The debris flow entered and partially dammed the Colorado River (Mike Yard, boatman, Humphry's Summit Adventures, Flagstaff, Arizona, oral commun., 1986), which had a mean discharge of about 24,000 ft<sup>3</sup>/s on July 25. Observers noted that the newly formed fan contained significant amounts of matrix immediately after the debris flow, but that the mud was quickly eroded from the fan. Higher discharges on the Colorado River in

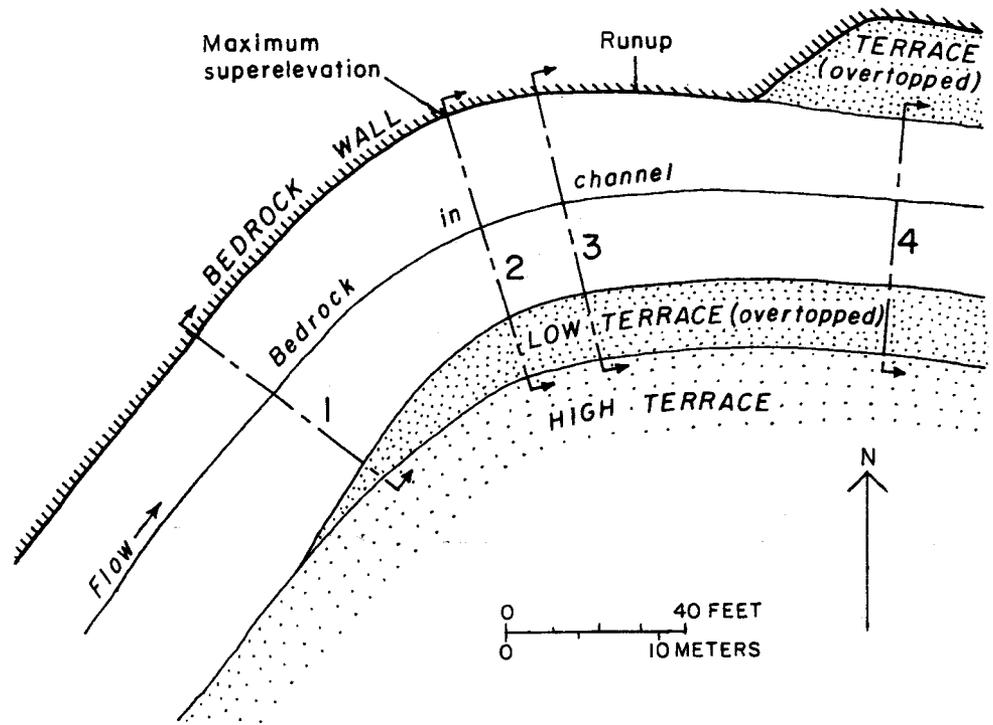
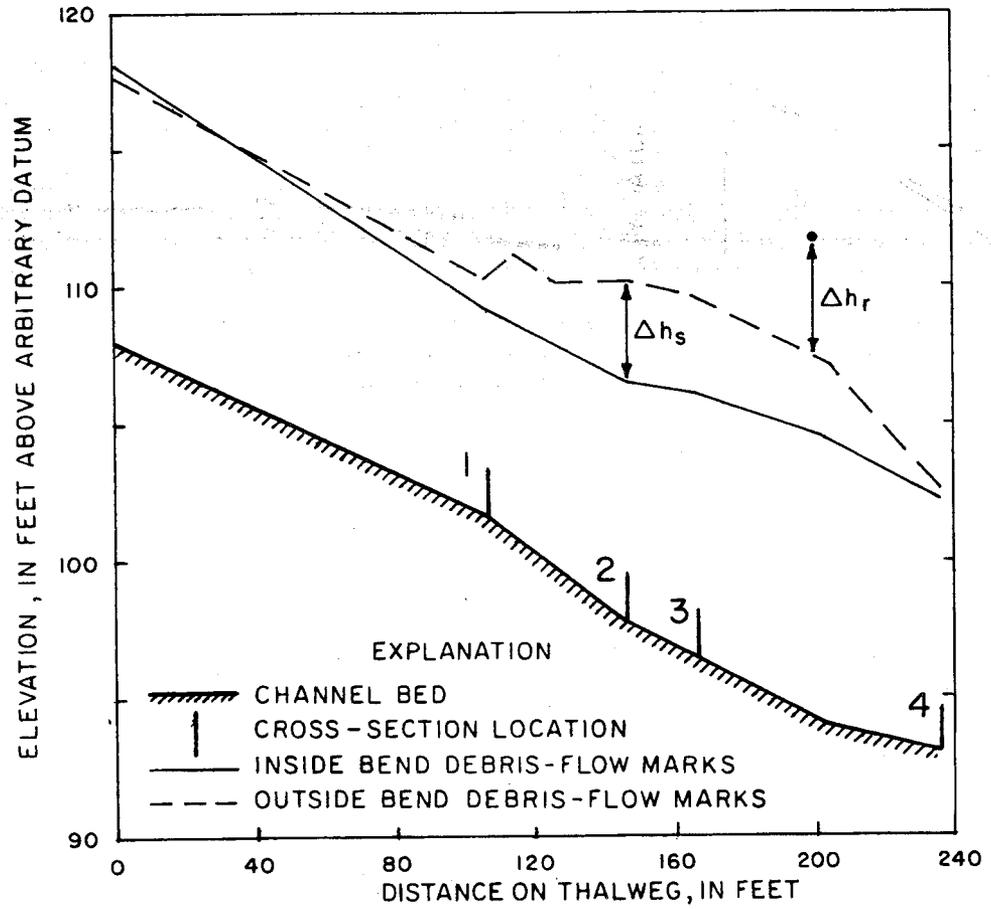
Figure 11.--Plan map and longitudinal profile for indirect-discharge site B in Monument Creek, 0.5 mile upstream from the Colorado River.

At site B (fig. 7), resistant Vishnu Schist forms the bed of the channel. A maximum superelevation of 3.7 ft was measured on this bend (fig. 11), which is 0.5 mi upstream of the Colorado River. A runup elevation of 2.1 ft was measured above the superelevation line. Velocities of 11.0 and 11.5 ft/s were calculated from the superelevation and runup evidence, respectively (table 4). As observed previously, cross sections in the bend had significantly larger areas than upstream and downstream cross sections; hence, the average of the upstream and downstream cross sectional areas (320 ft<sup>2</sup>; table 4) was used. The resulting discharge is between 3,600 and 4,000 ft<sup>3</sup>/s, depending upon whether velocity was calculated from runup or superelevation evidence. The water content of the peak flow, reconstituted from a sample collected near the site, was 27 to 29 percent by volume.

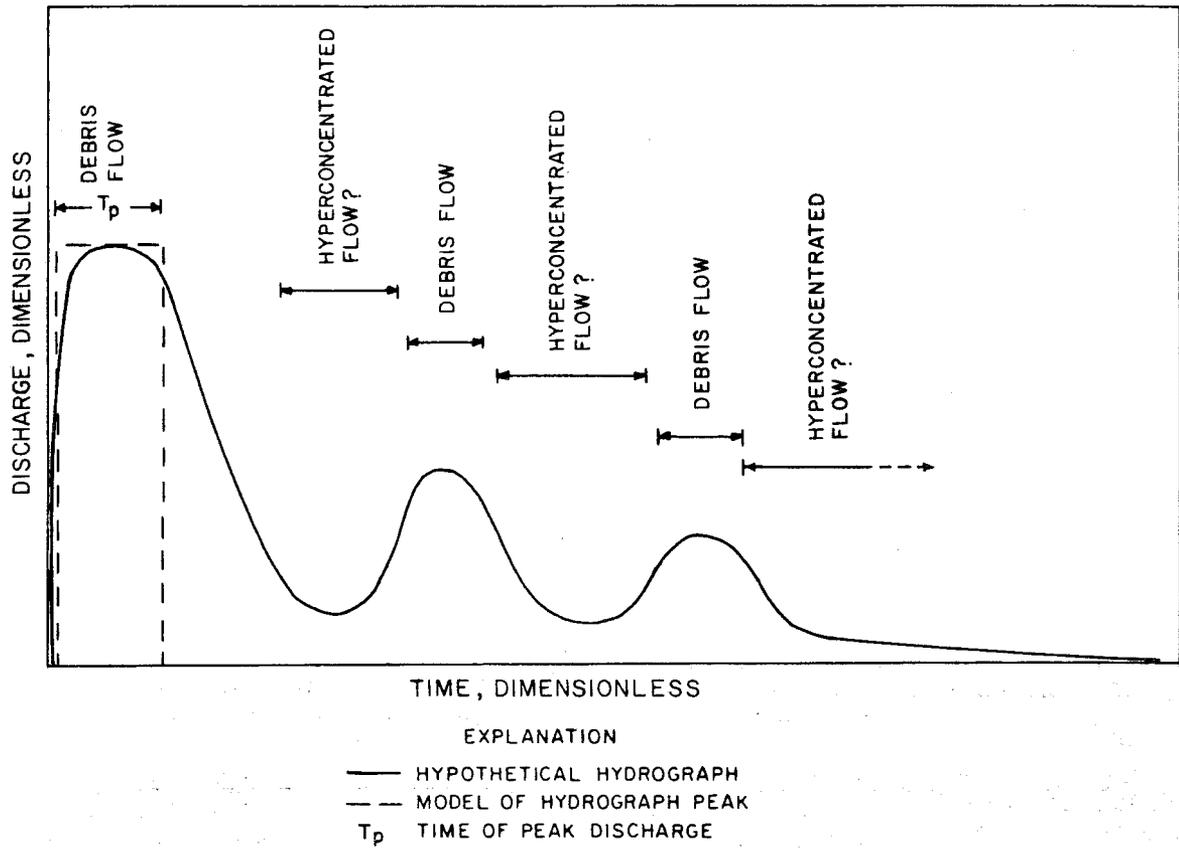
Figure 12.--Hypothetical hydrograph of the debris flow of 1984 in Monument Creek as suggested by stratigraphic evidence.

be modeled as a square wave with the recessional debris flows not reaching the debris fan (fig. 12). The resulting minimum duration times (table 6), which range from 1 to nearly 3 minutes, demonstrate the probable transitory nature of this event.

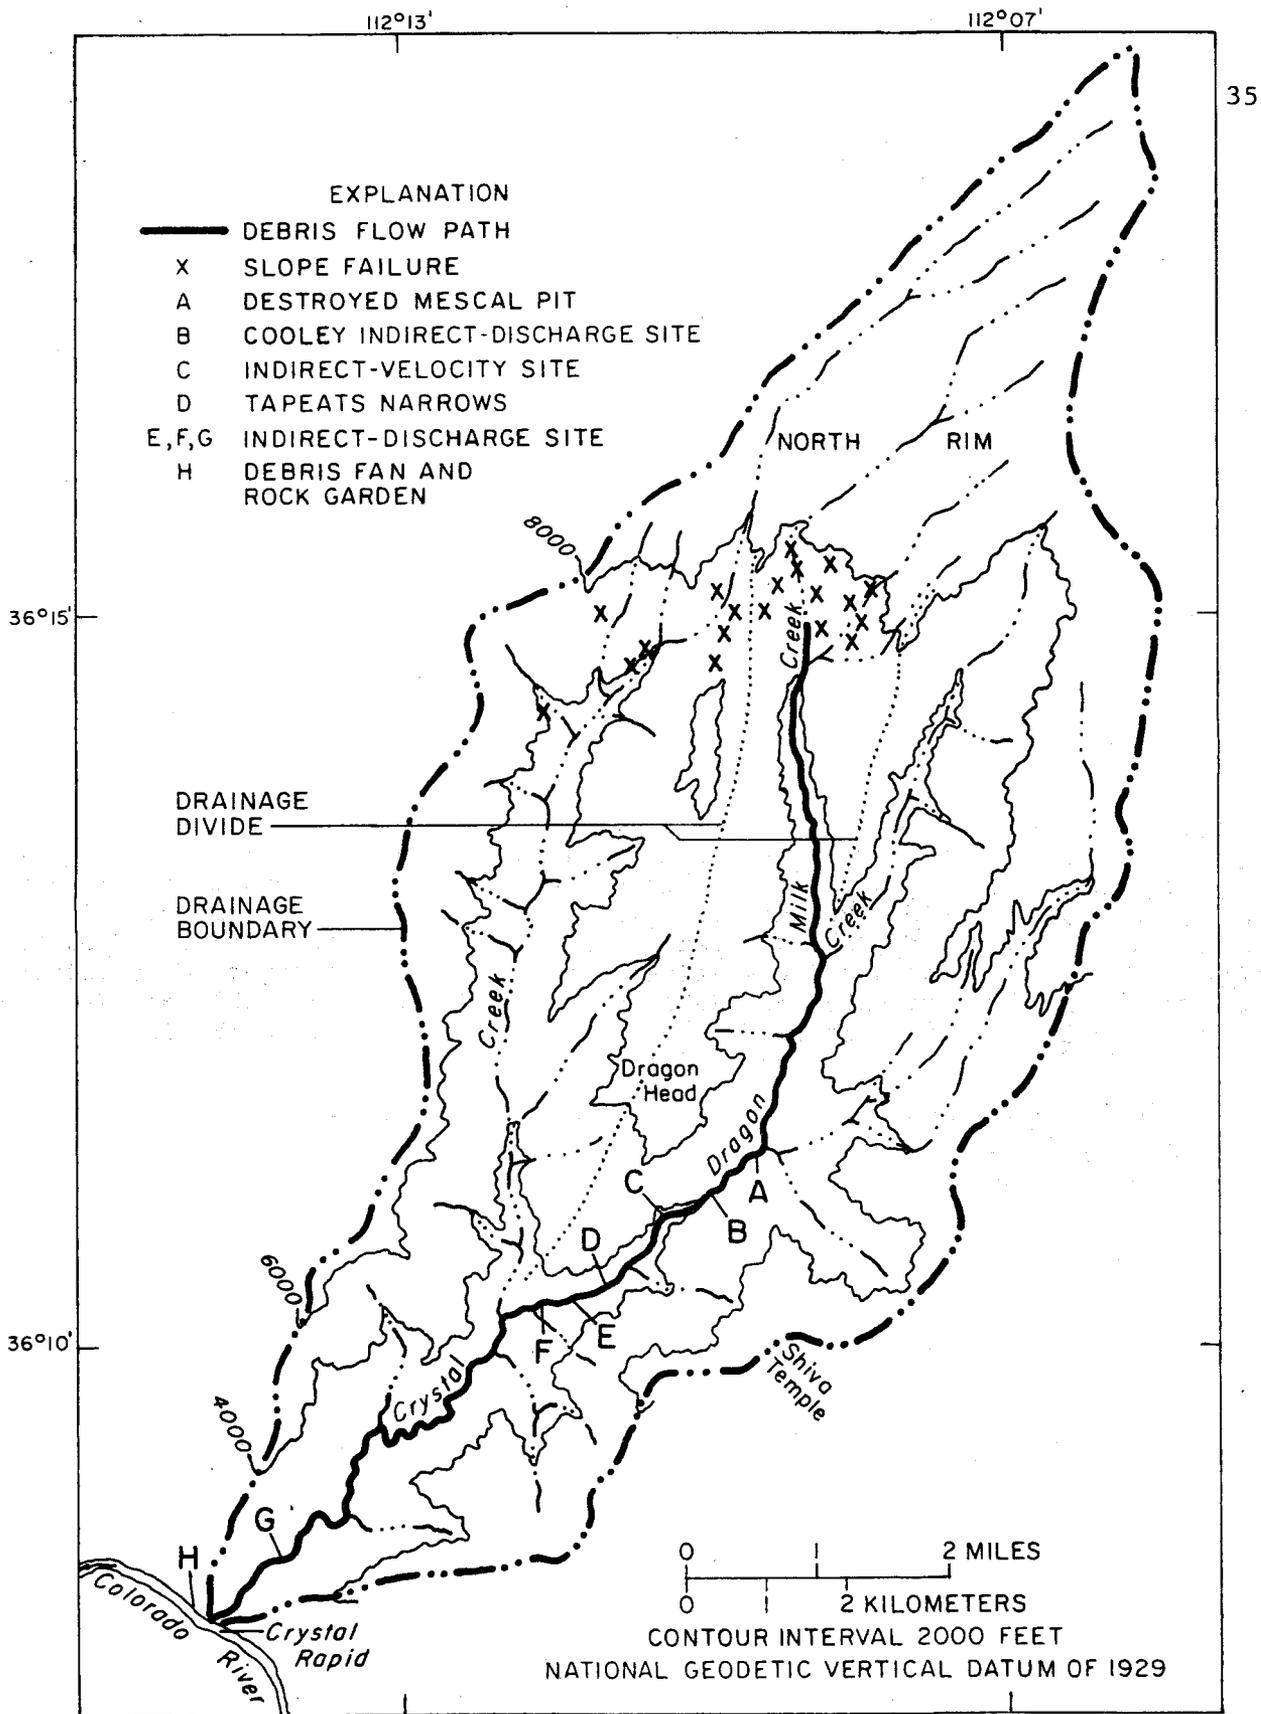
Figure 13.--The Crystal Creek drainage at mile 98.2 on the Colorado River.

The debris flow of 1966 left considerable stage and sedimentologic evidence of its passage in the Crystal Creek drainage. In Tapeats Narrows (site D, fig. 13), mudlines were observed 40 ft above the current channel. The red color of debris-flow matrix contrasted greatly with the brown soils on terraces and hillslopes. The damaged mesal pit (site A, fig. 13) was buried under 0.1 to 0.6 ft of red matrix deposit. The site, on the outside of a slight river bend, was inundated by the superelevated debris flow, but erosion was slight. Downstream, terraces of approximately the same height were not inundated.

Debris-flow deposits and mudlines have been preserved along the 4.5 mi of Crystal Creek below its confluence with Dragon Creek (fig. 13). The flow from Dragon Creek blocked Crystal Creek at the confluence with a 13-ft-high boulder deposit. Debris-flow deposits from Dragon Creek were found 300 ft upstream along Crystal Creek. Downstream, the debris flow entered a steep bedrock canyon in the Vishnu Schist and left mudlines as much as 20 ft above the current channel bed. Evidence for recessional debris flows after the main peak was preserved in the 2.5-mi-long reach upstream of the Colorado River. The heights of the recessional debris-flow deposits, which create a sawtooth appearance on the floodplain, are

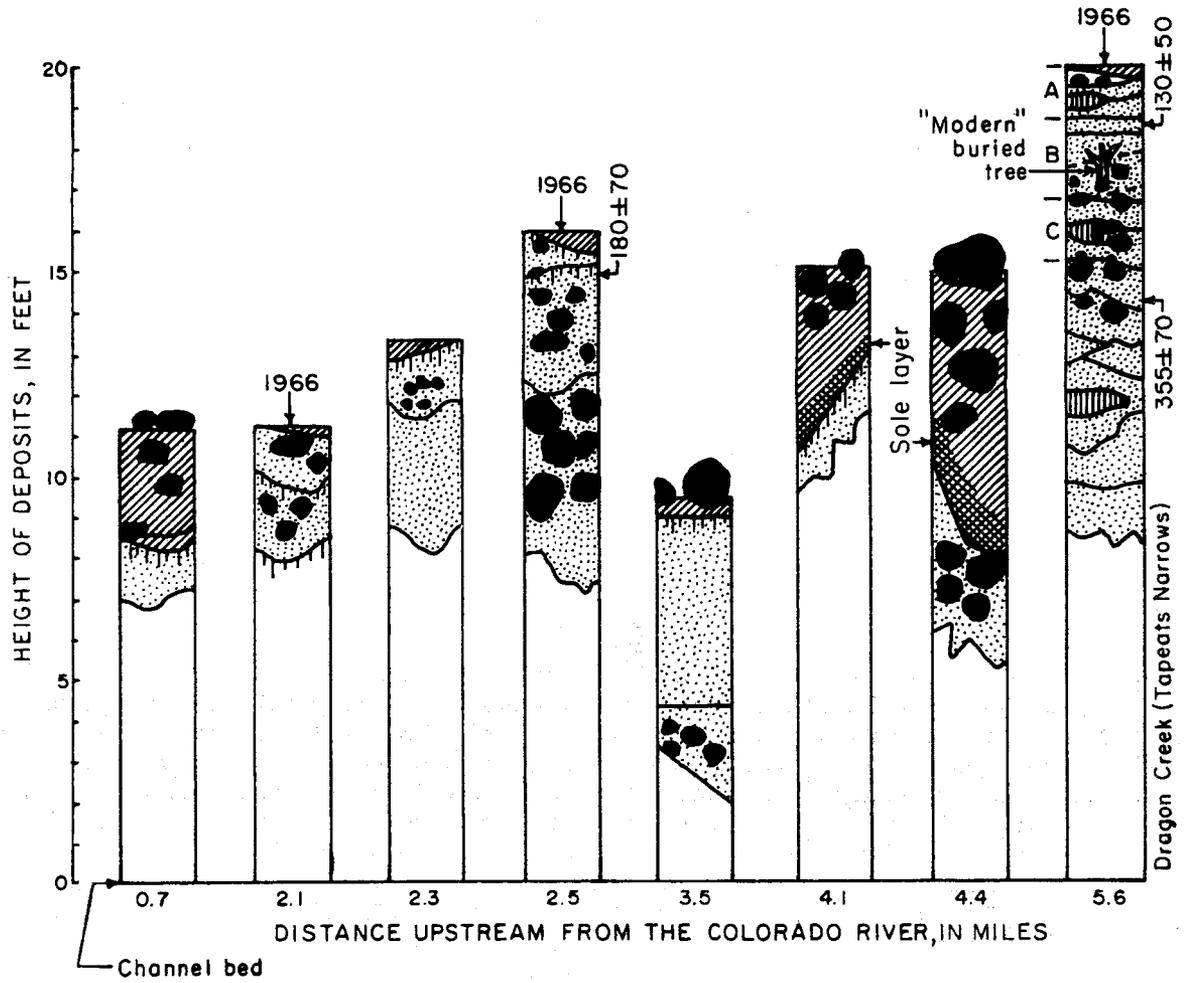
Figure 14.--Stratigraphy of debris-flow deposits in the Crystal Creek drainage.

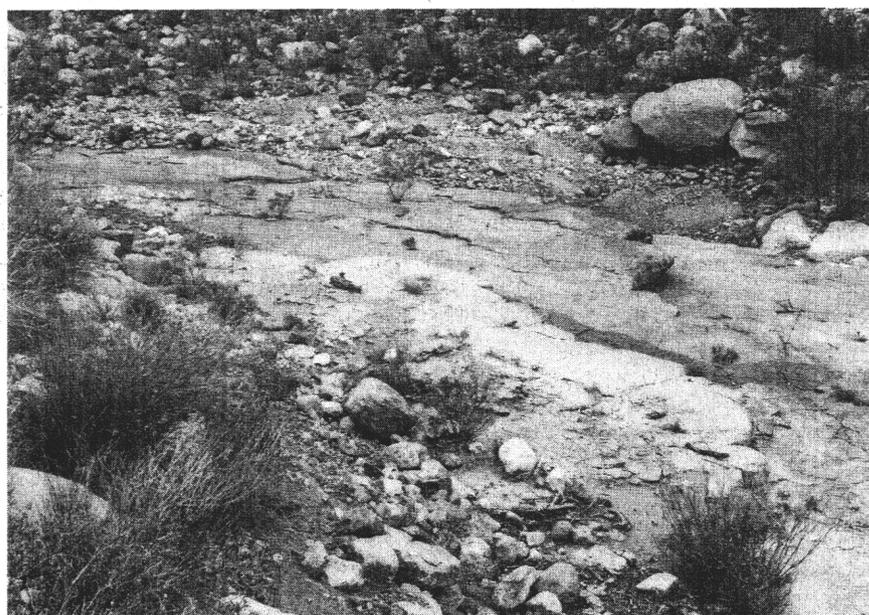
Figure 15.--Dragon Creek, 6.2 miles upstream from the Colorado River. The piece of driftwood at the left center of view B is not the same piece as in view A. Note in view B that the large rocks at the upper left and right have been moved downstream and the bank has collapsed in the foreground. Flow in the channel moves right to left.

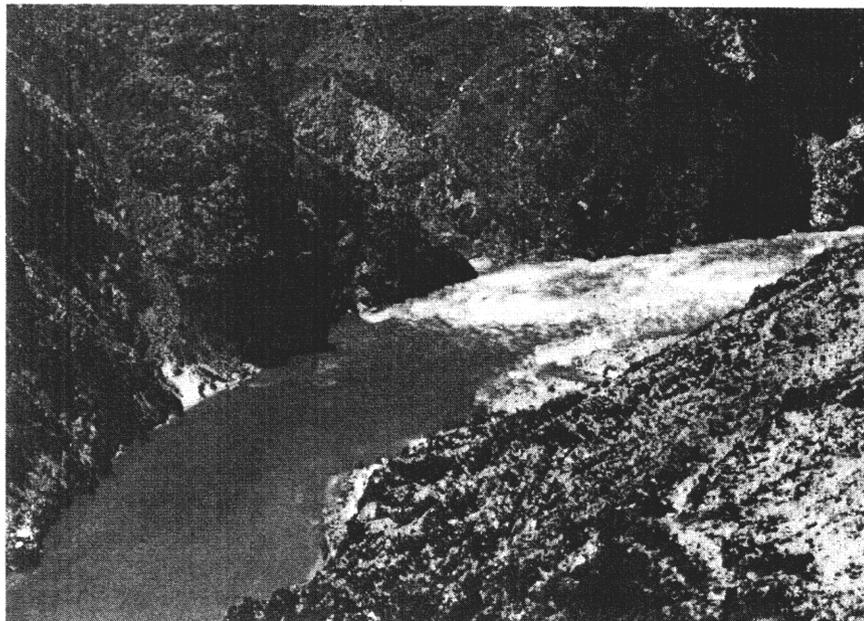
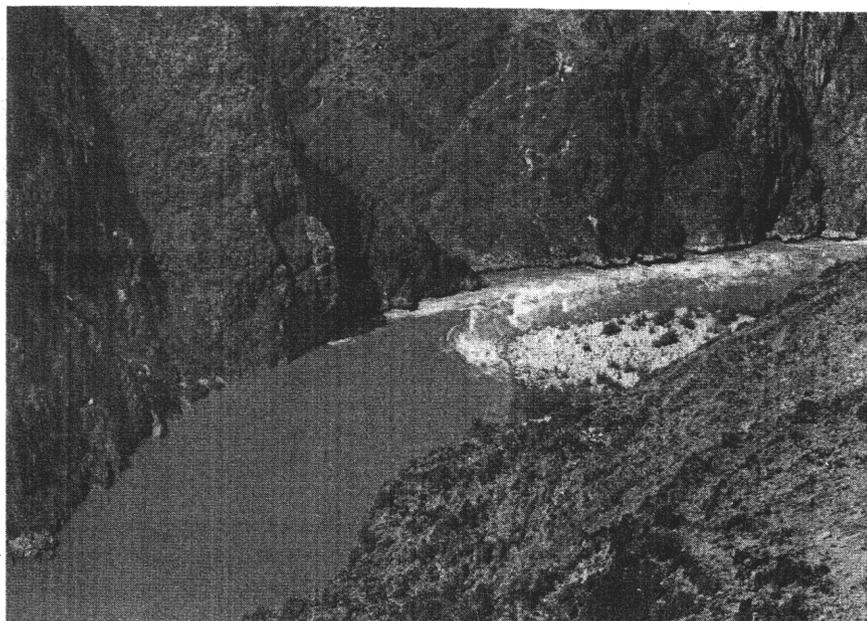
Figure 17.--Crystal Rapid at the mouth of Crystal Creek. The poor visual quality of view A results from deterioration of the original color slide. Note the small debris fan and smooth tongue of water entering the rapid at the right center of the river. The discharge of the Colorado River is 16,000 cubic feet per second. In view B, the tongue of the rapid has been forced to the left as a result of the debris fan deposited during the debris flow of 1966. The discharge of the Colorado River is 28,500 cubic feet per second.

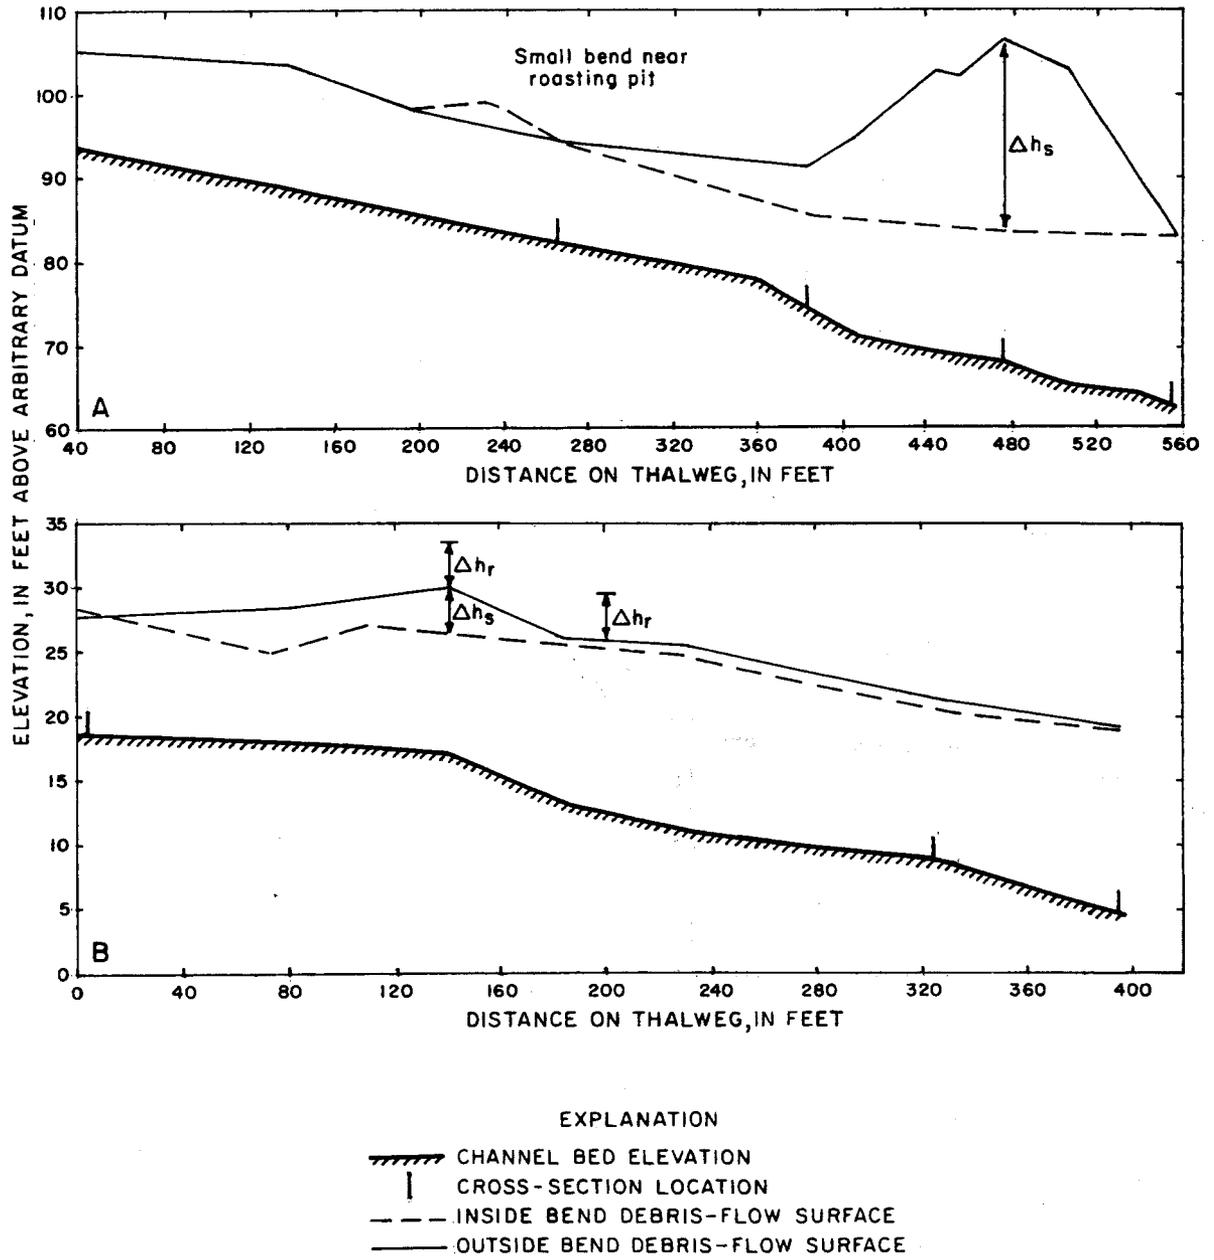
Figure 18.--Longitudinal profiles for indirect-discharge sites in the Crystal Creek drainage. A, Site G, 4.8 miles upstream from the Colorado River. B, Site I, 0.9 mile upstream from the Colorado River.

At site G, 0.9 mi upstream from the Colorado River, super-elevation and runup marks were preserved on the walls of Vishnu Schist and in cacti. Super-elevation evidence (fig. 18B) was used to calculate a mean velocity of 10.3 ft/s (table 9). However, mean velocities calculated from runup evidence at two points (fig. 18B) were 15.0 and 15.4 ft/s. As noted at all other super-elevation sites, the area of cross sections measured near super-elevation marks were significantly larger than the areas of cross sections upstream and downstream from the marks (table 9). We estimated a discharge of between 9,200 and 13,500 ft<sup>3</sup>/s for the debris flow on the basis of the range in velocities and cross-sectional areas. The water

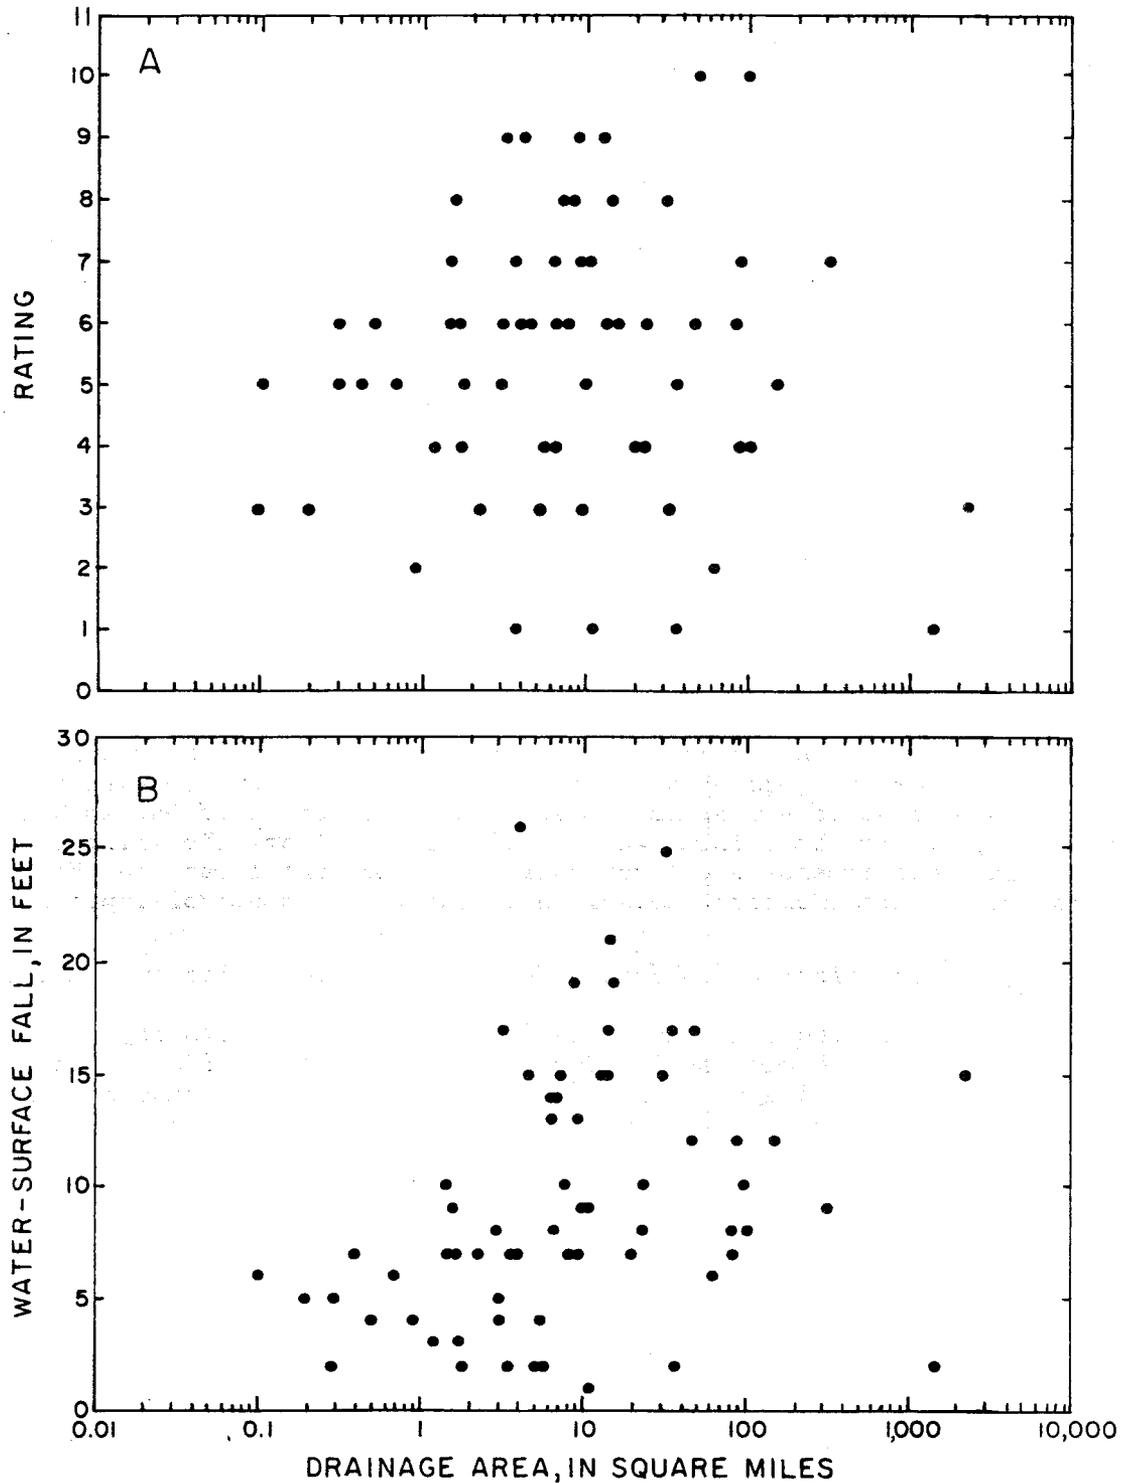
Figure 19.--Relation of characteristics of rapids and the contributing drainage area of the tributaries. *A*, Using the "rapid rating" (scale of 1 to 10; Stevens, 1983) for a discharge of 10,000 cubic feet per second in the Colorado River. *B*, Using the water-surface fall surveyed in 1921 and adjusted to 10,000 cubic feet per second. This fall may have significantly changed as a result of historic debris flows, especially at Crystal Rapid.

Drainage areas of contributing tributaries do not explain either water-surface fall or navigational difficulty of rapids on the Colorado River (fig. 19). Local channel factors also cannot explain these variables because rapids with similar navigational difficulties have different water-surface falls and constriction ratios (S. W. Kieffer, U.S. Geological Survey, written commun., 1986). Local channel conditions such as bedrock spurs and confining wall geometry may exacerbate a rapid. We attribute the noncorrelation of drainage area and rapid difficulty to the overwhelming control of rapid difficulty by local factors in each contributing drainage, particularly the size of debris-flow-transported boulders, the history of debris flows, and local channel conditions.

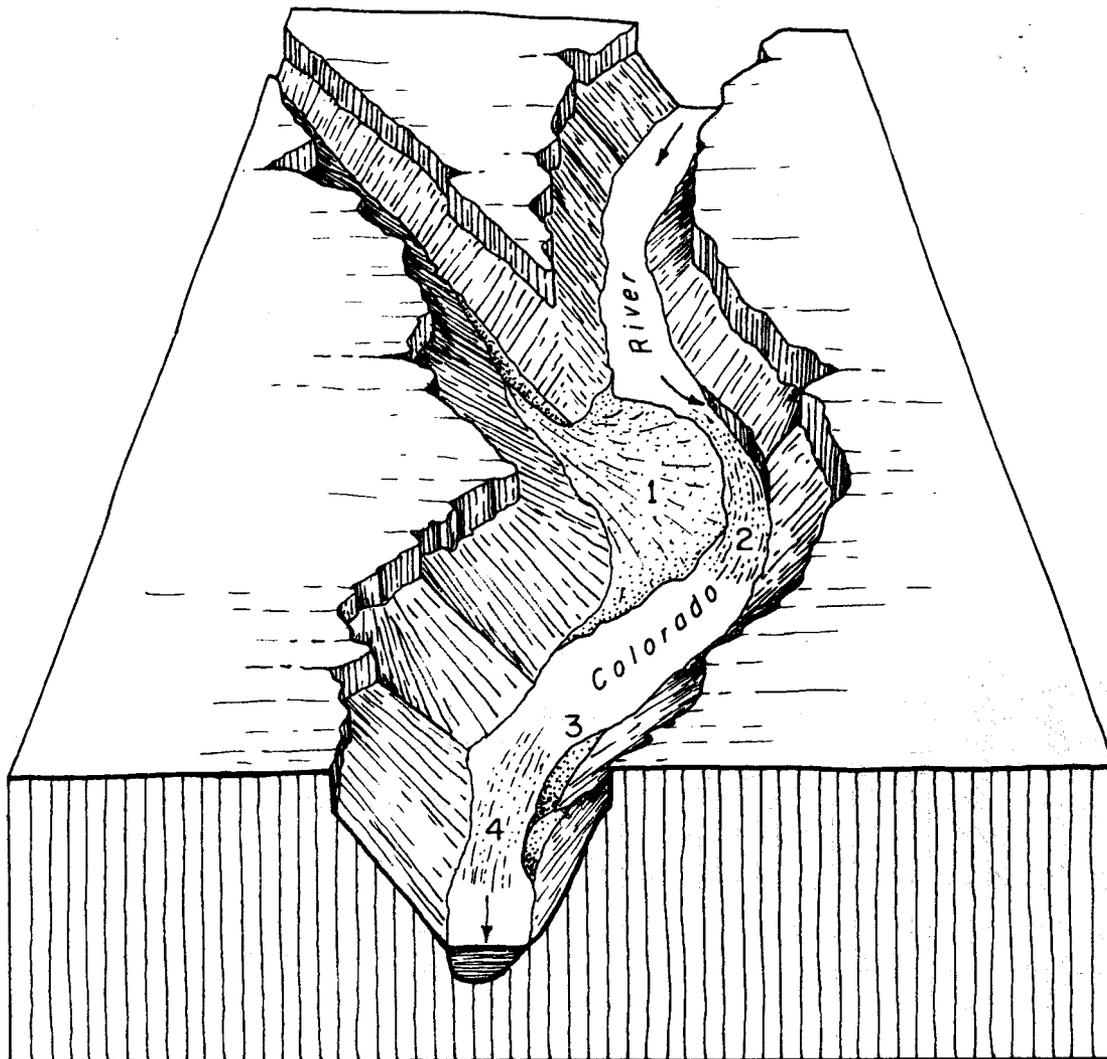
- 1 TRIBUTARY DEBRIS FAN
- 2 RAPID CONTROLLED BY LARGE IMMOBILE BOULDERS
- 3 DEBRIS BAR (synonymous with "island" or "rock garden")
- 4 RIFFLE OR RAPID CAUSED BY DEBRIS BAR

Control of local channel hydraulics extends beyond the rapid and debris-fan system. Prominent debris bars, referred to as islands or rock gardens, are formed downstream from the rapid by reworking of the debris fans after a debris flow. Commonly on the opposite side of the river from the tributary, these bars generally are composed of well-sorted, imbricated cobbles and boulders mixed with sand. At Crystal Creek, the rock garden greatly enlarged after the debris flow of 1966 and contains boulders that are unusually large for a debris bar. At Monument Creek, the island enlarged slightly after the 1984 debris flow. An island in the Colorado River at mile 66 (Stevens, 1983) appears to be maintained by periodic debris flows from the Lava-Chuar Creek drainage and Palisades Creek. Debris bars, particularly in the form of islands, provide a control on the longitudinal extent of eddy systems. Large debris bars induce secondary
